# **Shoreline Surveys of Oil-Impacted Marsh in Southern Louisiana, July to August 2010**

**Open-File Report 2011–1022**

**U.S. Department of the Interior  
U.S. Geological Survey**

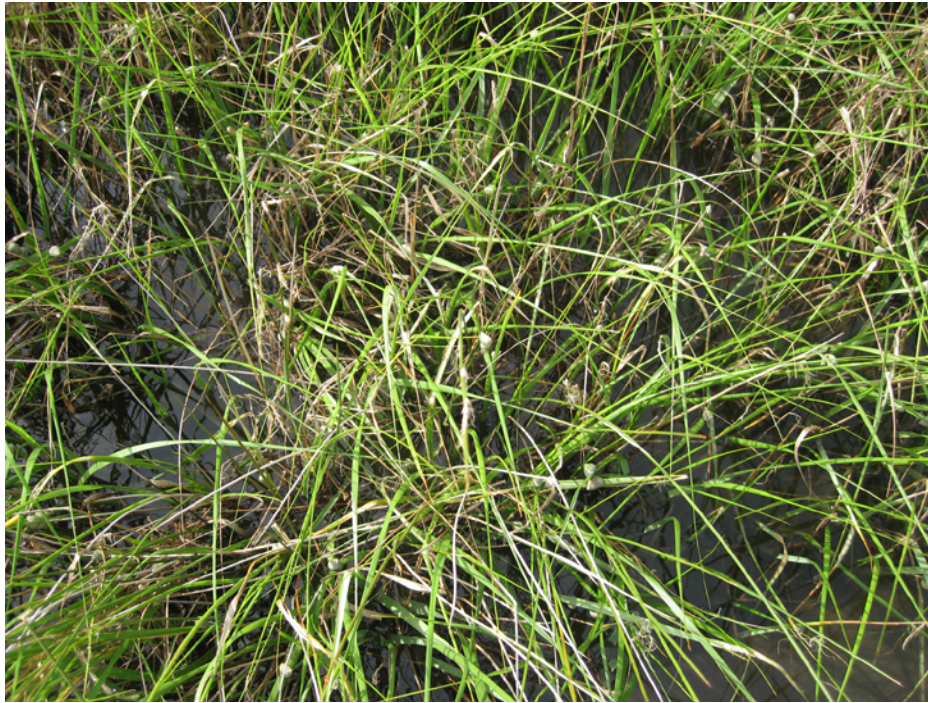
Figure 4. DWO-2-BAT-01 photo 1 taken on July 7, 2010. Site vegetation included *Spartina patens* and *Juncus roemerianus*. Oil was not observed at this site.

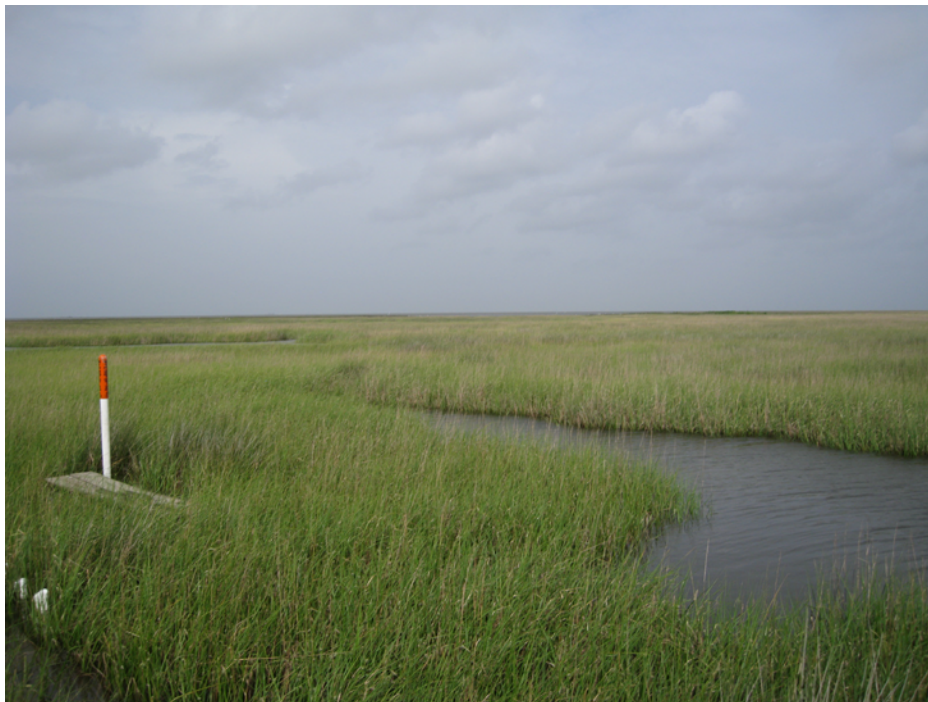
Figure 5. DWO-2-BAT-01 photo 2 taken on July 7, 2010. Site vegetation included *Spartina patens* and *Juncus roemerianus*. Oil was not observed at this site.

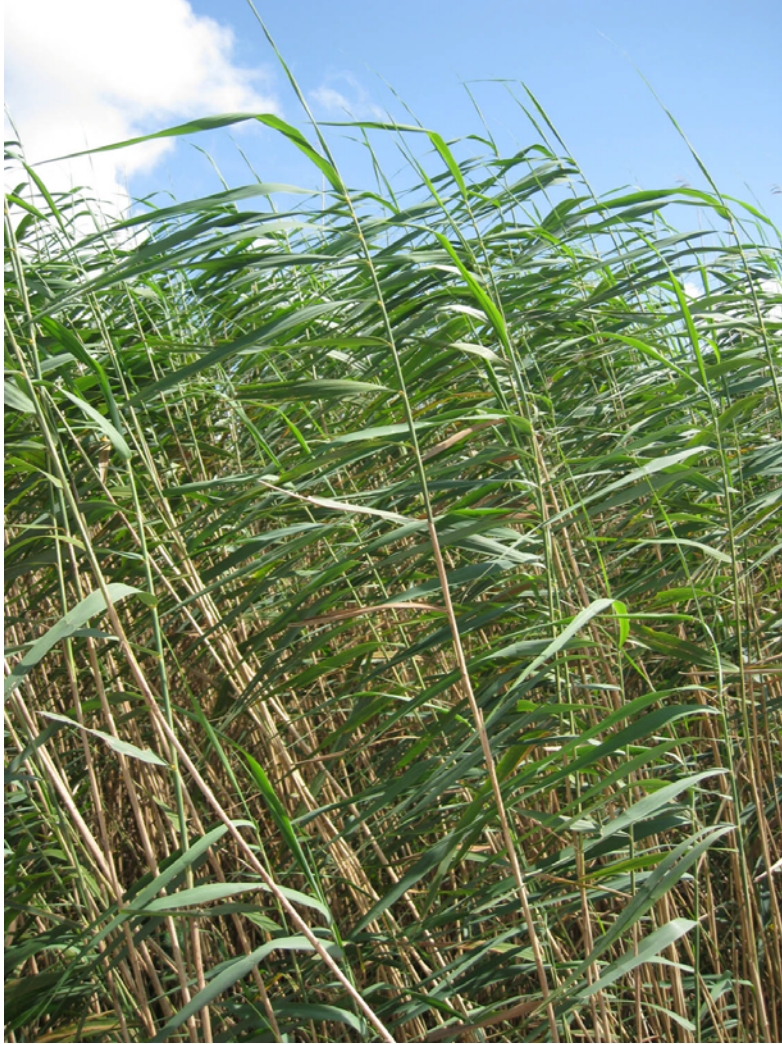
Figure 7. DWO-2-DEL-02 photo 2 taken on July 8, 2010. Site vegetation included *Phragmites australis*.

Oil was not observed at this site.

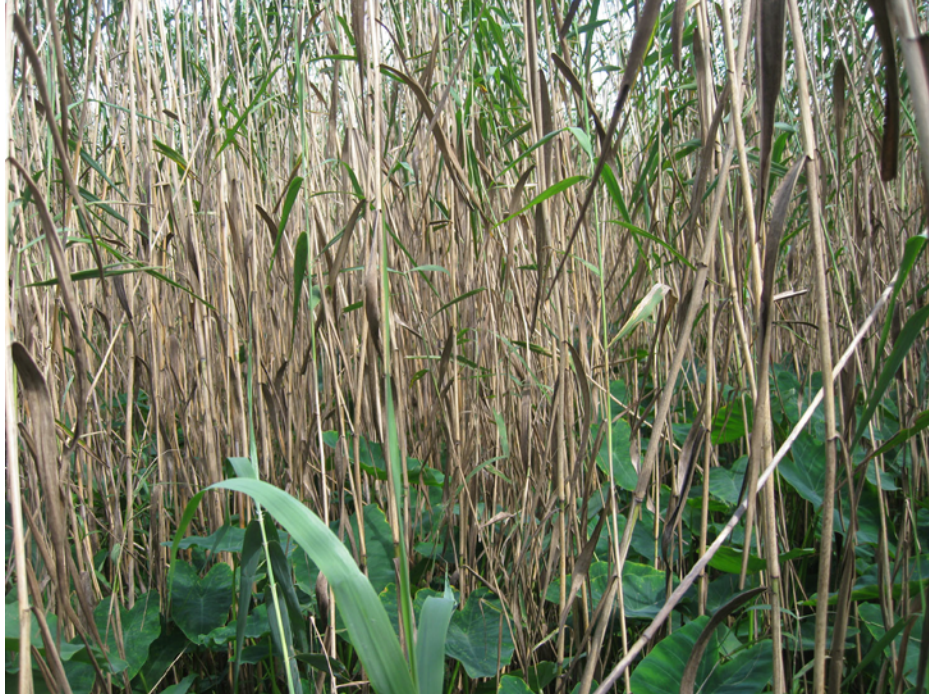
Figure 8. DWO-2-DEL-02 photo 3 taken on July 8, 2010. Site vegetation included *Phragmites australis*.

Oil was not observed at this site.

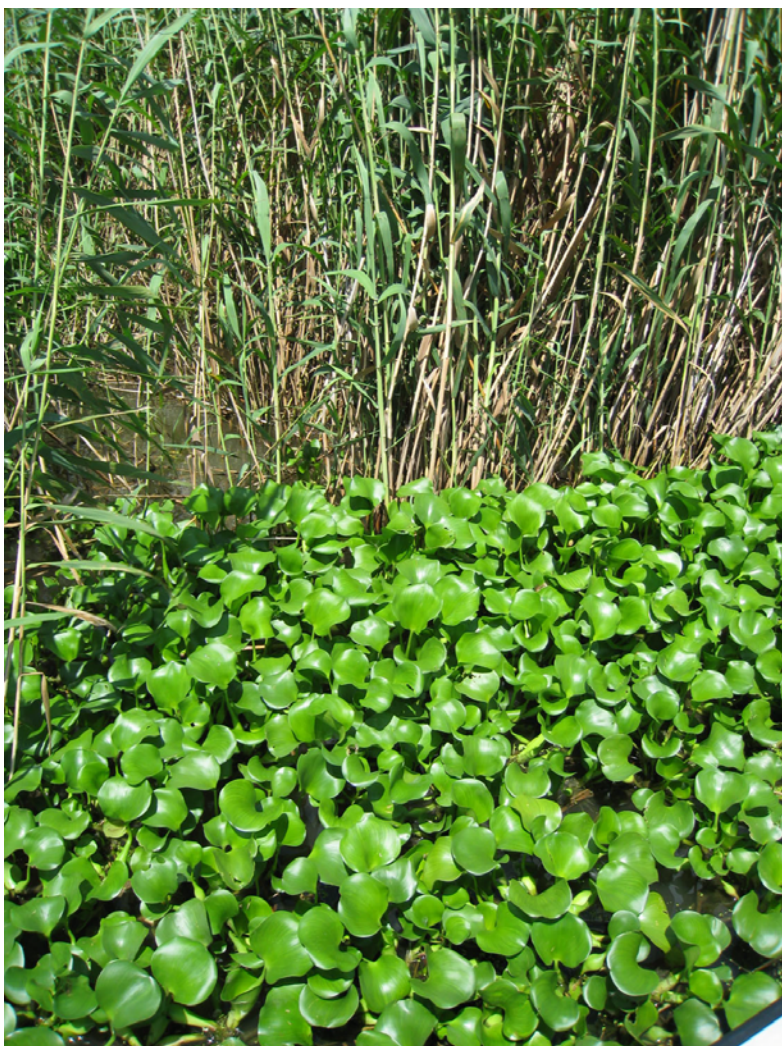
Figure 10. DWO-2-DEL-03 photo 2 taken on July 8, 2010. Site vegetation included *Phragmites australis* and *Eicchornia crassipes*. Oil was not observed at this site.

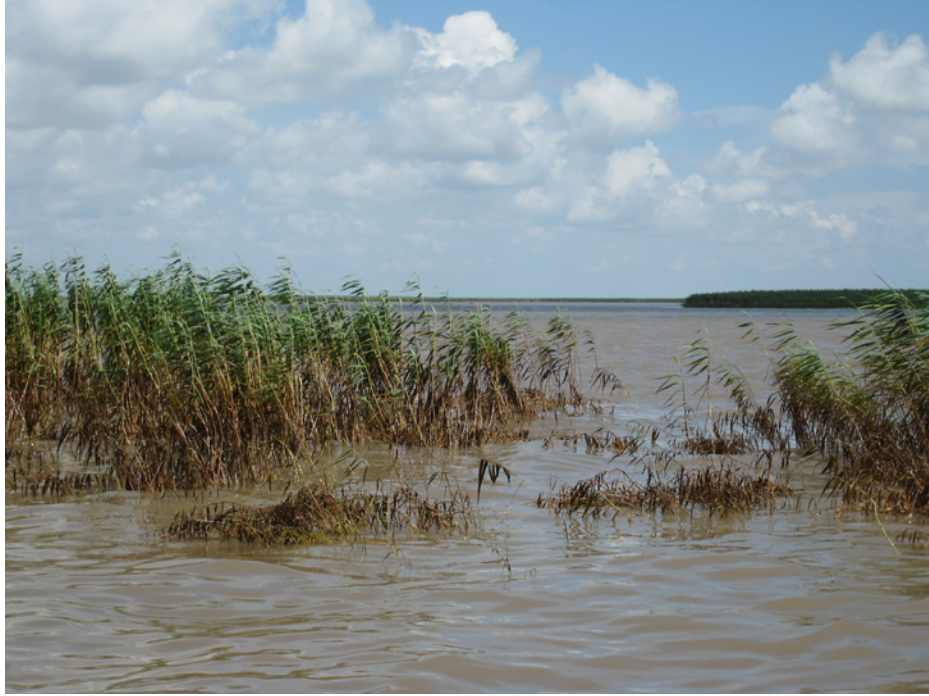
Figure 11. DWO-2-DEL-04 photo 1 taken on July 8, 2010. Site vegetation included *Phragmites australis*. Oiled vegetation was observed at this site, including oil-damaged canopy.

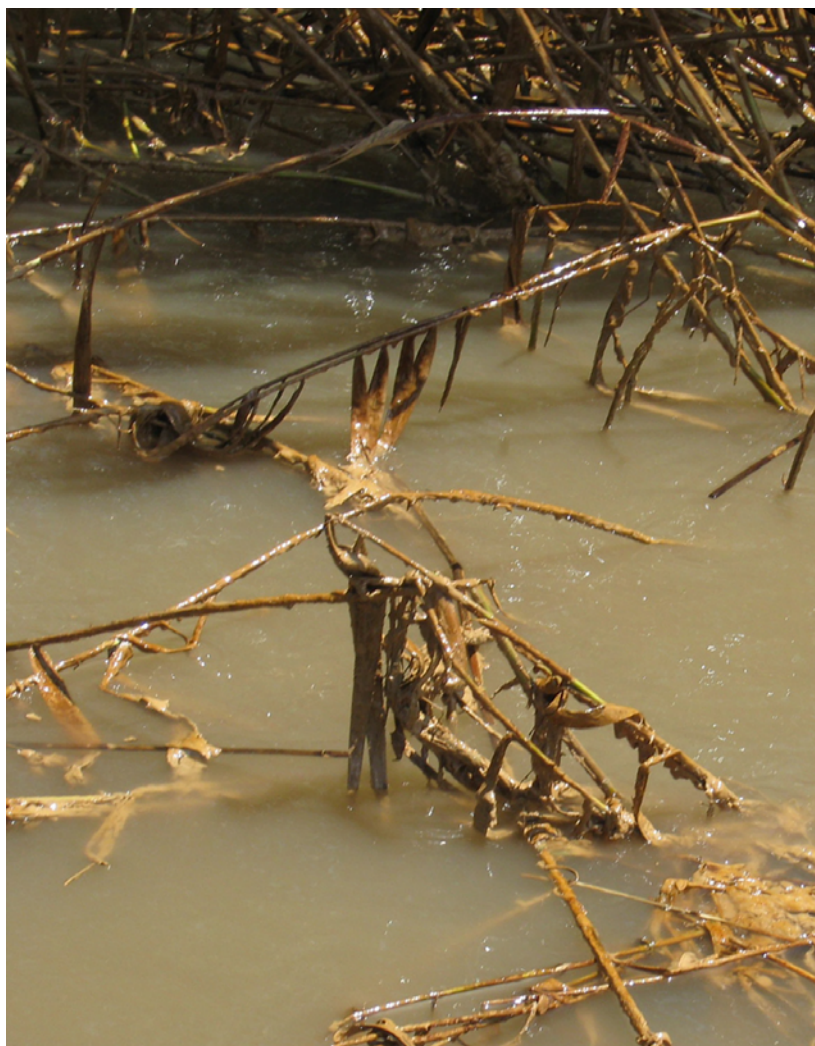
Figure 12 DWO-2-DEL-04 photo 2 taken on July 8, 2010. Site vegetation included *Phragmites australis*. Oiled vegetation was observed at this site, including oil-damaged canopy.

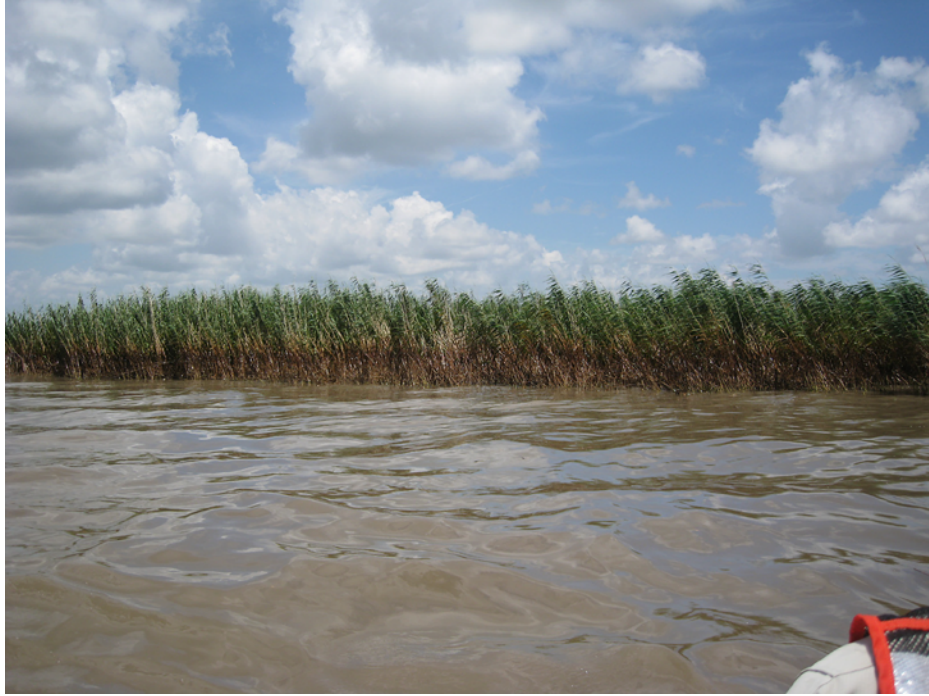
Figure 13. DWO-2-DEL-05 photo 1 taken on July 8, 2010. Site vegetation included *Phragmites australis*. Oiled vegetation was observed at this site, including oil-damaged canopy.

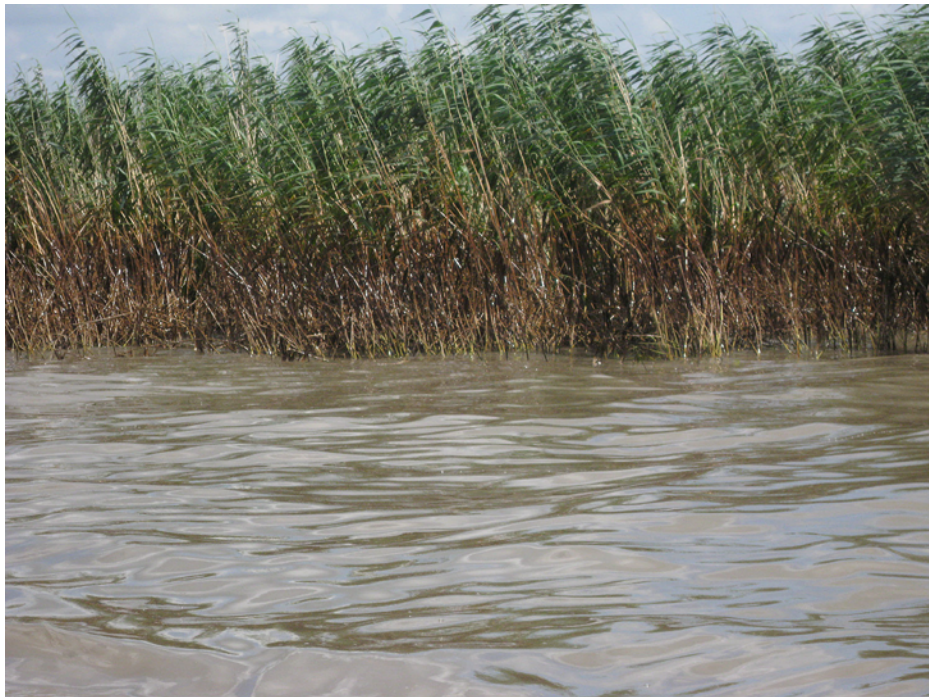
Figure 14. DWO-2-DEL-05 photo 2 taken on July 8, 2010. Site vegetation included *Phragmites australis*. Oiled vegetation was observed at this site, including oil-damaged canopy.

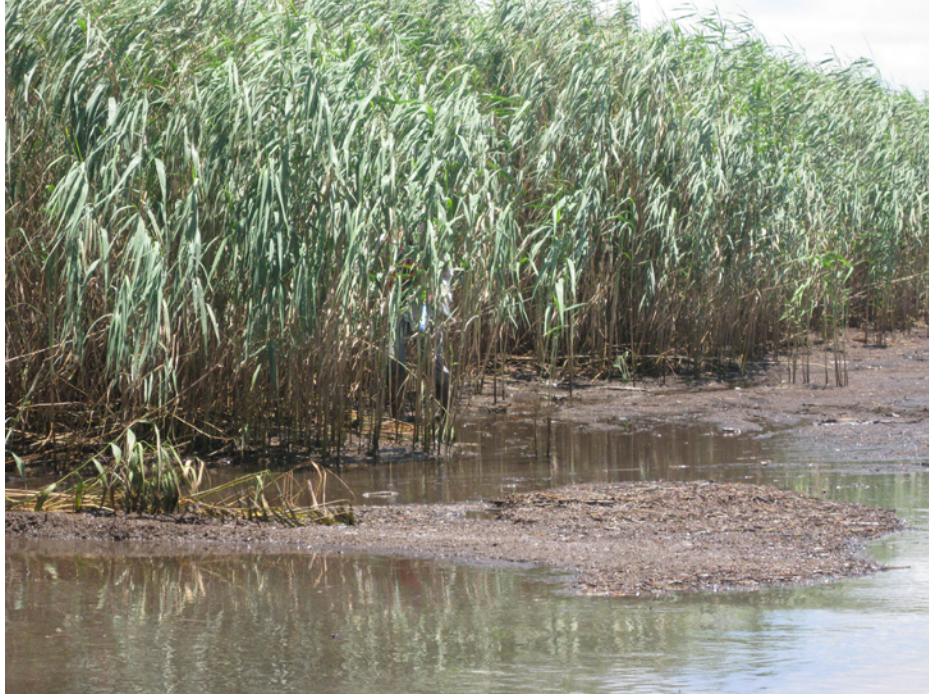
Figure 15. DWO-2-DEL-06 photo 1 taken on July 8, 2010. Site vegetation included *Phragmites australis*. Oil was not observed at this site.

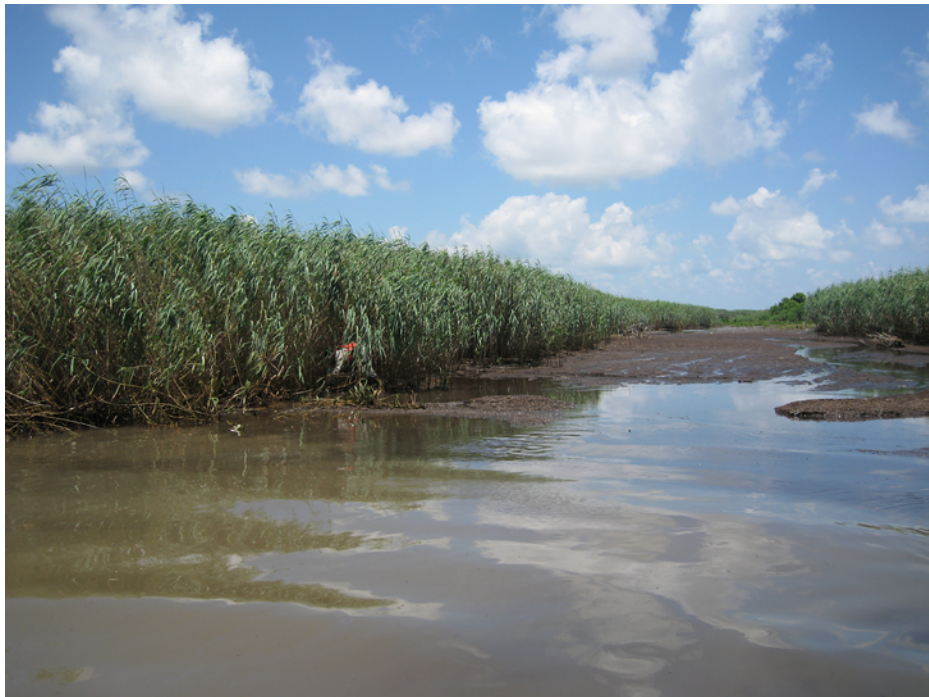
Figure 16. DWO-2-DEL-06 photo 2 taken on July 8, 2010. Site vegetation included *Phragmites australis*. Oil was not observed at this site.

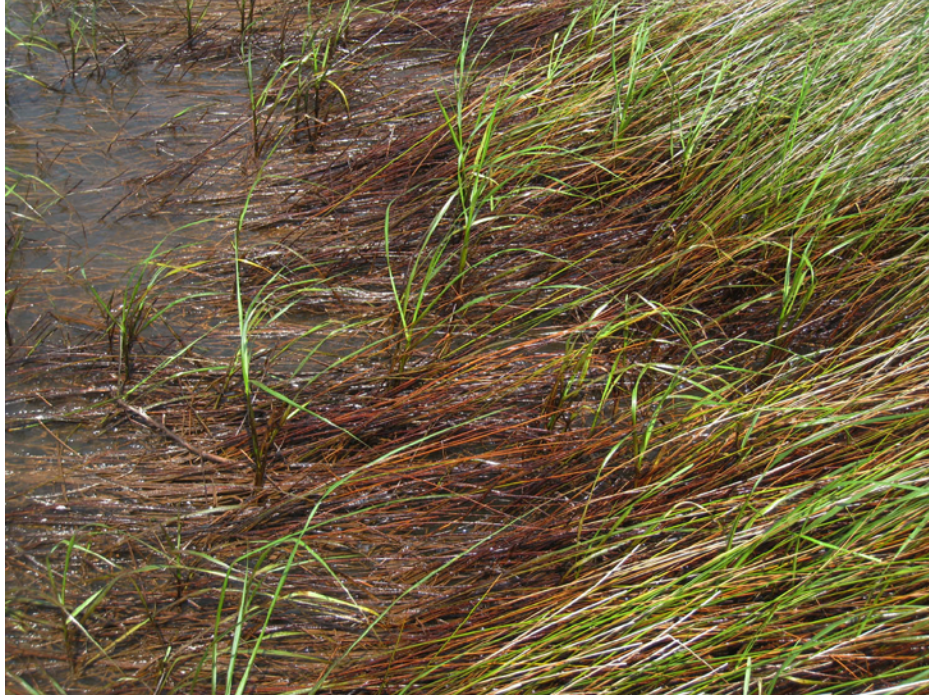
Figure 17. DWO-2-BAT-08 photo 1 taken on July 10, 2010. Site vegetation included *Juncus roemerianus* and *Spartina alterniflora*. Oiled vegetation was observed at this site, including oil-damaged canopy.

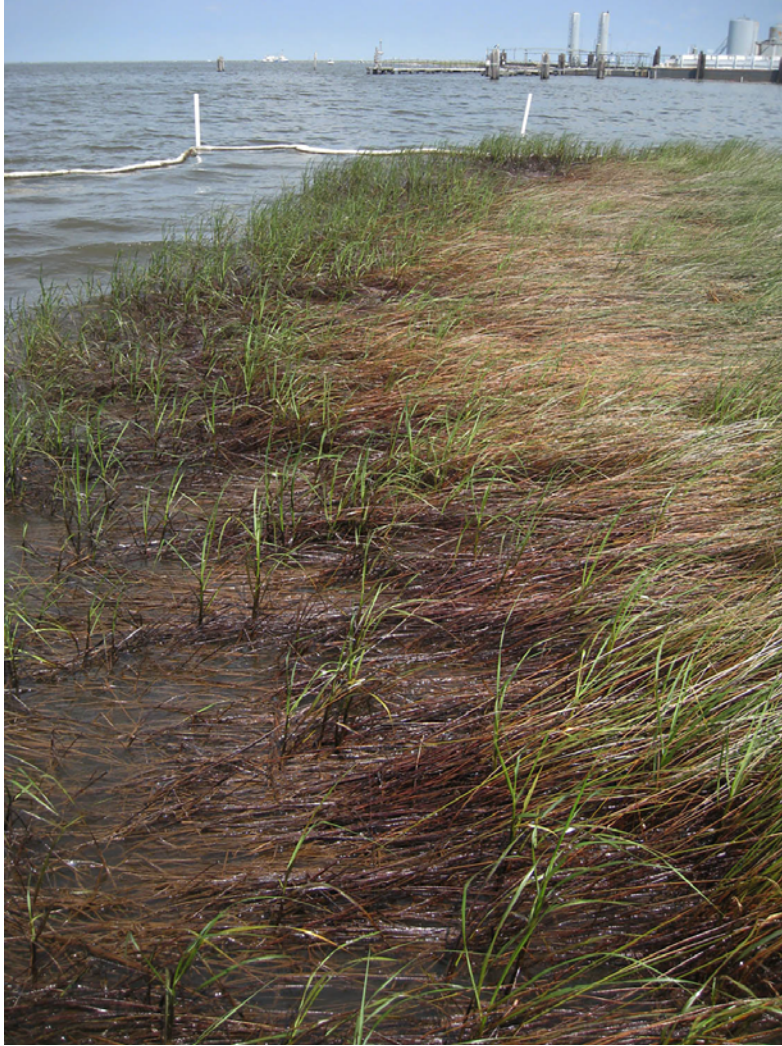
Figure 18. DWO-2-BAT-08 photo 2 taken on July 10, 2010. Site vegetation included *Juncus roemerianus* and *Spartina alterniflora*. Oiled vegetation was observed at this site, including oil-damaged canopy.

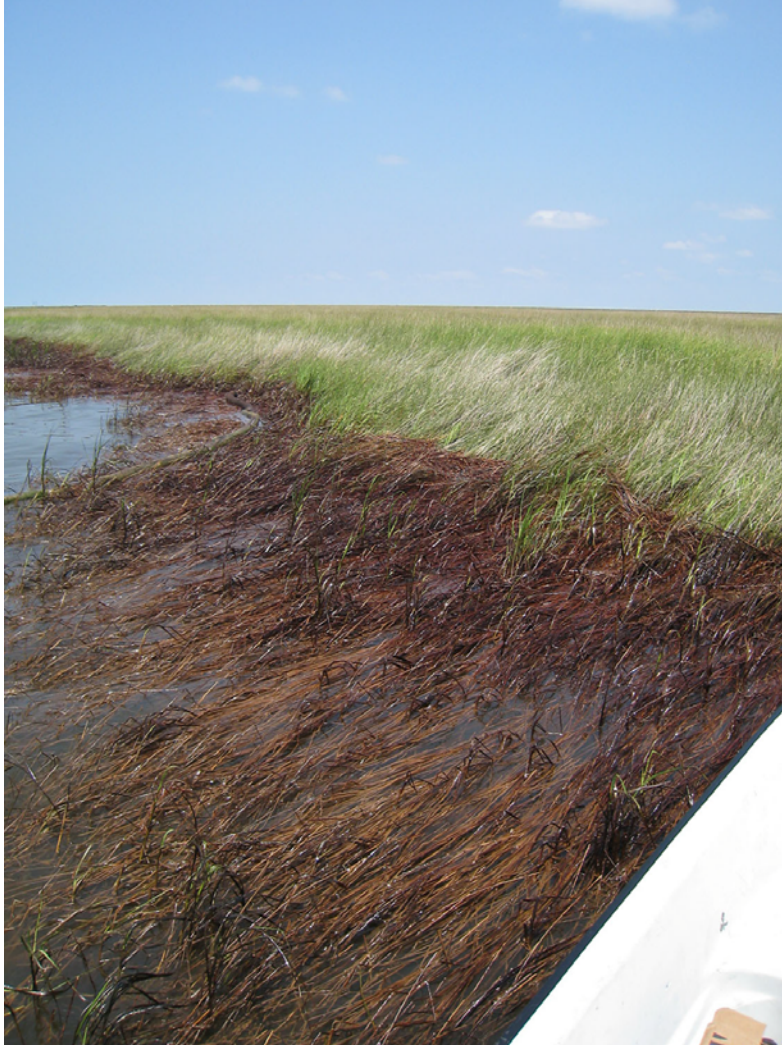
Figure 19. DWO-2-BAT-09 photo 1 taken on July 10, 2010. Site vegetation included *Spartina alterniflora* and *Juncus roemerianus*. Oiled vegetation was observed at this site, including oil-damaged canopy.

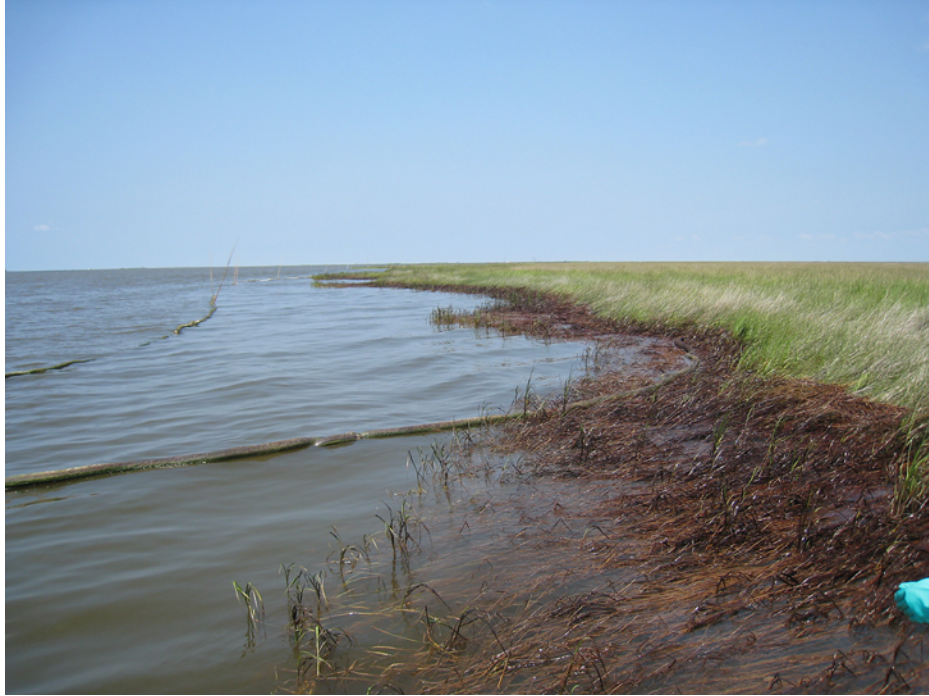
Figure 20. DWO-2-BAT-09 photo 2 taken on July 10, 2010. Site vegetation included *Spartina alterniflora* and *Juncus roemerianus*. Oiled vegetation was observed at this site, including oil-damaged canopy.

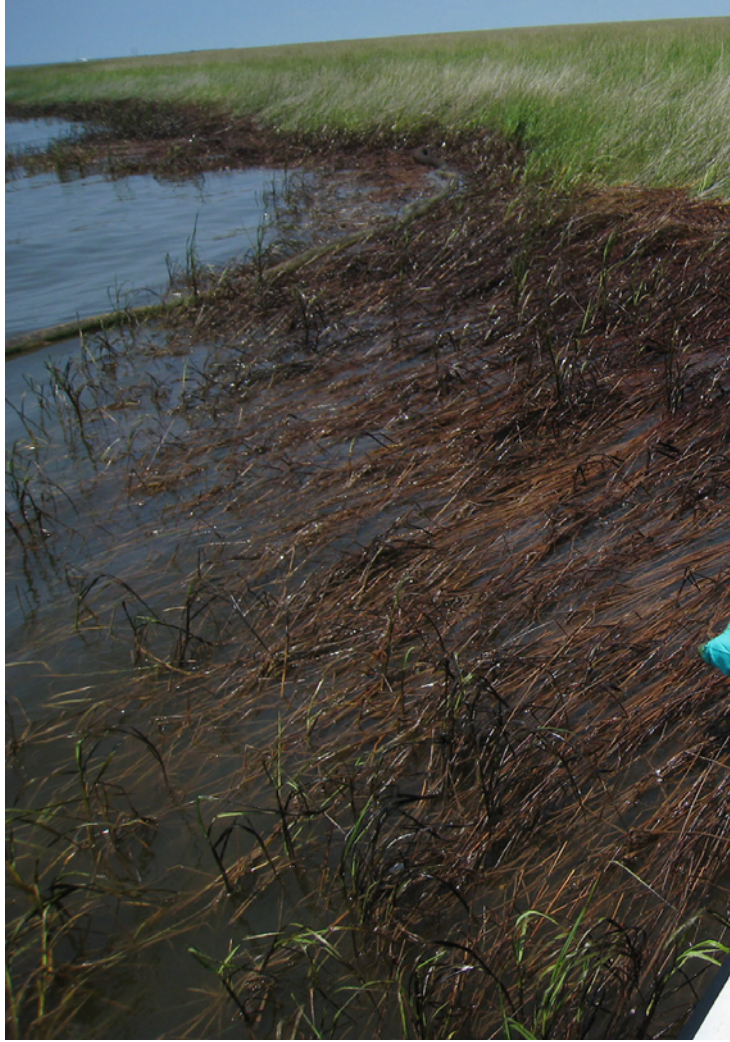
Figure 21. DWO-2-BAT-09 photo 3 taken on July 10, 2010. Site vegetation included *Spartina alterniflora* and *Juncus roemerianus*. Oiled vegetation was observed at this site, including oil-damaged canopy.

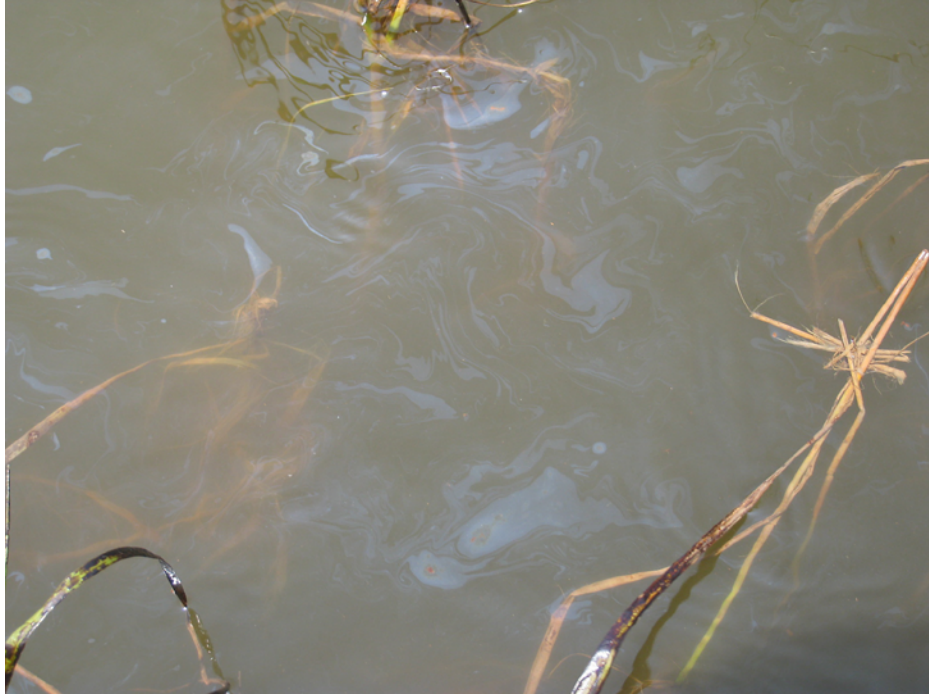
Figure 22 DWO-2-BAT-09 photo 4 taken on July 10, 2010. Site vegetation included *Spartina alterniflora* and *Juncus roemerianus*. Oiled vegetation was observed at this site, including oil-damaged canopy.

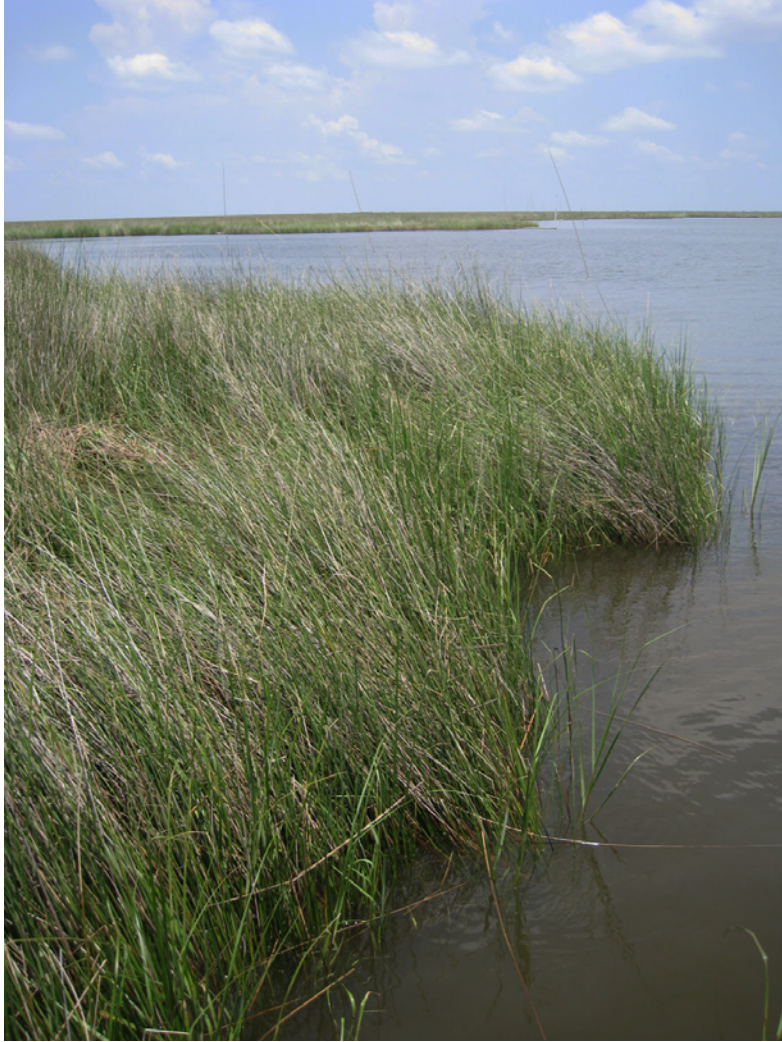
Figure 23. DWO-2-BAT-10 photo 1 taken on July 10, 2010. Site vegetation included *Juncus roemerianus* and *Spartina alterniflora*. Oil was not observed at this site.

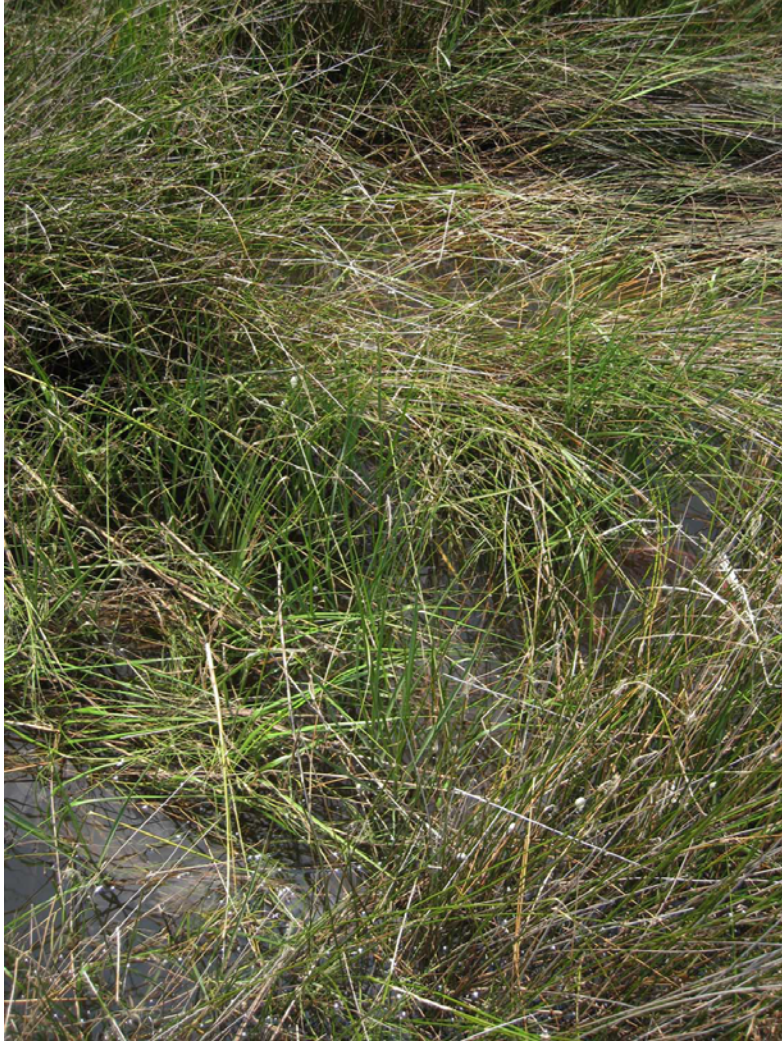
Figure 24. DWO-2-BAT-10 photo 2 taken on July 10, 2010. Site vegetation included *Juncus roemerianus* and *Spartina alterniflora*. Oil was not observed at this site.

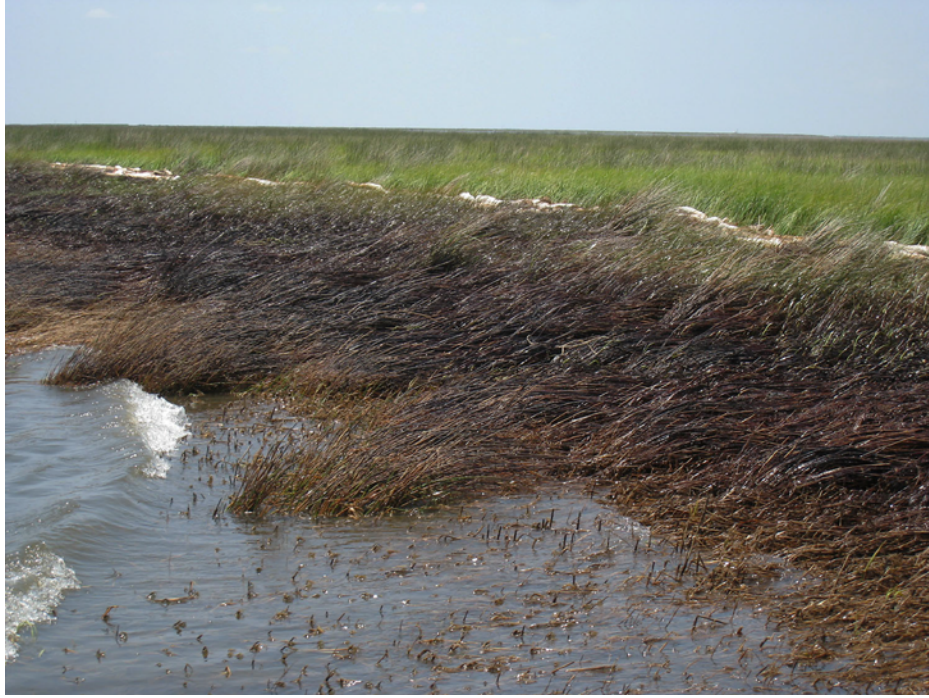
**Figure 25.** DWO-2-BAT-11 photo 1 taken on July 10, 2010. Site vegetation included *Spartina alterniflora* and *Juncus roemerianus*. Oiled vegetation was observed at this site, including oil-damaged canopy.

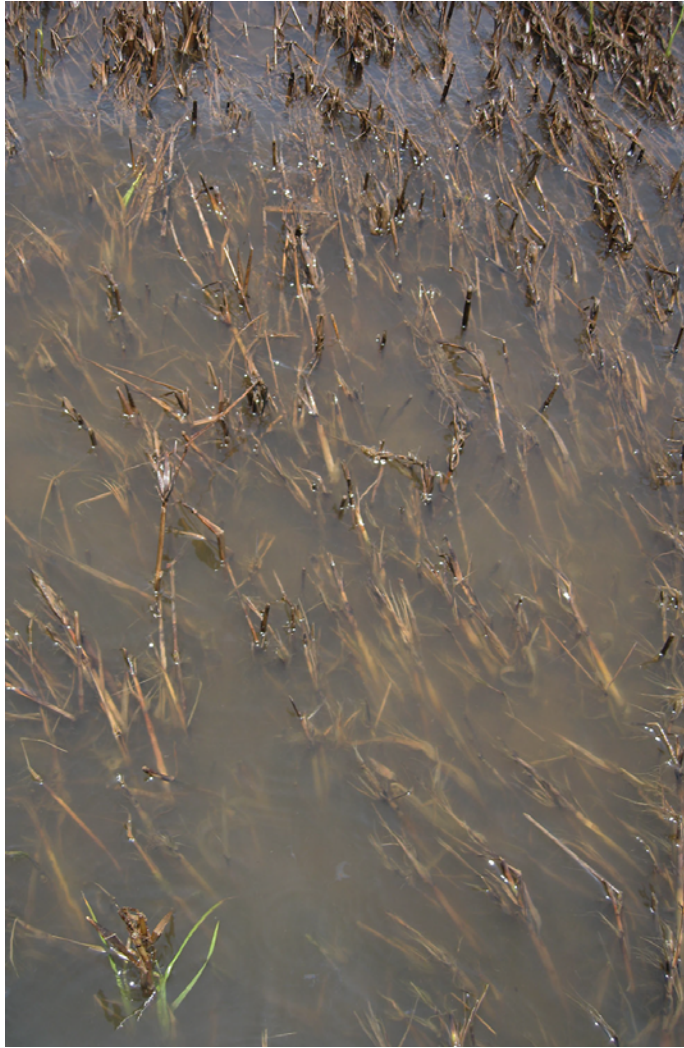
**Figure 27. DWO-2-BAT-11 photo 3 taken on July 10, 2010. Site vegetation included *Spartina alterniflora* and *Juncus roemerianus*. Oiled vegetation was observed at this site, including oil-damaged canopy.**

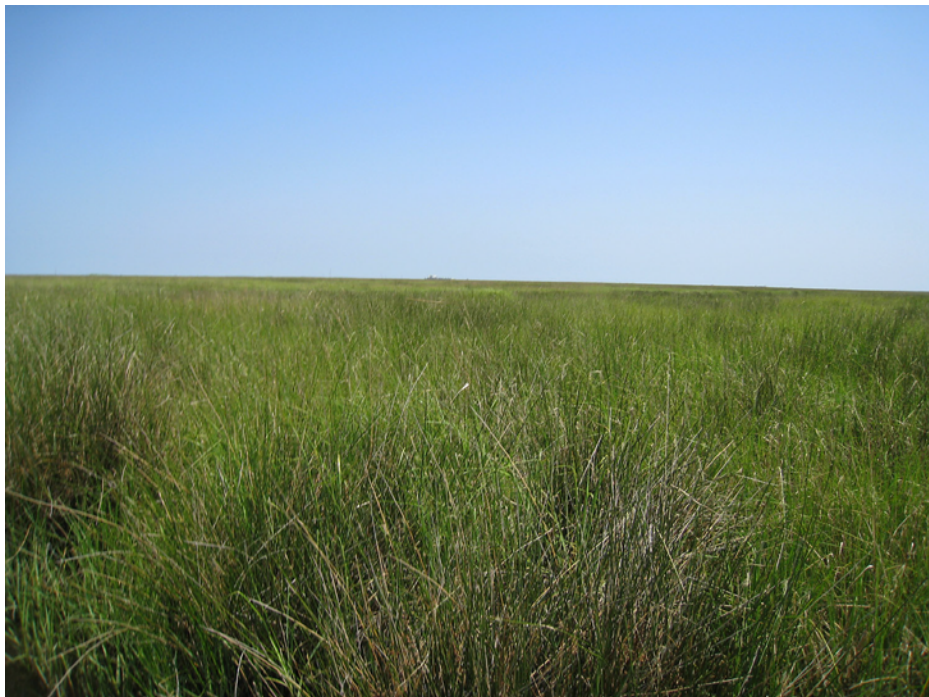
Figure 29. DWO-2-BAT-12 photo 2 taken on July 10, 2010. Site vegetation included *Spartina alterniflora* and *Juncus roemerianus*. Oil was not observed at this site.

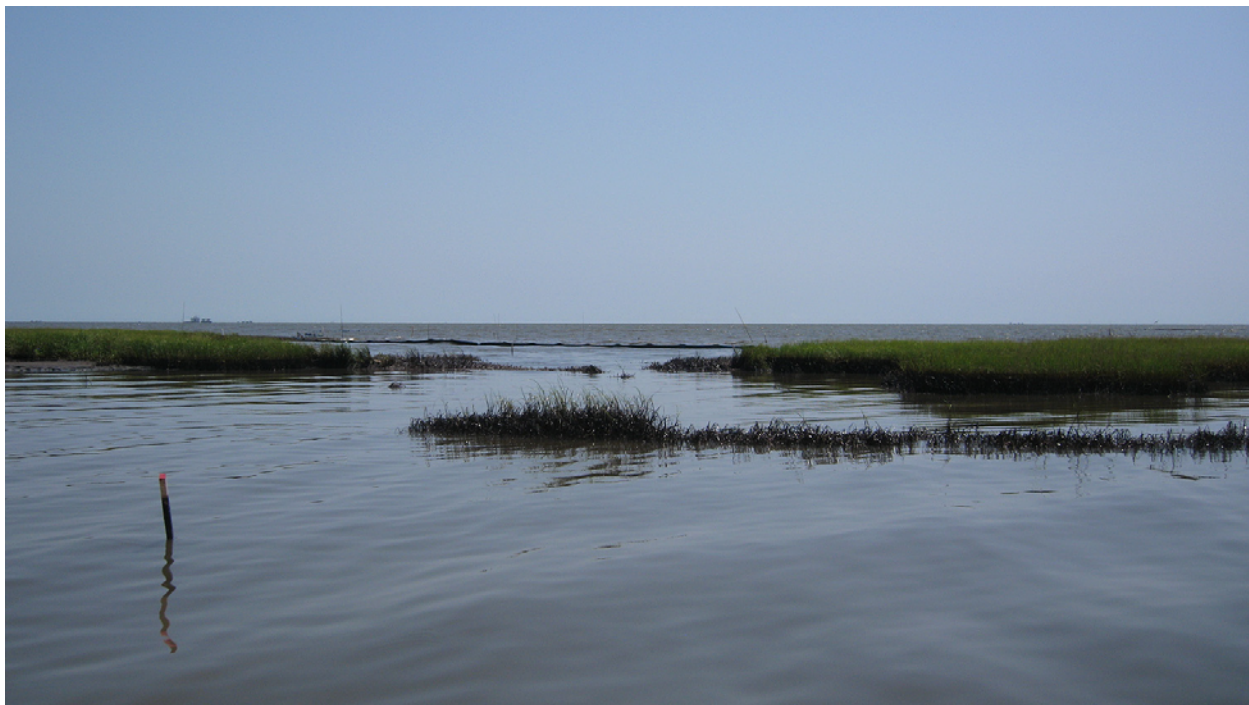
**Figure 30. OBS-2-BAT-01 photo 1 taken on July 10, 2010. Oiled vegetation was observed at this site, including oil-damaged canopy.**

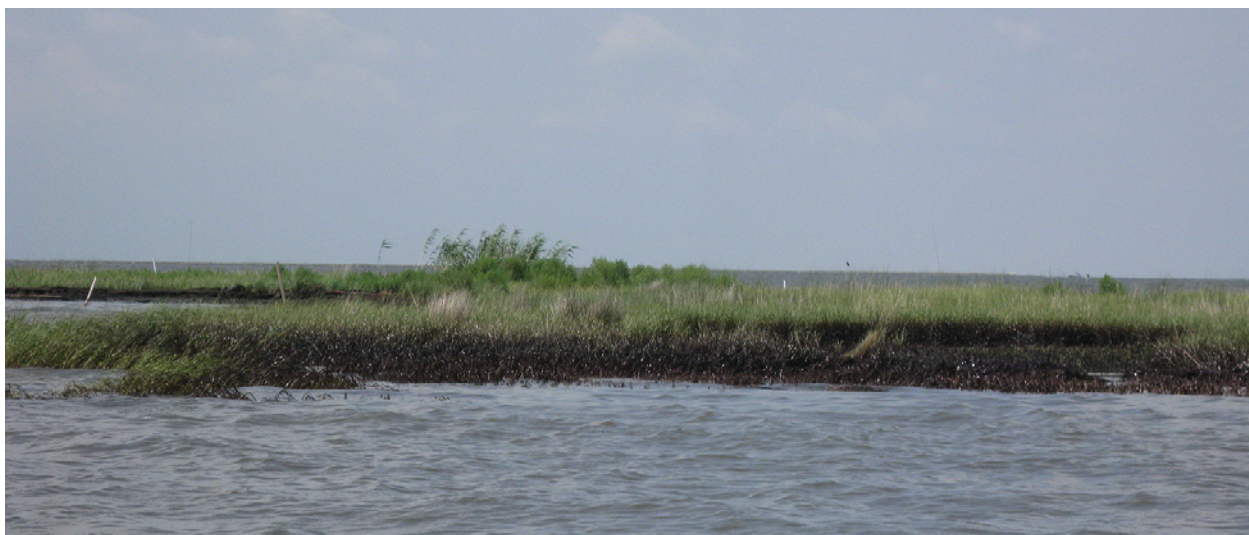
**Figure 31. OBS-2-BAT-02 photo 1 taken on July 10, 2010. Oiled vegetation was observed at this site, including oil-damaged canopy.**

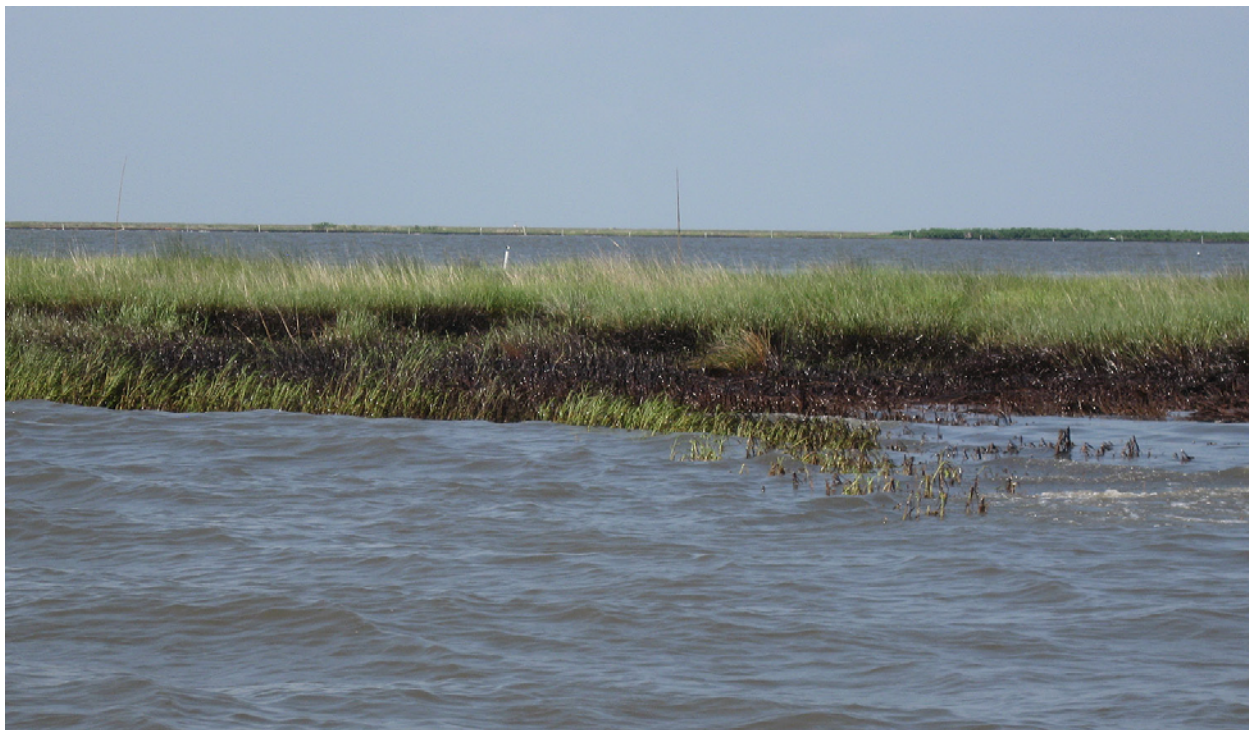
**Figure 32. OBS-2-BAT-02 photo 2 taken on July 10, 2010. Oiled vegetation was observed at this site, including oil-damaged canopy.**

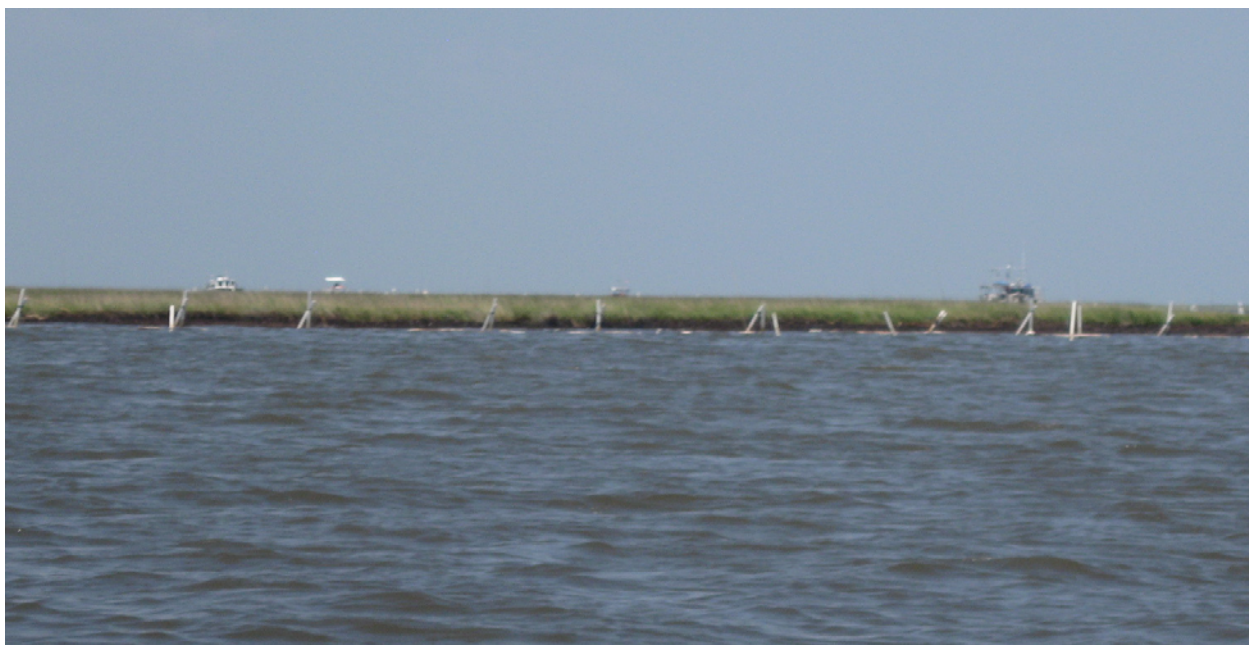
**Figure 33. OBS-2-BAT-03 photo 1 taken on July 10, 2010. Oiled vegetation was observed at this site, including oil-damaged canopy.**

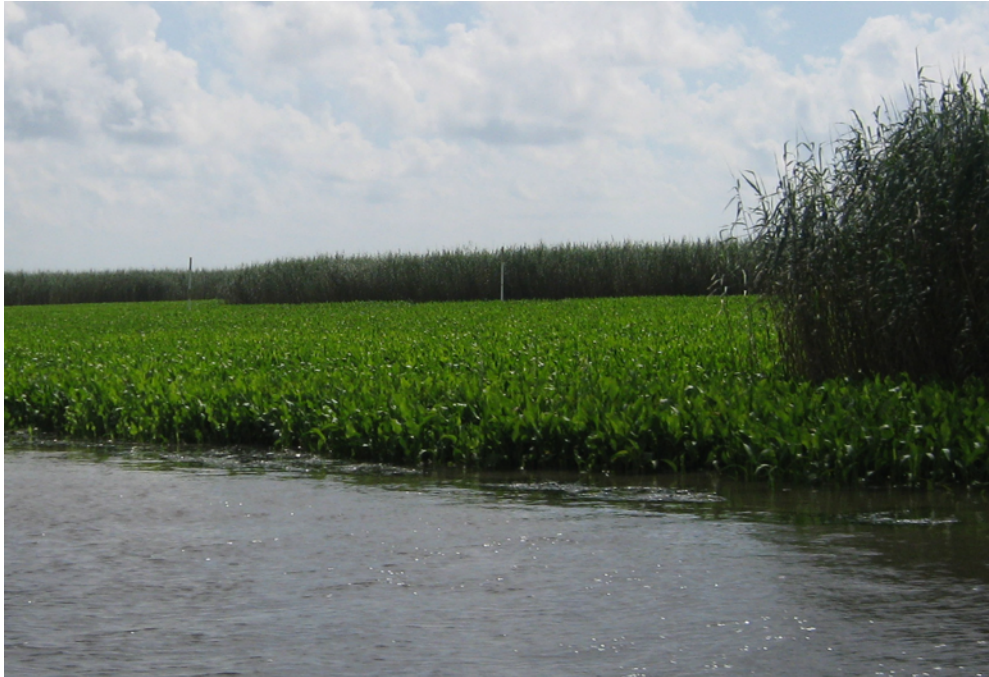
**Figure 34. OBS-2-DEL-09 photo 1 taken on July 8, 2010. Vegetation included bulltongue. Oil was not observed at this site.**

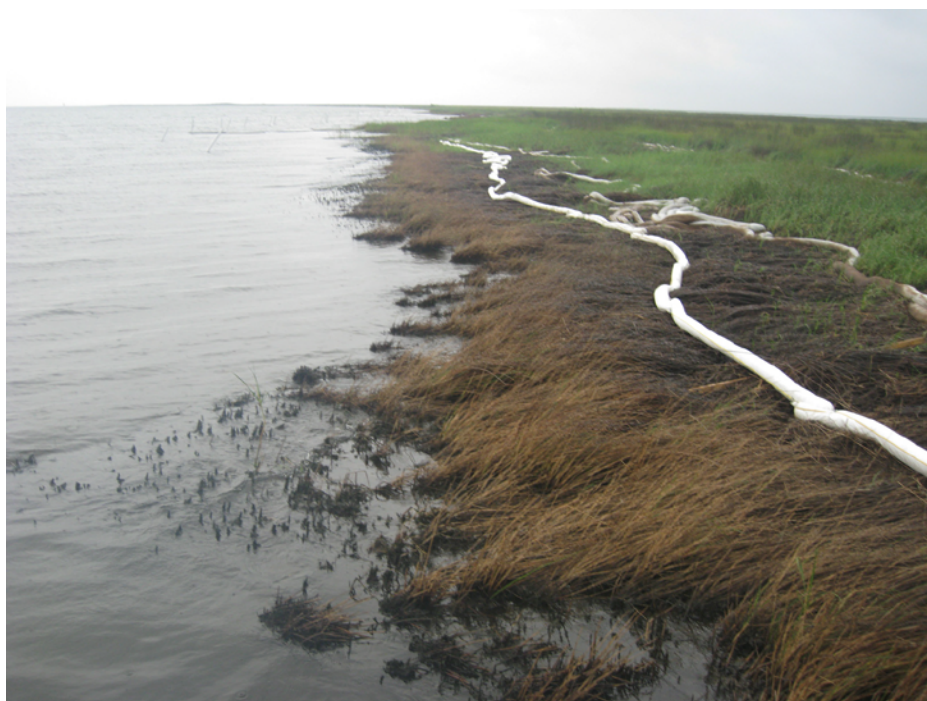
Figure 38. DWO-3-BAT-01 photo 1 taken on August 12, 2010. Site vegetation included *Juncus roemerianus* and *Spartina alterniflora*. Oiled vegetation and oil-damaged canopy were observed at this site.

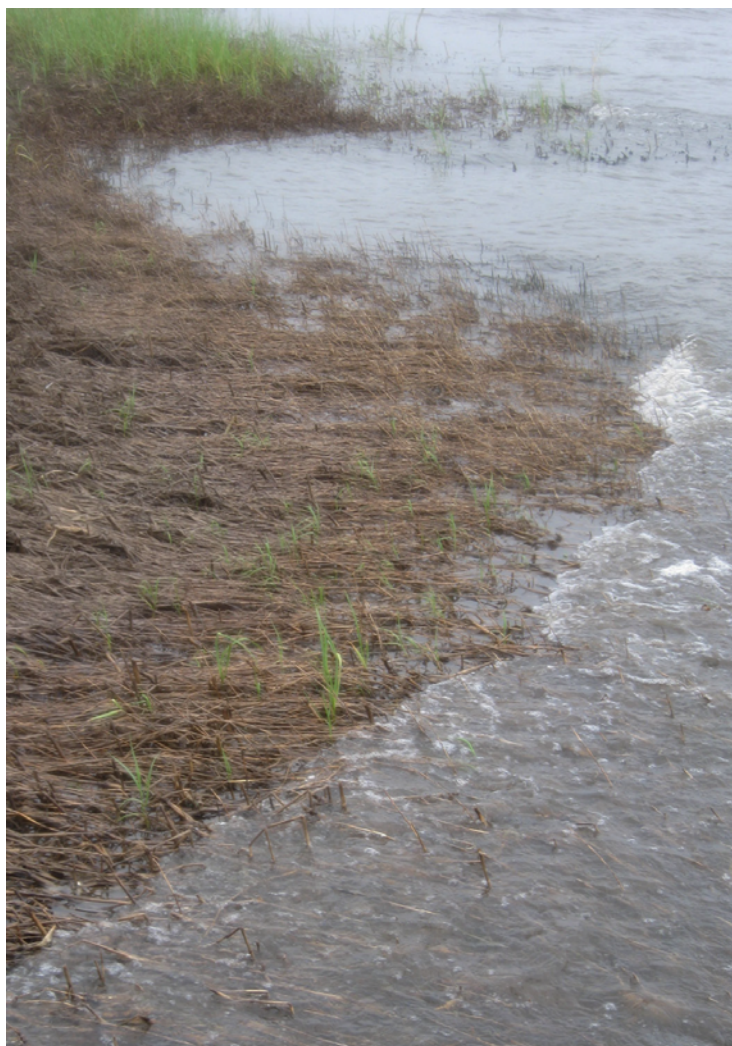
Figure 39. DWO-3-BAT-01 photo 2 taken on August 12, 2010. Site vegetation included *Juncus roemerianus* and *Spartina alterniflora*. Oiled vegetation and oil-damaged canopy were observed at this site.
