# **Shoreline Surveys of Oil-Impacted Marsh in Southern Louisiana, July to August 2010**

**Open-File Report 2011–1022**

**U.S. Department of the Interior  
U.S. Geological Survey**

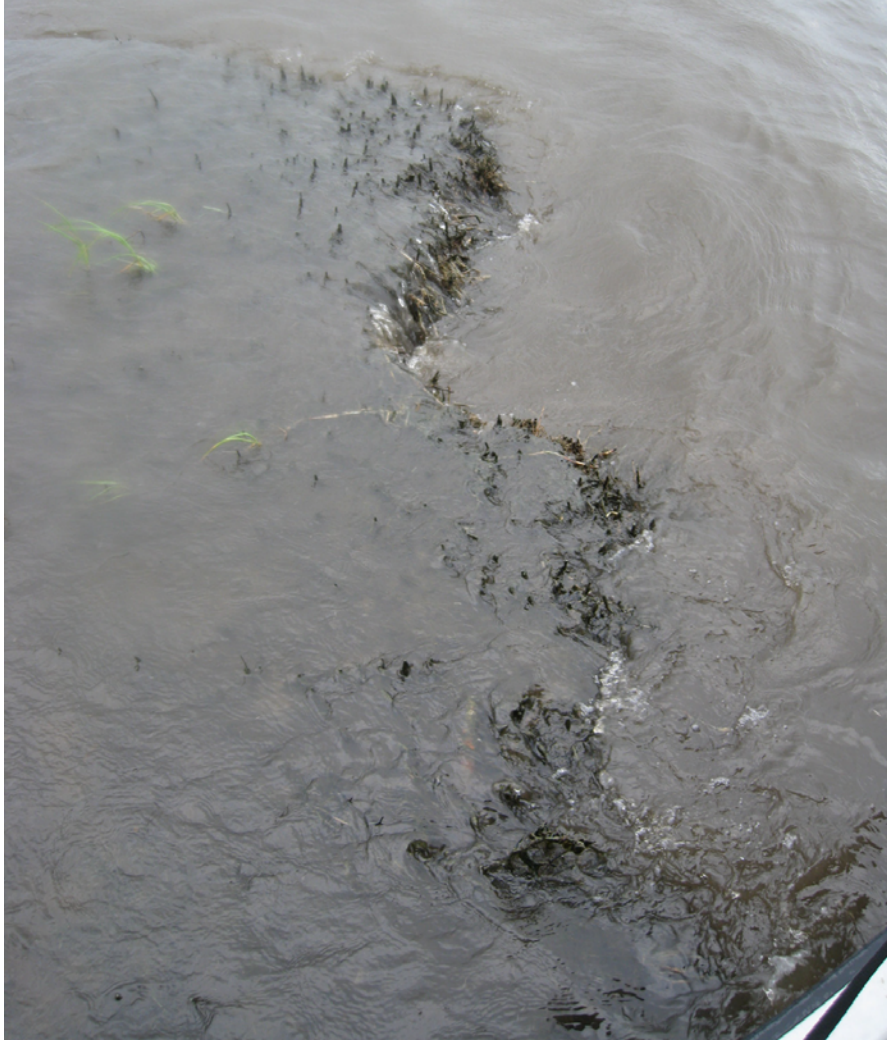
Figure 40. DWO-3-BAT-01 photo 3 taken on August 12, 2010. Site vegetation included *Juncus roemerianus* and *Spartina alterniflora*. Oiled vegetation and oil-damaged canopy were observed at this site.

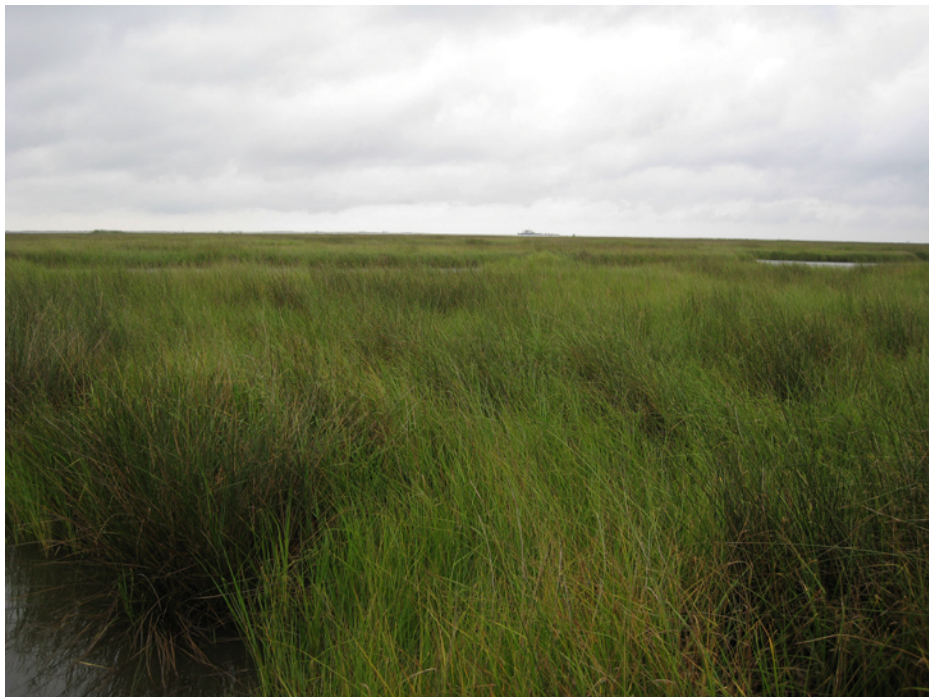
Figure 42. DWO-3-BAT-02 photo 2 taken on August 12, 2010. Site vegetation included *Spartina alterniflora* and *Juncus roemerianus*. Oil was not observed at this site.

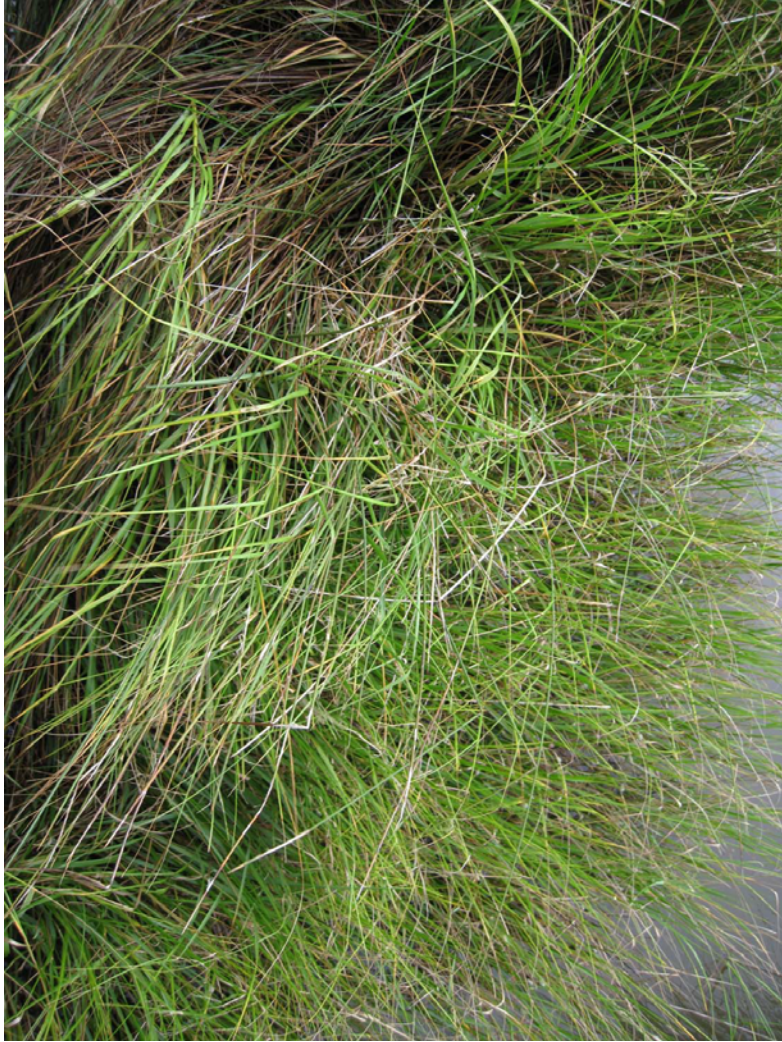
Figure 43. DWO-3-BAT-02 photo 3 taken on August 12, 2010. Site vegetation included *Spartina alterniflora* and *Juncus roemerianus*. Oil was not observed at this site.

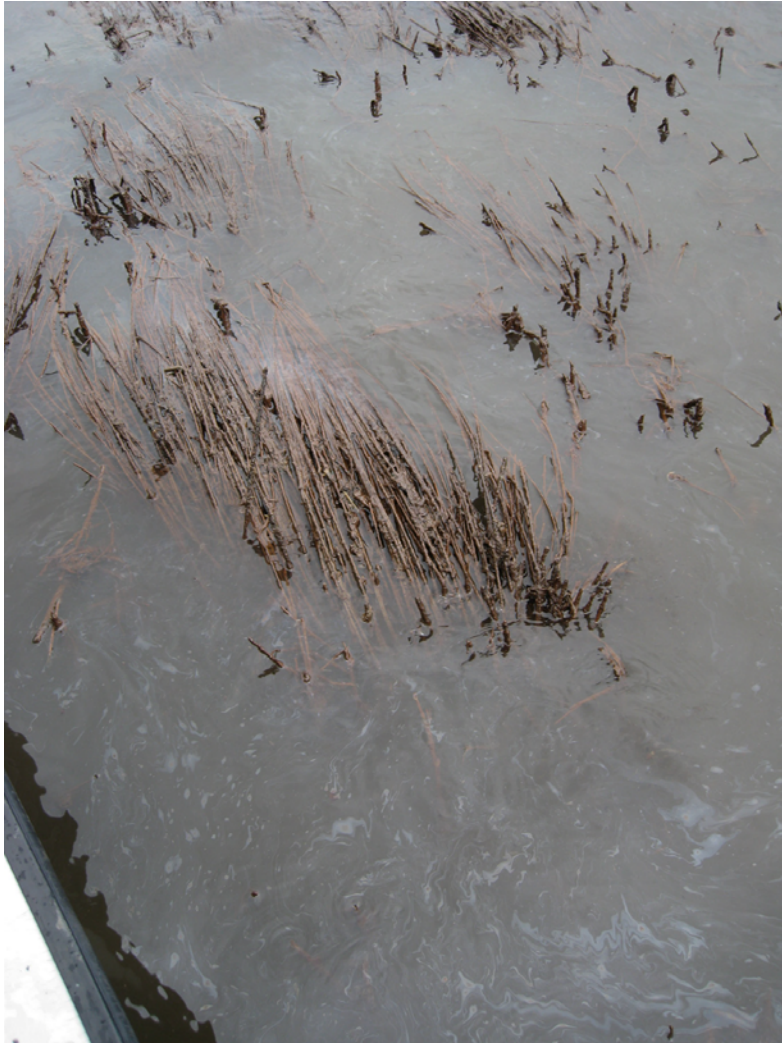
Figure 44. DWO-3-BAT-03 photo 1 taken on August 12, 2010. Site vegetation included *Spartina alterniflora* and *Juncus roemerianus*. Oiled vegetation and oil-damaged canopy were observed at this site.

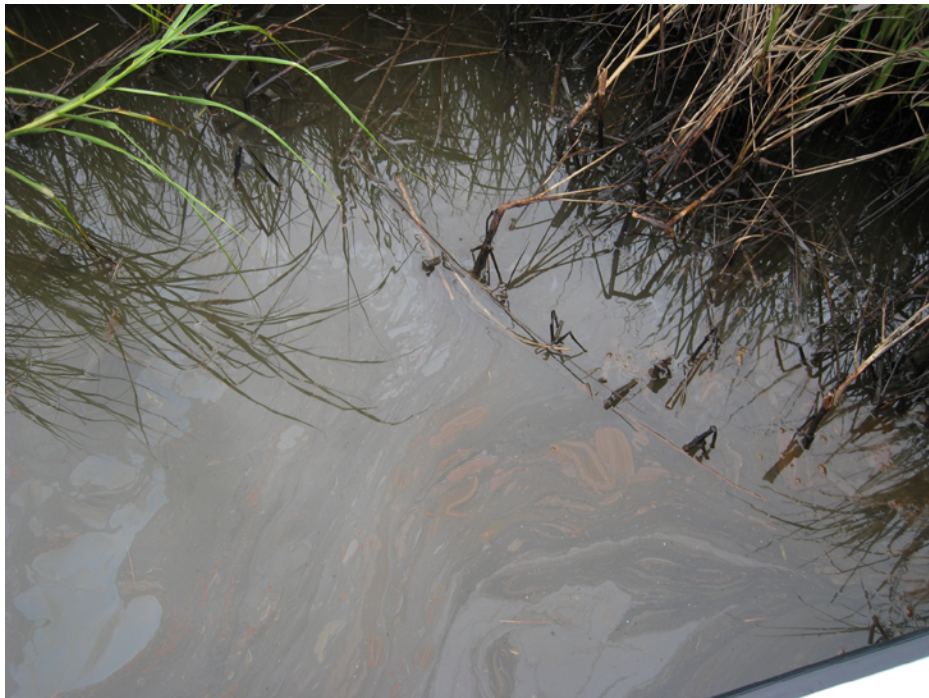
Figure 48. DWO-3-BAT-05 photo 2 taken on August 12, 2010. Site vegetation included *Spartina alterniflora*, *Juncus roemerianus*, and *Distichlis spicata*. Oiled stems were observed at this site.

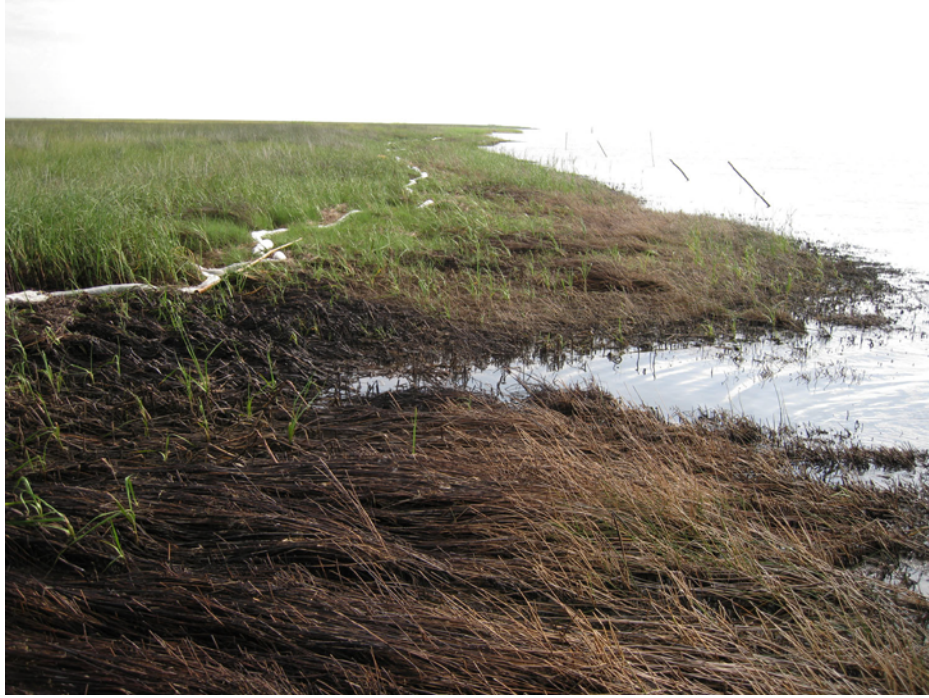
Figure 49. DWO-3-BAT-06 photo 1 taken on August 13, 2010. Site vegetation included *Juncus roemerianus* and *Spartina alterniflora*. Oiled vegetation and oil-damaged canopy were observed at this site.

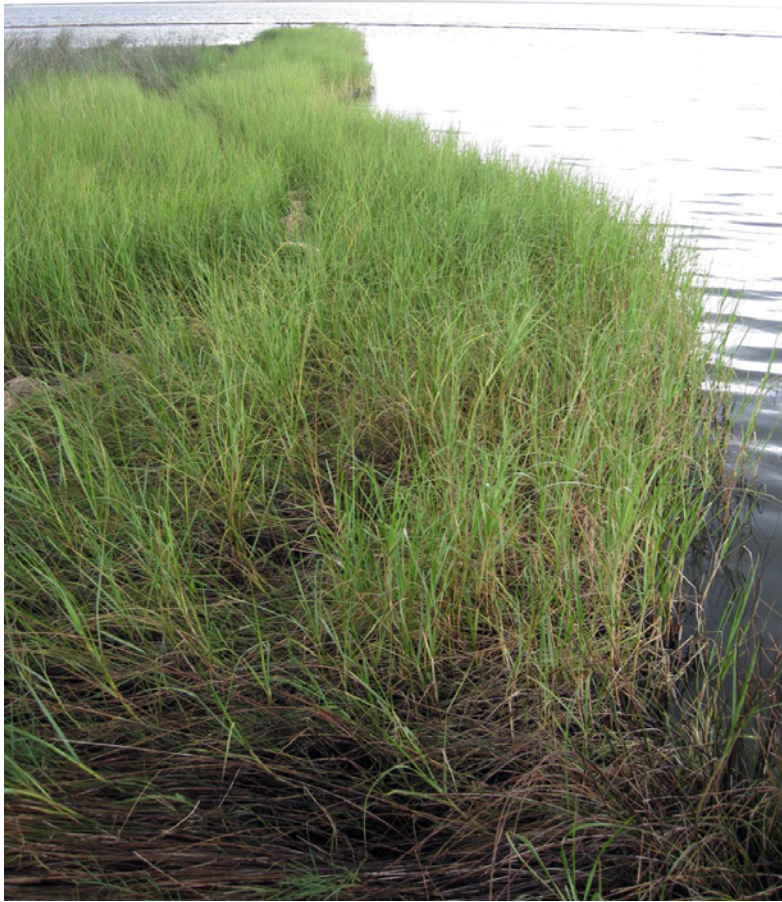
Figure 51. DWO-3-BAT-07 photo 1 taken on August 13, 2010. Site vegetation included *Spartina alterniflora*, *Juncus roemerianus*, *Distichlis spicata*, and *Iva frutescens*. Oiled vegetation and oil-damaged canopy were observed at this site.

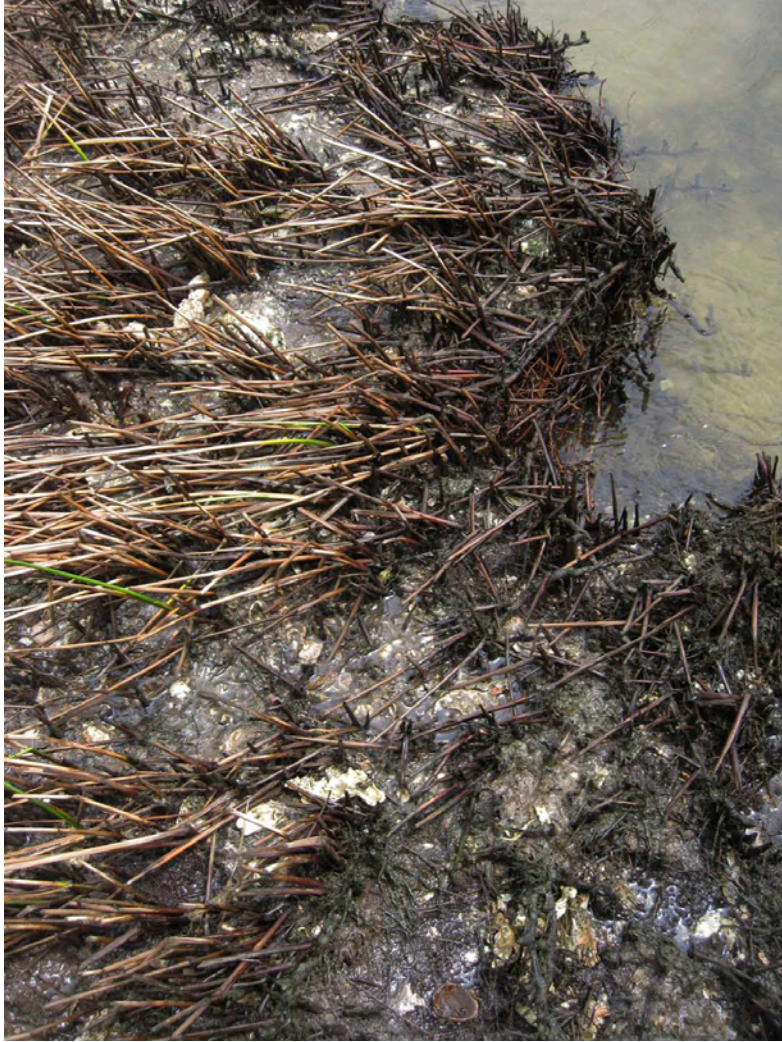
Figure 54. DWO-3-BAT-08 photo 2 taken on August 13, 2010. Site vegetation included *Spartina alterniflora* and *Distichlis spicata*. Oiled vegetation and oil-damaged canopy were observed at this site.

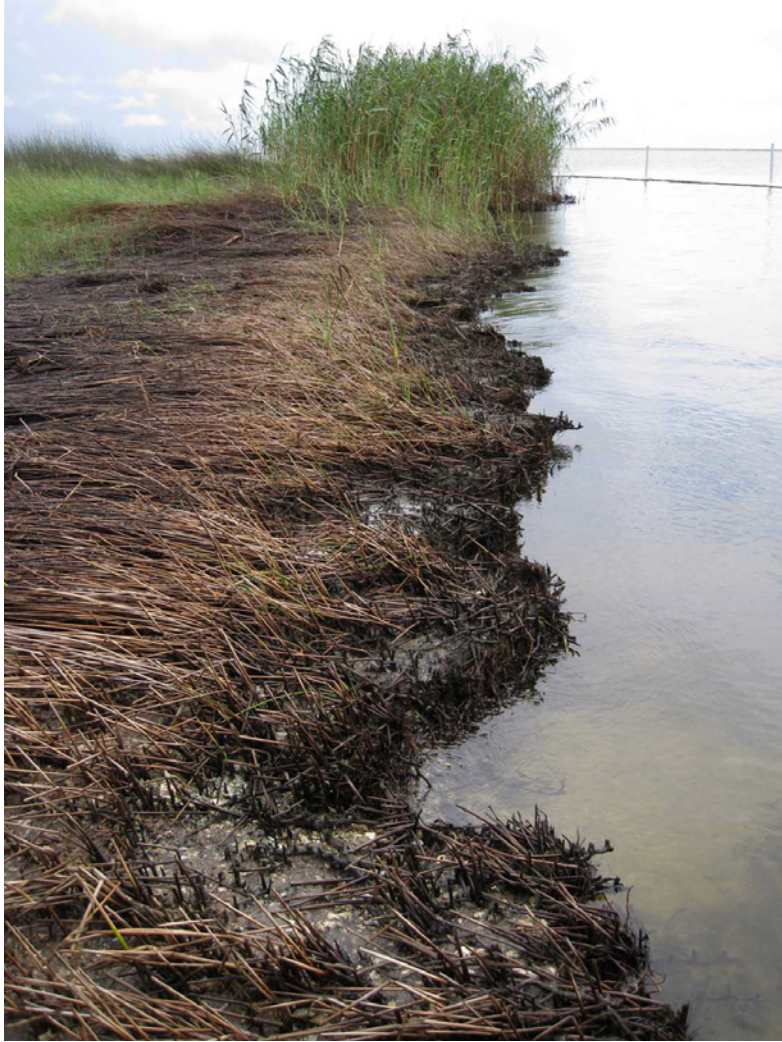
Figure 55. DWO-3-BAT-08 photo 3 taken on August 13, 2010. Site vegetation included *Spartina alterniflora* and *Distichlis spicata*. Oiled vegetation and oil-damaged canopy were observed at this site.

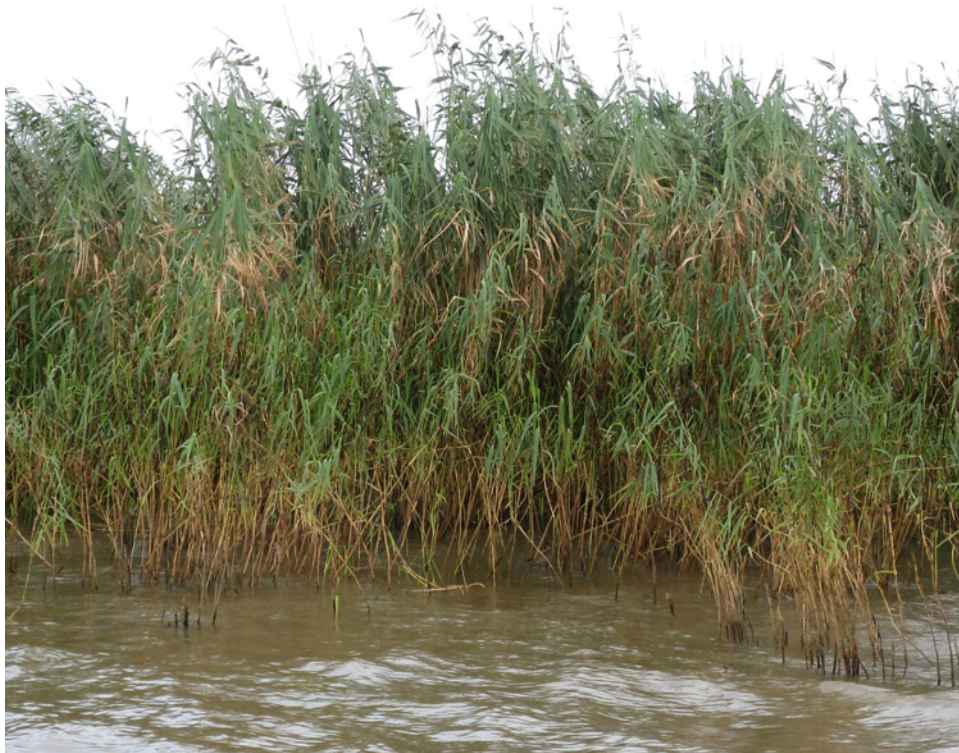
Figure 58. DWO-3-DEL-01 photo 1 taken on August 14, 2010. Site vegetation included *Phragmites australis*. Oiled vegetation was observed at this site, including some oil-damaged canopy.

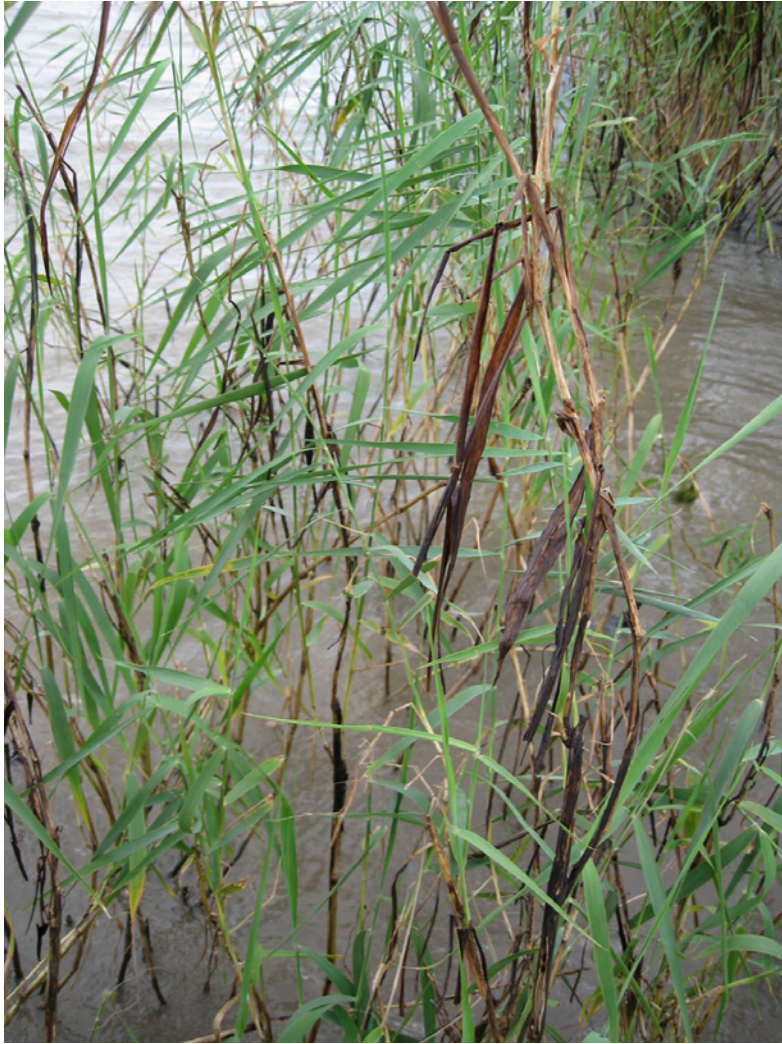
Figure 59. DWO-3-DEL-01 photo 2 taken on August 14, 2010. Site vegetation included *Phragmites australis*. Oiled vegetation was observed at this site, including some oil-damaged canopy.

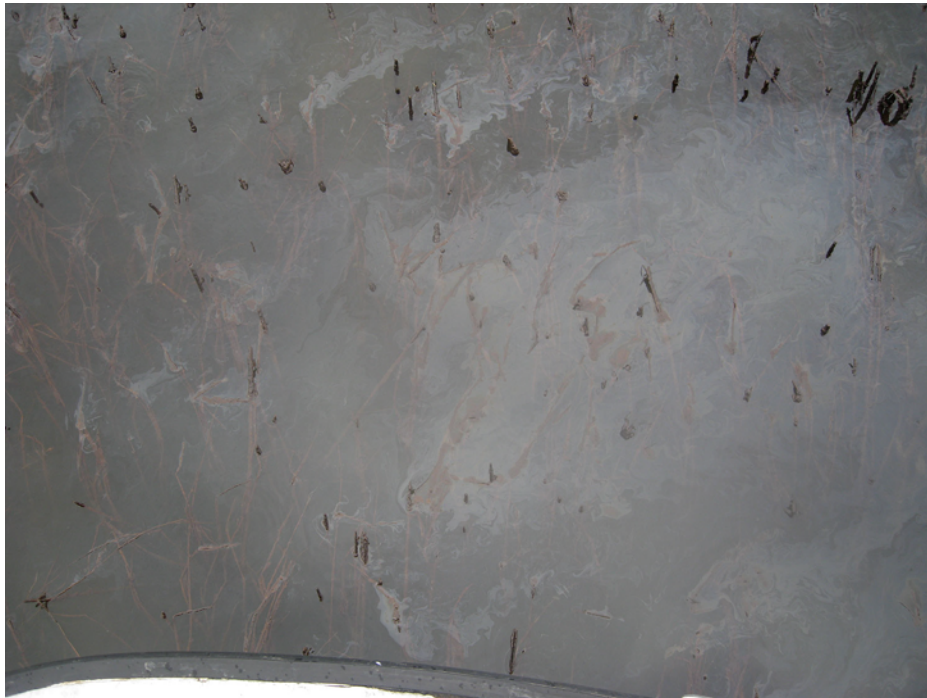
Figure 61. OBS-3-BAT-01 photo 2 taken on August 12, 2010. Site vegetation included *Spartina alterniflora* and *Juncus roemerianus*. Oiled vegetation and oil-damaged canopy were observed at this site.

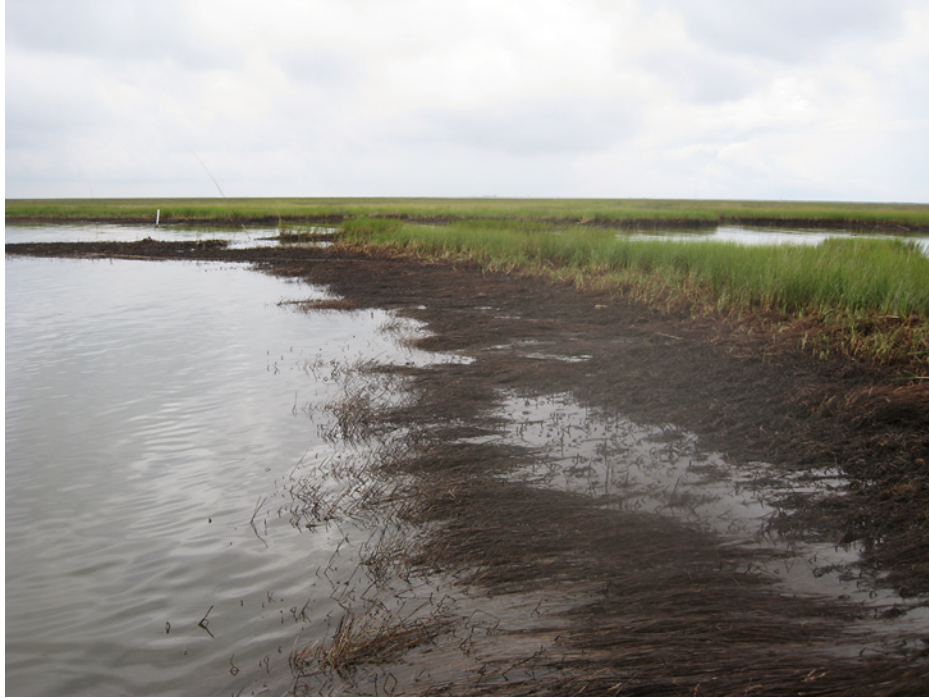
Figure 62. OBS-3-BAT-02 photo 1 taken on August 12, 2010. Site vegetation included *Spartina alterniflora* and *Juncus roemerianus*. Oiled vegetation and oil-damaged canopy were observed at this site.

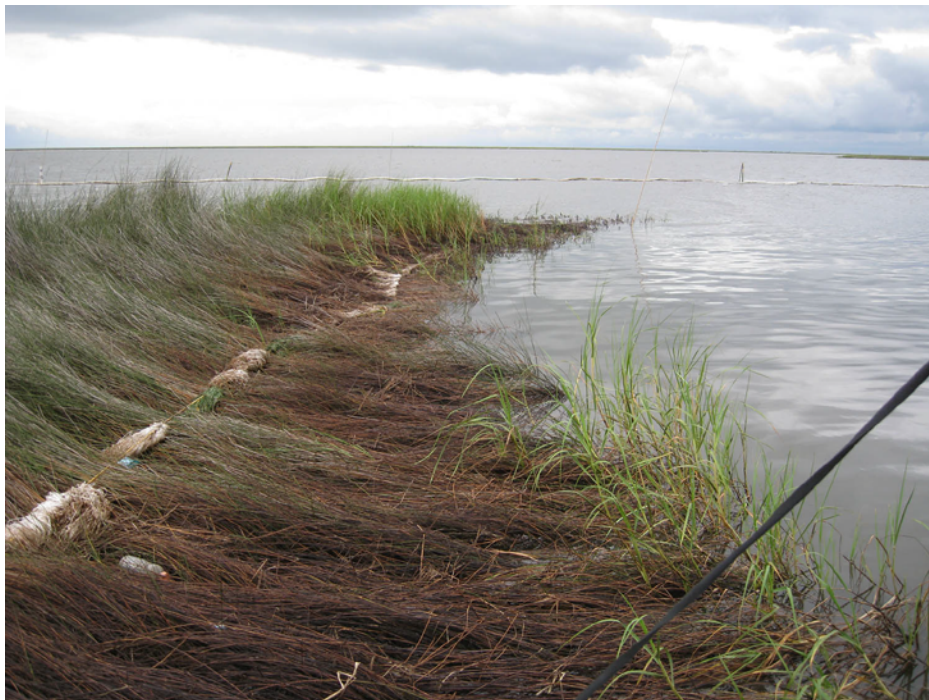
Figure 65. OBS-3-BAT-04 photo 1 taken on August 12, 2010. Site vegetation included *Juncus roemerianus* and *Spartina alterniflora*. Oiled vegetation and oil-damaged canopy were observed at this site.

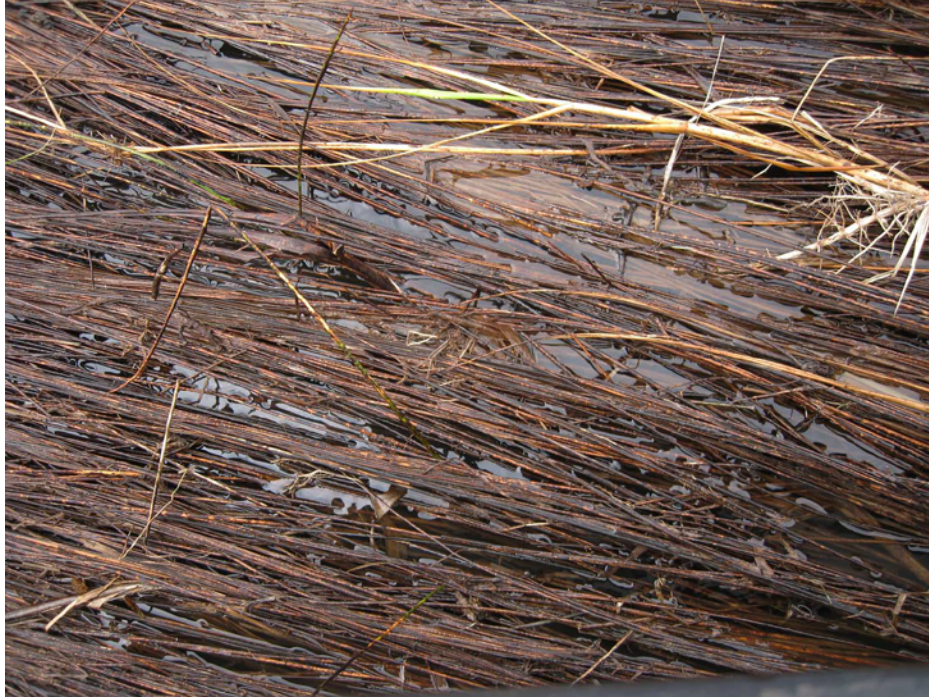
Figure 66. OBS-3-BAT-04 photo 2 taken on August 12, 2010. Site vegetation included *Juncus roemerianus* and *Spartina alterniflora*. Oiled vegetation and oil-damaged canopy were observed at this site.

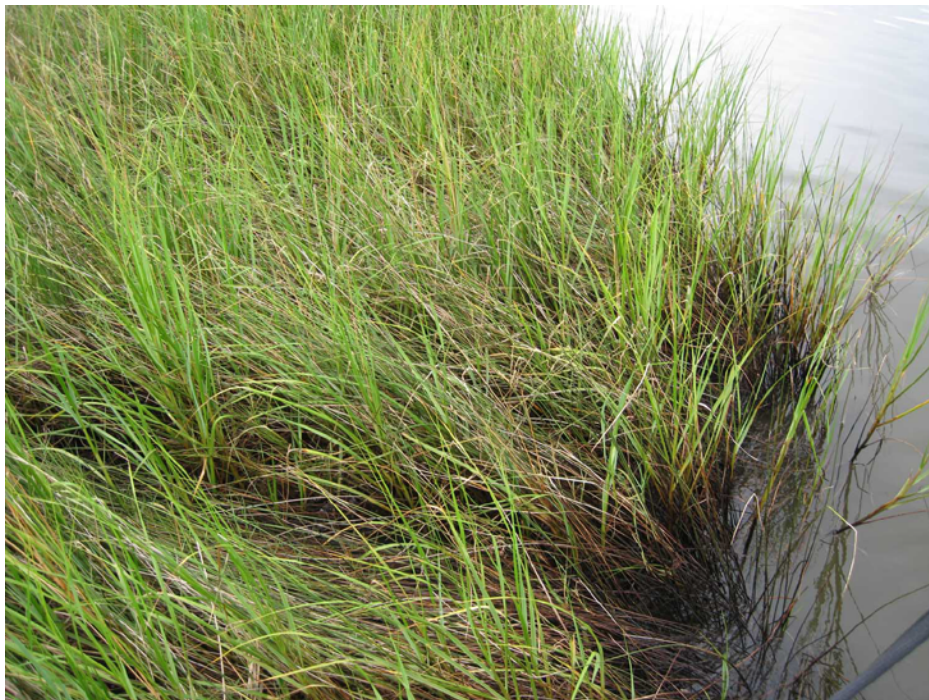
Figure 67. OBS-3-BAT-05 photo 1 taken on August 12, 2010. Site vegetation included *Spartina alterniflora*, *Juncus roemerianus*, and *Distichlis spicata*. Oiled stems were observed at this site.

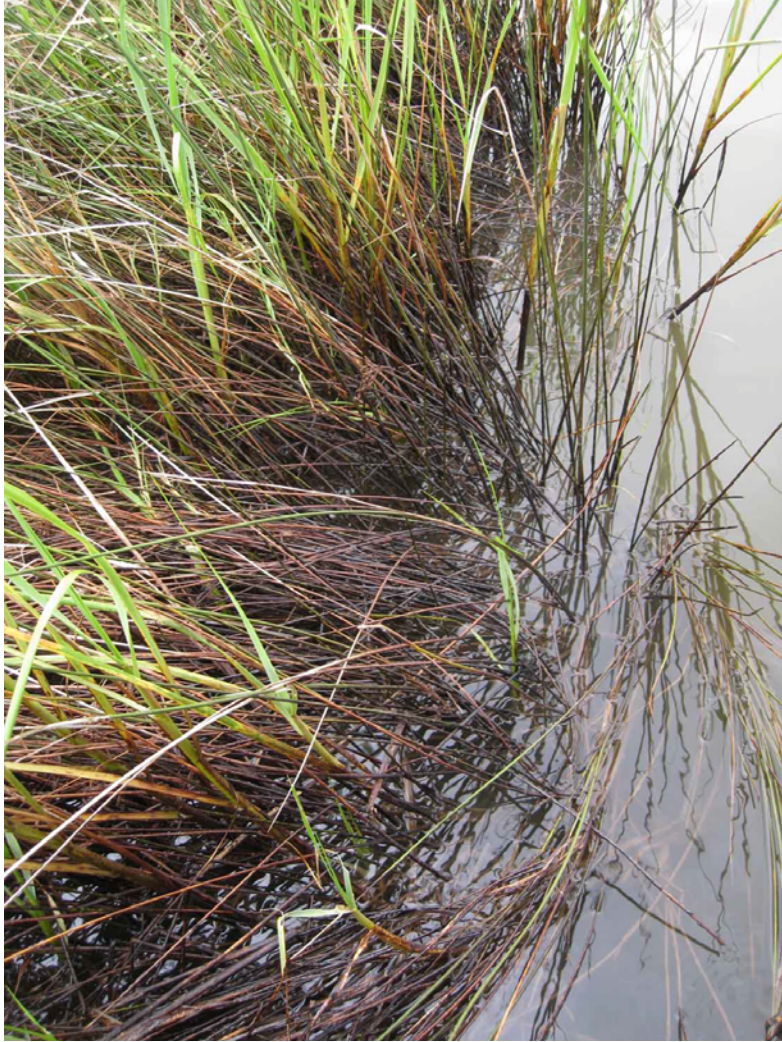
Figure 68. OBS-3-BAT-05 photo 2 taken on August 12, 2010. Site vegetation included *Spartina alterniflora*, *Juncus roemerianus*, and *Distichlis spicata*. Oiled stems were observed at this site.

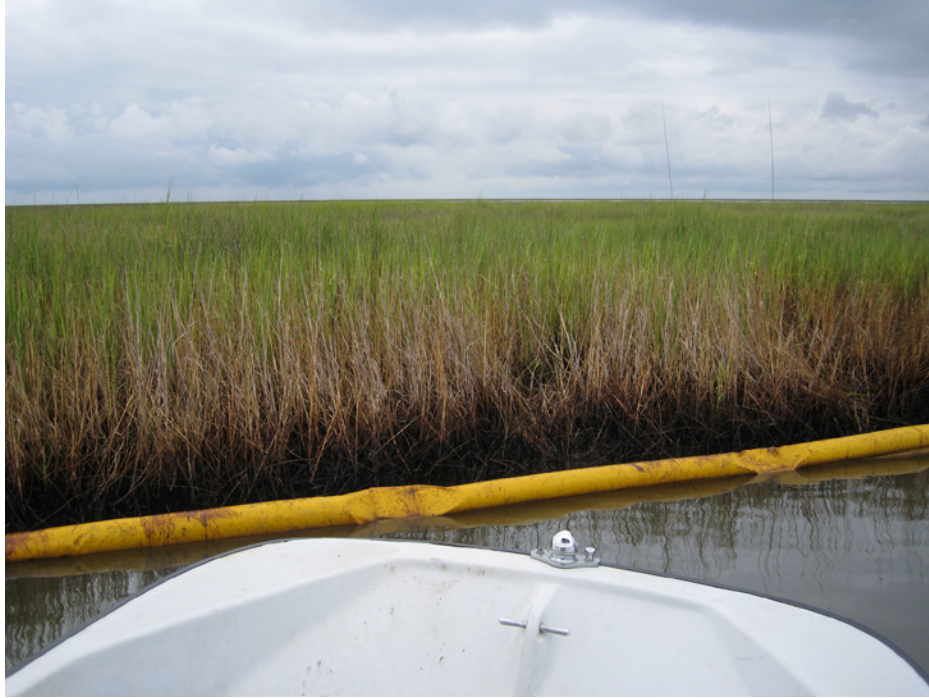
Figure 69. OBS-3-BAT-06 photo 1 taken on August 12, 2010. Site vegetation included *Spartina alterniflora* and *Juncus roemerianus*. Oiled stems were observed at this site.

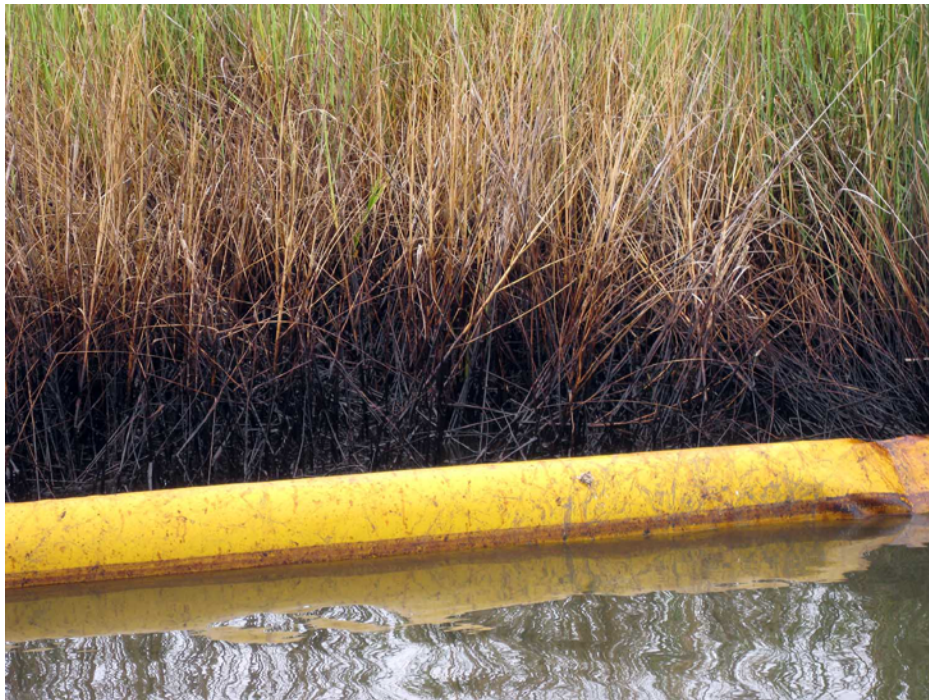
Figure 70. OBS-3-BAT-06 photo 2 taken on August 12, 2010. Site vegetation included *Spartina alterniflora* and *Juncus roemerianus*. Oiled stems were observed at this site.

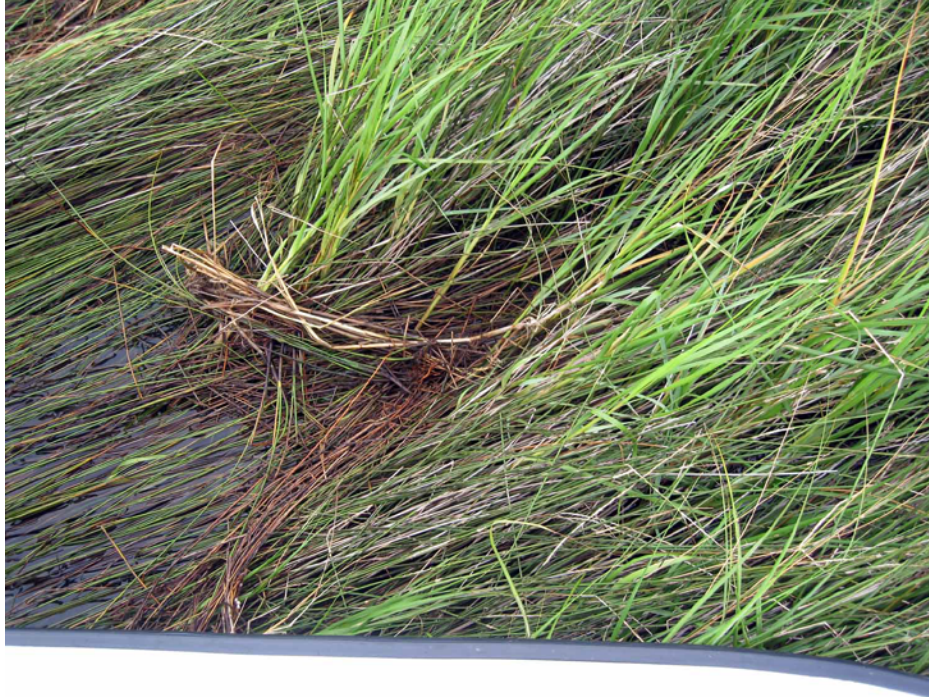
Figure 71. OBS-3-BAT-08 photo 1 taken on August 12, 2010. Site vegetation included *Juncus roemerianus* and *Spartina alterniflora*. Oiled vegetation and oil-damaged canopy were observed at this site.

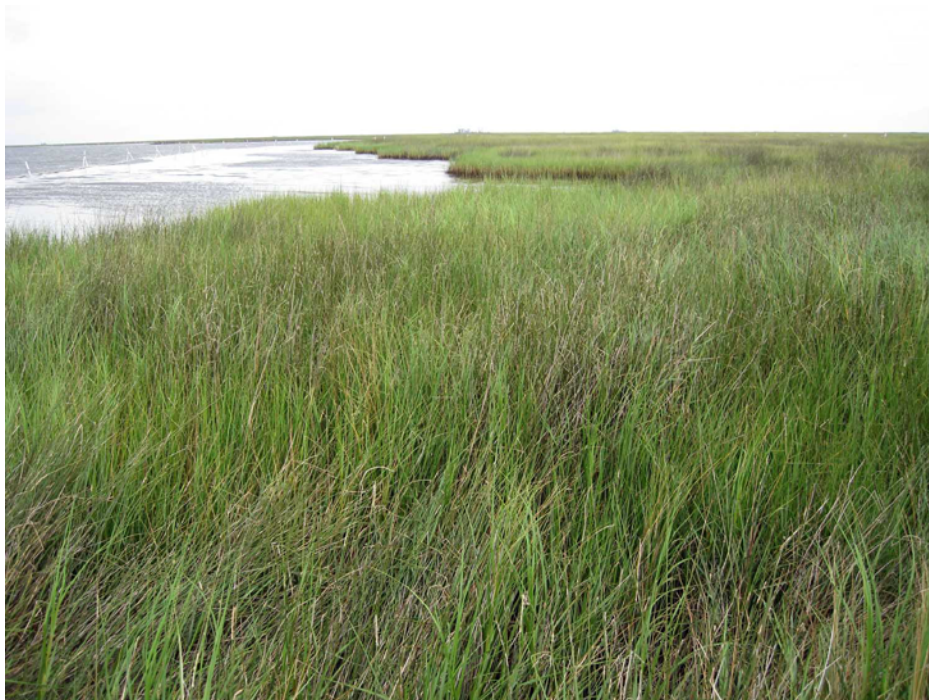
Figure 72. OBS-3-BAT-08 photo 2 taken on August 12, 2010. Site vegetation included *Juncus roemerianus* and *Spartina alterniflora*. Oiled vegetation and oil-damaged canopy were observed at this site.

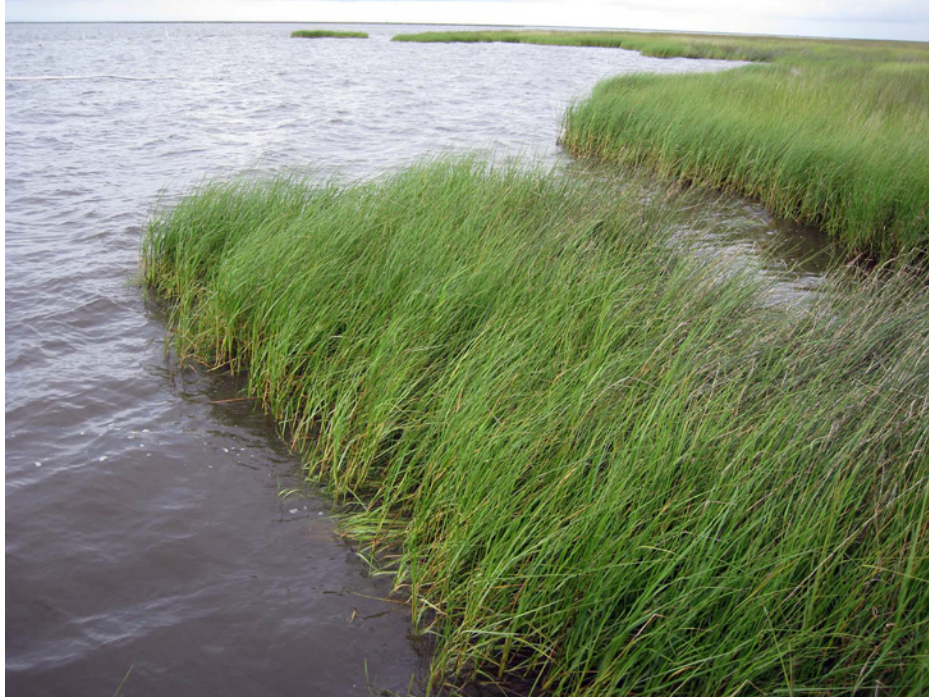
Figure 73. OBS-3-BAT-09 photo 1 taken on August 12, 2010. Site vegetation included *Spartina alterniflora* and *Juncus roemerianus*. Oil was not observed at this site.

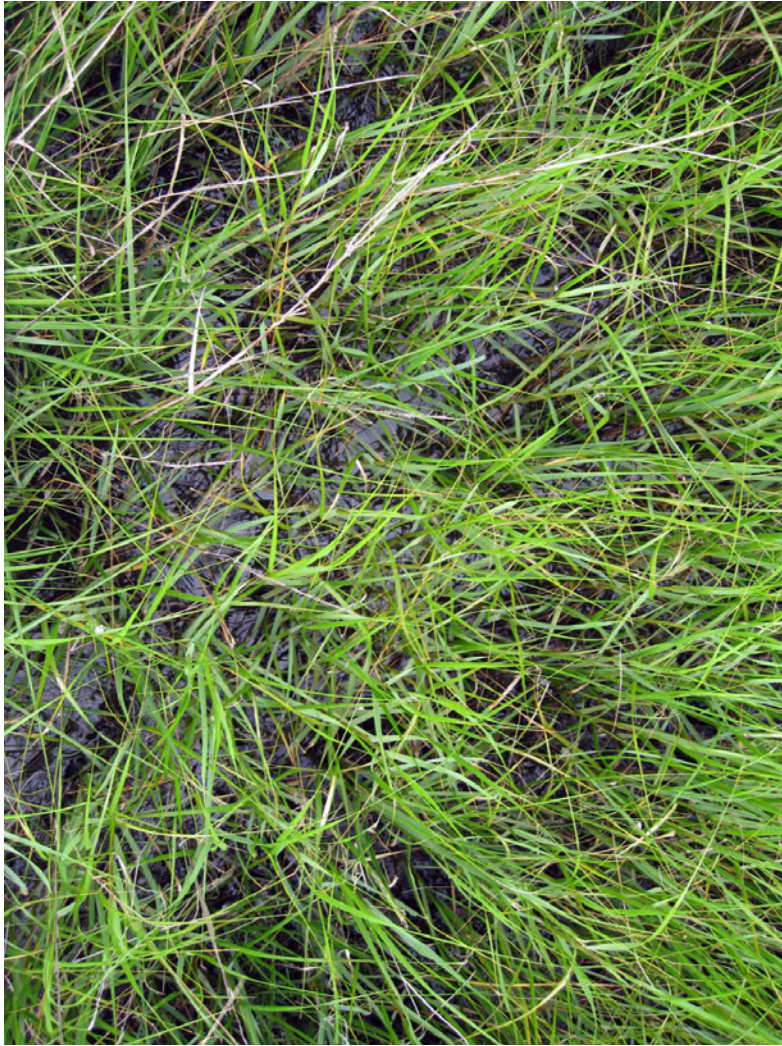
Figure 74. OBS-3-BAT-09 photo 2 taken on August 12, 2010. Site vegetation included *Spartina alterniflora* and *Juncus roemerianus*. Oil was not observed at this site.

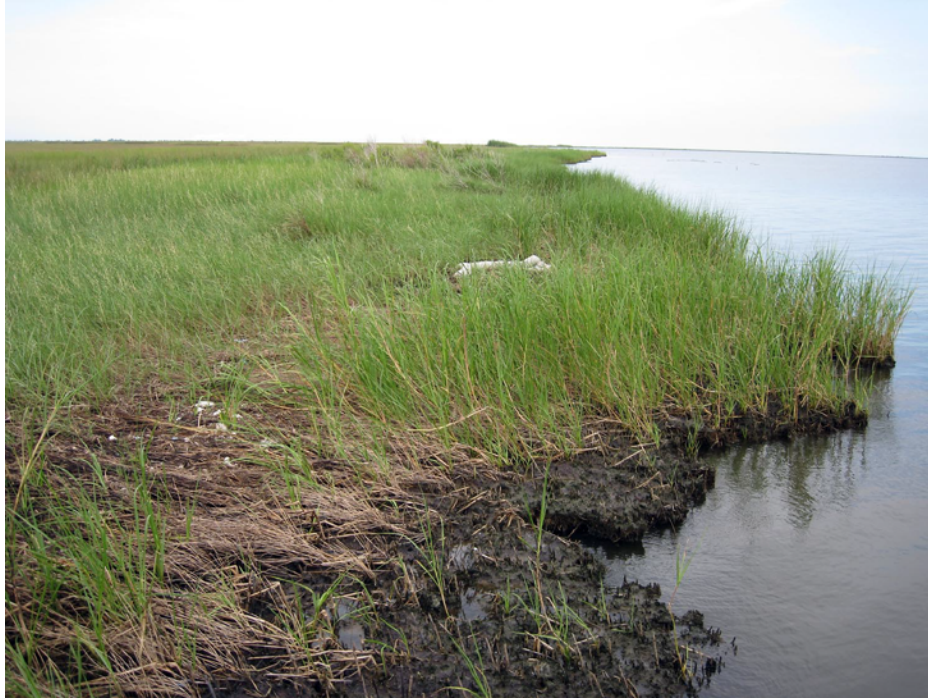
Figure 75. OBS-3-BAT-10 photo 1 taken on August 13, 2010. Site vegetation included *Spartina alterniflora* and *Spartina patens*. Oiled vegetation and oil-damaged canopy were observed at this site.

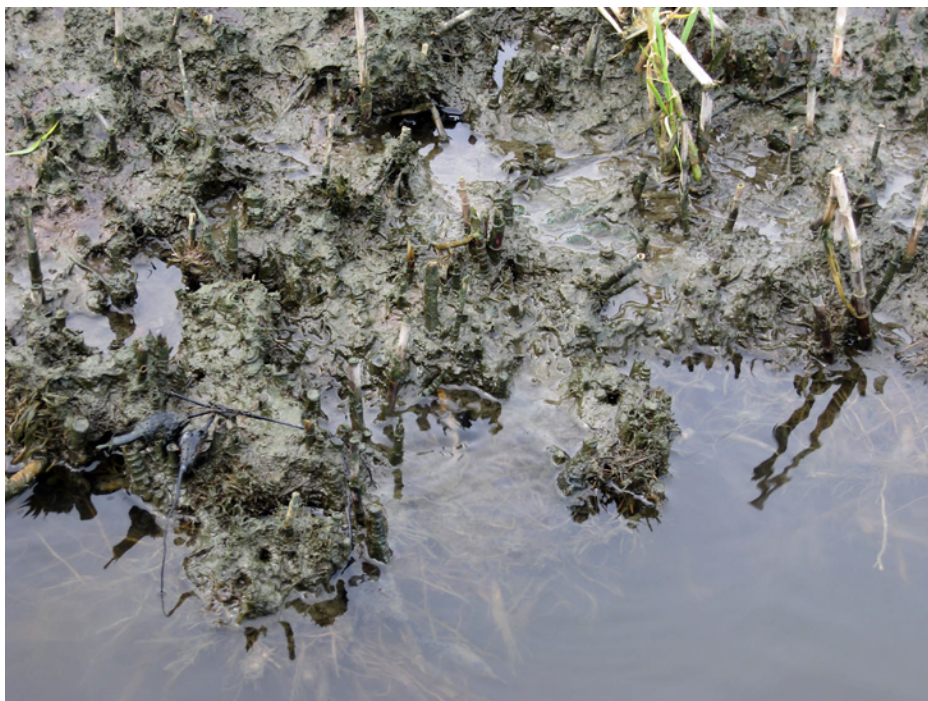
Figure 76. OBS-3-BAT-10 photo 2 taken on August 13, 2010. Site vegetation included *Spartina alterniflora* and *Spartina patens*. Oiled vegetation and oil-damaged canopy were observed at this site.

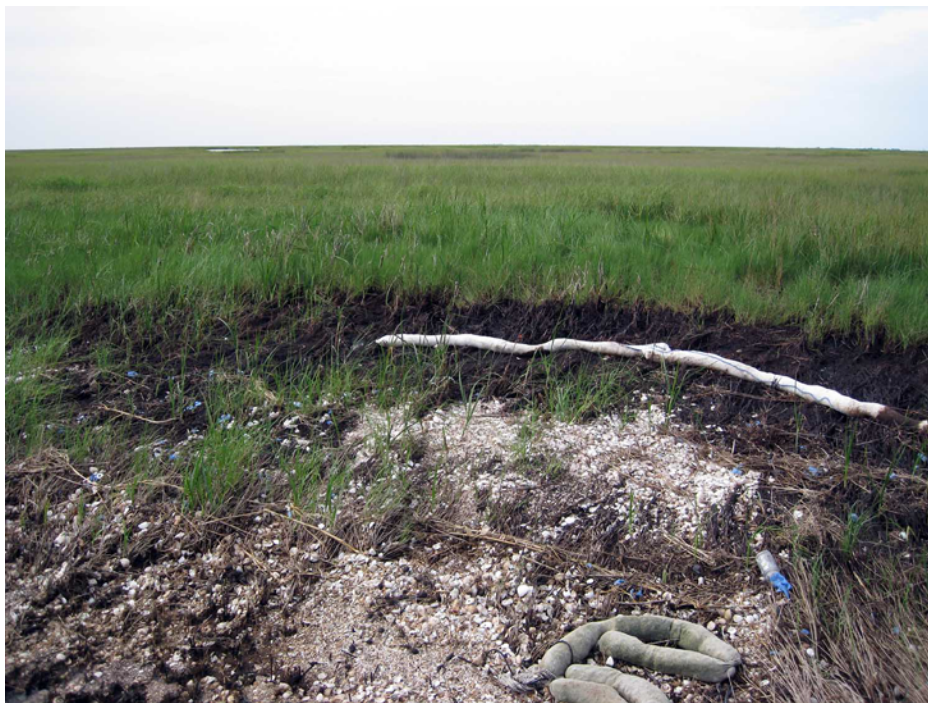
Figure 77. OBS-3-BAT-11 photo 1 taken on August 13, 2010. Site vegetation included *Spartina patens*.

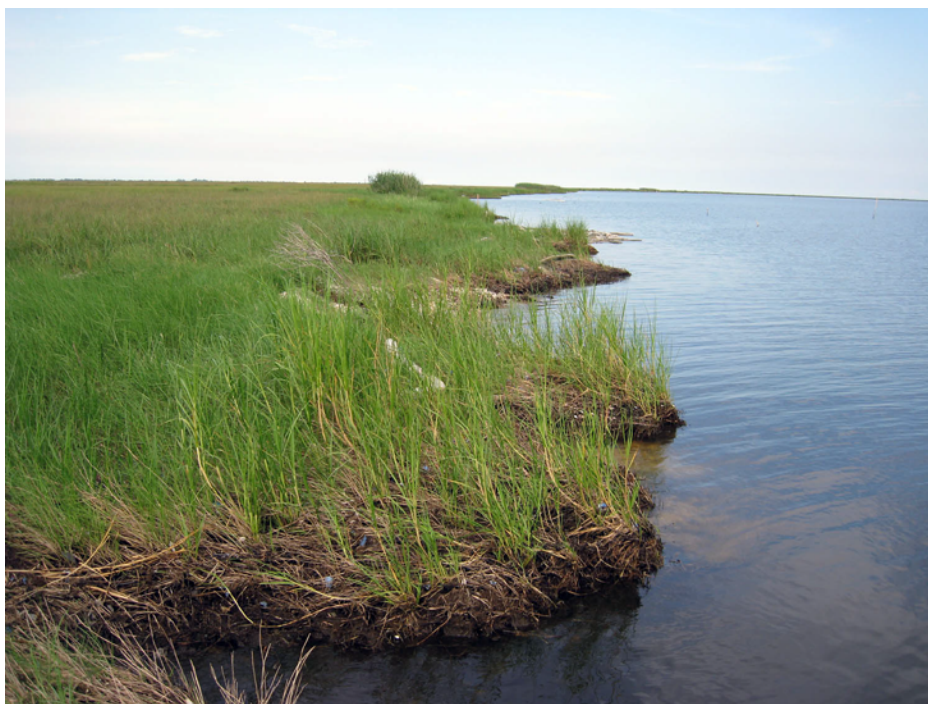
Figure 78. OBS-3-BAT-11 photo 2 taken on August 13, 2010. Site vegetation included *Spartina patens*.

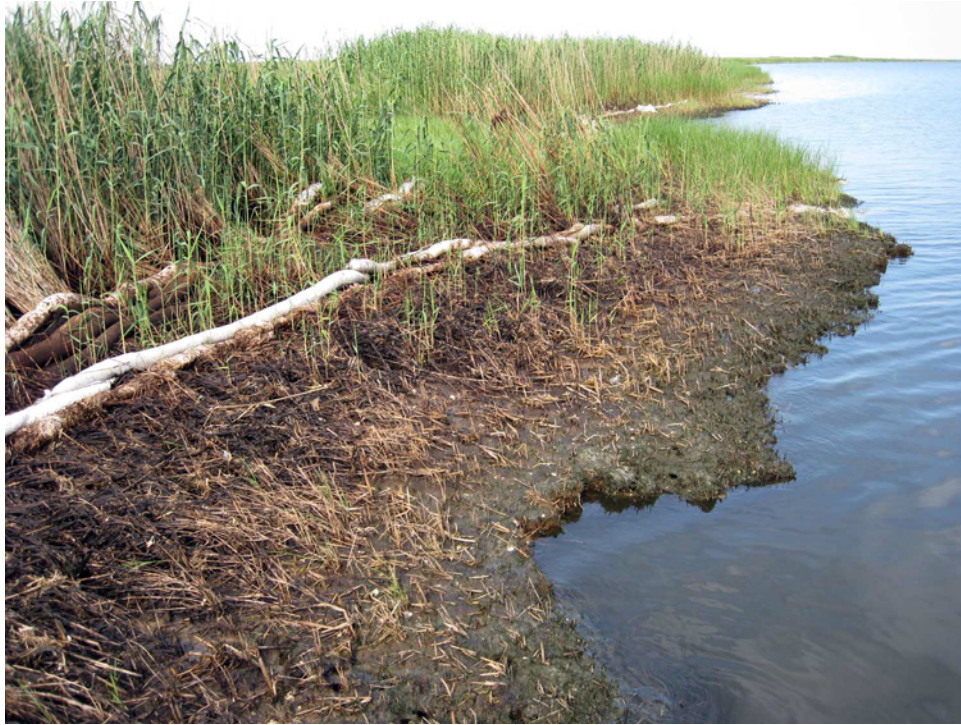
Figure 79. OBS-3-BAT-12 photo 1 taken on August 13, 2010. Site vegetation included *Phragmites australis* and *Spartina patens*. Oiled vegetation and oil-damaged canopy were observed at this site.

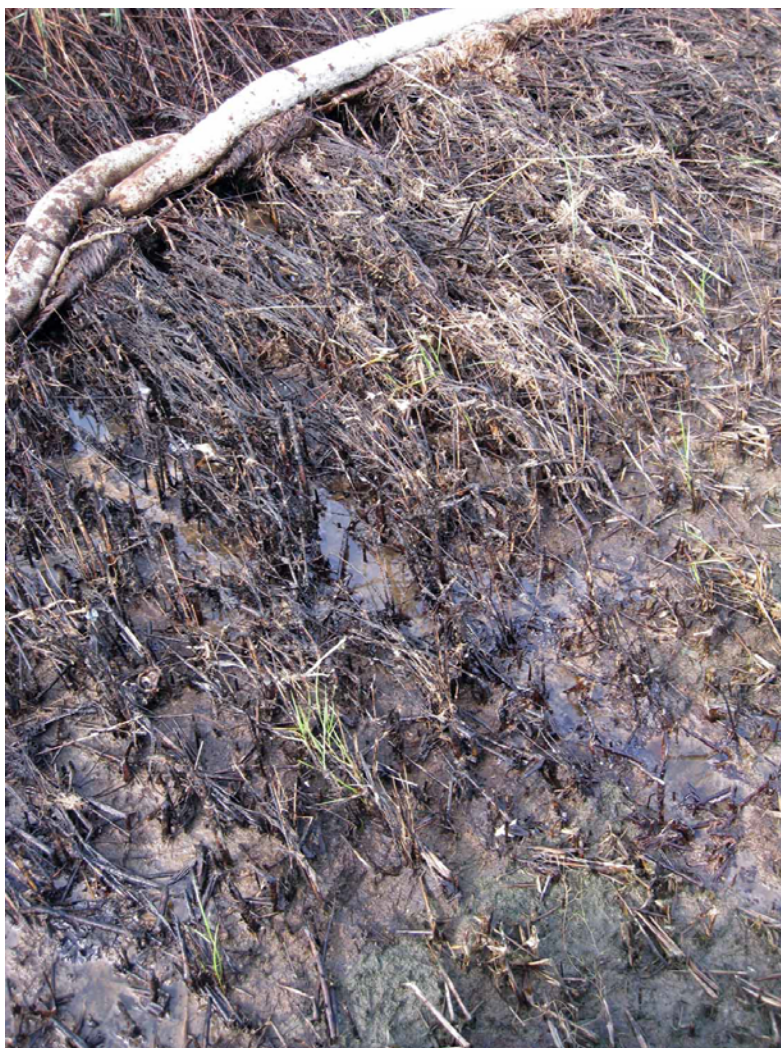
Figure 80. OBS-3-BAT-12 photo 2 taken on August 13, 2010. Site vegetation included *Phragmites australis* and *Spartina patens*. Oiled vegetation and oil-damaged canopy were observed at this site.

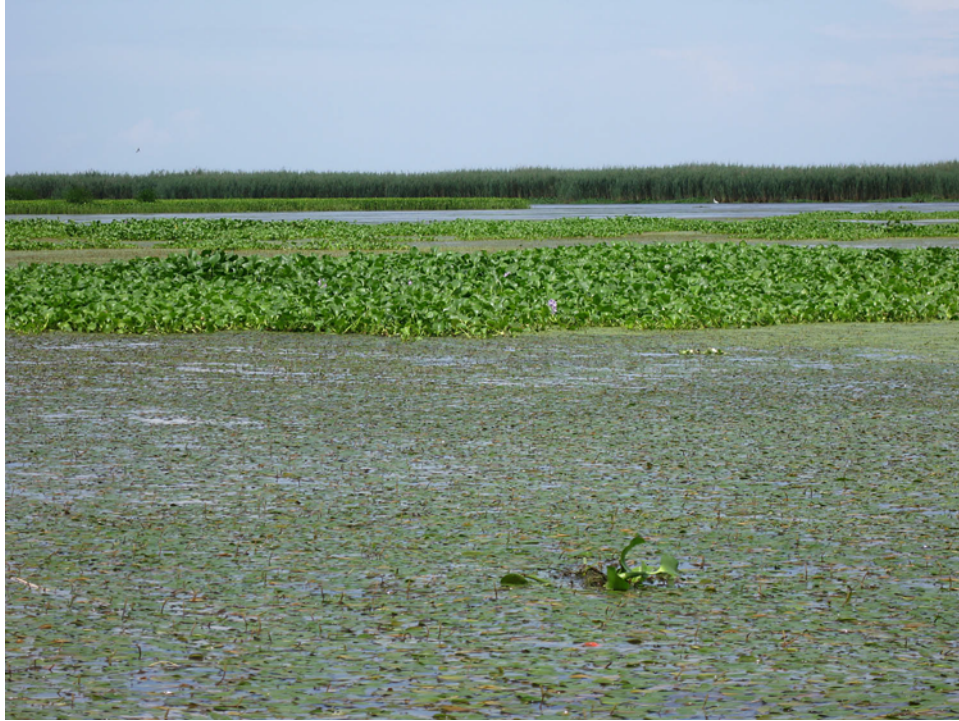
Figure 85. OBS-3-DEL-02 photo 1 taken on August 14, 2010. Site vegetation included *Nymphaea* sp. (foreground) and *Eicchornia crassipes*. Oil was not observed at this site.
