# **Shoreline Surveys of Oil-Impacted Marsh in Southern Louisiana, July to August 2010**

**Open-File Report 2011–1022**

**U.S. Department of the Interior  
U.S. Geological Survey**

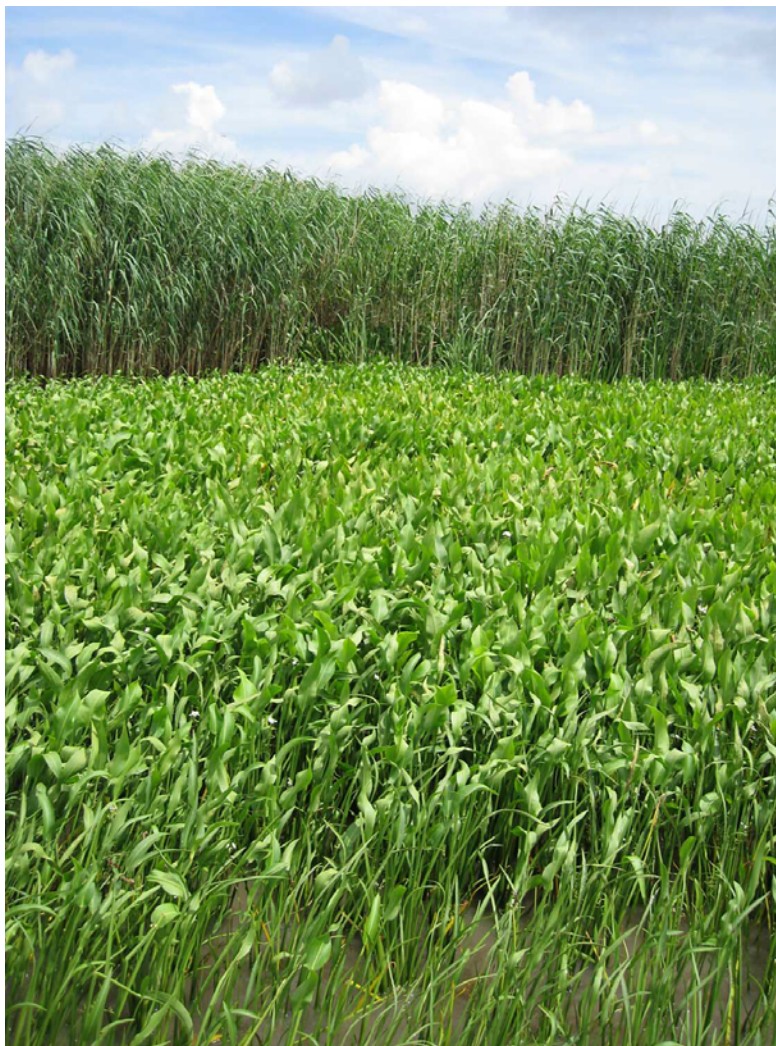
Figure 86. OBS-3-DEL-04 photo 1 taken on August 14, 2010. Site vegetation included *Sagittaria platyphylla* (foreground) and *Phragmites australis*. Oil was not observed at this site.

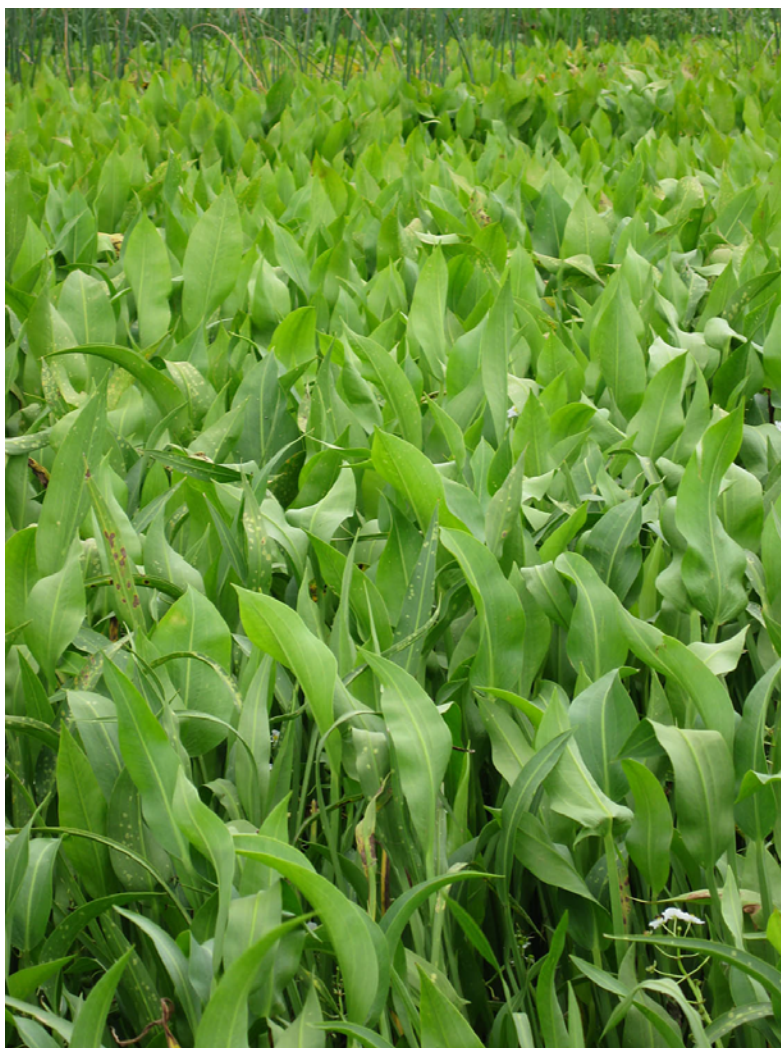
Figure 87. OBS-3-DEL-04 photo 2 taken on August 14, 2010. Site vegetation included *Sagittaria platyphylla* (foreground) and *Phragmites australis*. Oil was not observed at this site.

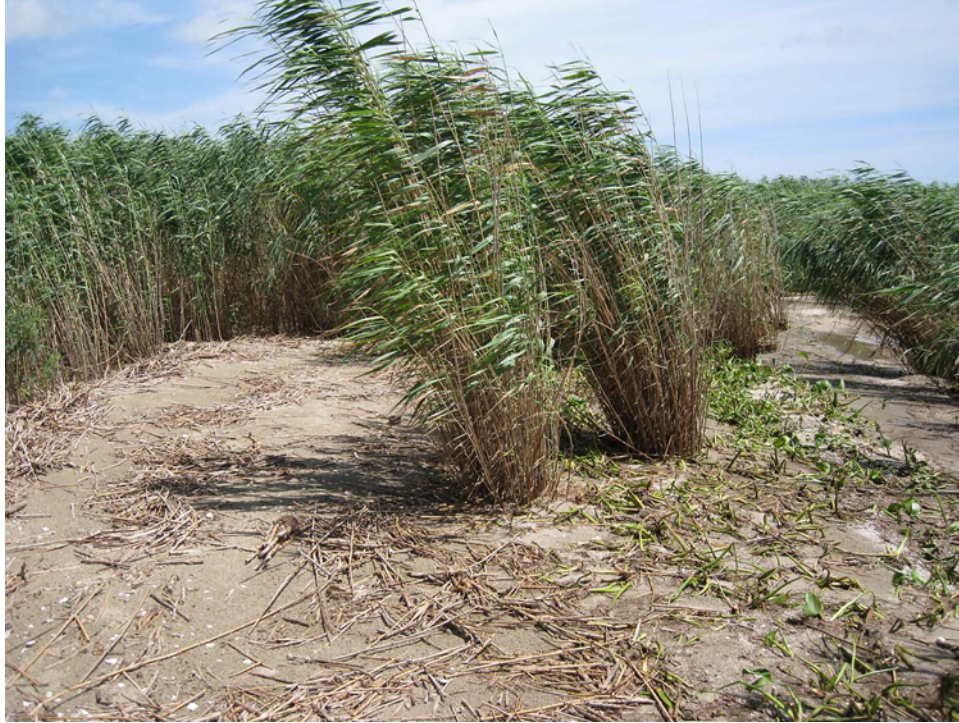
Figure 88. OBS-3-DEL-06 photo 1 taken on August 14, 2010. Site vegetation included *Phragmites australis* and *Eicchornia crassipes*. Oil was not observed at this site.
