Collection Methods, Data Compilation, and Lessons Learned from a Study of Stream Geomorphology Associated with Riparian Cattle Grazing along the Fever River, University of Wisconsin-Platteville Pioneer Agricultural Stewardship Farm, Wisconsin, 2004–11

Open-File Report 2016-1179

By Marie C. Peppler and Faith A. Fitzpatrick

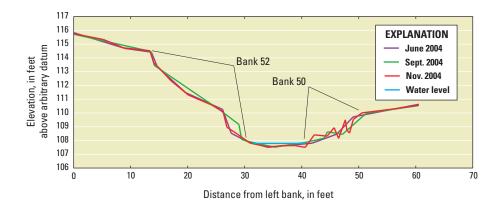
Figure 3. Changes in cross section 33 in Paddock 7 from June through November 2004.

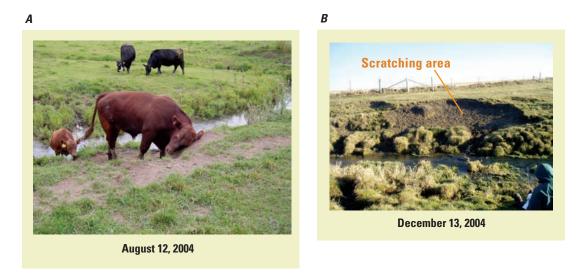
Figure 6. *A*, Cattle scratching themselves against bank 52 in Paddock 7 in August 2004, and *B*, the area where cattle scratched themselves against the bank in December 2004.

Eroding-terrace cuts are often enhanced by repeated cattle scratching. A bare spot may be formed initially by hydraulic erosion, which can lead to mass wasting at the outsides of bends or at areas of cow trampling. The bare area can then be expanded by cattle scratching. The areas used for scratching are typically scallop shaped and are formed by repeated head movement and hoof scraping (fig. 7A). Most, but not all, scratching areas have a direct hydraulic effect on the channel, because cattle paths connect the scratching areas to the stream at a non-constructed cattle crossing (fig. 7B). Eroding areas enhanced by scratching were recorded in the bank-measurement notes.

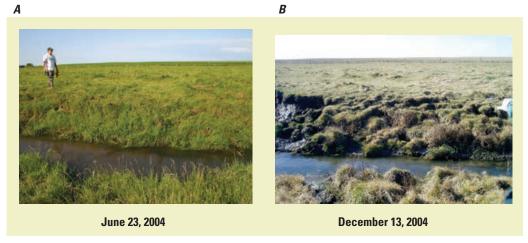
Figure 7. Development of bank slumps from cattle trampling, bank 36, Paddock 6 in 2004, *A*, in June, and *B*, in December. (Photo *A* by Randy Mentz)

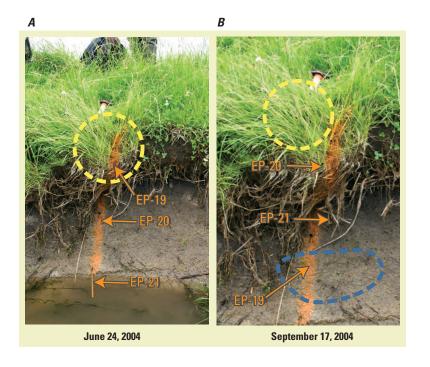
The array of three erosion pins was designed to facilitate the monitoring of mass wasting at the top of the banks, shortterm deposition at the water level, and overall erosion as the bank recedes. The typical failure mechanism for the banks was rotational block failure (fig. 8, bank 21). After the block failure at bank 21 that occurred between June 24, 2004, and September 17, 2004, the top erosion pin (EP–19) was dislodged and found in the stream in the remaining clump of slumped vegetation and roots. Depending on the amount of rotation and bank angle, sometimes the failed block would be found covering the bottom erosion pin.

Erosion pins at bank 21, Paddock 4 during a recorded bank failure in 2004, A, in June, and B, in September.

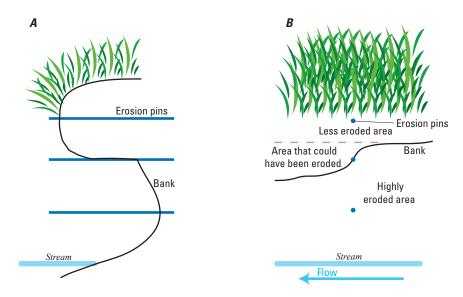
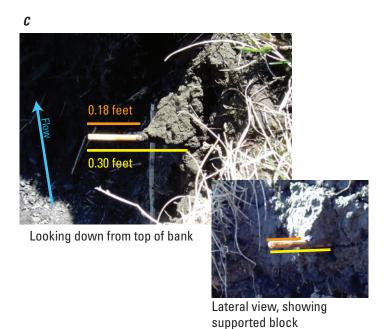
In some instances, erosion pins may prevent block failures. The erosion pins in the upper portions of the array, or the pins placed singly, as in bank 48 with EP44 and EP45, were placed to measure the block-type failures of chunks of bank that fall off the upper grassy portions of the bank. In the Fever River, undercutting is most obvious just beneath the base of the root zone, and it causes the upper sections of the banks to topple into the channel in large blocks held together by grass roots. Even a small diameter horizontal erosion pin has

the potential to keep the block from breaking loose entirely from the rest of the bank. An erosion pin can actually support a block in place at the base, perhaps stalling or preventing failure entirely (fig. 10).

Figure 9. Erosion pins providing bank protection A, in cross section, B, from instream, and photographs of C, erosion pin 19 with measurements on April 8, 2005.
