Castle Creek Tributary No. 2 near Rochford, South Dakota

(Miscellaneous ungaged site in the Cheyenne River basin,
USGS South Dakota Water Science Center)

Review of peak discharge for the flood of July 28, 1955

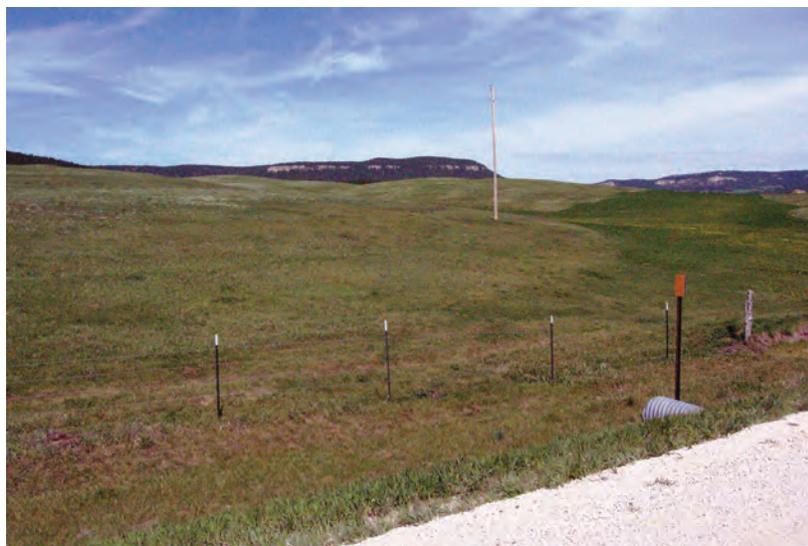
The original 18-in. culvert has been replaced with a 24-in. diameter culvert with spiraled corrugation. Therefore, the unusual entrance condition noted in the survey could not be examined. The county road also has been raised perhaps 1–2 ft and widened; the present culvert is about 50 ft long, whereas the original culvert length was 24 ft. Ralph Teller spoke to the county road crew chief, Heine Junge, who confirmed that the roadway has changed since 1955. It is unlikely, however, that there have been any significant changes to the basin that produced the flood. That basin, which is about 600 ft wide and extends about 1,000 ft upstream, has grass cover and no trees. Upstream from the roadway, the waterways are grassy swales, and there are no defined channels. Flow during extreme storms would essentially arrive at the roadway as sheet flow that converges at the culvert.

Figure A232. View looking upstream at the basin that produced the 1955 flood, Castle Creek Tributary No. 2 near Rochford, South Dakota, May 29, 2002. The basin perimeter is the grassed ridge in the near foreground (perhaps 300 yards away). The 1955 18-in. culvert has been replaced with a 24-in. culvert, and the road fill has been raised and is about twice as wide.

Recommendations: The original peak discharge of 98.9 ft³/s should be accepted as published, but rounded to 100 ft³/s, and rated fair.
