East Bijou Creek at Deertrail, Colorado

Review of peak discharge for the flood of June 17, 1965

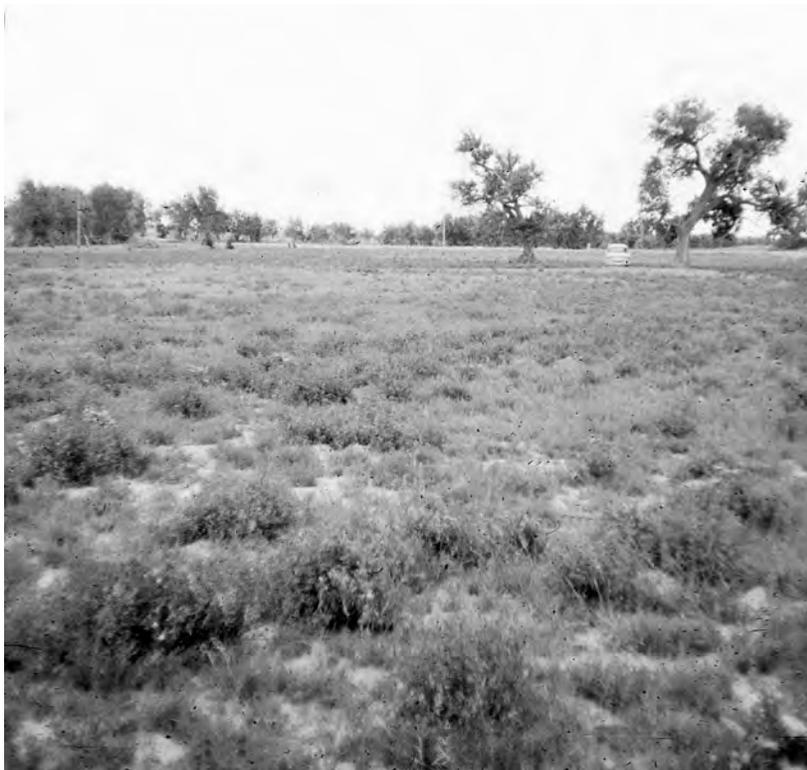
Figure A95. View of flood plain looking toward channel in slope-area reach, East Bijou Creek at Deertrail, Colorado, June 1965.

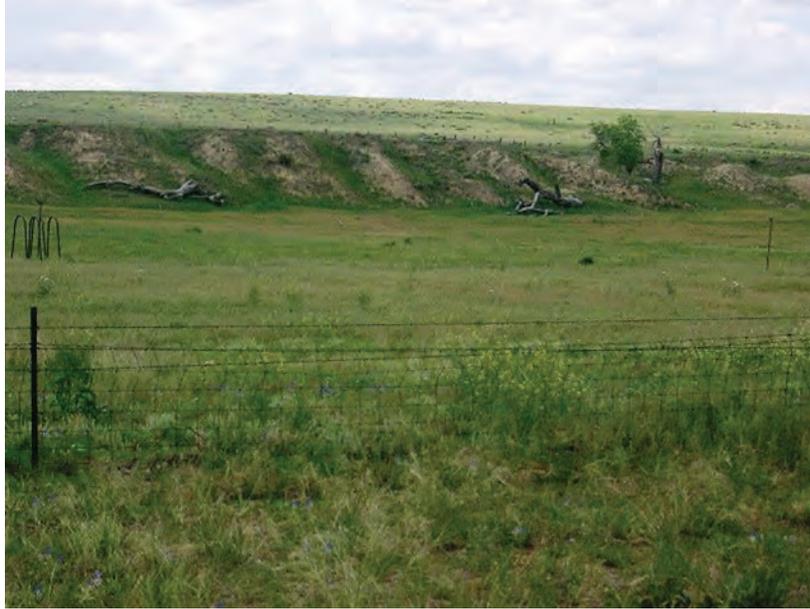
Figure A96. View looking across flood plain toward left bank high-water mark (woody debris), East Bijou Creek at Deertrail, Colorado, June 3, 2003.

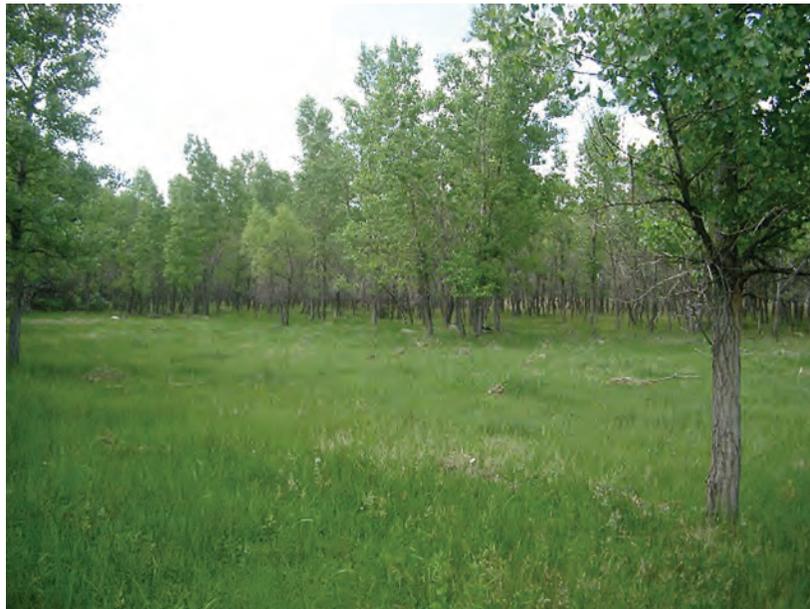
Figure A97. View of flood plain looking downstream with main channel in tree line, East Bijou Creek at Deertrail, Colorado, June 3, 2003.

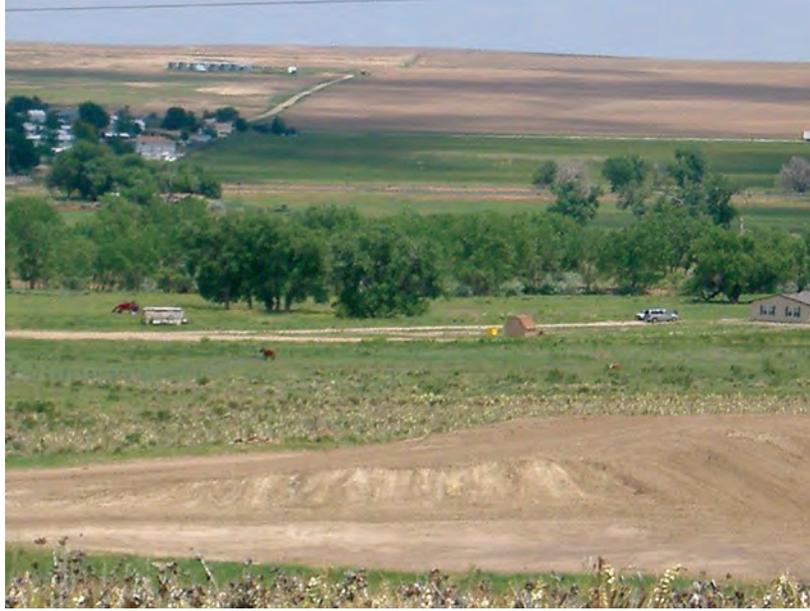
Figure A98. View from left valley side looking across flood plain and main channel toward slope-area reach, East Bijou Creek at Deertrail, Colorado, June 3, 2003. (Flow is from right to left.)

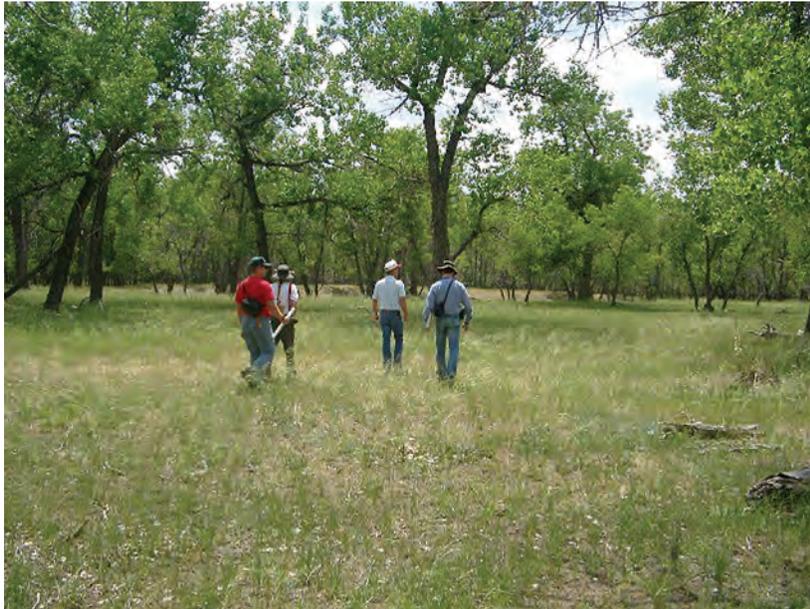
Figure A99. Walking on flood-plain surface toward main channel in slope-area reach, East Bijou Creek at Deertrail, Colorado, June 3, 2003. (Flow was 5-6 feet deep at this point during the 1965 flood.)
