Meyers Canyon near Mitchell, Oregon

(Miscellaneous ungaged site in the add John Day River basin,
USGS Oregon Water Science Center)

Review of peak discharge for flood of July 13, 1956

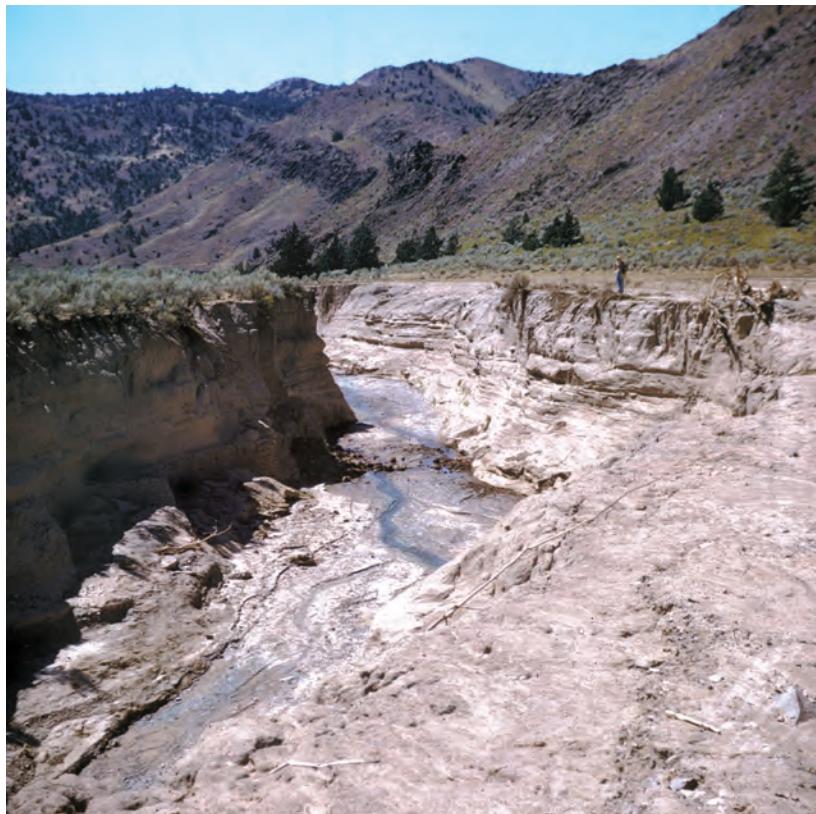
Figure A157. View looking downstream of slope-area reach, Meyers Canyon near Mitchell, Oregon, July 1956. Man standing at cross section B.

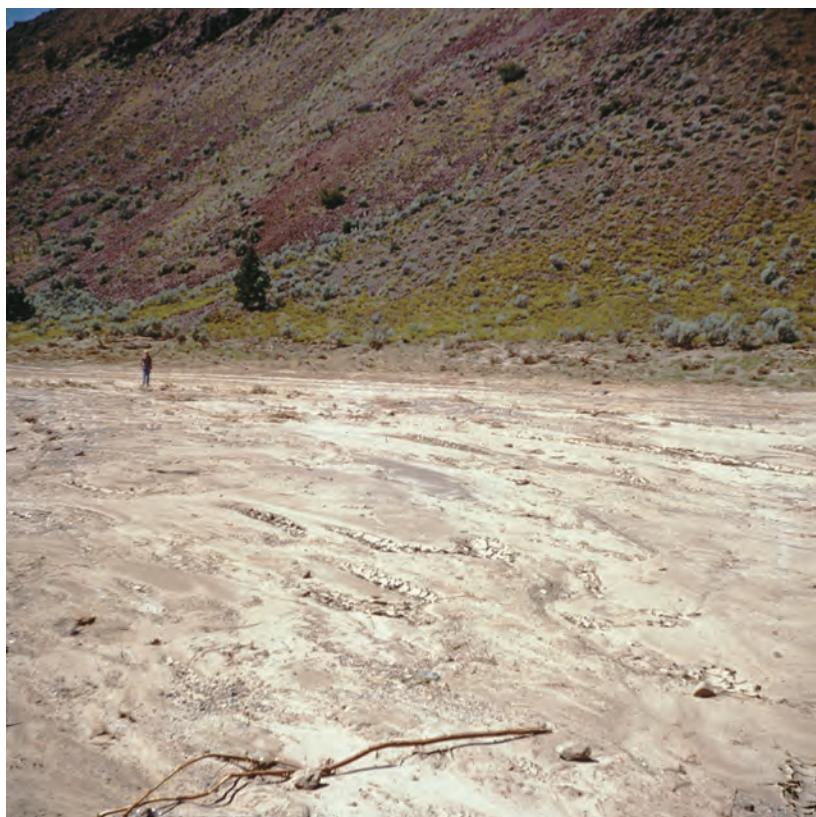
Figure A158. View of right-bank overflow, Meyers Canyon near Mitchell, Oregon, July 1956. Man standing at cross section B.

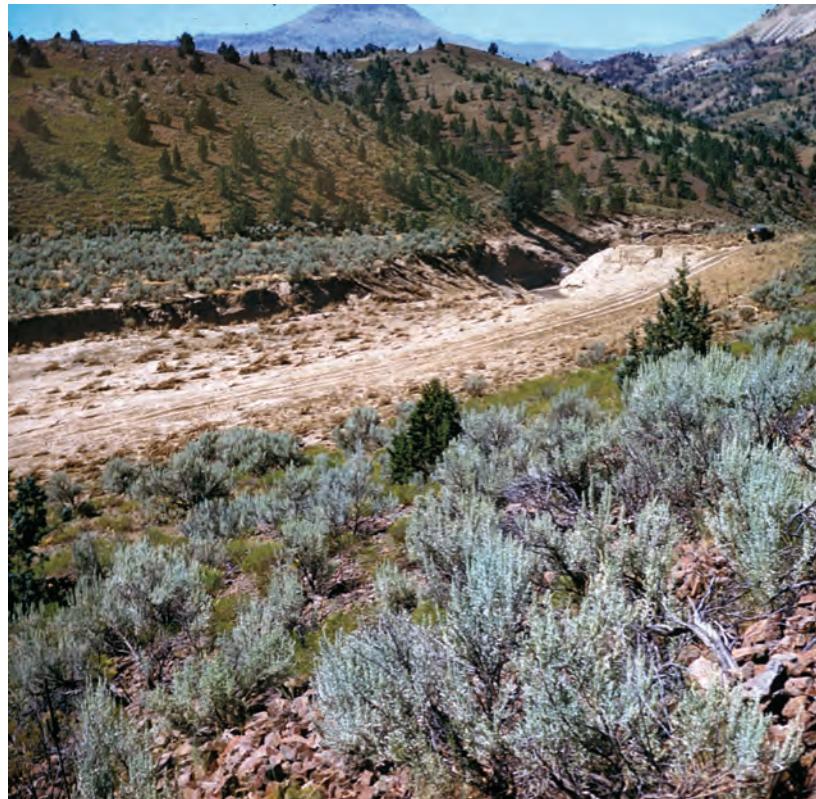
Figure A159. View looking downstream from above cross section B on right bank, Meyers Canyon near Mitchell, Oregon, July 1956.

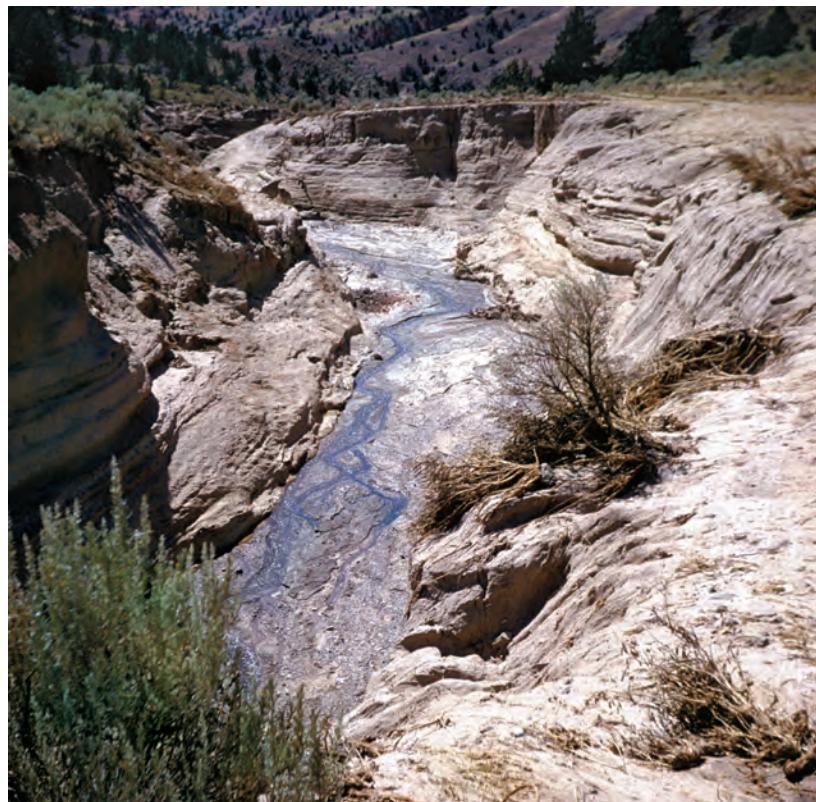
Figure A160. View looking downstream of cross section B to cross section C, Meyers Canyon near Mitchell, Oregon, July 1956.

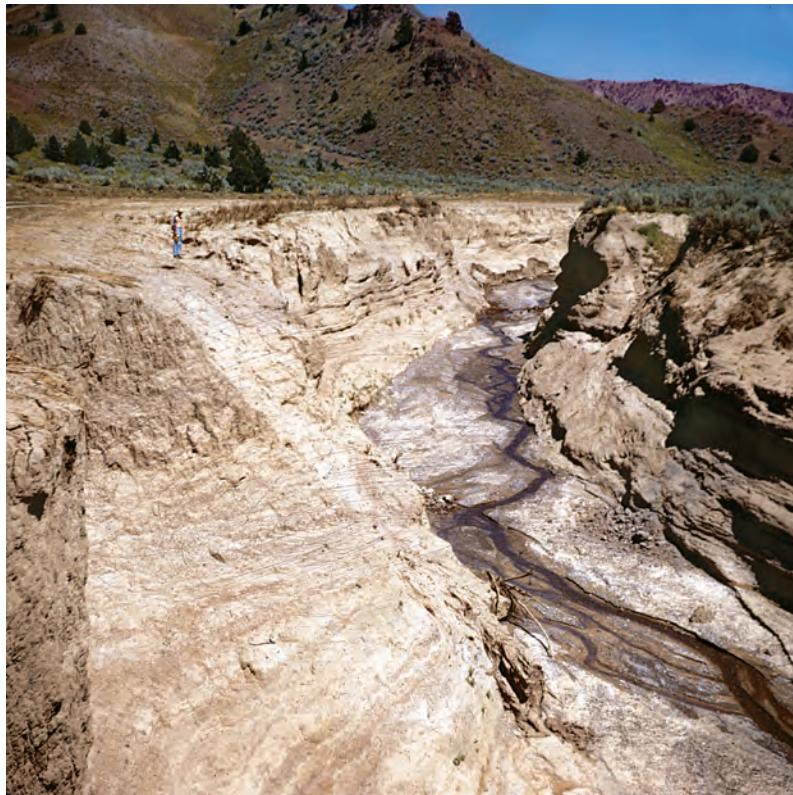
Figure A161. View looking upstream from downstream from cross section C, Meyers Canyon near Mitchell, Oregon, July 1956. Man standing at cross section C.

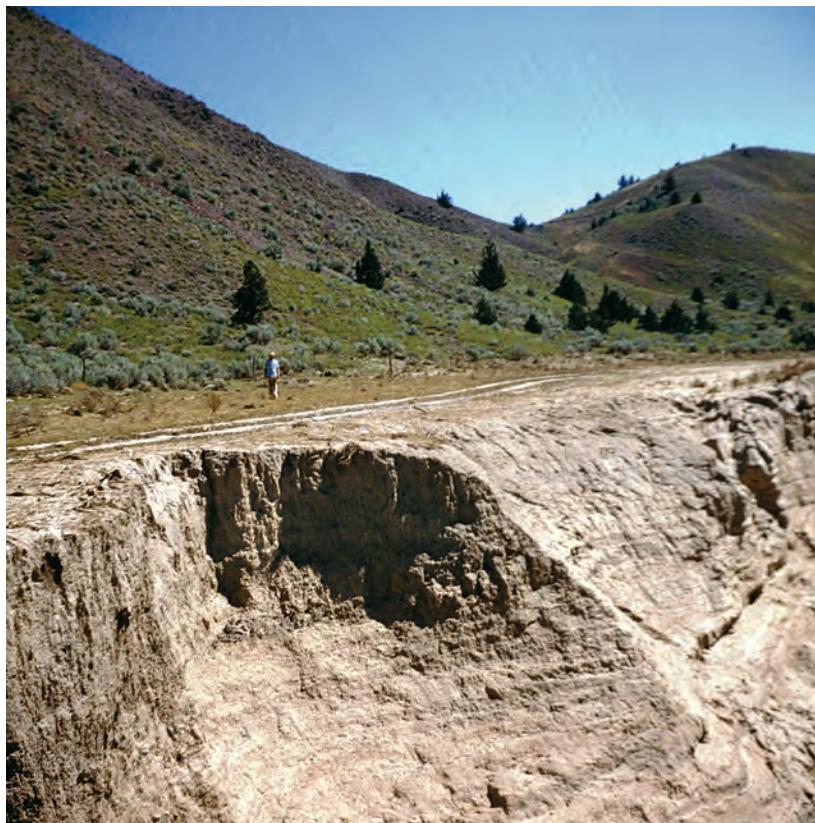
Figure A162. View looking upstream, Meyers Canyon near Mitchell, Oregon, July 1956. Man standing on right bank at cross section C.

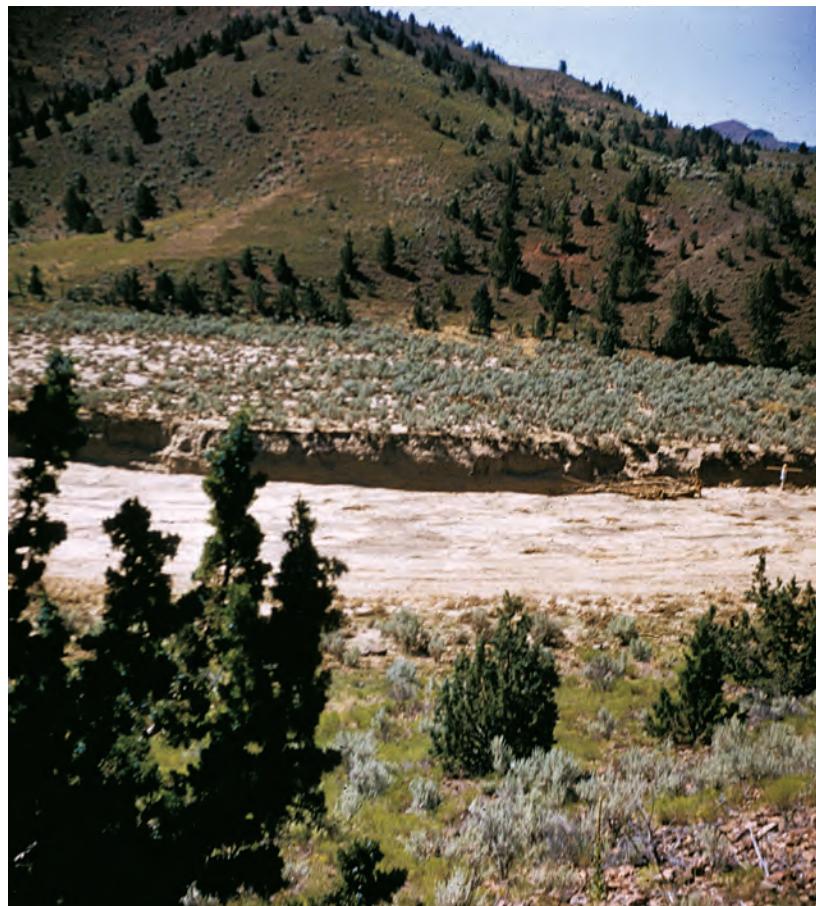
Figure A163. View looking from right to left bank, Meyers Canyon near Mitchell, Oregon, July 1956. Man standing at cross section C.

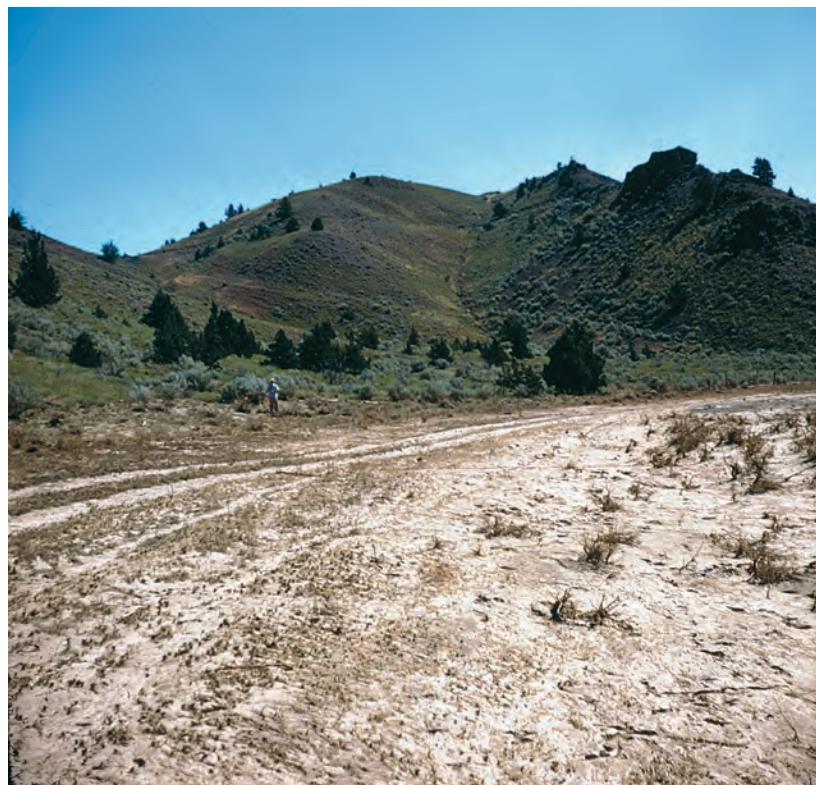
Figure A164. View looking upstream to cross section B, Meyers Canyon near Mitchell, Oregon, July 1956.

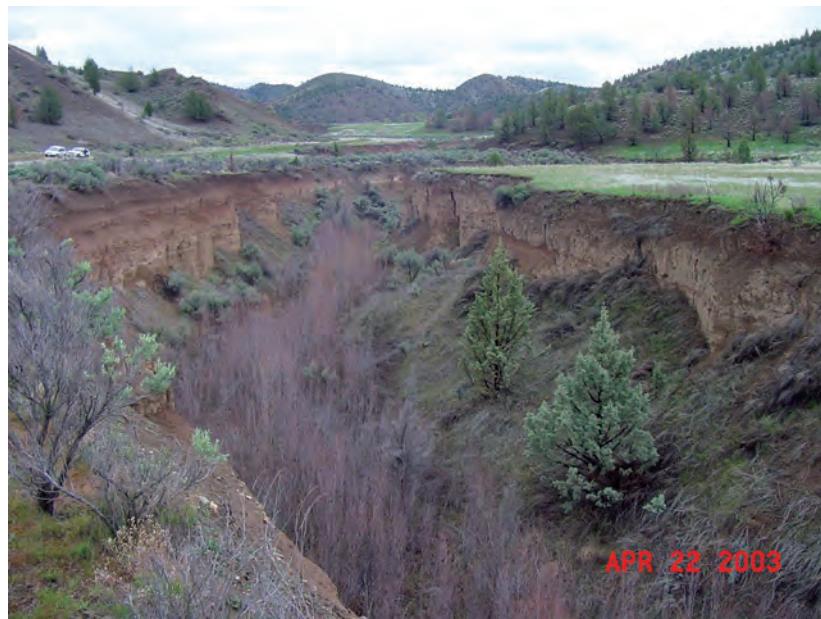
Figure A165. View looking upstream toward slope-area reach, Meyers Canyon near Mitchell, Oregon, April 22, 2003.

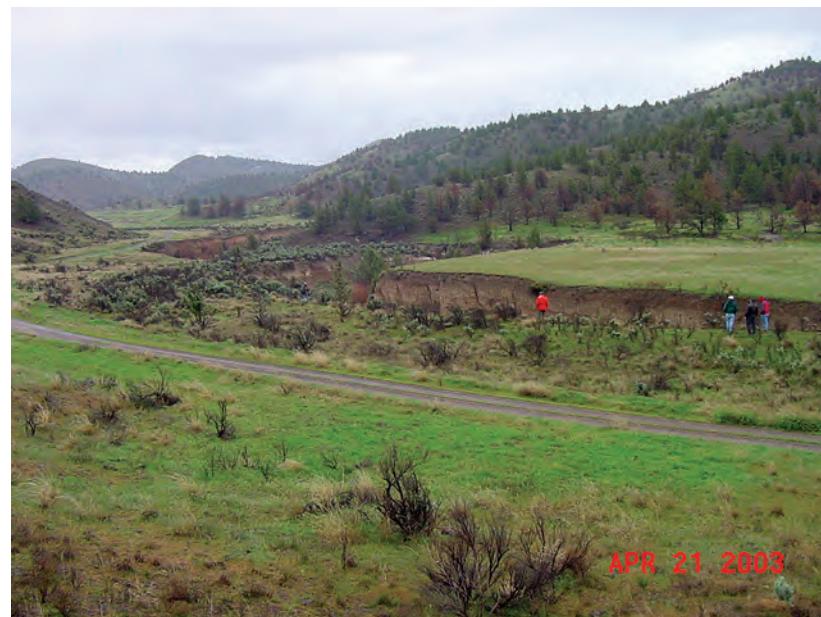
Figure A166. View looking upstream from right-bank hillslope across to slope-area reach, Meyers Canyon near Mitchell, Oregon, April 21, 2003.

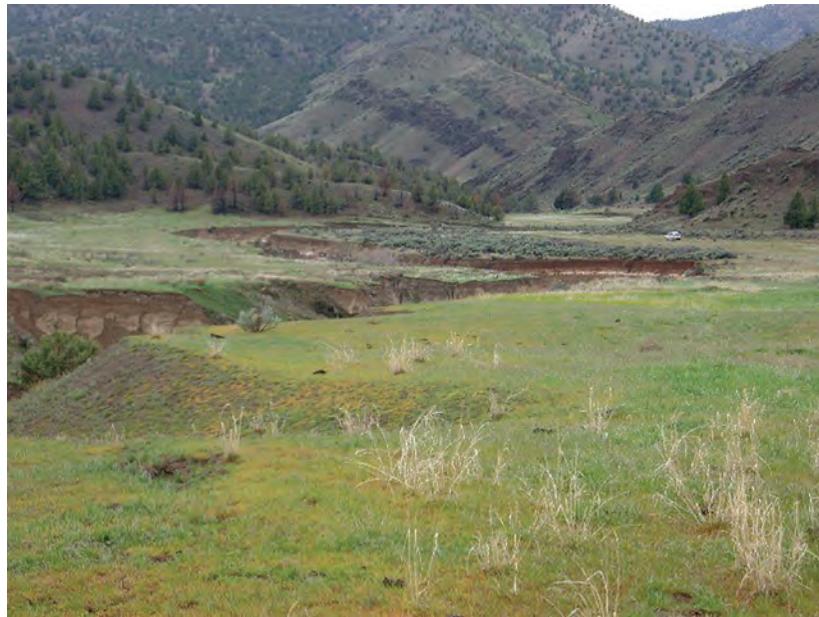
Figure A167. View looking downstream from area on right bank where flow likely broke out of canyon, Meyers Canyon near Mitchell, Oregon, April 21, 2003.

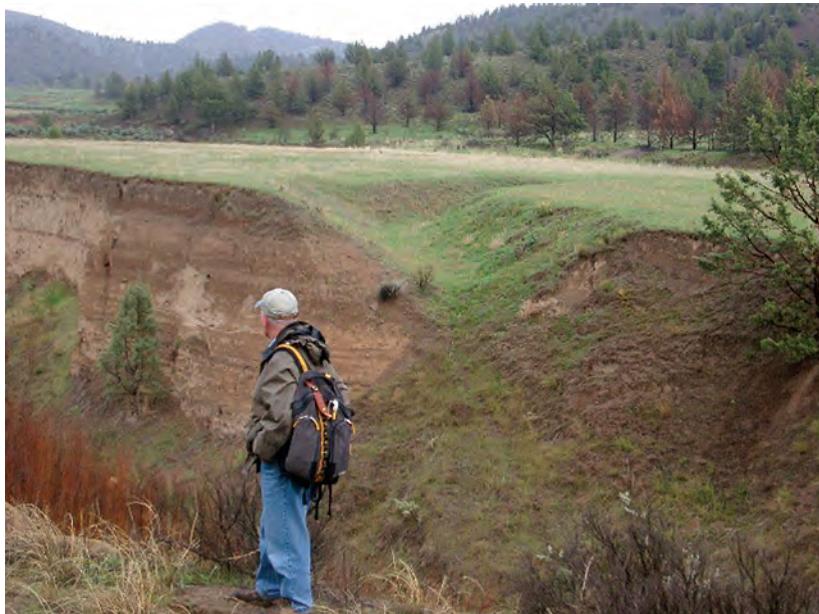
Figure A168. View from right bank looking across canyon toward possible return-flow gully that channeled flood-plain overflow back into canyon, Meyers Canyon near Mitchell, Oregon, April 21, 2003.

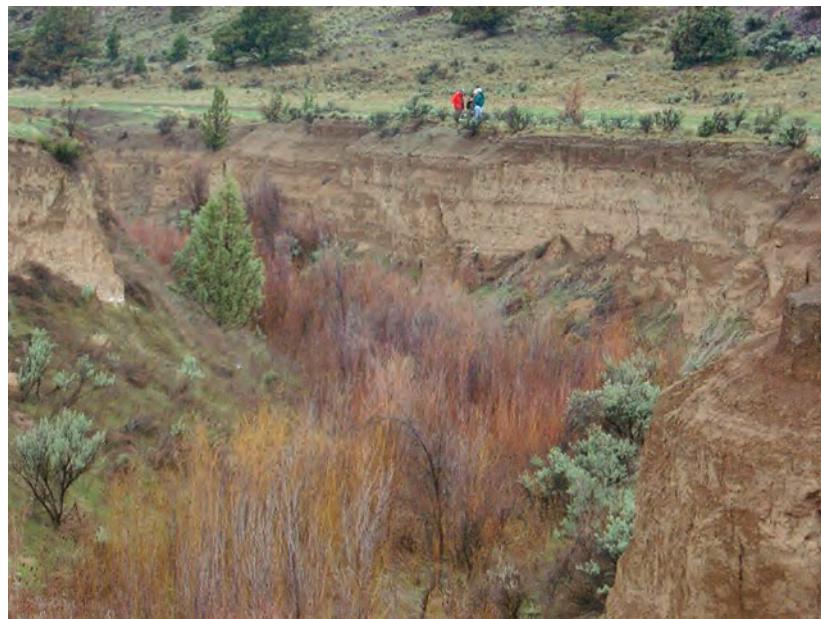
Figure A169. View looking downstream from left bank toward right bank and people standing in slope-area reach, Meyers Canyon near Mitchell, Oregon, April 21, 2003.

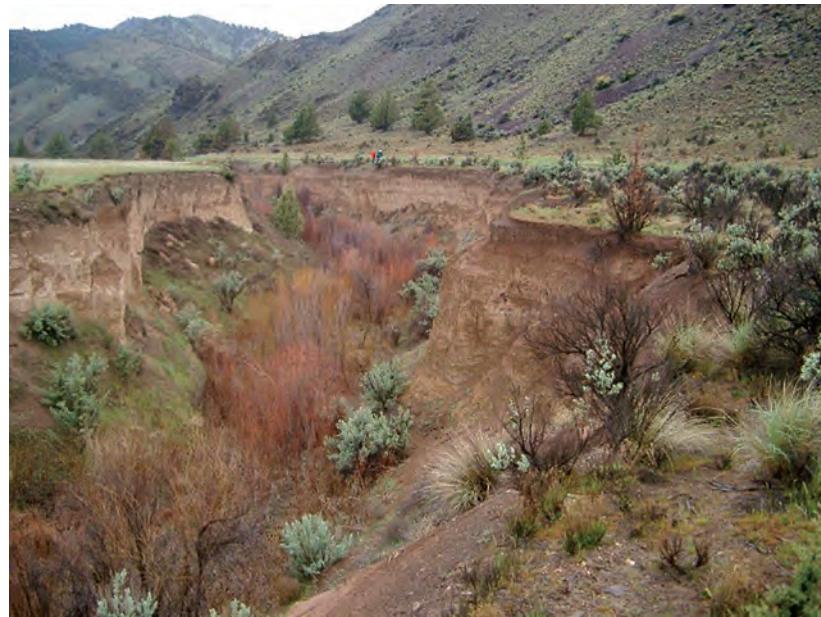
Figure A170. View looking downstream into main canyon toward slope-area reach, Meyers Canyon near Mitchell, Oregon, April 21, 2003.

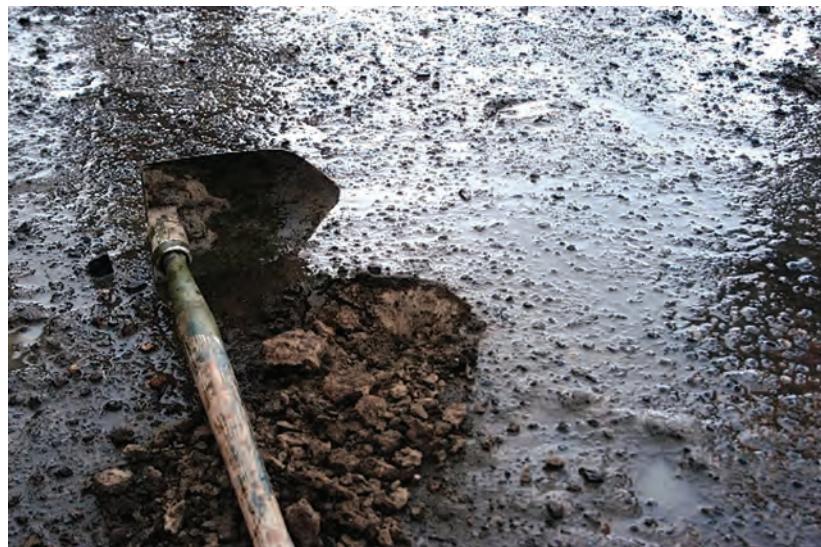
Figure A171. Overland flow following rainfall in upstream part of Meyers Canyon Basin, Oregon, April 21, 2003. Almost no infiltration into fine-grained surficial material.
