**EFFECT OF BANK PROTECTION MEASURES,  
STEHEKIN RIVER, CHELAN COUNTY, WASHINGTON**

**Water-Resources Investigations Report 85-4316**

**Prepared in cooperation with the  
NATIONAL PARK SERVICE**

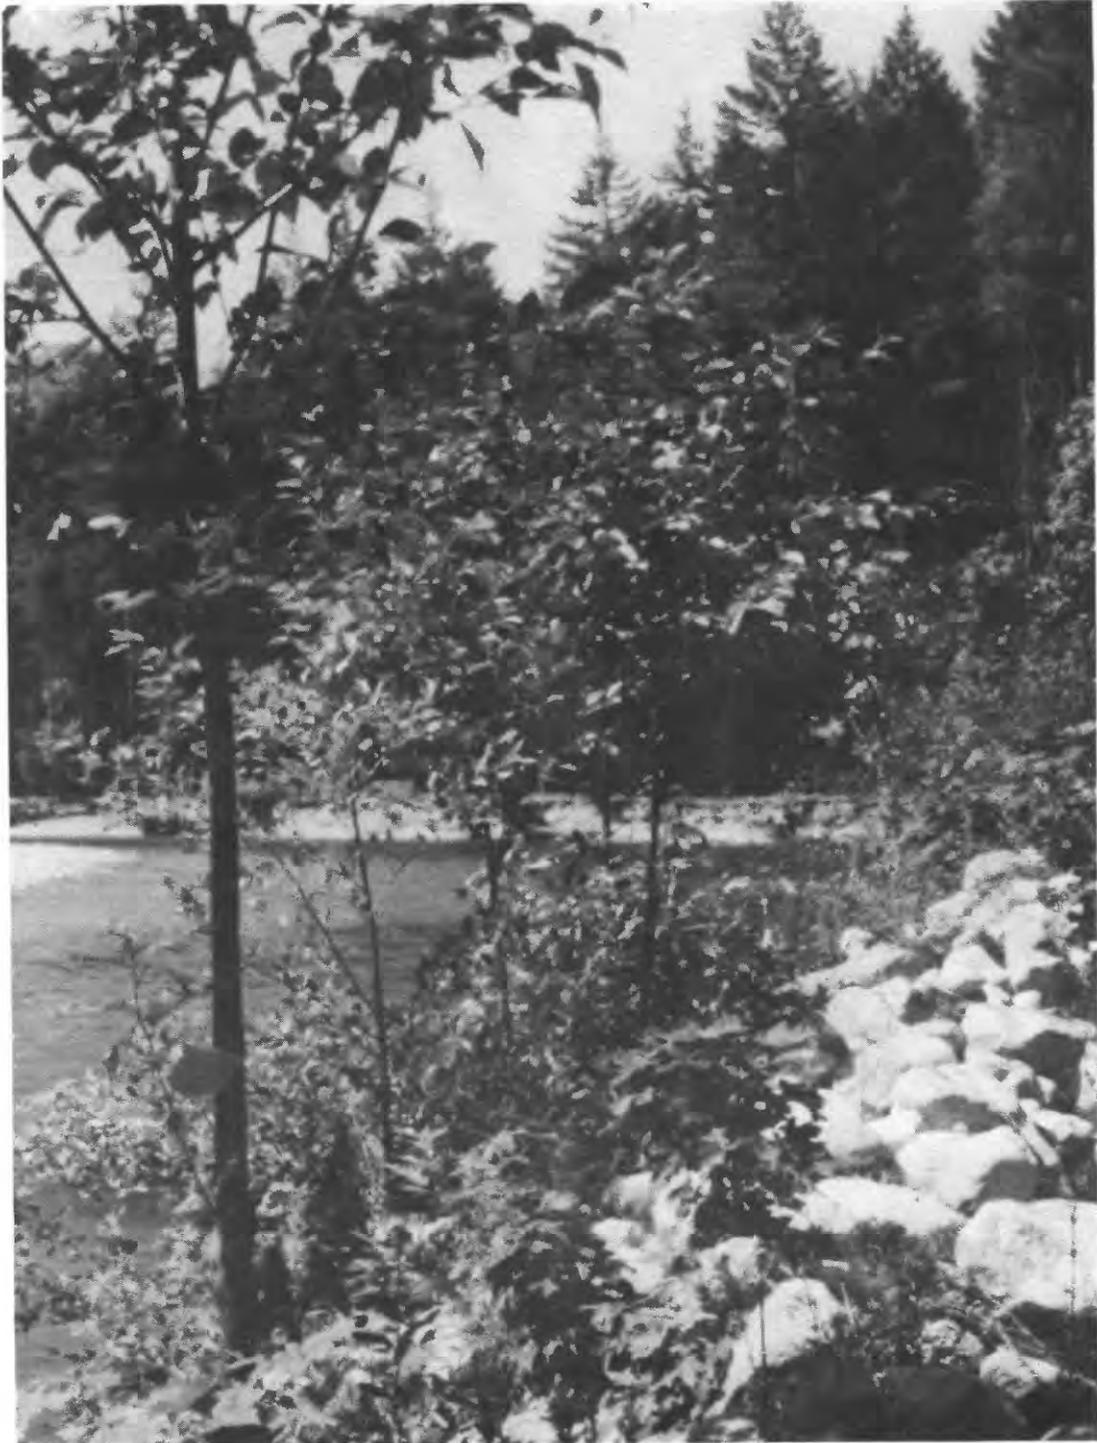
FIGURE 2. – View of eroding bank (center background), looking upstream of site 1.

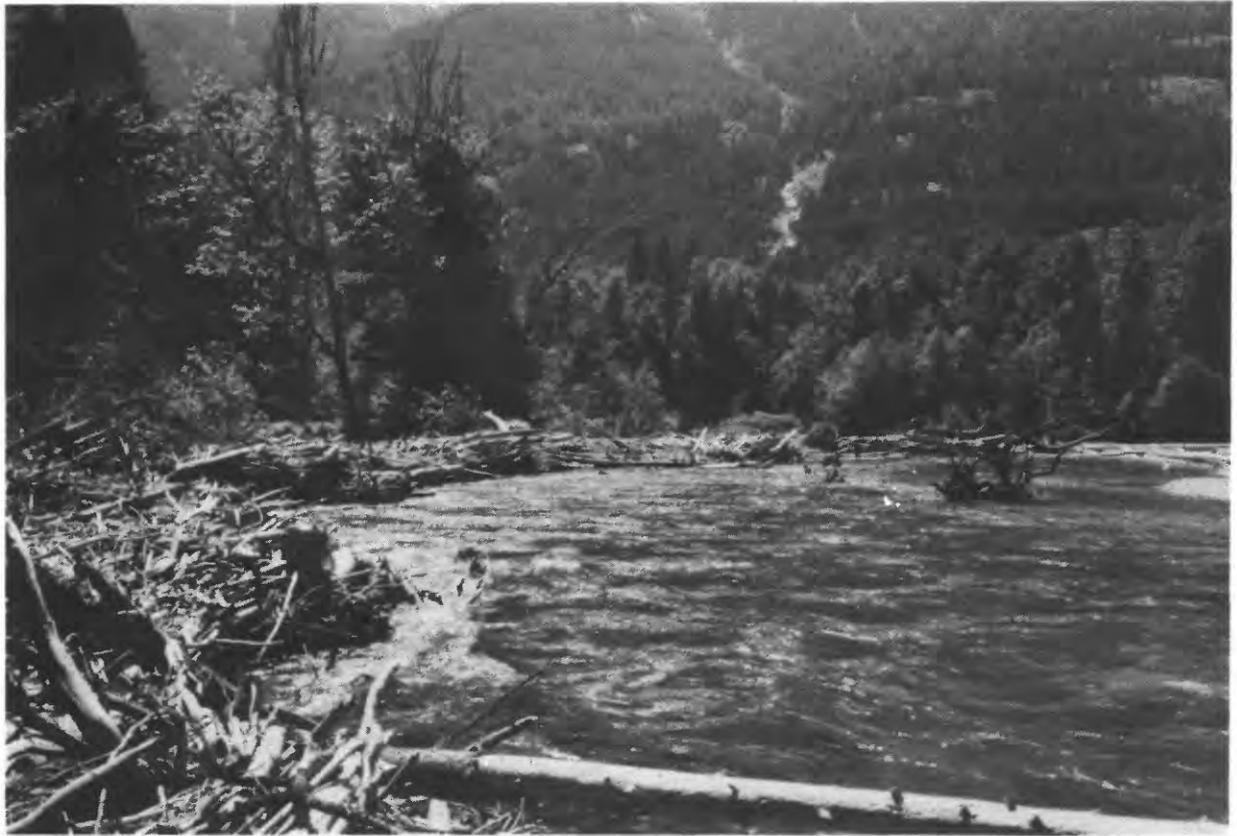
As bank erosion progresses, trees are undermined, eventually toppling into the river to form floating debris that often lodges somewhere in or along the channel. In some cases, as shown in the photograph in figure 3, extensive amounts of such debris can lodge on the outside of bends and provide a natural barrier against erosion. In other cases, particularly near the river's mouth, debris jams in the channel have caused the cutting of new channels and the abandonment of old channels.

FIGURE 3. – View looking downstream at the accumulation of natural debris protecting the outside of a river bend upstream of site 7.

Sites 6 and 7 are on the outside of a river bend (fig. 7). At site 6 some erosion is evident, but at site 7 the accumulation of debris is essentially armoring the riverbank (fig. 3). As indicated in table 4, the use of armor at any of these sites causes little change in flood velocities and elevations, except at cross section AA where some increases would occur.

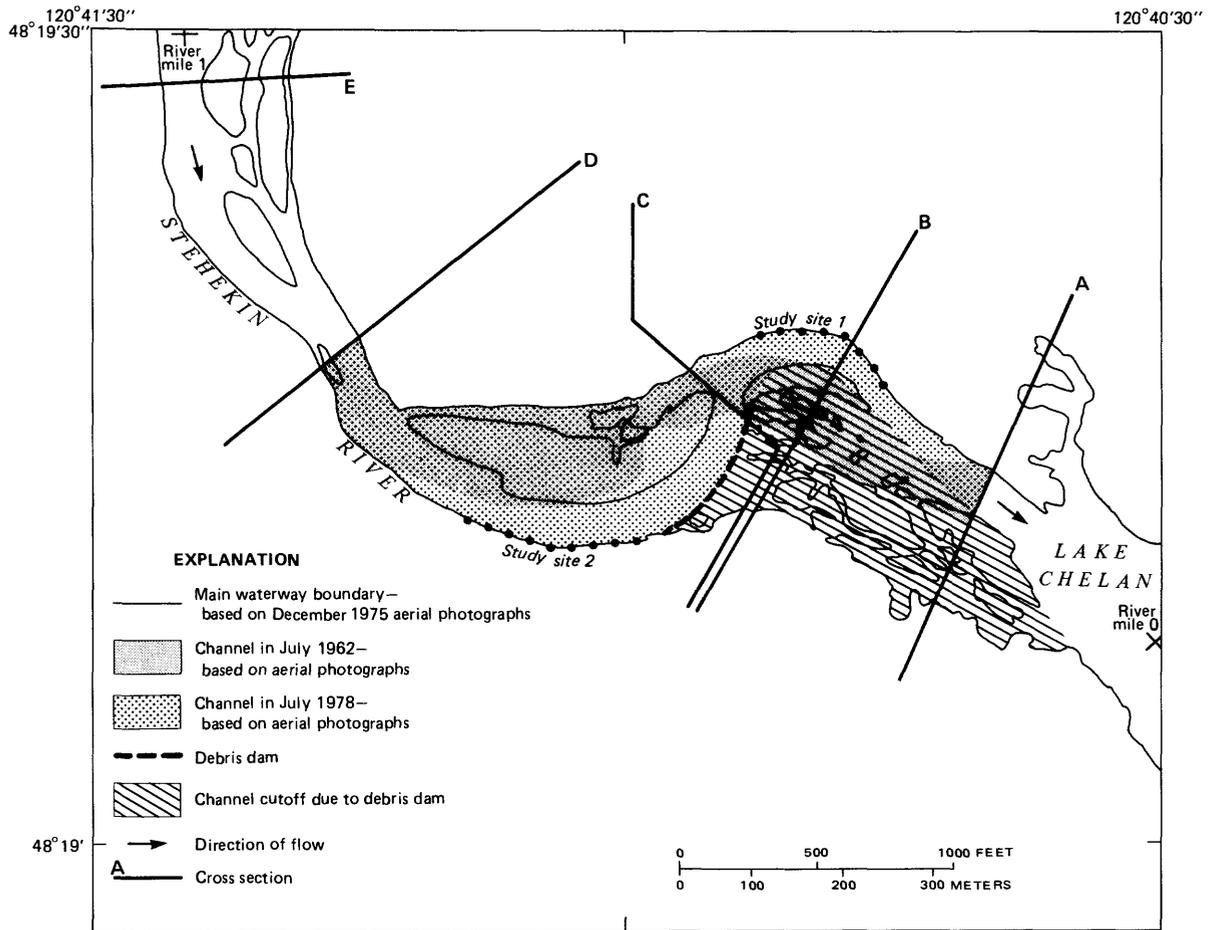
Boundaries based on aerial photographs from 1962 have been sketched in figures 5 and 6 to indicate the considerable erosion that has occurred relative to the conditions in 1975. The 1978 boundaries are also shown on figure 5. These changes are most pronounced from 1962 to 1975, particularly at sites 1, 2, 3, and 4. At these sites, some of the banks appear to have eroded 100 to 200 feet in length along bends. Much of the change probably occurred in June 1974 during the highest flow of the 1962 to 1975 period.

FIGURE 5. — Channel changes at Stehekin River sites 1 and 2  
(from Federal Emergency Management Agency, 1980).

The erosion caused by flow directed toward the north bank between cross sections B and C at site 1 (fig. 5) could possibly be eliminated by rerouting the flow through the old cutoff channel at cross section B. The large debris dam blocking the upstream end of the old channel and the overgrown vegetation in the old channel would need to be removed and the existing open channel closed in order to reroute the flow. Routing the entire flow through this channel, which is smaller than the existing channel, caused a velocity increase of 3.2 feet per second and an elevation increase of 1 foot at cross section B (table 2). At cross section D the velocity decreased 0.9 foot per second and elevation increased 1 foot. Changes further upstream were insignificant. If the old cutoff channel were to be opened and the existing open channel were to remain open, some of the flood flow would be diverted away from site 1, which would likely reduce flood velocities and elevations, but the investigation of this condition was not within the scope of this study.

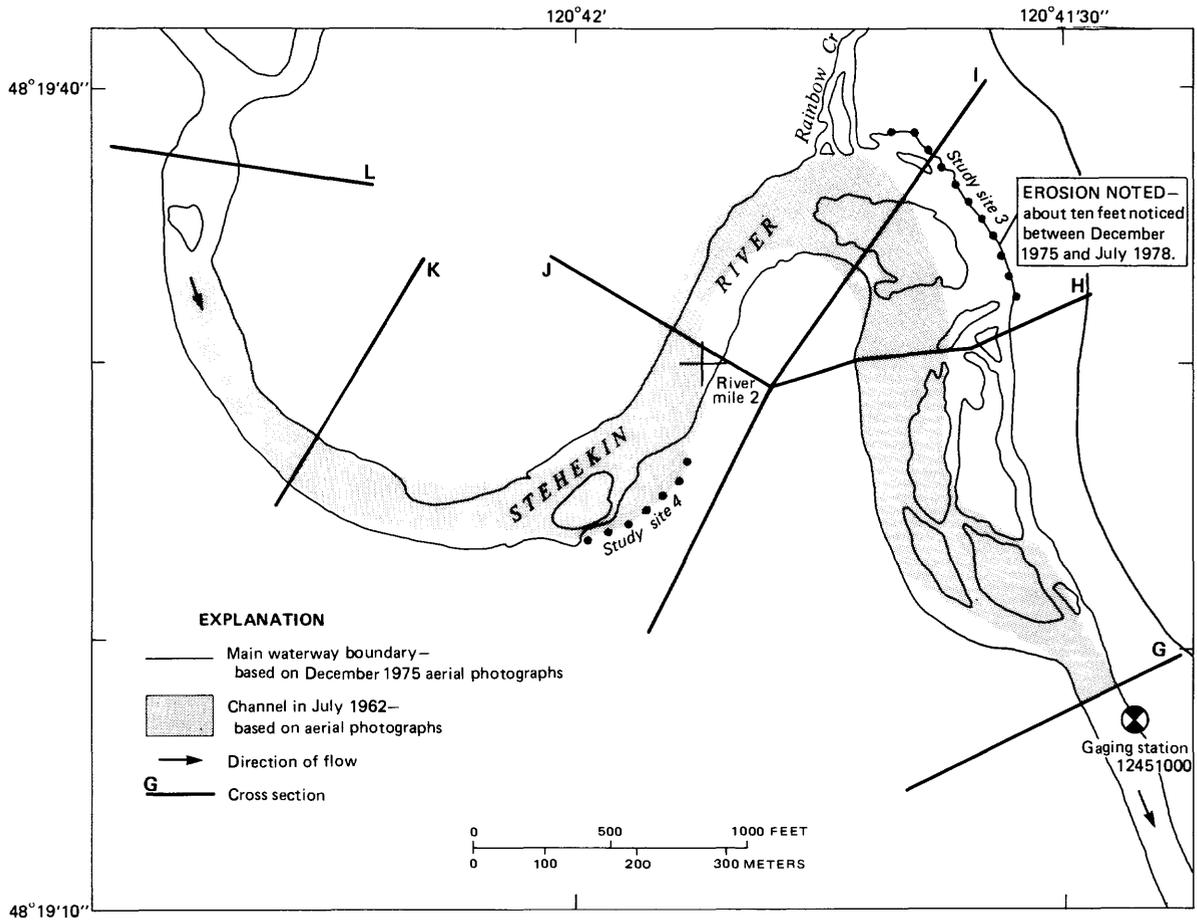
FIGURE 6. — Channel changes at Stehekin River sites 3 and 4 (from Federal Emergency Management Agency, 1980).

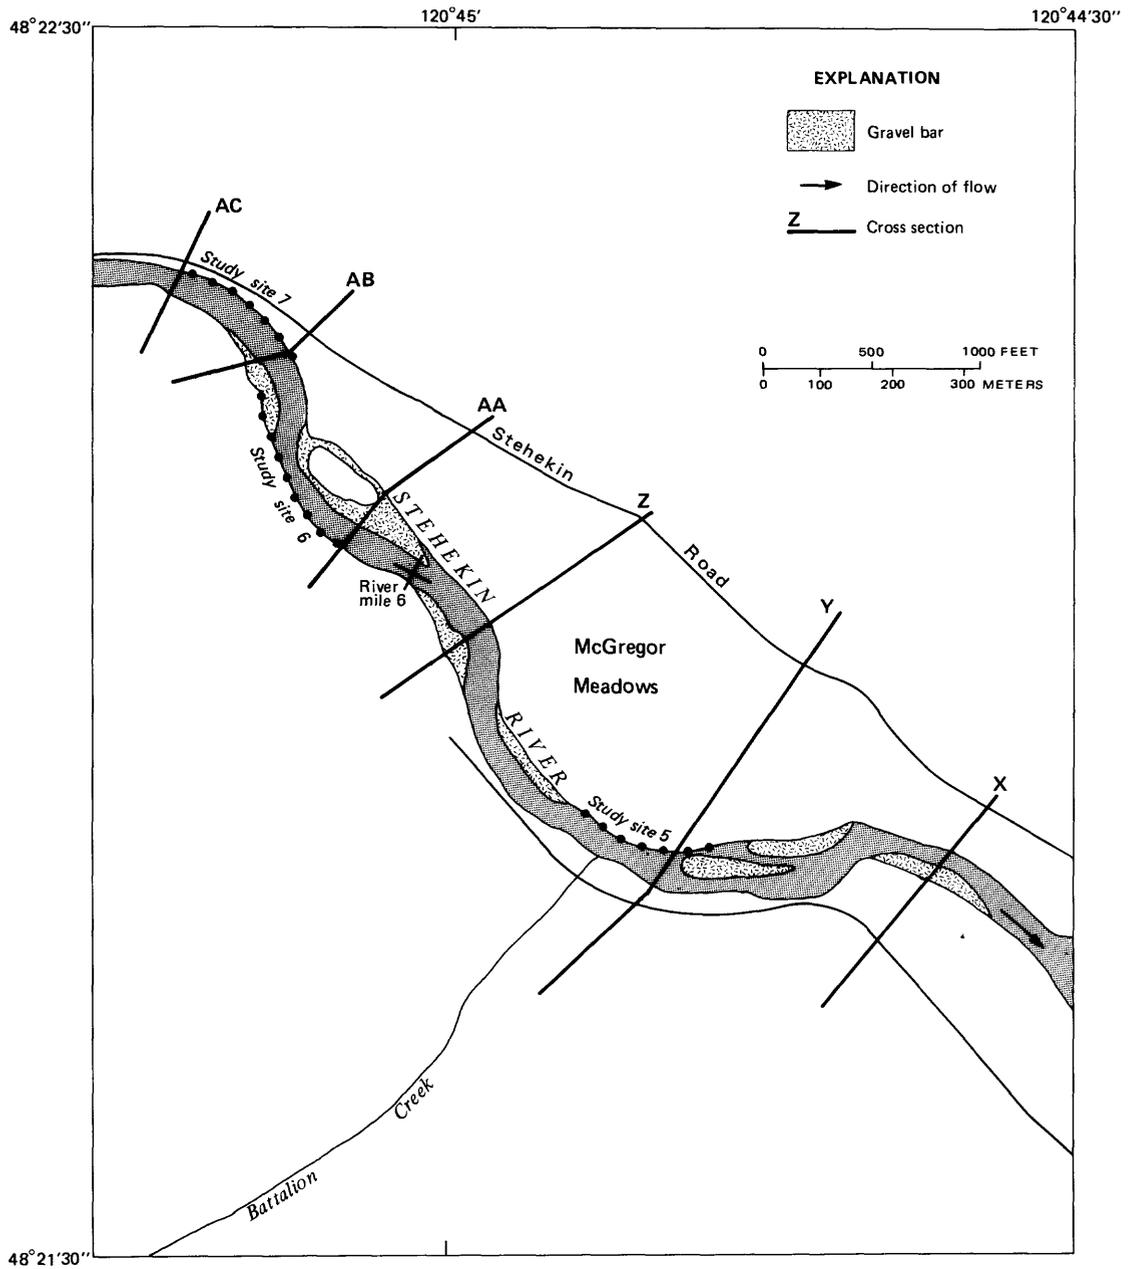
FIGURE 7. – The July 1978 channel configuration of the Stehekin River at sites 5, 6, and 7 (from aerial photographs).
