An Account of Preliminary Landslide Damage and Losses Resulting from the February 28, 2001, Nisqually, Washington, Earthquake

Open-File Report 03-211

U.S. Department of the Interior
U.S. Geological Survey

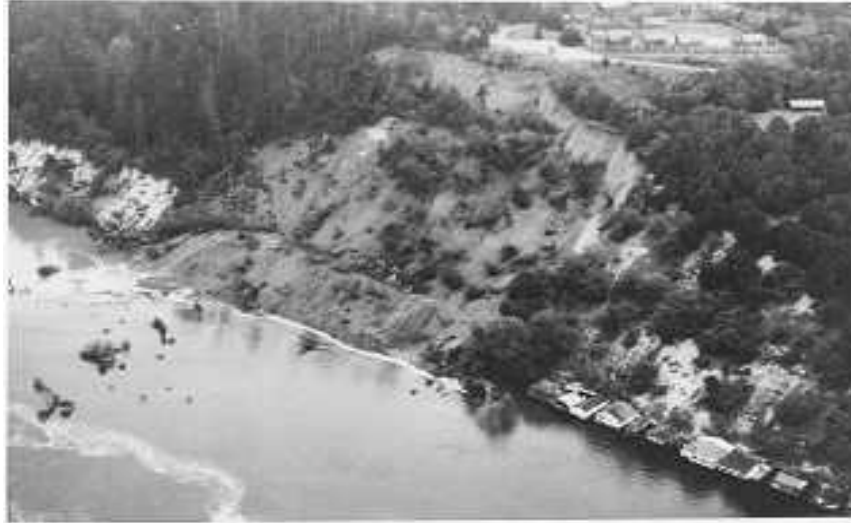
Figure 2—Salmon Beach, near Tacoma, Washington area after the 1949 Puget Sound earthquake (Photo by Associated Press).

Salmon Beach, a community located north of the Tacoma Narrows bridge, near Point Defiance and Tacoma, Washington, was previously damaged by landslides that occurred as a result of the 1949 Puget Sound earthquake (Figure 2). Landslides occurred here again during the 2001 Nisqually earthquake and the Salmon Beach landslide is considered to be the landslide with the current highest hazard (Figure 3). This landslide was approximately 1,000 cubic meters (1,300 cubic yards) in volume, and demolished two houses (Figures 4 and 5) located at the base of the steep bluff along the shores of Puget Sound. A larger slide of about 10,000-20,000 cubic meters (13,000 to 26,000 cubic yards) of material remained poised on the slopes above the houses and threatened eight additional dwellings. This larger slide slid between 20 and 25 feet (6.6 and 8.3 meters) and has a scarp 20 to 25 feet (6.6 to 8.3 meters) high and approximately 20 feet (60 meters) in length along the top of the bluff. Eight houses were red-tagged as a result of inspection by Pierce County officials when notified of the existence of the larger landslide. Sewer, water, and electrical lines were also damaged by the landslide (Figures 6 and 7). Two homeowners associations that manage Salmon Beach and the city of Tacoma Public Utilities department (D. Koberstein, oral commun., 2001) have estimated total losses for the 2001 Salmon Beach landslide activity at \$1,505,428.

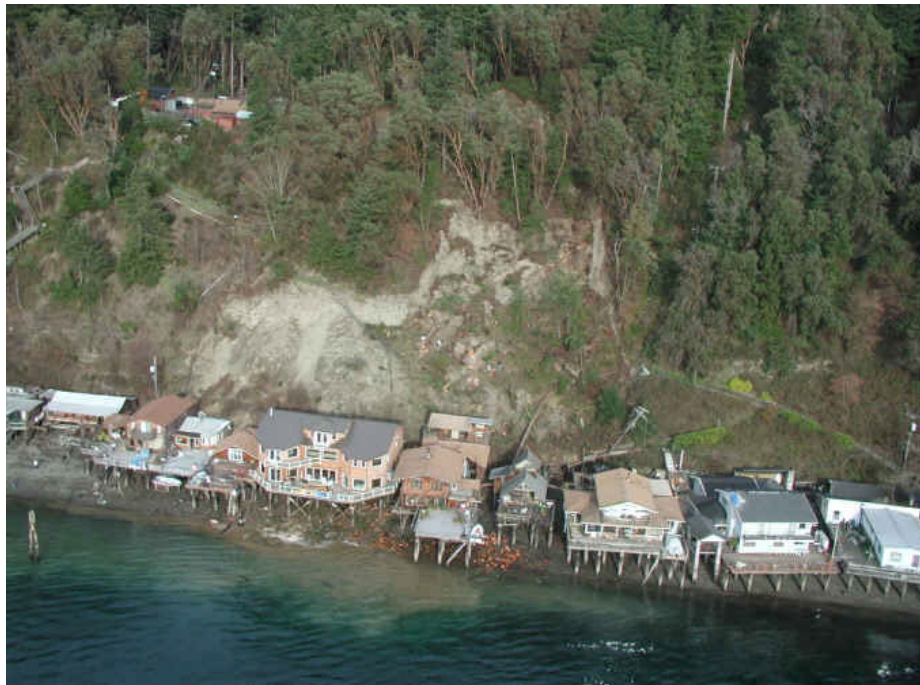
Figure 3—Salmon Beach landslide area, near Tacoma, after the 2001 Nisqually earthquake. Puget Sound is in the foreground (Photo from Bray and others, 2001)

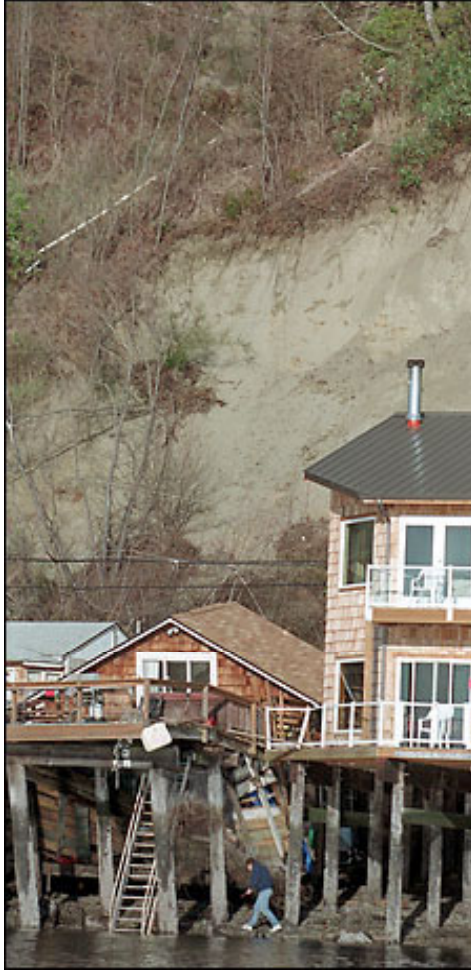
Figure 4—Close-up photo of one of the Salmon Beach houses damaged by a landslide, shortly after the Nisqually earthquake occurred (Photo courtesy of The Seattle Times).

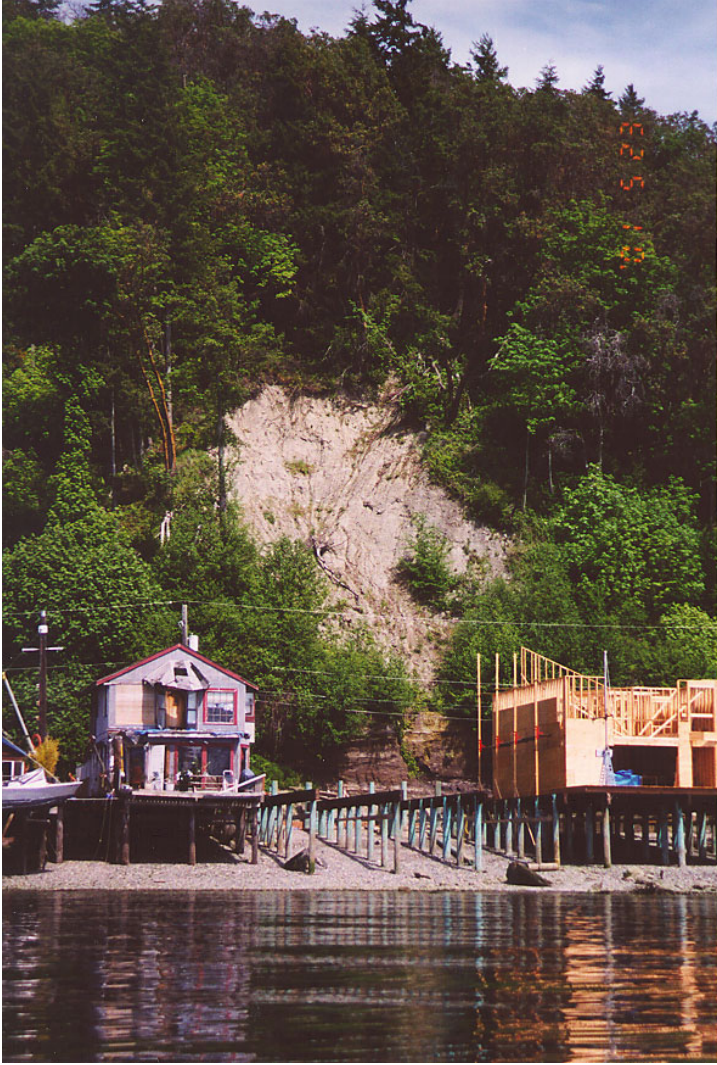
Figure 5–Salmon Beach house, destroyed by landslide. The house was damaged and then was torn down. The house under construction to the right, is being rebuilt, as it was also destroyed by the landslide (Photo taken in June, 2001 by Lynn Highland, USGS).

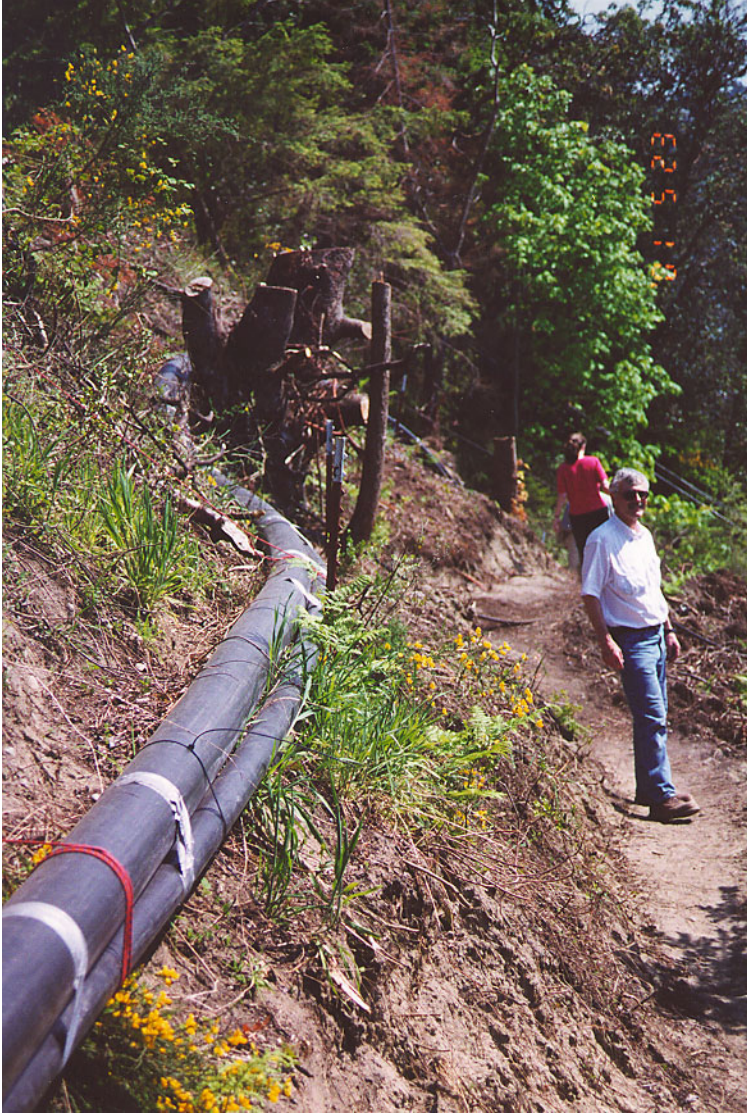
Figure 6–water and sewer line, temporarily relocated on top of landslide material, Salmon Beach landslide. Original sewer and water lines were damaged by the slide (Photo taken in June, 2001 by Lynn Highland, USGS).

- The estimate from a geotechnical consulting company (unnamed) for slope re-grading in landslide area is \$325,000.
- The damage to the sanitary sewer line is \$20,000; the cost to bury the line is \$20,000, for a total of \$40,000 damage. This was a temporary fix, not a permanent solution.
The line will be buried along hillside trail to top of slope (residential parking area)

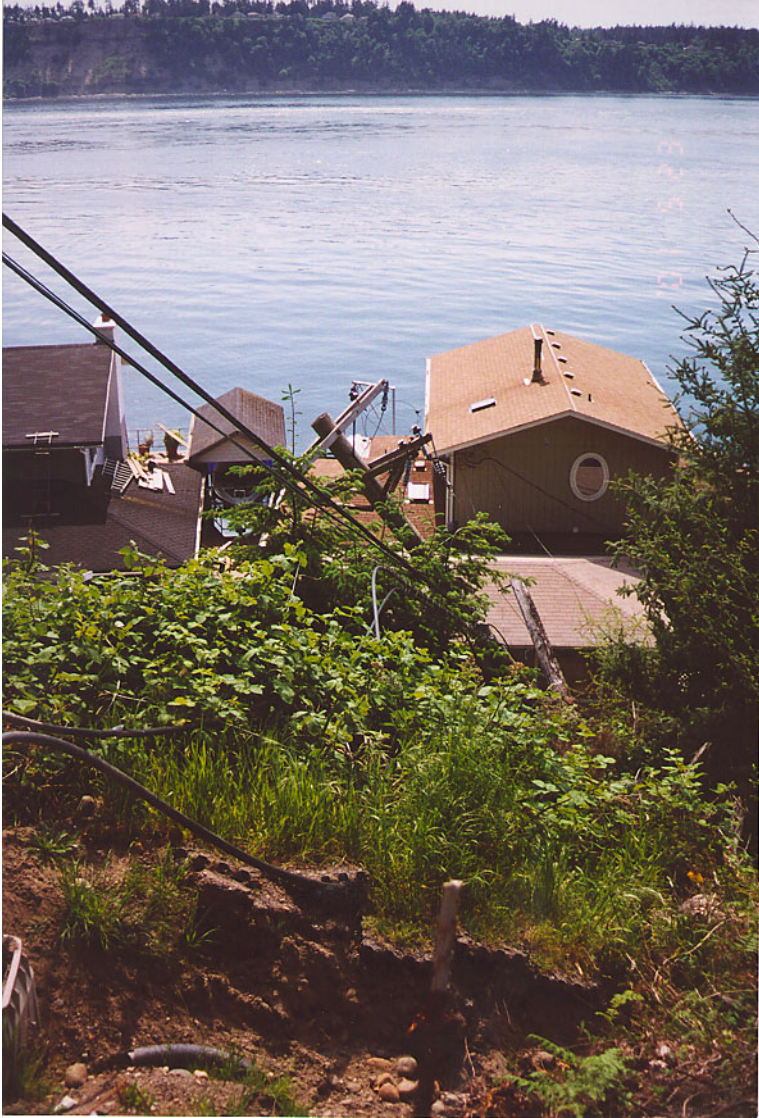
Figure 7—Looking toward Puget Sound from the Salmon Beach landslide. The landslide damaged electrical utility poles and electrical lines in the Salmon Beach community (Photo taken June, 2001 by Lynn Highland, USGS).

- Tacoma Power and Light, an electrical provider, performed temporary wiring and replacing of electrical wires and poles at a cost of \$40,000.00.
- As a more permanent solution, replacement of wiring infrastructure was performed at an additional \$20,000.00 This action placed power poles on the base of the slope, onto the flat part of the beach.

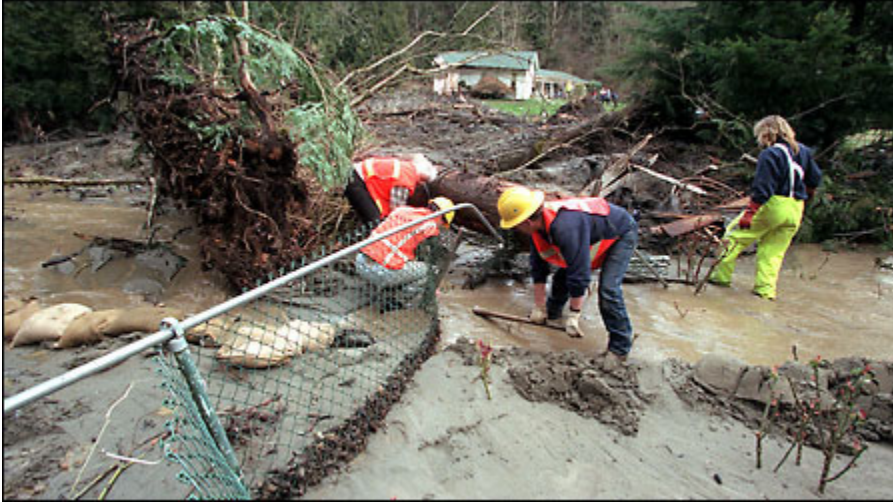
The earthquake triggered failure of glacial deposits, estimated at 50,000 cubic yards (38,000 cubic meters), along the right bank of the Cedar River at River Mile 5.0 near the city of Renton. The landslide completely demolished 200 meters (200 yards) of King County's Punnett-Briggs Revetment, a public flood-erosion-control facility. This landslide blocked the Cedar River and created a reservoir until earth-moving equipment could be sent to the site and a ditch dug through the slide debris (Figures 8 and 9). Significant ponding and overbank flooding upstream of the blockage resulted in immediate flooding of two homes and several yards, together with significant portions of the City of Renton's Ron Regis Park (Figure 10). Impounded water in Ron Regis Park re-entered the river through a previously constructed salmon spawning channel adjacent to the landslide dam causing considerable erosion (King County Department of Natural Resources, oral commun., 2002).

Figure 8–Cedar River landslide, near Renton (Photo courtesy of The Seattle Times).

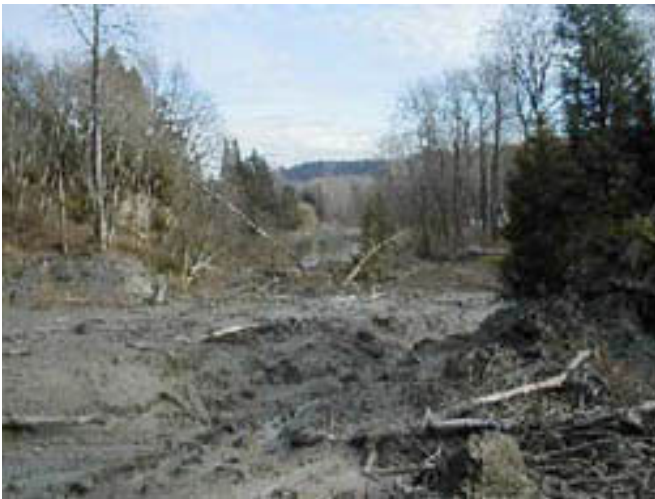
In South Renton, a second landslide just upstream from the landslide that dammed the Cedar River formed at the base of a steep bluff. This mudflow carried about 10,000 cubic yards (7,600 cubic meters) of soil, trees and debris down to the Cedar River. The mudflow slammed into a house about 70 meters (70 yards) down slope nearly breaking it in two and filling about half of the structure with debris. A woman who had just run out of the house during the earthquake narrowly avoided being buried by landslide debris that filled the kitchen where she had been standing (Figure 11). Damage estimates for these landslides have been estimated to be \$1,714,400. (King County Department of Natural Resources, written commun., 2002).

Figure 9–An additional landslide that blocked the Cedar River and caused flooding (Photo courtesy King County, Department of Natural Resources and Parks, February, 2001).

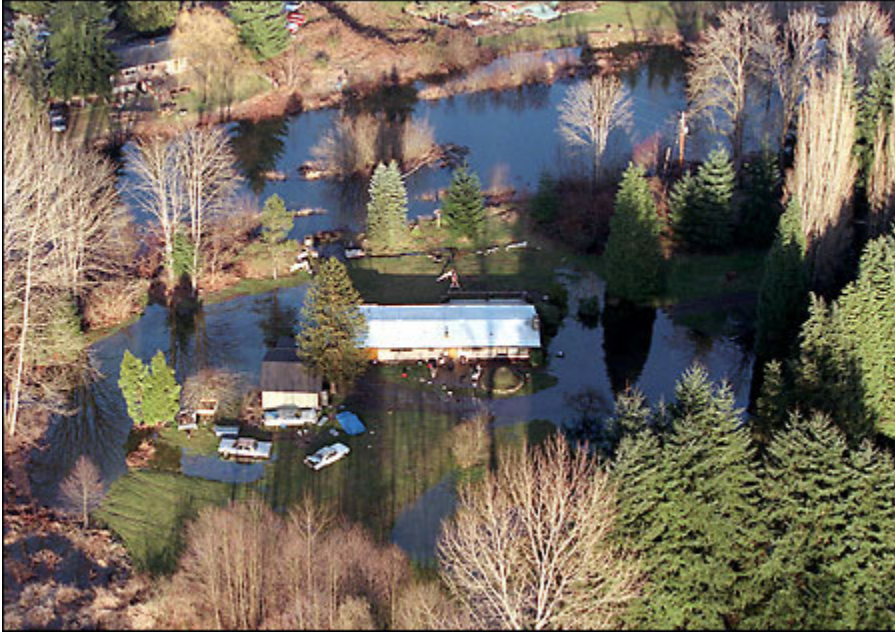
Figure10—Aerial view of flooding caused by landslide that partially dammed the Cedar River (Photo courtesy King County, Washington, February, 2001).

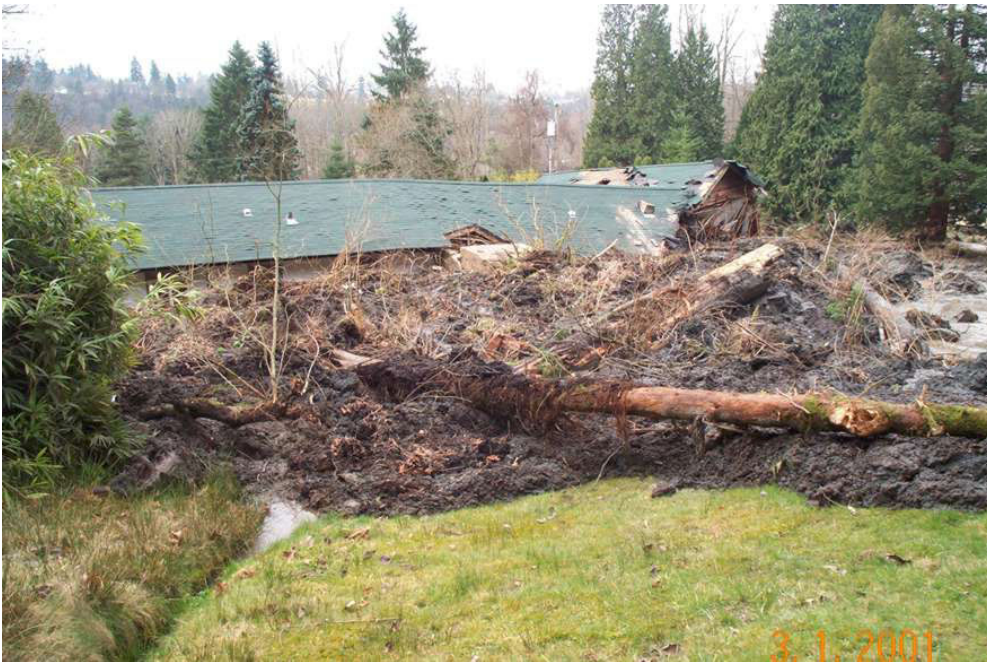
Figure11—House damaged by landslide along Cedar River—landslide deposits are at the center of the photo (Photo courtesy of King County, Washington, February, 2001).

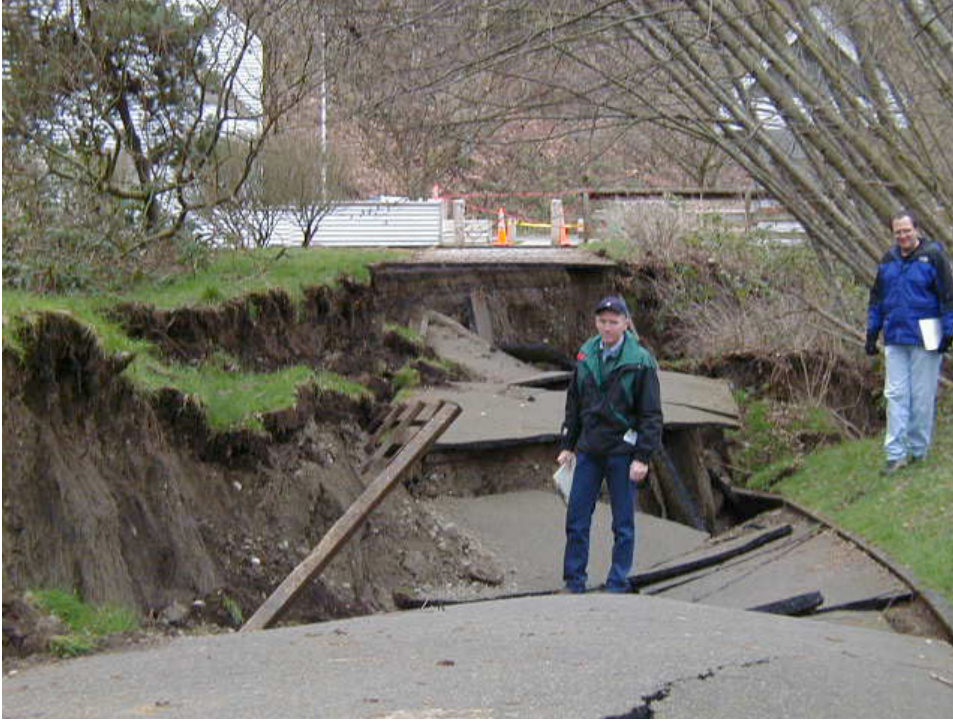
Deschutes Parkway is underlain by fill, and artesian springs emerge within the fill. The Parkway is constantly failing and causing problems. During the earthquake, loose sandy soil under the Parkway liquefied, then flowed down slope toward Capitol Lake, collapsing part of the thoroughfare, and temporarily closing the road. This area had experienced similar lateral spreading and ground failures in the 1949 and 1965 Puget Sound earthquakes (Chleborad and Schuster, 1998). There was no way to put in an auxiliary or temporary road immediately after the failure. At the south end of the parkway, another landslide occurred 6 weeks after the earthquake. This damage will take approximately 3 years to repair – 2 years to get permits and one year for construction, during which time the Parkway will be closed (T. Meade, Public Works Department, Olympia, Washington, oral commun. 2002).

Several lateral spread landslides occurred around the margins of Capitol Lake. The dike on the southern margin of the lake failed in several places; some of the cracks that formed contained ejected silt, indicating that liquefaction occurred. Water and sewer lines crossing the area were broken in places. Deschutes Parkway on the west margin of the lake was closed in several places because of slumping along the edge of the lake. (U.S. Geological Survey, unpub. data, 2001, [<http://geohazards.cr.usgs.gov/wa/>]). Estimated landslide damage to Capitol Lake, Marathon Park, and Deschutes Parkway was approximately \$22,200,000 (T. Meade, Public Works Department, City of Olympia, written commun., 2002). See Figures 12 – 18 for photos of landslide and lateral spreading damage to these areas.

Figure 12–Capitol Lake, Olympia, landslide damage (Photo courtesy of WSDOT, February, 2001).

- Landslide and lateral-spreading damage to the Deschutes Parkway: the City of Olympia has submitted a claim of \$20 million to Federal Highways Administration.

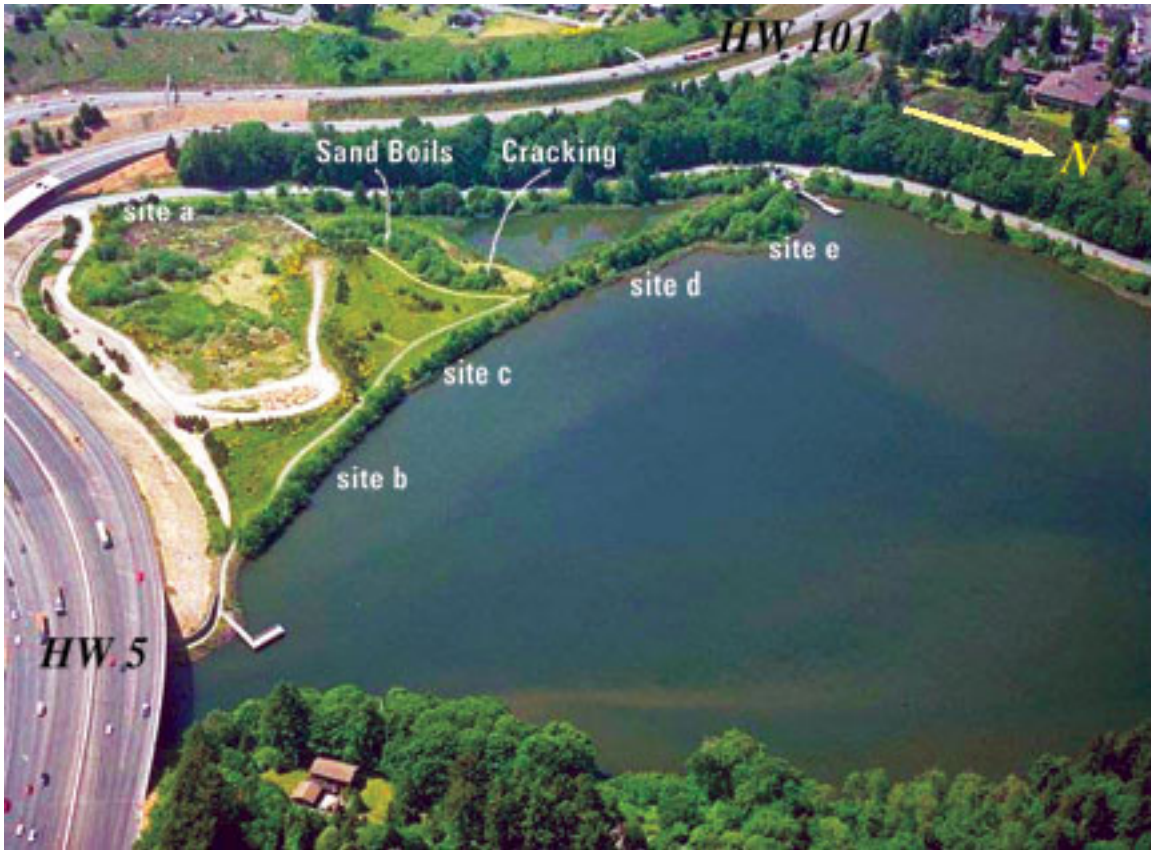
Figure 13–Slope failures/lateral spreads – Capitol Interpretive Center, near the Deschutes Parkway, Olympia (Photo from Bray and others, 2001). Figures 14 through 18 show close-up photos of damage at each lettered site (a through e) indicated here.

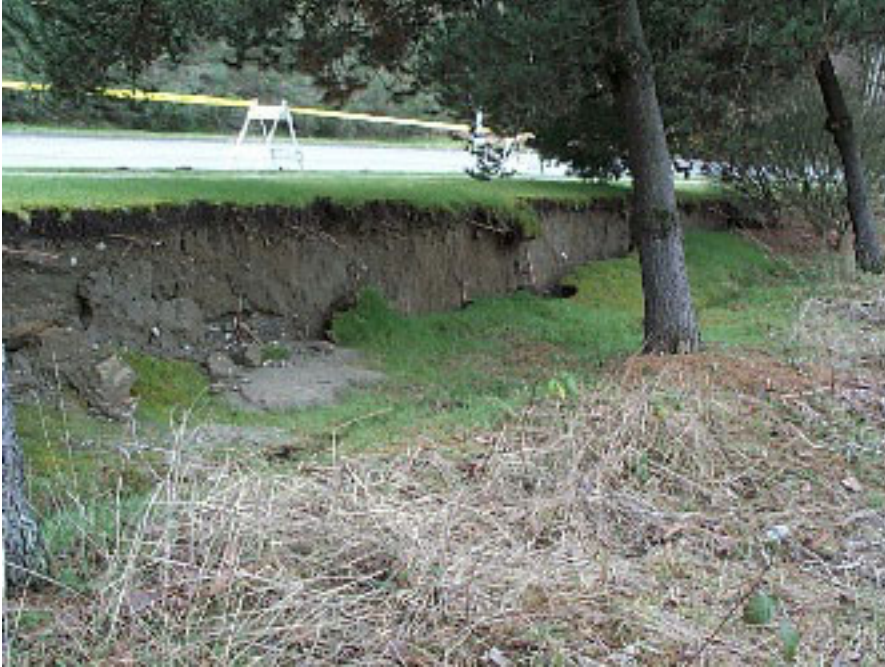
Figure14—Site a, Figure 13—Headscarp of lateral spread showing remains of sand boil (after heavy rain). The total length of the scarp is approximately 200 feet (60 m) with a maximum vertical drop of 3 feet (1 m) (Photo from Bray and others, 2001).

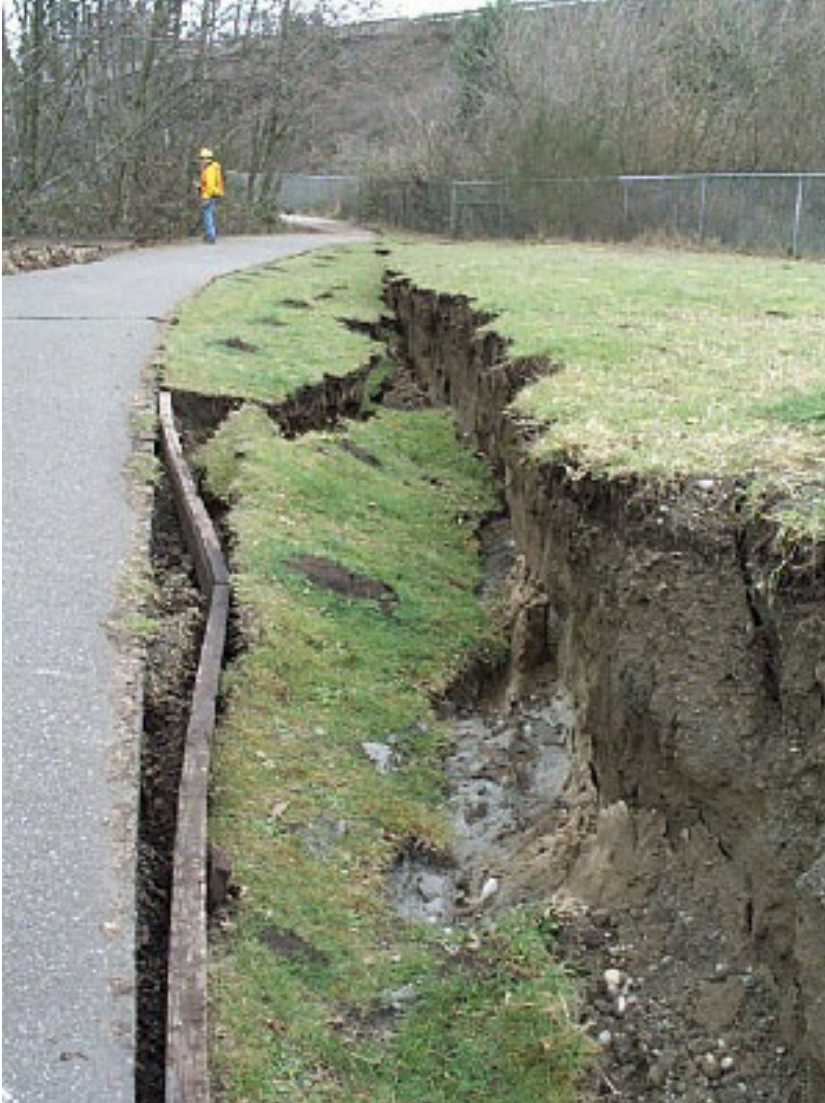
Figure 15–Site b, Figure13–Lateral spread of embankment at Capitol Interpretive Center (Photo from Bray and others, 2001). (GPS location: N47.04270°, W122.91090°).

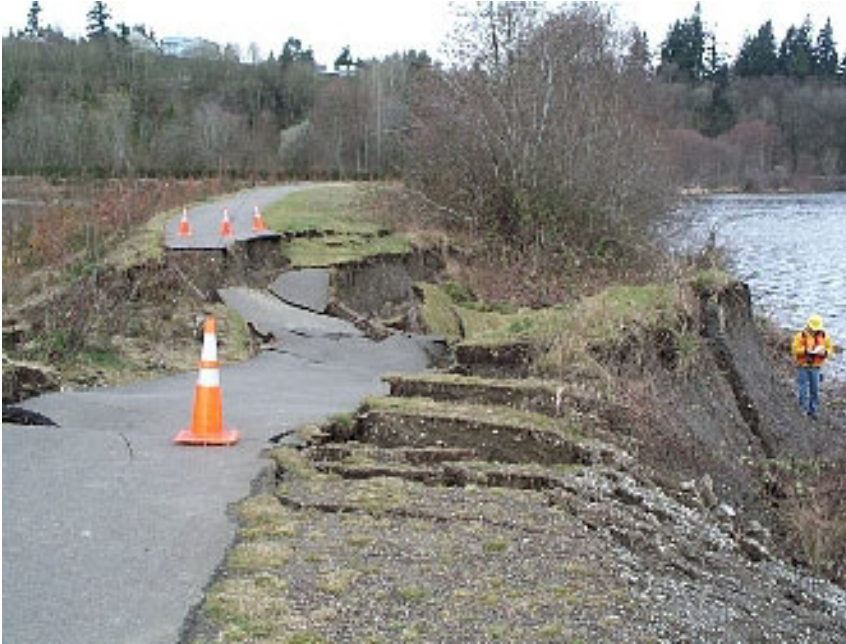
Figure 16–Site c, Figure13–East-to-west view of lateral spread of embankment at Capitol Interpretive Center. The length of the damage is approximately 75 feet (225 m) (Photo from Bray and others, 2001). (GPS location: N47.02396°, W122.90660°).

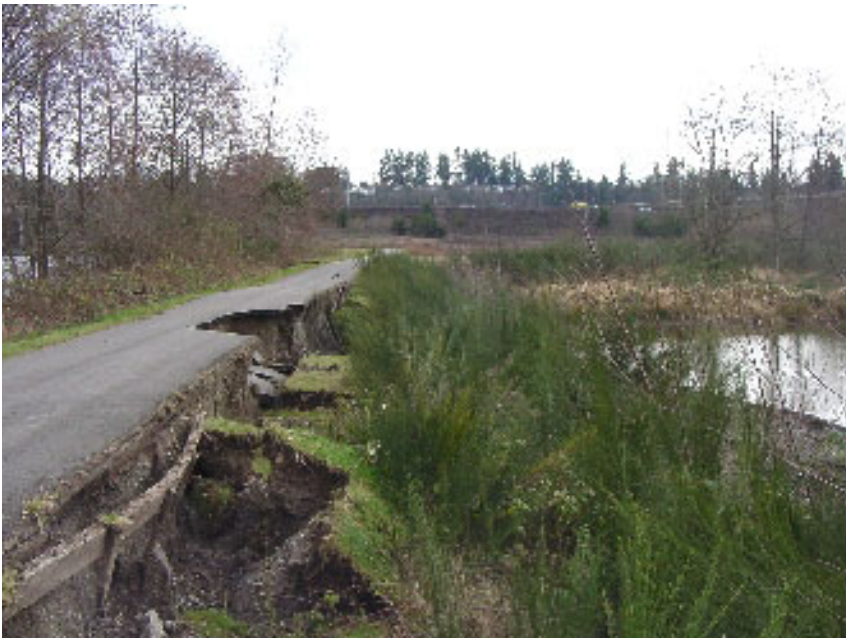
Figure17–Site d, Figure13–East-to-west view of embankment failure (lateral spread) at Capitol Interpretive Center (Photo from Bray and others, 2001). (GPS location: N47.02447°, W122.90784°).

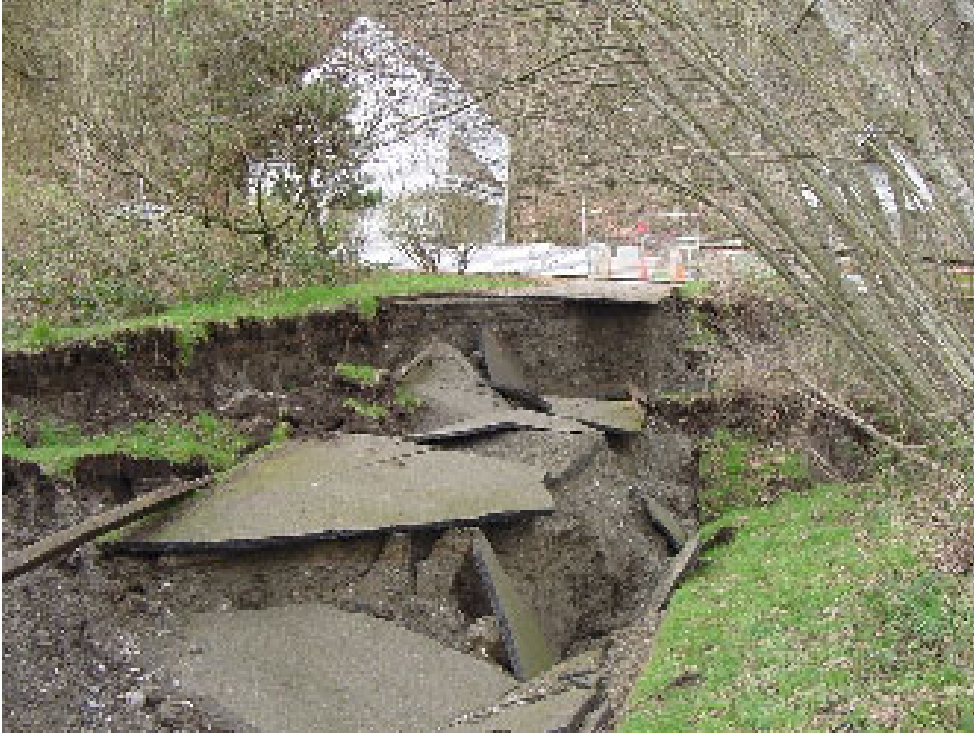
Figure 18–Site e, Figure 13–Failure of embankment due to liquefaction and lateral spreading at Capitol Interpretive Center (Photo from Bray and others, 2001). (GPS location: N47.02525°, W122.91000°).

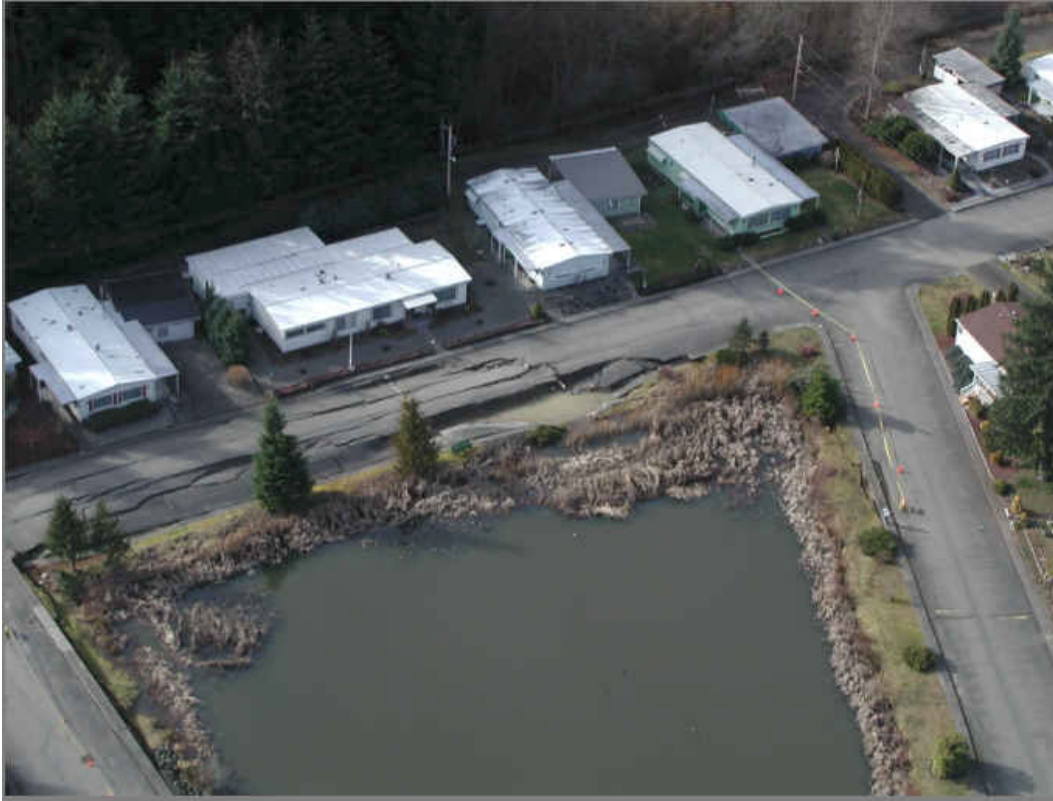
A lateral spread occurred around the perimeter road of Sunset Lake. This area also suffered other instances of lateral spreading, liquefaction, and sand boils, with damage to mobile homes (Bray and others, 2001) (Figures 19 and 20). Damage estimates were not available, at this writing, for this area.

Figure 19—Aerial view of the lateral spread that occurred along a perimeter road of Sunset Lake, near Tumwater. The street affected by the flow is roughly aligned north-south where north is toward the bottom right corner of the photo (Photo from Bray and others, 2001).

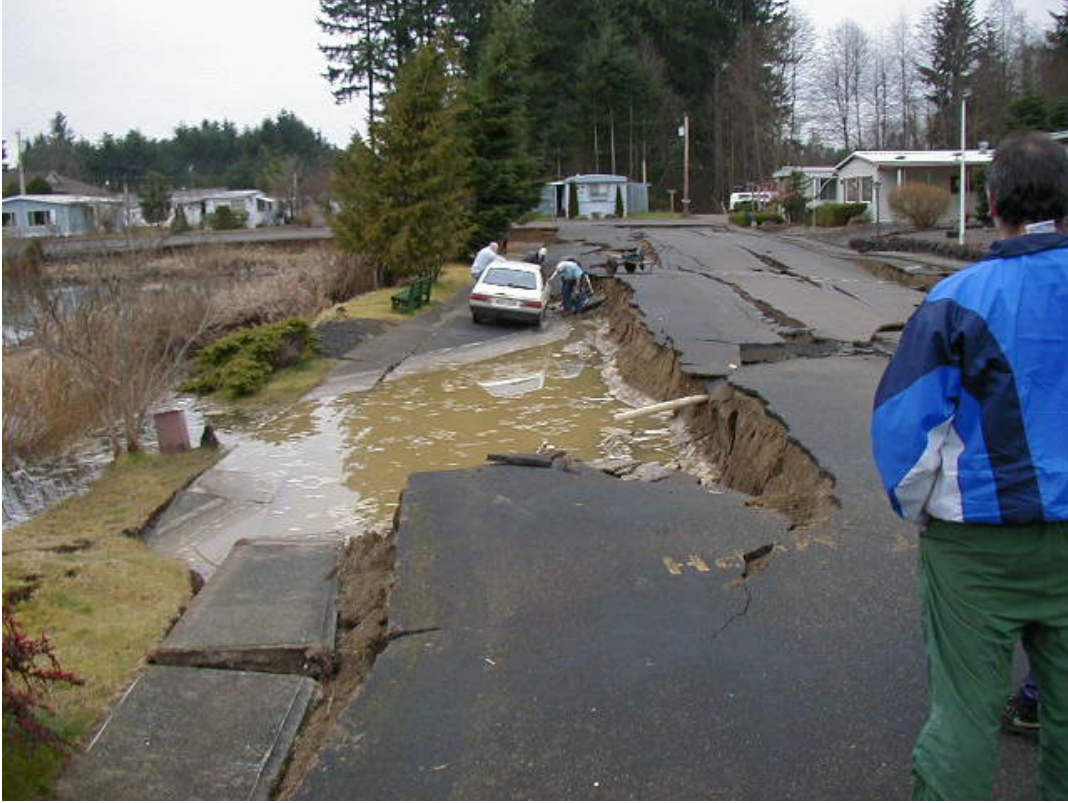
Figure 20—Close-up view of road failure at Sunset Lake, near Tumwater (Photo by Steven Kramer, University of Washington, Seattle).

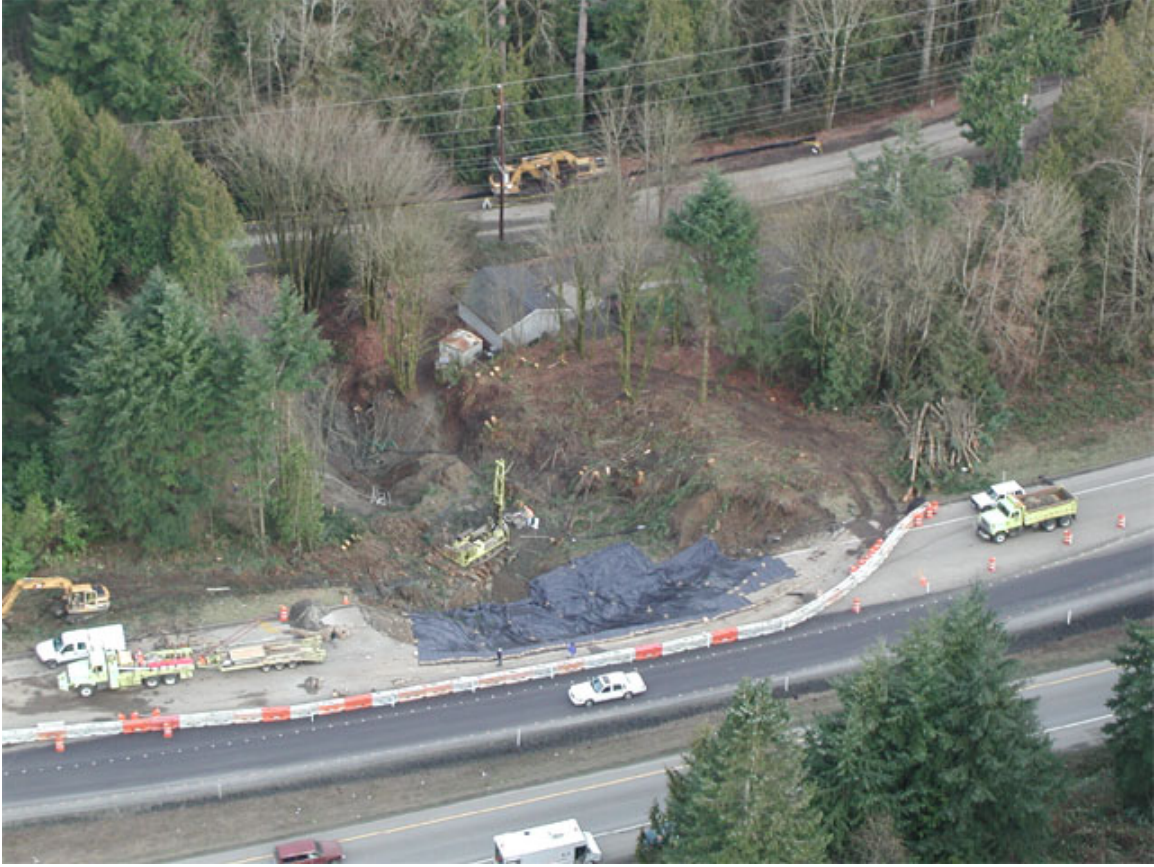
| Landslide | Landslide location: Latitude/longitude (where known) City/County in Washington | Preliminary dollar losses (where ob- tainable) – in year 2002 dollars | Comments |
|--|--|--|---|
| U.S. Highway 101 Near Sate Road 8 | 47°03'30" N 123°00'49" W | \$919,570 | Fill failure/slump; debris flow |

Figure 21–Landslide in U.S. Highway 101 road embankment near State Road (SR) 8 junction, northwest of Olympia. The earth embankment crosses a ravine that was carrying water at the time of the earthquake. The failed material moved down slope approximately 150 m and partially covered the road that parallels U.S. Highway 101 to the north (Photo from Bray and others, 2001) (GPS location: N47.05834°, W123.01365°).

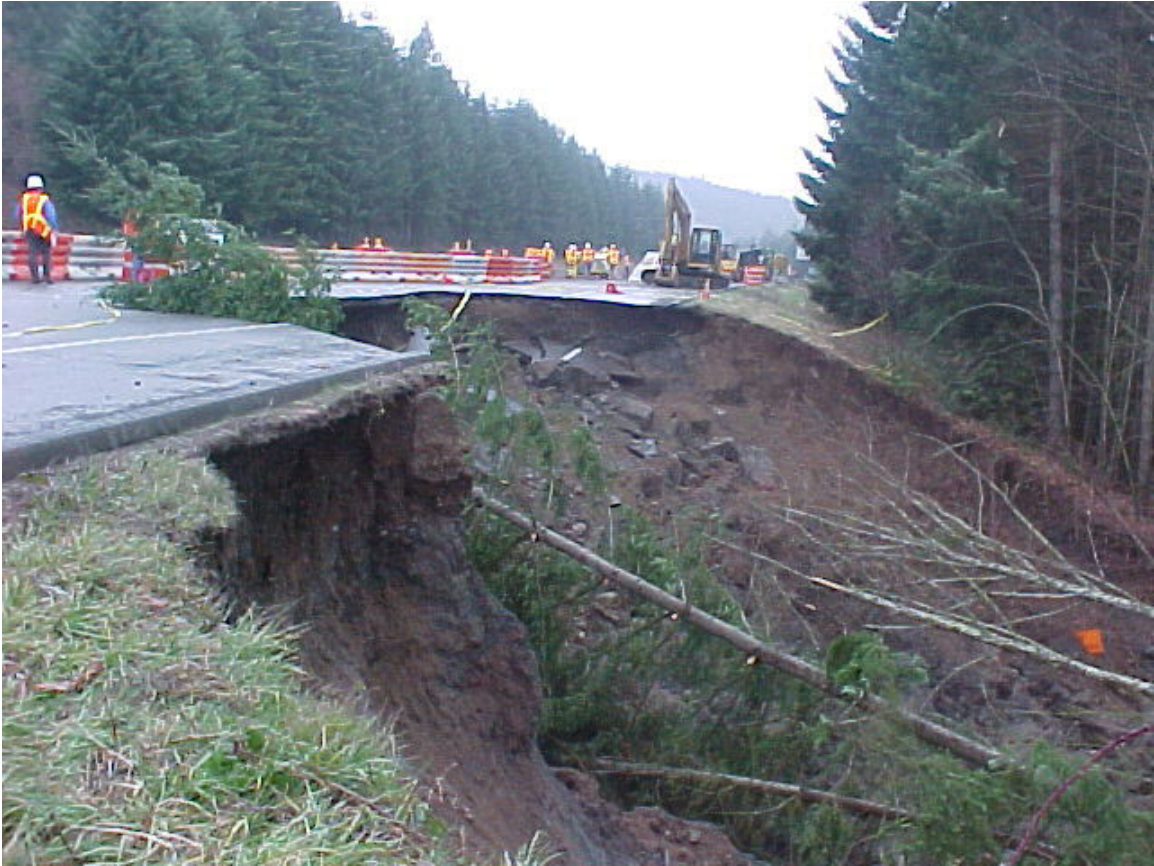
Figure 22—Close-up of U.S. Highway 101 landslide. The curved headscarp of the landslide is 24 m wide, and the total width of the landslide at the edge of the road is 35 m (Photo from Bray and others, 2001) (GPS location: N47.05834, W123.01365°).

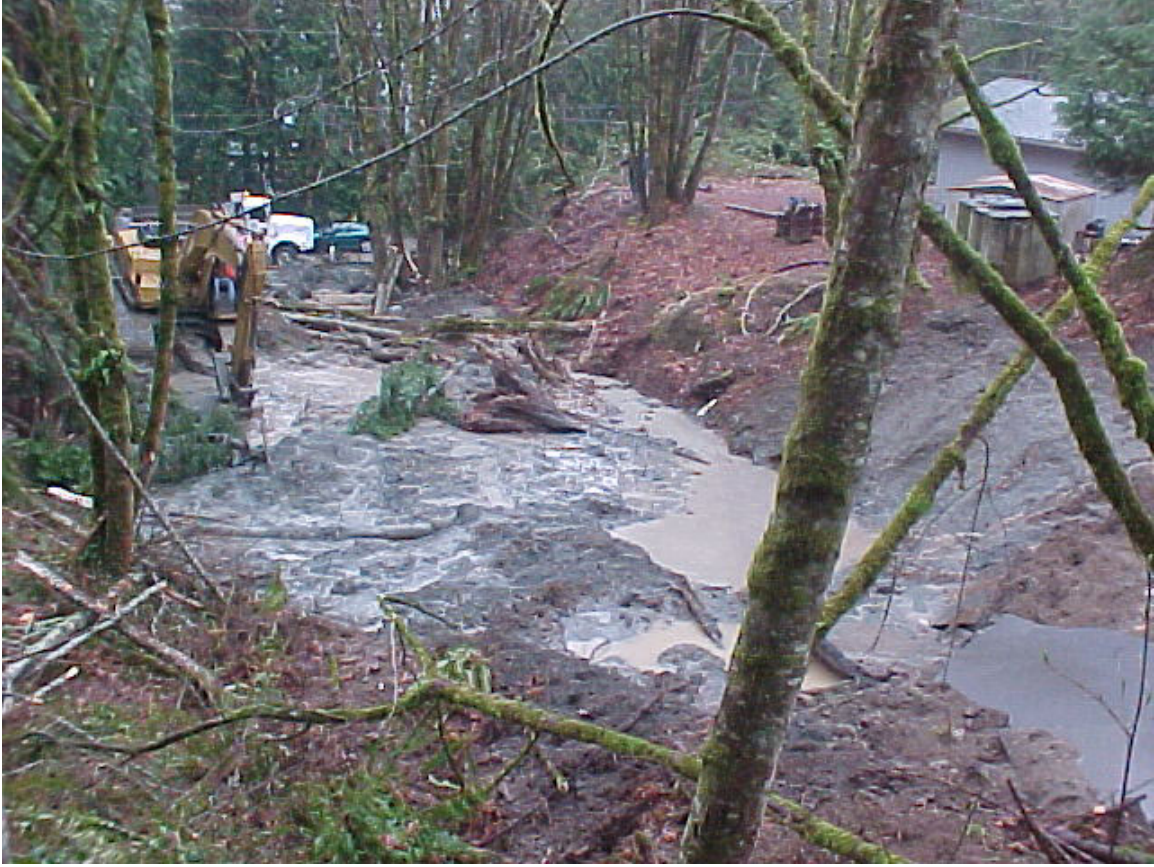
Figure 23.--View of runout of material down slope from the U.S. Highway 101 earth embankment landslide (Photo from Bray and others, 2001) (GPS location: N47.05834°, W123.01365°).

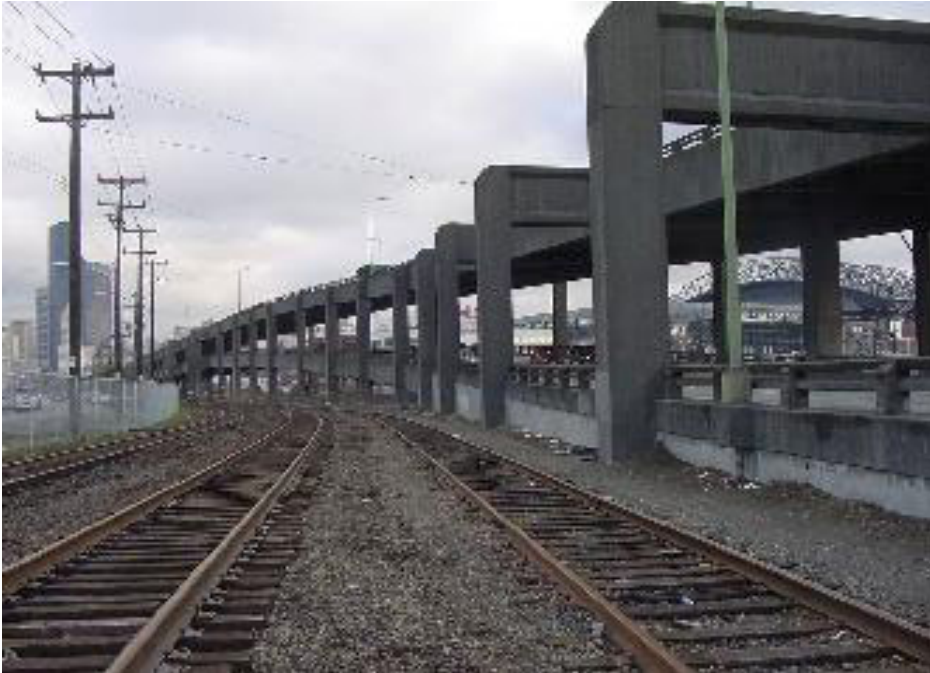
The viaduct, completed in its entirety in 1956, did not include special reinforcing for earthquake resistance. Studies conducted by WSDOT in 1995-96 indicated that the Viaduct alignment is underlain by loose fill soils with a high susceptibility to liquefaction. It was concluded that widespread liquefaction would occur along the Viaduct in response to a peak ground acceleration of 0.16g. The study also indicated that widespread liquefaction would also likely result in failure of the Alaskan Way Seawall (adjacent to the viaduct) and massive lateral spreading of the adjacent soil. After the Nisqually earthquake, liquefaction features were observed in the South of Downtown district and the Harbor Island area of Seattle; however, none of these surface manifestations was observed beneath the viaduct, and there was no indication of failure of the Alaskan Way Seawall following the earthquake (WSDOT, 2001). One of the areas that sustained ground failure at the Alaskan Way Viaduct, is shown in Figure 24.

Figure 24—Photo of the Alaskan Way Viaduct, Seattle, showing location of point at which northern boundary of observed liquefaction occurred (Photo by Bray and others, 2001).

The Washington Department of Transportation (2001) Report of the Structural Sufficiency Committee recommends replacing the viaduct, because retrofitting it would cost about as much as replacement, and the resulting retrofitted structure would not last as long as a replacement. Currently there are several options for replacement. WSDOT and the City of Seattle are working together on the plans, since the adjacent seawall is owned by the City of Seattle and is a crucial structural element for replacement of the viaduct. Some of the replacement options are: replace in kind, replace with a tunnel, or replace with a boulevard.

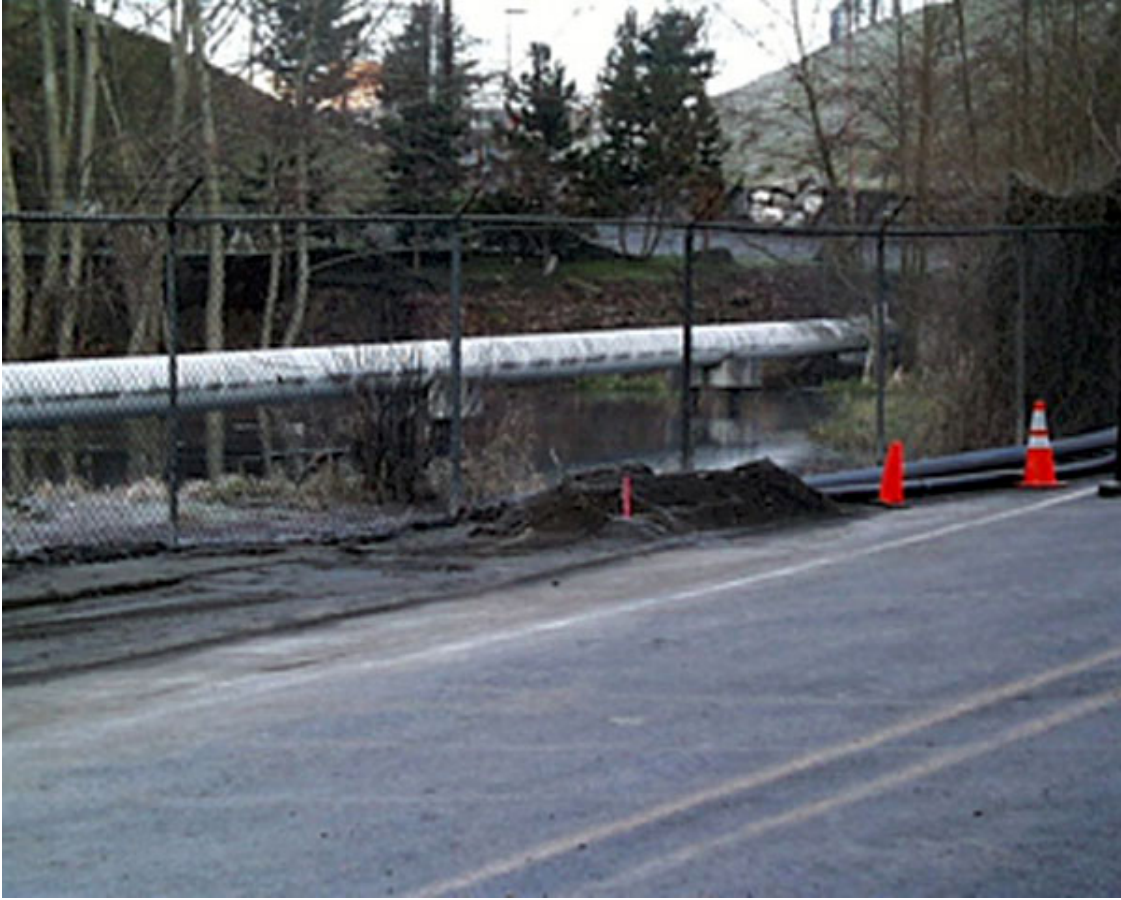
Figure 25–Chambers Road embankment failure and landslide. Sewer line repair using high-density polyethylene. Water-distribution line (undamaged) crosses adjacent to the bridge. Behind the water line on the far bank is a small landslide with several trees within sliding block (Photo by Bray and others, 2001) (GPS location: N47.1917°, W122.5733°).

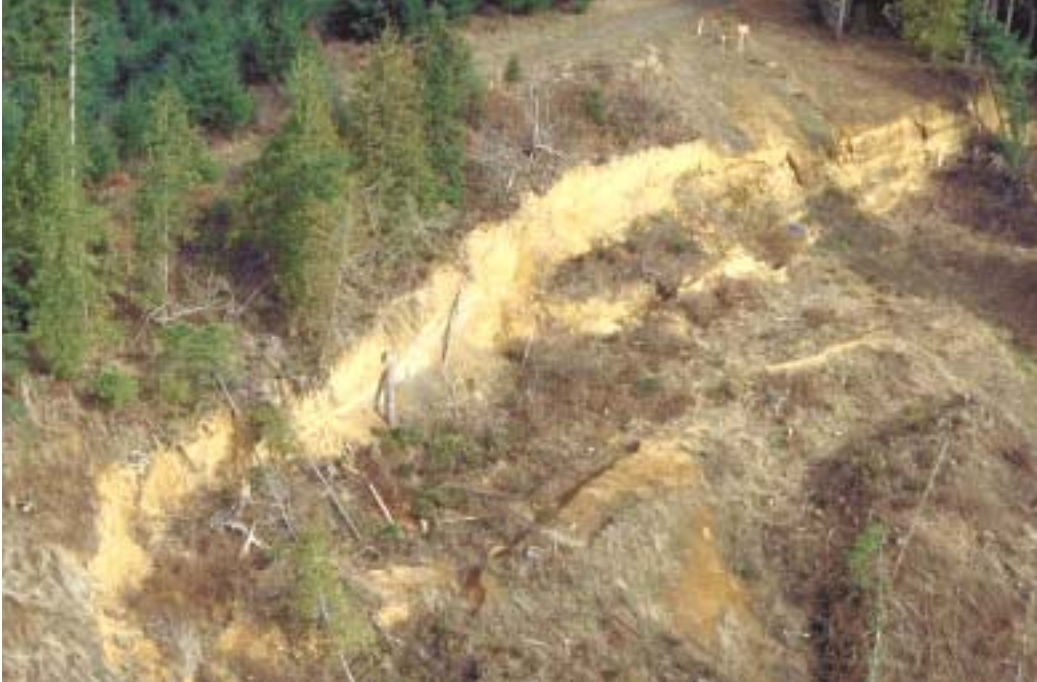
Figure 26—Photo of pipeline slide near Null’s Crossing (Lewis County), near Chahallis (GPS location: N46 42 19.9°, W122 49 41.5°) (Photo by Bray and others, 2001).

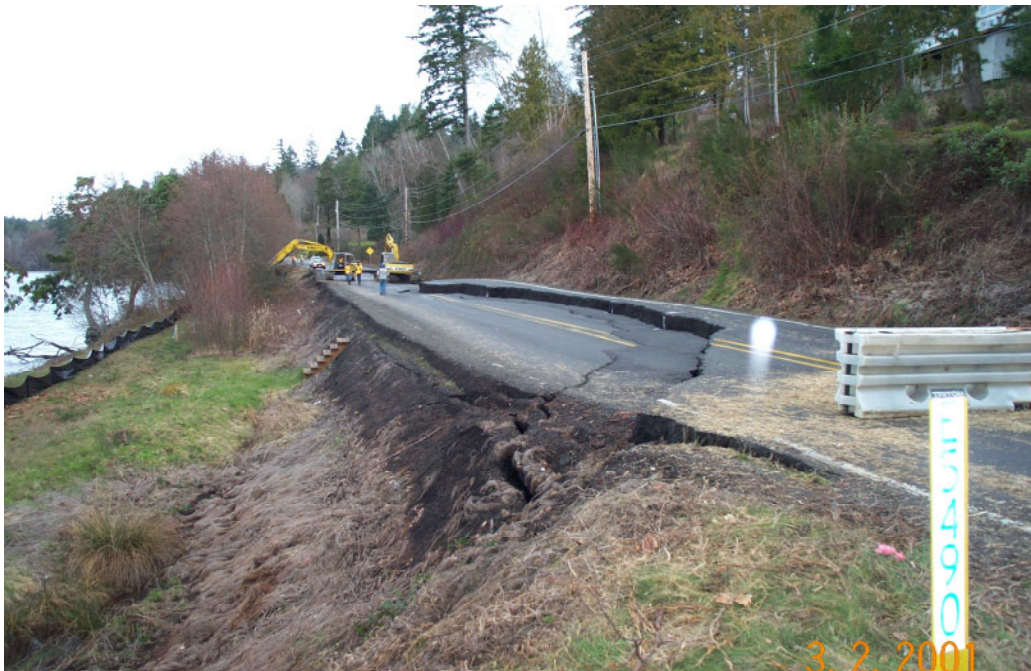
2. State Road (SR) 202 near Snoqualmie Falls cracked and the shoulder fell away (Bray and others, 2001).
3. Victor Fill area near the City of Port Orchard experienced a slump in artificial fill. The vertical displacements of the highway along the slide scarp were as much as 60 centimeters (24 inches). Damage estimates are \$159,898, which includes temporary repairs, and restoration of the highway to service (Scott Woodruff, WSDOT, oral commun., 2001) (Figure 27).

Figure 27—Victor Fill area landslide, near Port Orchard (Photo by Ed Harp, U.S. Geological Survey).
