Kinematics of the Aspen Grove Landslide, Ephraim Canyon, Central Utah

U.S. GEOLOGICAL SURVEY BULLETIN 1842-F

Description and analysis of deformational
structures and of spatial and temporal
patterns of movement of the landslide

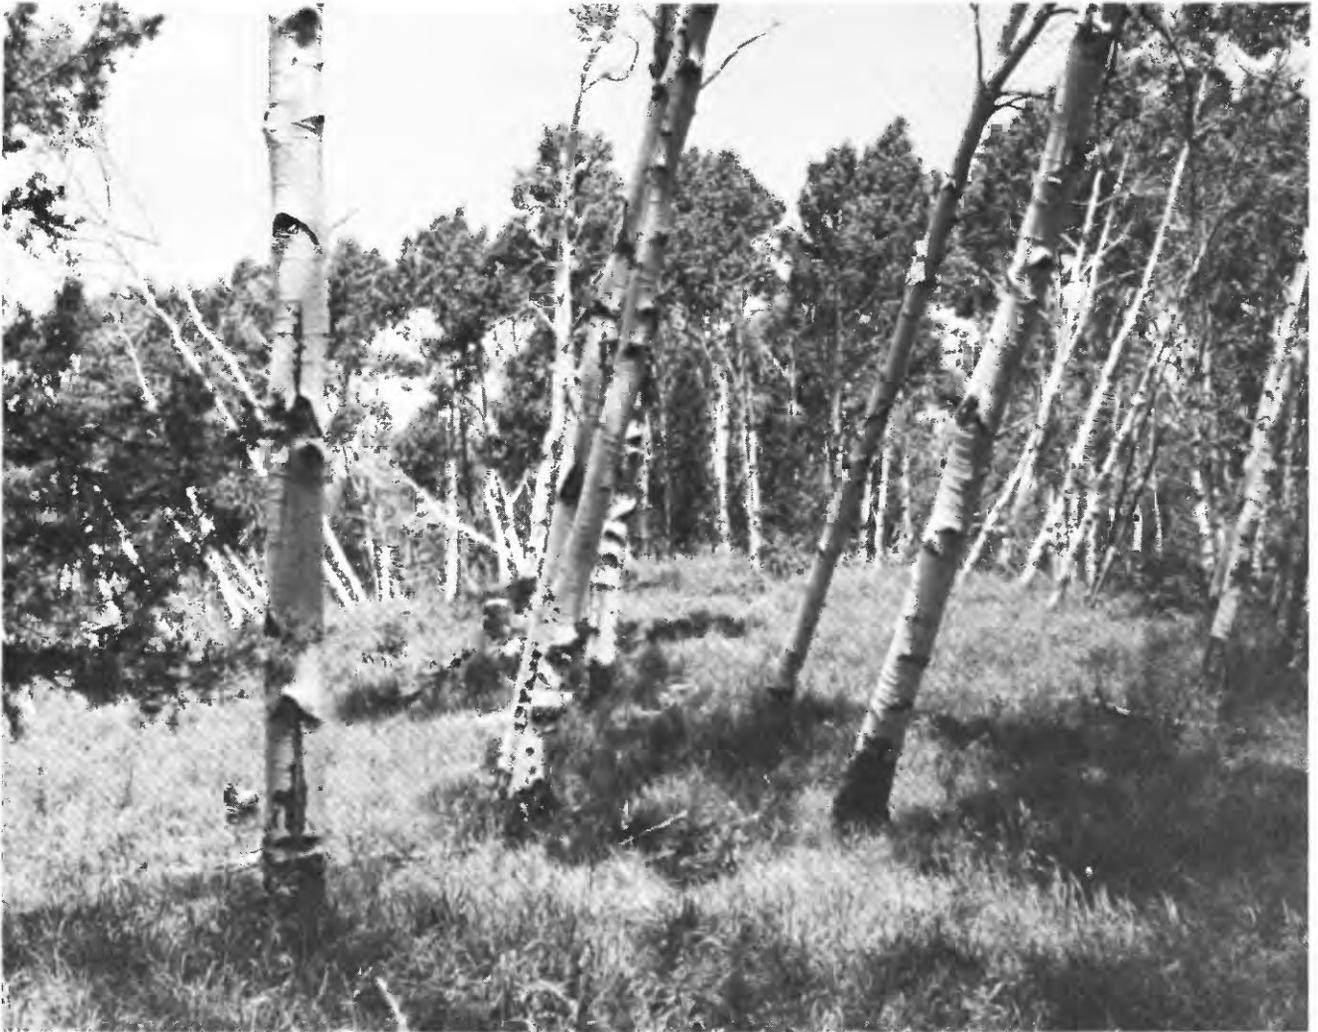
Figure F27. Leaning trees on the dome in July 1985. View to the north. Trees upslope (right in photograph) from the dome lean to the right; those downslope lean to the left. Trees in foreground (on the side of the dome) lean toward the observer. Displacement direction is from right to left.
