# The Slumgullion Earth Flow: A Large-Scale Natural Laboratory

U.S. GEOLOGICAL SURVEY BULLETIN 2130

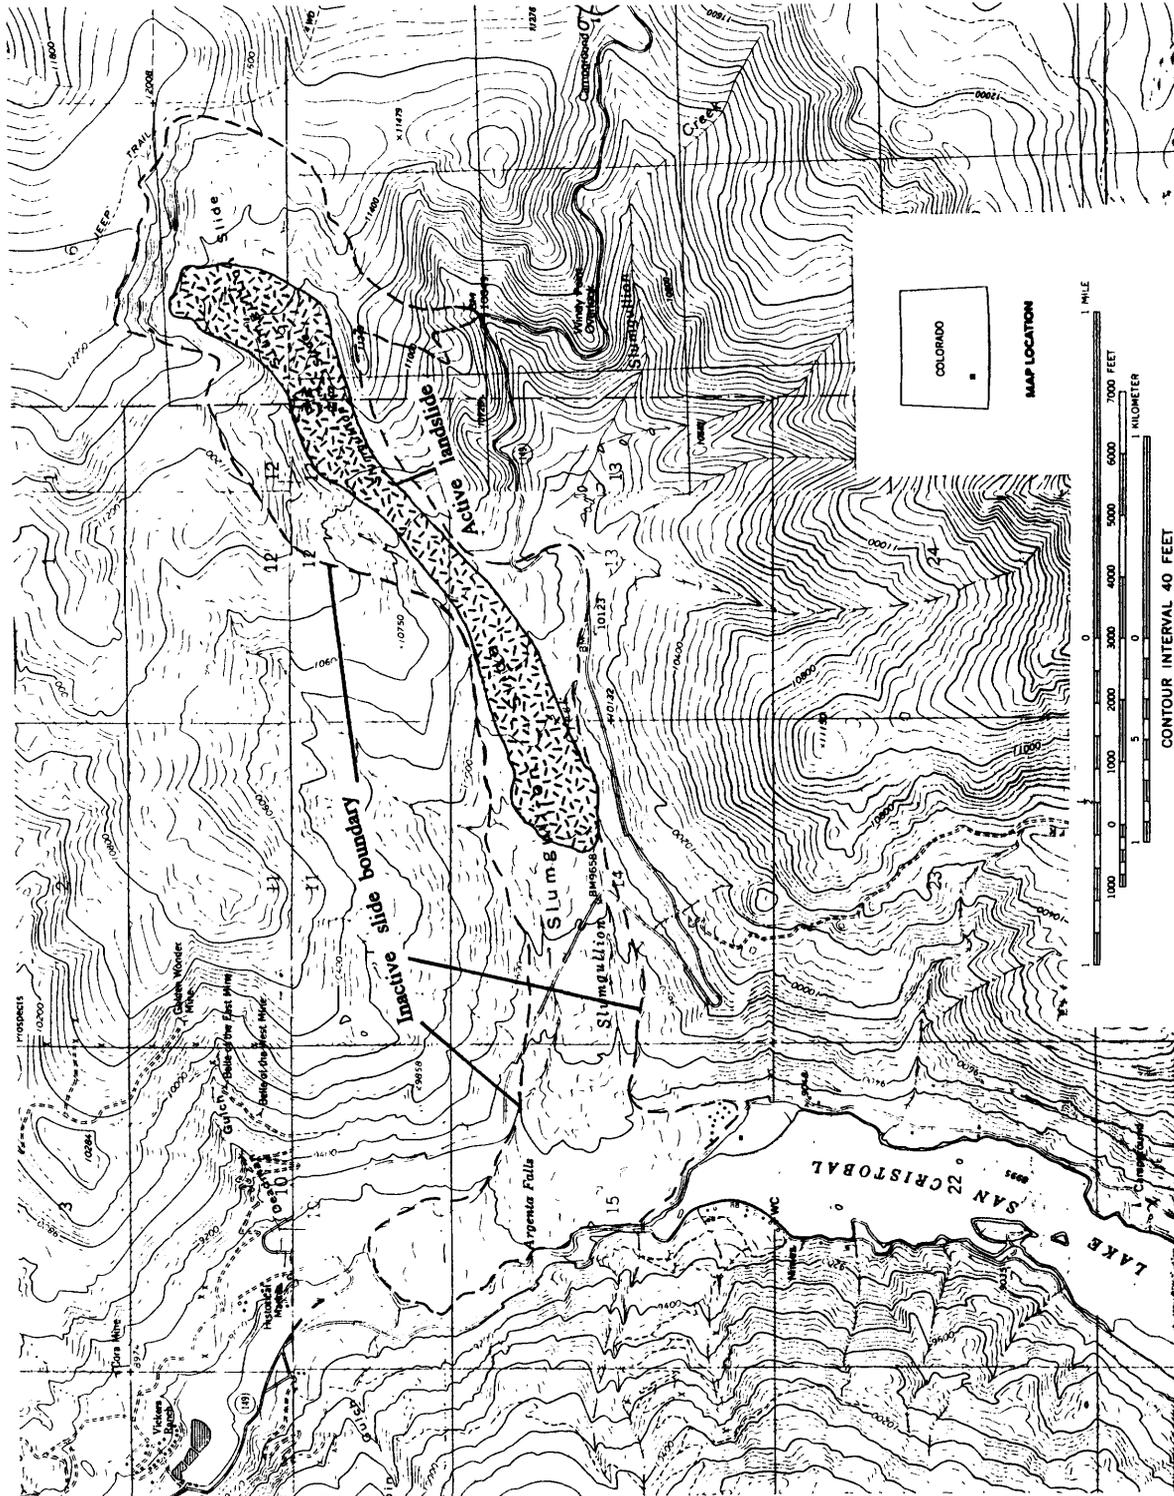
Figure 1. Topographic map and location of the Slumgullion earth flow.

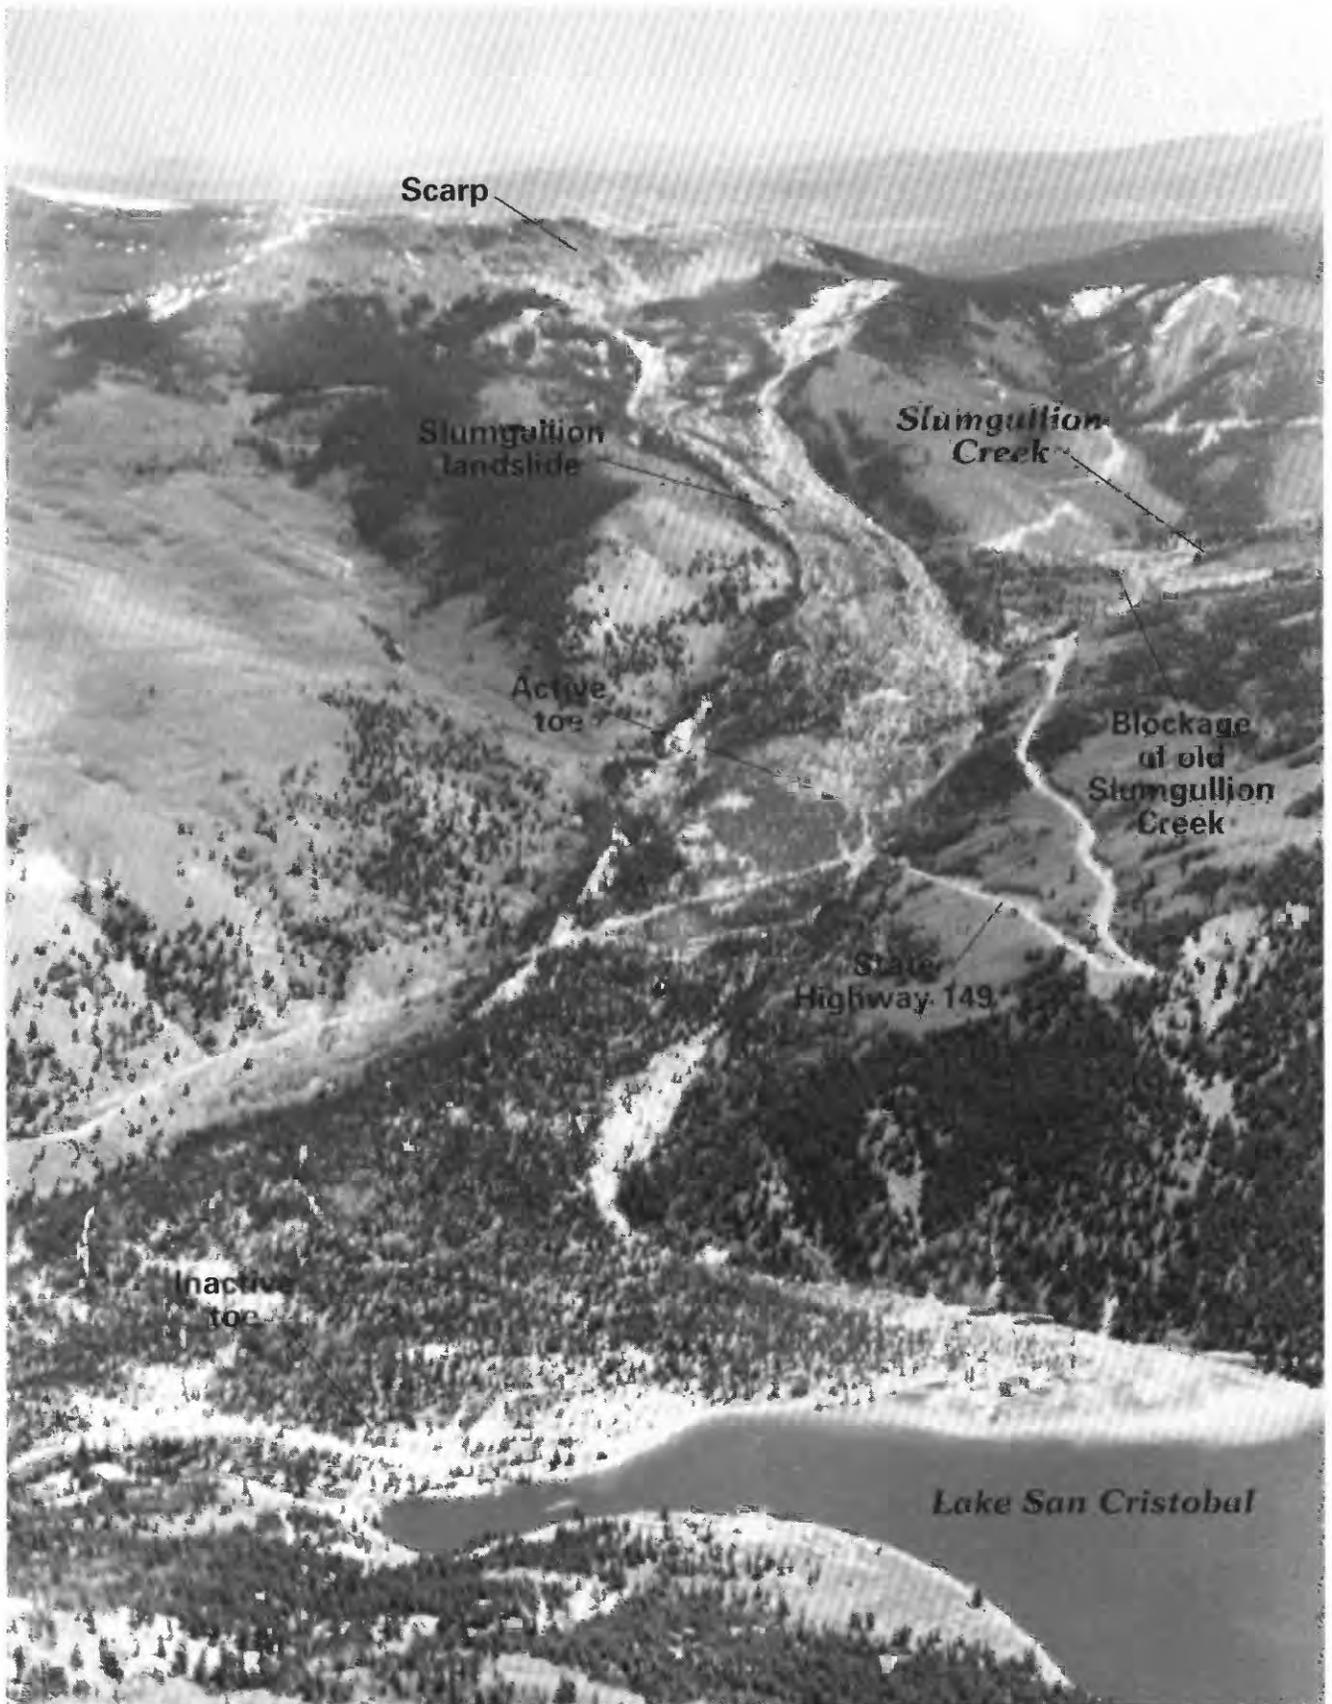
**Figure 2.** Slumgullion earth flow. Lake San Cristobal is at lower right. The inactive landslide extends from the lake uphill to the active toe. Active toe is prominent light-colored bulge uphill from where Colorado State Highway 149 crosses the earth flow. Active flow extends from active toe to prominent main scarp at top of photograph.

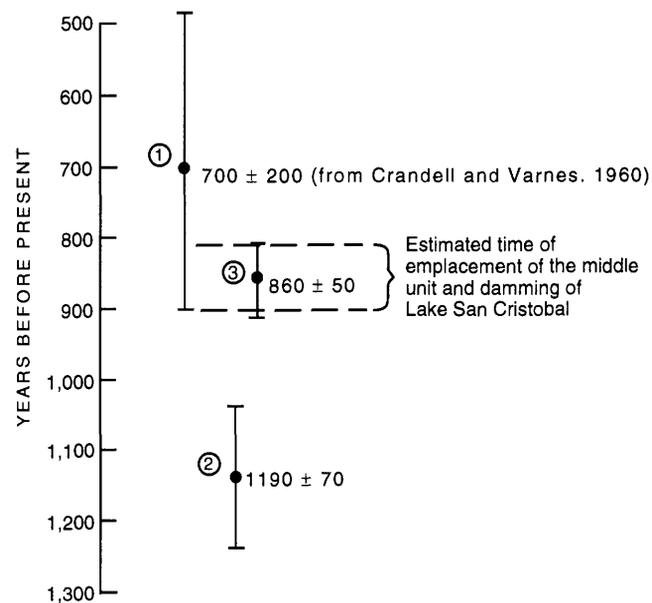
Figure 4. Diagram showing radiocarbon ages of wood obtained from just above basal contact of middle unit near toe of the Slumgullion landslide. Estimated time of emplacement of the middle unit is based on the younger radiocarbon ages because the age range of dead wood on the forest floor at any given time spans at least a few centuries. Circled numbers correspond to sample locations shown in figure 2. Vertical lines represent  $\pm 1$  standard deviation of the error in counting the radioactive disintegration of the modern standard, background, and sample.

The radiocarbon age of the oldest wood found beneath deposits of the middle unit provides a minimum age of about 1.1 ka for the oldest landslide unit (fig. 4). Chleborad (1993 and this volume) describes deposits of the oldest unit on the upland south of the upper part of the main slide path. These deposits contain wood that yielded four radiocarbon ages ranging from 1,630±50 to 1,130±60 yr B.P.

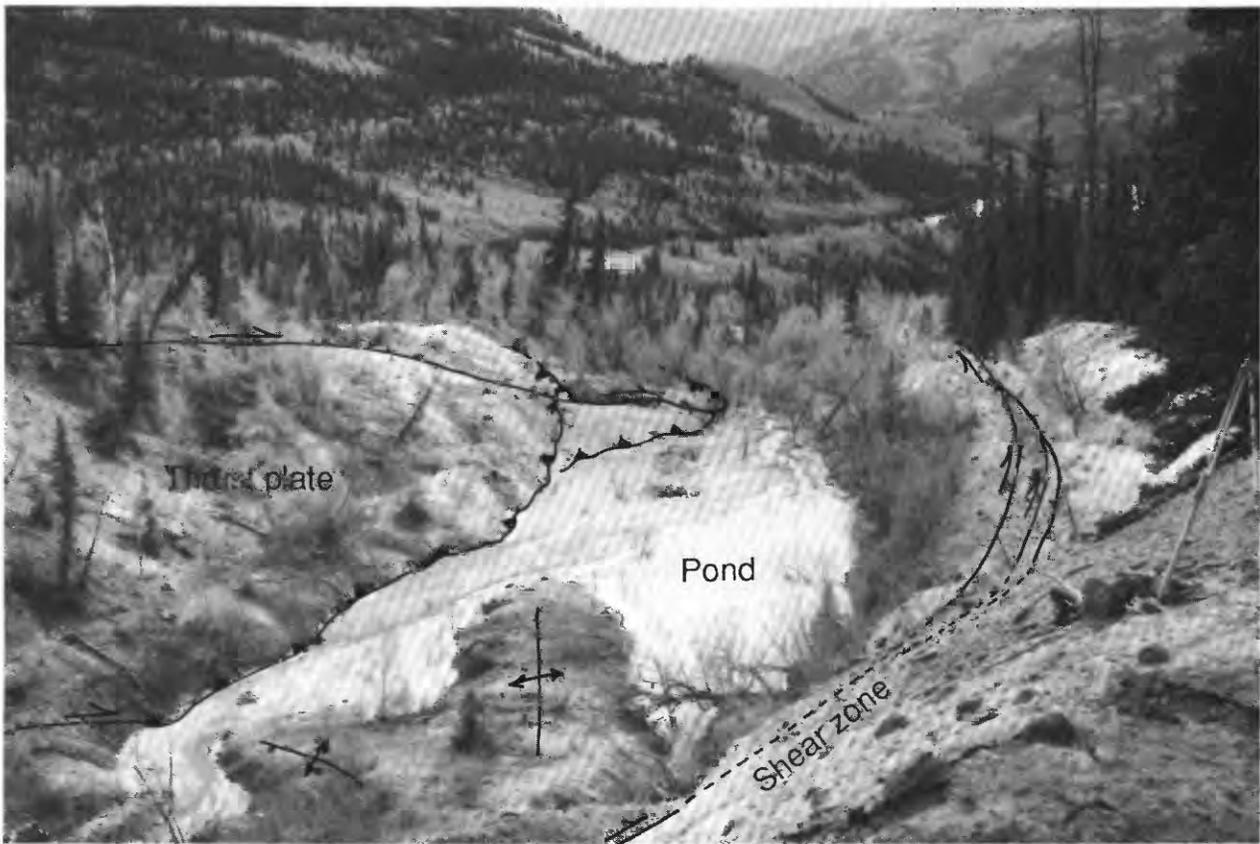
**Figure 2.** Pull-apart basin at step in right flank of the landslide (about 10850 N., 8850 E., see figure 1 for location). Annotated view looking downslope along right flank about 300 m below the narrowest part of the active landslide. Here, the landslide abruptly becomes wider. The right-lateral strike-slip shear zone on the landslide boundary is in the trough in the lower middle and curves along the right side of the view. The landslide widens at this step in the flank and others like it (fig. 1). Shown here are the typical structures formed in the downslope end of the widening section. We call the overall structure a pull-apart basin because of similarities to such basins in tectonic settings. Solid lines indicate visible active traces of the bounding faults, and dashed lines indicate projected traces where faults are obscured.

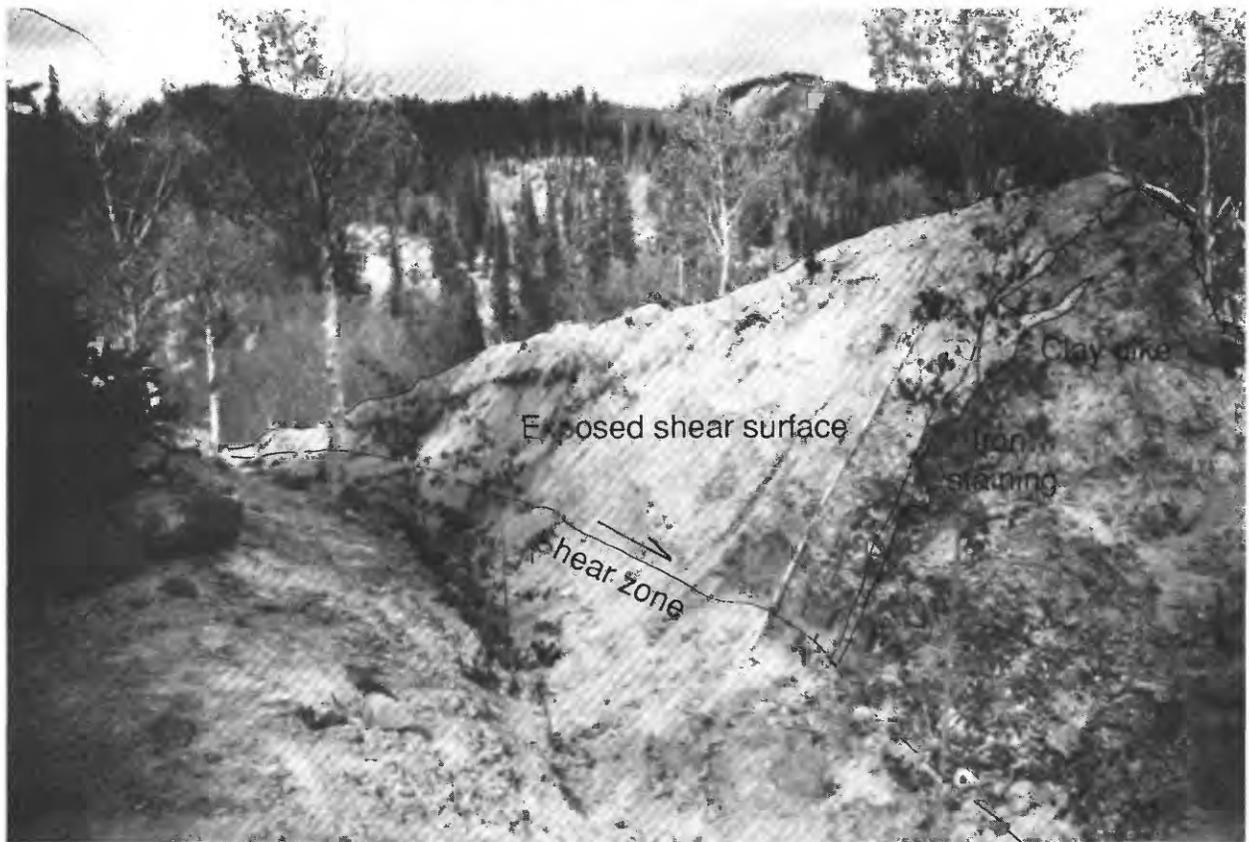
**Figure 3.** Annotated view looking upslope at flank ridge on right flank of the landslide (about 10530 N., 8370 E. Tape is 2 m long. See figure 1 for location). A 1.5-m-wide transverse crack exposes a cross-sectional view of the ridge (dark area surrounded by clay dike and the hachured line). Landslide material in the exposed face is stony, heterogeneous, and has a blocky structure. Near the left side of the ridge, the fracture surfaces defining the blocky structure are iron stained. A scarp at the outboard side of ridge (light area at center) exposes an emergent part of the lateral shear surface. This shear surface is between the crest and the trace of the right-lateral shear zone (shown by a solid line where the trace is visible, dashed where obscured). The scarp

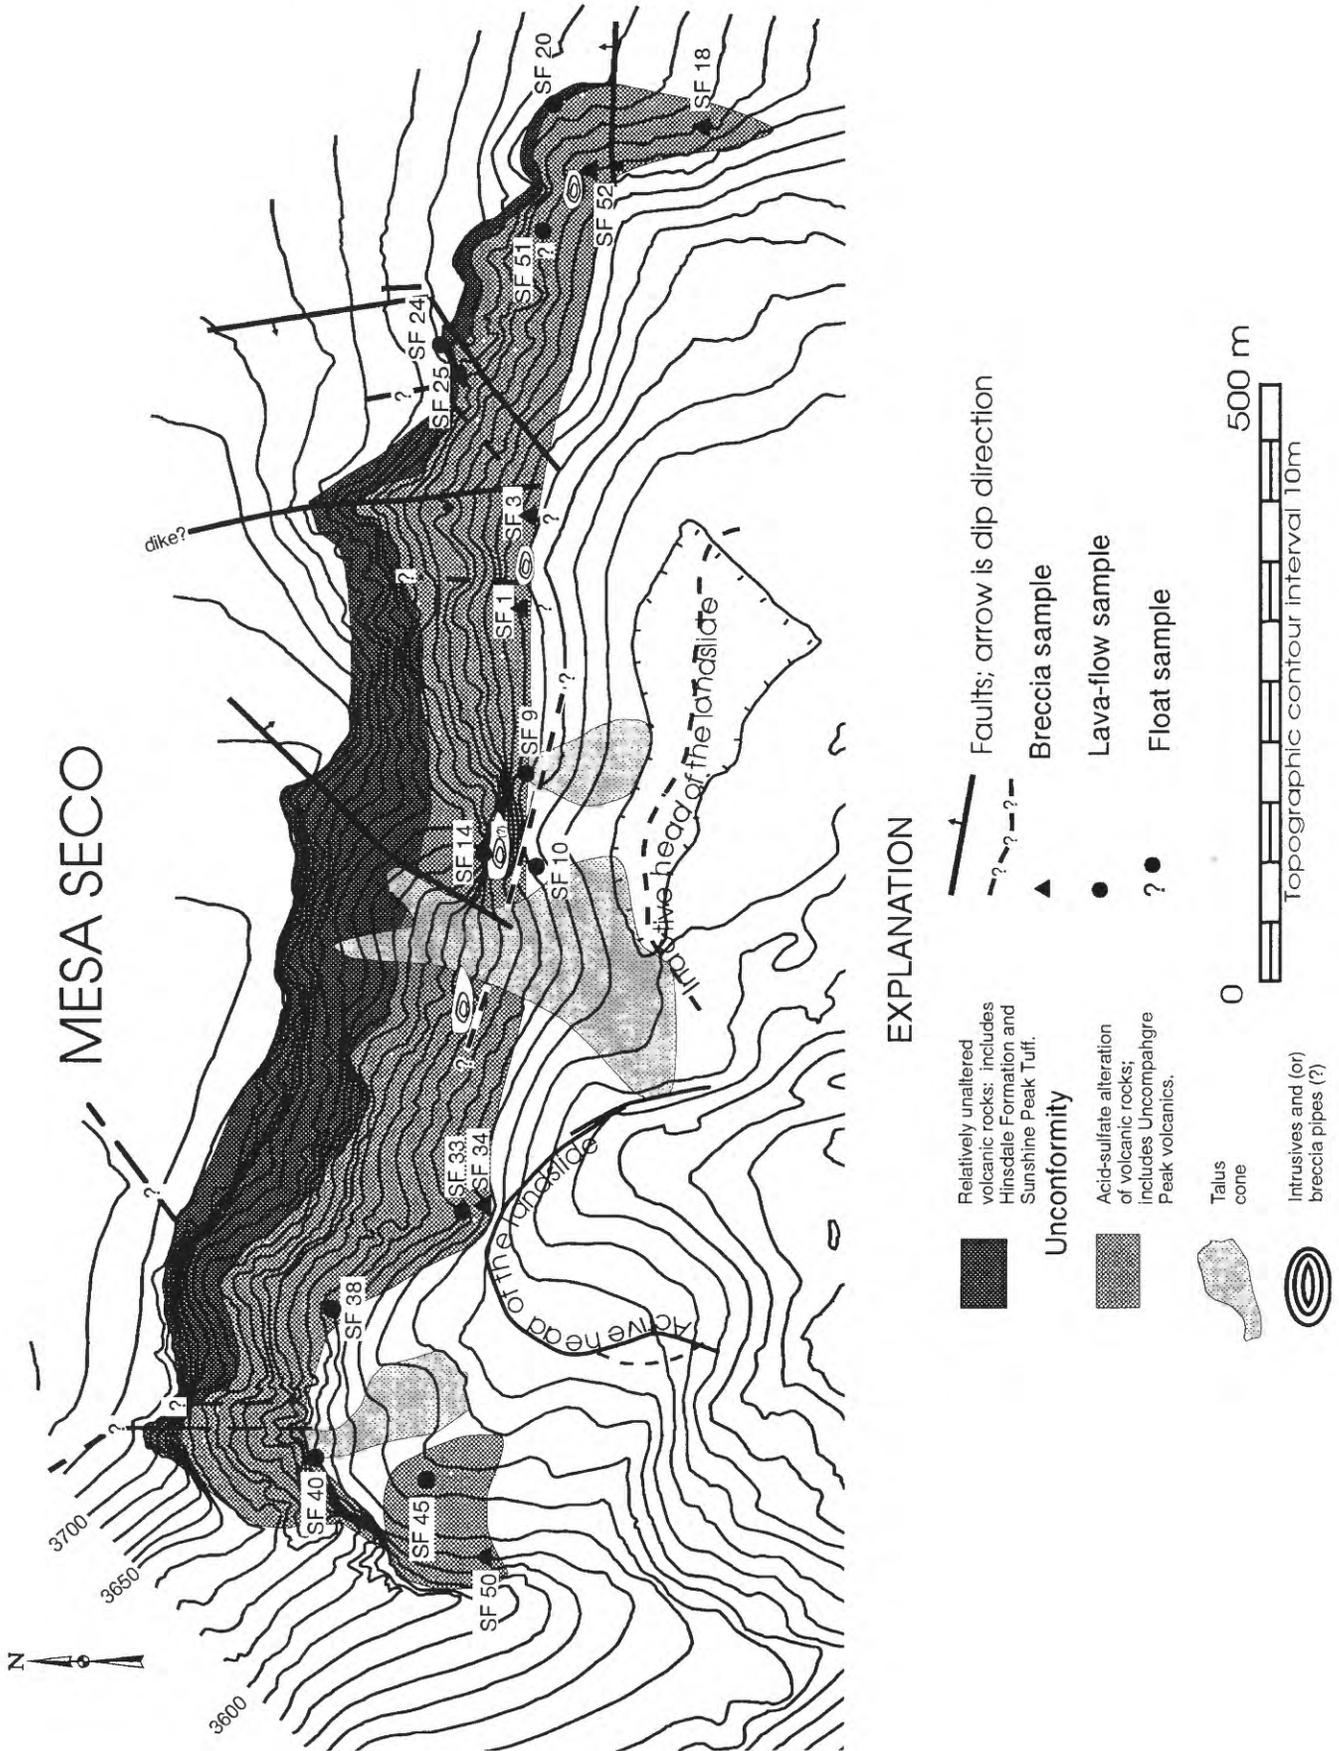
Figure 1. Preliminary geologic map of the main scarp of the Slumgullion landslide.

collected at the base of the scarp supplemented in situ samples that were collected from accessible outcrops along the sides of the scarp (fig. 1). The results of thin-section and bulk X-ray analyses of unaltered volcanic rock were compared with thin sections and X-ray traces of altered volcanic rock to determine the change in mineralogy caused by hydrothermal alteration (table 1). Powdered bulk samples were X-rayed using  $\text{CuK}\alpha$  radiation on a Philips-type 150-100-21 goniometer from  $2^\circ$  to  $65^\circ$   $2\theta$  at a scan speed of  $2^\circ$   $2\theta$  per minute. A Cambridge Mark 2 scanning electron microscope (SEM) with an attached energy-dispersive X-ray (EDX) was used to confirm the identity of the alteration mineralogy.

Of interest is the distribution of the alunite and jarosite minerals, which are later alteration products (fig. 3). The presence of these potassium sulfate minerals suggests that hydrothermal fluids associated with the intrusives were potassium rich. Alunite occurs with silica (opal?) around the intrusives in breccia zones and along the fault system. Jarosite, the more iron-rich potassium sulfate mineral, is peripheral to the alunite and forms a cement between breccia fragments. Smectitic clay is found in the main scarp but is more common near and in the active head of the landslide (fig. 1).

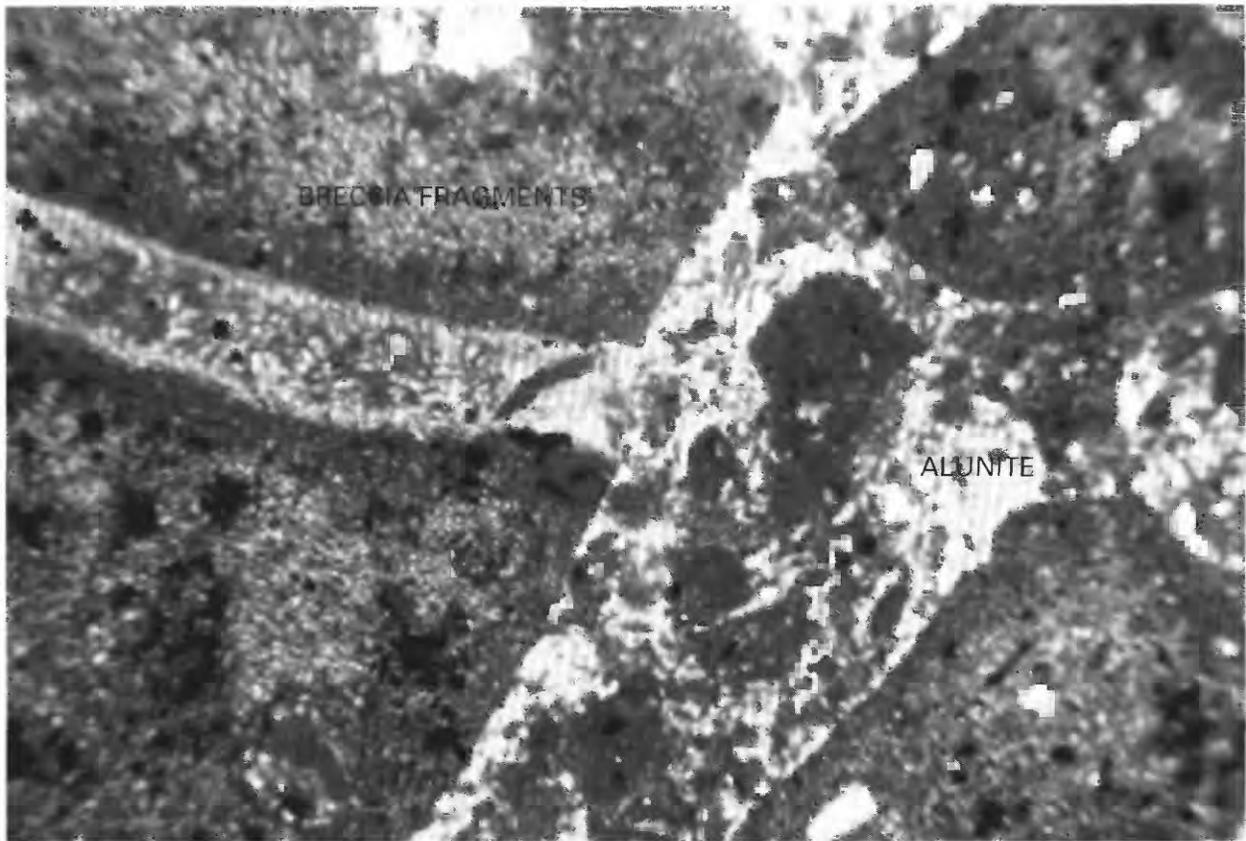
**Figure 2.** Photomicrograph of sample SF 25 (see fig. 1). Very angular breccia fragments cemented by silica and alunite. Horizontal field of view is approximately 2.5 mm.

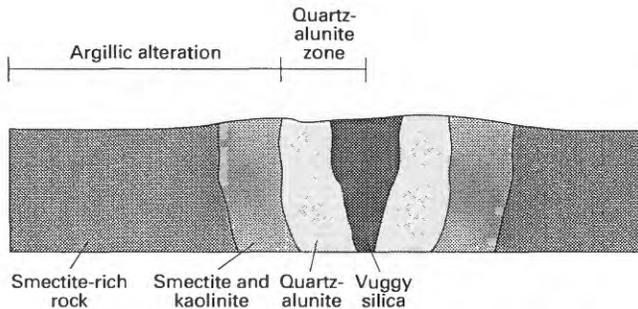
**Figure 4.** Sketch showing typical hydrothermal alteration zones in breccia pipes along the main scarp. Modified from Steven and Ratté (1960).

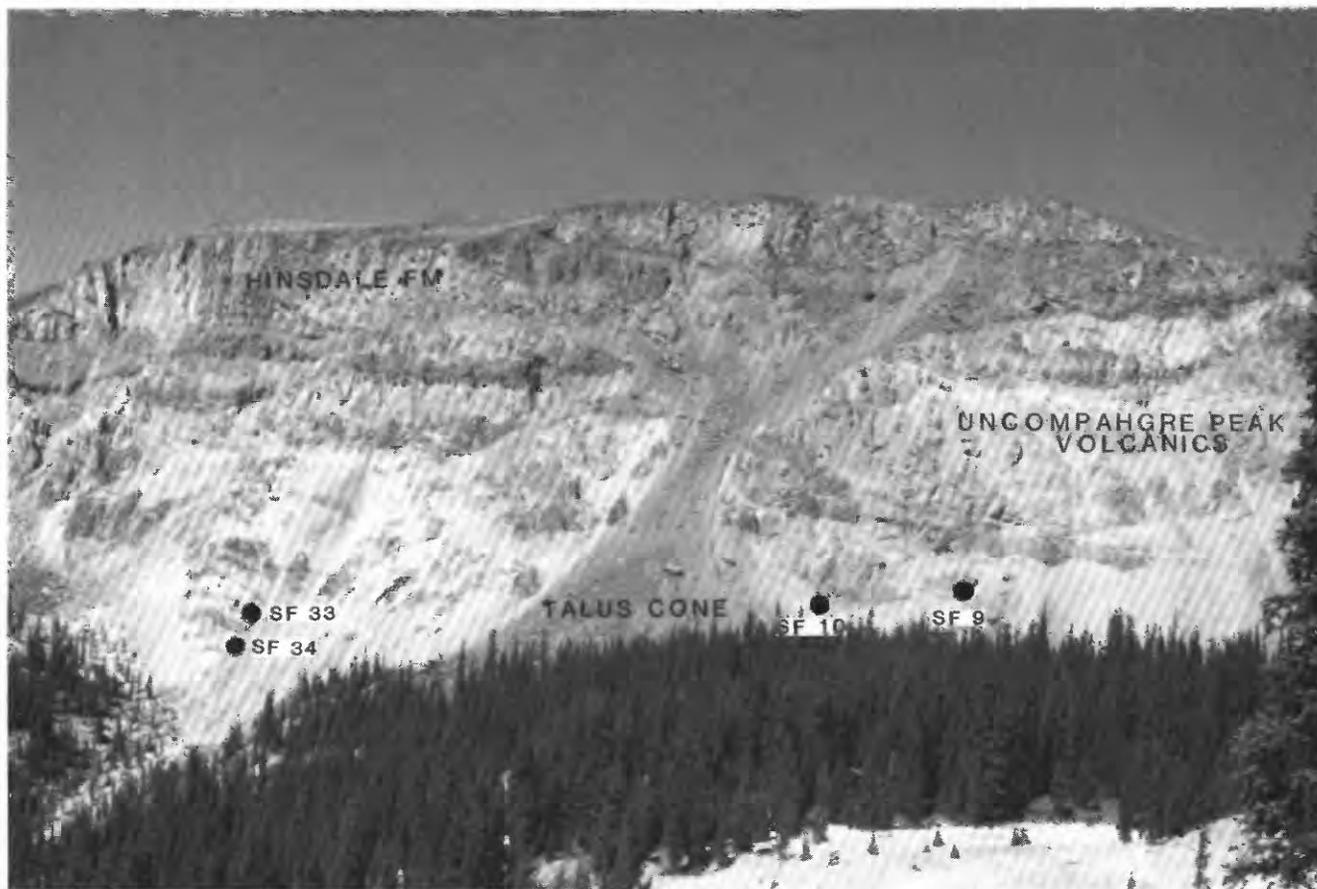
**Figure 5.** Portion of the main scarp showing Hinsdale Formation overlying Uncompahgre Peak volcanics and the major talus cone.

The instability of the main scarp is attributed to steep topography, intersection of faults, and to the high degree of alteration of the volcanic rocks. The main-scarp area of the Slumgullion landslide has been subjected to several generations of hydrothermal brecciation and alteration. The high degree of alteration in conjunction with the structural fabric is considered to be a prime factor in the original failure of the rock that formed the landslide. Failure of the main scarp has occurred in wide argillitic alteration zones surrounding the breccia pipes.

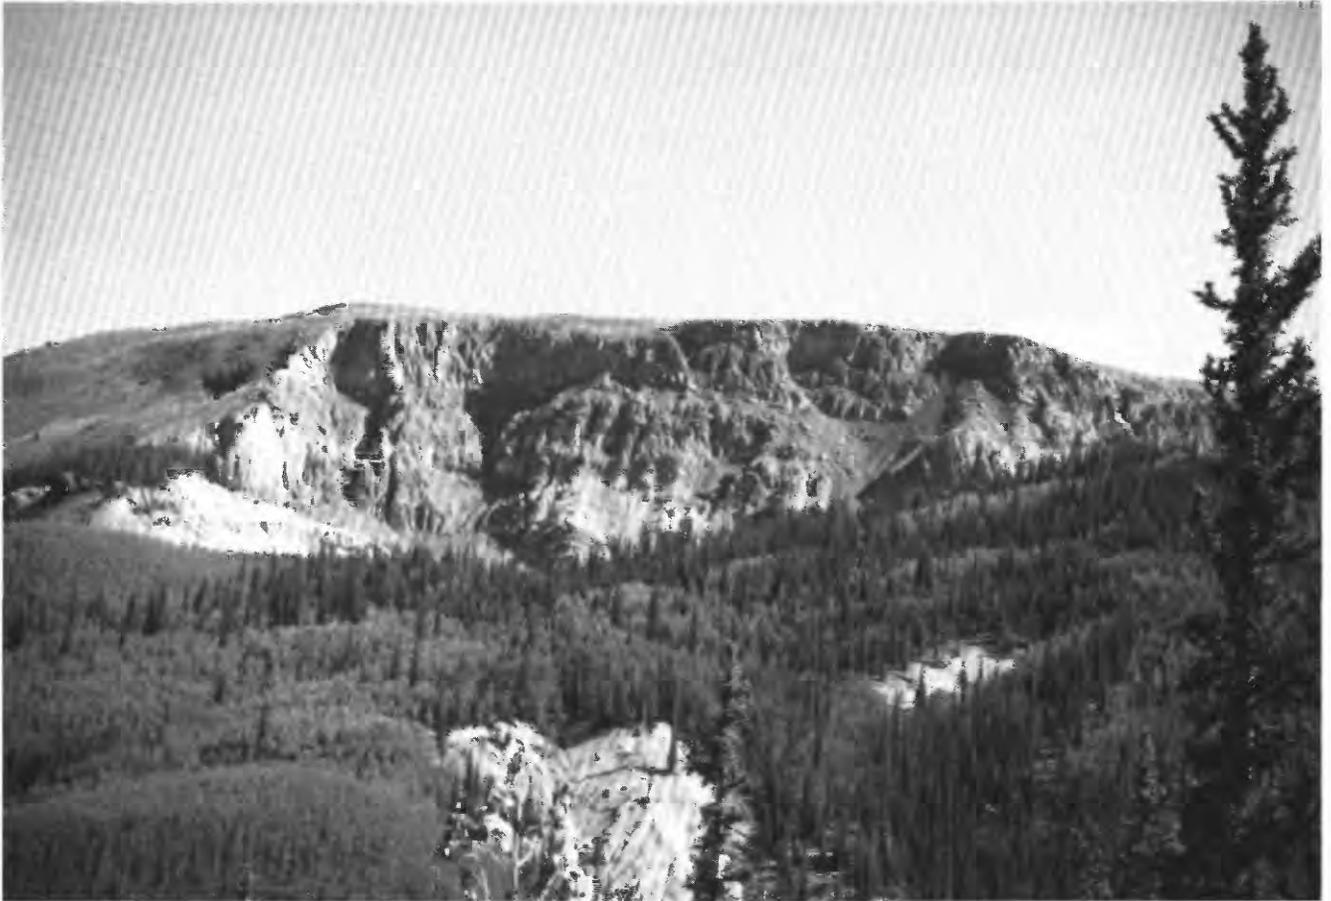
**Figure 1.** Main scarp of the Slumgullion landslide (August 1992 photograph).

High-quality individual terrestrial (i.e., ground-based) photographs of the Slumgullion main scarp taken in 1905 by Whitman Cross of the U.S. Geological Survey are available from the Photo Archives of the U.S. Geological Survey Library, Denver, Colo. Unfortunately, no archival stereopairs of the main scarp are available; thus, quantitative analysis of morphogenetic changes are not possible. Instead, these photographs were replicated by the authors in 1992 and 1993 from the exact sites at which the archival photos were taken. This was done with a modern 35-mm camera and a 35-mm to 105-mm "zoom" lens that could closely approximate the framing of the 1905 photos. By careful comparison of the new photos with the archival photos, it is possible to note local changes in main-scarp geometry, but it is not possible to determine quantitatively the amount or volume of retreat at these points. An example comparing 1905 Cross photography of the main scarp and a photograph taken by the authors in 1992 is presented in figure 4. Comparison of these photos indicates that, since 1905, major changes in surface geometry have occurred in weaker rocks (Diehl and Schuster, this volume) at mid-height on the rock face near the center of the wall (between the arrows in fig. 4A). Little change has taken place in the more resistant rocks at the top of the wall.

Beginning in 1982, the authors have taken their own terrestrial photographs of the more active parts of the main scarp, avalanche chutes, and talus deposits, especially in the sector of the scarp between the arrows in figure 4A. These photographs are being compared to current photos and will be compared to future photos taken from the same positions to obtain rough estimates of degradation of the most active parts of the scarp. An example of such a comparison over a period of 3 yr is presented in figure 5, where differences in distribution of rock-fall boulders from the main scarp can be seen at the toe of the talus apron.

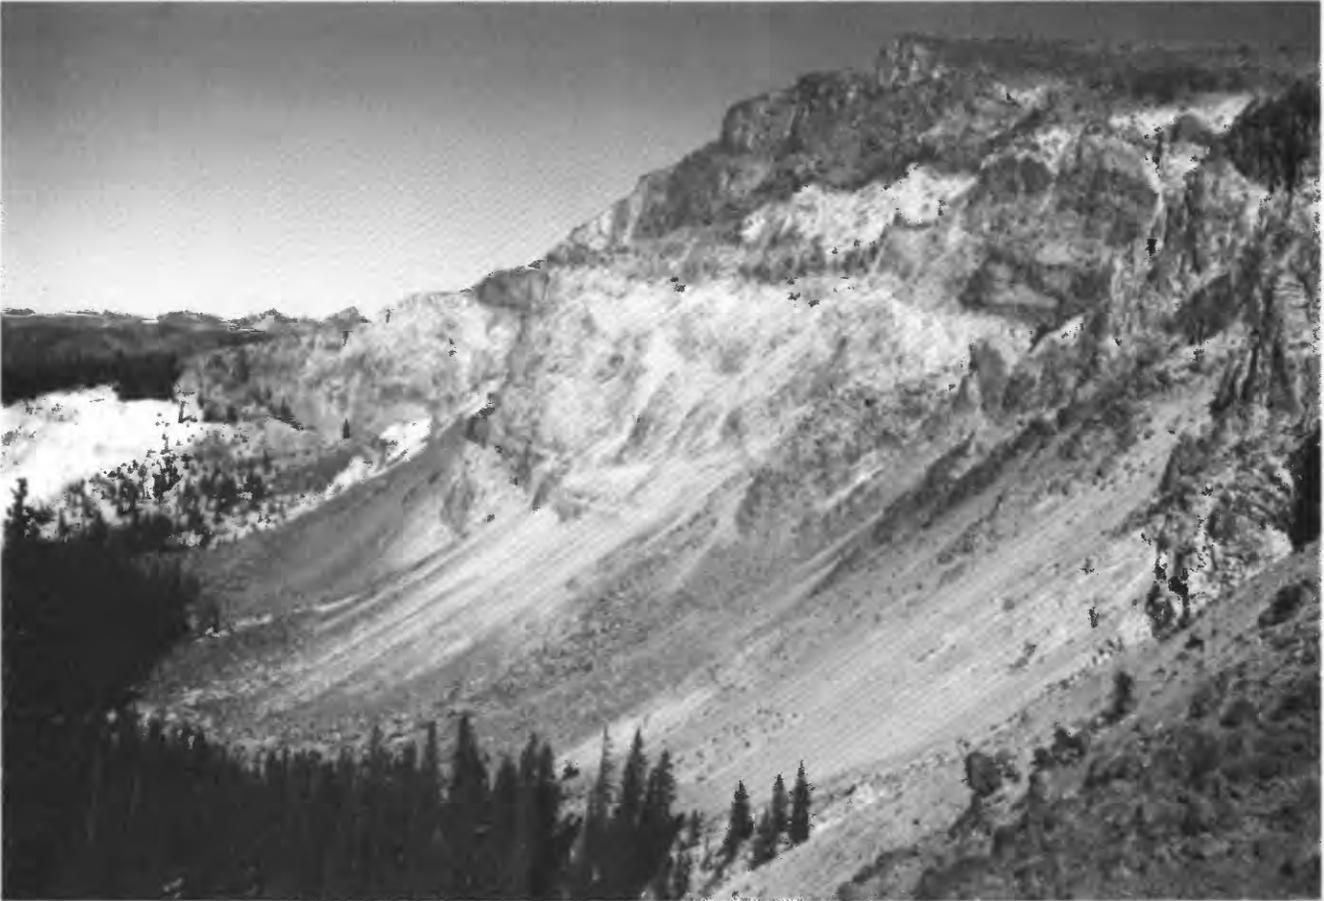
**Figure 2.** Talus cones forming an apron of volcanic rock-fall material (foreground and left center) beneath the main scarp of the Slumgullion landslide (August 1992 photograph). Approximate camera position is depicted as a circled "2" on map in figure 6.

Active rock-avalanche chutes are located along main-scarp faults and fault intersections. These chutes funnel rock debris from the main scarp to the talus apron at its base (fig. 2). The talus deposits are made up of angular cobble- to boulder-sized blocks of volcanic rock. The large boulders, some as large as automobiles (fig. 3), are derived from failure of the main scarp along vertical joints in the resistant Hinsdale Formation at the top of the scarp (Diehl and Schuster, this volume). The talus deposits load part of the head of the landslide and potentially serve as a long-term driving force applied to the mass. However, we have little idea of the rate of accumulation of this rock-fall/rock-avalanche material, and it seems to have little effect on the currently active part of the landslide.

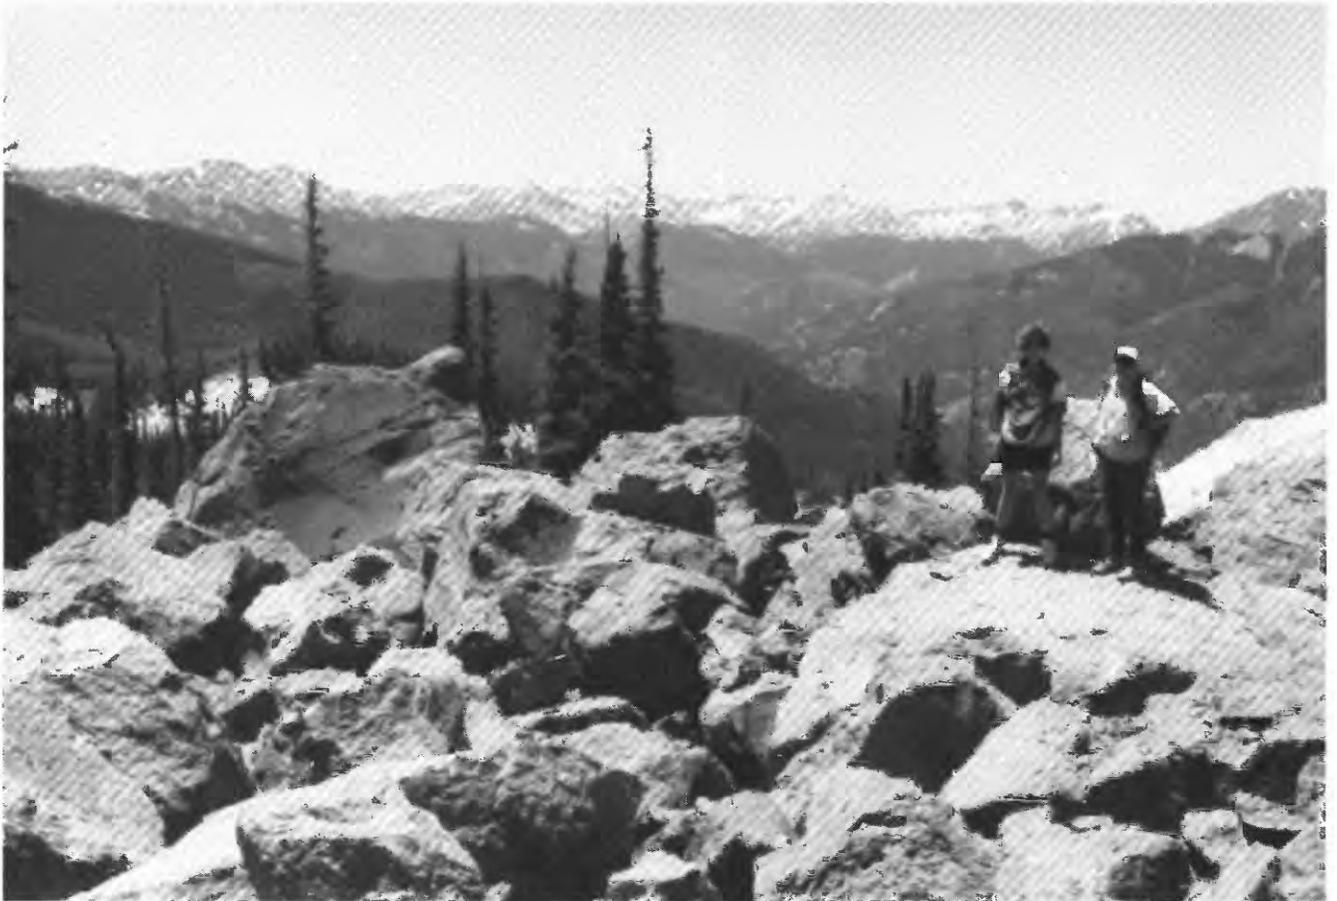
**Figure 3.** Large boulders at toe of talus apron (July 1993 photograph). Approximate camera position is depicted as circled “3” on map in figure 6.

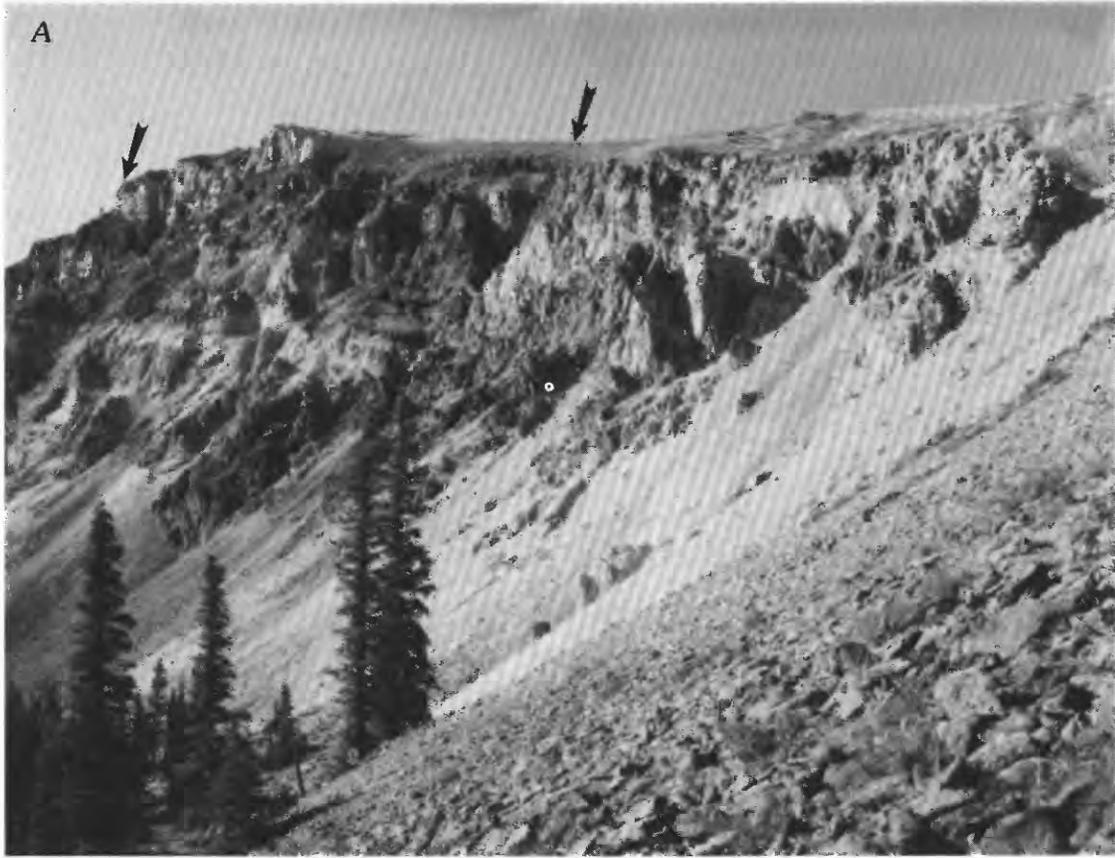
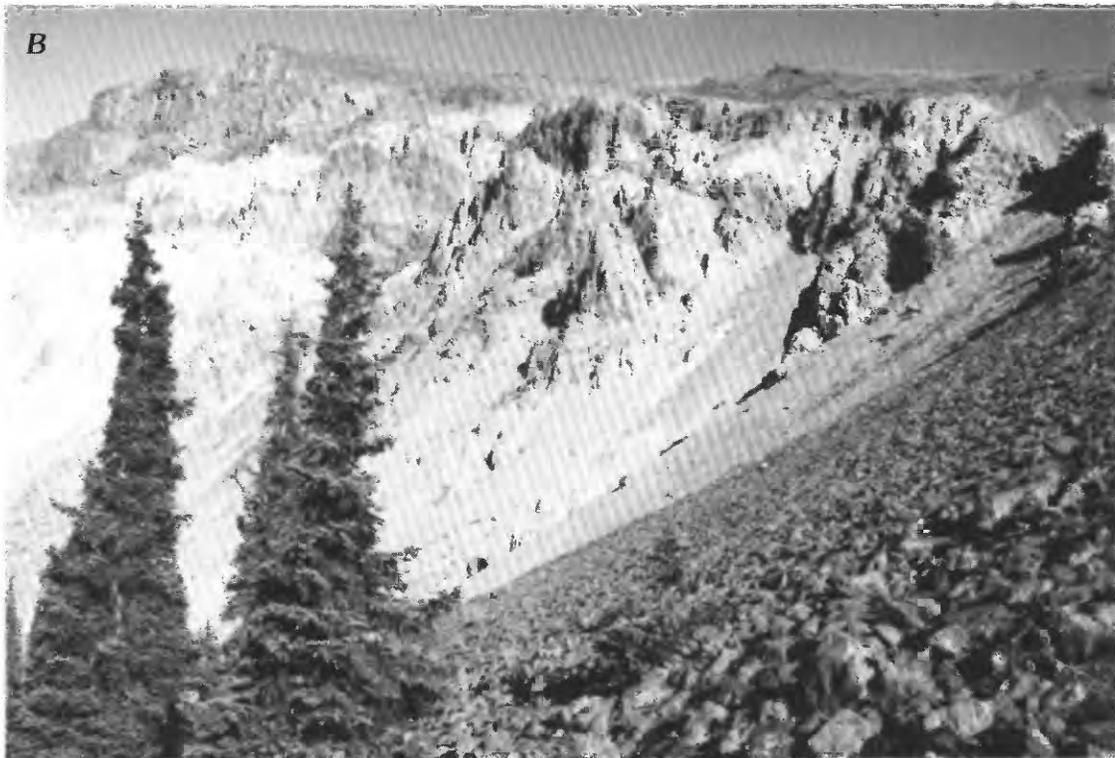
**Figure 4** (facing page). Comparison of 1905 main-scarp photograph (A) by Whitman Cross to September 1992 photograph (B) from same position by the authors. The two photographs indicate that, during this 87-yr period, considerable material was removed from midheight of the main scarp in the area between the two arrows of the 1905 photograph. The approximate camera position is depicted as a circled “4” on figure 6.

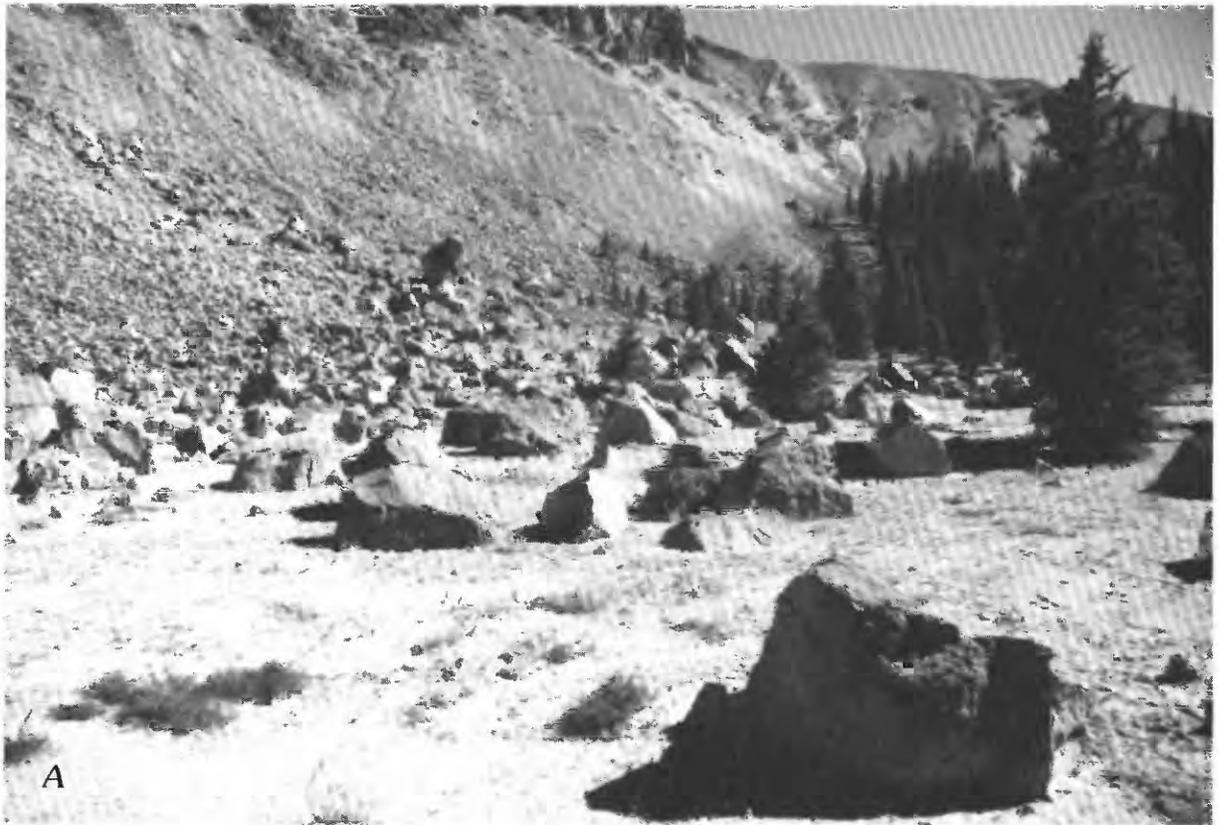
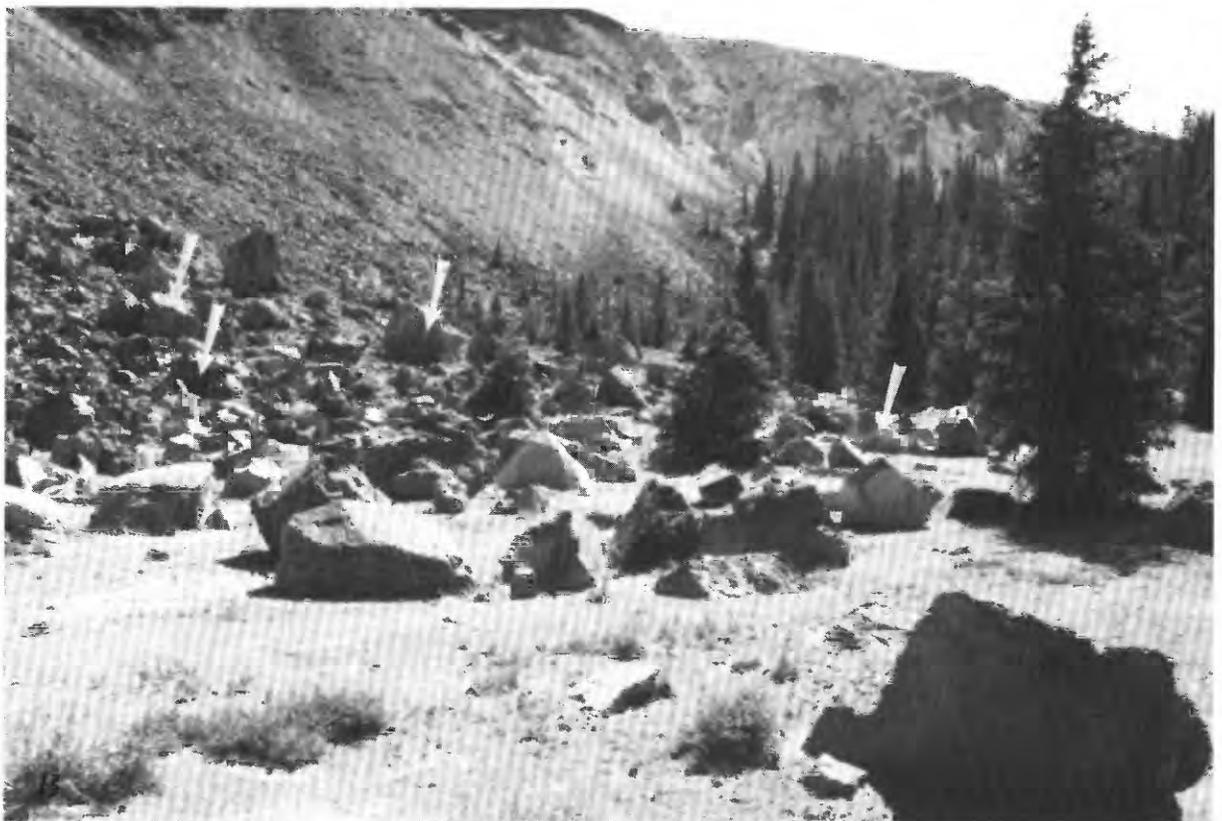
**Figure 7.** Stereographic photographs of portion of main scarp taken with Hasselblad camera from permanent photographic stations no. 8 (photograph *A*) and no. 7 (photograph *B*), September 26, 1992. Positions of photographic stations are indicated in figure 6. This stereopair and pairs taken from other stations can be used to produce a “vertical” topographic map of the main scarp.

stations (fig. 6) about 100 m apart on a line about 1 km in front of the main scarp. From these, a series of stereographic photo pairs (fig. 7) was taken with a calibrated Hasselblad camera. A vertical topographic map of the main scarp as it was in 1992 will be produced using these stereopairs. In future years, the camera stations can be reoccupied, the 1992 stereopairs replicated, and new vertical topographic maps produced. By “subtracting” a new DTM from the 1992 version, the amount of retreat and the volume of failed main scarp can be determined. Because the rate of retreat is very slow, it may be decades before substantial changes will be noted. Thus, our photos will be placed in USGS archives for future use and comparisons.
