# The Slumgullion Earth Flow: A Large-Scale Natural Laboratory

U.S. GEOLOGICAL SURVEY BULLETIN 2130

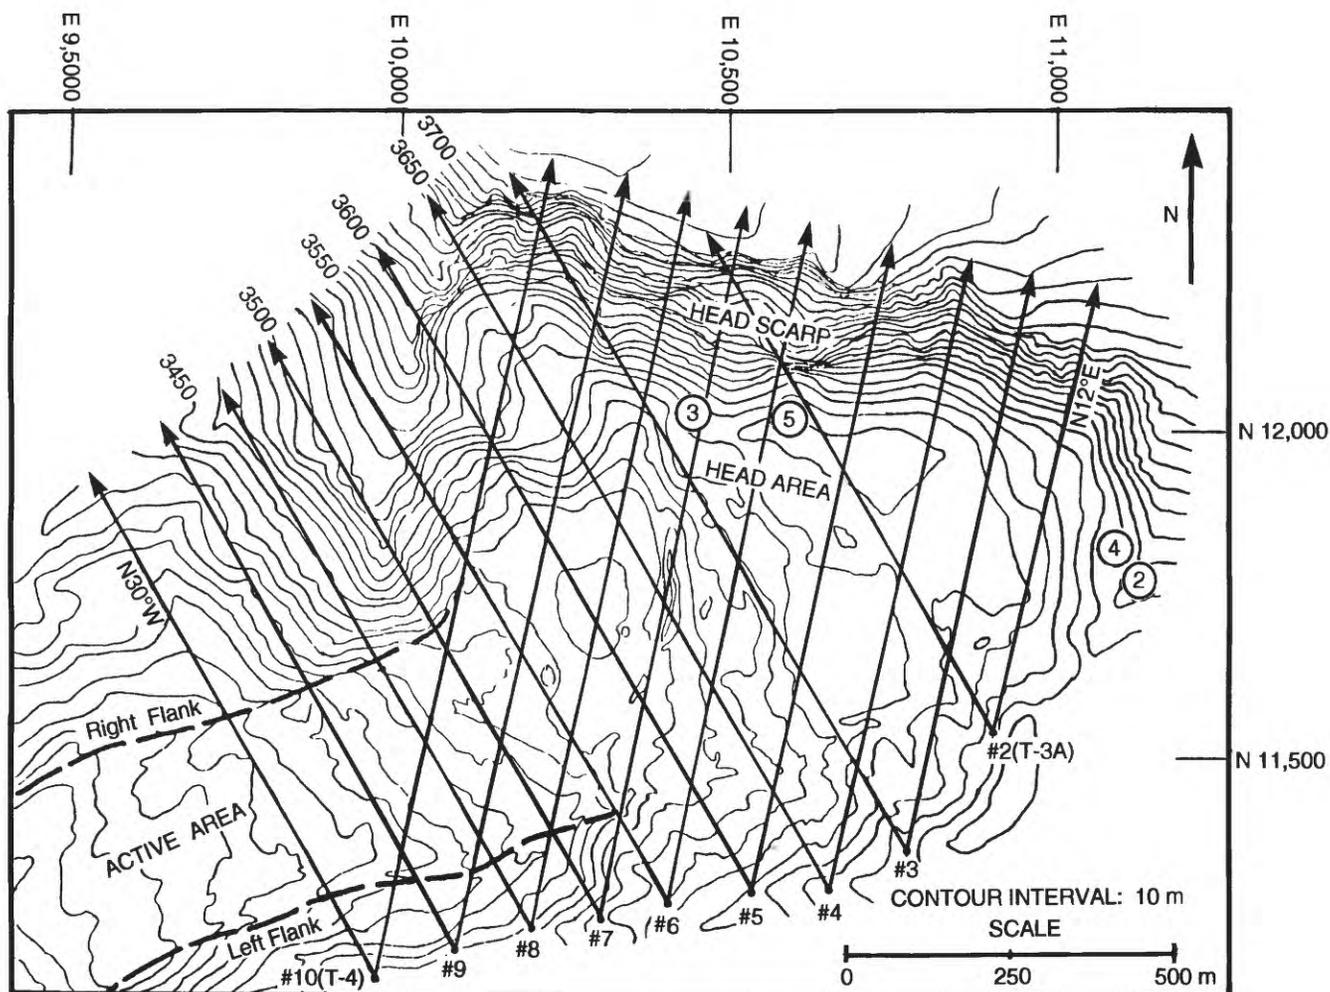
**Figure 6.** Map showing locations of nine permanent camera stations from which stereopairs (fig. 7) were taken at bearings of N. 12° E. and N. 30° W. in September 1992. Approximate camera positions for photographs in figures 2, 3, 4, and 5 are indicated by circled numbers. Grid ticks on map borders represent local coordinate system in meters.

stations (fig. 6) about 100 m apart on a line about 1 km in front of the main scarp. From these, a series of stereographic photo pairs (fig. 7) was taken with a calibrated Hasselblad camera. A vertical topographic map of the main scarp as it was in 1992 will be produced using these stereopairs. In future years, the camera stations can be reoccupied, the 1992 stereopairs replicated, and new vertical topographic maps produced. By “subtracting” a new DTM from the 1992 version, the amount of retreat and the volume of failed main scarp can be determined. Because the rate of retreat is very slow, it may be decades before substantial changes will be noted. Thus, our photos will be placed in USGS archives for future use and comparisons.

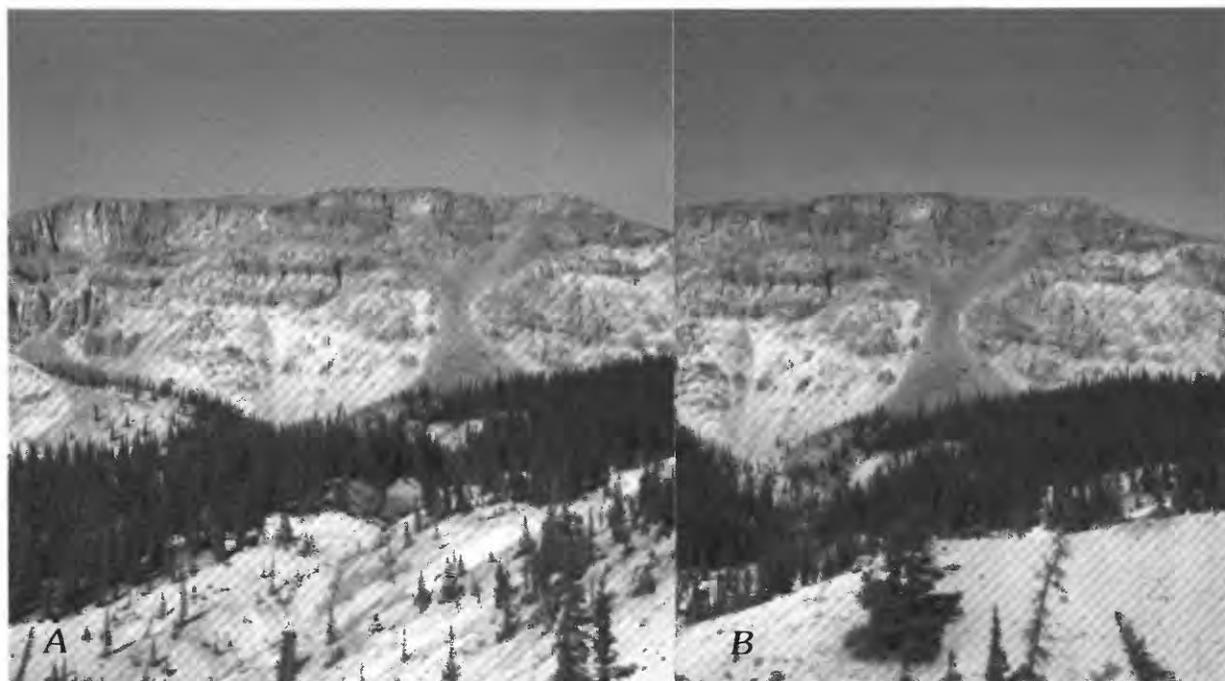
**Figure 7.** Stereographic photographs of portion of main scarp taken with Hasselblad camera from permanent photographic stations no. 8 (photograph *A*) and no. 7 (photograph *B*), September 26, 1992. Positions of photographic stations are indicated in figure 6. This stereopair and pairs taken from other stations can be used to produce a “vertical” topographic map of the main scarp.

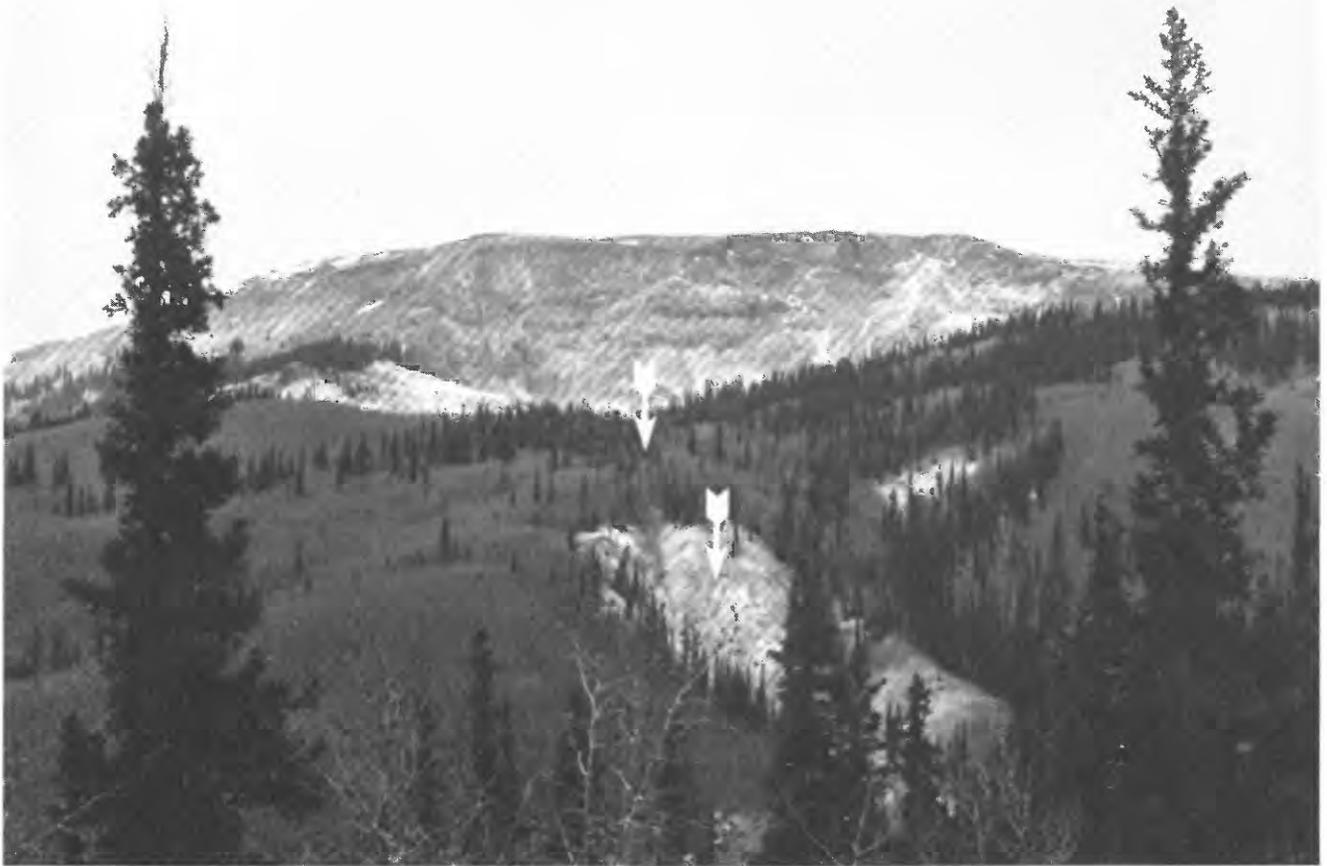
**Figure 1.** Panoramic view (looking north) of the area of the newly identified landslide deposit (middle foreground). Arrows point to the exposed lower (distal) part of the deposit and the tree-covered, hummocky upper part. The 250-m-high main scarp of the Slumgullion landslide is in background. Photograph taken from Windy Point Overlook, located approximately 0.8 km south of the deposit.

A newly identified landslide deposit covering an area of more than 100,000 m<sup>2</sup> immediately adjacent to an upper part of the Slumgullion landslide (fig. 1) was studied to determine its origin, age, and relationship to the Slumgullion landslide. The deposit was mapped, surface features and materials were examined and described, stratigraphic relationships were noted, and samples of wood buried in the deposit were collected for radiocarbon dating (Chleborad, 1993). The surface of the newly identified landslide deposit is composed of fine-grained, altered volcanic debris and scattered and locally concentrated fragments and blocks of volcanic rock. The overall appearance of the deposit is similar to other parts of the Slumgullion landslide that have been characterized as older and inactive. Figure 2 shows the location of the newly identified deposit with respect to previously recognized boundaries of the inactive and active parts of the Slumgullion landslide. The location, orientation, and composition of the deposit indicate that it is part of a landslide that originated in the Slumgullion landslide source area. Comparison of the location of the deposit with a published reconstruction of the pre-Slumgullion topography suggests that a large volume of landslide debris that originated near the present 250-m-high main scarp filled the upper valley below the main scarp and spilled over a 60-m-high, east-west trending ridge (divide). The spillover (newly identified landslide deposit) moved in a southwesterly direction down a ravine in the drainage basin of Slumgullion Creek. Subsequent mass movement of the valley fill within the previously recognized bounds of the Slumgullion landslide truncated the original deposit, leaving a steep scarp and exposing a basal contact with underlying colluvium (fig. 2). The apparent sensitivity of the movement of the newly identified landslide debris to the existing topography suggests that it was emplaced as a relatively slow moving landslide rather than as a catastrophic failure that overran the topography. Based on initial results of the study, it was concluded

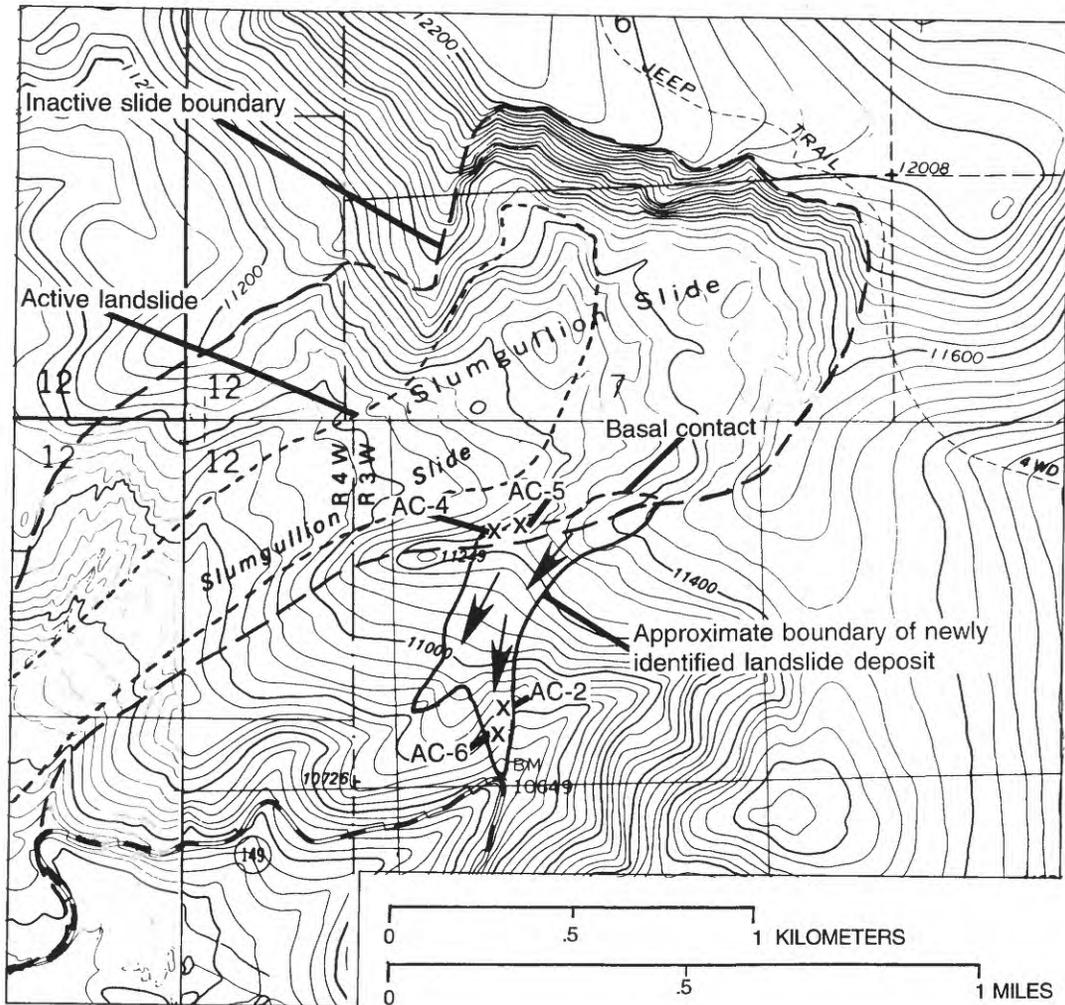
**Figure 2.** Topographic map of the upper area of the Slumgullion landslide showing the location of the newly identified landslide deposit. The previously recognized active and inactive landslide boundaries are from Parise and Guzzi (1992). The X's mark the locations of radiocarbon sample sites AC-2, AC-4, AC-5, and AC-6. Arrows indicate the

Wood found buried in clay-rich landslide debris at the distal and truncated ends of the deposit (locations AC-2, AC-4, AC-5, and AC-6 in fig. 2) yielded conventional radiocarbon ages ranging from 1,130 to 1,630 yr B.P. (table 1). At locations AC-2 and AC-6, near the distal end, samples were taken from each of two partly buried logs (partly exposed by erosion) located several meters above the base of the deposit (fig. 3). Wood samples AC-2 and AC-6 were identified as *Abies* (fir) and *Pinus* (pine), respectively (Paleo Research Laboratories, unpub. report, 1994). The logs were not extensively decayed allowing sampling and dating of the outer 10 to 20 rings. Partial excavation revealed tree bark and branches on outer parts of the logs indicating that few, if any, of the external rings were missing as a result of decay or erosion. At locations AC-4 and AC-5, at the truncated end of the deposit, wood fragments (maximum dimension approximately 0.2 m) concentrated in a zone at the basal contact with the pre-slide surface were also sampled for dating. Calibrated  $\pm 2\sigma$  ranges for the radiocarbon ages of the samples (table 1) were obtained by applying the tree-ring calibration curves of Stuiver and Reimer (1993).

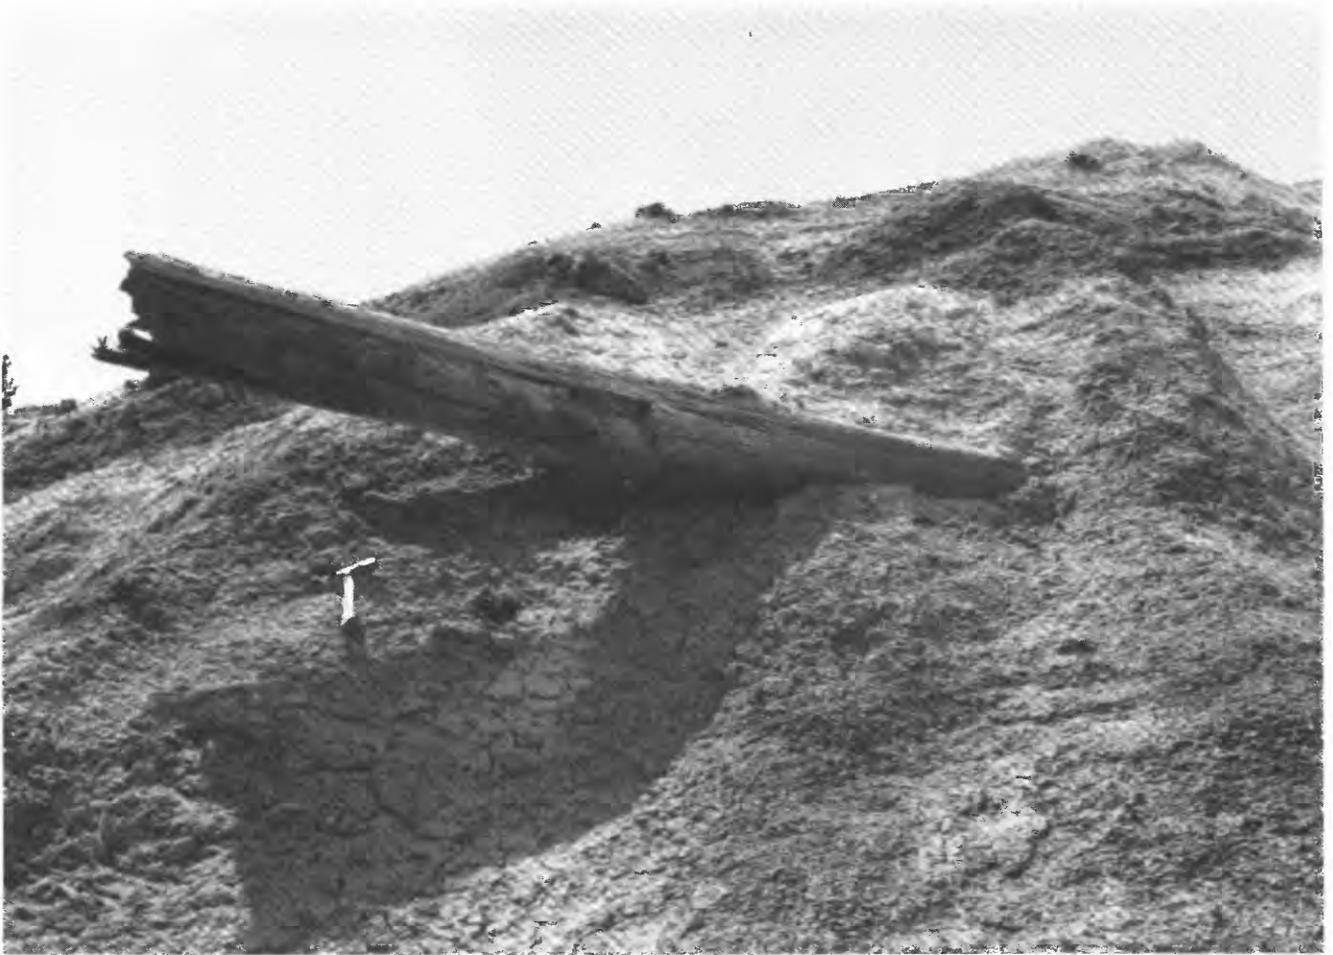
**Figure 3.** Photograph of partly buried log located at an elevation of about 3,290 m on the distal end of the newly identified landslide deposit (AC-2 on fig. 2). Wood from the outer 10–20 rings of the log yielded a conventional radiocarbon age of  $1,130 \pm 60$  yr B.P. (table 1). Bark is present on buried part of log.

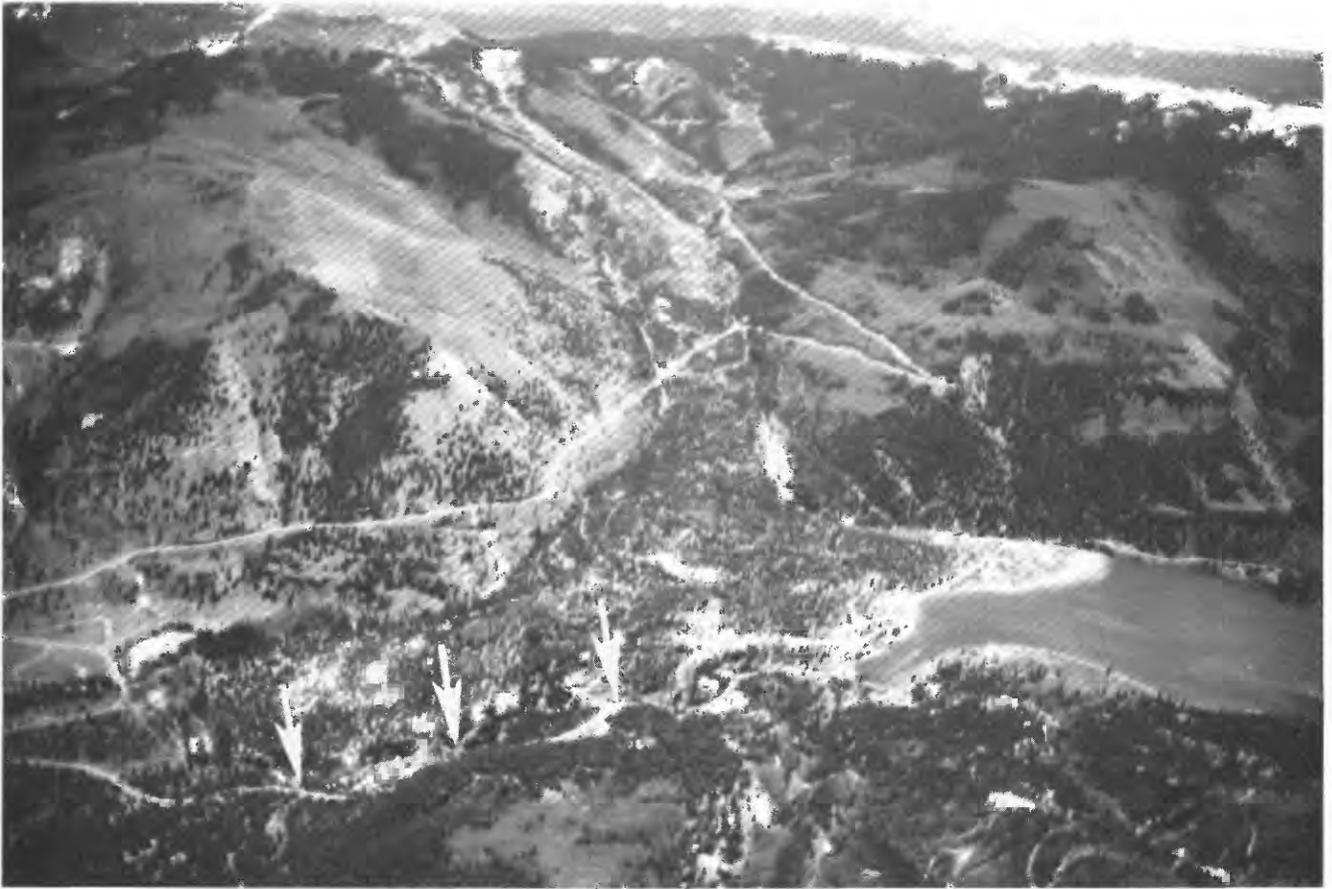
**Figure 1.** Oblique aerial view of the Slumgullion earth flow. The toe of this landslide formed the natural blockage of the Lake Fork of the Gunnison River that impounds Lake San Cristobal. Path of natural lake outlet channel across the dam at the toe of the landslide is indicated by arrows.

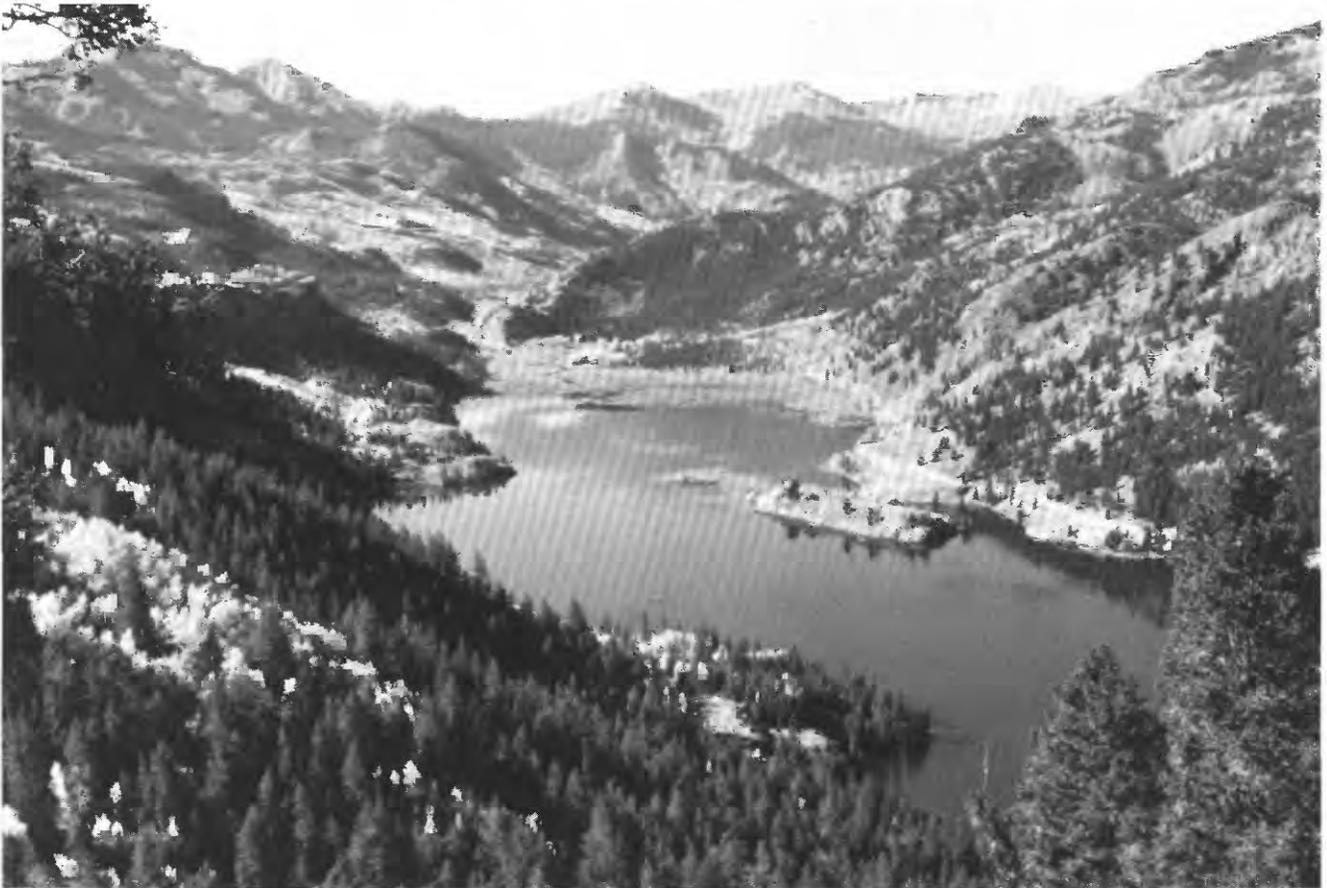
**Figure 2.** Lake San Cristobal, looking upstream toward the headwaters of the Lake Fork of the Gunnison River.

About 700 yrs ago, the Slumgullion earth flow dammed the Lake Fork of the Gunnison River impounding Lake San Cristobal, which today is 3.3 km long, 27 m deep, and has a volume of about 14 million m<sup>3</sup>. Except for an average of 10 m of erosional downcutting of the natural outlet channel across the dam, little change has occurred in the geometry or character of the dam since it was formed. Because the channel now appears to be stable in regard to erosion, there is no reason to expect failure of this broad, fairly flat dam.

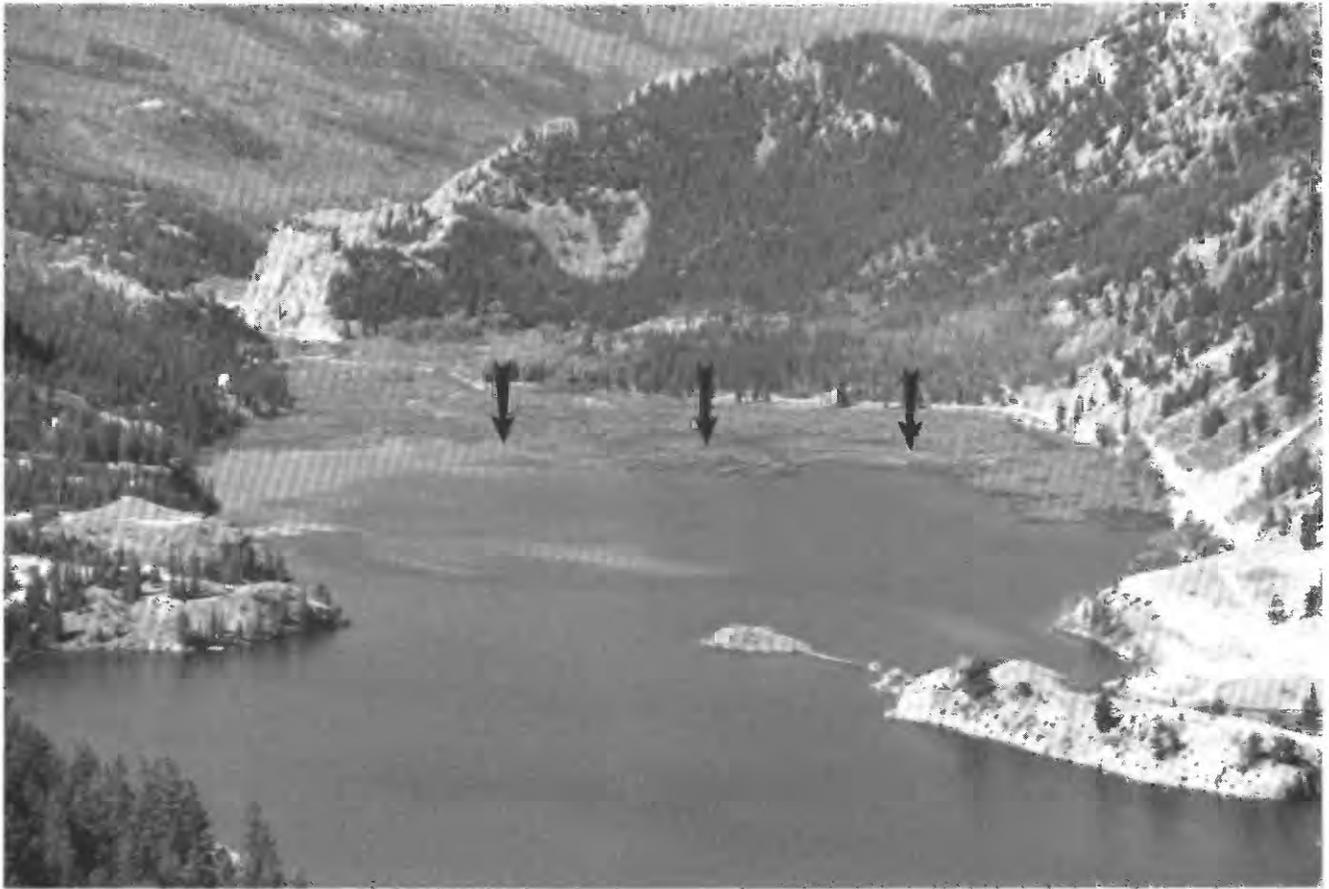
**Figure 3.** Post-landslide delta (arrows) at the head of Lake San Cristobal. This delta, which began to be deposited as the lake filled 700 yr ago, occupies about one quarter of the original lake basin.

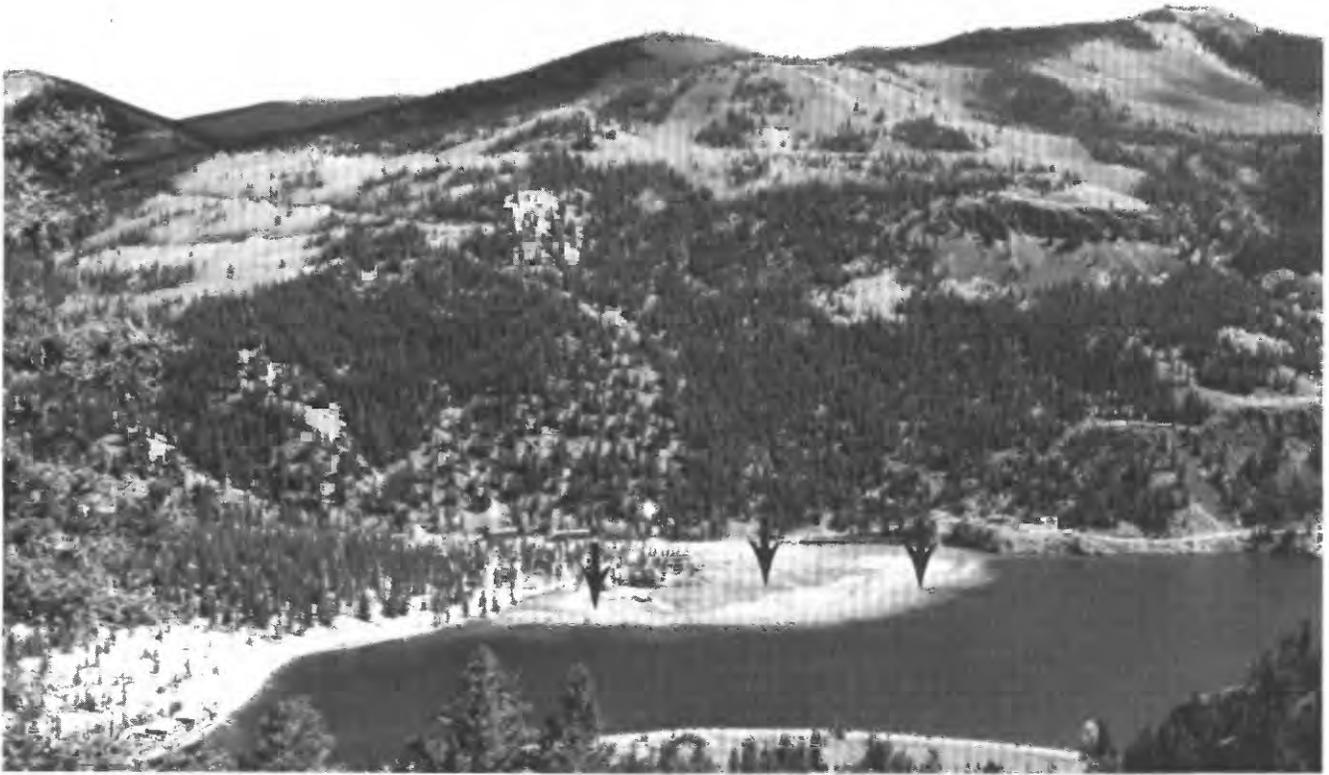
**Figure 4.** Looking east across the downstream end of Lake San Cristobal at the delta of Slumgullion Creek (arrows; see fig. 5 for location). This delta is a fan that has formed by erosion of material on the surface of the Slumgullion earth flow and deposition of this material in Lake San Cristobal by Slumgullion Creek. Deposition probably began to occur soon after the original earth flow occurred about 700 yr ago and is continuing at present.

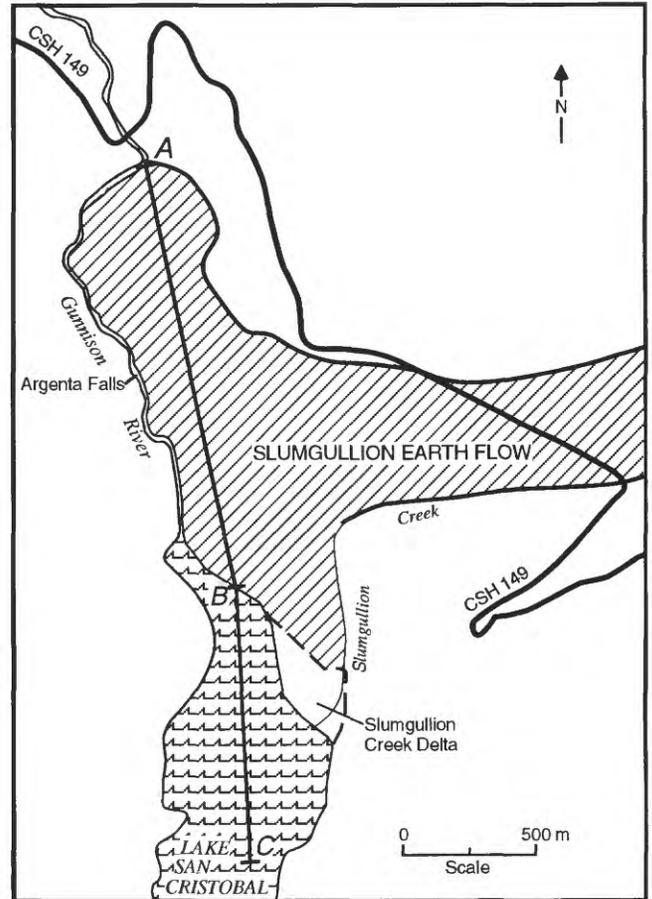
**Figure 5.** Outline map of the lower end of the Slumgullion earth flow and the blockage of the Lake Fork of the Gunnison River. Line ABC indicates the approximate location of the pre-landslide Lake Fork of the Gunnison River. CSH, Colorado State Highway.

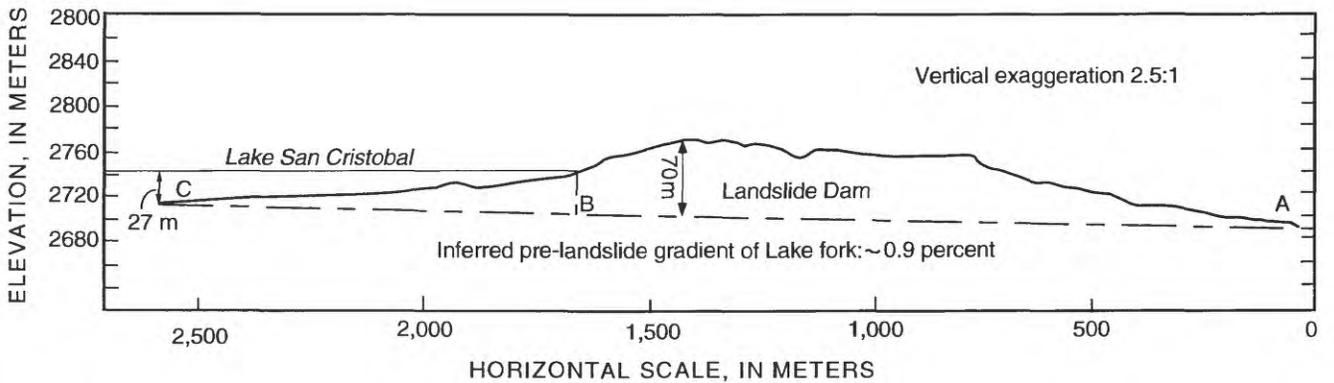
**Figure 6.** Surface profile across the Slumgullion landslide dam along line ABC, the estimated pre-slide position of the Lake Fork (fig. 5). The lower line shows the estimated straight-line gradient of the pre-slide Lake Fork.

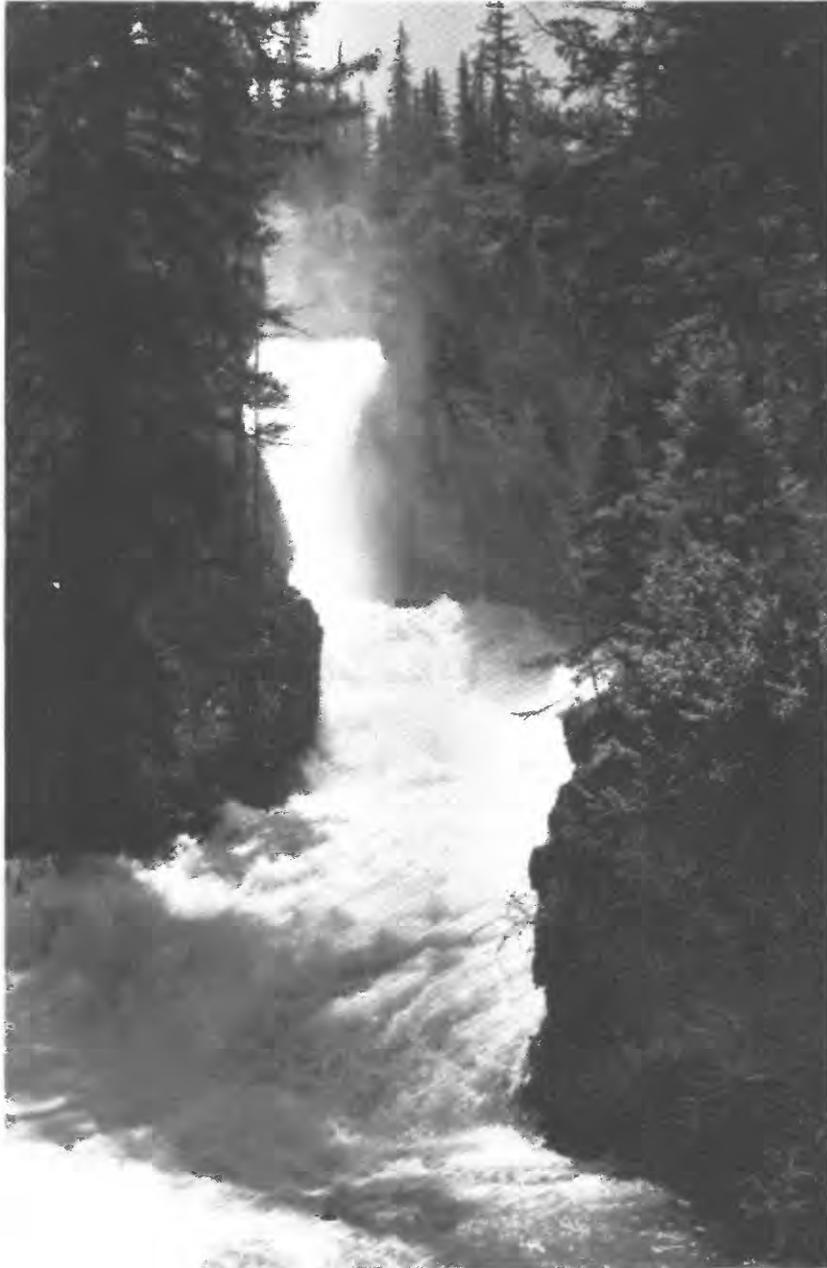
**Figure 7.** Argenta Falls on the Lake Fork outlet channel. This 25-m-high falls has been incised in volcanic bedrock since overtopping of the landslide dam about 700 yr ago.

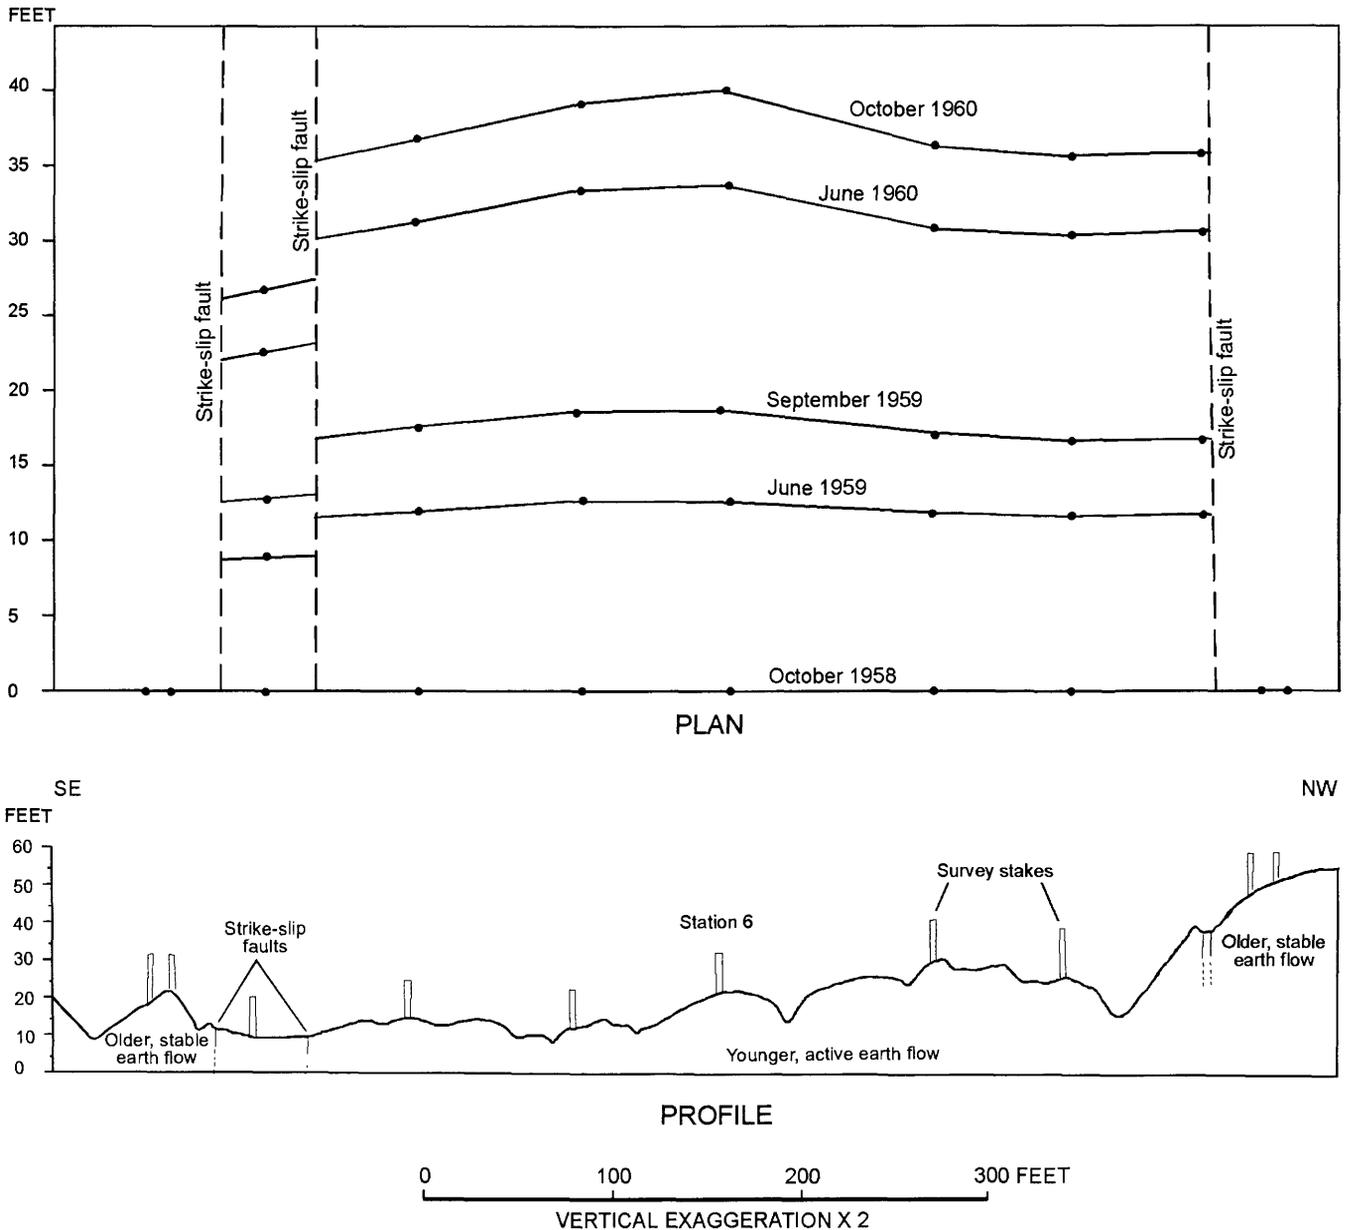
**Figure 1.** Plan and profile of movement at locality D (see fig. 3) in narrow part of the active Slumgullion Slide, between October 1958 and October 1960 (from Crandell and Varnes, 1961).

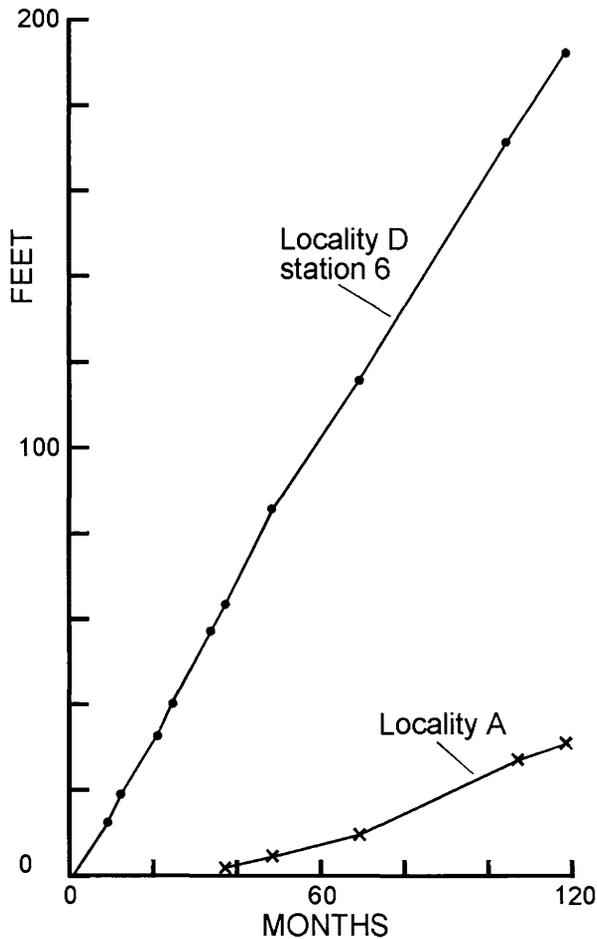
**Figure 2.** Displacements for the period 1958–68 of station 6, locality D, near the center of the slide, and at locality A, at the toe of the active front (see fig. 3).

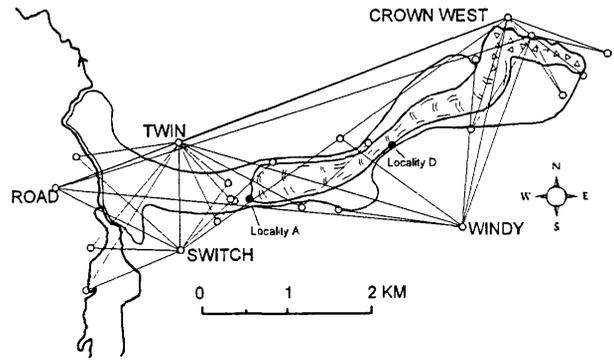
**Figure 3.** Triangulation-trilateration network at the Slumgullion Slide, showing a few of the station names. The active part is patterned within the borders of the older, inactive landslide.

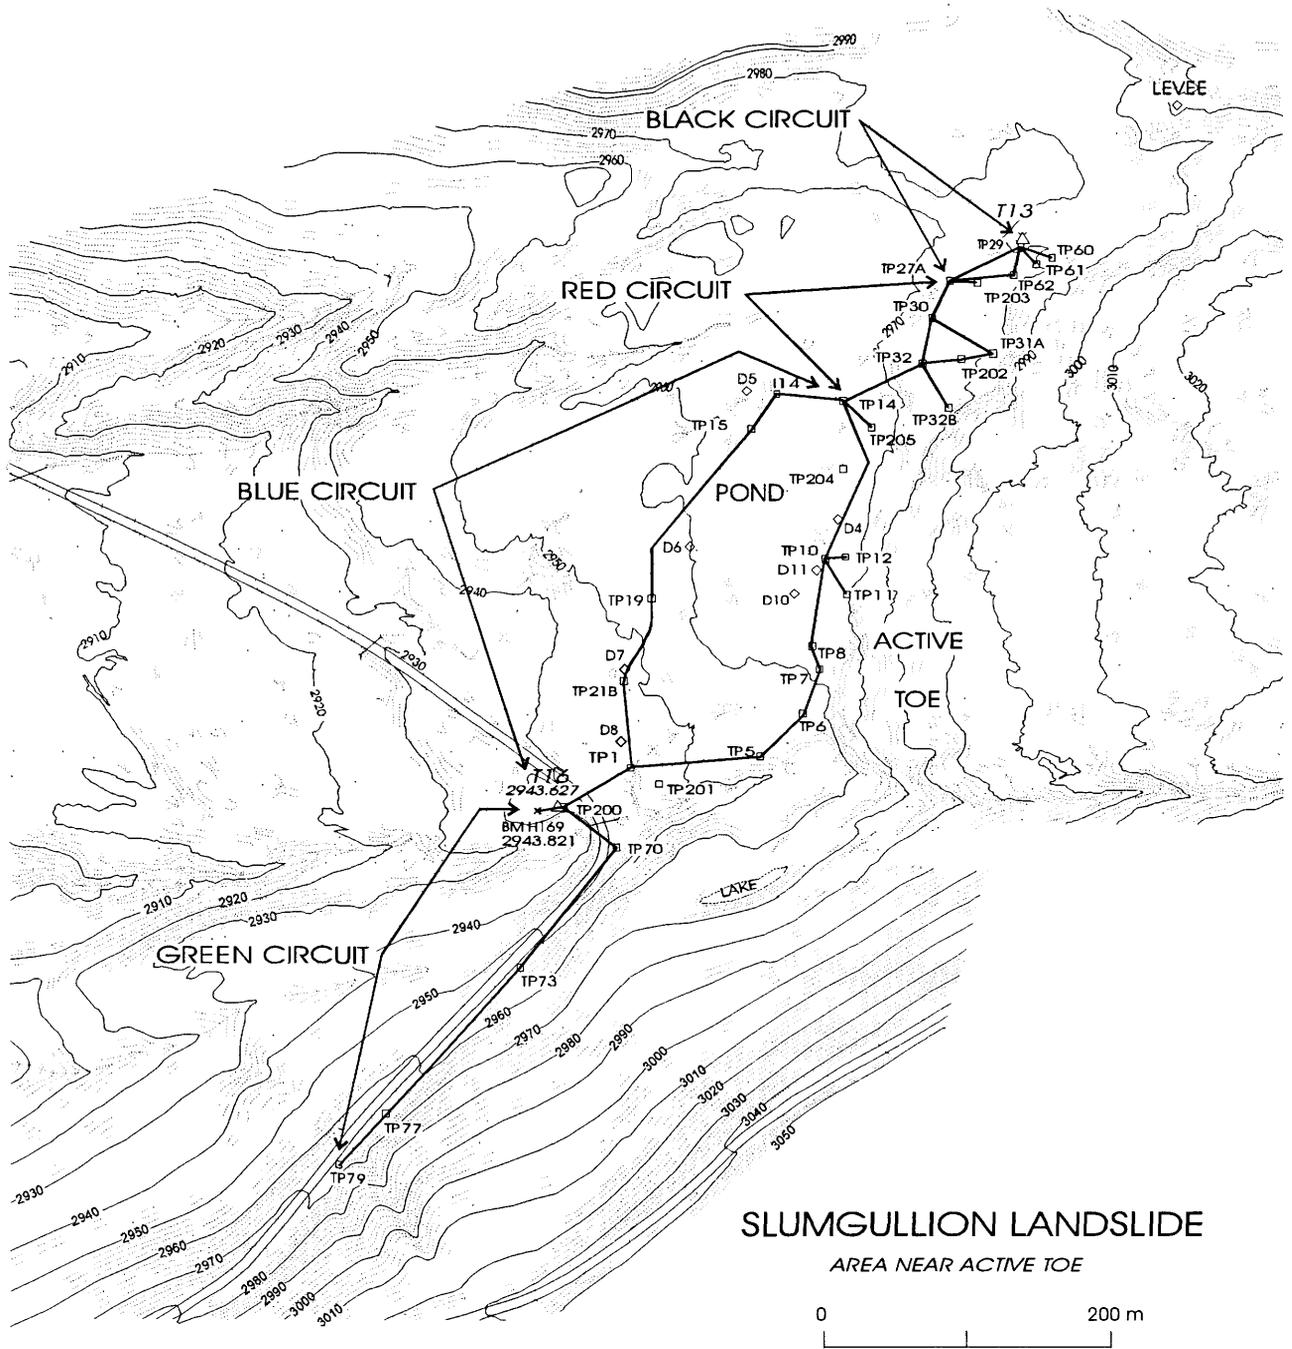
Figure 4. Map of the area near the active toe of the Slumgullion Slide, showing circuits of leveled lines.

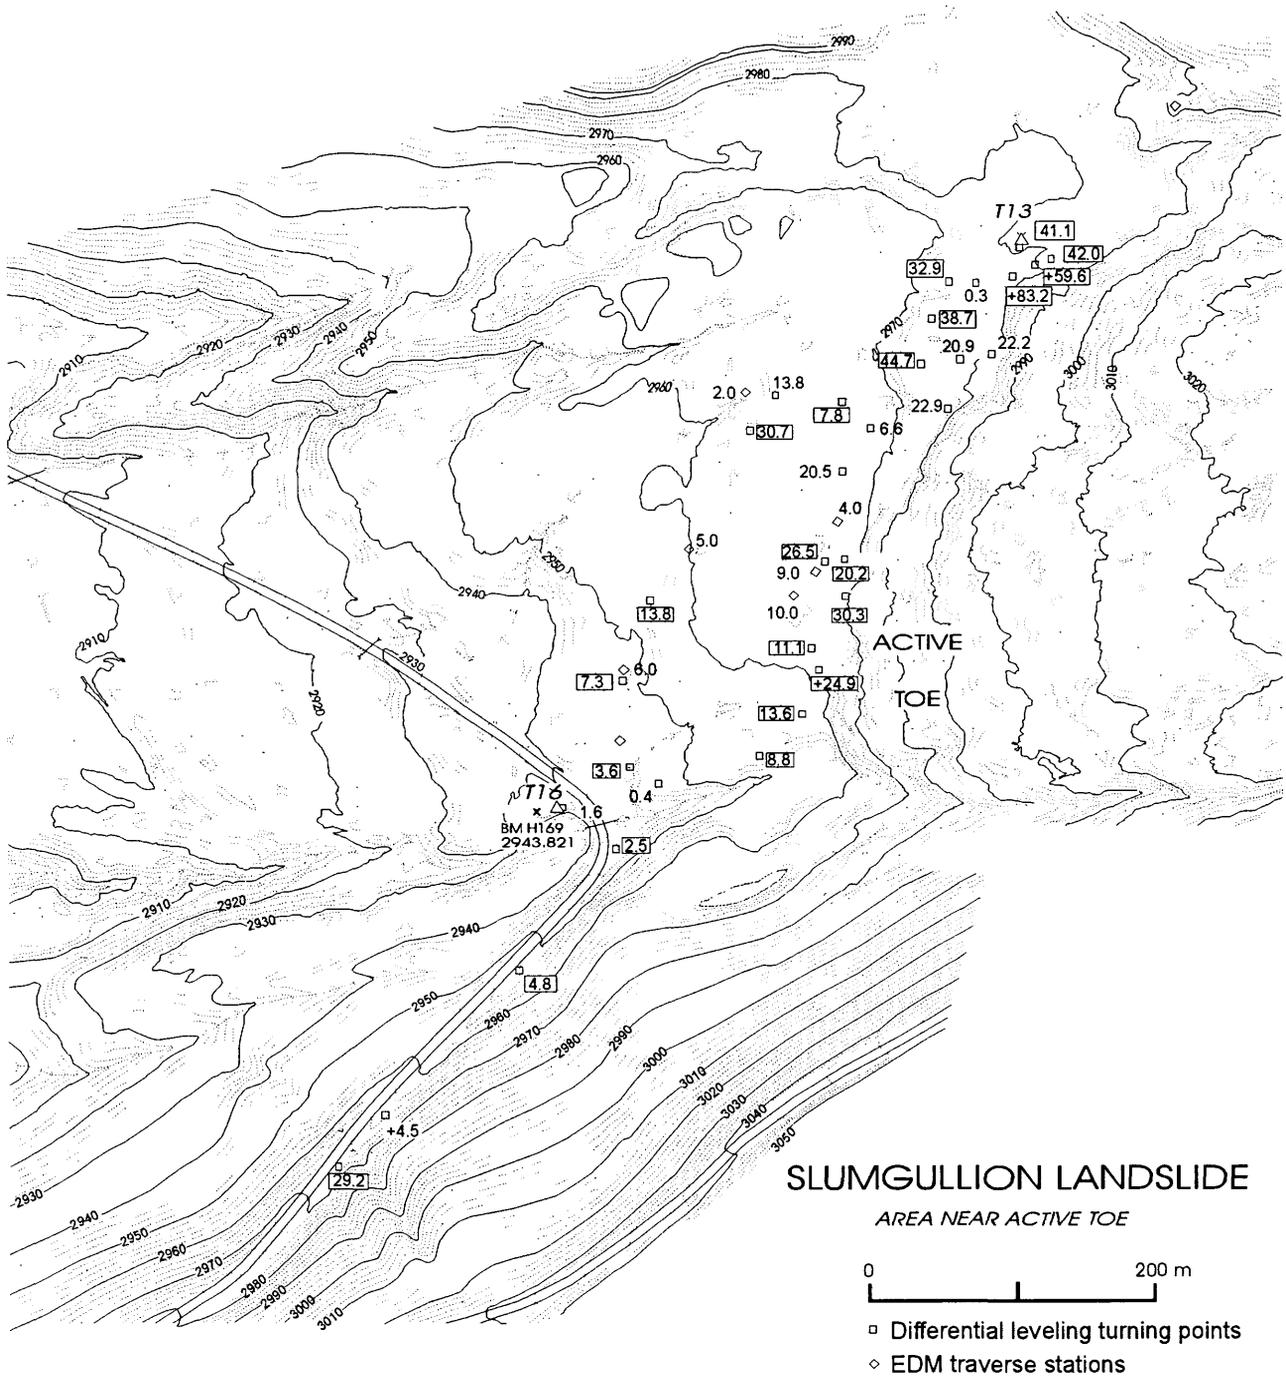
**Figure 5.** Vertical movements, in millimeters, near the active toe, 1991–93. All movements are downward unless marked “+.” Boxed values are for 2 yr, unboxed values are for 1 yr only. EDM, electronic distance measurement.

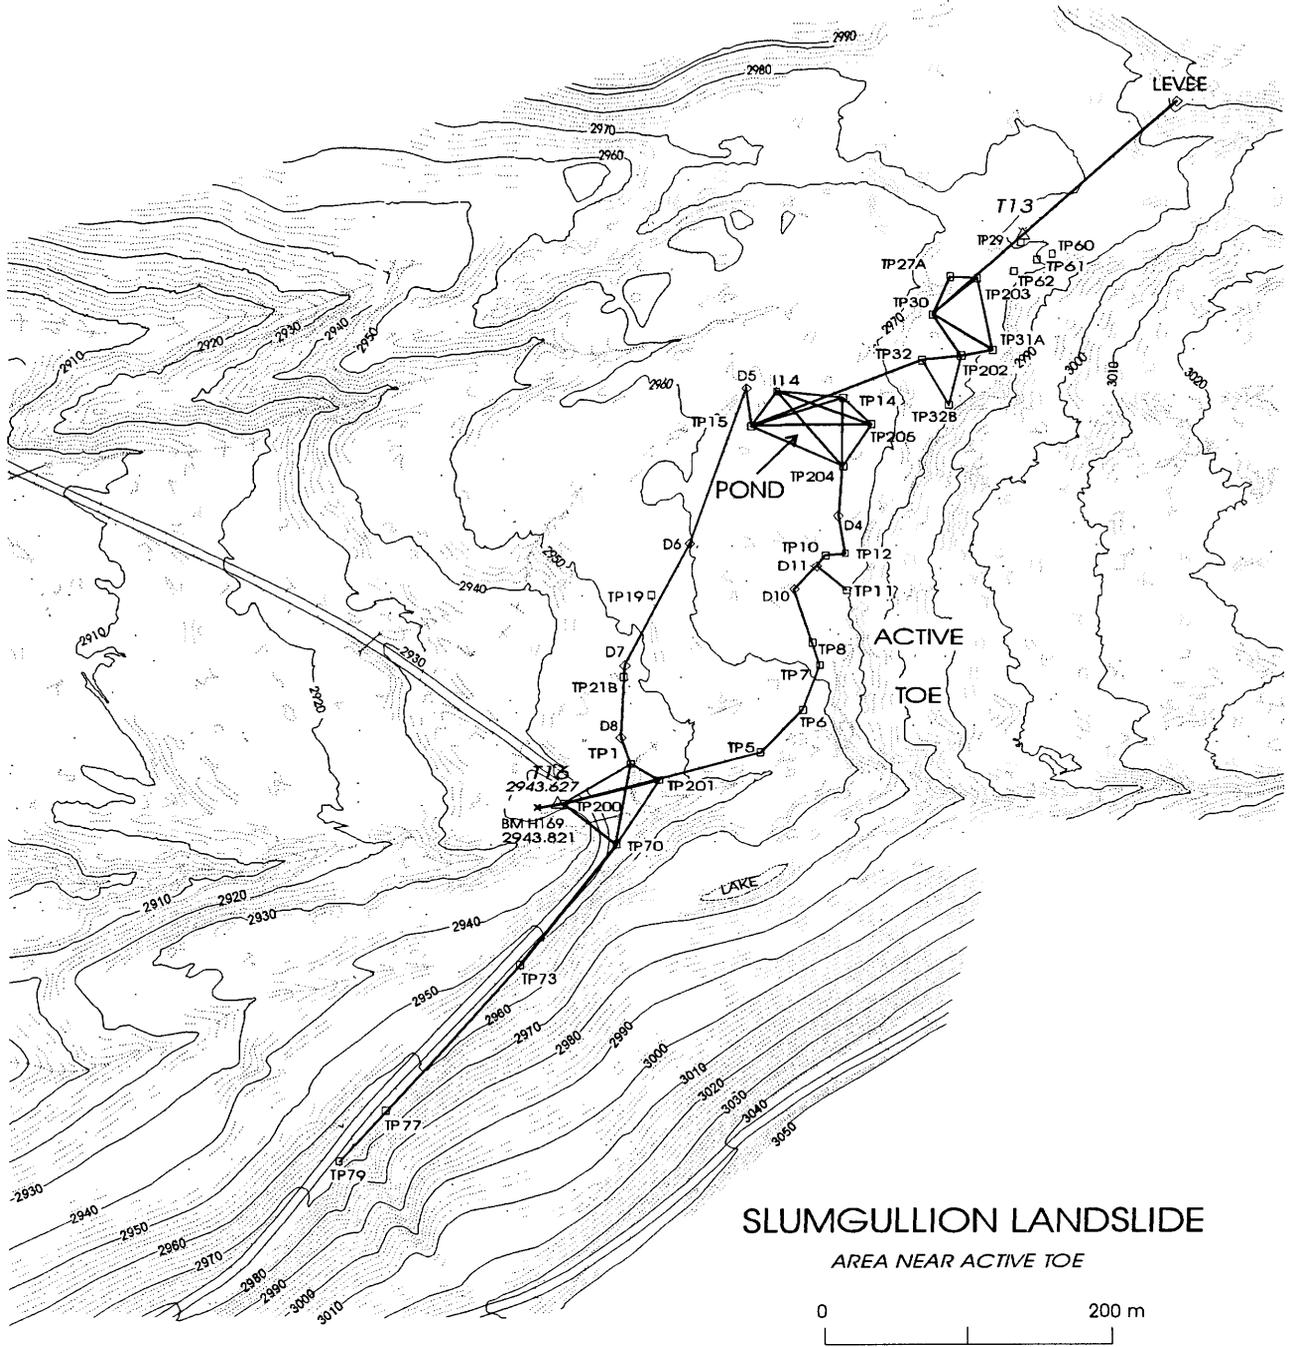
Figure 6. Map of the area near the active toe of the Slumgullion Slide, showing electronic distance measurement (EDM) traverses, quadrilaterals, and triangles.
