# The Slumgullion Earth Flow: A Large-Scale Natural Laboratory

U.S. GEOLOGICAL SURVEY BULLETIN 2130

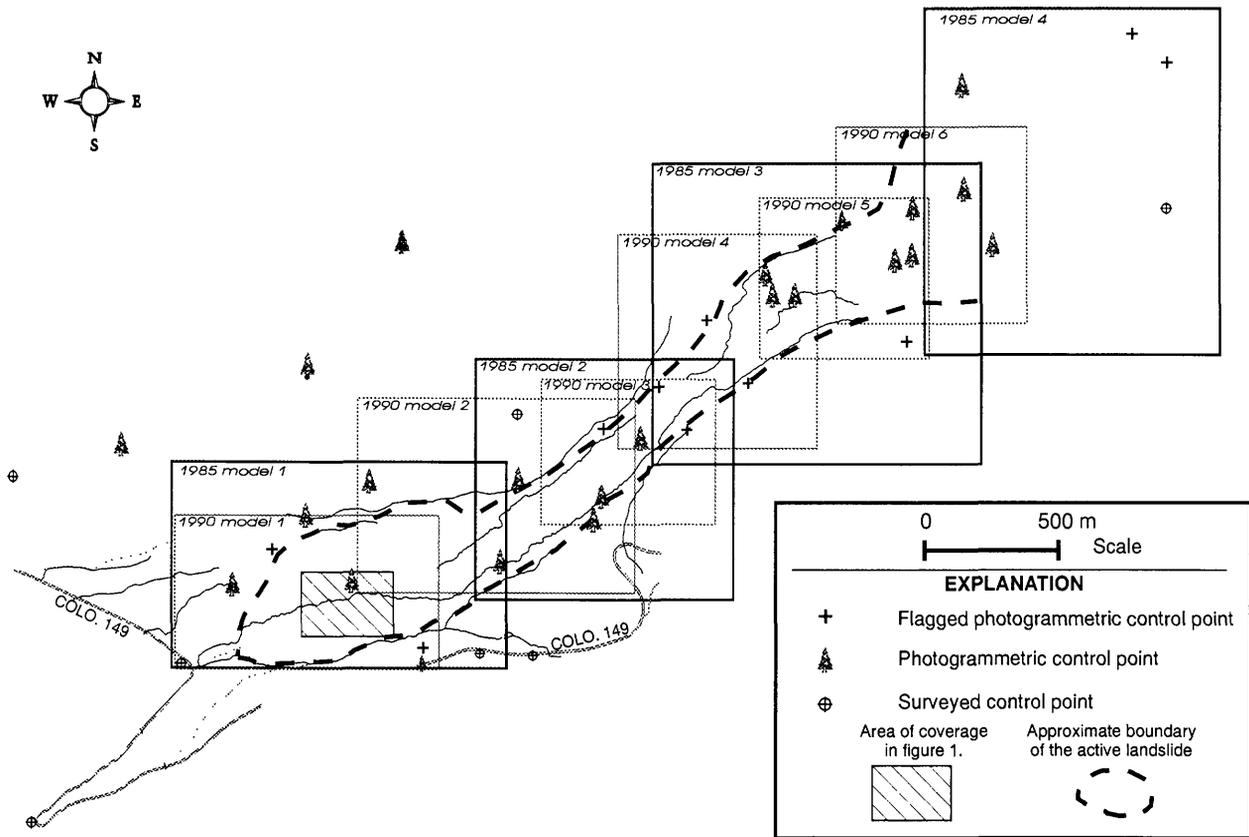
Figure 2. Distribution of ground control points and positions of stereo models with relation to the active landslide.

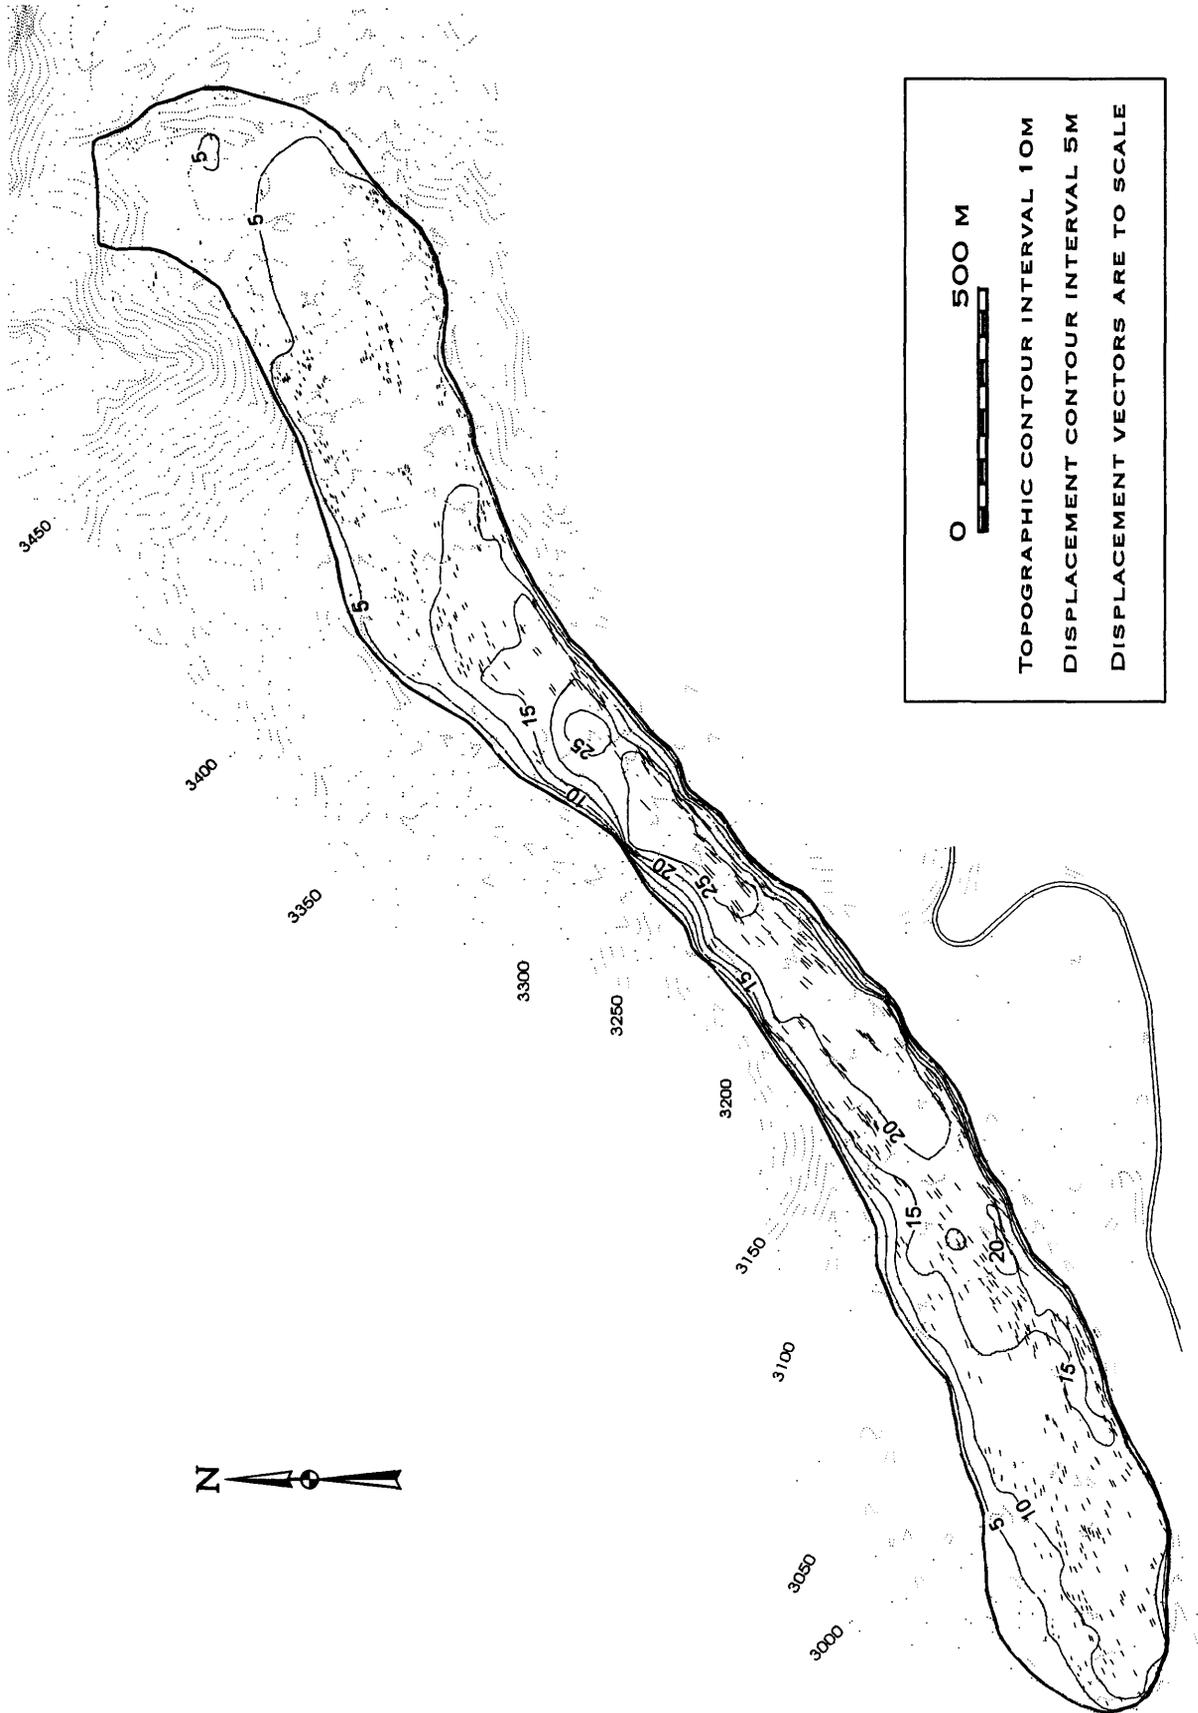
Figure 3. Slumgullion landslide horizontal displacement vectors and contours, 1985–90.

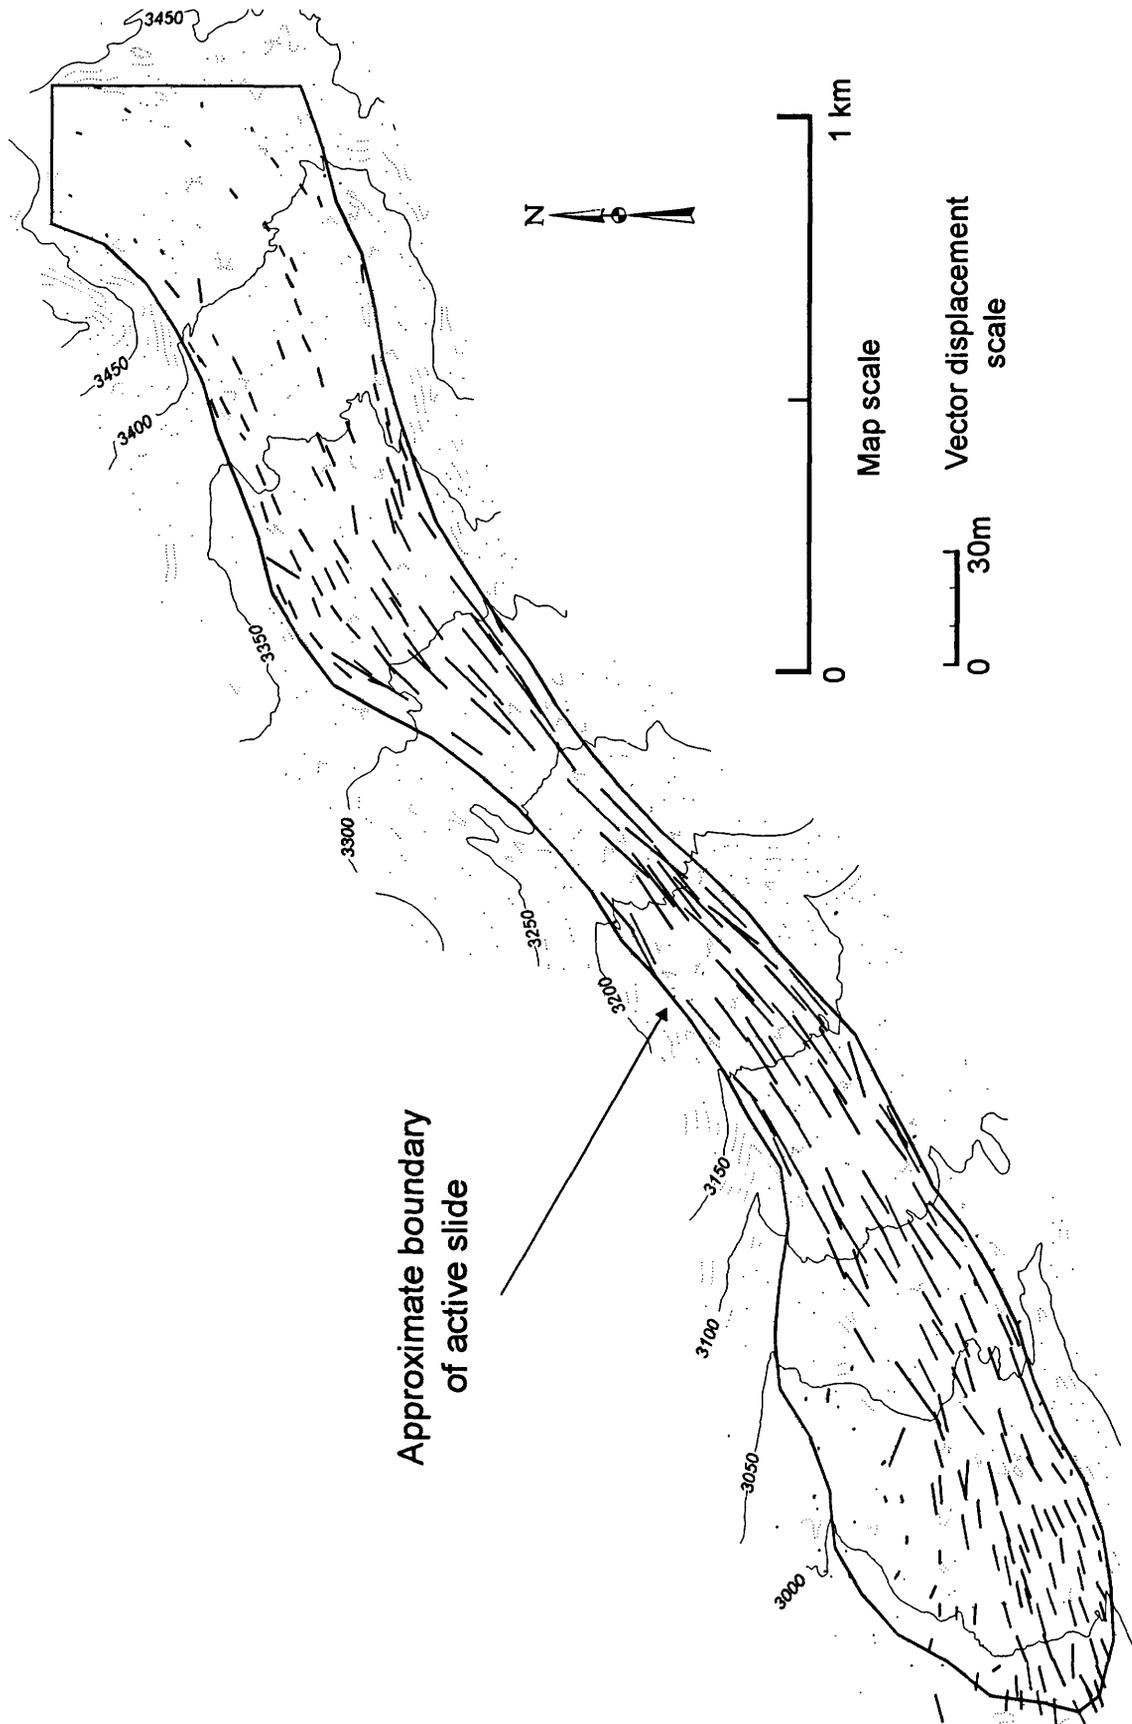
Figure 1. Map of active part of the Slumgullion landslide showing vectors of horizontal displacement between 1985 and 1990. Topographic contour interval is 10 m. All vectors are directed downslope, from upper right to lower left.

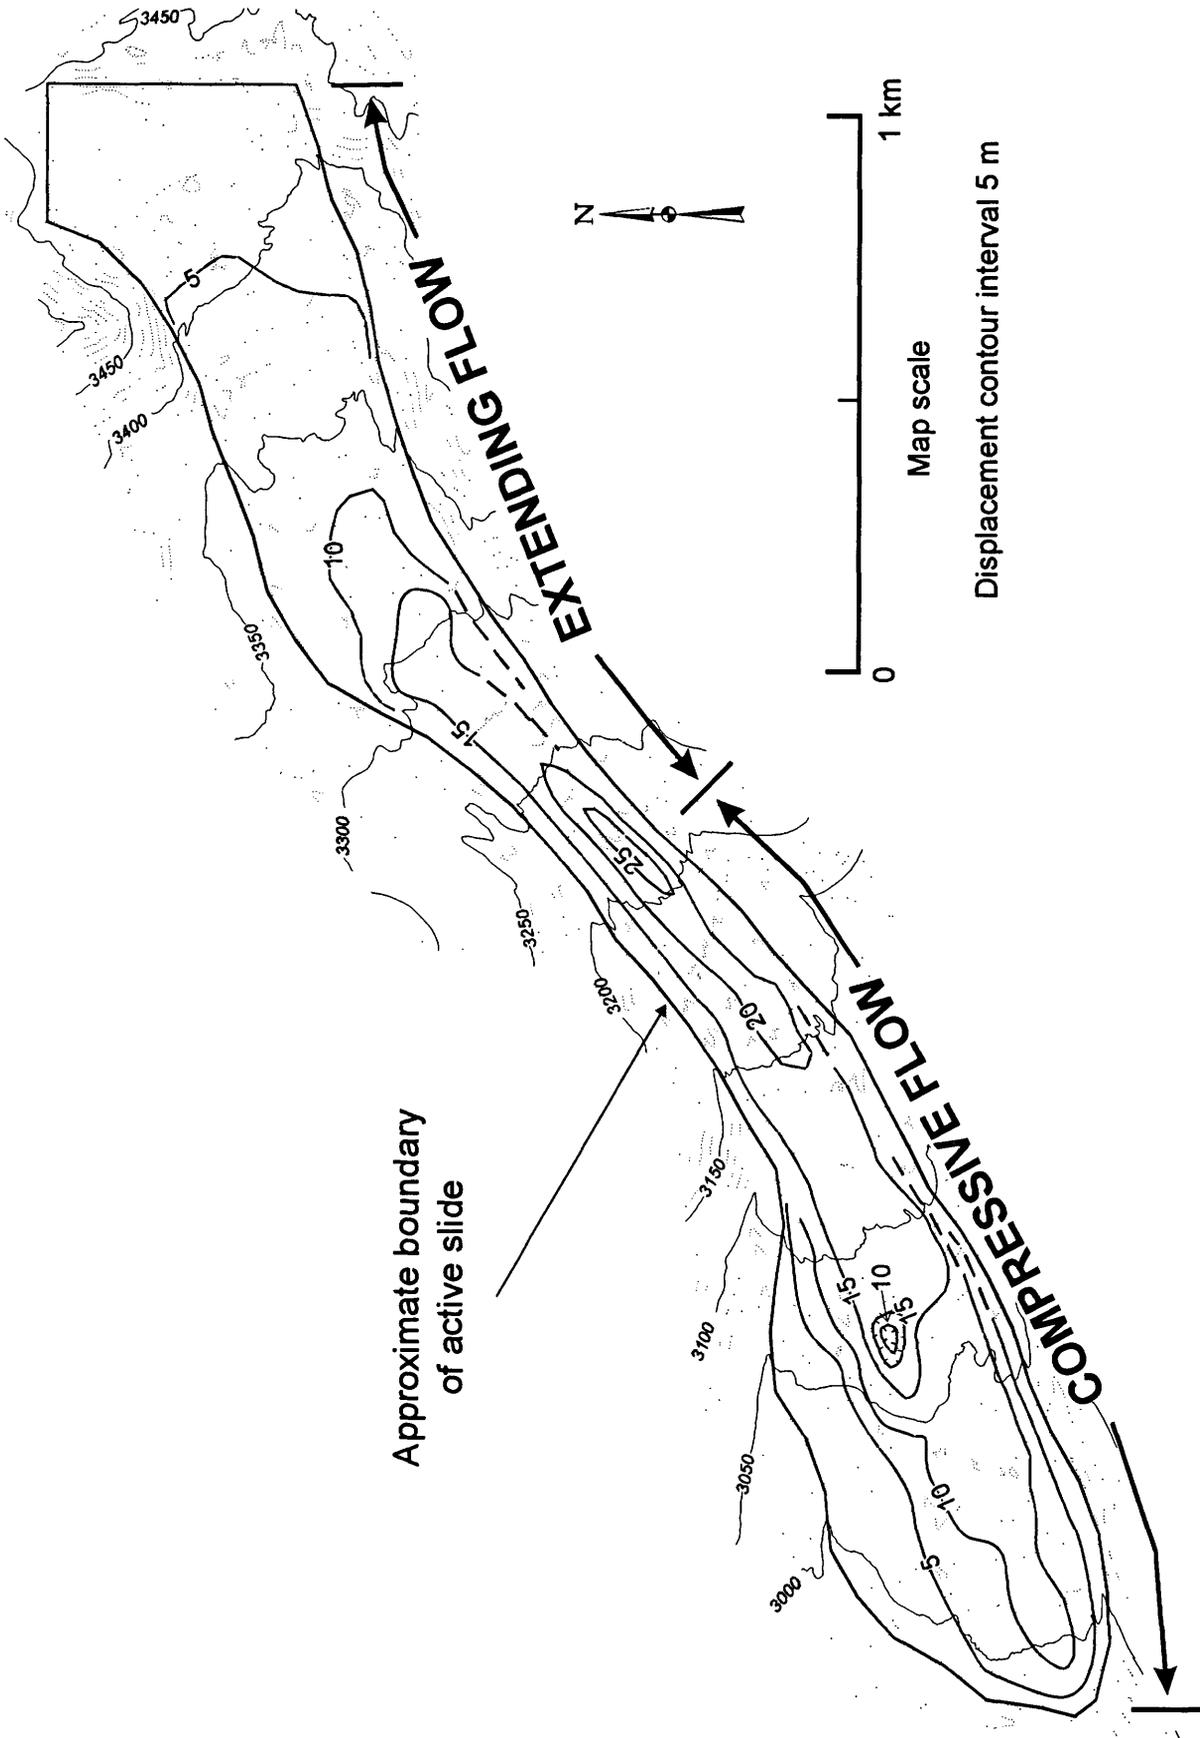
Figure 2. Map of active part of the Slumgullion landslide showing contours of horizontal displacement between 1985 and 1990. Contours were drawn by hand from magnitudes of vectors shown in figure 1.

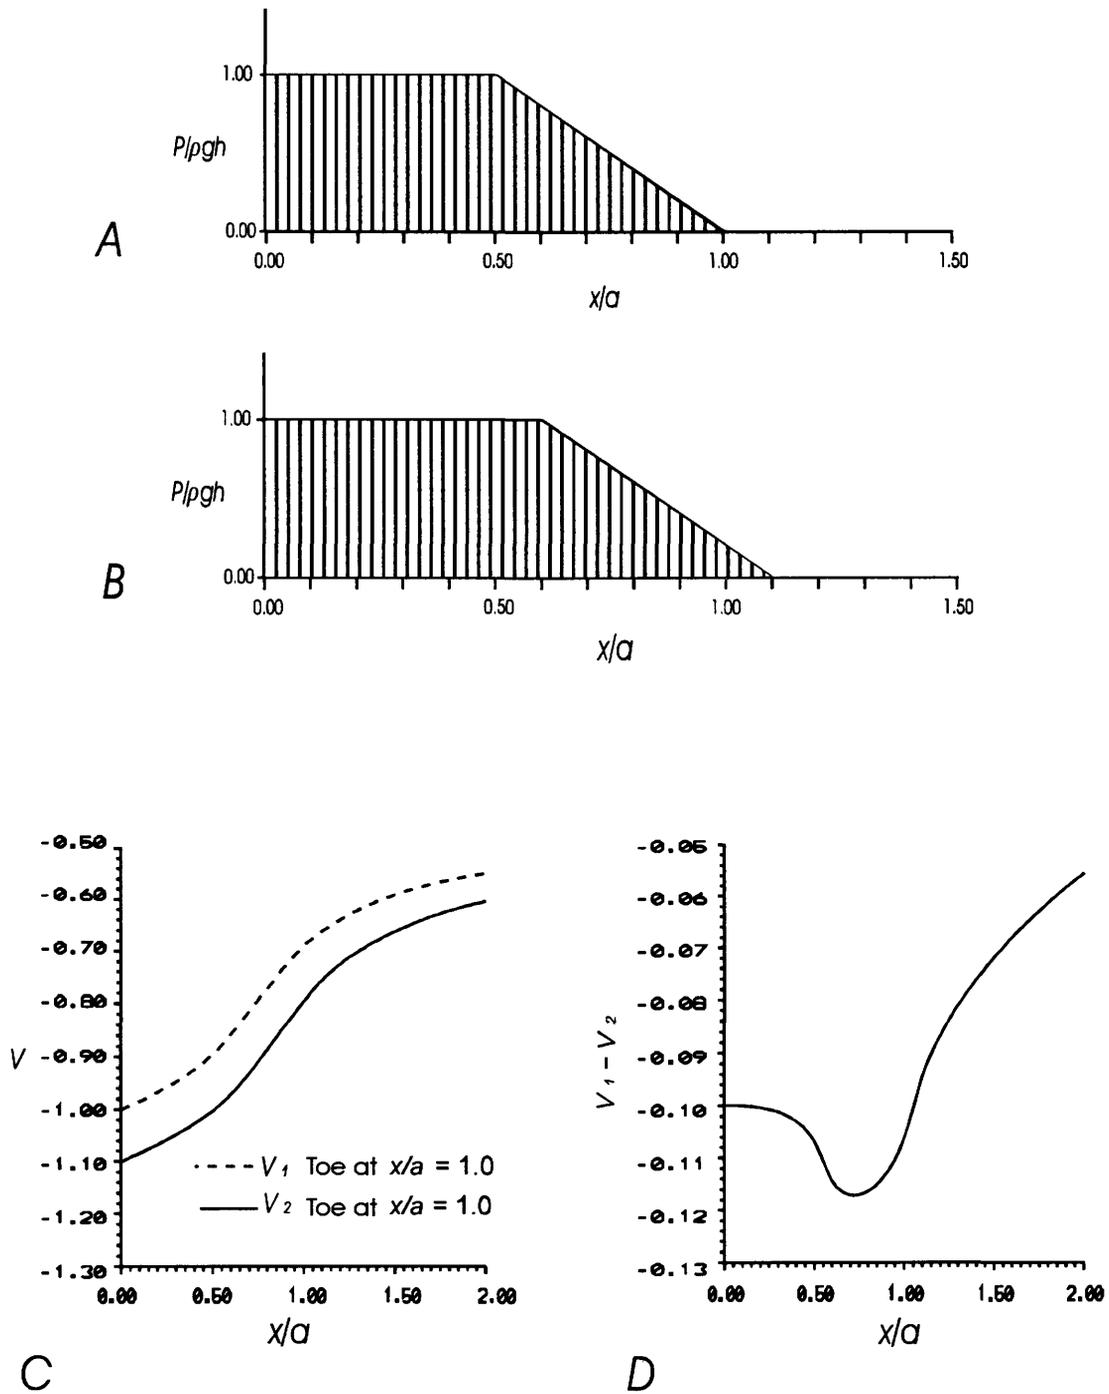
**Figure 3.** A, Normalized vertical loading for an idealized landslide with a toe initially at  $x/a=1.0$ . B, Normalized vertical loading after the toe of the landslide has advanced to  $x/a=1.1$ . C, Normalized deflection,  $V_1$ , caused by the initial loading and normalized deflection,  $V_2$ , caused by the additional loading after advance of the toe. D, Deflection differences caused by the advance of an idealized landslide toe from  $x/a=1.0$  to  $x/a=1.1$ .

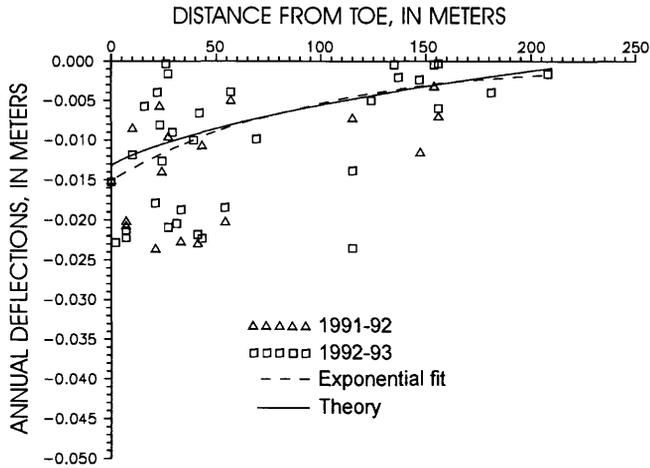
Figure 4. Predicted and measured annual downward deflections ahead of the active toe of the Slumgullion landslide 1991-93.

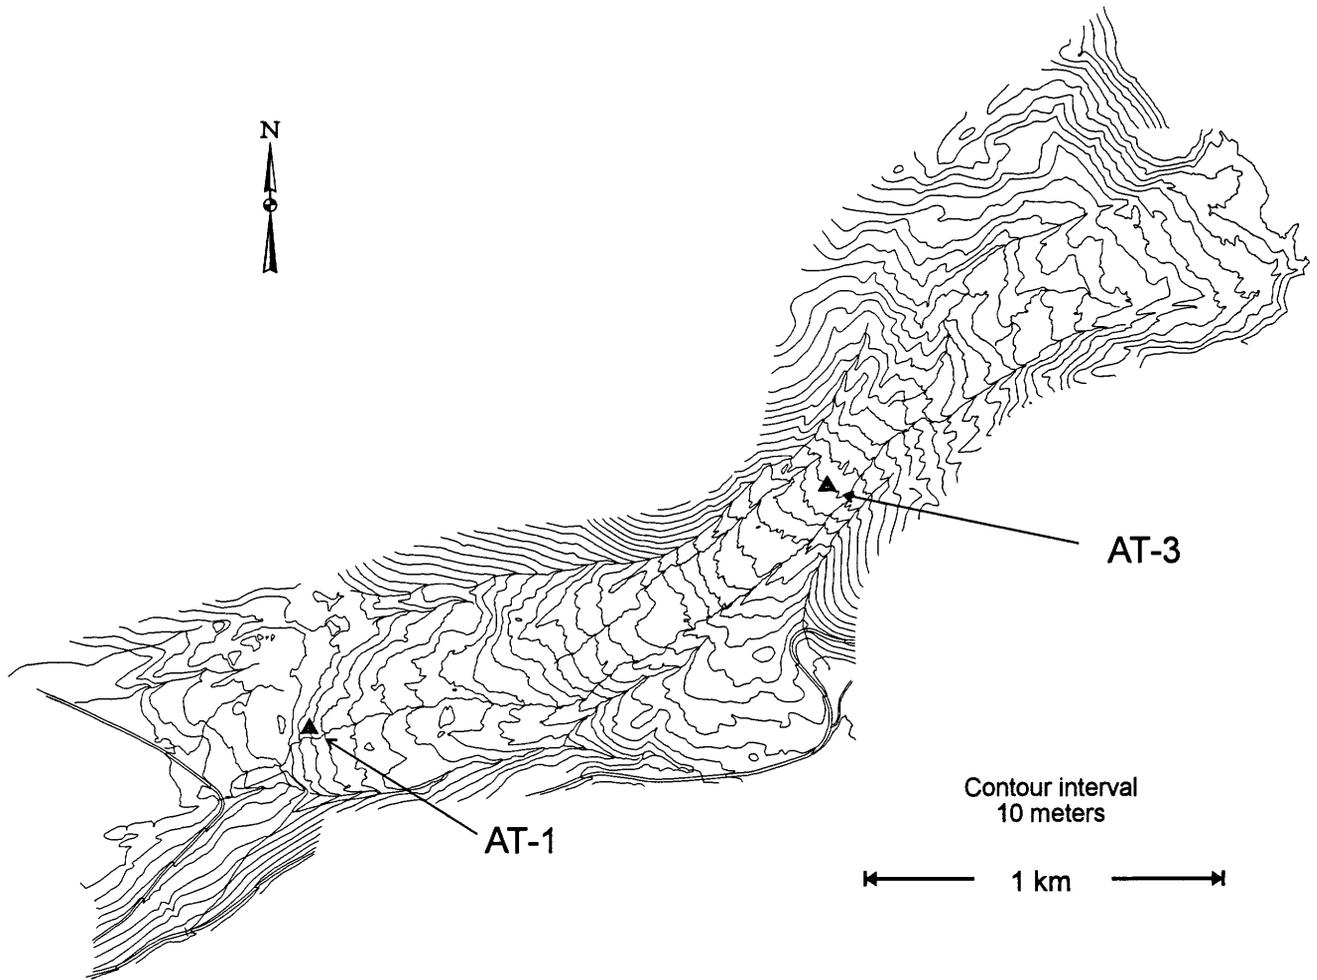
**Figure 1.** Map showing the locations of block sample sites AT-1 and AT-3 on the active portion of the Slumgullion landslide. Based on a local coordinate system (Cartesian north (N)-east (E)-elevation in meters) developed by Varnes and others (1993). The locations of block sample sites AT-1 and AT-3 are 10,175 N; 7,505 E; 2,980 m; and 10,785 N; 8,950 E; 3,200 m, respectively.

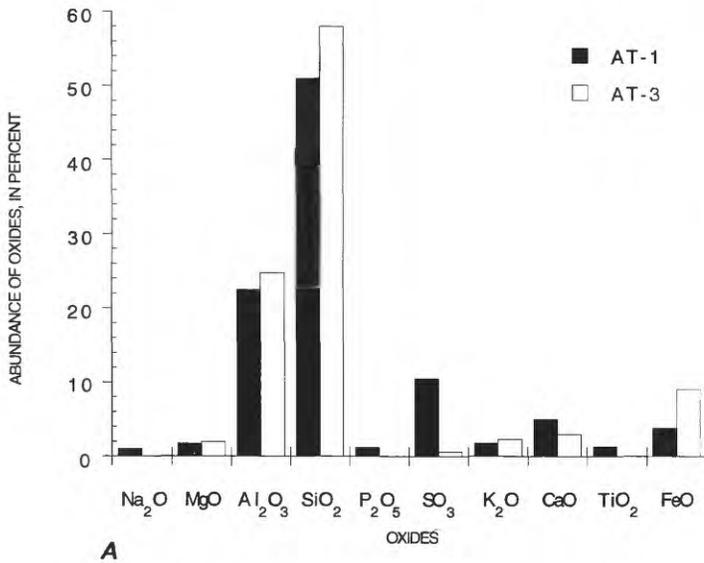
**Figure 2.** A, Bulk composition data for samples AT-1 and AT-3. Results are the averages of three analyses of AT-1 and two analyses of AT-3. B, Scanning electron photomicrograph of smectite from Slumgullion landslide sample AT-3.

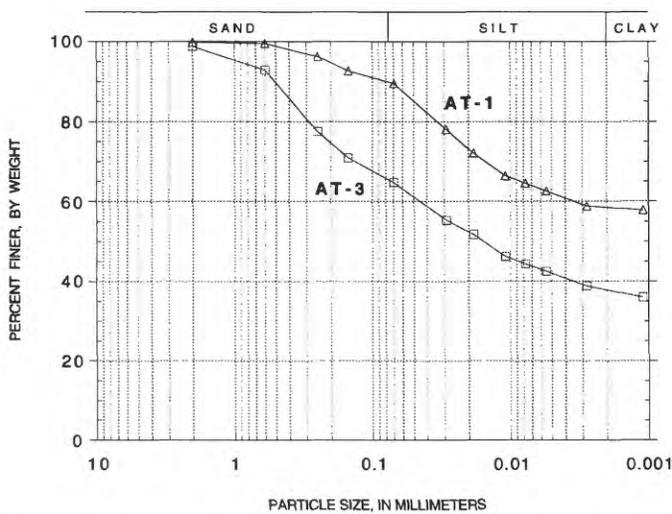
**Figure 3.** Particle size distribution curves for samples AT-1 and AT-3 from the active part of the Slumgullion landslide.

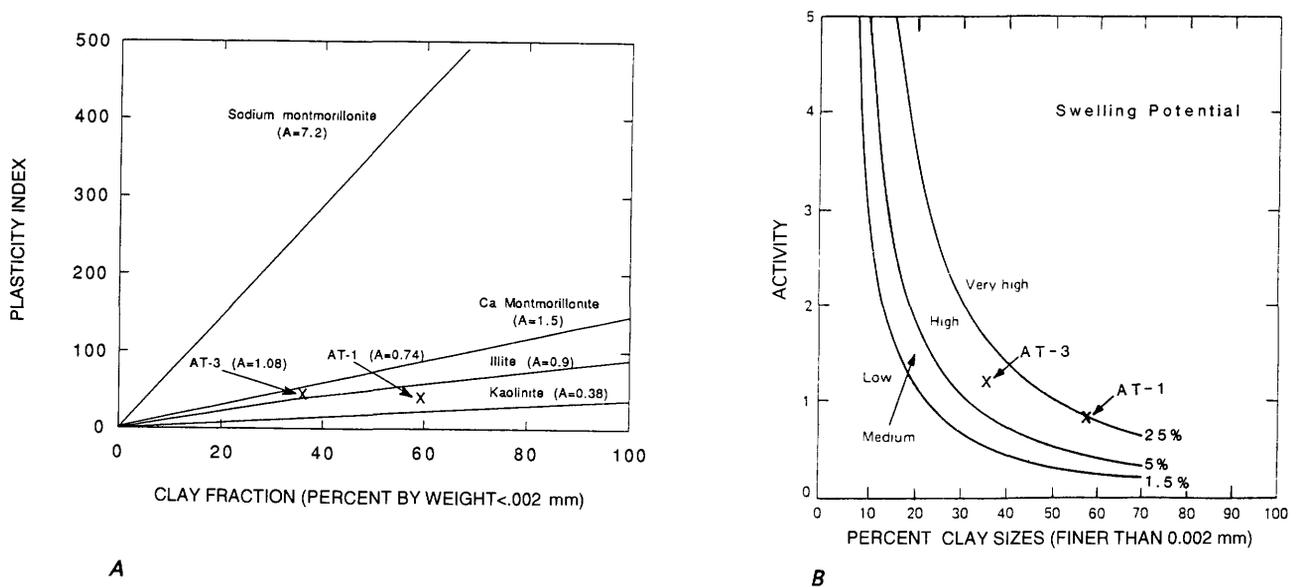
**Figure 5.** A, Graph showing relationship between plasticity index and clay fraction for common clay types (from Skempton, 1953). Soil samples AT-1 and AT-3 from the active part of the Slumgullion landslide are plotted on the graph for comparison. Typical activities (A) of the clay minerals and for samples AT-1 and AT-3 are in parentheses. Note that samples AT-1 and AT-3 have activities that are lower than might

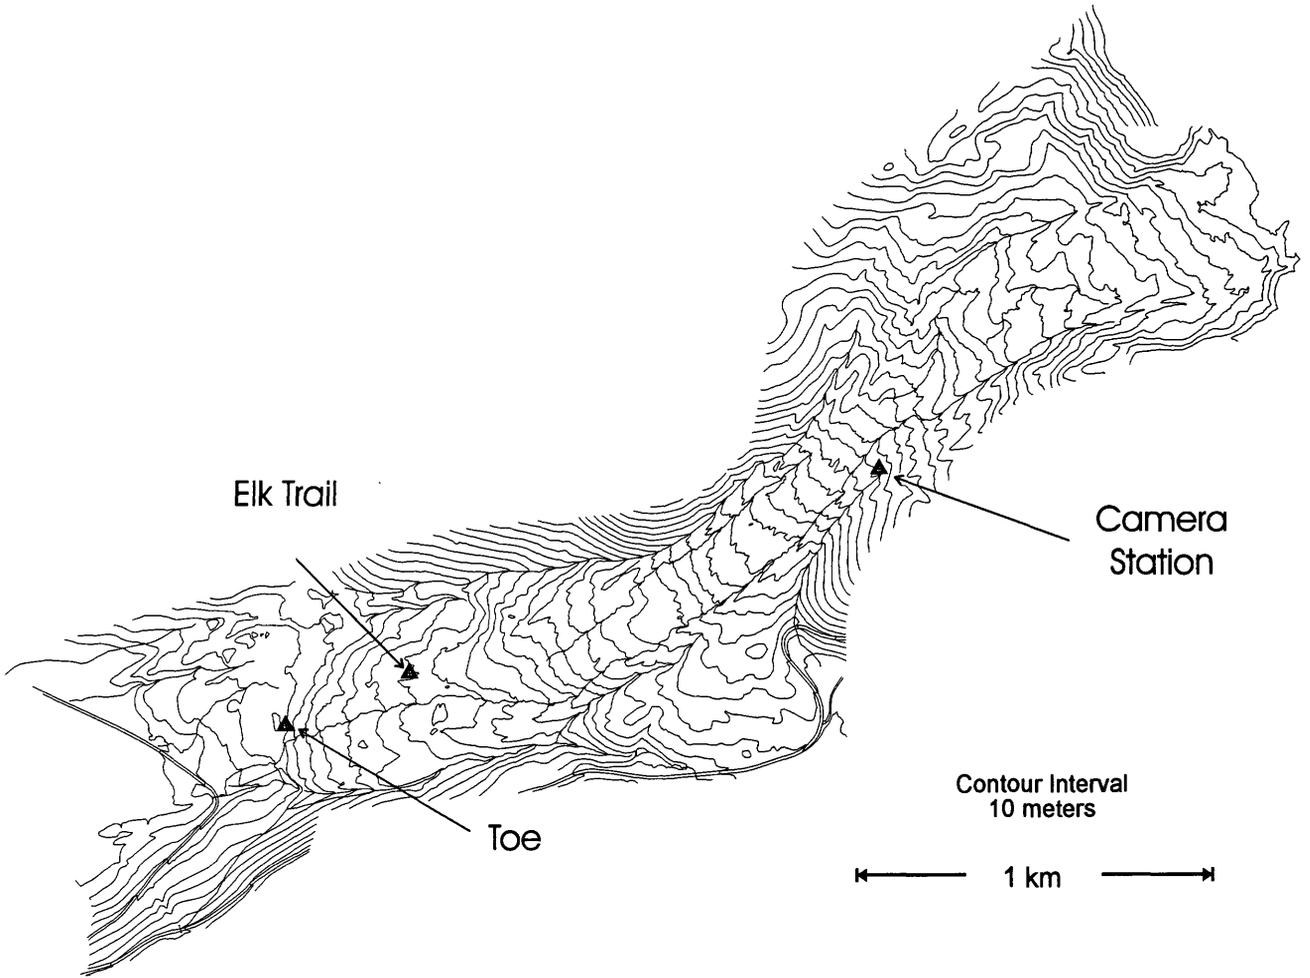
Figure 1. Creepmeter locations on the active portion of the Slumgullion landslide.

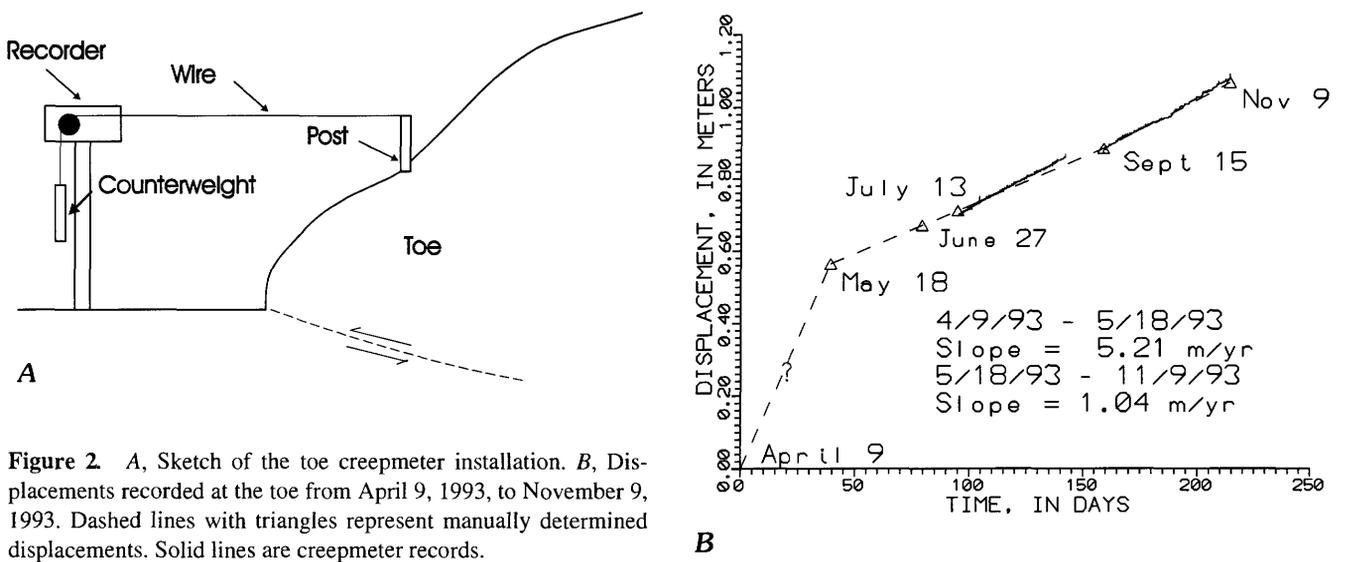
Figure 2 A, Sketch of the toe creepmeter installation. B, Displacements recorded at the toe from April 9, 1993, to November 9, 1993. Dashed lines with triangles represent manually determined displacements. Solid lines are creepmeter records.

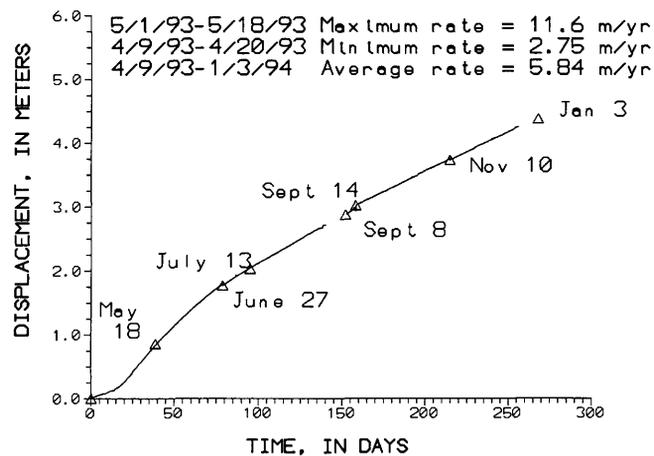
**Figure 5.** Displacements recorded at the Camera Station creepmeter installation from July 13, 1993, to January 3, 1994. Triangles represent manually determined displacements. Solid lines are creepmeter records.

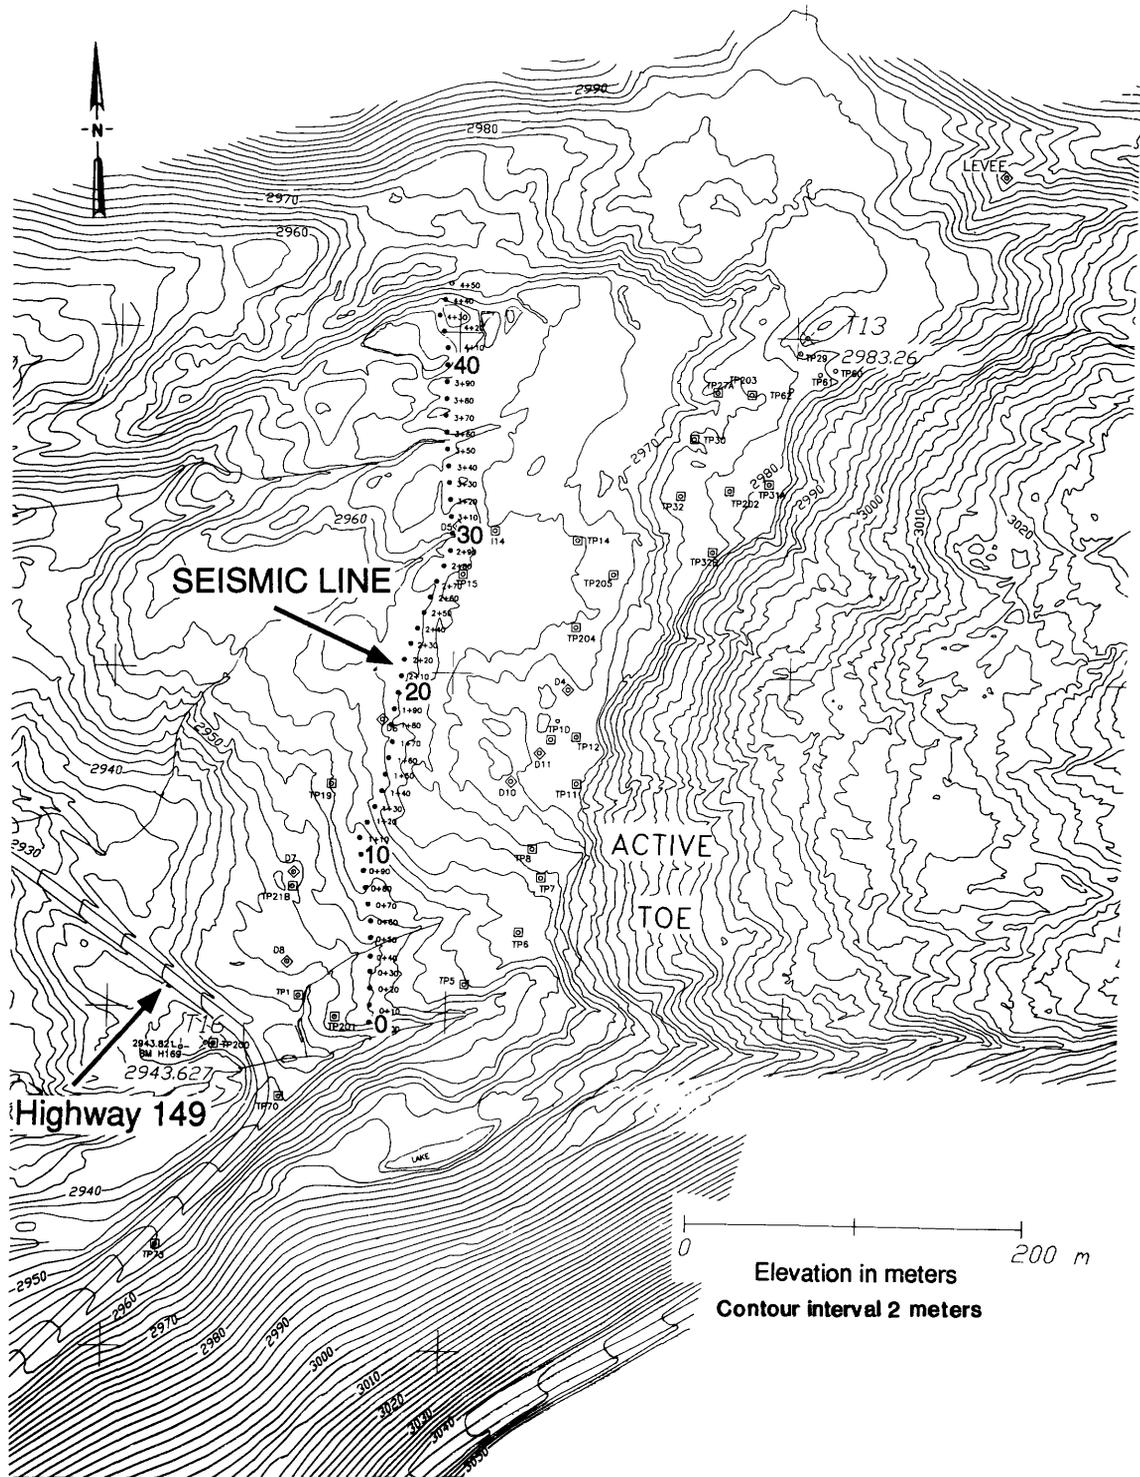
**Figure 1.** Location map of co-located north-south seismic refraction and reflection profiles. Seismic lines are located on the older, inactive portion of the slide, just below the active toe. Solid circles are stations for the refraction survey. Diamonds and squares are pre-existing survey grid stations. Large numbers (0, 10, 20, 30, and 40) on the seismic line are reference positions, located about 100 m apart, that are used in the text to describe the data. These numbers also annotate the data at the top of figures 4 and 5. Small numbers (0+10, 0+20, etc.) annotate intermediate seismic stations. Stations beyond position 40 are in a marshy area. Elevations in meters. Contour interval 2 m.

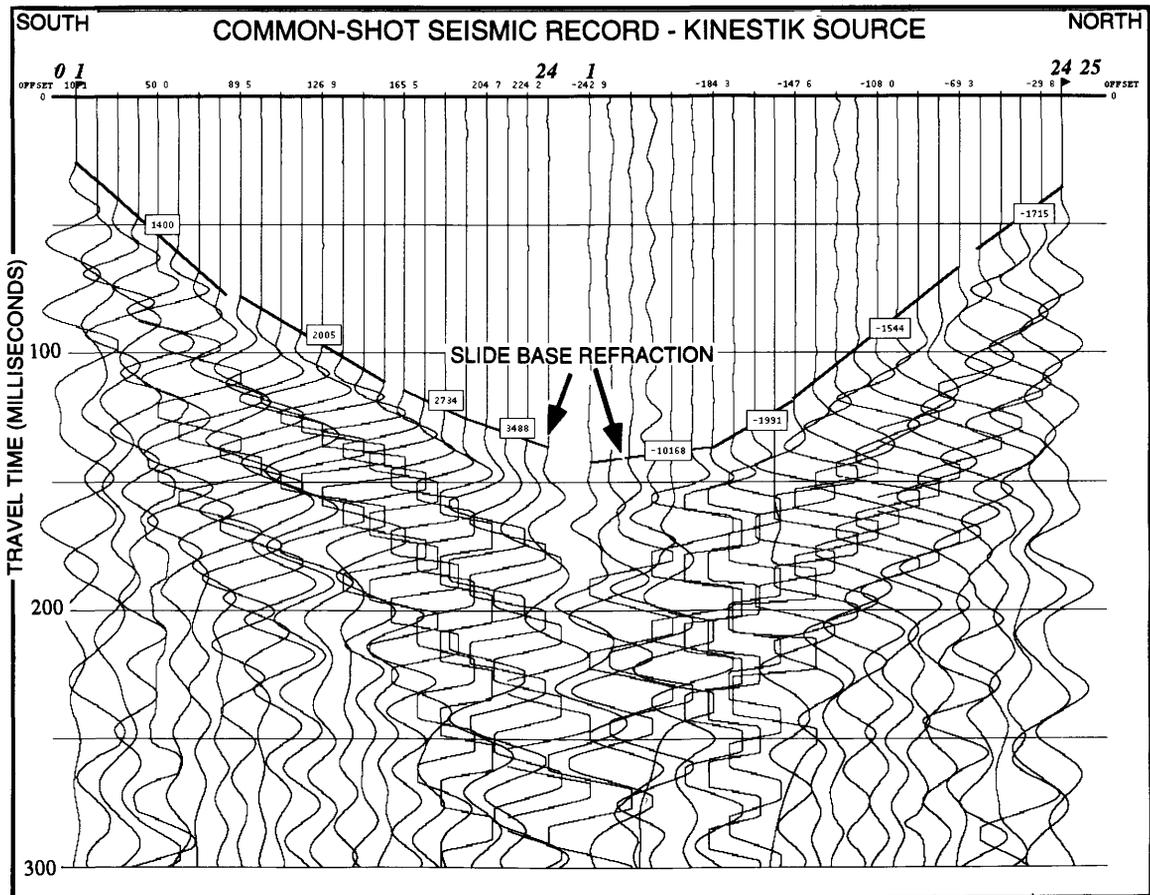
**Figure 2.** Two 24-channel seismic records acquired with Kinestik explosives for refraction interpretation. These data were acquired with geophones located at positions 1 through 24 (station 2+40 on figure 1) and the source at position 0 (left side of figure) and position 25 (right side of figure). Positions 0 through 25 are indicated on the seismic line shown in figure 1. Numbers in italics along the top are the ground stations.

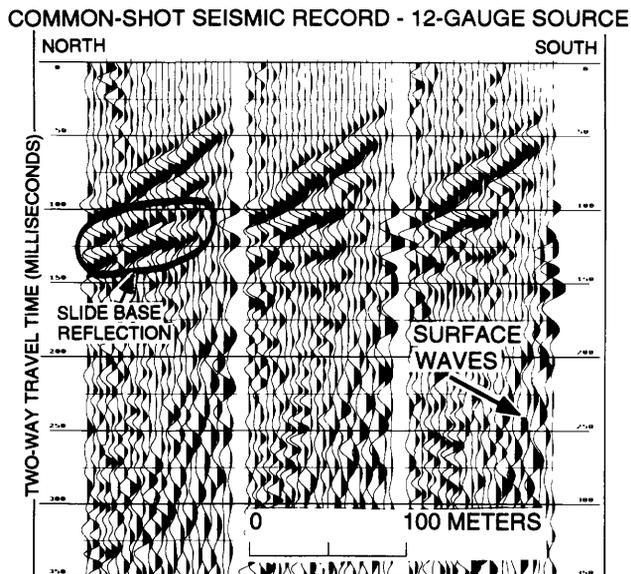
**Figure 3** (facing column). Three 24-channel seismic records acquired with the 12-gauge shotgun source for reflection interpretation. These data were acquired between positions 22 and 32 (fig. 1). Seismic reflections and surface waves are annotated on the records.

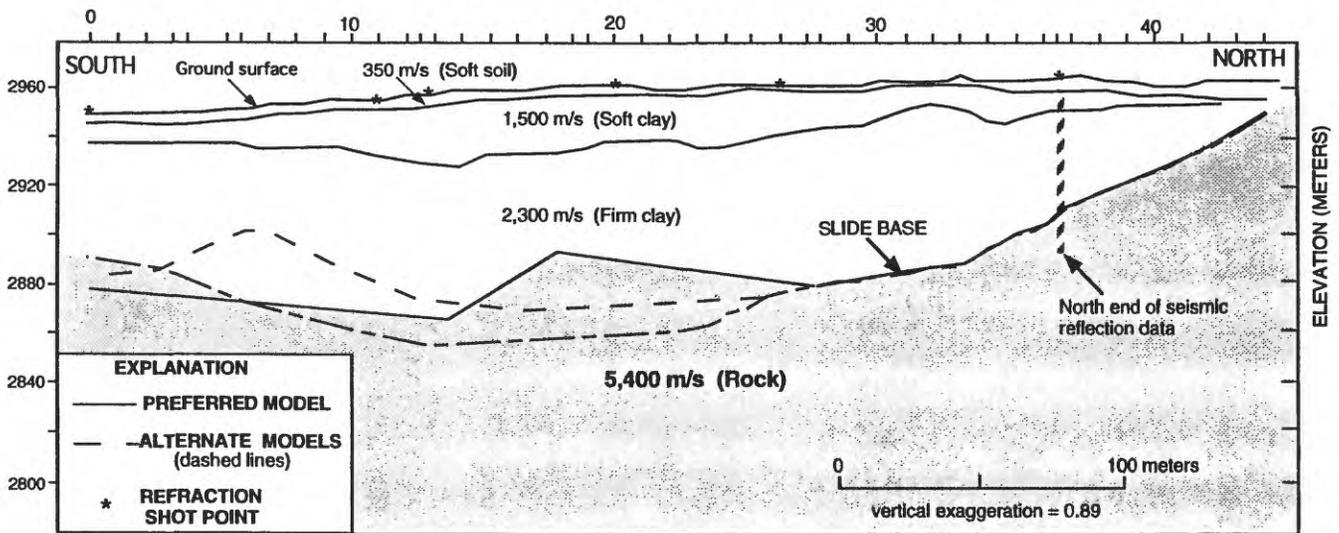
**Figure 4.** Refraction data interpretation showing the topography of the ground surface, the four distinct seismic-velocity layers, and the alternate refraction models. The vertical tick marks on the horizontal axis at the top of the figure show the true positions of the geophone stations and shotpoints. Asterisks mark the shotpoint positions on the ground surface.

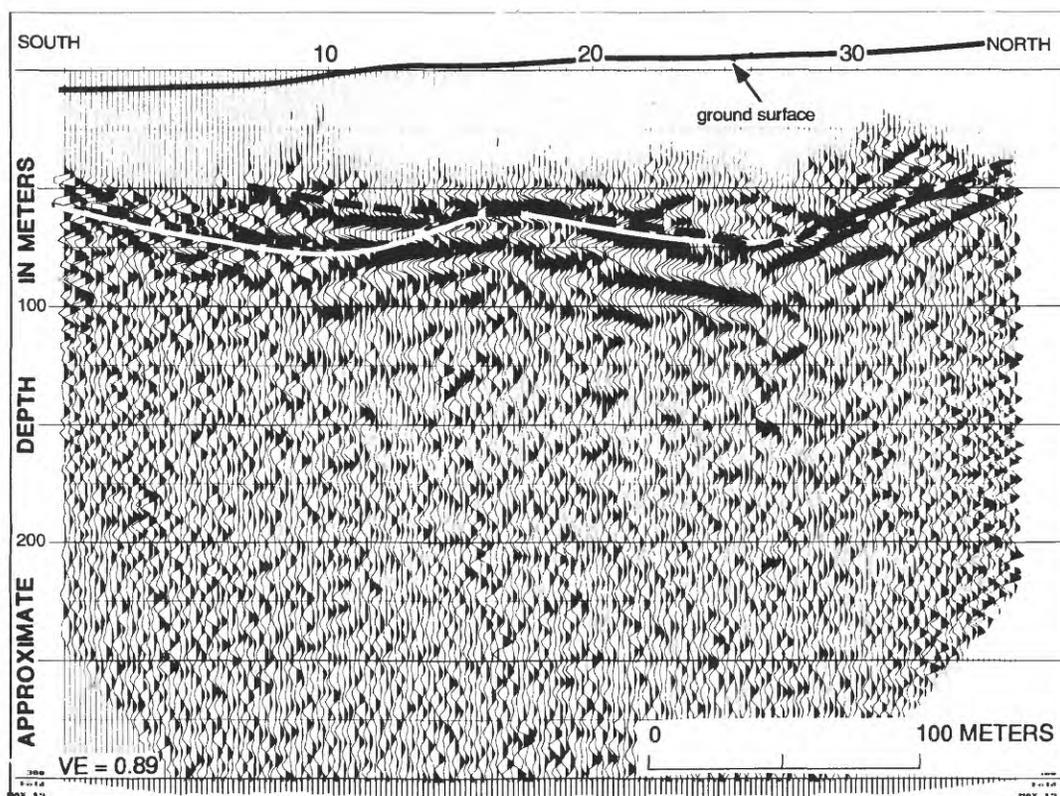
**Figure 5.** Stacked reflection profile depth section showing the main bedrock reflection (dashed horizon) and one overlying reflection. Position of preferred bedrock refraction model from figure 4 is shown as white line. Vertical exaggeration (VE) is 0.89.

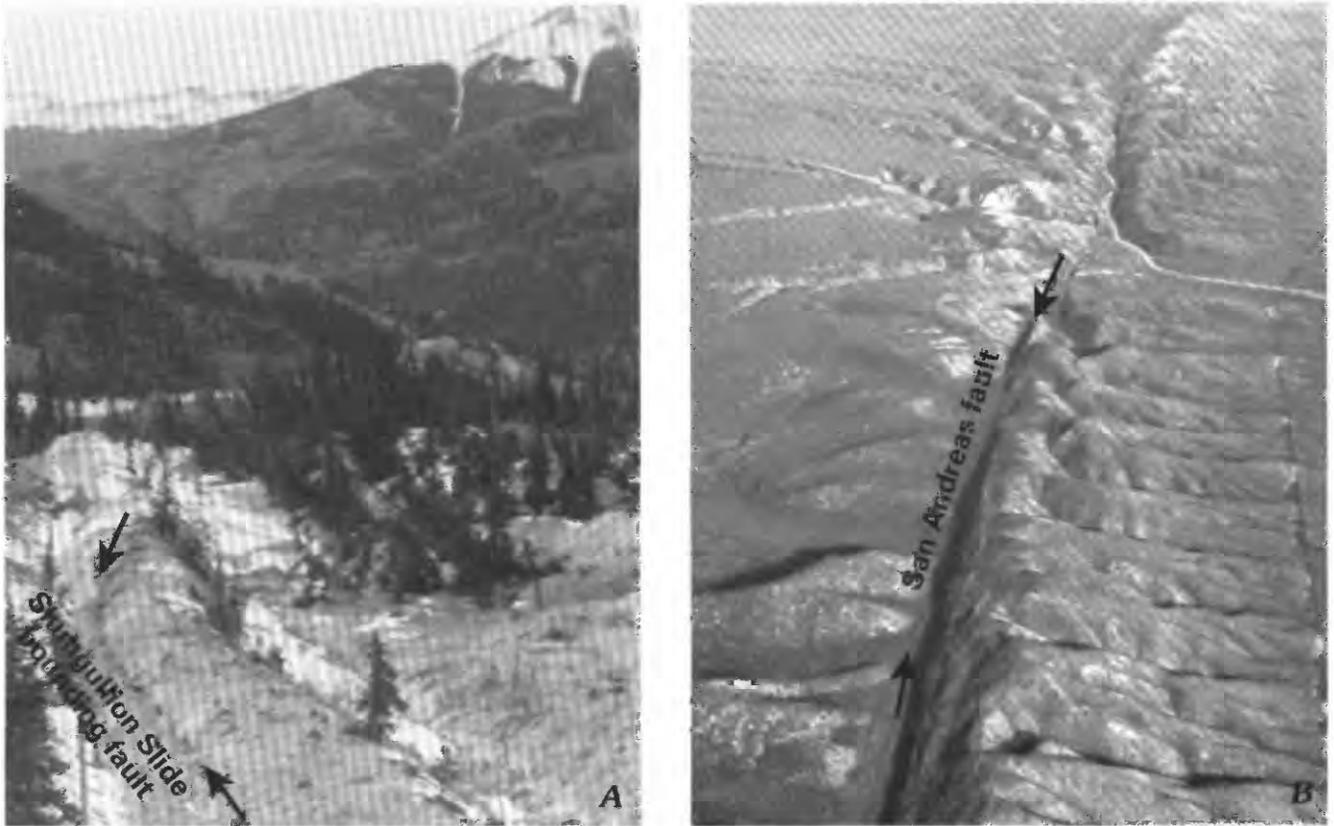
**Figure 1.** A, View looking along the trend (indicated by arrows) of a slide-bounding strike-slip fault on the Slumgullion landslide in Colorado. The ridges parallel and adjacent to the fault, often called levees, are composed of unconsolidated, highly dilated sandy soil. B, View along the trend of the strike-slip San Andreas fault in the Carizzo Plains of California. Note the similarity

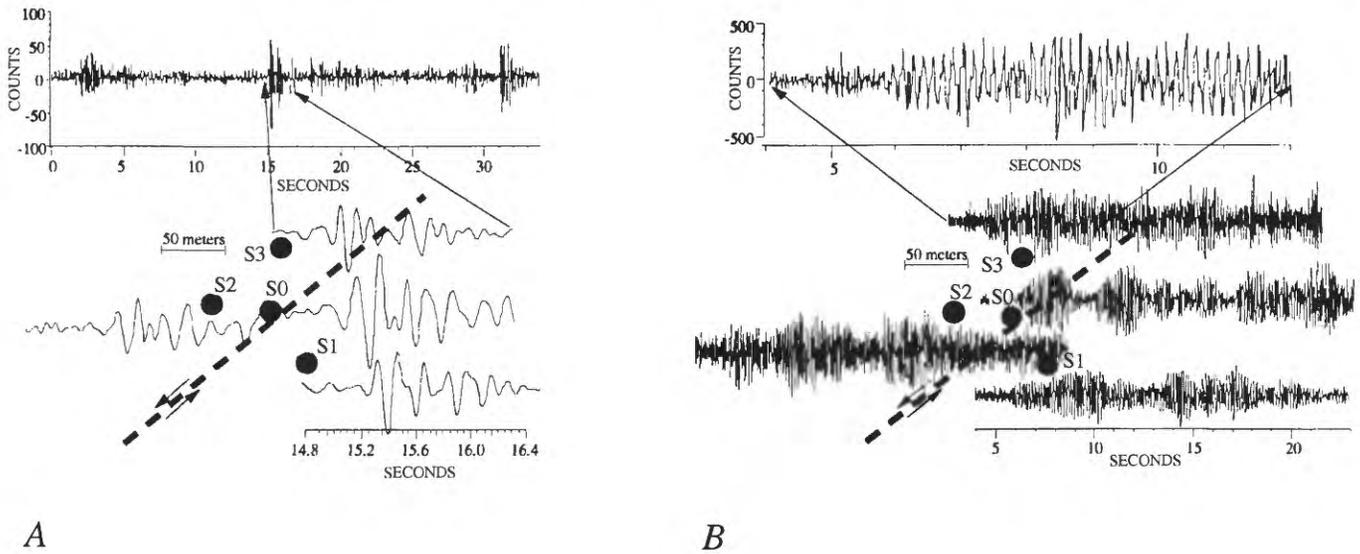
**Figure 4.** Seismic ground motions recorded on the Slumgullion landslide. All traces shown were recorded by the digital microarray and are plotted on the same amplitude and time scales. Only vertical-component seismograms are shown, each was recorded by the sensor denoted by the nearest corresponding shaded circle

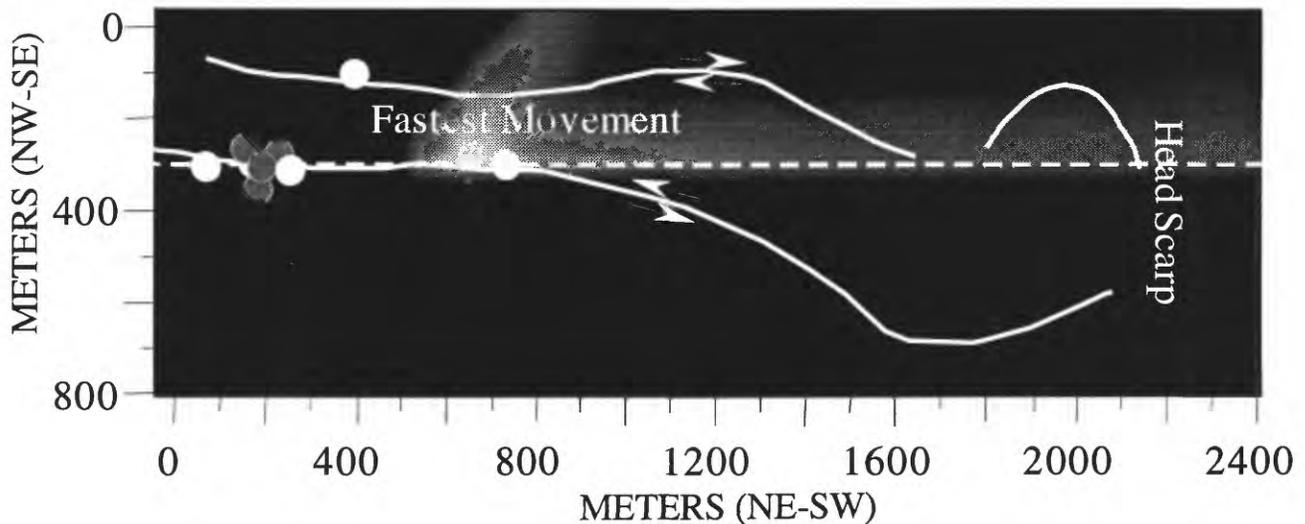
**Figure 5.** A map-view distribution of slidequake source location probability confidence levels at the ground surface (denoted by shading; the whitest shading indicates the most probable location). We assume a velocity structure that varies only in the lateral direction and that observed signals are surface waves traveling along straight-line trajectories between the source and seismic station. The shear (or group) velocity northwest of the dashed line is 0.286 km/sec and is 3.600 km/sec to the southeast. Circles indicate seismic stations (white, analog; gray, digital),
