# The Slumgullion Earth Flow: A Large-Scale Natural Laboratory

U.S. GEOLOGICAL SURVEY BULLETIN 2130

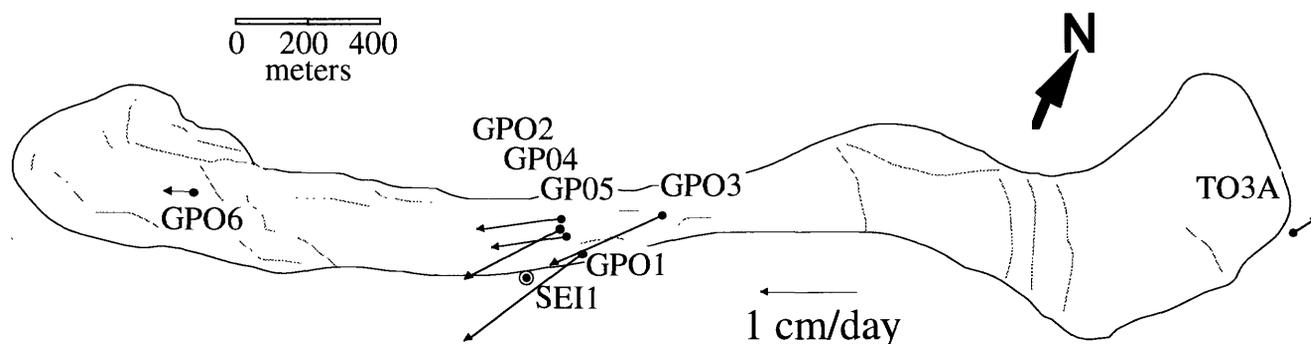
**Figure 1.** Location of GPS stations on the Slumgullion landslide and bench-mark velocities calculated during a 4-day measurement period. The coordinates of station SEI1 are held fixed relative to the rest of the network. Stations SEI1 and TO3A are thought to be located on the inactive portion of the slide. Velocity measurement errors (table 1) suggest the motion of station TO3A may be within the measurement noise. Dotted lines indicate the location of major structural elements on the landslide.
