GEOLOGICAL SURVEY
CIRCULAR 601-B

Urban Sprawl and Flooding in Southern California

By S. E. Rantz

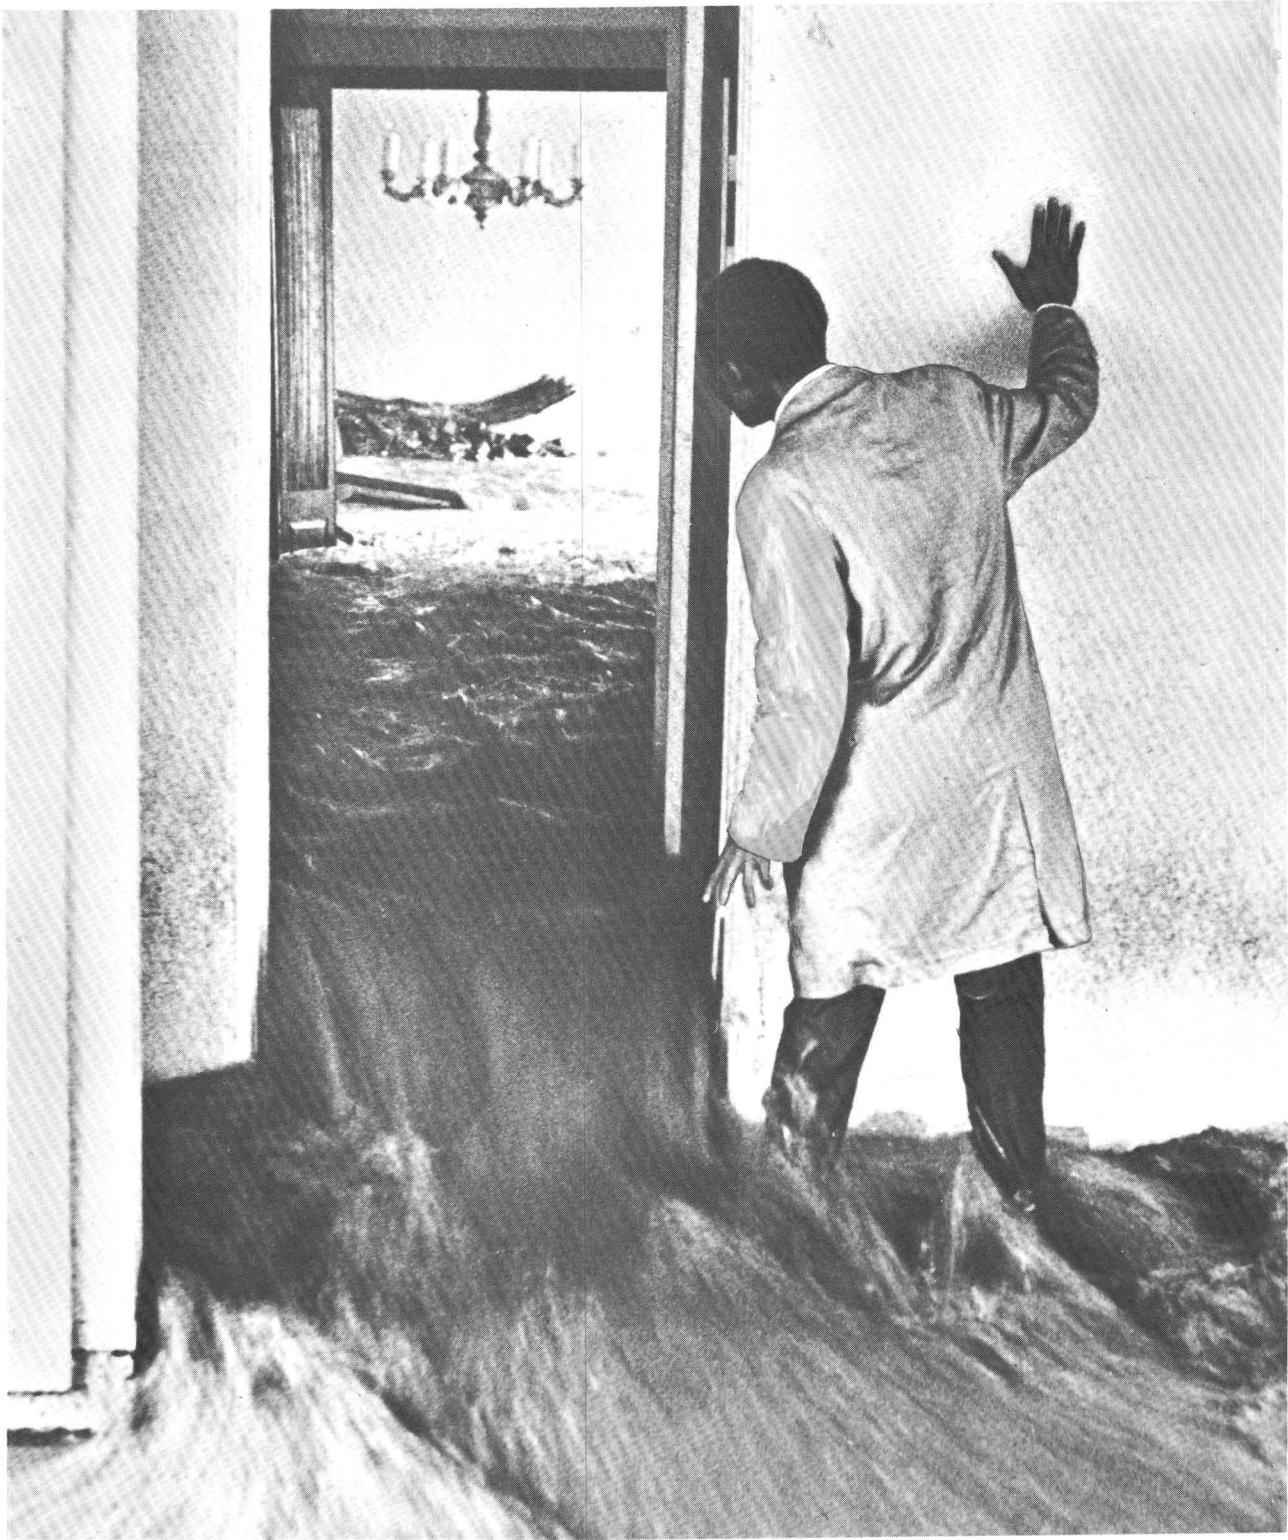
Floodwater rushing through doorway of home in Mandeville Canyon, a Los Angeles suburb. Photograph courtesy of Los Angeles Times.

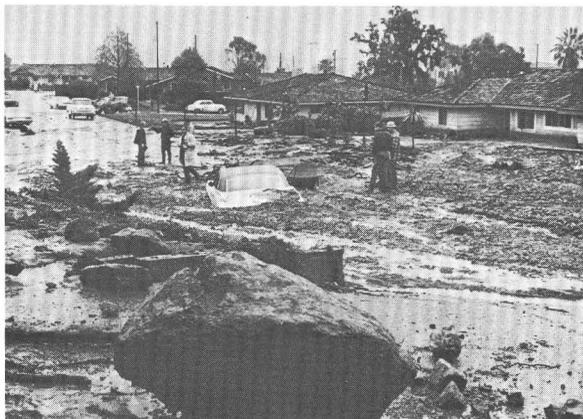
Figure 2.—Result of mudflow in Glendora, January 22. Photograph courtesy of Los Angeles Times.

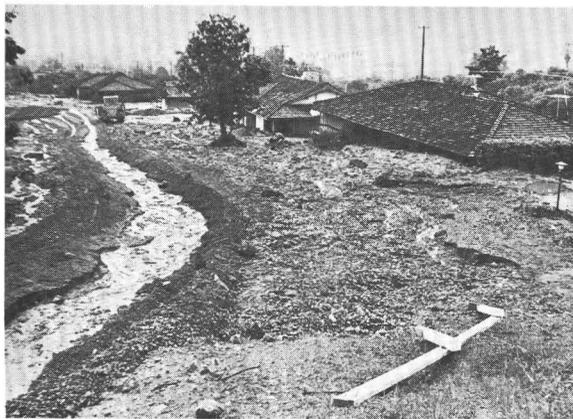
Figure 3.—Result of landslide (mudslide) in Glendora, January 26. Water has cut a channel through the mudslide. Photograph courtesy of Los Angeles Times.

In Los Angeles County, flooding was confined primarily to the headwater tributaries of the principal streams—the San Gabriel and Los Angeles Rivers—and to the smaller canyon streams that are directly tributary to the ocean. The heavy runoff of the San Gabriel and Los Angeles Rivers was stored in flood-control reservoirs and released at rates compatible with the capacity of downstream flood channels. In the mountain and foothill areas, however, the rapidly rising tributaries of those two rivers left their banks and created havoc. Bridges, roads, and streets were washed out and homes were destroyed or damaged; thousands of persons were evacuated. The sediment and debris carried by the streams added to the misery. Debris flows occurred again at Glendora to add to the damage suffered in the earlier phase of the storm. Damage of a similar nature, but not as severe, occurred in Highland Park, Sherman Oaks, Verdugo Hills, Brentwood, Bel-Air, Hollywood Hills, Encino, and Glendale. Landslides, more aptly termed mudslides, also created much damage in those towns and buried seven persons alive in their beds when the slides entered their homes. Topanga Creek, a small stream directly tributary to the ocean, swelled to the size of a river. Almost 1,000 persons in Topanga Canyon were isolated when homes and roads were destroyed by water and mudslides, and three persons were smothered when mud swept through their home. On the coastal plain, street flooding occurred in many towns such as Manhattan Beach, El Segundo, and Long Beach. (See figures 3, 4, and 5.)

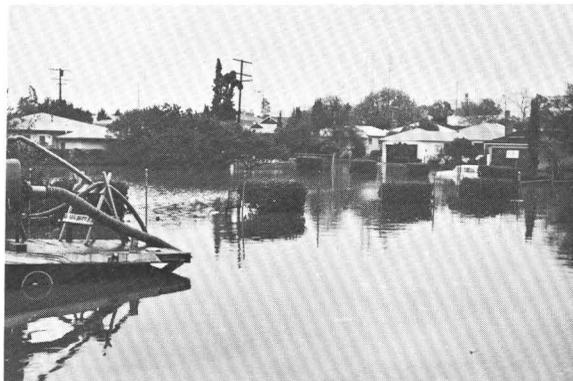
Figure 4.—Street flooding in El Segundo. Photograph courtesy of Police Department, city of El Segundo.

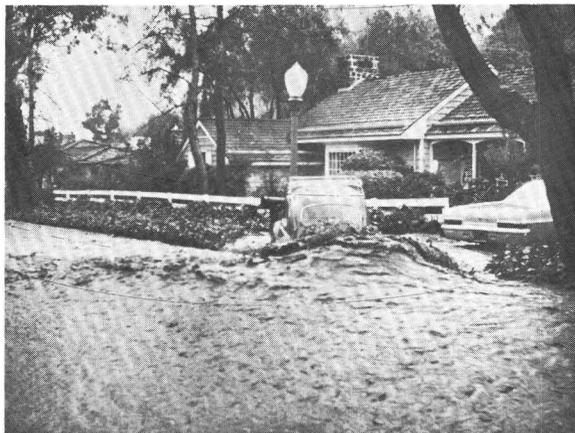
Figure 5.—Floodwater flowing down Casiano Road in Bel-Air (suburban Los Angeles) jams parked car against fence and lamppost. Photograph courtesy of World-Wide Photos.
