GEOLOGICAL SURVEY CIRCULAR 689

**Effects of the
May 5–6, 1973, Storm
in the Greater Denver Area,
Colorado**

By Wallace R. Hansen

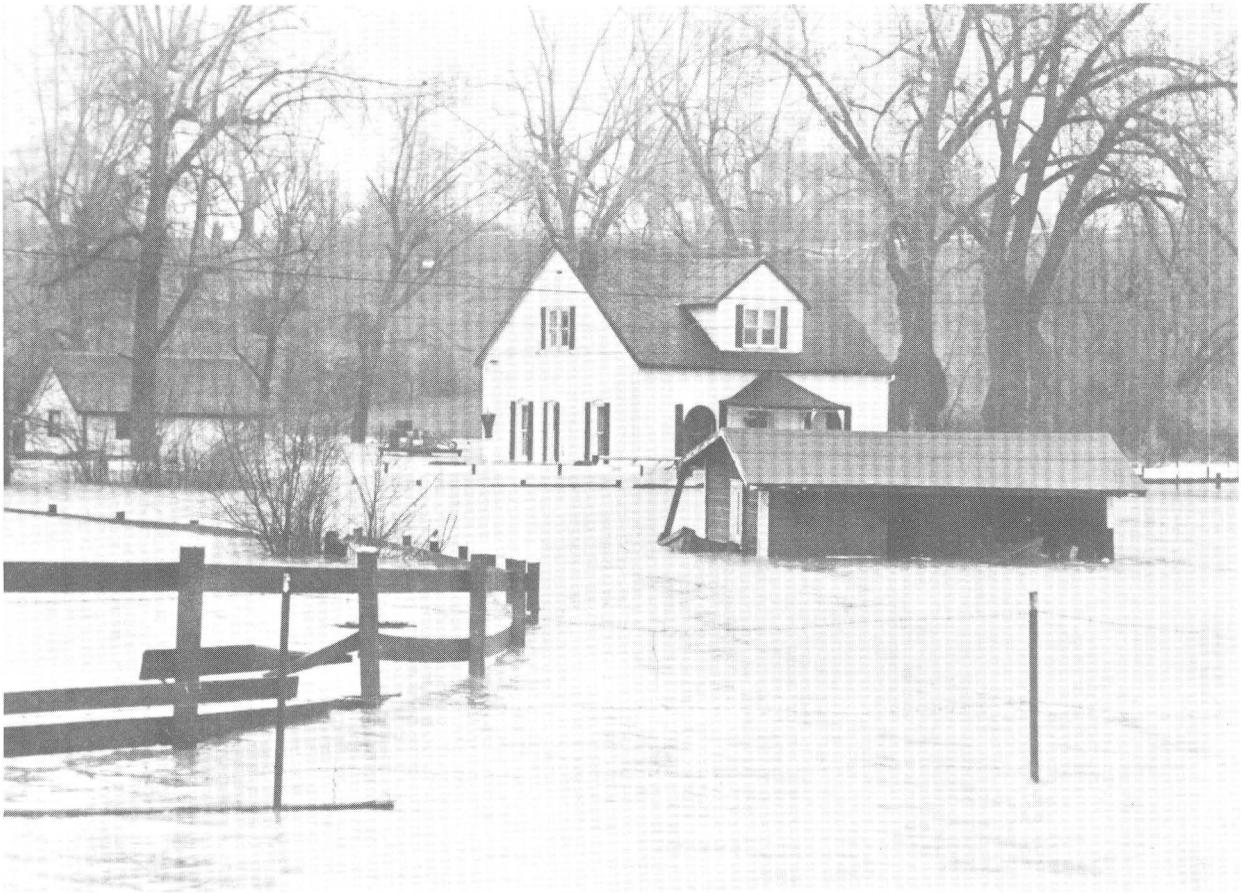
FIGURE 2. — Flooding at East Jefferson Avenue and South Emerson Street in Englewood, caused by the overflow of Little Dry Creek. Denver Post photograph by John Prieto, May 6, 1973.

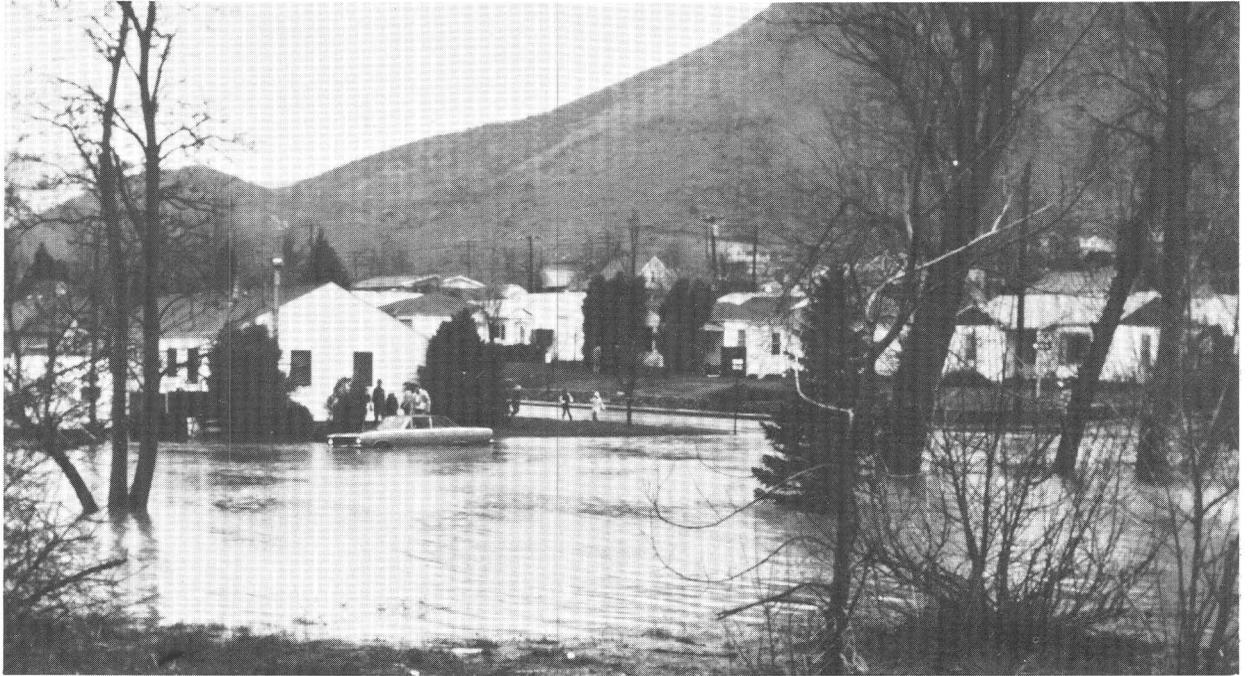
FIGURE 3. — Flooding along Kennys Gulch at 21st and Ford Streets in Golden. Urban runoff and overflow of Welch ditch exceeded capacity of storm drains. Photograph by John R. Keith, May 6, 1973, at height of storm.

In many built-up areas artificial drainage systems were inadequate to accommodate the runoff, and water quickly rose to flood levels (fig. 3). Proportionately, the amount of runoff that reached trunk drainages in built-up areas was much larger than in nonbuilt-up areas of equal size, simply because runoff which other- wise would have infiltrated the ground drained off totally from impervious roofs, sidewalks, streets, gutters, and pavements. Drains designed to accommodate modest rainstorms were over- whelmed or blocked with debris, and as tribu- tary drain systems merged, the problem was compounded. Many areas, such as much of Lakewood, simply lack adequate facilities to handle heavy storm runoff (The Lakewood Sen- tinel, May 10, 1973). Facilities that may have been adequate in the past, moreover, were sud- denly unable to accommodate the surge of water from new subdivisions higher in the watershed. As growth continues, smaller and smaller storms are able to generate larger and larger discharge.

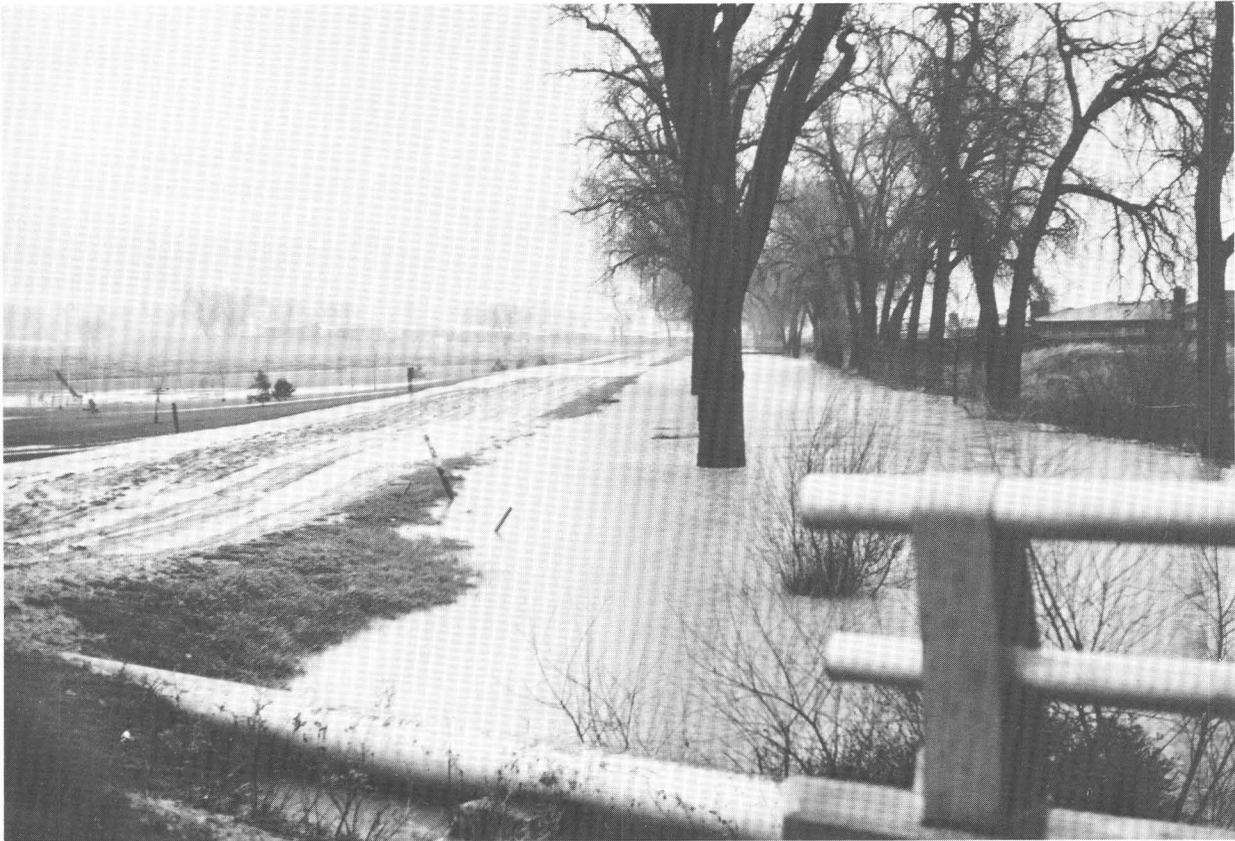
FIGURE 4.— Highline Canal out of its banks and flooding across Bible Park in southeast Denver, May 6, 1973. Photograph by L. Scott Tucker, executive director, Urban Drainage and Flood Control District (Denver).

senal, intercepting many small drainages en route. Highline Canal was out of its banks in many places (fig. 4), especially in southeast Denver, where many basements were flooded. At Wellshire Municipal Golf Course it threatened Skeel Reservoir, which has no spillway and nearly overtopped its dam. Downstream at the Rocky Mountain Arsenal, overflow from the canal and the Montbello ditch breached Upper Derby dam, sent a surge of water into Lower Derby Lake, and threatened Irondale, 3 miles to the northwest. According to Quentin Hornback of the Denver Water Board (oral commun., relayed by Robert M. Lindvall) many small tributaries of the South Platte poured water into canals and ditches, such as Highline.

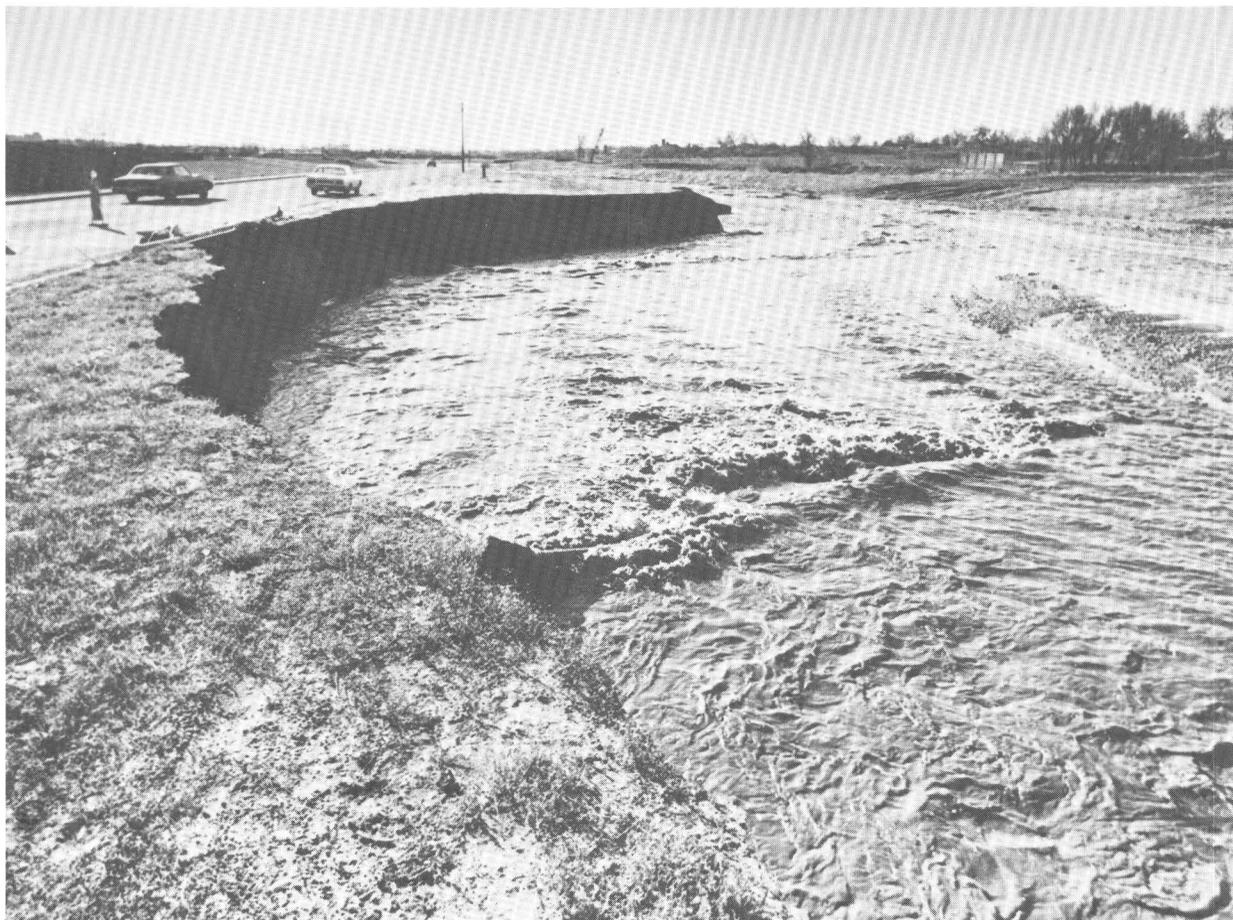
FIGURE 6. — Severe bank scour by Bear Creek at West Dartmouth Avenue and South Newland Street, May 9, 1973. Denver Post photograph by Bill Wunsch.

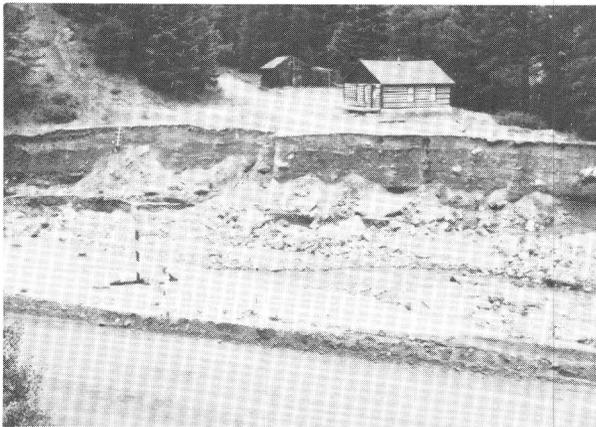
FIGURE 8.—Severe scour by West Creek between Deckers and Woodland Park. State Highway 67 and many mountain cabins were damaged or destroyed. Before the flood, road beside cabin in background joined Highway 67 in foreground. Photograph June 1973 by Brent N. Petrie, consultant on land and water resources.

West Creek damaged and closed State Highway 67 between Deckers and Woodland Park to the south; two small reservoirs failed in sequence, the upstream one first, by overtopping, thereby swamping the lower dam and creating a "wall" of water that destroyed much of the highway and several mountain homes (fig. 8).

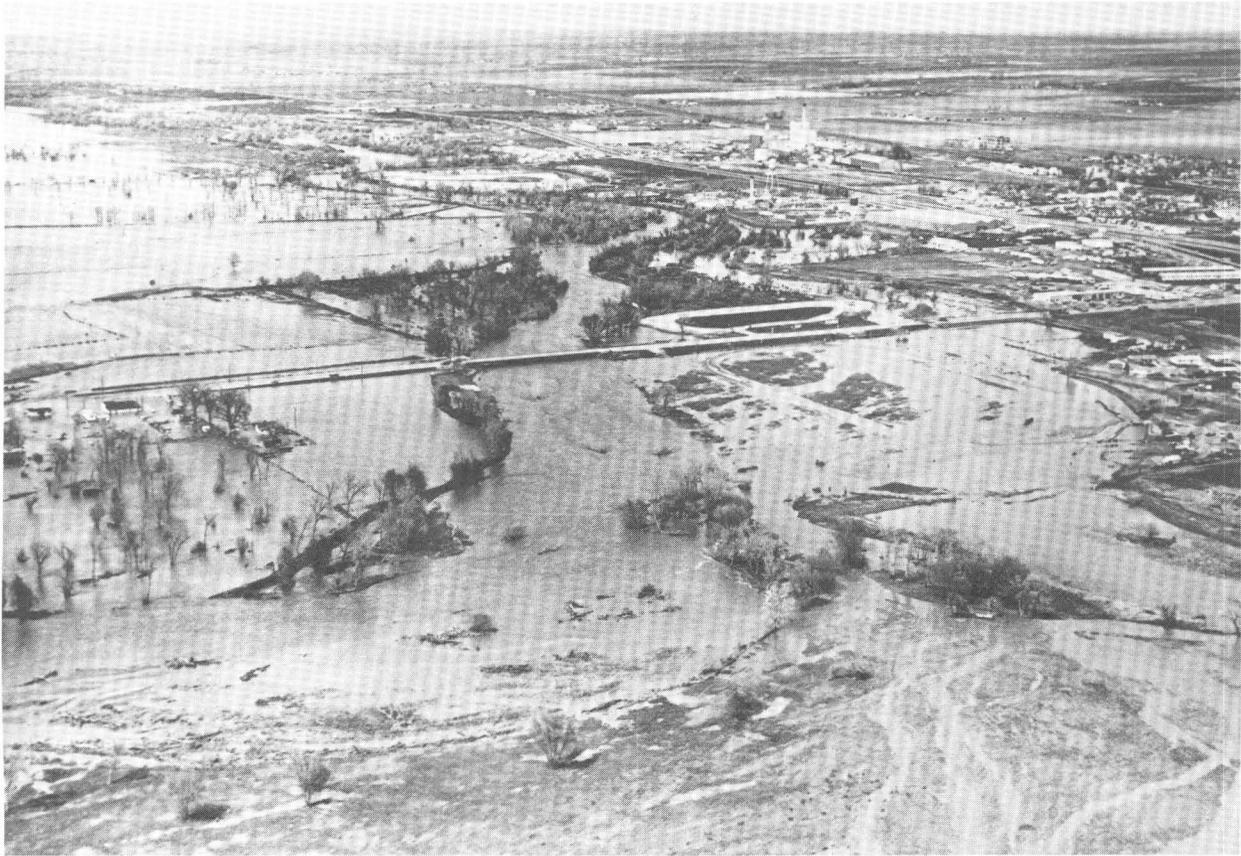
FIGURE 9. — South Platte River just west of Brighton, May 6, 1973. Silt and mud damaged hundreds of acres of cropland and pasture. Aerial view is northeast toward East 160th Avenue in middle distance. Denver Post photograph by Barry Staver.

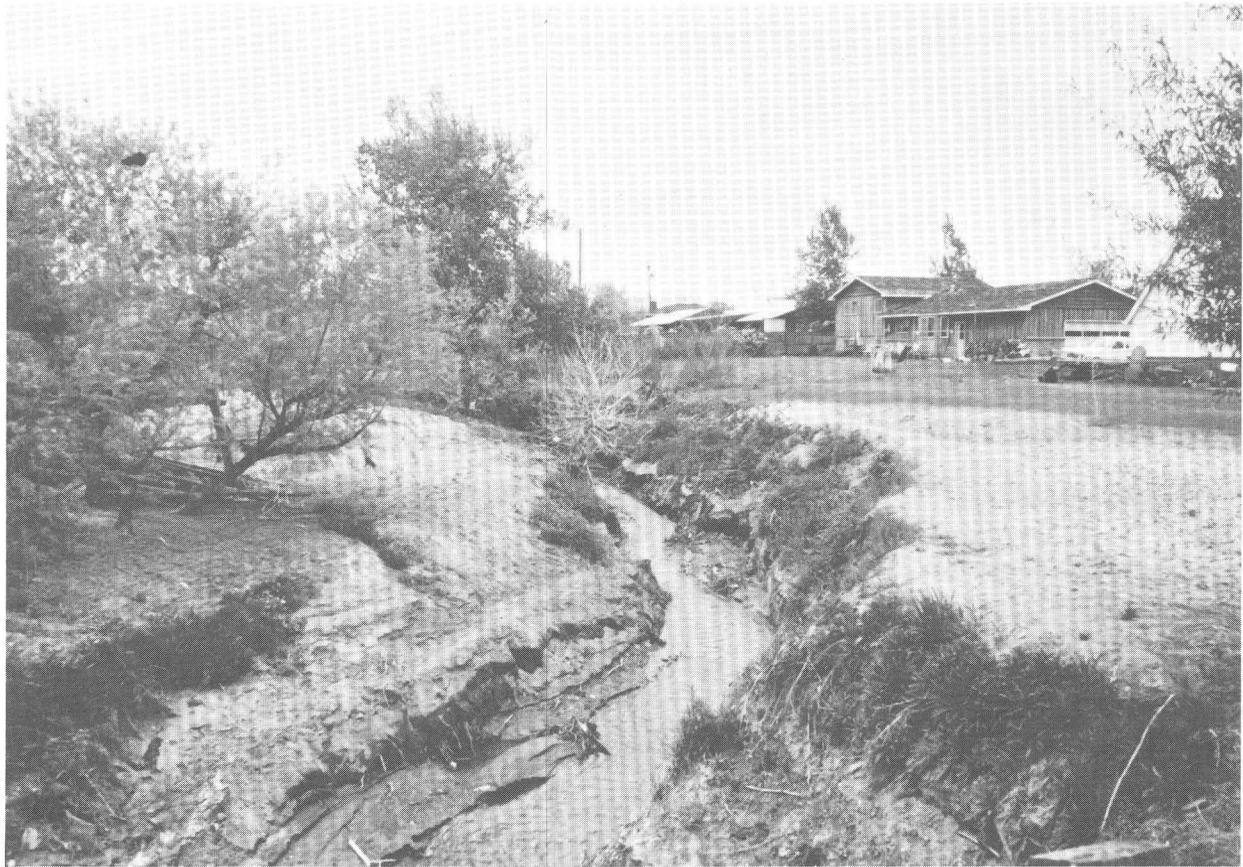
FIGURE 10. — Overbank sediments deposited along McIntyre Gulch at Holland Street in Lakewood, when culvert under street, behind observer, was unable to accommodate flood crest. Similar blockages caused flooding and sedimentation in many other places in Greater Denver area.

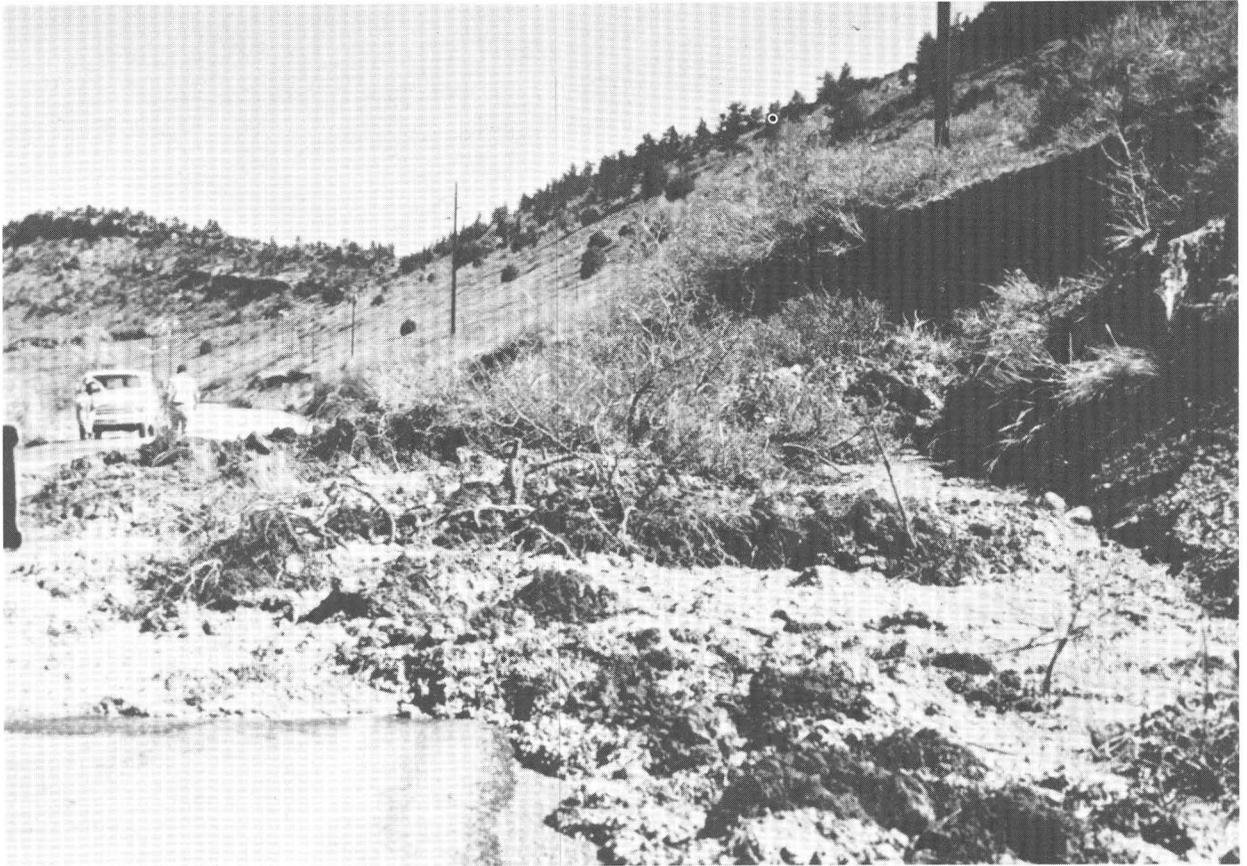
FIGURE 13. — Debris-mudflow blocking Hogback Road about 1 mile north of Morrison on west side of Dakota hogback. Photograph by Eugene R. Hampton, May 7, 1973.

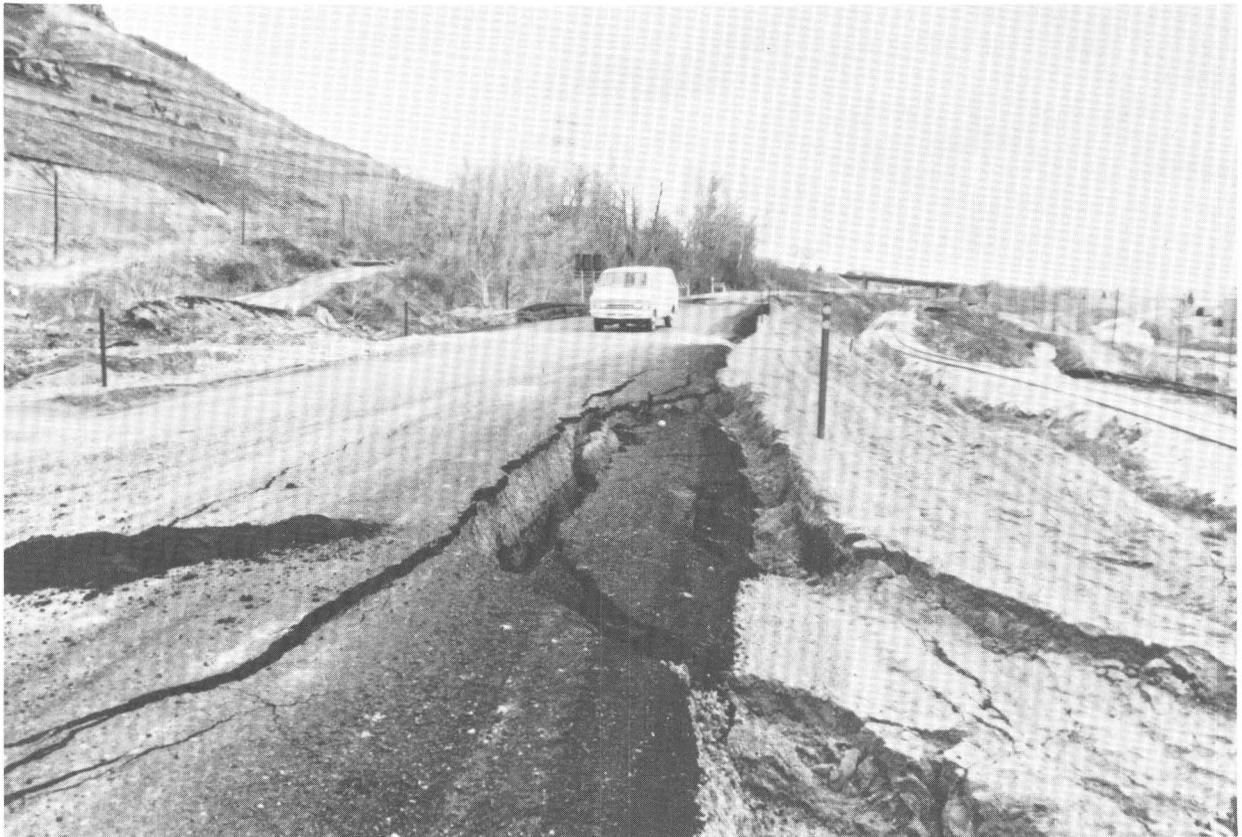
FIGURE 14. — Landslide in Denver Formation on old Colorado Highway 58, one-half mile east of Golden at foot of North Table Mountain. This slide has been intermittently active for many years and has been a continuing problem for highway and railroad maintenance people. Present activity was aggravated by the May 5-6 rains.

Because of the heavy moisture take-up by the Highway 58 slide, the damage potential of continued movement had been very large, involving an imminent threat to new Colorado Highway

58, continuing damage to West 44th Avenue, continuing damage to the Colorado and Southern Railroad tracks, potential disruption of the Farmers Highline Canal, and a serious threat to the Coors Co. sewage-disposal plant. The Colorado Highway Department, therefore, has taken steps to rectify the conditions that led to slide movements in the past.

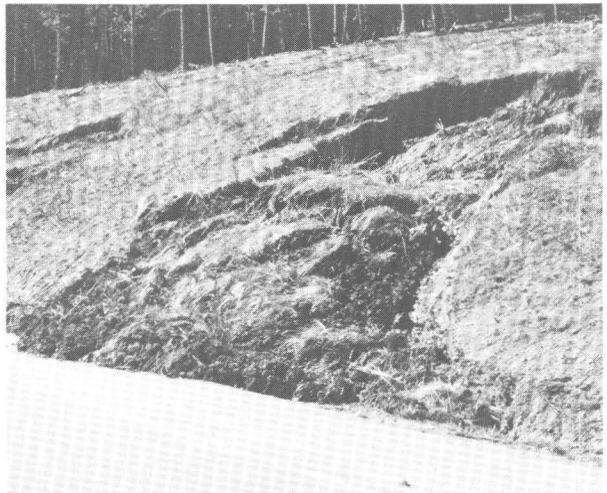
FIGURE 15. — Small debris slide on eastbound exit ramp of Interstate 70 at Genessee Mountain. Material is loam slope dressing and colluvium.

Many small slumps, earthflows, and mudflows appeared in backfilled areas along Interstate 70 in the mountains (fig. 15). Most of these were superficial failures involving only topsoil or dressing on sloping rock cuts. Mudflows appeared mostly on steep slopes where grass seeded the previous summer and fall had not yet established a protective turf. Even a good cover of turf, however, will not prevent slumping — in contrast with mudflowage — if the subsoil is saturated. The effects of the above

failures to date have not been hazardous, but they will present continuing maintenance problems unless arrested, and they could, perhaps, lead to some blockage of traffic lanes.

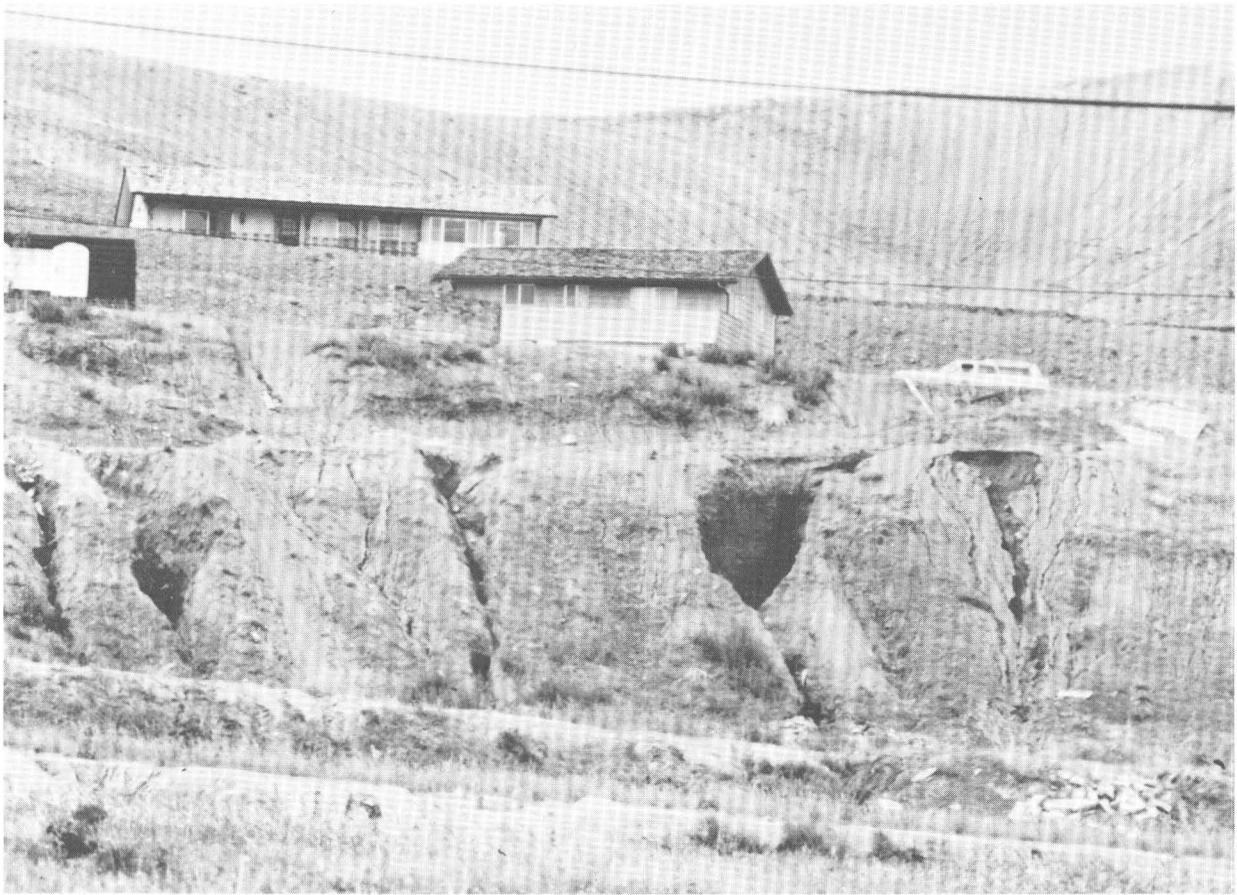
FIGURE 19. — Gullying on a steep hillside previously denuded of vegetation and topsoil.

Heavy earthmoving equipment has made possible the economic development of large tracts of land. Such construction practices in the Greater Denver area, however, commonly denude large acreages of land for extended periods of time prior to construction and, during heavy rainstorms, greatly increase the vulnerability of the land to sheet wash, gullying, scour, mudflowage, and sedimentation (fig. 19). These costly storm effects can be reduced if, following the lead of the highway builders, provisions are made for rapid, even temporary, revegetation with fast-growing grasses and herbs to reestablish protective ground covers, reduce erosion, and retard runoff. Better yet, careful analysis of the landscape at the planning stage can often minimize the initial alteration of the natural land surface
