# Channel Conditions in the Lower Toutle and Cowlitz Rivers Resulting from the Mudflows of May 18, 1980

By R. E. Lombard, M. B. Miles, L. M. Nelson,  
D. L. Kresch, and P. J. Carpenter

GEOLOGICAL SURVEY CIRCULAR 850-C

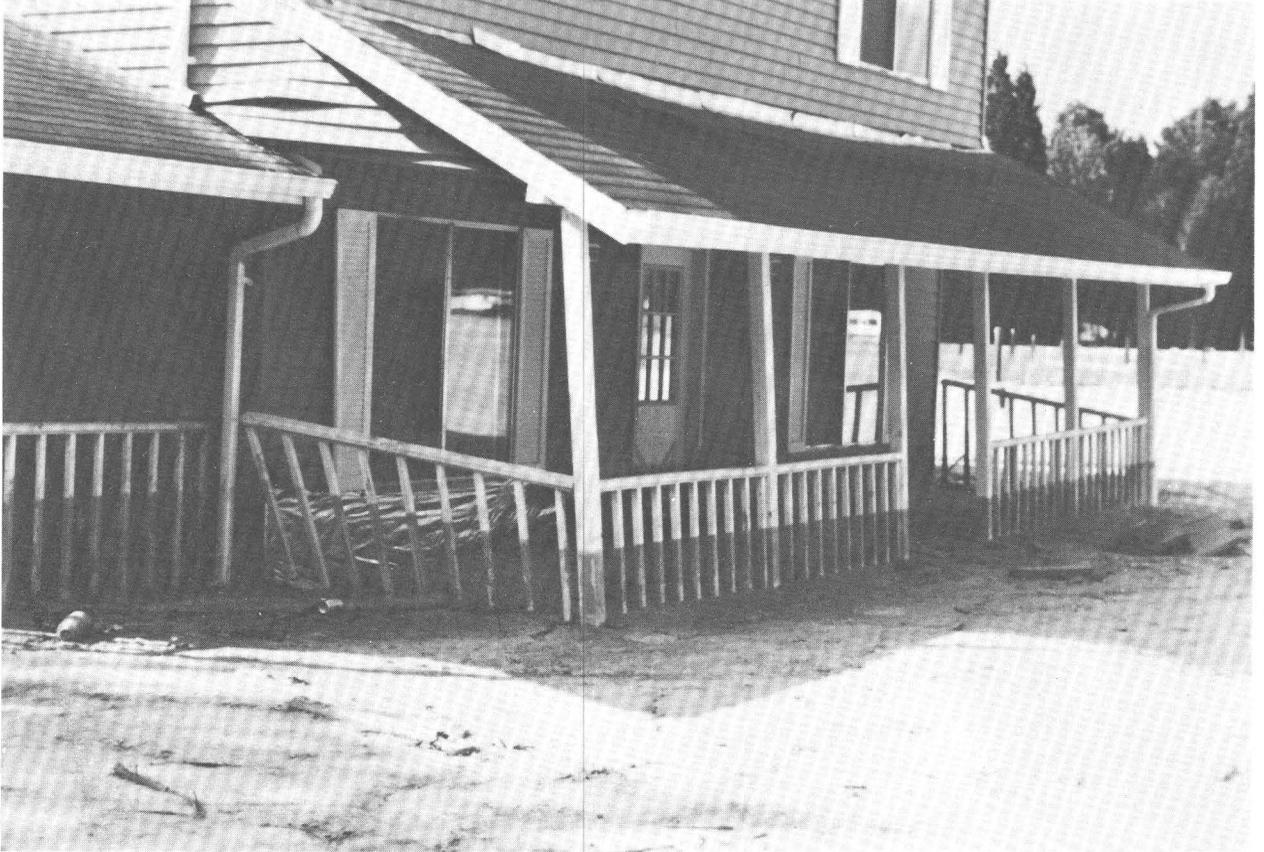
FIGURE 5. - Mudflow damage to farmhouse located approximately 1 1/2 miles south of Castle Rock on the west bank of the Cowlitz River.

confluence, but overbank deposits were not extensive. Figures 4-9 show the aftermath of overbank flow at various places along the lower Toutle and Cowlitz Rivers.

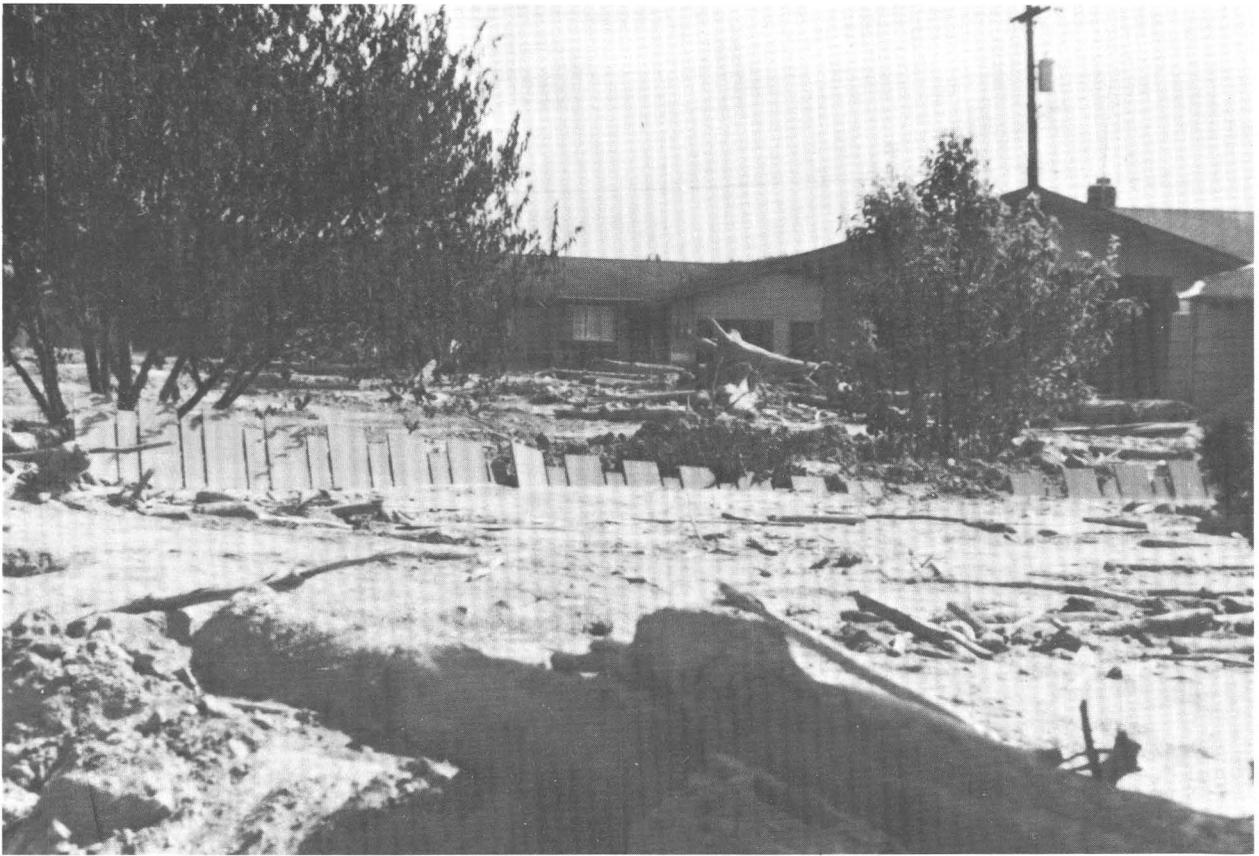
FIGURE 6. - Mudflow destruction along the Cowlitz River at a housing subdivision across the river from Castle Rock. Several houses were damaged beyond repair and were subsequently removed.

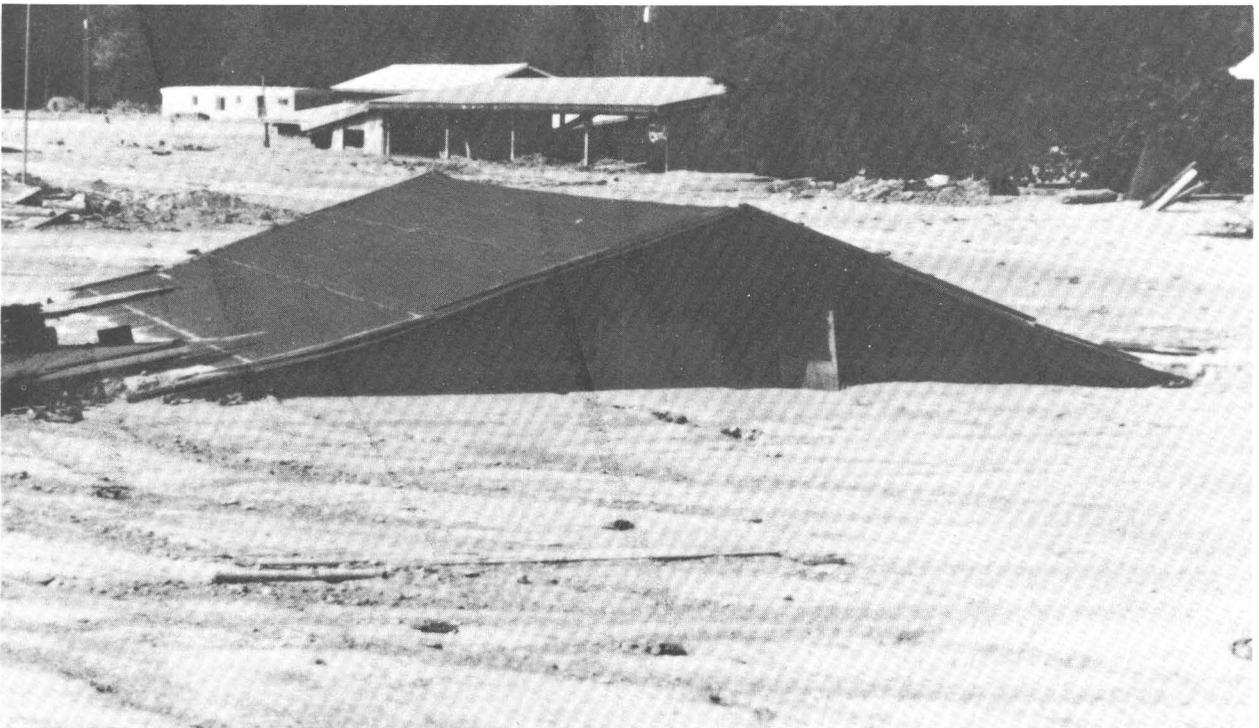
FIGURE 7. - Mudflow destruction of farm buildings approximately 1 ½ miles south of Castle Rock. About 8 ft of debris covers the ground in this area on the west bank of the Cowlitz River.

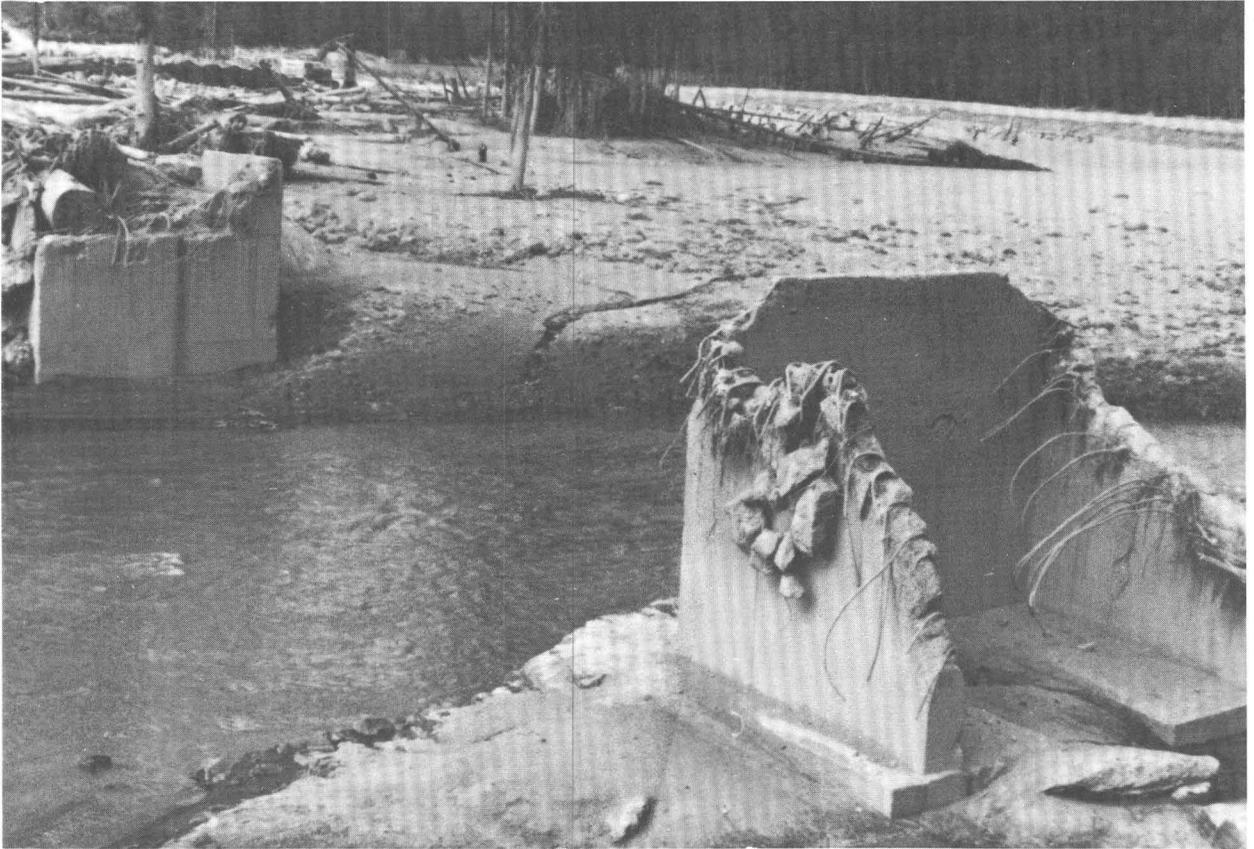
FIGURE 8. - Remains of the North Fork Toutle River bridge at Weyerhaeuser Logging Camp 19, Kid Valley.

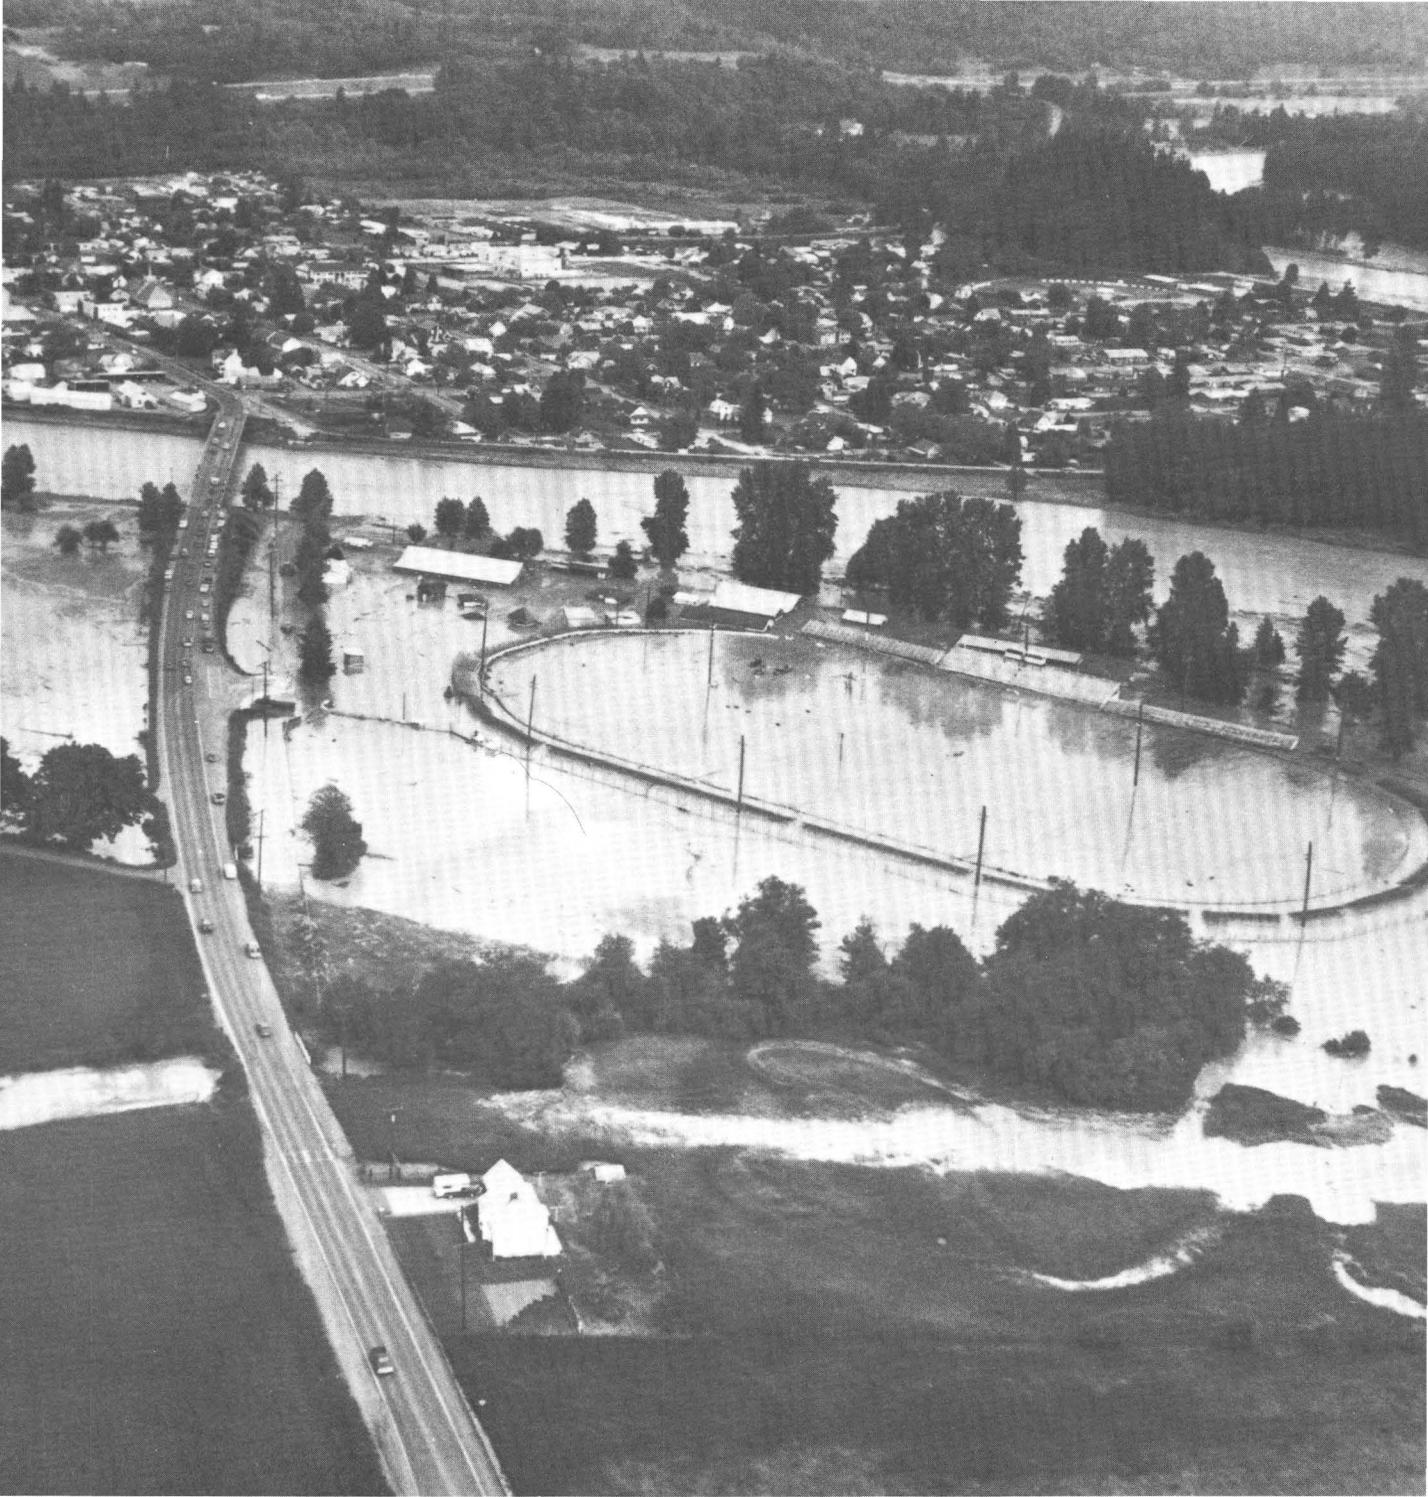
FIGURE 9. - Flooding at fairgrounds across the river from Castle Rock, Washington. From 3-5 ft of sediment were deposited over the entire fairgrounds, resulting in cancellation of the annual fair. Photograph taken May 19, 1980.

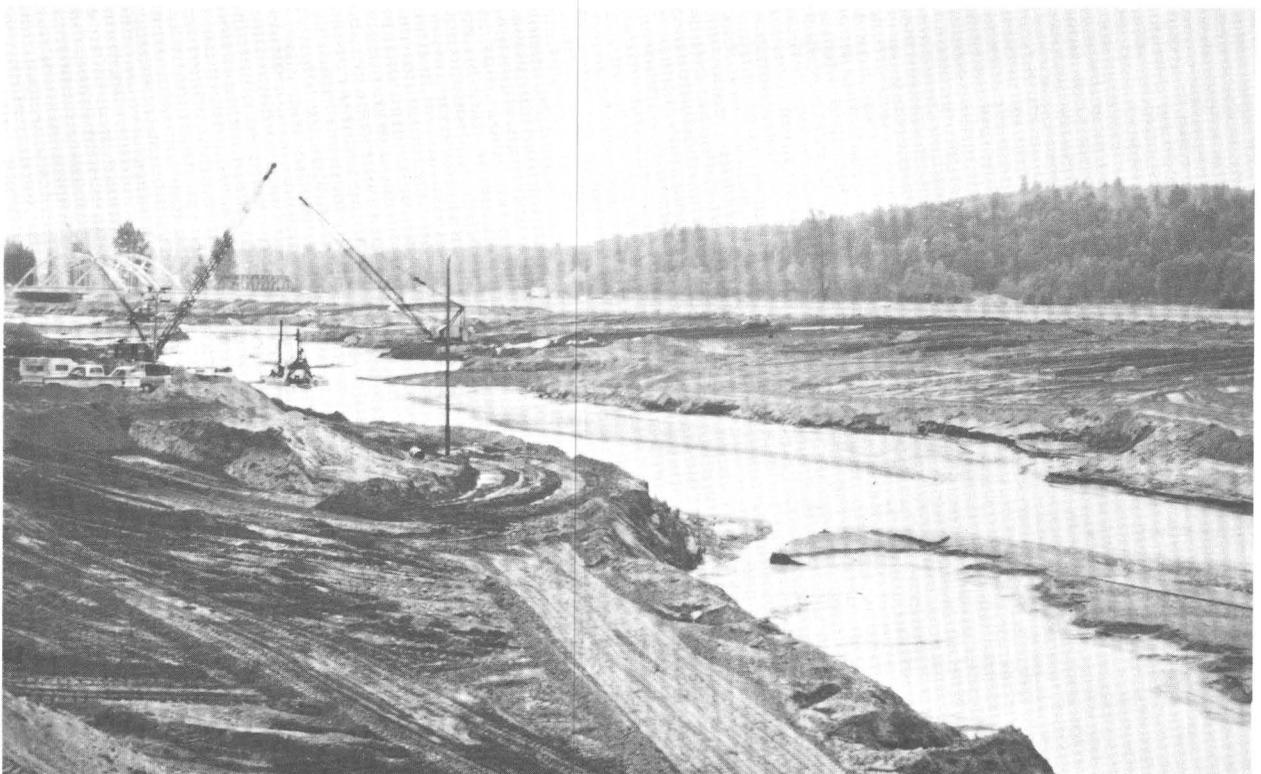
FIGURE 12. - Dredging operations on the Toutle River just upstream from its confluence with the Cowlitz River. Photograph taken September 11, 1980.

The Corps of Engineers began dredging operations in the lower Cowlitz River on June 10, 1980 (see fig. 12). By June 19, 1980, 120,000 cubic yards of sediment had been removed from the lower end of the river, but no effect was noted on the stage-discharge relation at the Castle Rock gage. As of September 30, about 18 million cubic yards of sediment had been removed, and dredging was continuing at the rate of about 1/3 million cubic yards per day. By November 1, 1980, the Corps of Engineers planned to have removed enough sediment from the Cowlitz River channel to increase its bankfull (flood stage) capacity to 50,000 cubic feet per second - 26,000 cubic feet per second less than the bankfull capacity prior to the mudflows.
