Hydrographic Surveys at Seven Chutes and Three Backwaters on the Missouri River in Nebraska, Iowa, and Missouri, 2011–13

Data Series 909

U.S. Department of the Interior
U.S. Geological Survey

By Justin R. Krahulik, Brenda K. Densmore, Kayla J. Anderson, and Cory L. Kavan

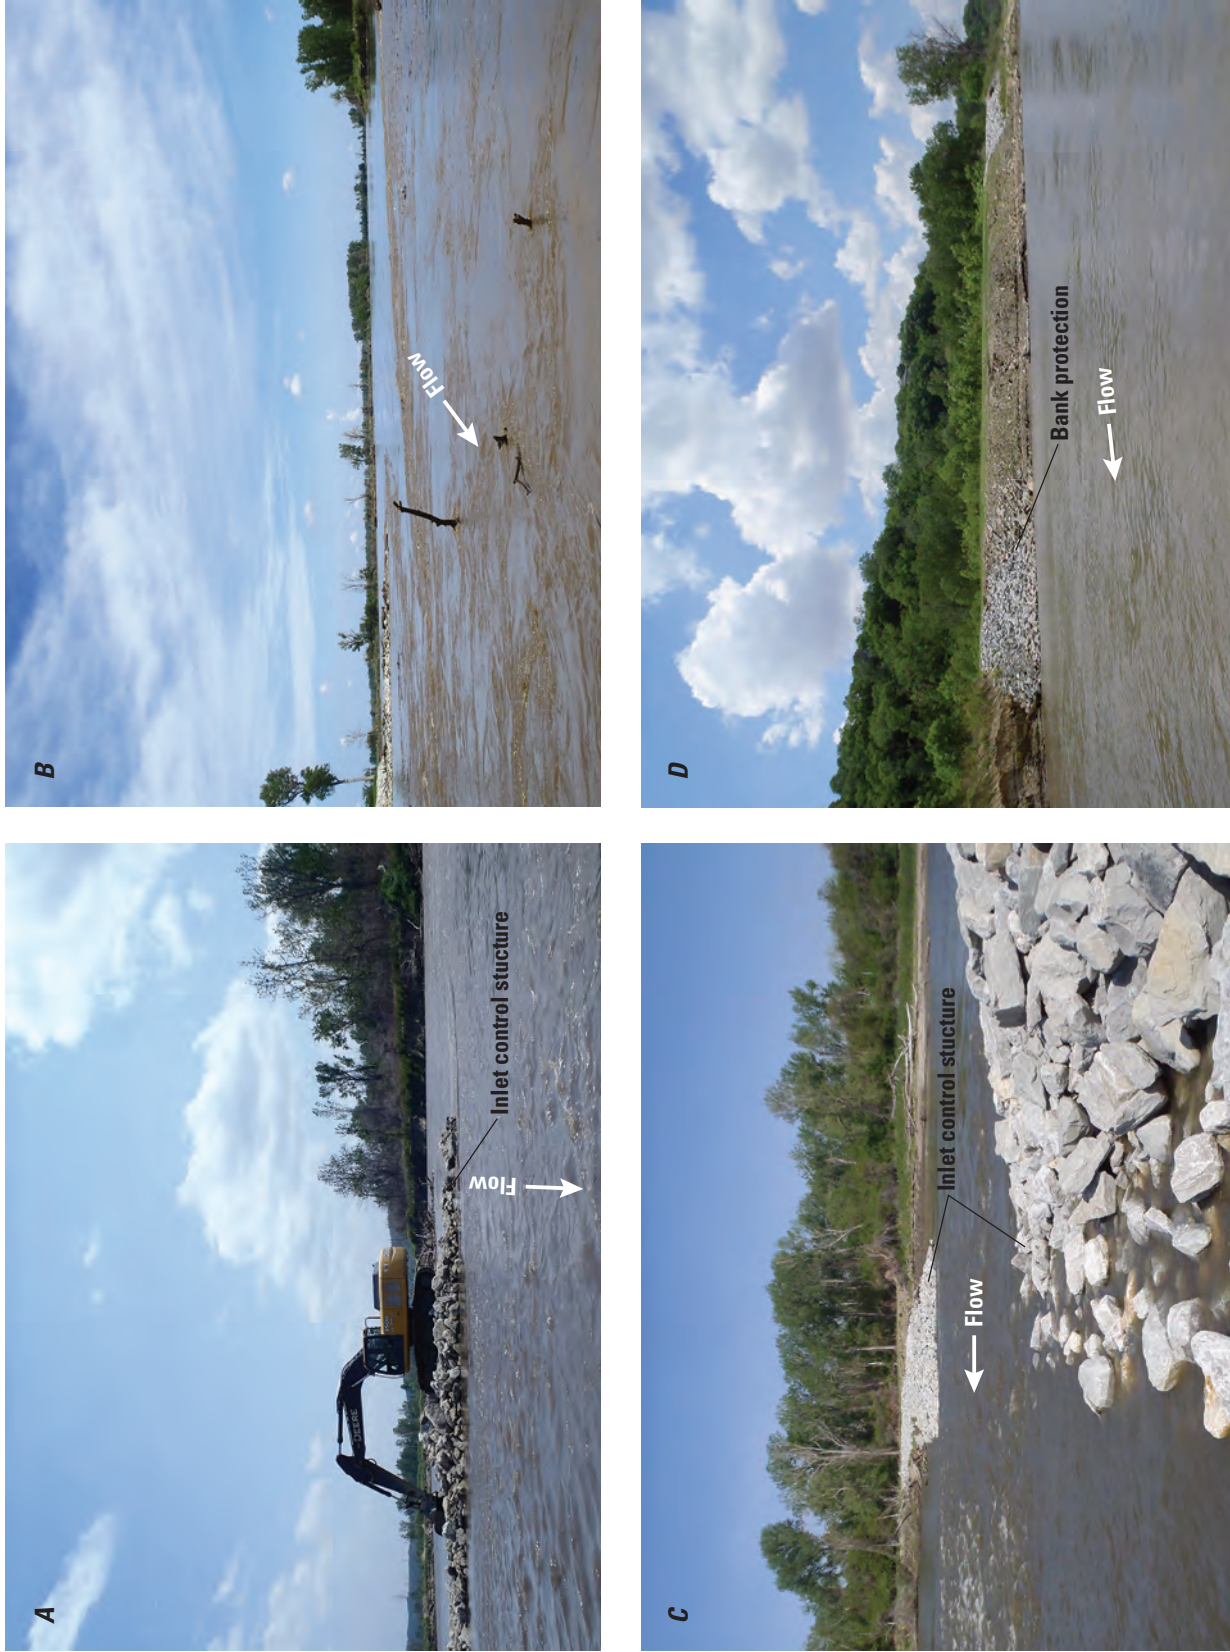
Figure 2. Control structures at Missouri River chutes, 2011–13. *A*, Construction of a new inlet control structure at Derooin chute, 2013. *B*, Turbulent water around the inlet control structure and snags at Lower Hamburg chute, 2014. *C*, New control structure within Lower Hamburg chute, 2014. *D*, Limited bank protection on an eroded bank at Tobacco chute, 2014.

The split of total discharge between the Missouri River main channel and the chutes was consistent with observed effects of the 2011 Missouri River flood (deposition, erosion, degradation of entrance control structures, flanking of internal control structures, chute widening) at most chutes as noted by the U.S. Army Corps of Engineers and U.S. Fish and Wildlife Service (2013). Many chute entrances and control structures were damaged by floodwater in 2011, allowing a larger percent of the Missouri River total discharge to flow through the chute than originally intended in the chute design. The designed flow split varies by chute, but is typically 10–12 percent of the total discharge (U.S. Army Corps of Engineers and U.S. Fish and Wildlife Service, 2013). The USACE repaired many of these chutes in 2012 and 2013, and effects of these repairs as well as changes in total discharge can be seen in the discharge split between the Missouri River main channel and the chute in data collected for this study. It is likely that the repairs affected the water depths and riverbed elevations not only at the construction site, but throughout the chutes and backwaters—however, there is no way to distinguish the changes contributed specifically to the repairs from general post-flood geomorphic changes. Also, survey data could not be

collected over newly built and repaired structures because of safety concerns (rough water flowing over the new structures, heavy machinery still working on structures, and difficulty walking on new structures because the rip-rap was still settling into place). In addition to total discharge and discharge splits, the mean velocity of the cross section collected during each discharge measurement is reported. Cross sections selected for discharge measurements typically were uniform, narrow areas of the chute, and are not necessarily representative of the entire chute, but represented the best locations to accurately measure discharge. Therefore, even when mean velocities of discharge measurement cross sections were greater than 0.6 m/s, there were likely areas along the cross section and many areas throughout the chute that did have flow velocities less than 0.6 m/s.

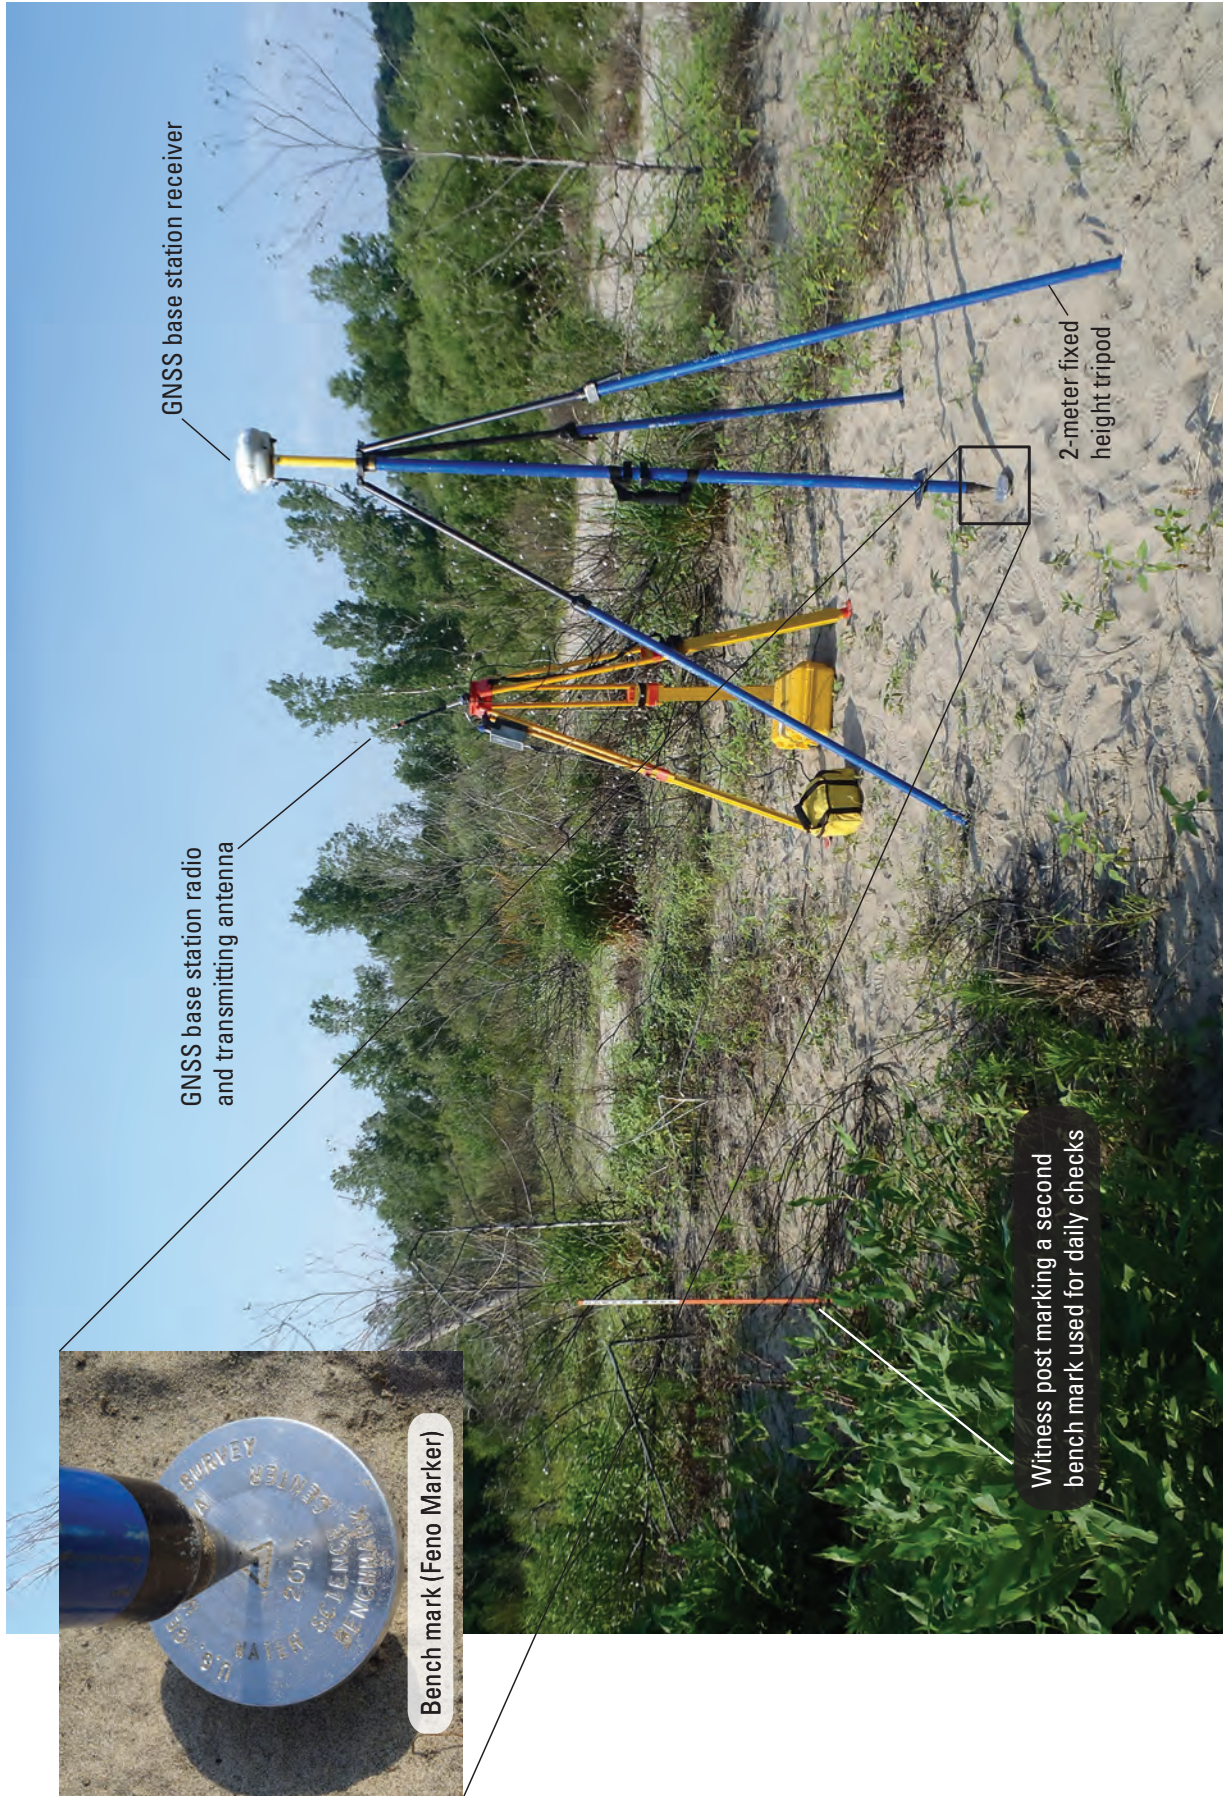
Figure 3. Real-Time Kinematic (RTK) Global Navigation Satellite System (GNSS) base station and bench mark at Deroin chute, Missouri, 2013.

The RTK GNSS surveying required USGS surveyors to walk along the banks with an RTK GNSS rover with an antenna mounted on a 2-m adjustable-height pole. The surveyors located each transect and collected elevation measurements by setting the foot of the pole flat on the riverbed or riverbank, leveling the pole, and taking a measurement. The RTK GNSS surveys included main-objective points to be surveyed at three positions on each transect, whenever possible: top of bank (left and right), toe of bank (left and right), and edge of water (left and right, denoted in the data file as “we”). Additional data points were collected between these main-objective points and into the channel to ensure a point spacing less than 15 m. The RTK GNSS surveys extended into the channel as far as water depths and substrates allowed for safe wading conditions. Water-surface elevations (denoted in the data file as “ws”) were surveyed at the same point at the beginning of the day and at the end of the day, and these locations extended upstream and downstream from the bathymetric survey data collected during that day. Similarly, water-surface elevations were collected at the upstream and downstream cross section of backwaters. This water-surface elevation collection method allowed the hydrographic surveying software to account for water-surface slope as well as changing river stage when converting the bathymetric survey depth to elevation.
