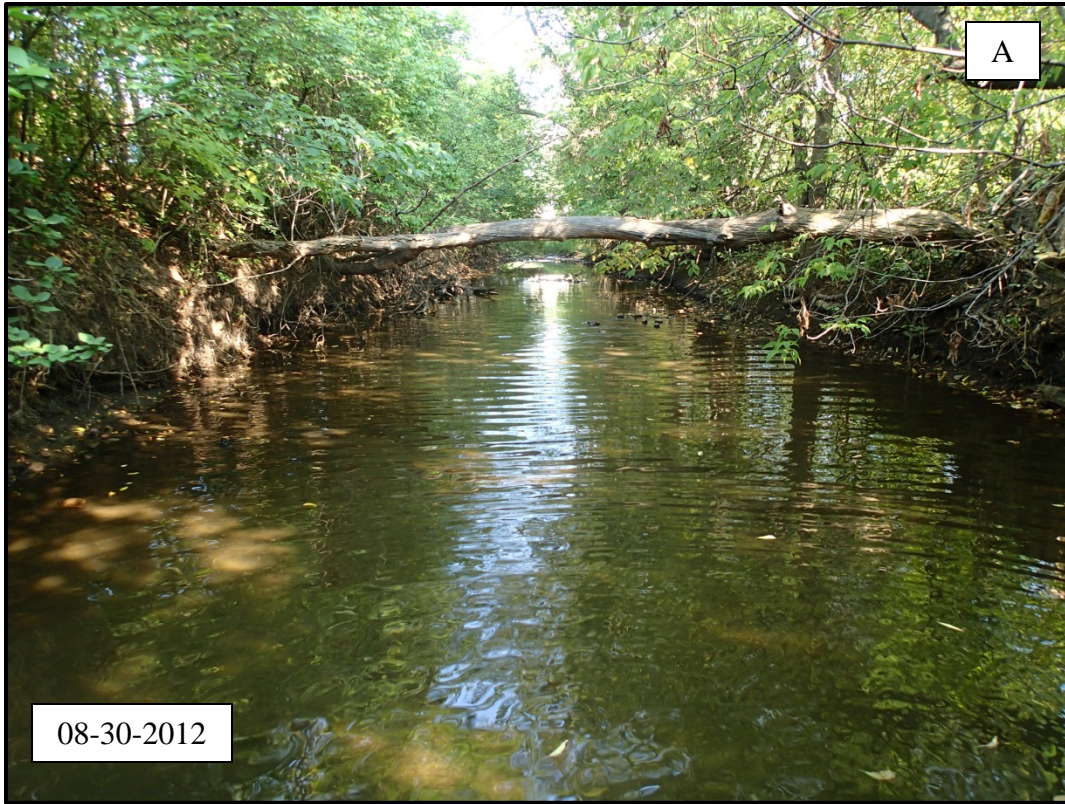
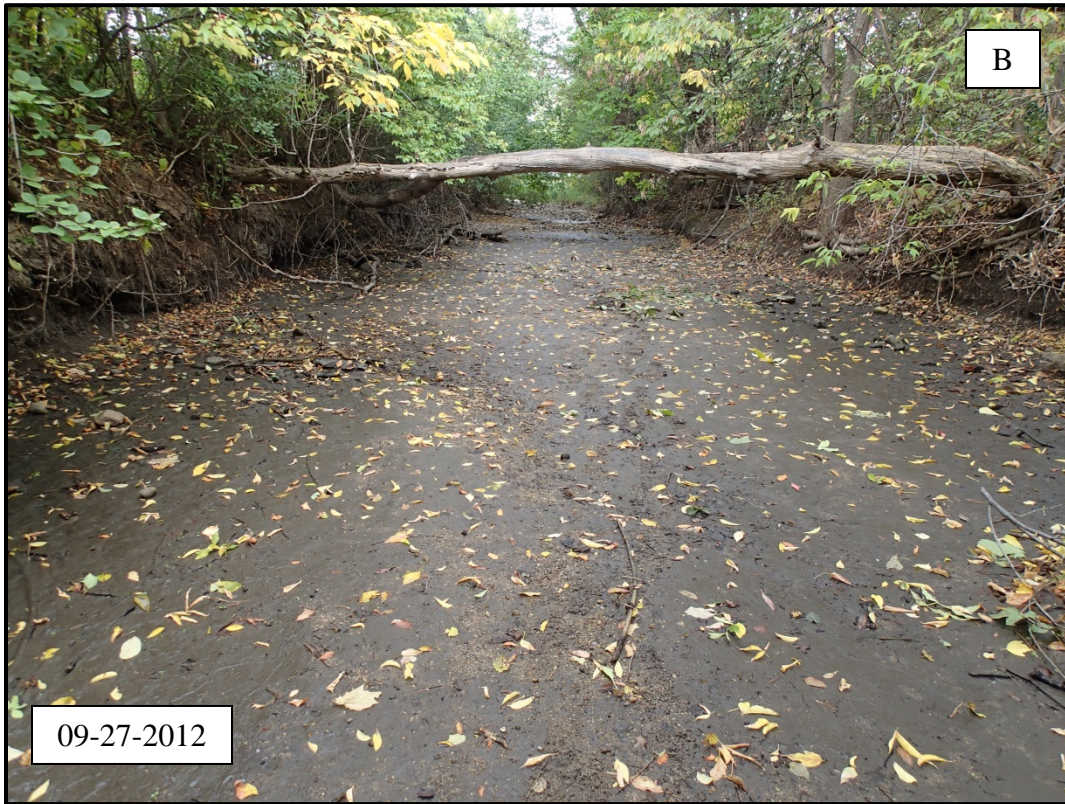
Figure 3: Comparison of flow conditions at Underwood Creek site 1 (0408708562) at time of geomorphic and habitat site assessment (A) on August 30, 2012, and at the time of the river walk-through (B) on September 27, 2012. Photographs taken by James Blount, USGS.
