The Los Angeles Dam Story

U.S. Geological Survey Fact Sheet-096-95, January 1995
GPO 1995-684-845

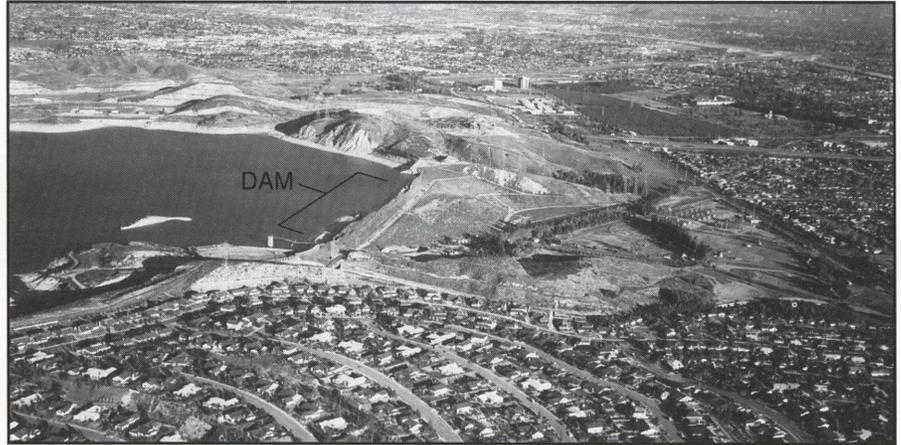
Perched above the densely populated San Fernando Valley, the Lower San Fernando Dam—predecessor to the Los Angeles Dam—holds a large reservoir, 1.6 miles long and as much as 130 feet deep. Severe damage of the dam during the 1971 San Fernando earthquake forced residents to evacuate homes in a 6-mile-long area down the valley. The reservoir was the terminus of the main aqueduct system for Los Angeles, which supplied 80% of the city's water. Aerial view looking northeast.

Moments after the San Fernando earthquake of 1971, only a thin dirt wall stood between 80,000 people in the San Fernando Valley of southern California and 15 million tons of water poised behind a heavily damaged dam. The 142-foot-high Lower San Fernando Dam was perilously close to failure. At any moment a strong aftershock could have triggered a disaster. As it was, residents in an 11-square-mile area were forced to evacuate, while the water behind the earthen dam was lowered, a process that took 3 days.

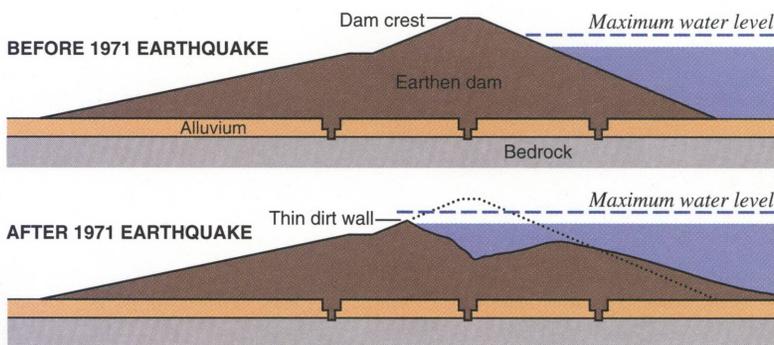
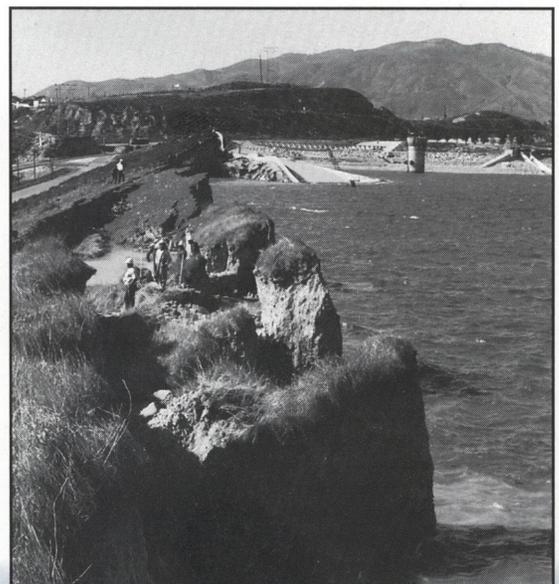
The 1971 San Fernando earthquake shook loose a massive slide in the upstream slope of the Lower San Fernando Dam that lowered the crest about 30 feet. The slide carried away much of the crest and upstream concrete facing of the 2,100-foot-long dam. As shown in the photograph at right, only a narrow shattered wall of dirt remained. Had the reservoir behind the dam been at its maximum height, water would have overtopped and rapidly eroded the dam, flooding the valley below. The dam was constructed between 1912 and 1915 using construction methods that provided weak resistance to earthquake shaking.

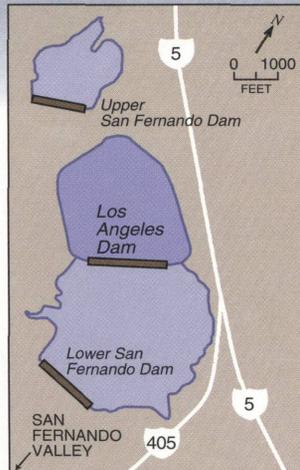
The Los Angeles Dam and Reservoir lie between the storm water retention basins formed by the old Lower and Upper San Fernando Dams.

The new \$33 million Los Angeles Dam and Reservoir was built in 1975-76 about 3,000 feet up the valley from the old Lower San Fernando Dam. However, the old dam was not dismantled. Instead, it was

reconstructed—though not to meet the USGS shaking estimates—to provide a holding basin for storm water and to back up the new dam.

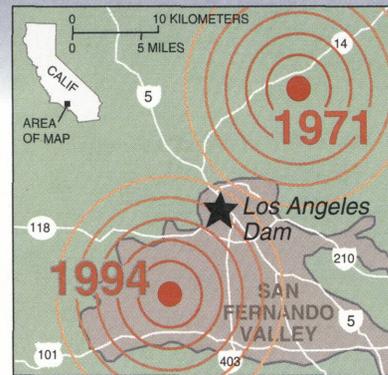
The Los Angeles/San Fernando dams site (star) lies between the 1971 San Fernando and 1994 Northridge earthquakes (dots).

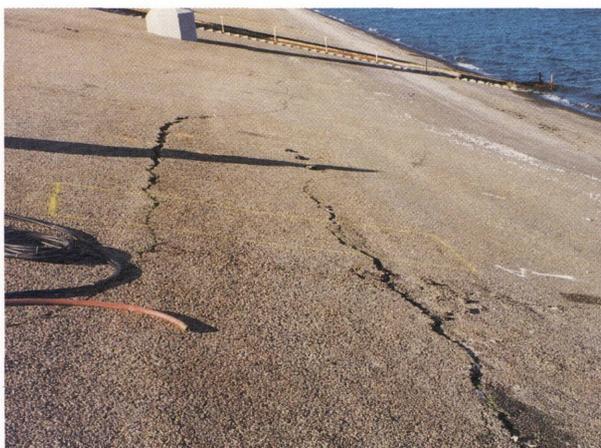
The 1994 Northridge earthquake cracked the surface pavement on the upstream slope of the Los Angeles Dam. Overall, the dam, designed to withstand severe shaking, suffered very little damage. (Courtesy of Los Angeles Department of Water and Power.)

Two decades later, the 1994 Northridge earthquake put the Los Angeles Dam to the test. The Northridge earthquake was almost equal in magnitude to the previous San Fernando earthquake. Ground shaking was very strong, with amplitudes among the highest ever recorded but consistent with the USGS estimates. Yet the dam showed only minor deformation and superficial cracking. Despite the intense shaking, the crest of the dam moved only 1 inch sideways and settled only 3.5 inches. In contrast, the Lower San Fernando Dam again suffered heavily. Cracking and movement seriously damaged the upstream slope. Had the old dam been holding as much water as it had in 1971, the damage would have been far greater—at least equaling that from the 1971 earthquake.
