Effects of wildfire on the hydrology of Frijoles and Capulin Canyons in and near Bandelier National Monument, New Mexico

Introduction

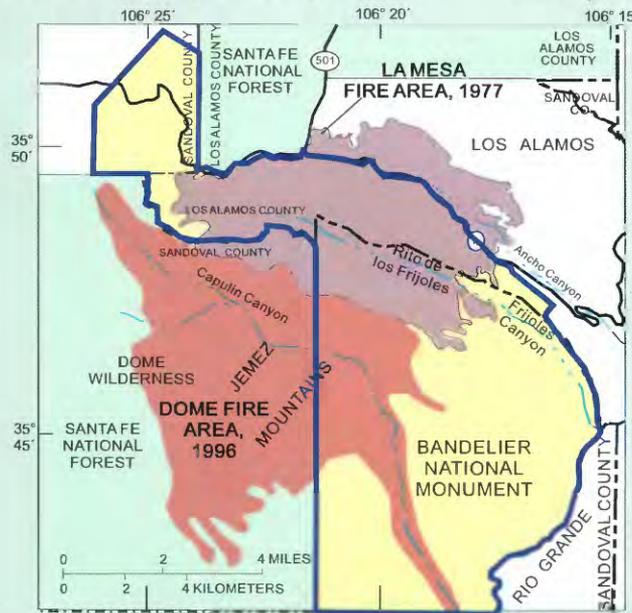
Figure 1. Location of Bandelier National Monument, extent of 1977 La Mesa wildfire, and extent of 1996 Dome wildfire.

In June 1977, the La Mesa wildfire burned 15,270 acres in and near Frijoles Canyon in Bandelier National Monument (BNM) and the adjacent Santa Fe National Forest, New Mexico (fig. 1). In April 1996,

The study area is located in and near BNM in north-central New Mexico and includes parts of Frijoles Canyon and Capulin Canyon (fig. 1). Streamflow in these watersheds originates at higher elevations near the east rim of the Jemez Mountains, is in an easterly direction, and eventually enters the Rio Grande.

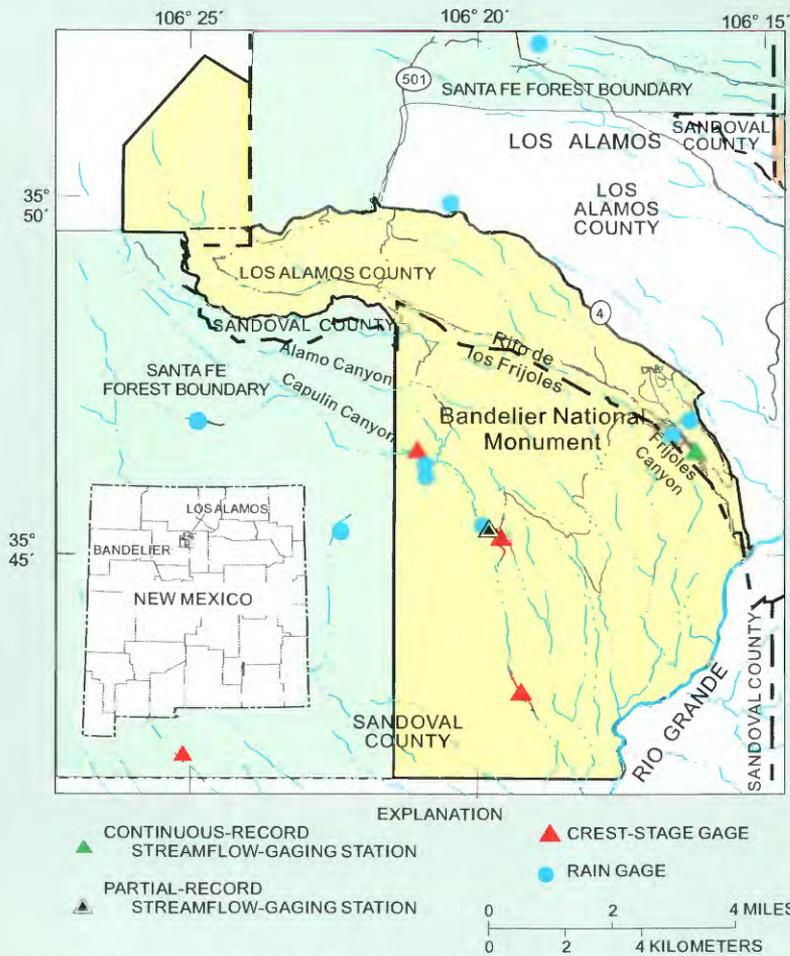
Figure 2. Frijoles Canyon and Capulin Canyon watersheds and location of selected gaging stations and rain gauges.

Rainfall was recorded and streamflow was monitored from 1996 to 1998 in and near Capulin Canyon after the 1996 Dome wildfire. The locations of selected rain gages, crest-stage gages, and streamflow-gaging stations are shown in figure 2. Slope-area and step-backwater indirect measurements were made at the three crest-stage gages and gaging station. The hydrologic assessment after the fire in Capulin Canyon was based, in part, on analysis of the gaging-station record for Frijoles Canyon collected before and after the 1977 La Mesa fire. Suspended-sediment samples of La Mesa post-fire runoff were collected from 1977 to 1988; samples also were collected as part of the USGS National Water-Quality Assessment (NAWQA) Program from 1993 to 1995. For a complete description of the methods used during this study, the reader is referred to Veenhuis (2002).

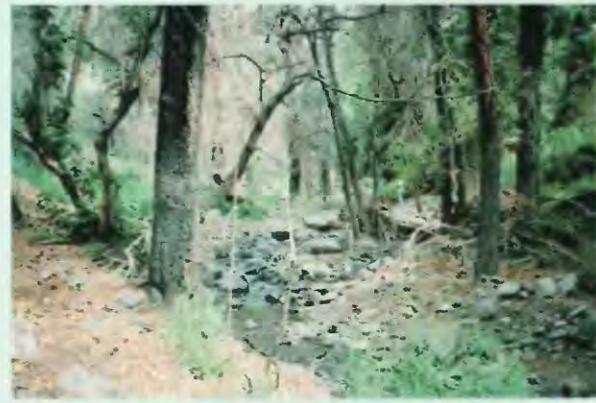
Average flow in Capulin Canyon.

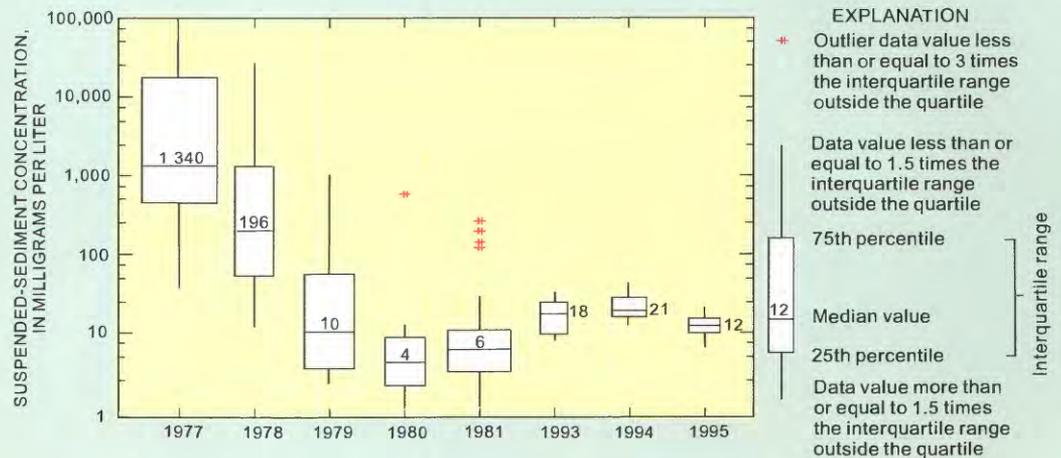
Figure 3. Suspended-sediment concentrations in samples collected in Frijoles Canyon.

During the NAWQA Program from 1993 to 1995, 22 suspended-sediment samples were collected; concentrations ranged from 6 to 44 mg/L (milligrams per liter), with a 3-year median of 16 mg/L (fig. 3). Streamflow during sample collection ranged from 0.26 to 8.4 ft³/s, with a median of 1.4 ft³/s. Because grasses and brush had re-established on the exposed soil by 1993, samples probably were collected long enough after the fire to be representative of a pre-fire unburned watershed in this type of geologic setting.

mg/L in 1977 in comparison with 16 mg/L in samples collected from 1993 to 1995 (fig. 3). Suspended-sediment concentration and streamflow show similar patterns after a fire: a substantial increase the first year after the fire with a gradual decrease for about 3 years thereafter.

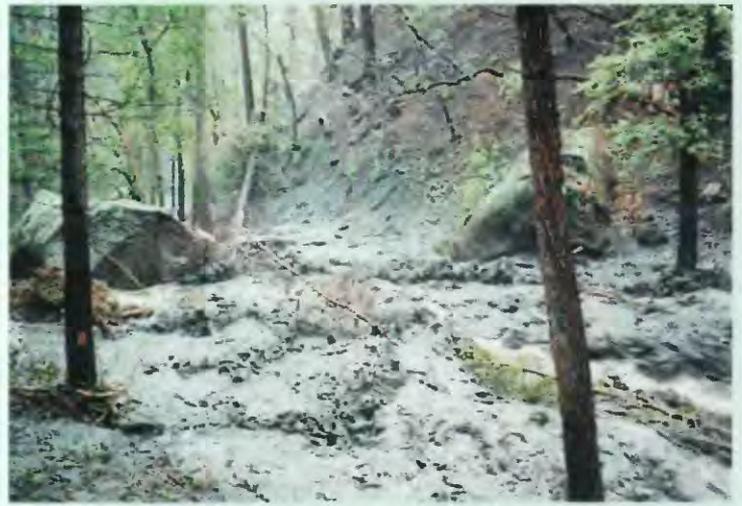
Runoff in Capulin Canyon during a storm on July 10, 1996. Silvery color of water is due to ash.

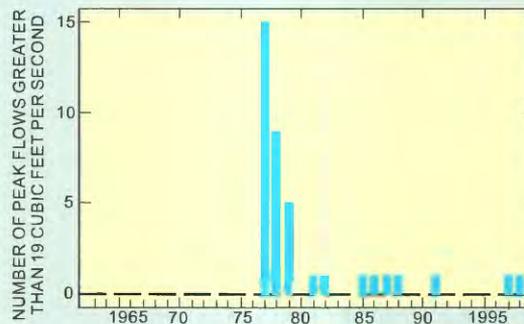
Figure 4. Number of peak flows greater than 19 ft³/s in Frijoles Canyon.

maximum peak flow was 19 ft³/s. From 1977 to 1979, the number of peak flows greater than 19 ft³/s was 15 in 1977, 9 in 1978, and 5 in 1979 (fig. 4). Of these flows, seven were greater than 100 ft³/s in 1977 and again in 1978 and three were greater in 1979. Similar to pre-fire peak flows, most of the larger flows occurred during July,

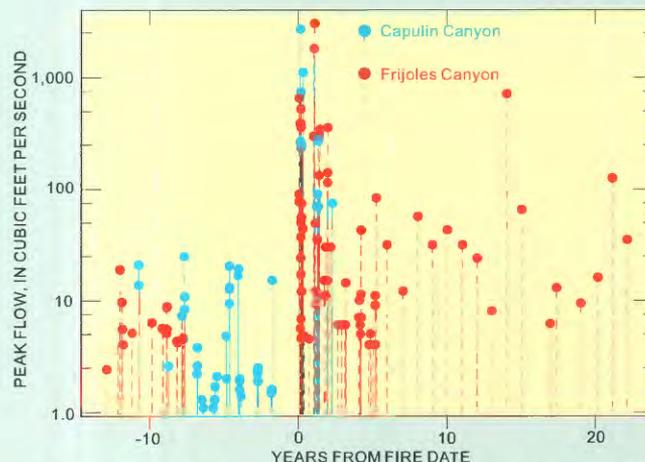
Figure 5. Peak flows in Frijoles Canyon before and after the 1977 La Mesa wildfire and in Capulin Canyon before and after the 1996 Dome wildfire.

The maximum peak flow recorded in Capulin Canyon (drainage area about 14.1 square miles) after the 1996 wildfire was 3,630 ft³/s. Peak flows decreased to less than 400 ft³/s in 1997 despite some large rainfalls within the watershed (Veenhuis, 2002). The re-establishment of vegetation the first year after the wildfire is probably responsible for most of the decrease in flows. By 1998, peak flow in the canyon had decreased to less than 160 ft³/s, but still was an order of magnitude larger than the pre-fire median annual peak flow. Peak flows at the most downstream gaging station in each canyon were about 160 times the maximum recorded peak flow prior to the fires. Increases in peak flows in response to the 1977 and 1996 fires are quite similar (fig. 5).

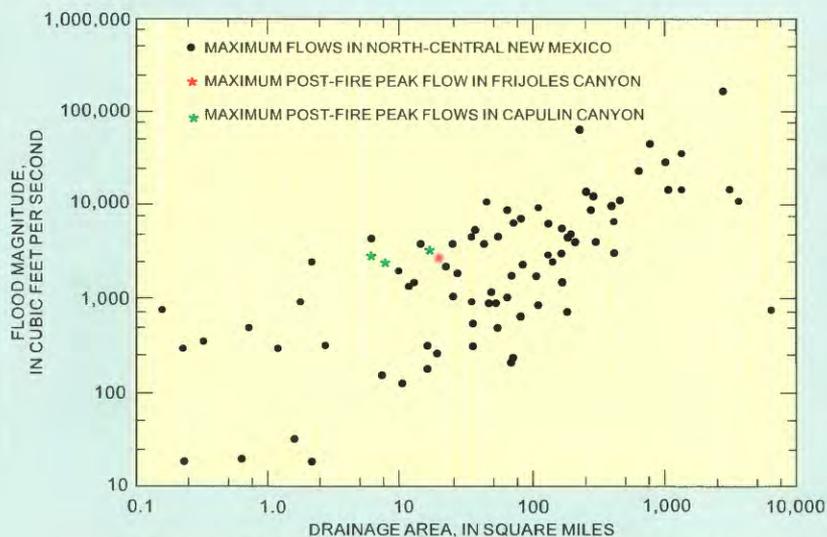
Figure 6. Maximum post-fire flood magnitudes (modified from Waltemeyer, 1996).

Maximum post-fire peak flows in Frijoles and Capulin Canyons and maximum peak flows in north-central New Mexico in relation to drainage area (Waltemeyer, 1996) are shown in figure 6. Although maximum post-fire peak flows in these two canyons are orders of magnitude larger than pre-fire peak flows, they are no larger than what was measured for similar drainage areas in north-central New Mexico. When large floods occur in watersheds that lack effective vegetative cover, the peak flow in a particular drainage area is more a function of rainfall intensity.

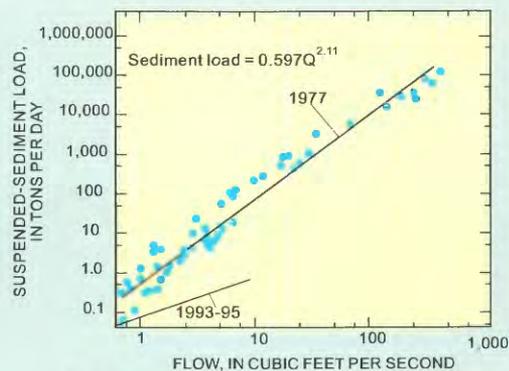
Figure 7. Instantaneous suspended-sediment load compared to flow, Rito de los Frijoles.

Suspended-sediment concentrations in relation to flow in Frijoles Canyon immediately after the 1977 fire and for 1993-95 are shown in figure 7. The relation between load and streamflow was used with mean

daily streamflow to calculate annual suspended-sediment load. About 20 tons per year of suspended sediment were transported past the Frijoles Canyon gaging station during the 1993-95
