Effects of Post-Wildfire Sedimentation on Leopard Frog Habitat in Saguaro National Park

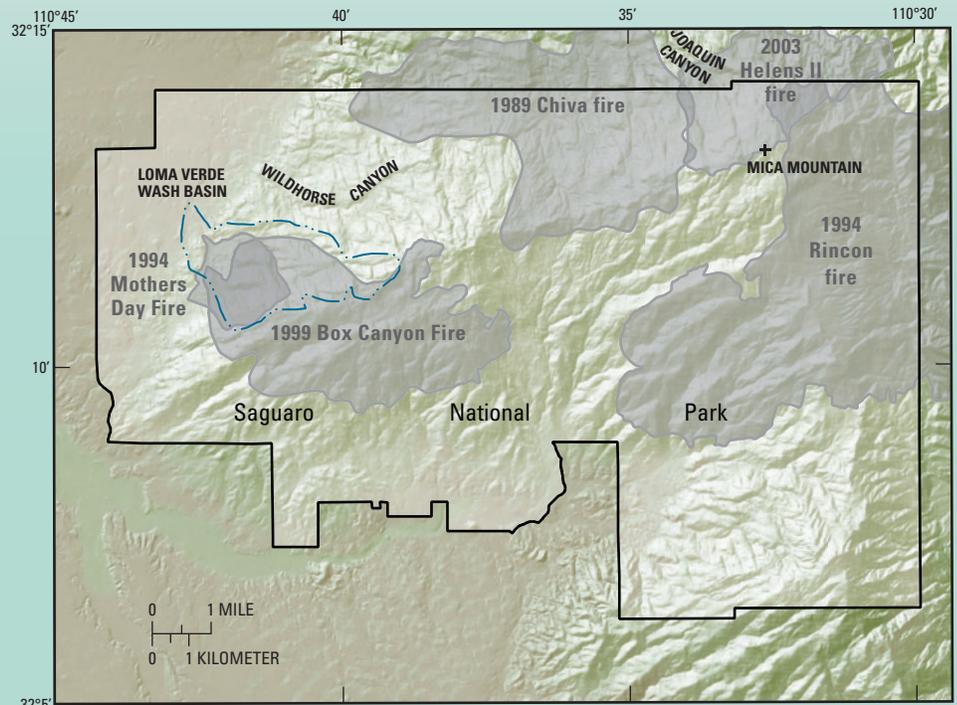
Figure 1. Saguaro National Park (black boundary) and extent of major fires occurring since 1989.

Within Saguaro National Park's Rincon District, a combination of factors, including past fire-management practices and high production of fuels during wet years followed by exceptionally dry years, has resulted in five hot, destructive wildfires covering about 40,000 acres in the past 16 years (fig. 1). Burn areas typically result in higher volumes of storm runoff compared to runoff in the same areas during pre-fire conditions. Higher stream runoff is accompanied by widespread erosion in upland areas and

Fires have swept through nearly 40 percent of the park's forests, grasslands, and scrublands since 1989, burning about 50 percent of the forested areas and 35 percent of chaparral and desert scrublands and grasslands. The Chiva, Mothers Day, and Box Canyon fires accounted for most of the burned acreage in scrublands and grasslands, and the Rincon and Helens II fires primarily burned upper elevation forests and woodlands. Nearly the entire 1,000 acres of mixed conifer forest on Mica Mountain, the smallest vegetation zone in the park, was affected by the Helens II fire of 2003 (fig. 1). The north slope of Mica Mountain was particularly hard hit by the fire, which wreaked

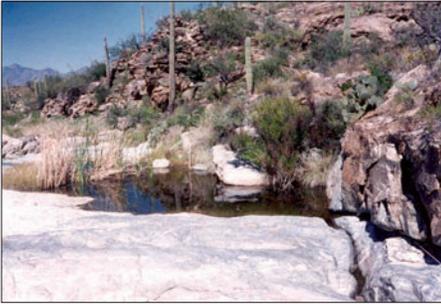
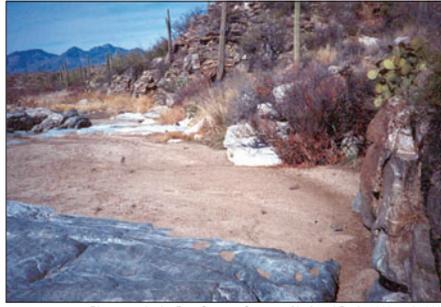
Figure 3. A tinaja in Loma Verde Wash before (left) and several months after (right) the Box Canyon fire of 1999. Within 2 years of the fire, all of the tinajas downstream from this one had filled with sand.

Runoff from the first rains following the Box Canyon fire carried large amounts of ash to ephemeral stream channels of Loma Verde Wash that left the waters in the pools inky black and greatly raised water temperatures. Although the stew of chemicals found in wildfire residue may have had some detrimental effects on the leopard frogs and other aquatic creatures, subsequent flows flushed the ash from the pools and a breeding population continued in the wash. Less than 2 years after the fire, however, a slug of gravel and coarse sand had made its way from the watershed slopes and headwaters into the uppermost pools, burying them to depths of 3 to 6 feet (fig. 3). Within 3 years after the fire, all but a few of the 32 pools in which

leopard frogs had been observed were buried in sediment. All 24 pools that had been identified as breeding pools were buried and remained so as of summer 2005.

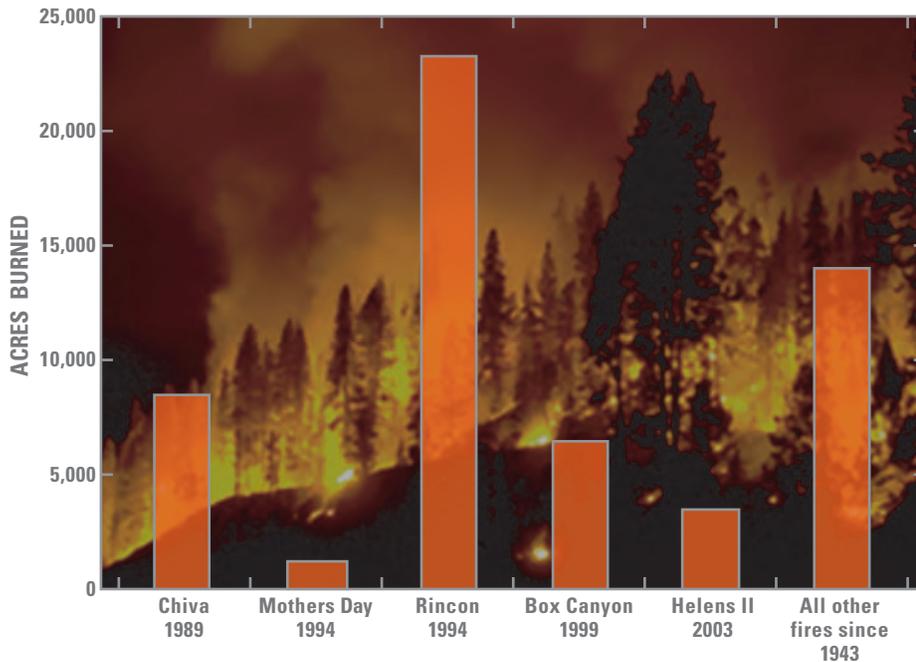
Figure 4. Fire history of Rincon District of Saguaro National Park since 1943.

From 1943 through 2003, at least 40 fires affected over 57,000 acres in and adjacent to Saguaro National Park lands in the Rincon Mountains. Just six fires, however, burned about 92 percent of that total, and nearly 75 percent of the burned acreage was caused by five wildfires after 1988 (fig. 4). Of those recent fires, the Rincon fire of 1994 was by far the largest historical fire, burning about 23,300 acres in the park and in Coronado National Forest lands surrounding the park. Burned acreage is based on the perimeter of the fire area and may include sizeable swaths of vegetation that are untouched by fire as well as many individual trees and other plants that are lightly burned and survive.

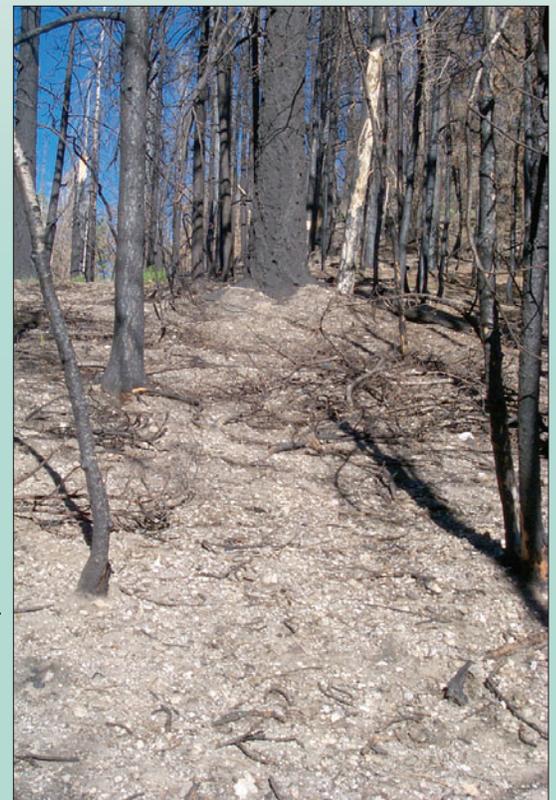
Figure 5. Mixed conifer forest on the north slope of Mica Mountain was destroyed by the Helens II fire in 2003.

near-total destruction on many stands of Ponderosa pine and other conifers (fig. 5); however, other stands within the fire area were virtually untouched and many trees survived the fire despite charring of trunks and branches.

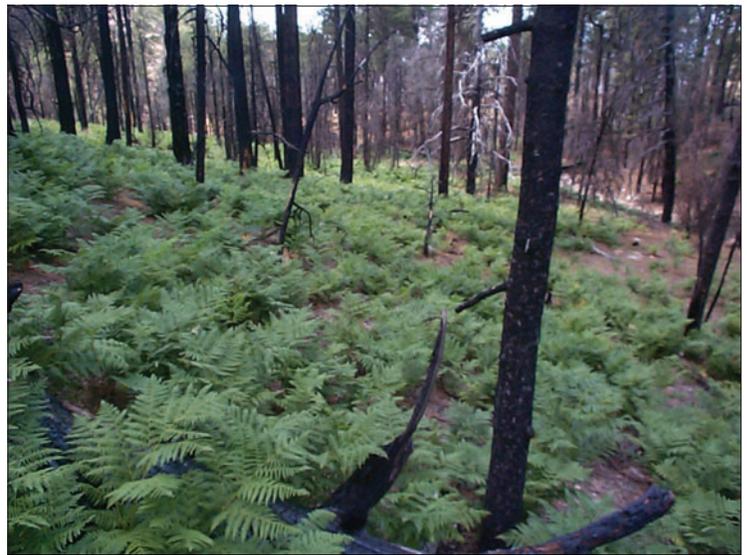
Figure 6. Bracken fern in the Helens II burn area on Mica Mountain has begun to stabilize soils on hillslopes two years after the fire, July 2005.

of Joaquin Canyon below the burn area. The next visit took place in July 2005, following a slightly wetter than average winter. Fresh rills and gullies were noted on some of the steeper slopes in the burn area as well as small debris flows on some slopes. Debris flows are mass movements consisting of a slurry of water and sediment in which the sediment transported can range from the smallest clay, silt, and sand particles to boulders. On other slopes, however, dense stands of bracken fern appear to have begun stabilizing areas that had been subject to sheetwash erosion and some rill development in the first year after the fire (fig. 6).
