# 1976 Big Thompson Flood, Colorado

General Information Product 35

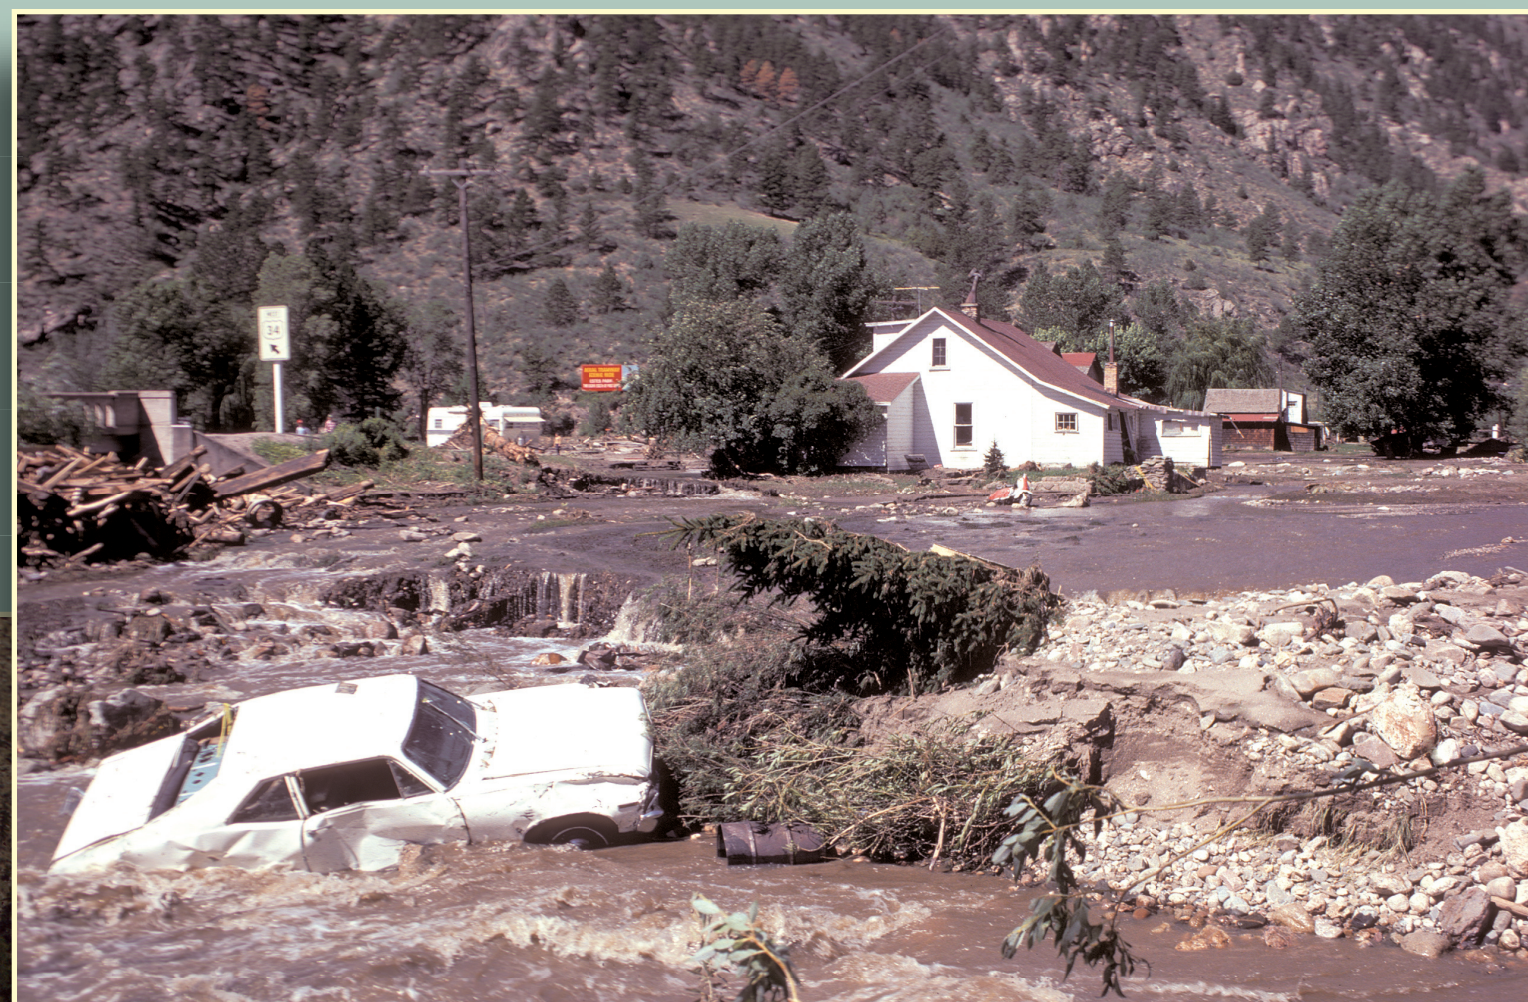
Damaged car and house at the confluence of the North Fork Big Thompson and Big Thompson Rivers in Drake.

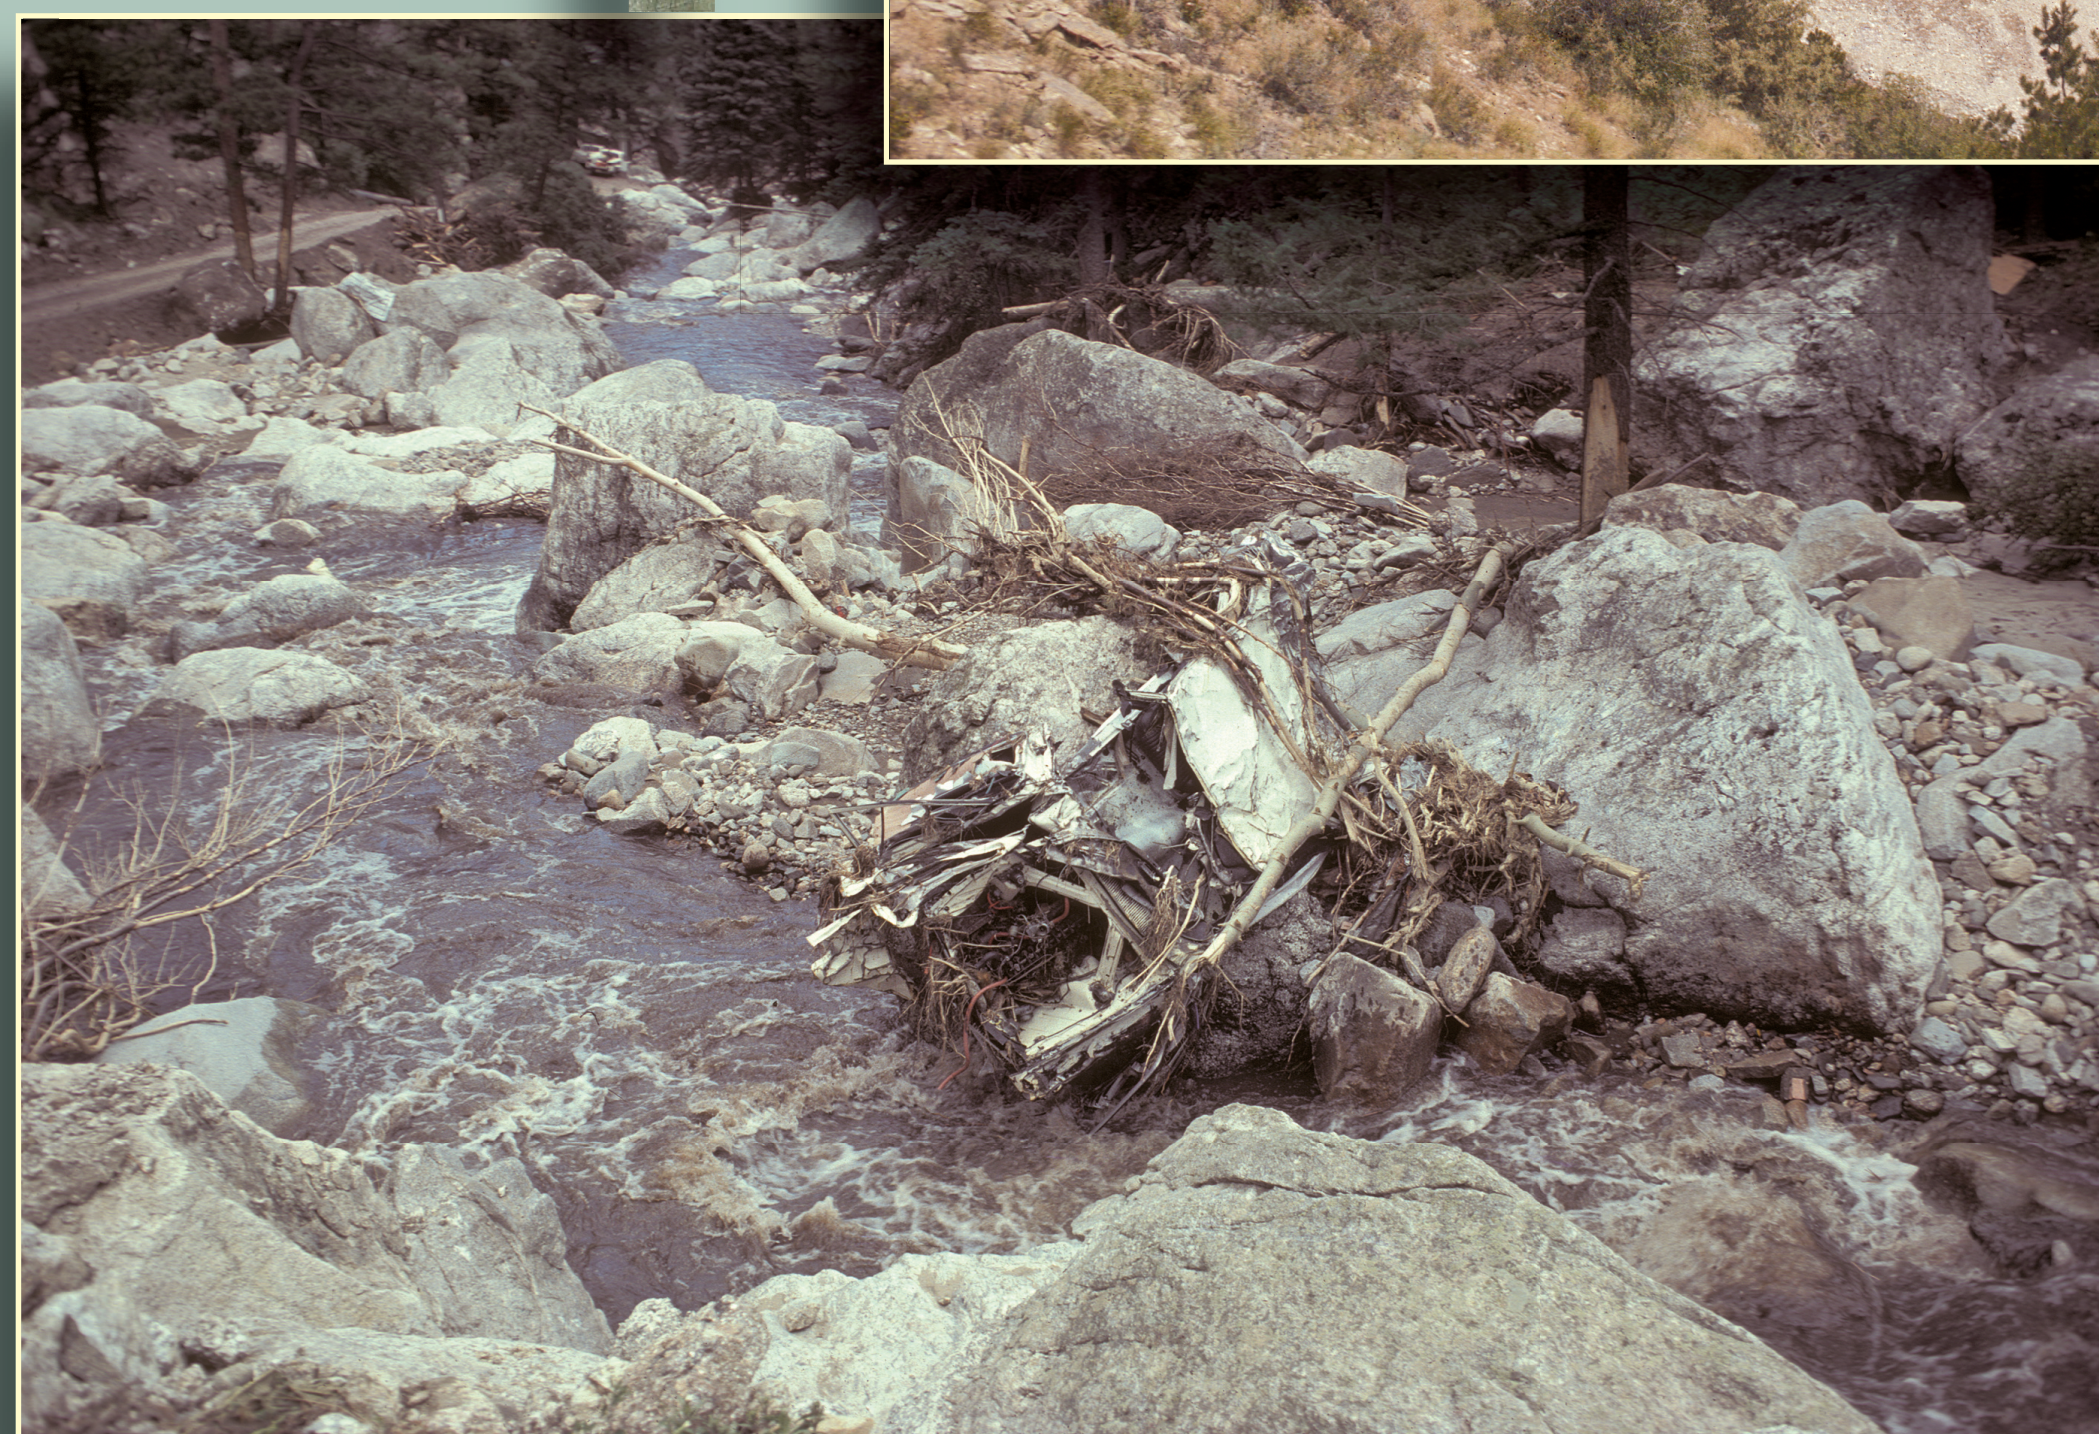
Remains of an automobile flattened and wrapped around a large boulder in the North Fork Big Thompson River about 4.5 miles upstream from Drake. Flow is from right to left. The U.S. Army Corps of Engineers removed 197 flood-damaged vehicles in the North Fork Big Thompson and Big Thompson Rivers.

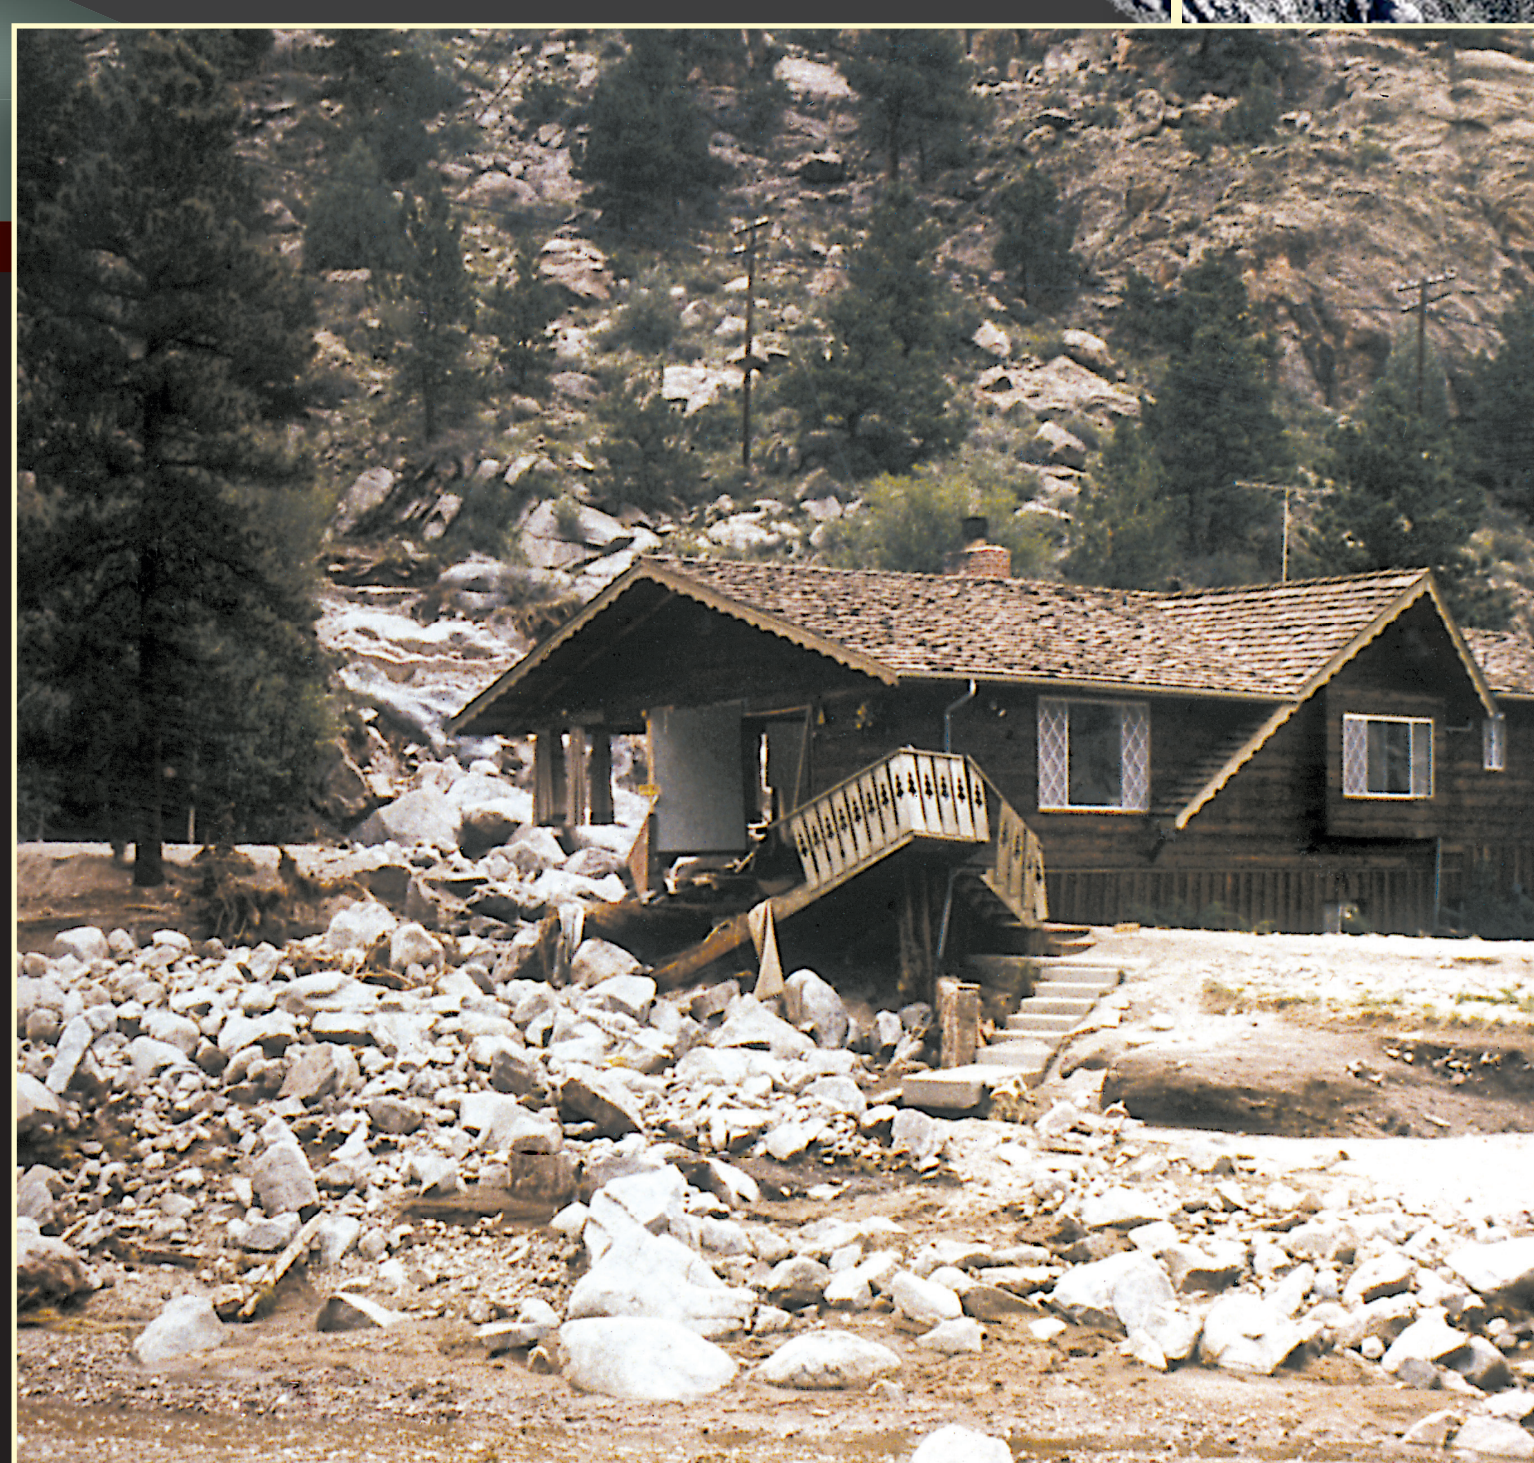
This house was built on an alluvial fan that was produced by sediment discharged from a side canyon. Floodwaters from the side canyon crushed part of the house and pushed it about 4 feet off its foundation. Mile 91.1, Big Thompson River.

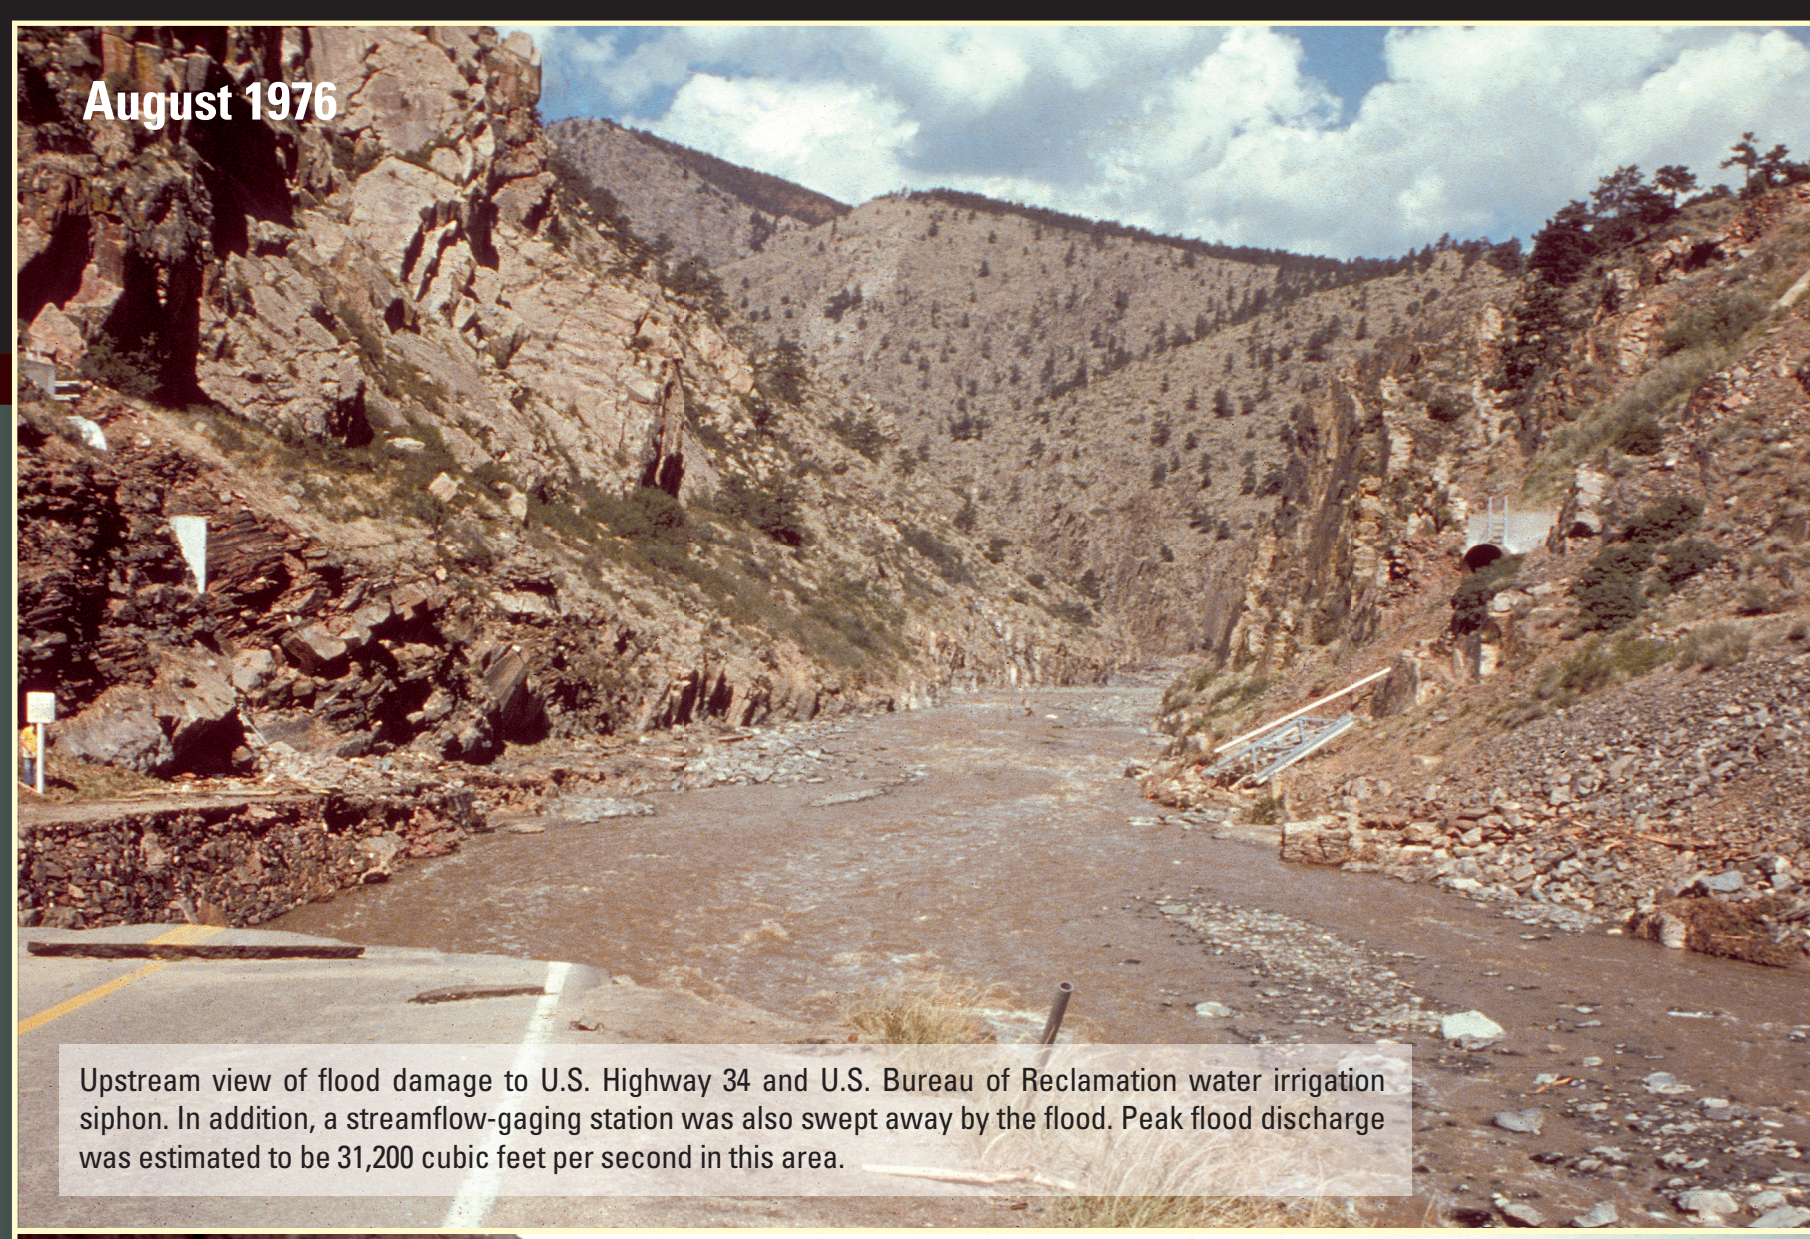
Upstream view of flood damage to U.S. Highway 34 and U.S. Bureau of Reclamation water irrigation siphon. In addition, a streamflow-gaging station was also swept away by the flood. Peak flood discharge was estimated to be 31,200 cubic feet per second in this area.

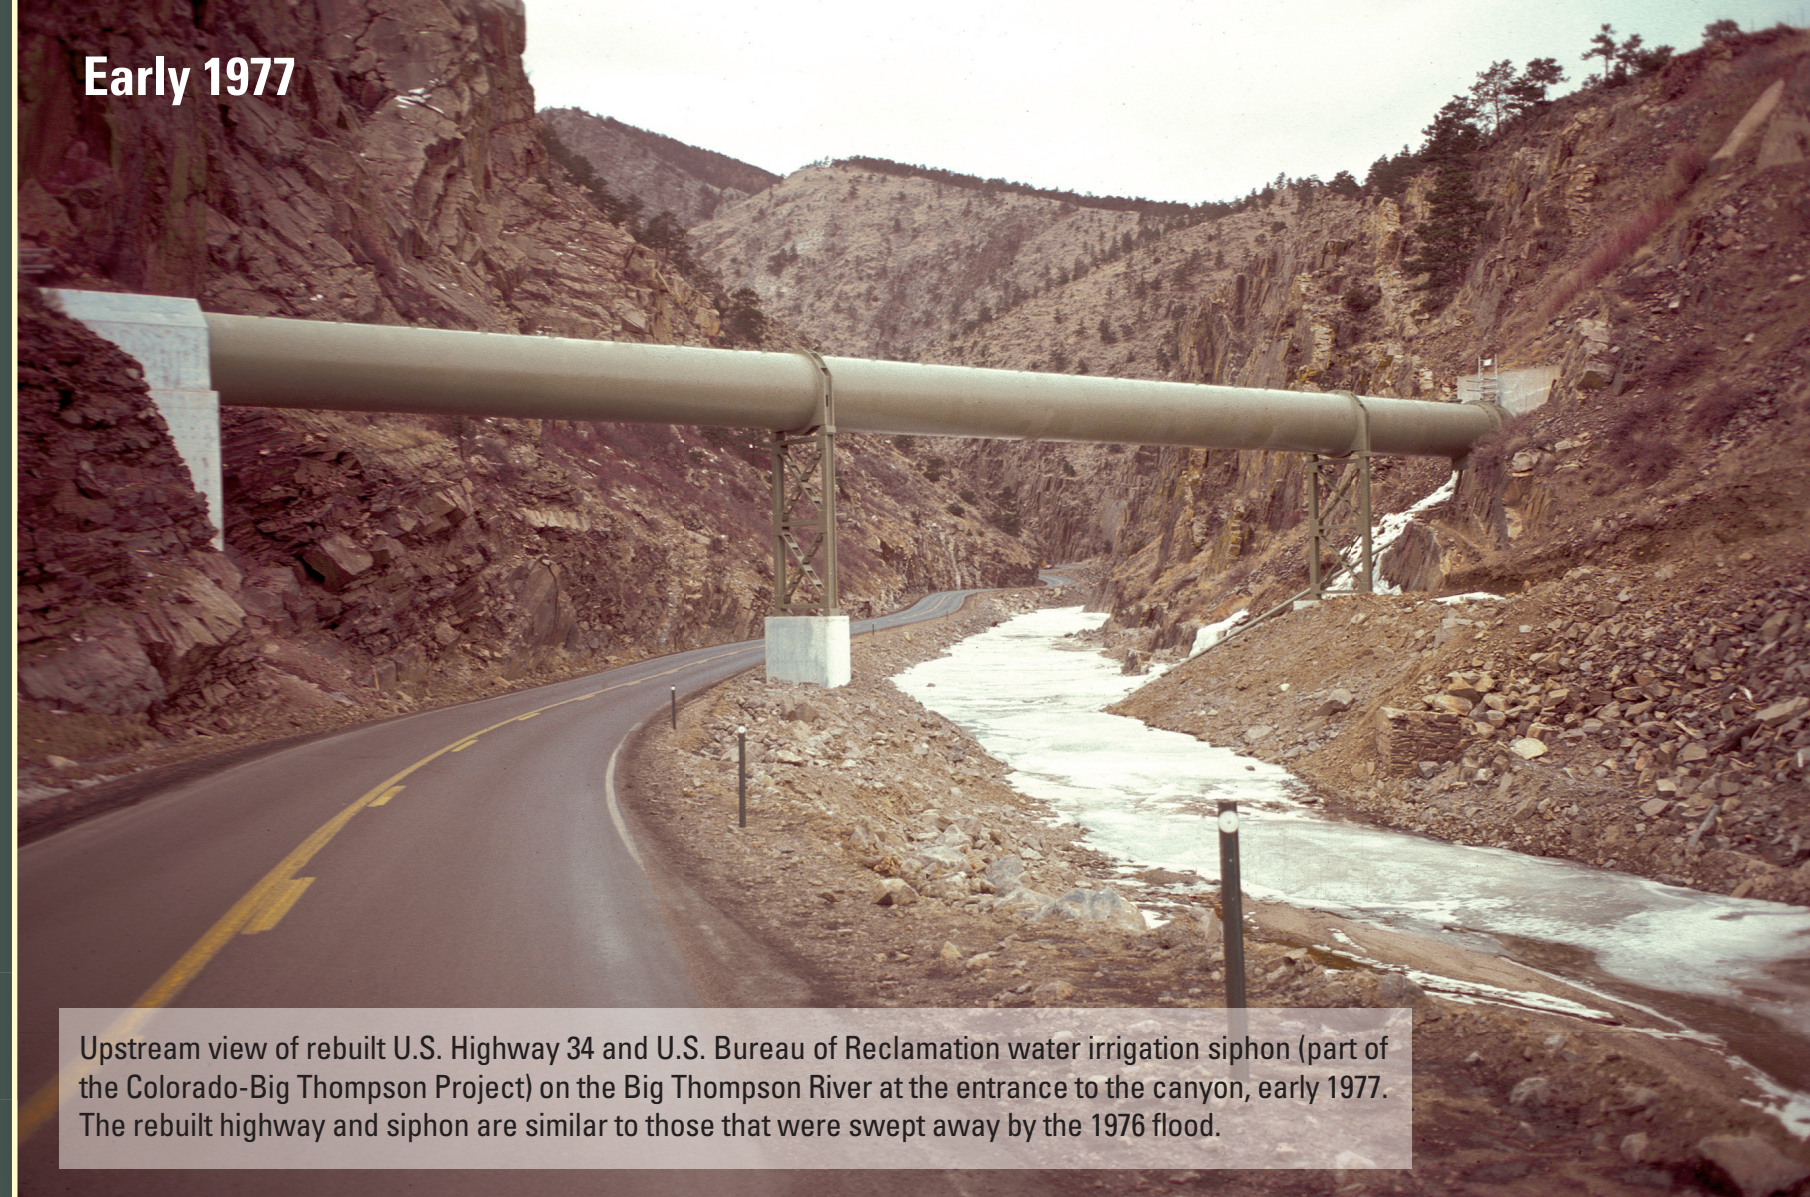
Upstream view of rebuilt U.S. Highway 34 and U.S. Bureau of Reclamation water irrigation siphon (part of the Colorado-Big Thompson Project) on the Big Thompson River at the entrance to the canyon, early 1977. The rebuilt highway and siphon are similar to those that were swept away by the 1976 flood.

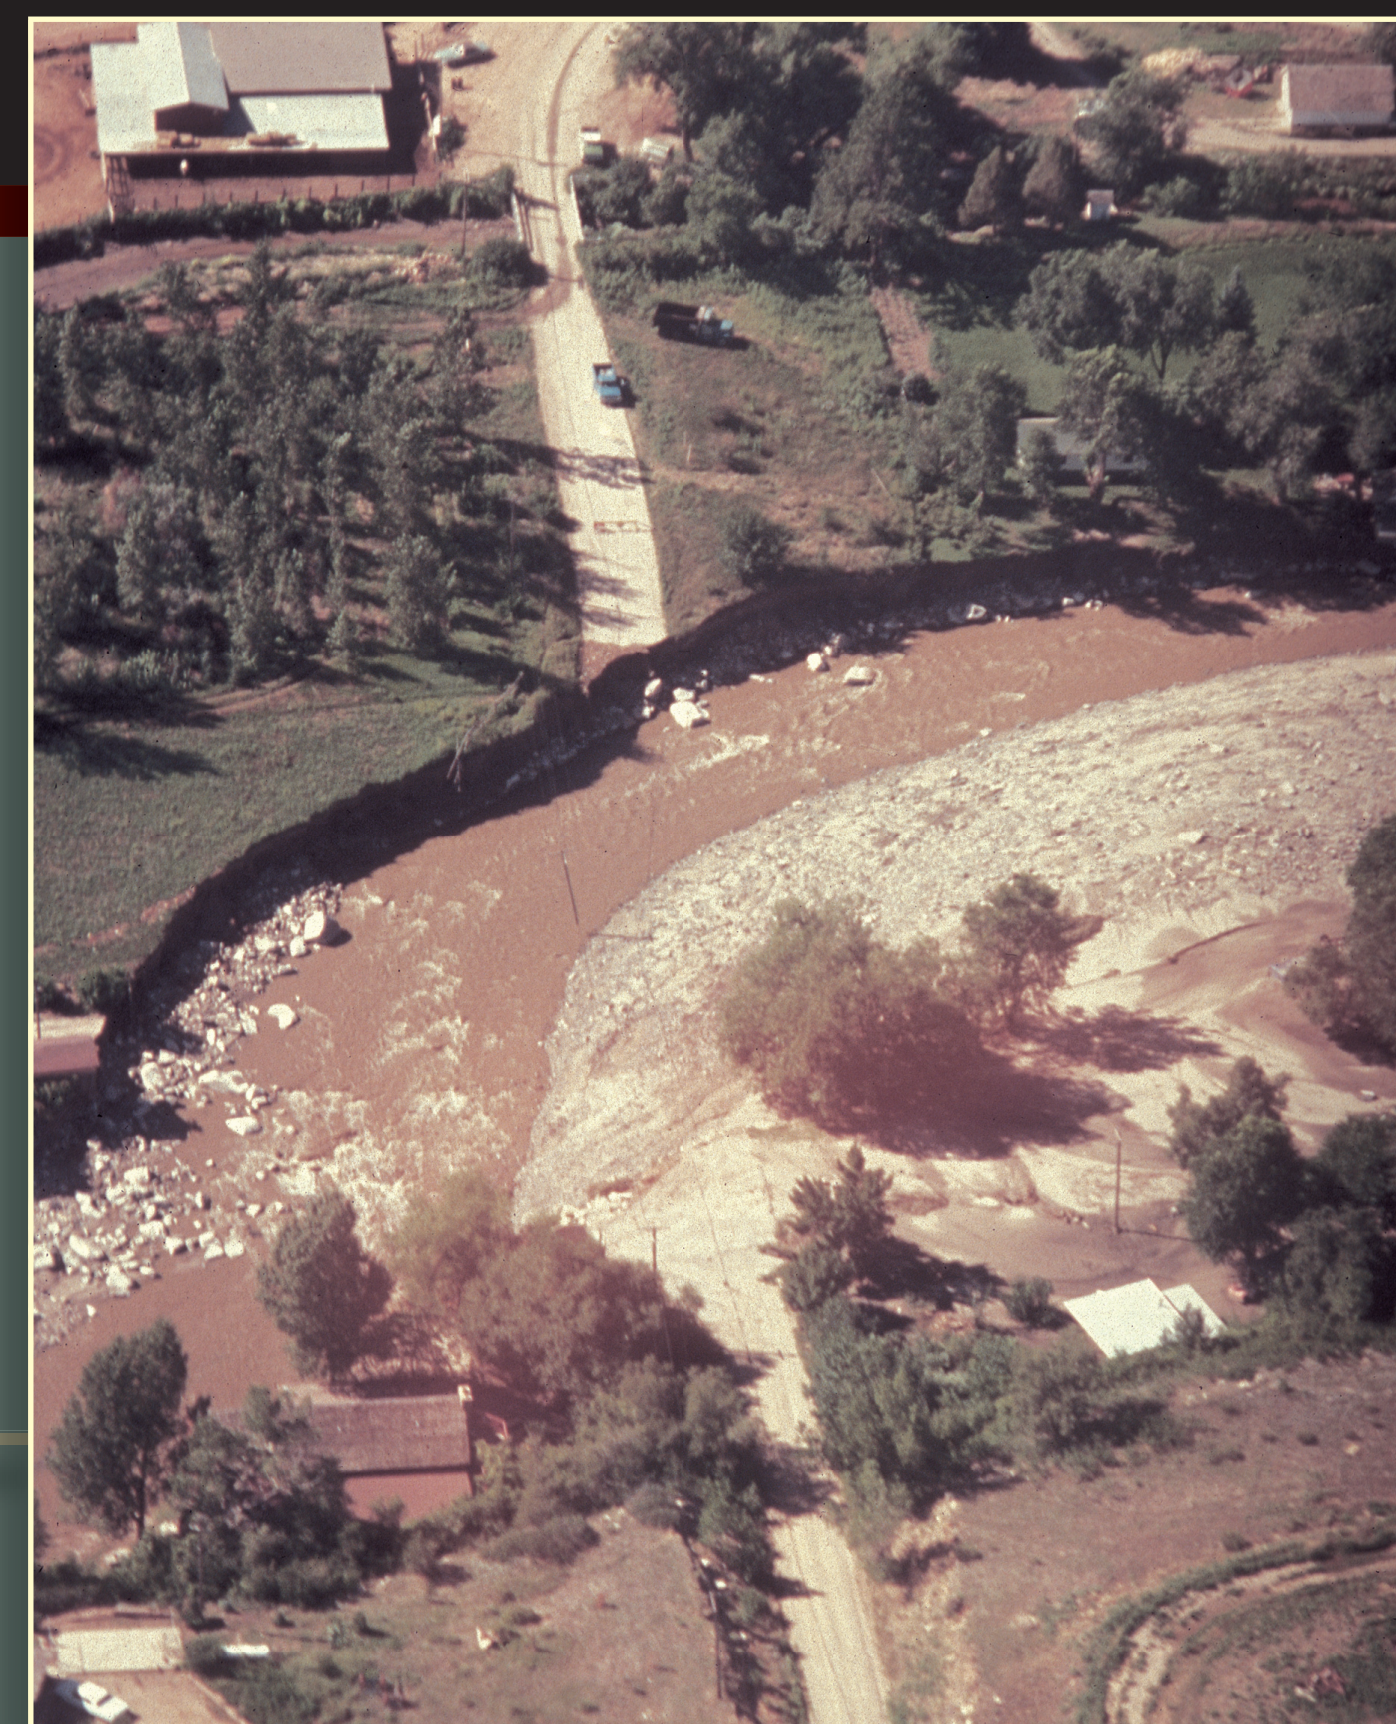
Bridge washed out on the Big Thompson River near Loveland as seen from a helicopter. Flow is from right to left.

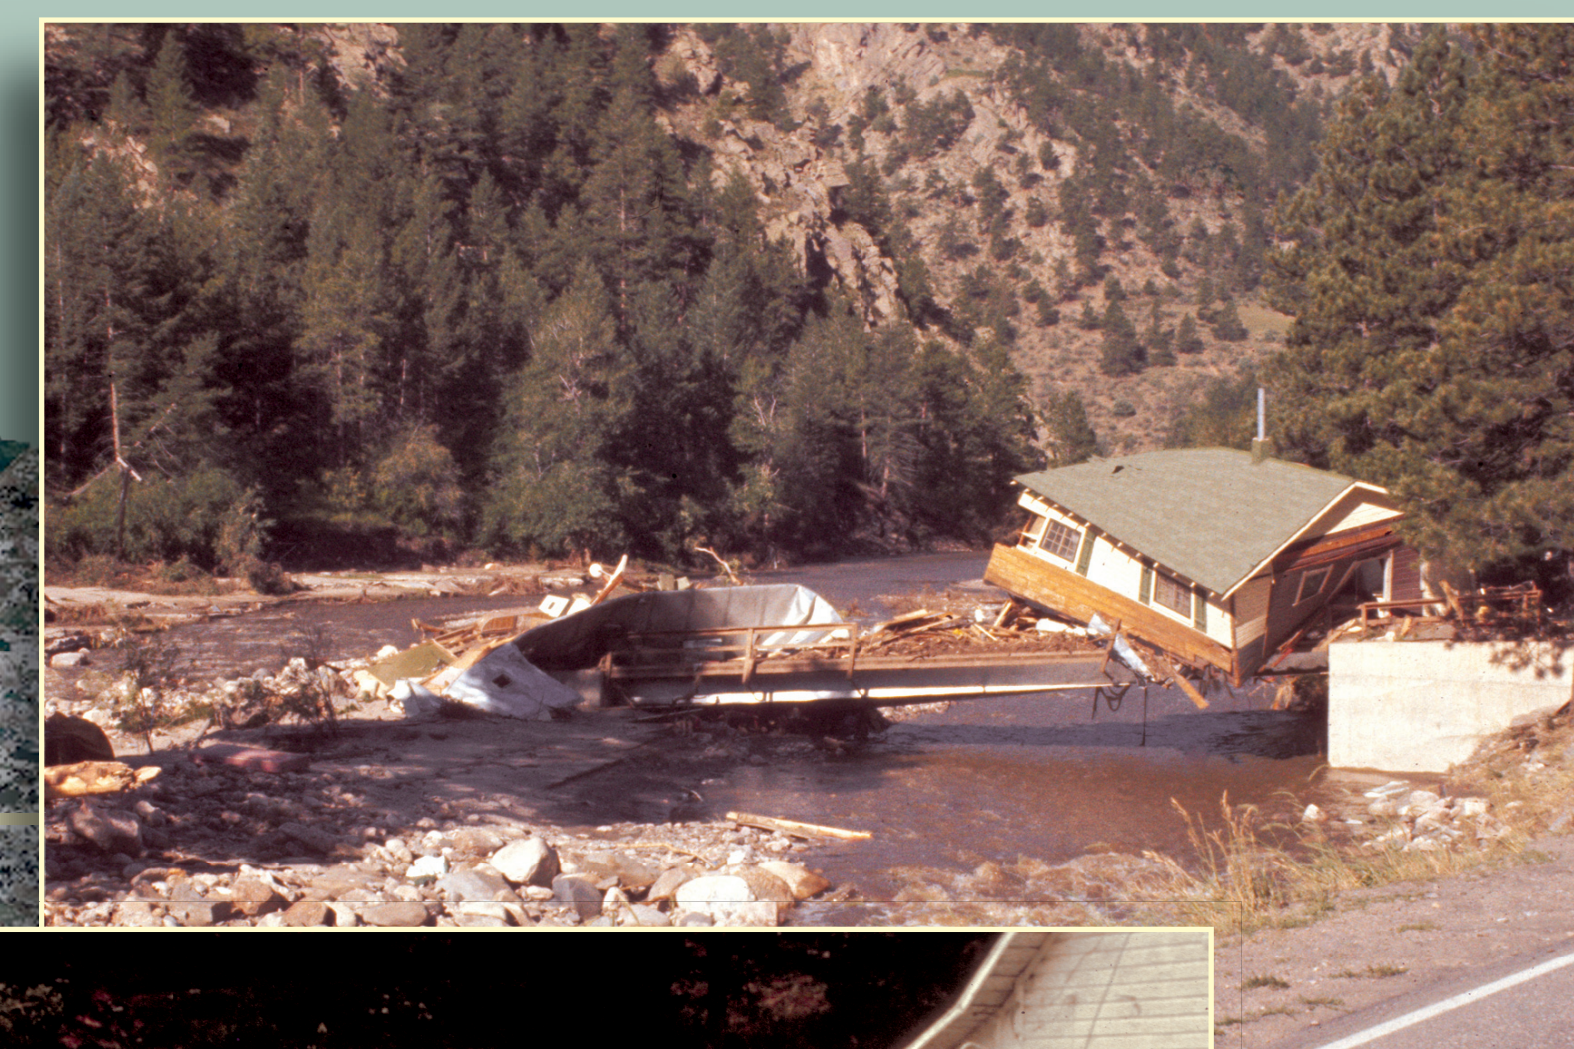
Upstream view of flood-displaced house that is lodged on a bridge. About 0.5 mile downstream from Drake. Peak flood discharge was estimated to be 30,100 cubic feet per second in this area.

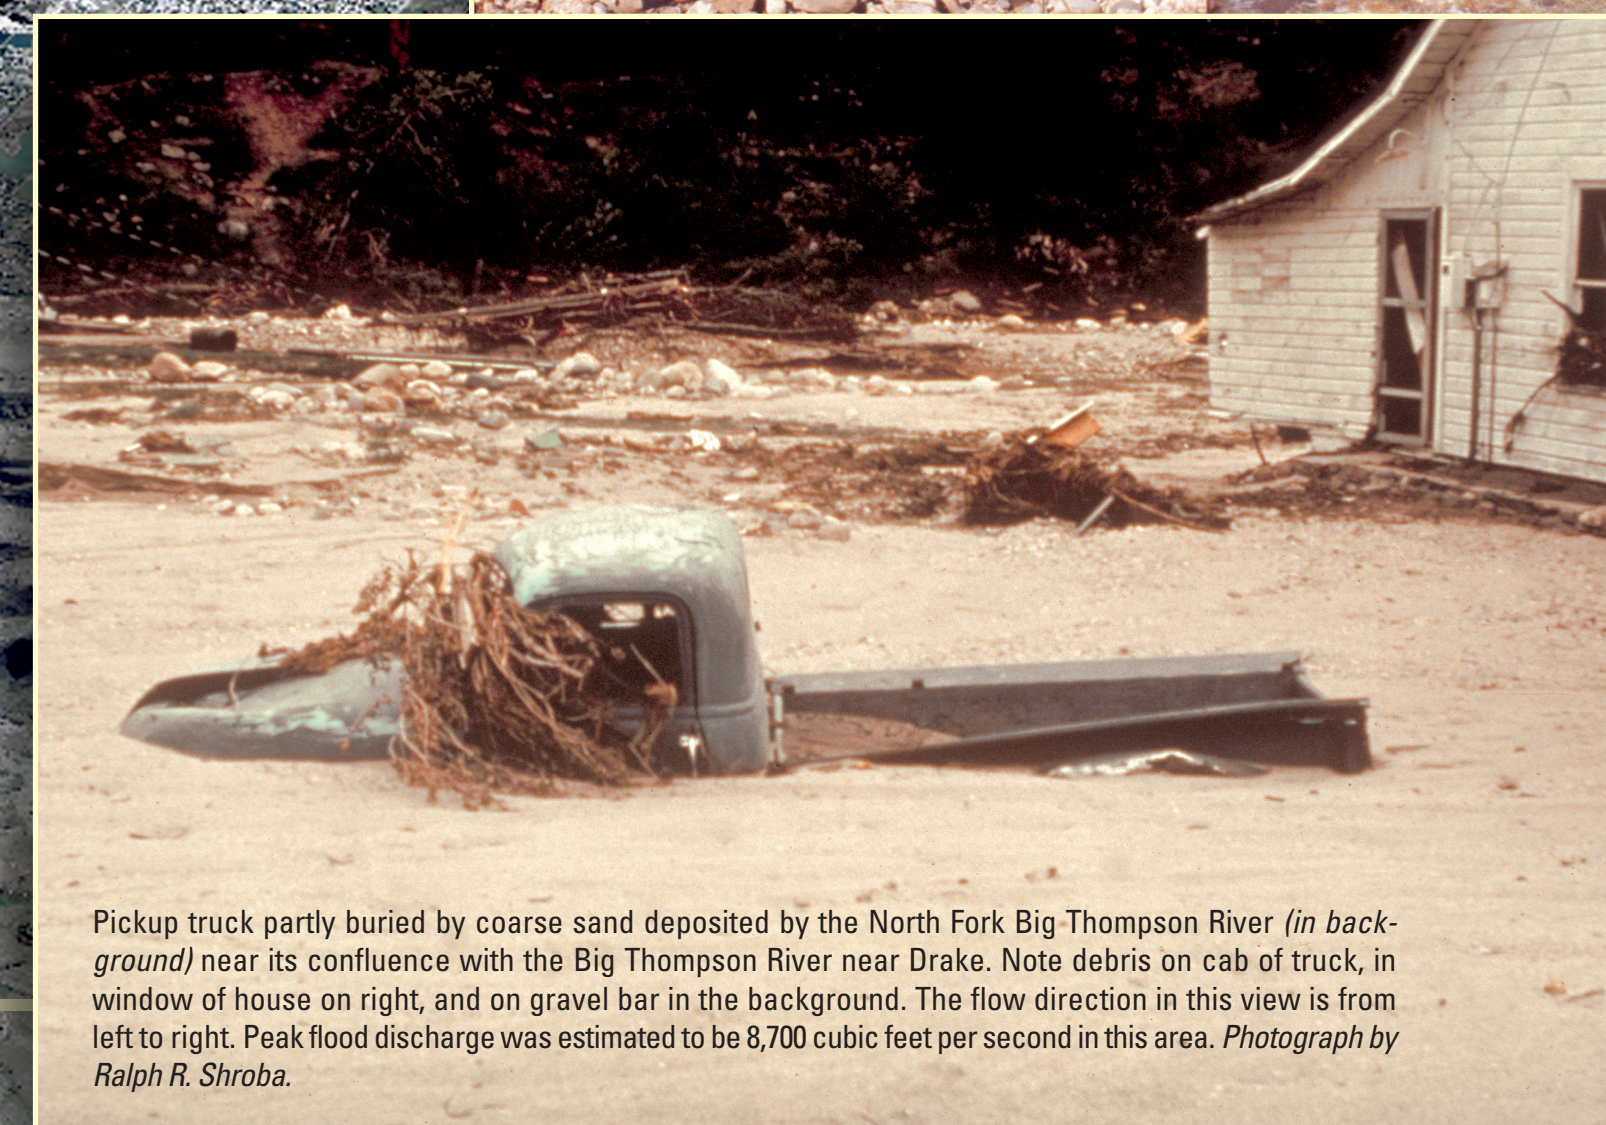
Pickup truck partly buried by coarse sand deposited by the North Fork Big Thompson River (in background) near its confluence with the Big Thompson River near Drake. Note debris on cab of truck, in window of house on right, and on gravel bar in the background. The flow direction in this view is from left to right. Peak flood discharge was estimated to be 8,700 cubic feet per second in this area. Photograph by Ralph R. Shroba.

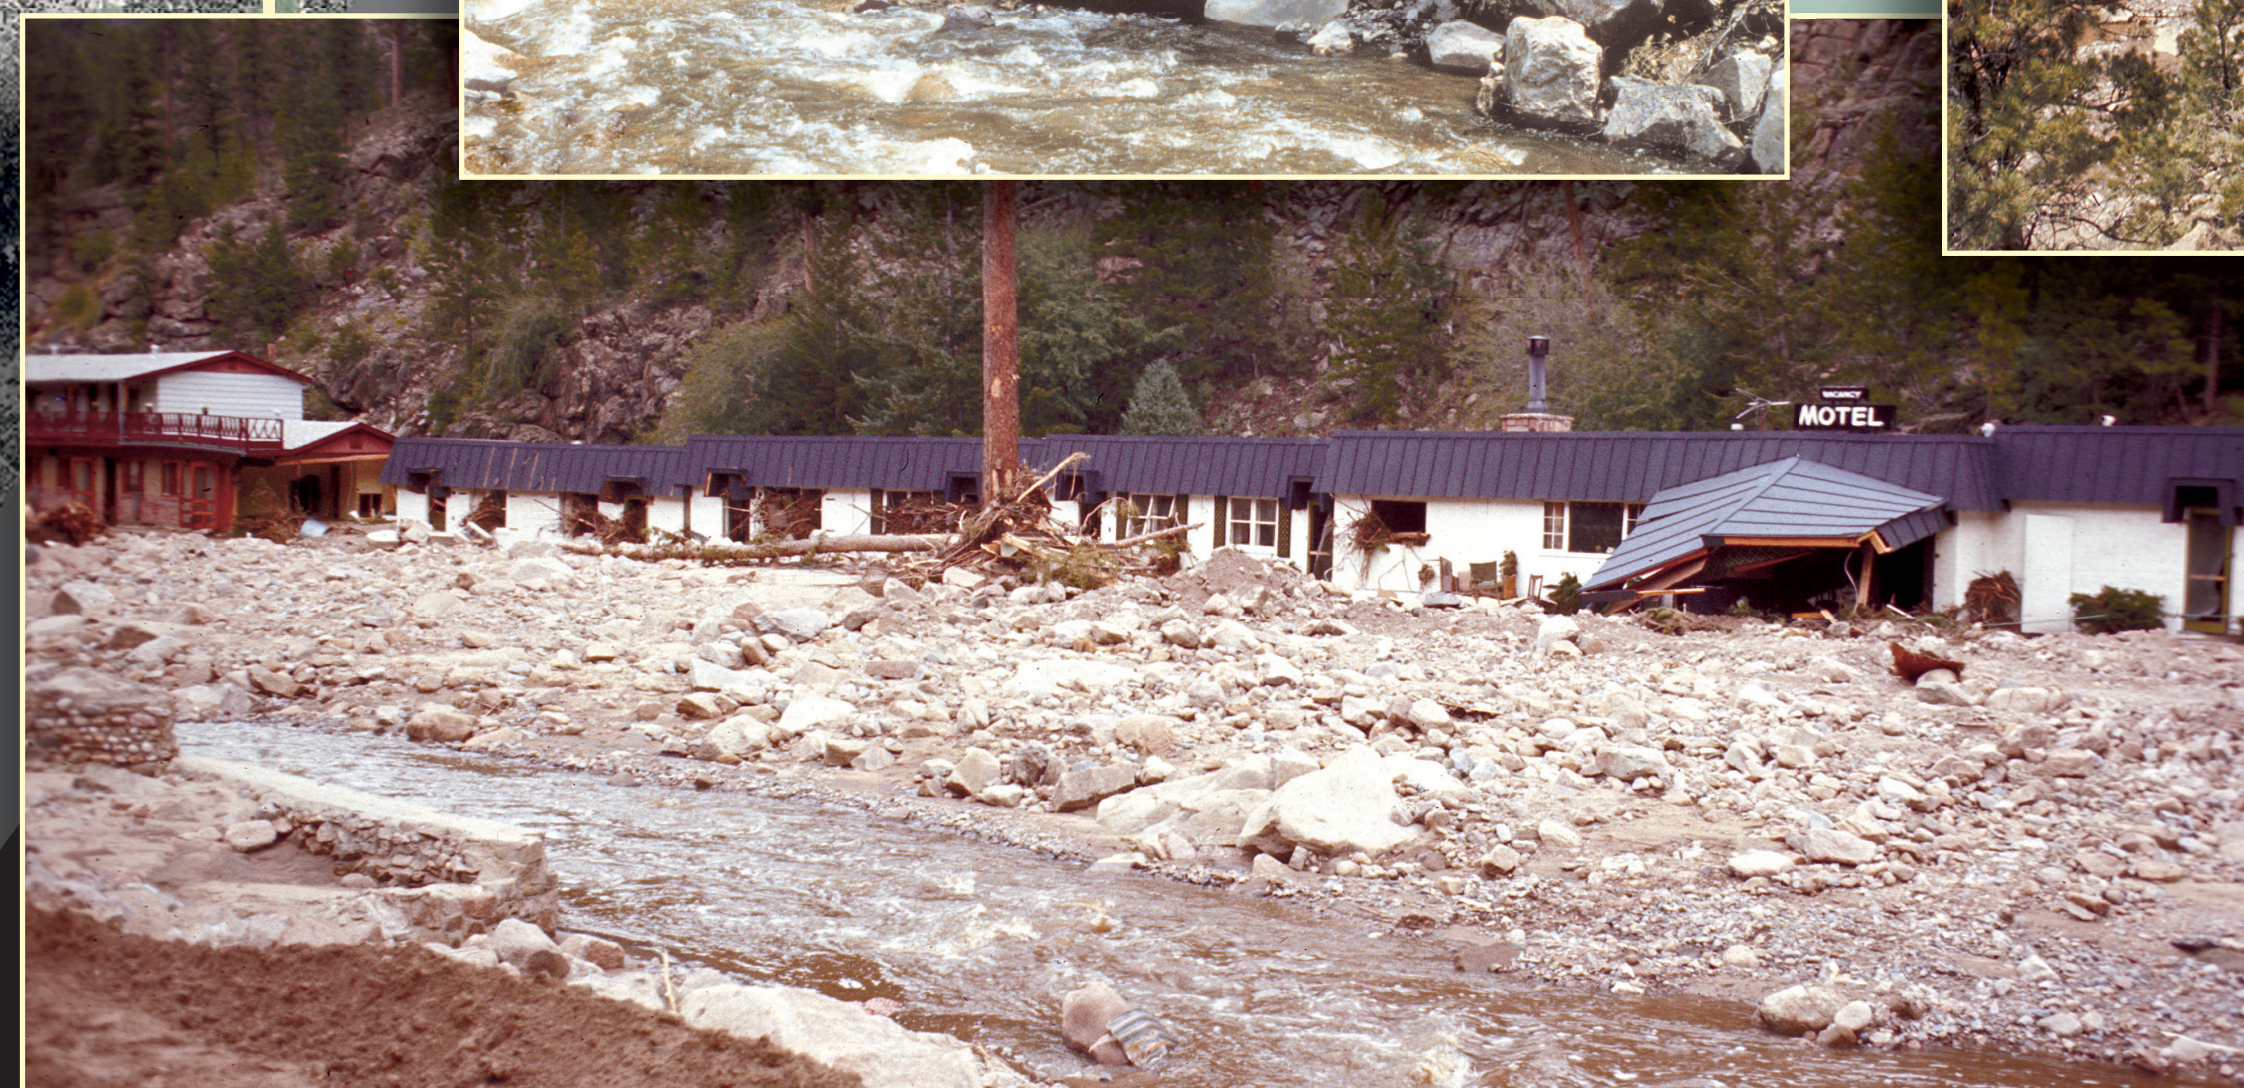
Downstream view of damaged Nihart Motel on the Big Thompson River near Glen Comfort.
