MAN AGAINST VOLCANO:

**THE
ERUPTION
ON
HEIMAEY,
VESTMANN ISLANDS,
ICELAND**

UNITED STATES
DEPARTMENT OF THE INTERIOR
GEOLOGICAL SURVEY

USGS: INF-75-22

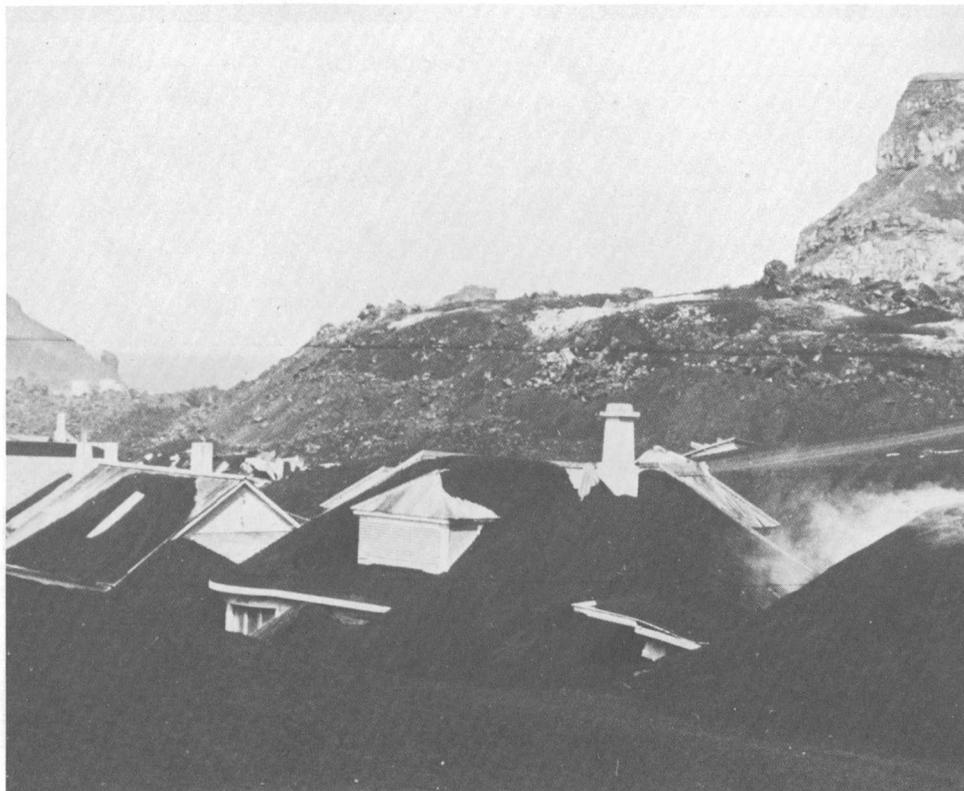
View on July 23, 1973, north across homes partially buried by tephra in the eastern part of Vestmannaeyjar. The lava flow looms in the background. Cases that are moving through the tephra rise from the house on the right. The houses will eventually be exhumed and restored.

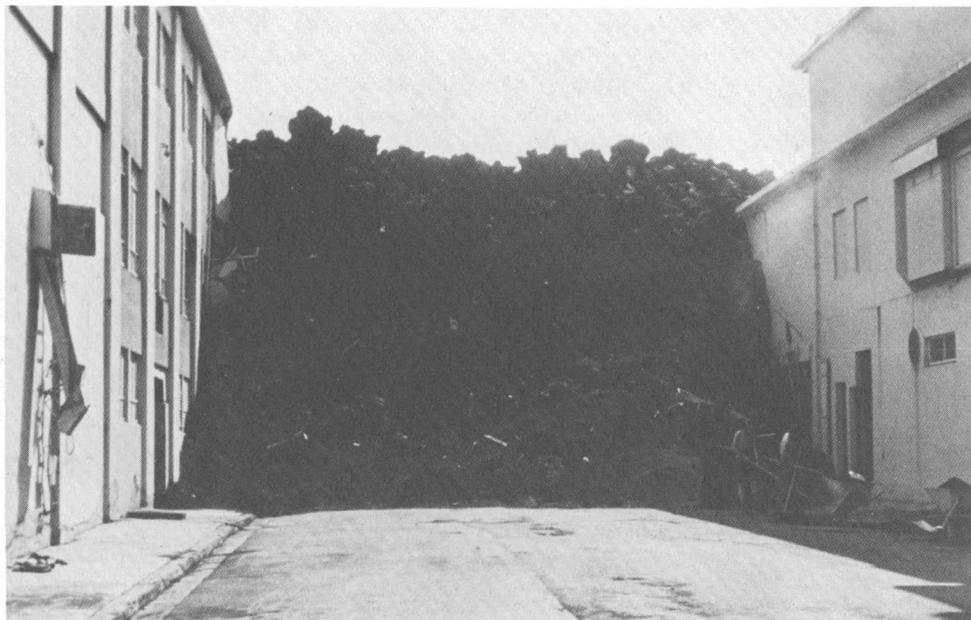
View on July 23, 1973, southeast from dock area in the northern part of Vestmannaeyjar toward edge of lava flow where it stopped against and between two fish-factory buildings. Two boys can be seen in the right background sweeping up the tephra. By July 1974 the lava had been completely removed and restoration of the factories had begun.

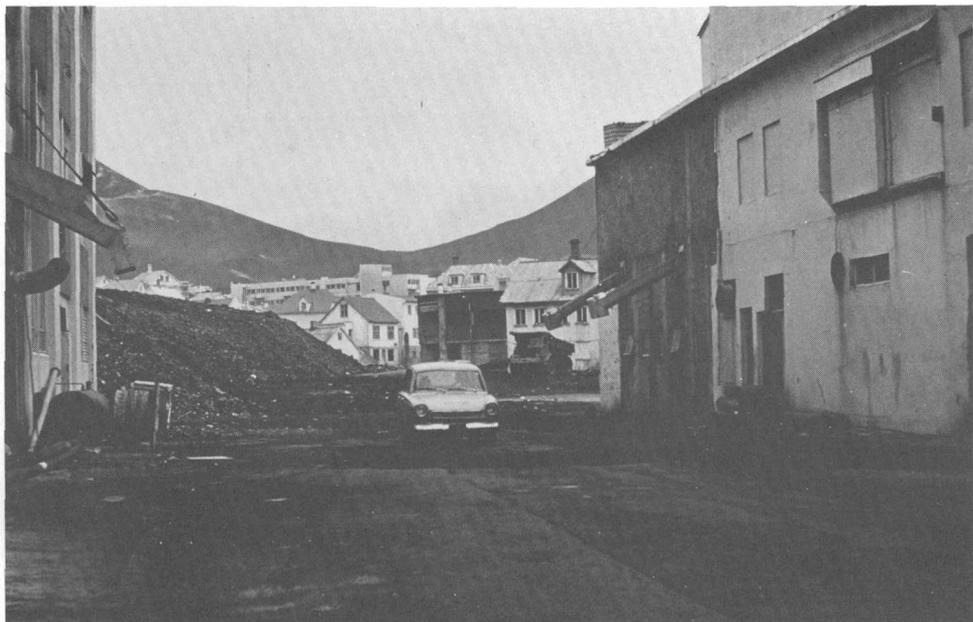
View on July 7, 1974, southeast from dock area in the northern part of Vestmannaeyjar after removal of lava flow which had stopped against and between two fish-factory buildings.

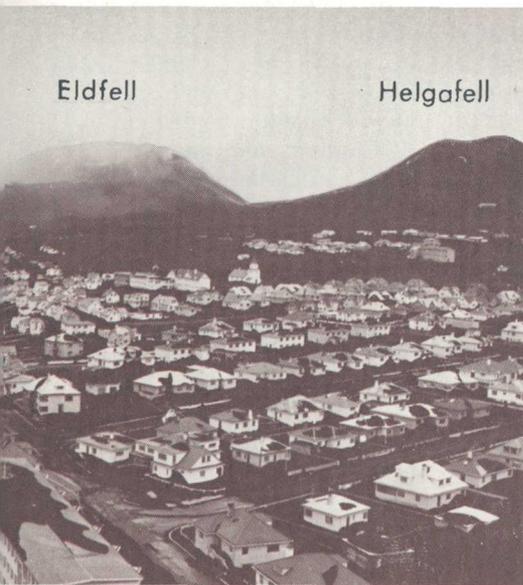
Part of northeastern Heimaey and the eastern part of the town of Vestmannaeyjar showing deployment of pipes along northwestern edge of new lava flows on April 15, 1973, and access roads (dashed lines) bulldozed onto and through the lava field. Intake pumps are positioned along two harbor piers. (Modified from Jónsson and Matthíasson, 1974.)

Water was pumped directly on the flow front at sea level and was also pumped through a number of primary plastic pipes. Each main pipe was branched into a series of smaller pipes. In addition, a large steel pipe was used. More than 19 miles of pipe (75 percent plastic) and 43 pumps were eventually employed in the cooling program.

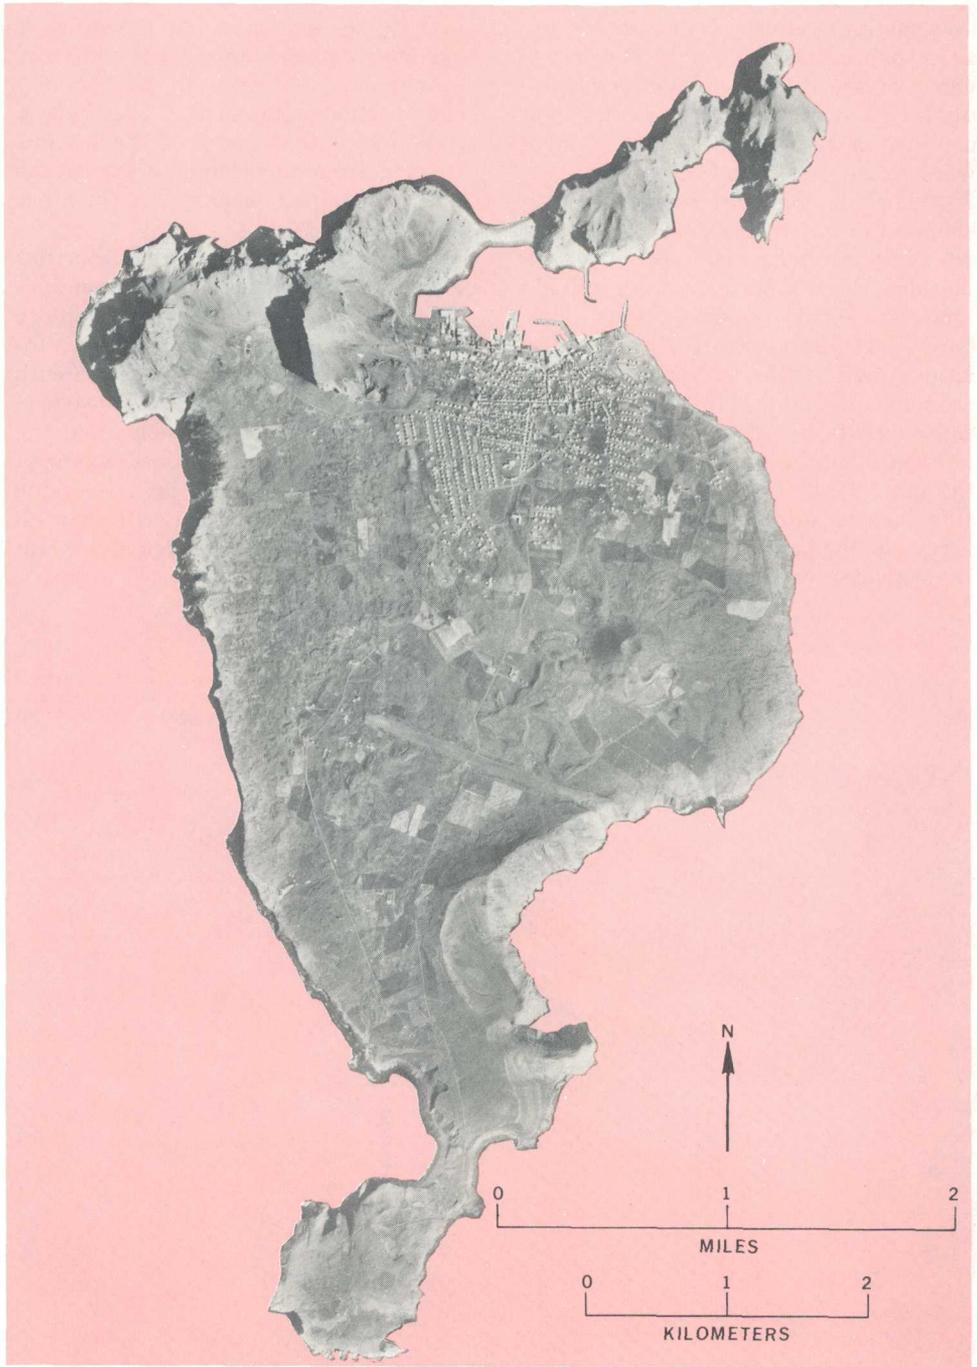
Vertical aerial photograph taken on August 4, 1960, of the island of Heimaey, Vestmann Islands, Iceland, showing the fishing port of Vestmannaeyjar, the crater of Helgafell Volcano, and the single airstrip. (U.S. Air Force.)

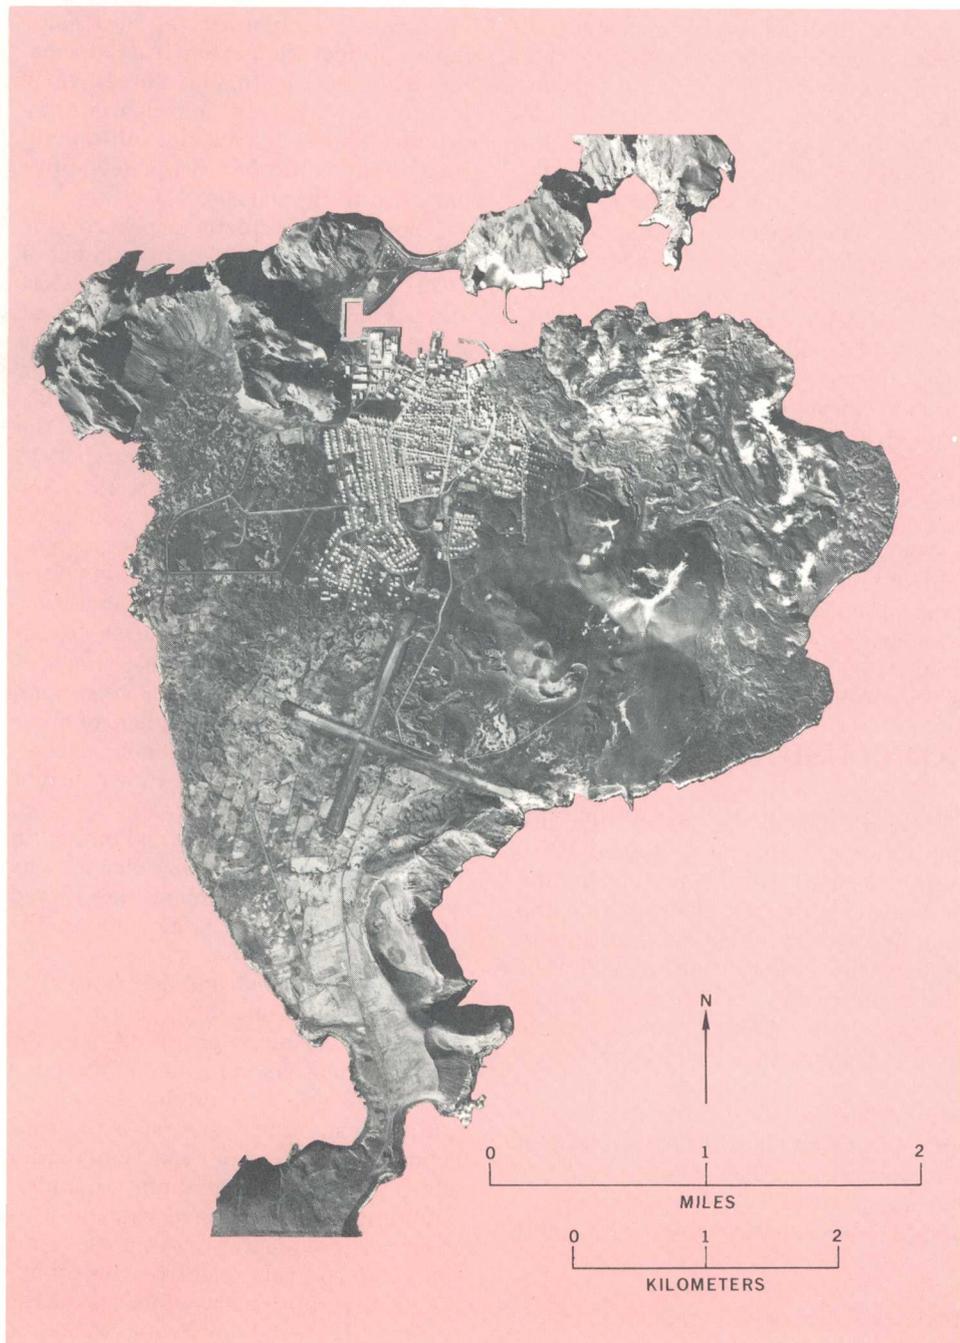
Vertical aerial photograph taken on September 8, 1973, of the island of Heimaey, Vestmanna Islands, Iceland, showing the fishing port of Vestmannaeyjar, the craters of Helgafell and Eldfell Volcanoes, the double airstrip, and the new land on the east. (Icelandic Geodetic Survey.)
