## FLOODS IN THE GUAYANILLA-YAUICO AREA, PUERTO RICO

By  
Fred K. Fields  
1971

### FLOODS IN THE GUAYANILLA-YAUICO AREA, PUERTO RICO

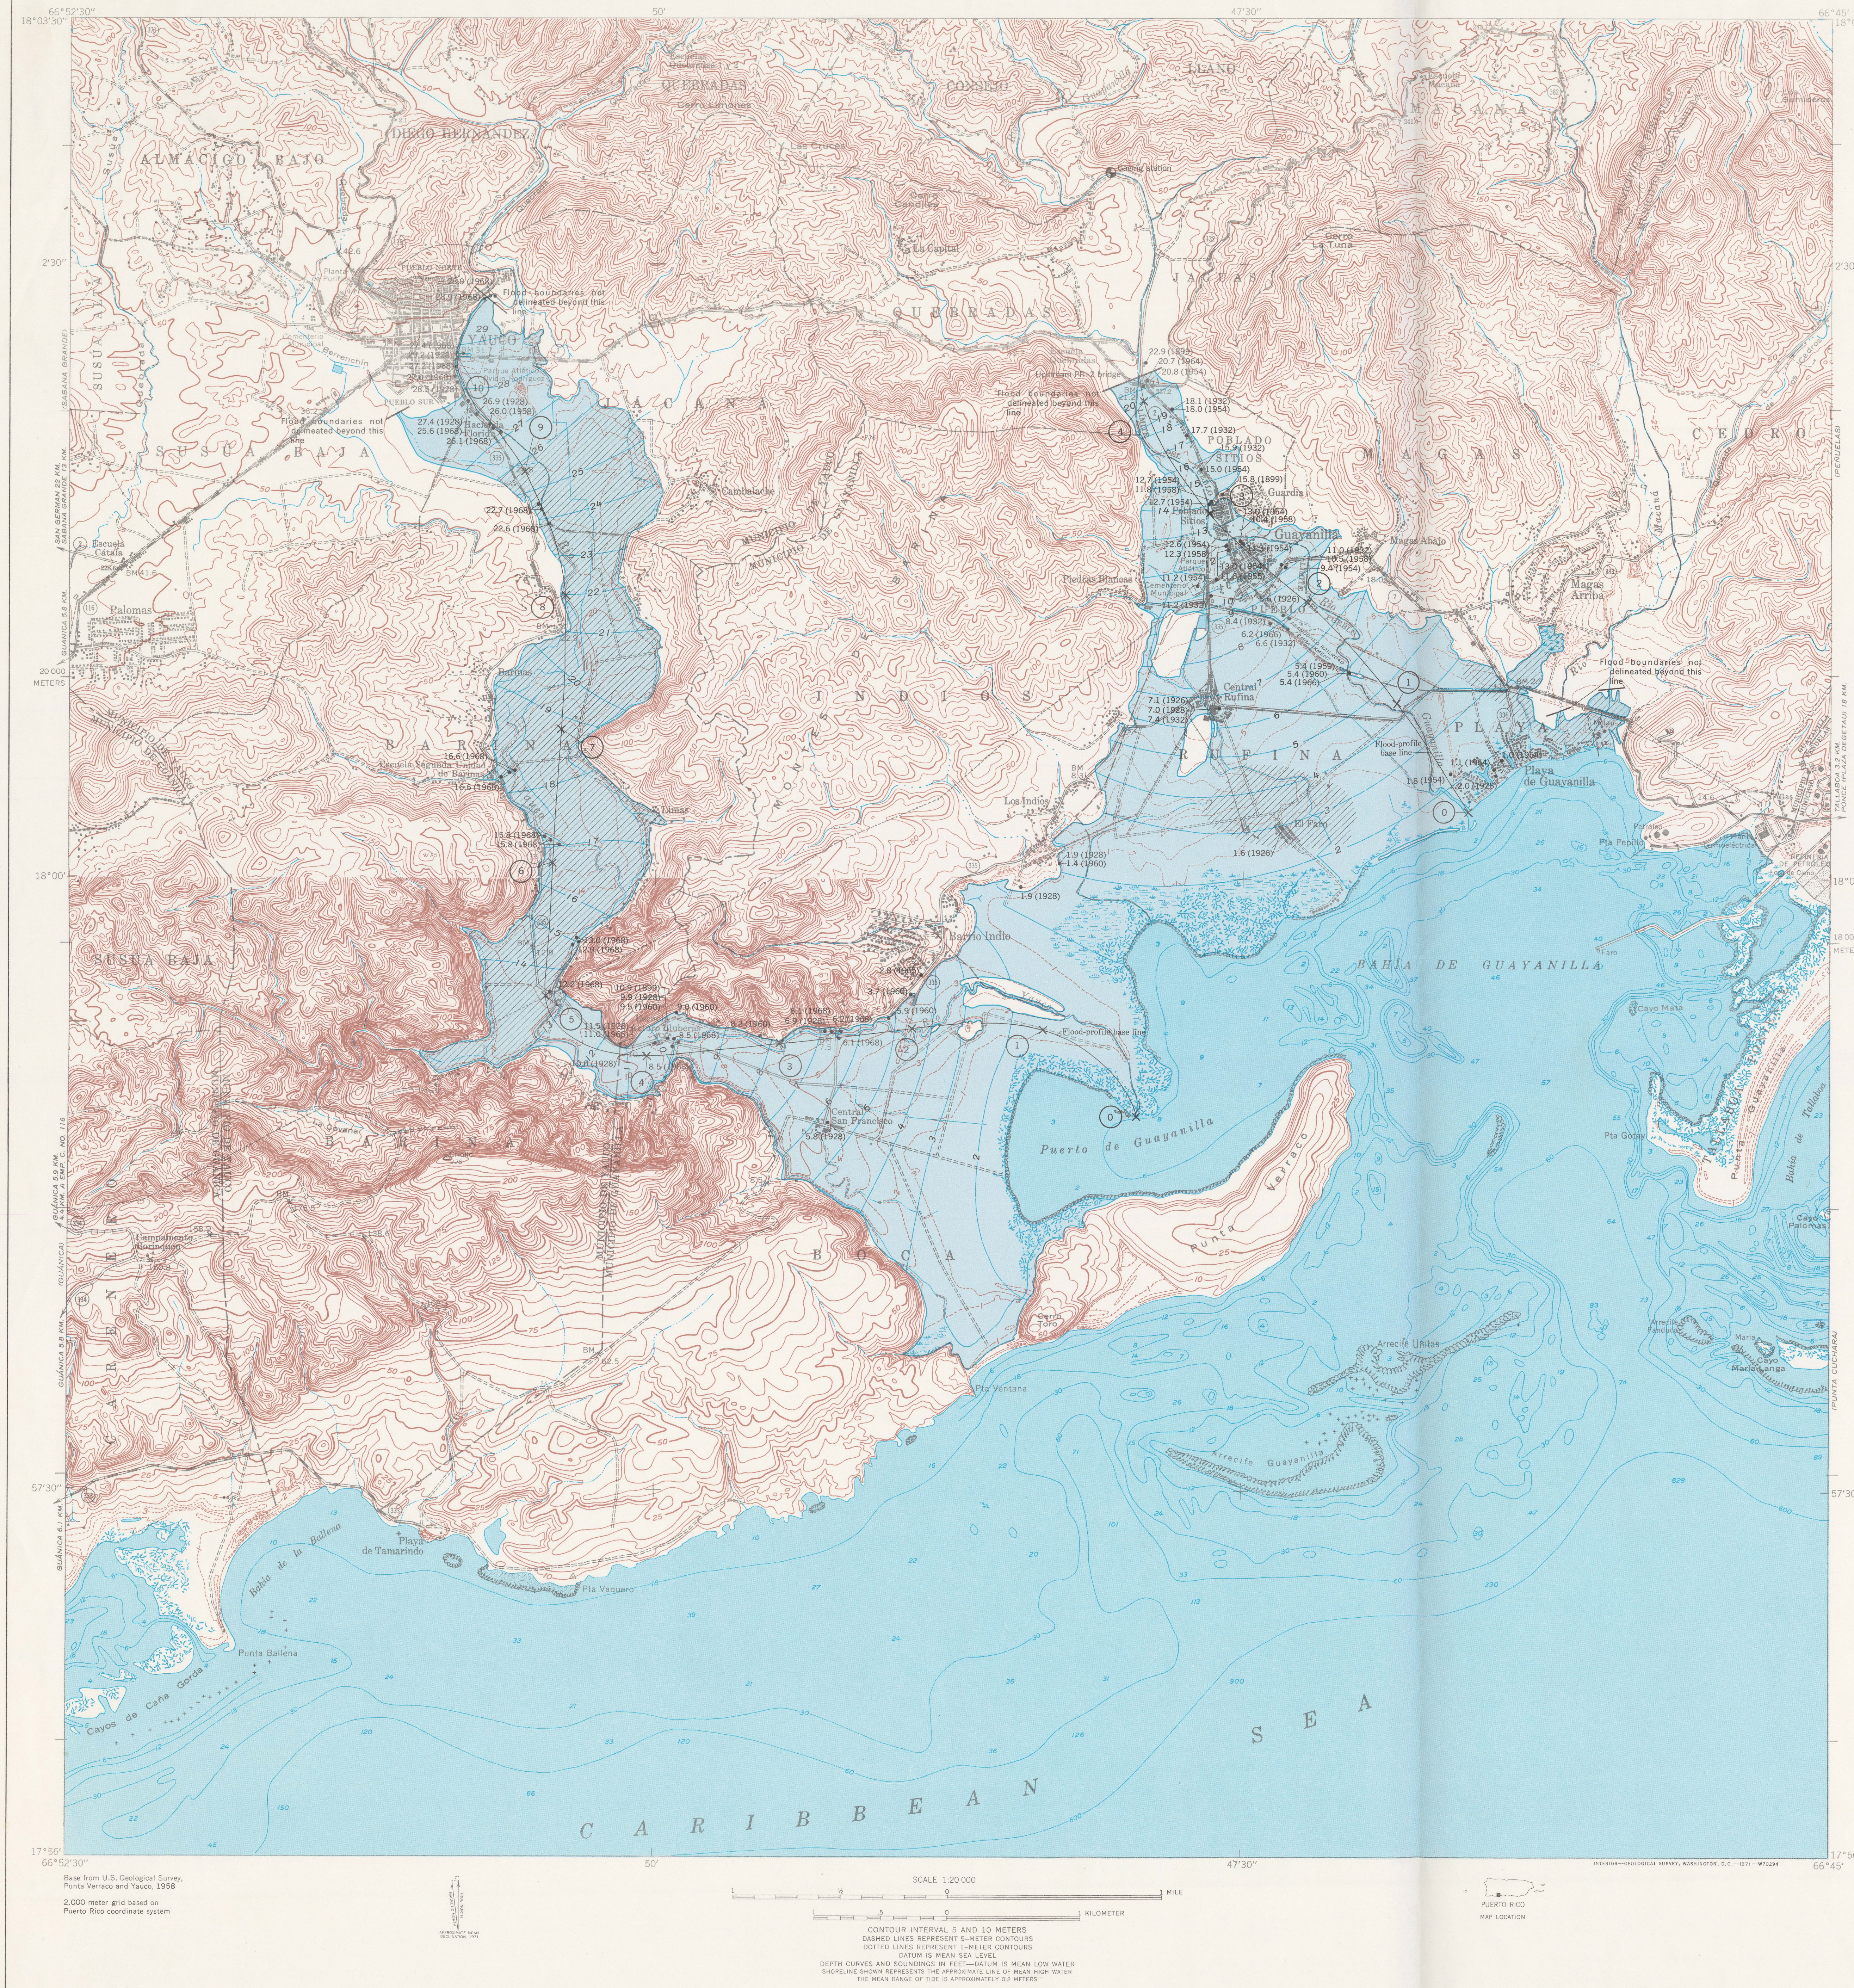
- Flood of September 15, 1928, patterned where estimated
- Boundary of 1928 flood, dashed where estimated
- Kilometers upstream from mouth measured along profile base line
- Estimated water-surface elevation for 1928 flood; contour interval 1 meter. Water-surface contour not determined below elevation of 2 meters. Datum is mean sea level.
- Floodmark elevation, in meters above mean sea level, and year of flood

**Inundated area.**—The area inundated by Rio Yauco during the 1928 flood is shown on the topographic map. The delineated boundary reflects the channel and flood-plain conditions at the time of the 1928 flood. No attempt was made to ascertain the effect of later changes in the channel and flood plain, or in runoff characteristics.

**Water-Surface Elevations.**—The estimated water-surface contours of the September 13, 1928, flood for both basins and of the 1932 and 1954 floods at Guayanilla are shown on the topographic maps.

**Depth of Flooding.**—Depth of flooding at any point may be estimated by subtracting the ground elevation from the water-surface elevation. Each is shown by contours on the map. Intermediate estimates of depth may be determined by interpolation.

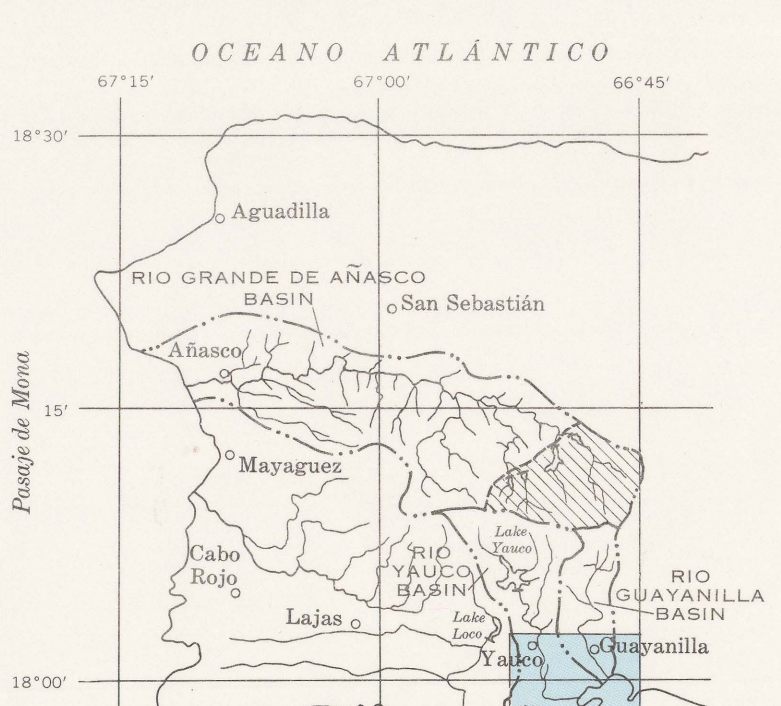
FIGURE 1.—Location of Rio Guayanilla and Rio Yauco drainage basins.

The Rio Guayanilla basin is the easterly basin of the study area shown in the location sketch, figure 1. It has a drainage area of 18.5 square miles at the U.S. Geological Survey gaging station 2.4 kilometers north of Guayanilla, and 20.9 square miles at the upstream Highway PR-2 bridge of three Highway PR-2 bridges across Rio Guayanilla. The total drainage area of the basin is about 31 square miles.

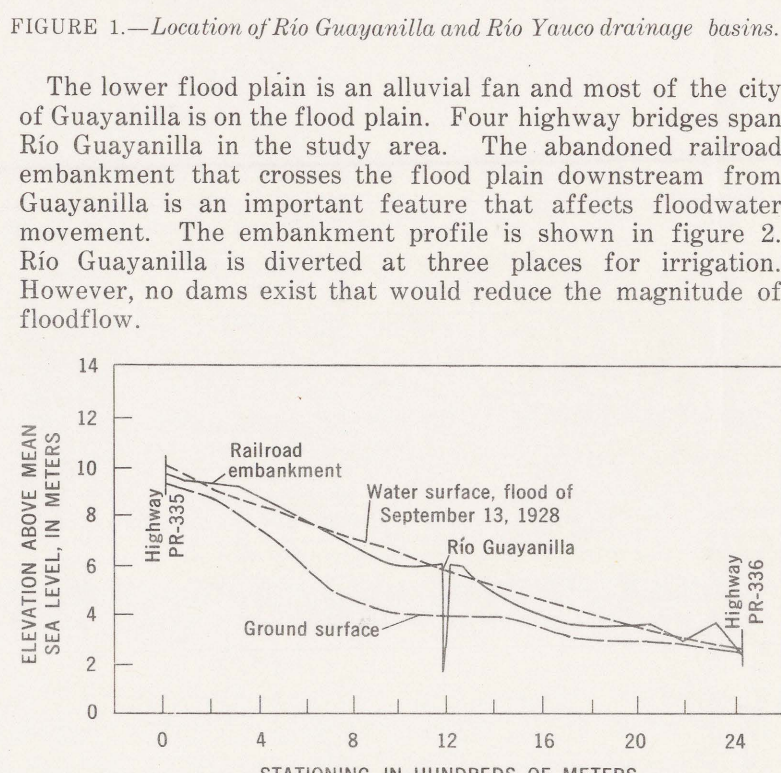
FIGURE 2.—Profile of abandoned railroad embankment between Highway PR-25 and PR-26.

The lower flood plain is an alluvial fan and most of the city of Guayanilla is on the flood plain. Four highway bridges span Rio Guayanilla in the study area. The abandoned railroad embankment that crosses the flood plain downstream from Guayanilla is an important feature that affects floodwater movement. The embankment profile is shown in figure 2. Rio Guayanilla is diverted at three places for irrigation. However, no dams exist that would reduce the magnitude of floodflow.

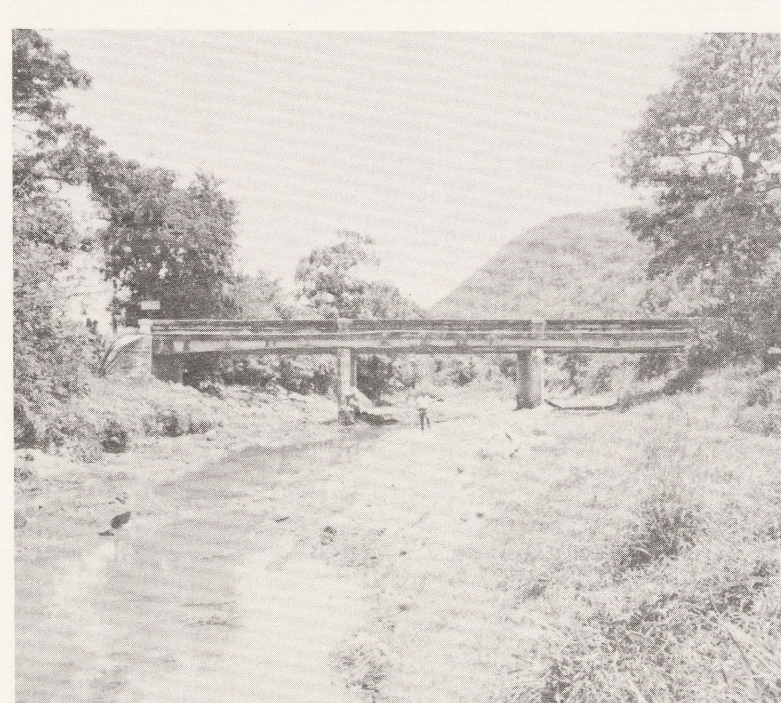
FIGURE 3.—Upstream Highway PR-2 bridge spanning Rio Guayanilla. The 1954 flood reached the low beam of this bridge. The top of the bridge railing is about the same elevation as the crest of the 1928 flood.

**Flood history.**—The earliest floods documented in this basin occurred in 1876 and 1886. Stages of these floods, cited in highway damage reports, could not be recovered. The flood of August 5, 1959, is the greatest known flood. Since the 1959 event, major floods occurred in 1928, 1929, 1932, and 1954. Small floods, being less destructive and less spectacular, usually are soon forgotten. However, flood elevations were recovered for the lesser floods that occurred in 1955, 1958, 1960, 1965, and 1966. A tabulation of flood stages and estimated discharges at the upstream Highway PR-2 bridge (of three Highway PR-2 bridges in Guayanilla) is given below. The bridge is shown in figure 3.

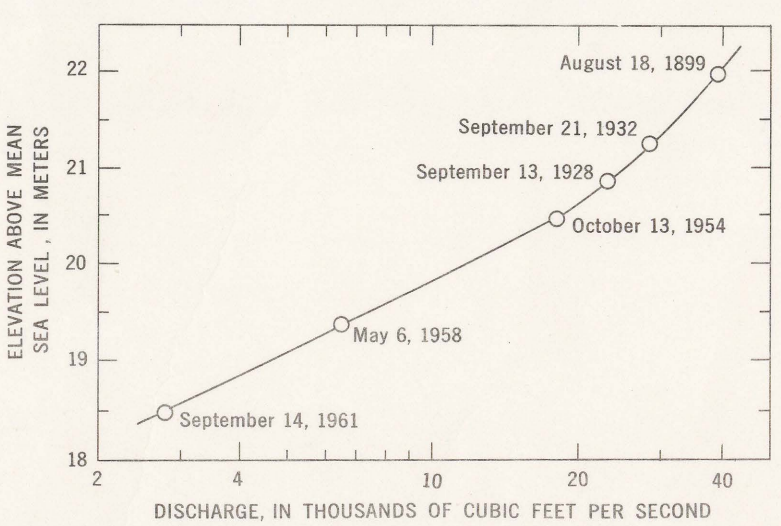
FIGURE 4.—Stage-discharge relation of Rio Guayanilla at upstream Highway PR-2 bridge.

The 1928 flood stage was not established at the upstream Highway PR-2 bridge. Flood elevations farther downstream indicate the magnitude of the flood was slightly less than that of the 1928 flood. Stage and corresponding discharge at this site permit the development of the stage-discharge relation shown in figure 4.

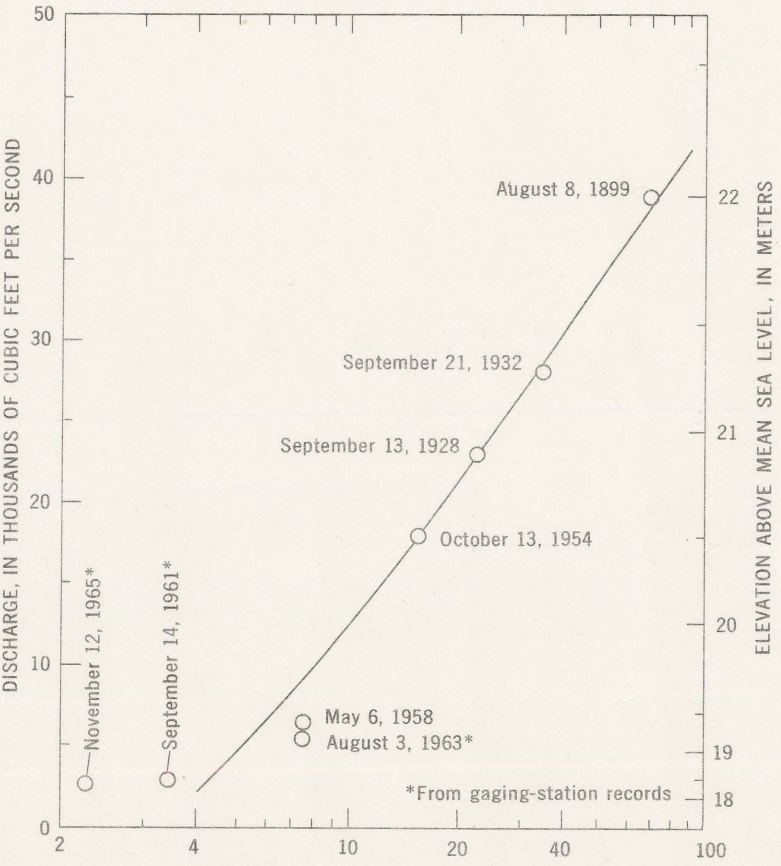
FIGURE 5.—Flood-frequency relation of Rio Guayanilla at upstream Highway PR-2 bridge.

**Flood frequency.**—Historical floodmark elevations were used in conjunction with discharge records collected at the Rio Guayanilla near Guayanilla gaging station, unadjusted for the intervening 2.4 square miles of drainage area, to establish a flood-frequency relation at the upstream Highway PR-2 bridge. The general relation of recurrence interval to river stage and discharge is shown in figure 5. Stage and discharge for selected recurrence intervals are tabulated below.

At the upstream bridge on Highway PR-2, a flood elevation of 20.0 meters has an indicated 10-year recurrence interval. However, the 20.0 meter elevation was exceeded 3 times during the 7-year period 1958-62. It thus is emphasized that recurrence intervals are average figures—the average number of years in which floods of a specific magnitude have been equated or exceeded.

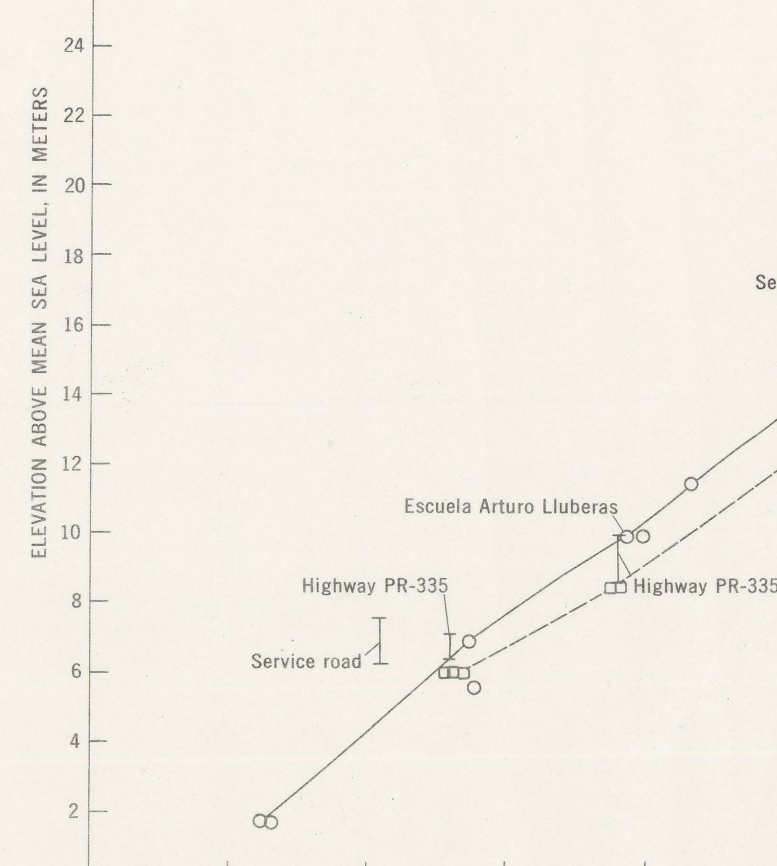
FIGURE 8.—Flood profiles, Rio Yauco.

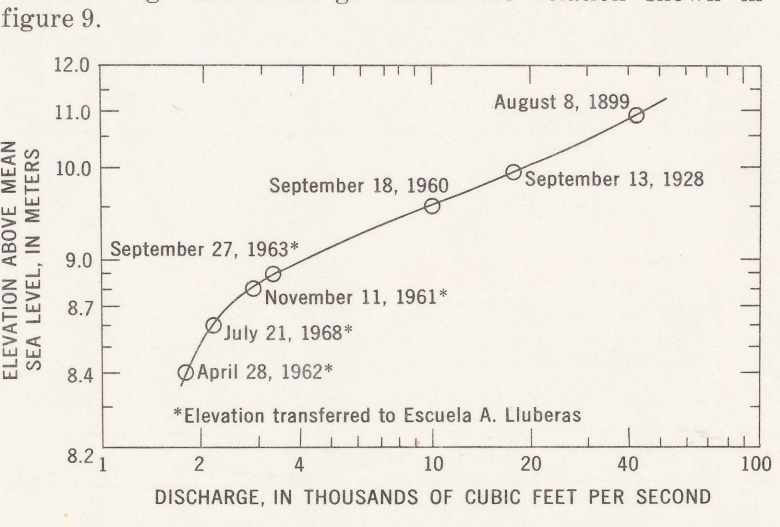
FIGURE 9.—Flood stage-discharge relation of Rio Yauco at Escuela Arturo Lluberas.

Flood stages after 1926 were collected at the Highway PR-335 bridge about 50 meters east of the school. These elevations have been transferred upstream to the school as a common point on the basis of the indicated water-surface slope. Flood stage and discharge define the relation shown in figure 9.

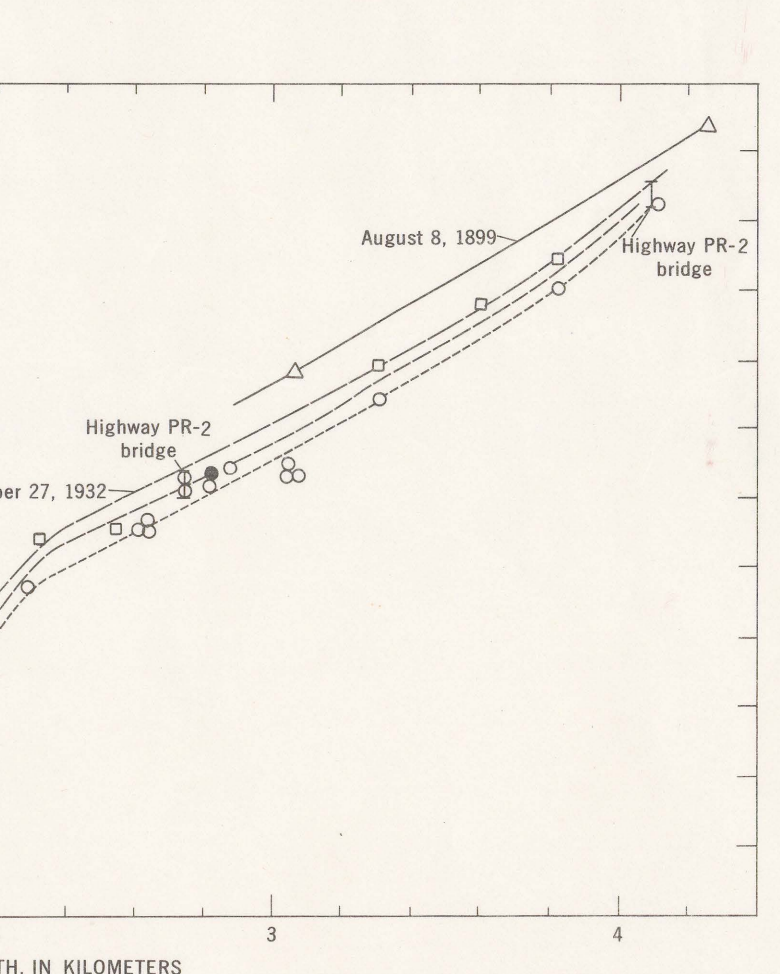
FIGURE 10.—Flood profiles, Rio Yauco.

**Flood profiles.**—The 1928 and 1966 flood elevations, referenced to the arbitrary base line on the topographic map, are shown in figure 10. The 1928 water-surface profile between the elevation range of 13 to 26 meters is not defined by flood marks, but it has been estimated. An average value of high-water marks was used near the elevation of 28 meters. Although several residents along the reach from 5 to 9 kilometers upstream from the mouth recalled the 1928 flood, the west edge of the valley has been changed, mainly by road construction, and old landmarks have been erased. One resident recalled that the flood reached Escuela Segunda Unidad de Barinas, but could point out no definite elevation of the flood. The profile has a probable accuracy of 0.5 meter at elevations above 12 meters.

The flood of July 21, 1968, was not a major event, but its profile provides a basis for estimating the 1928 flood profile. Rio Yauco is confined at low discharge by small levees downstream from about kilometer 2.5. The 1968 profile below this point is not applicable for comparison with the 1928 flood and is not shown.

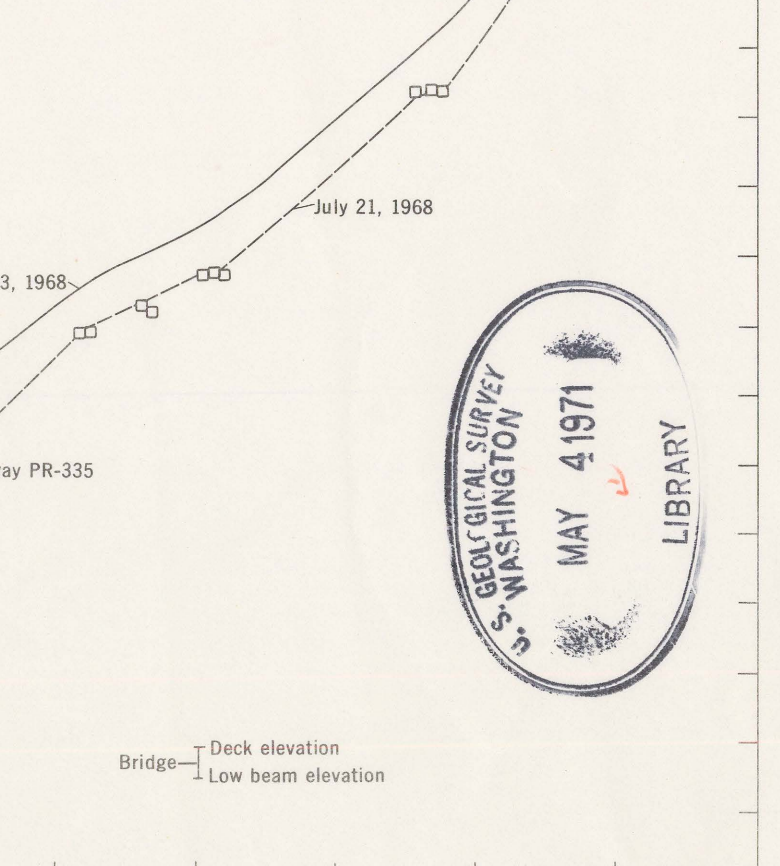
**Flood profiles, Rio Yauco.**—The graph shows elevation above mean sea level in meters (0 to 24) versus distance upstream from mouth in kilometers (0 to 10). The curve shows a logarithmic relationship between elevation and distance, with a peak at about 21.5 meters for a distance of 10 kilometers. The graph includes a scale bar (1:20,000) and a north arrow.

FIGURE 11.—Flood profiles, Rio Yauco.
