#### DESCRIPTION OF SCENE

## VIKING LANDER 2 RECTIFIED PHOTOMOSAIC MORNING SCENE - CAMERA 1 - SECTOR 4

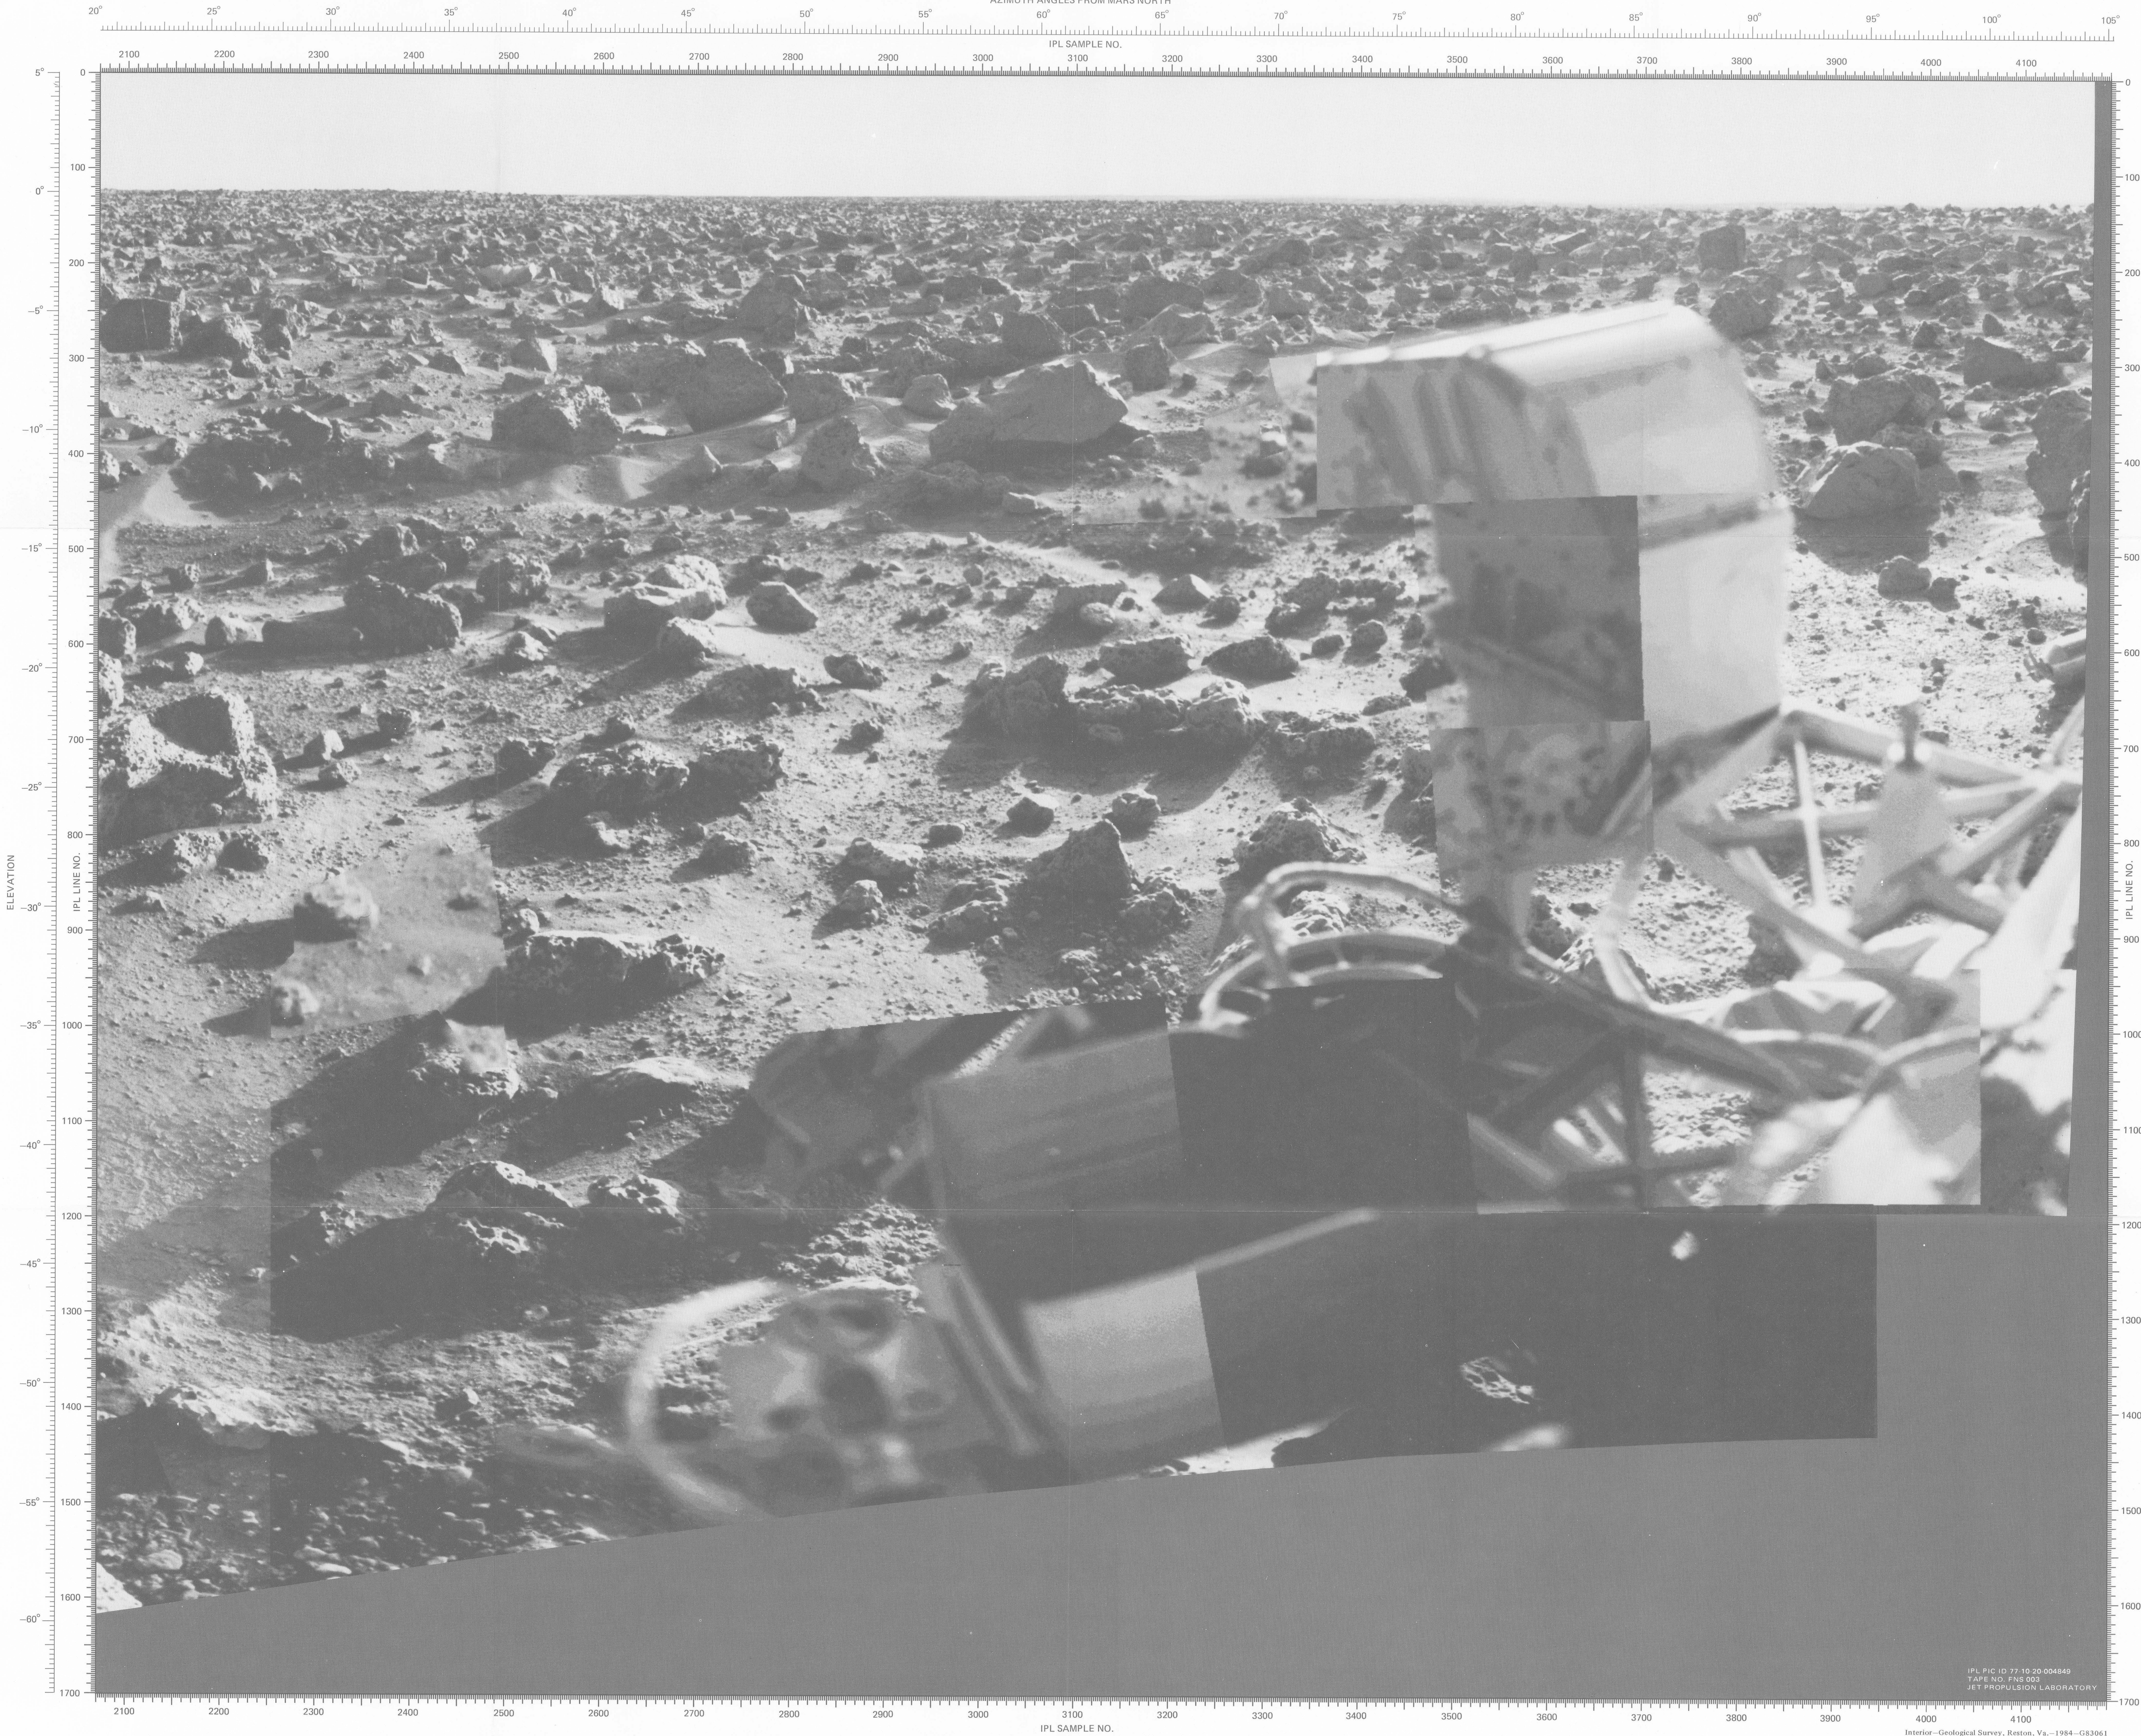
This view to the east shows a flat, rockstrewn landscape with a few small drifts of very fine-grained material scattered among the rocks (line 350, sample 2900). The rocks range from a centimeter to meters in size and are very similar to each other: subangular, equidimensional, and profusely pitted or vesicular. They have a narrower range of sizes (10-20 cm) than those of the Viking 1 site. The rocks appear to be evenly distributed out to the horizon. Barely visible in the far distance just above the horizon line 120, sample 3500) are several bright plateaus which may be ejecta lobes from the crater Mic, a large 160-km-diameter crater that lies about 170 km east of the lander. A trough 1 m wide and about 10 cm deep extends from left to right across the foreground 8 m in front of the lander (line 450, sample 2580; line 530, sample 3250). Several small drifts occur by the floor of the trough (line 430, sample 2600). The trough is part of a roughly polygonal network of troughs. A number of possible origins have been proposed for the troughs, some of which involve freezing and thawing, contraction cracks of cooling lava, or desiccation of clay soils.

The fine-grained material forming the surface between the blocks in the foreground is bound in a coherent crust 1 or 2 mm thick, that breaks into platy fragments when disturbed (line 1530, sample 2300).

The object at the right center of the scene (line 350, sample 2700) is the surface-sampler. The true form of the instrument is not apparent because its image is a mosaic of three pictures that were taken when the instrument was in different positions. These pictures were selected so that a minimum of the surface would be occulted. The box-like structure at the lower left (line 1150, sample 2300) is the housing or cover in which the meteorological instruments were stowed during the launch and transit to Mars. The meteorological boom and instrument were deployed after landing.

The cameras on the Viking Lander acquire data by sampling in equal increments of elevation and azimuth angle. In the accompanying mosaic, 8 mm subtends a 1° horizontal or vertical angle, regardless of the place of measurement within the panorama. If the martian surface were flat, one pixel (0.04°) on the surface would be 1 mm wide at 60° camera elevation and 2 m wide at the horizon 3 km away. Characteristically for this type of imaging system, most straight lines in the scene appear curved in the reconstruction. This representation of the picture data differs from that of a conventional camera having "point perspective" picture geometry, in which rays are projected from object space, through the perspective point in the camera lens, to an image plane in the camera.

The geometry of the lander pictures is complicated by additional factors. Because both landers are tilted with respect to the horizon, on the uncorrected pictures the horizon resembles a sine curve. Computer rectification of the pictures results in a straight horizon along which vertical angles can be measured with respect to the local gravity vector, and horizontal angles can be measured from martian north. These angles are not related in any simple way to the azimuth and elevation angles given in "camera coordinates" for the uncorrected pictures.

There are other geometric distortions due to the camera: optic path distortion that affects a light ray after it passes the camera window; and camera-system distortions, or "bold-down" errors, that are caused by the way the cameras are mounted on the lander. The geometric transformation used in creating the mosaics took into account the optic path distortion but not the "bold-down" errors. However, along the horizon, the error in azimuth angle is equal to the rotational "bold-down" error for each camera to an accuracy of less than 1 pixel. The scale "azimuth angles from Mars" has been adjusted to take into account this correction.

The residual azimuth angle errors are less than 1 pixel along the horizon and become larger with steeper elevation angles and large lander tilts. For the worst case, Lander 2, camera 1, this error is a maximum of 5.7 ± 1 pixel at 60° elevation. The somewhat azimuthal-angle-dependent residual elevation error is a maximum of 3 ± 1 pixel for Lander 2, camera 1, and approximately 1 pixel for the other cameras.
