**LANDSLIDES AND RELATED FEATURES**

OF THE MATEWAN, W. VA. - KY. QUADRANGLE

by  
William F. Outerbridge  
1982

U.S. Geological Survey  
OPEN FILE MAP 82-51 (E-15)

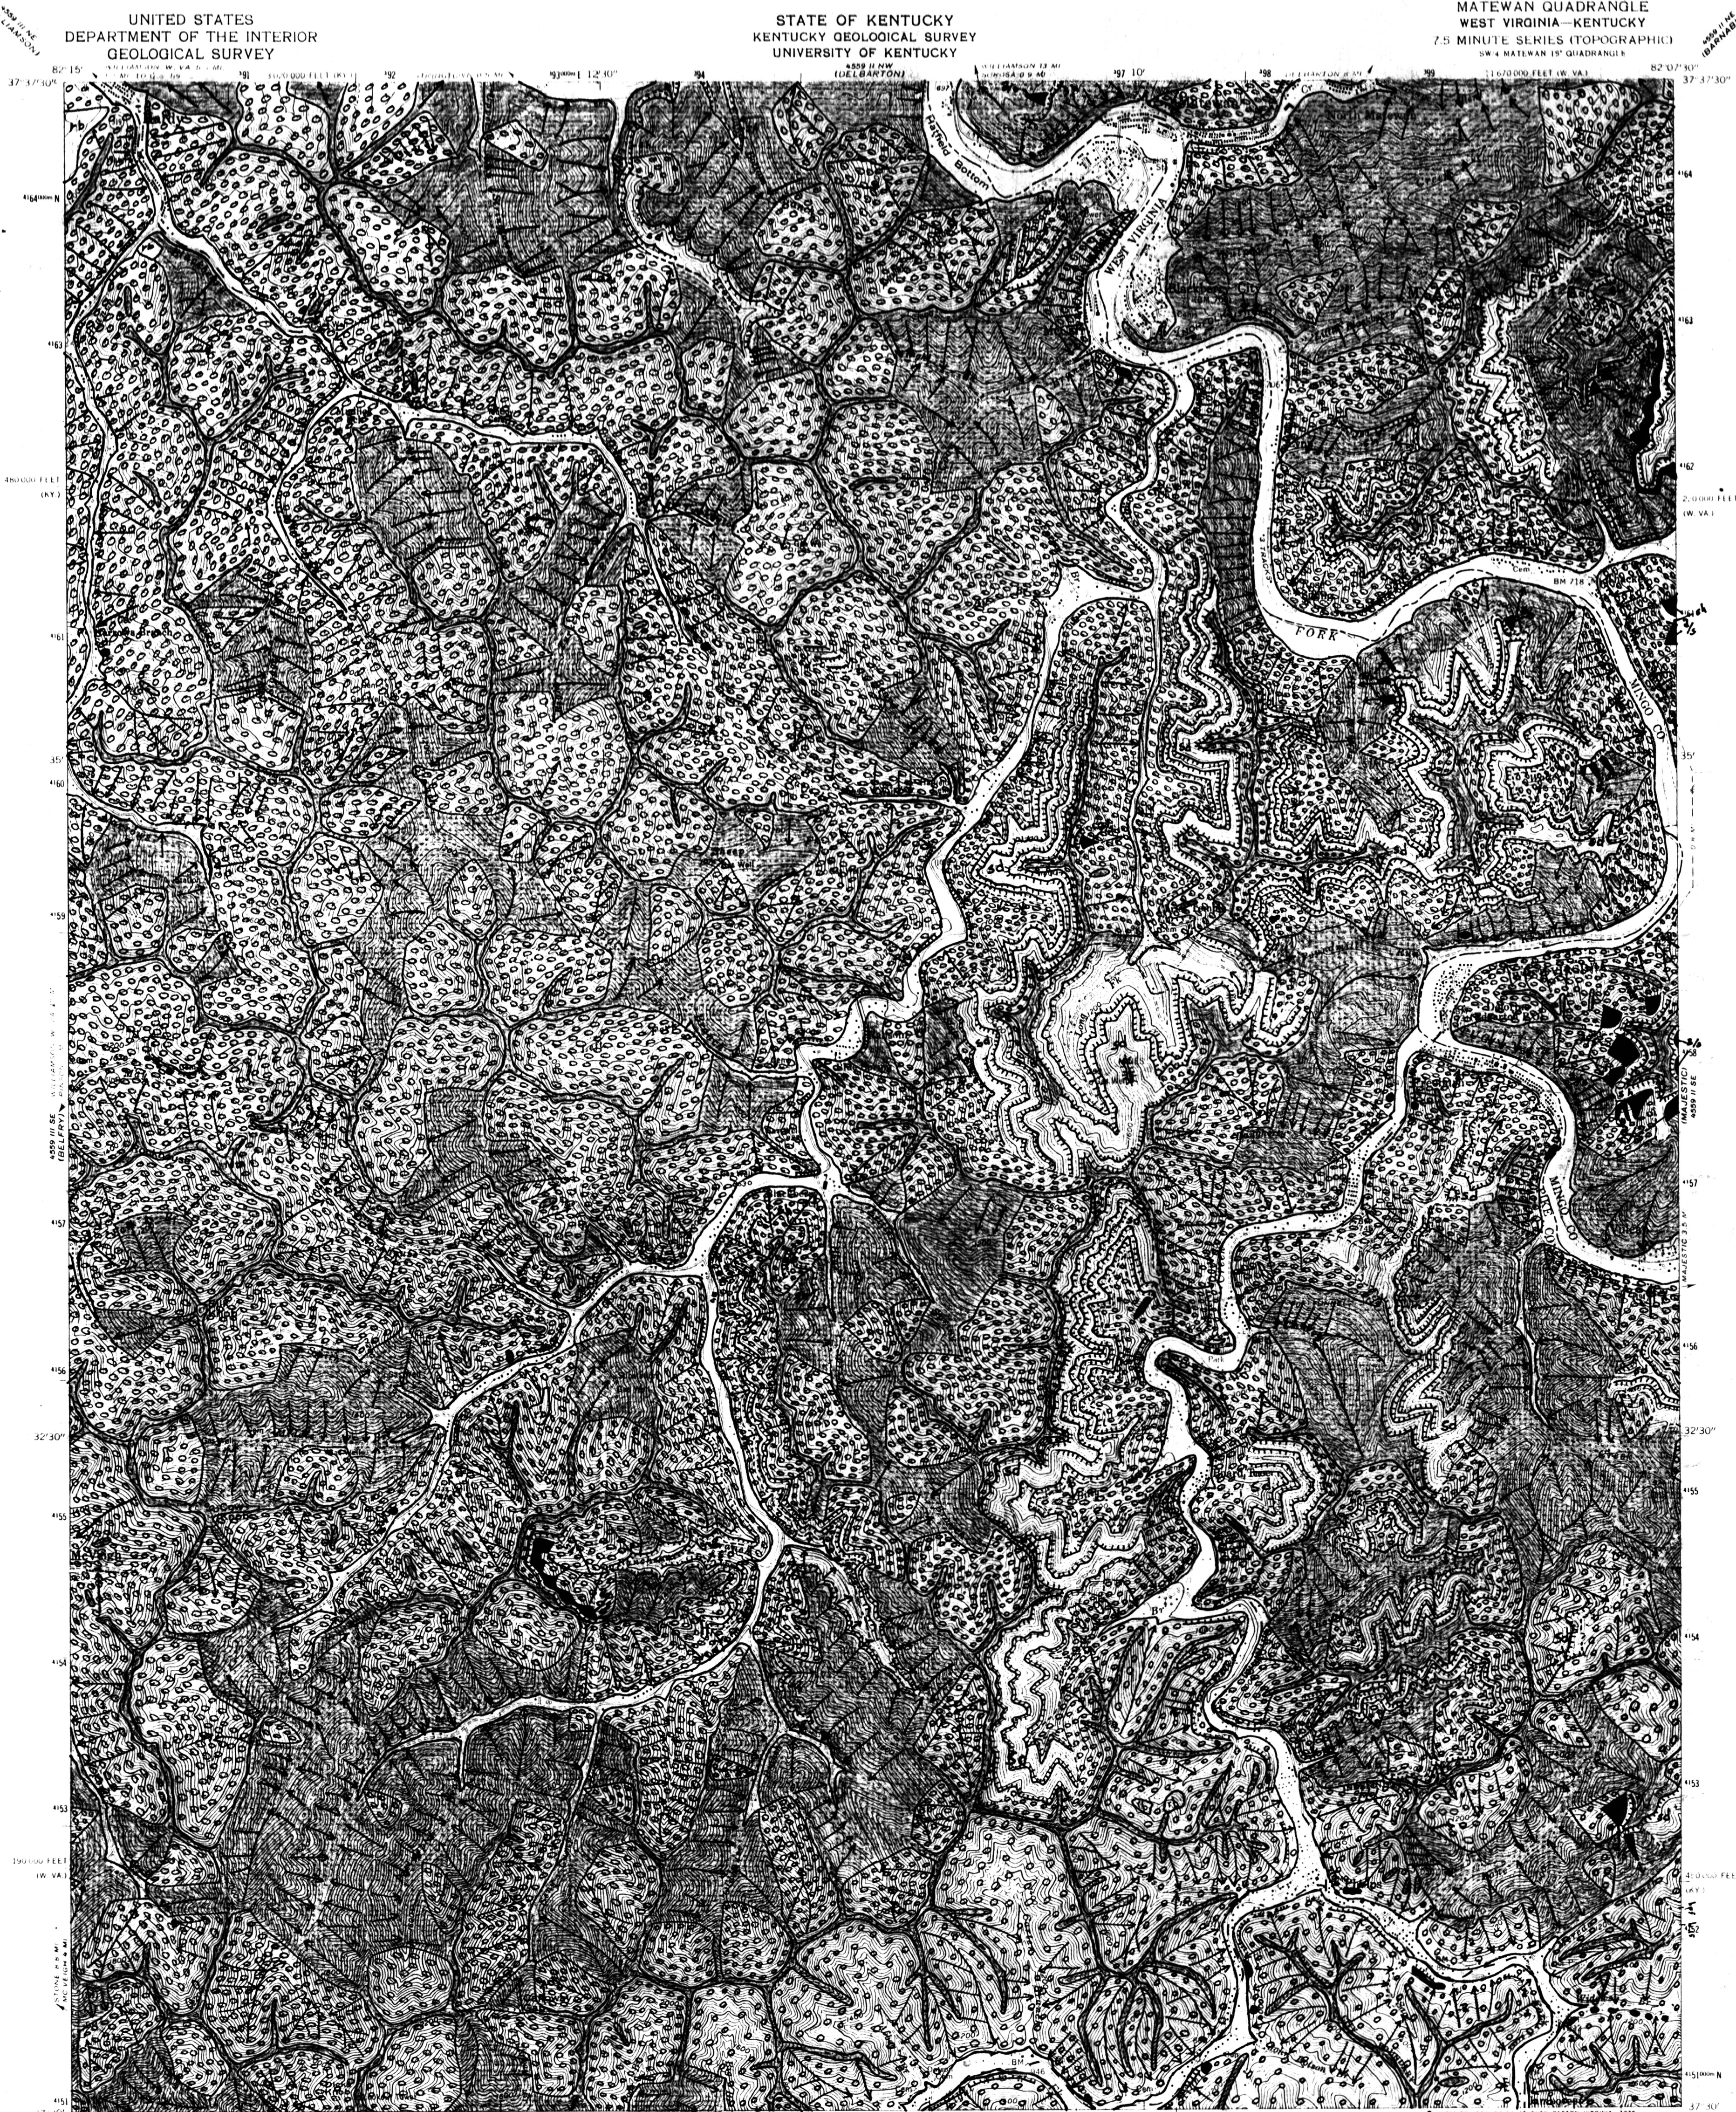
MATEWAN, W. VA. - KY.  
SW 4 MATEWAN 15' QUADRANGLE  
N 47° 30' W 20° 15' E  
1954

**ACTIVE OR RECENTLY ACTIVE LANDSLIDE**  
Complex landslide composed of earthflow, debris slide, earth and rock slump. Identified from historical records, and from scars, debris and other field evidence. Ground extremely unstable; sliding accelerated by excavation, loading and changes in drainage conditions. May include areas with several active slides too small to be shown separately. Questioned where doubtful.

**OLD LANDSLIDE**  
Area of extensive hummocky ground caused by earthflow and earth and rock slump. Lacks clear evidence of active sliding. Relatively stable in natural, undisturbed state, generally not affected by small structures properly sited in areas away from the edge of the toe; can be reactivated by extensive, rapid excavation, loading, and changes in ground water and surface water conditions. Area of old landslide probably includes recent ones not identified from field evidence or otherwise documented. Upslope boundary of landslide generally defined by modified scarp, but downslope (toe) may be gradational and not well defined. Questioned where doubtful.

**COMBINATION LANDSLIDE**  
Area of recent and old slides in which individual slides are not identified.

**COLLUVIAL SLOPE**  
Valley wall along major streams with slope as steep as 40° (85%); stony, clayey silt soil up to 50 ft. (15 m) thick; commonly buttressed by a terrace or bench at the toe of the slope; very susceptible to sliding by cutting of toe area, removal of terrace or bench, and overloading; slide commonly activated without apparent cause.

**COLLUVIAL SLOPES WITH LANDSLIDES**  
Landslides too small or obscure to map individually.

**AREAS SUSCEPTIBLE TO DEBRIS FLOWS AND DEBRIS AVALANCHES**  
Primarily shallow, narrow ravines and chutes with accumulation of stony colluvium generally 10 ft. (3 m) or less in thickness; susceptible to rapid movement during intense rainfall. Most ravines and chutes designated show evidence of former debris flows and avalanches. Symbol & designates historical debris flow or debris avalanche.

**AREAS SUSCEPTIBLE TO ROCKFALL**  
Steep, locally vertical, natural and man-made slopes and cliffs, 15 ft. (4.5 m) or more high; formed dominantly of sandstone, limestone, sandy shale, mudstone and claystone. Interbedded mudstone, claystone and shale weather rapidly leaving sandstone and limestone rock faces unsupported.

**SOIL AND ROCK SUSCEPTIBLE TO LANDSLIDING**  
Soil and rock similar to that involved in landslides elsewhere in map area; primarily areas underlain by claystone, mudstone and shale associated with other rock types. Rock weathers rapidly on exposure forming clayey soil highly susceptible to sliding. Includes coves (U-shaped, shallow valleys) containing thick layers of clayey soil that are very susceptible to sliding where excavation breaks continuity of slope and where overloaded by artificial fill.

**AREAS LEAST PRONE TO LANDSLIDES**  
Map areas in which no patterns or symbols are shown; primarily valley floors, ridge tops and broad benches; modification by excavation and fill may lead to local landslides.
