RIVERTON, TENN.
N3622.5 - W8500/7.5

LANDSLIDES AND RELATED FEATURES

OF THE RIVERTON, TENN. QUADRANGLE

U.S. Geological Survey
OPEN FILE MAP 82-653 (D-8)

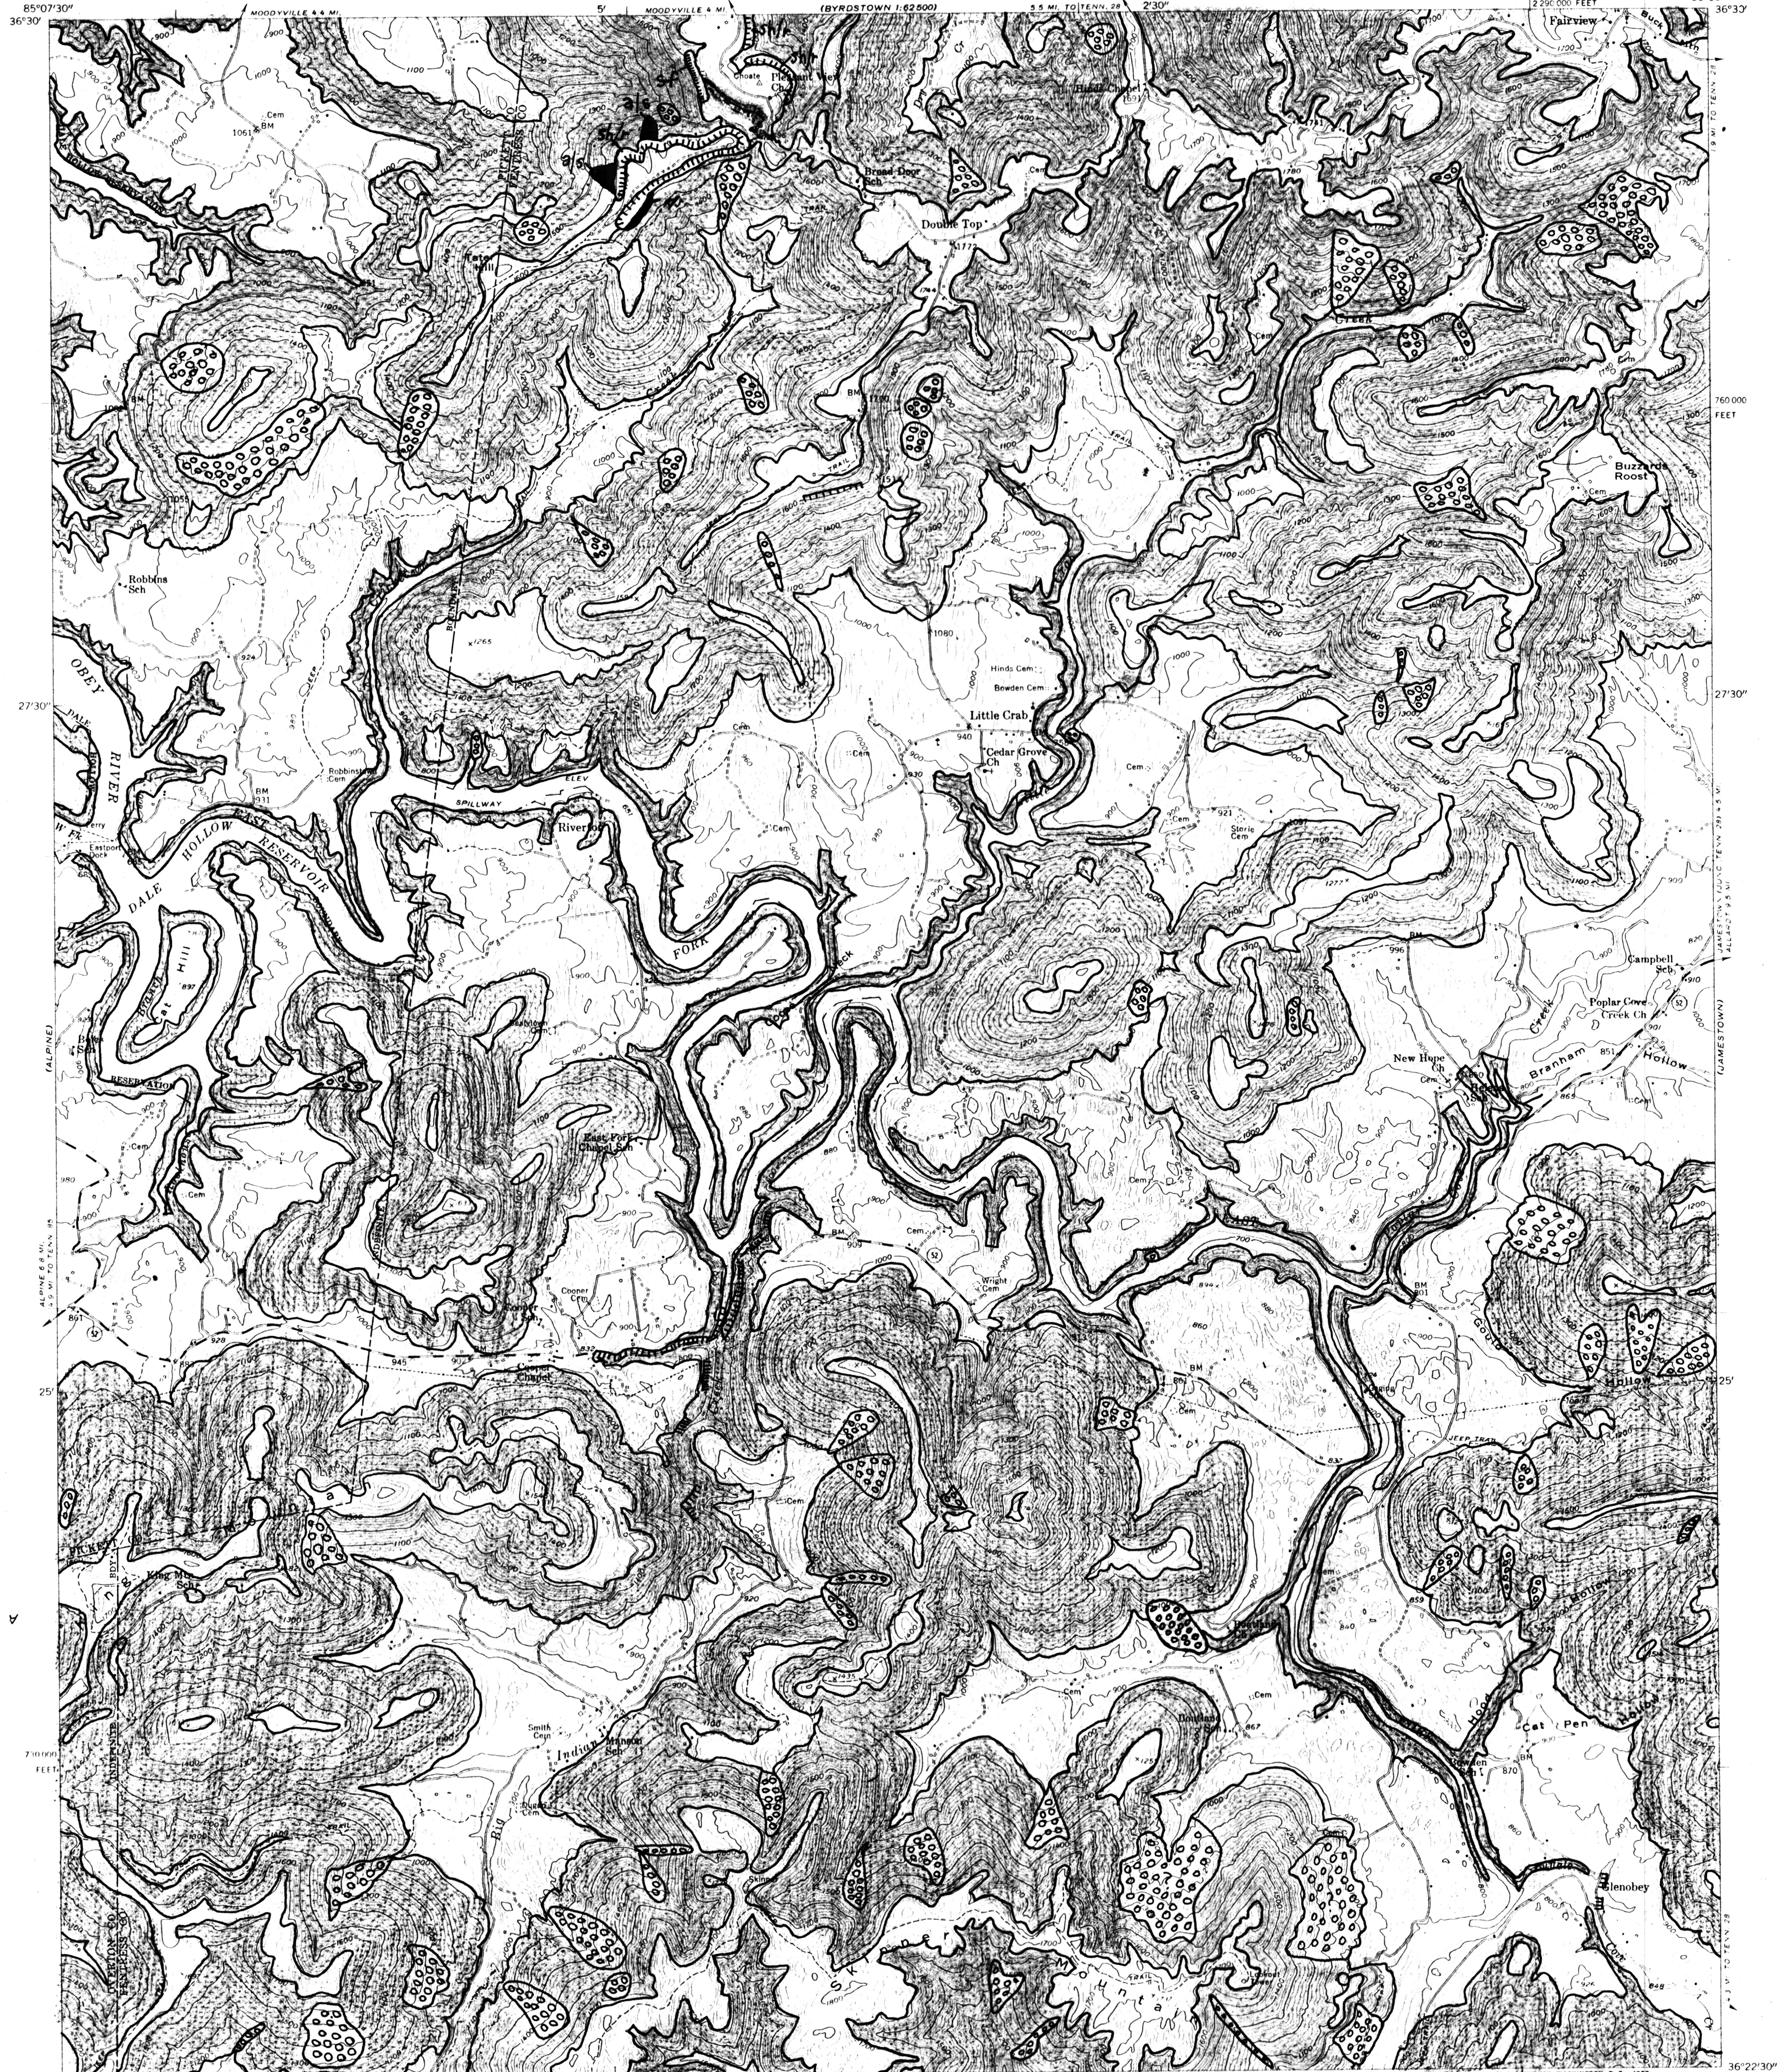
Landslides and related features interpreted from aerial photographs:
1:20,000 (Black and White) 1970
1:40,000 (Black and White) 1978
1:80,000 (Black and White) 1975
Photointerpretation and field check 1979-1980
This report is preliminary and has not been reviewed for conformity with U.S. Geological Survey editorial standards.

**ACTIVE OR RECENTLY ACTIVE LANDSLIDE**
Complex landslide composed of earthflow, debris slide, earth and rock slump. Identified from historical records, and from scars, debris and other field evidence. Ground extremely unstable; sliding accelerated by excavation, loading and changes in drainage conditions. May include areas with several active slides too small to be shown separately. Questioned where doubtful.

**OLD LANDSLIDE**
Area of extensive hummocky ground caused by earthflow and earth and rock slump. Lacks clear evidence of active sliding. Relatively stable in natural, undisturbed state; generally not affected by small structures properly sited in areas away from the edge of the toe; can be reactivated by extensive, rapid excavation, loading, and changes in ground water and surface water conditions. Area of old landslide probably includes recent ones not identified from field evidence or otherwise documented. Upslope boundary of landslide generally defined by modified scarp, but downslope (toe) may be gradational and not well defined. Questioned where doubtful.

**COMBINATION LANDSLIDE**
Area of recent and old slides in which individual slides are not identified.

**COLLUVIAL SLOPE**
Valley wall along major streams with slope as steep as 40° (85%); stony, clayey silt soil up to 50 ft. (15 m) thick; commonly buttressed by a terrace or bench at the toe of the slope; very susceptible to sliding by cutting of toe area, removal of terrace or bench, and overloading; slide commonly activated without apparent cause.

**COLLUVIAL SLOPES WITH LANDSLIDES**
Landslides too small or obscure to map individually.

**AREAS SUSCEPTIBLE TO DEBRIS FLOWS AND DEBRIS AVALANCHES**
Primarily shallow, narrow ravines and chutes with accumulation of stony colluvium generally 10 ft. (3 m) or less in thickness; susceptible to rapid movement during intense rainfall. Most ravines and chutes designated show evidence of former debris flows and avalanches.

**AREAS SUSCEPTIBLE TO ROCKFALL**
Steep, locally vertical, natural and man-made slopes and cliffs, 15 ft. (4.5 m) or more high; formed dominantly of sandstone, limestone, sandy shale, mudstone and claystone. Interbedded mudstone, claystone and shale weather rapidly leaving sandstone and limestone rock faces unsupported.

**SOIL AND ROCK SUSCEPTIBLE TO LANDSLIDING**
Soil and rock similar to that involved in landslides elsewhere in map area; primarily areas underlain by claystone, mudstone and shale associated with other rock types. Rock weathers rapidly on exposure forming clayey soil highly susceptible to sliding. Includes coves (U-shaped, shallow valleys) containing thick layers of clayey soil that are very susceptible to sliding where excavation breaks continuity of slope and where overloaded by artificial fill.

AREAS LEAST PRONE TO LANDSLIDES
Map areas in which no patterns or symbols are shown; primarily valley floors, ridge tops and broad benches; modification by excavation and fill may lead to local landslides.

NOTE
Information shown is intended as a general guide to ground conditions as of the date of field check. Additional landslides and rockfalls should be anticipated in all map units. The map unit depicts the dominant condition in the area delineated and variations in slope stability may occur at any point in the unit. This map is suitable for general planning purposes and as a supplement to more detailed studies for site selection. The map cannot be used as a substitute for detailed geologic and engineering investigations to establish design and construction criteria of specific sites. Some symbols may not appear on this map because the description is applicable to a series of maps.
