*Descriptions and Elevations for Bench Marks
at Mammoth Lakes, California*

Open-File Report 91-630

PURPOSE OF REPORT

This report describes new bench marks installed by the Cascades Volcano Observatory (CVO) leveling crew during the fall of 1989. In addition, improved descriptions are given for bench marks installed by the U.S. Geological Survey (USGS) in 1982, 1983, and 1985, and bench marks installed by the National Geodetic Survey (NGS) in 1986.

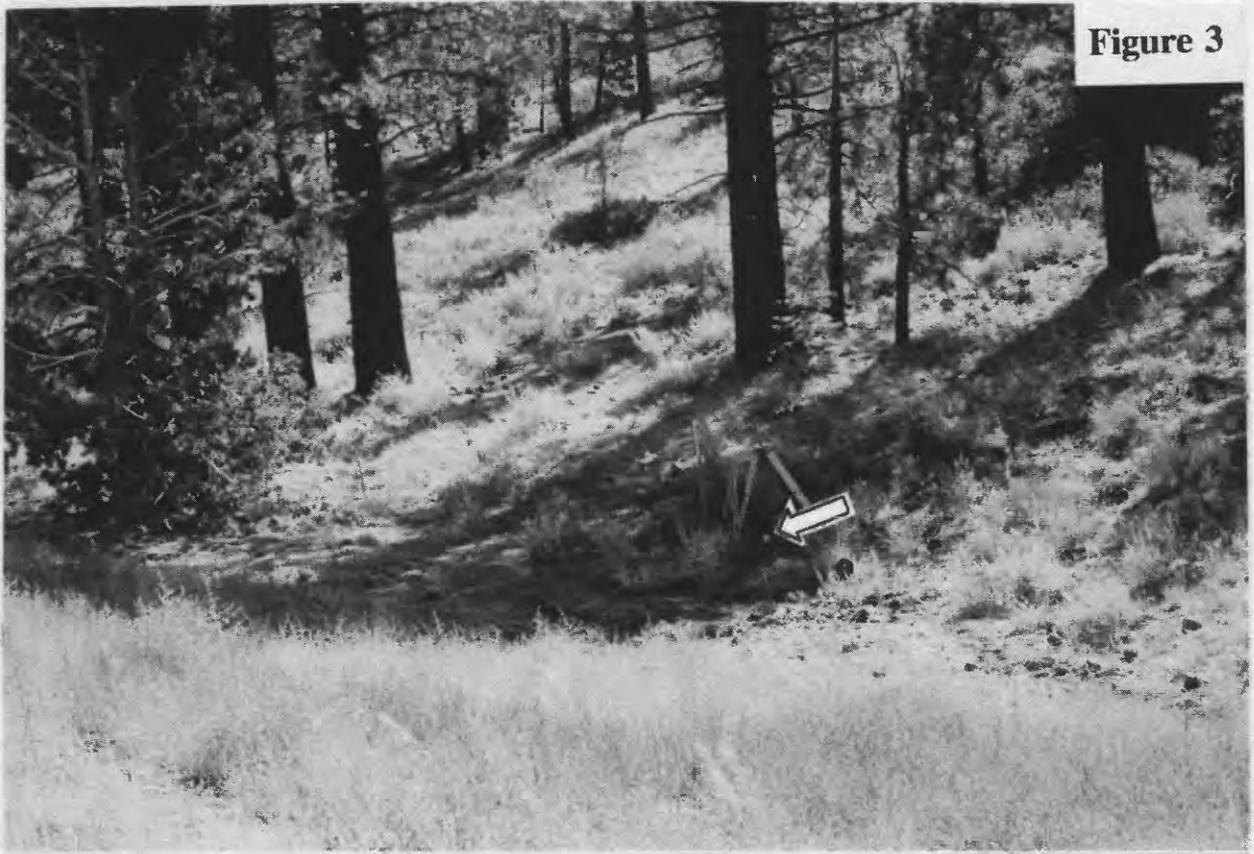
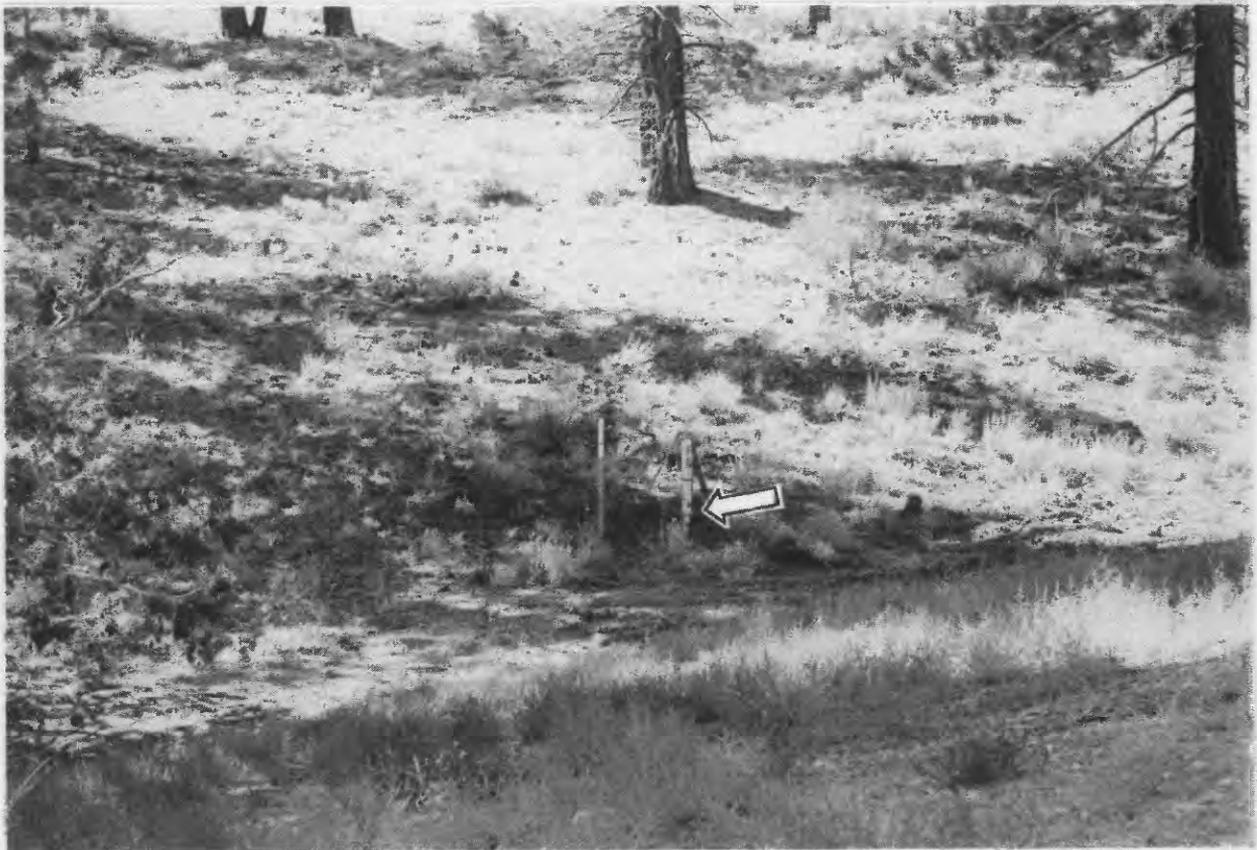
Figure 3

View looking southeast
Arrow at tripod points to bench mark

View looking southwest
Arrow at tripod points to bench mark

- STA 907 1.59 km (1.0 mi.) east along the east-bound lane of State Highway 203 from the entrance to the post office at Mammoth Lakes. Bench mark is welded on the top of a 5 cm (2 in.) diameter pipe projecting 20 cm. (8 in.) above the ground level, 12 m (40 ft.) south of the centerline of State Highway 203, and 0.6 m (2 ft.) south of a metal "Right of Way" post (See figure 3). Bench mark is stamped "907 54.65 77331".

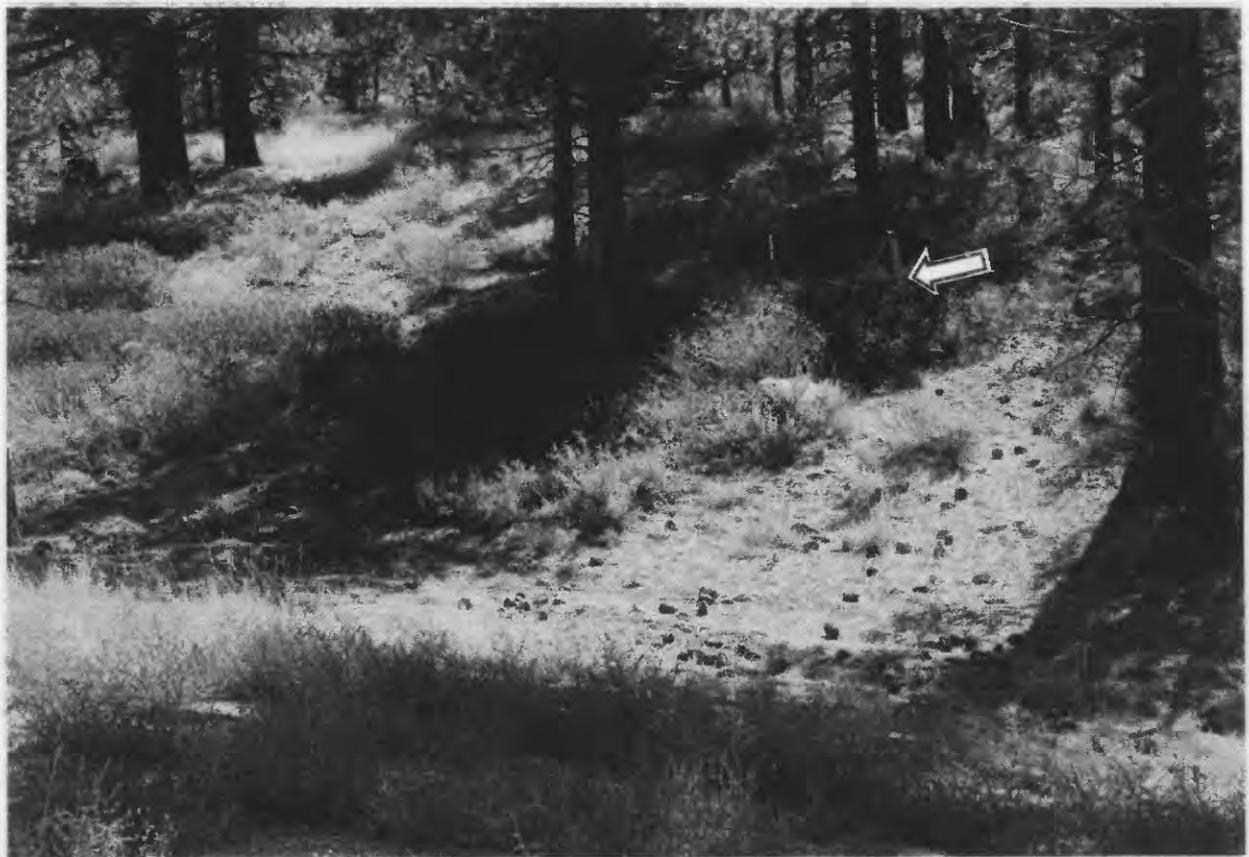
View looking south
Arrow at tripod points to bench mark

View looking southeast
Arrow at tripod points to bench mark

- 3 LRM 1.67 km (1.05 mi.) east along the east-bound lanes of State Highway 203 from the entrance to the post office at Mammoth Lakes. Bench mark is cemented at the east end of a 2 X 2 m (6 X 6 ft.) portion of a rock outcrop projecting 0.6 m (2 ft.) above the ground, 2 m (6 ft.) west of a witness post, 23 m (75 ft.) south of the center of State Highway 203, and "in line" with a "55" MPH speed sign. (See figure 4). Bench mark is stamped "3 LRM 1985". Note: New mortar was poured around the bench mark.

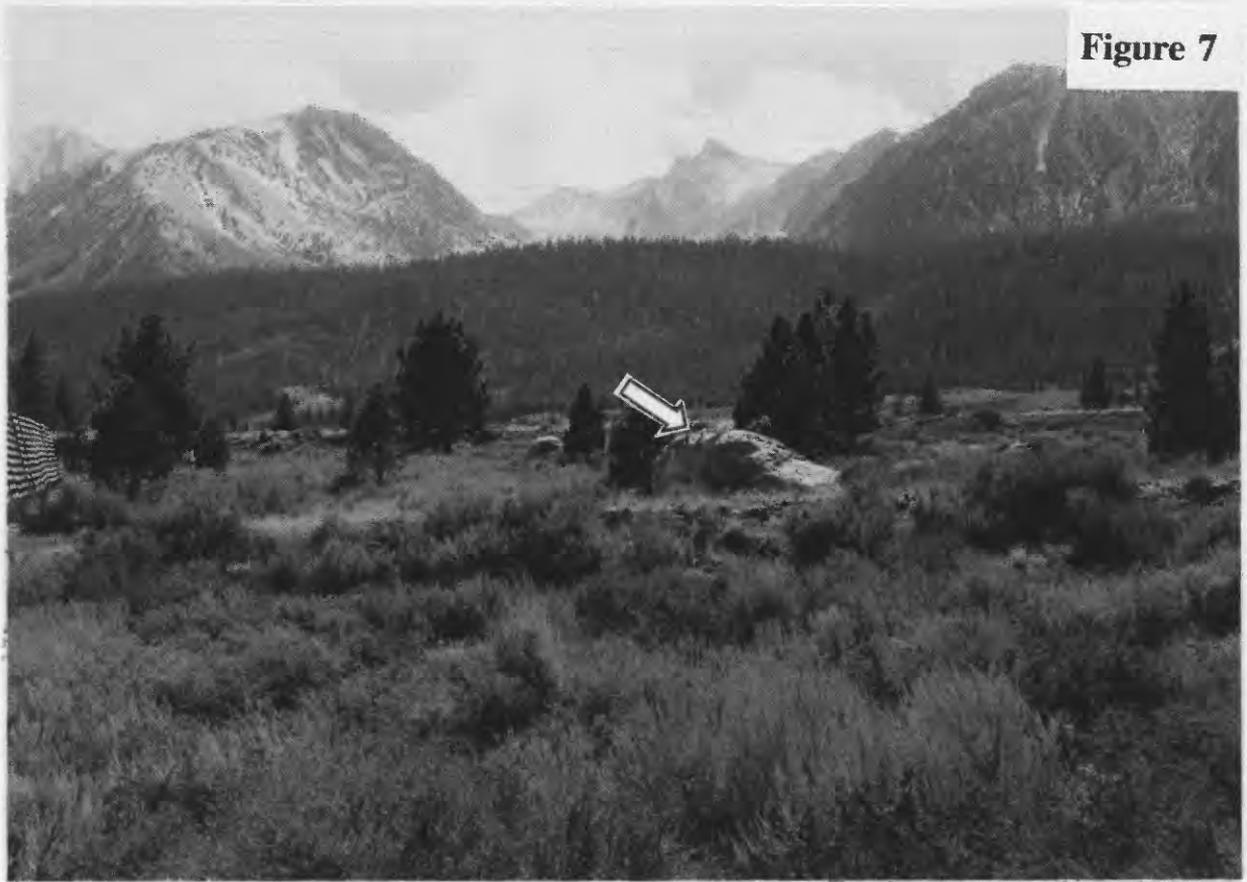
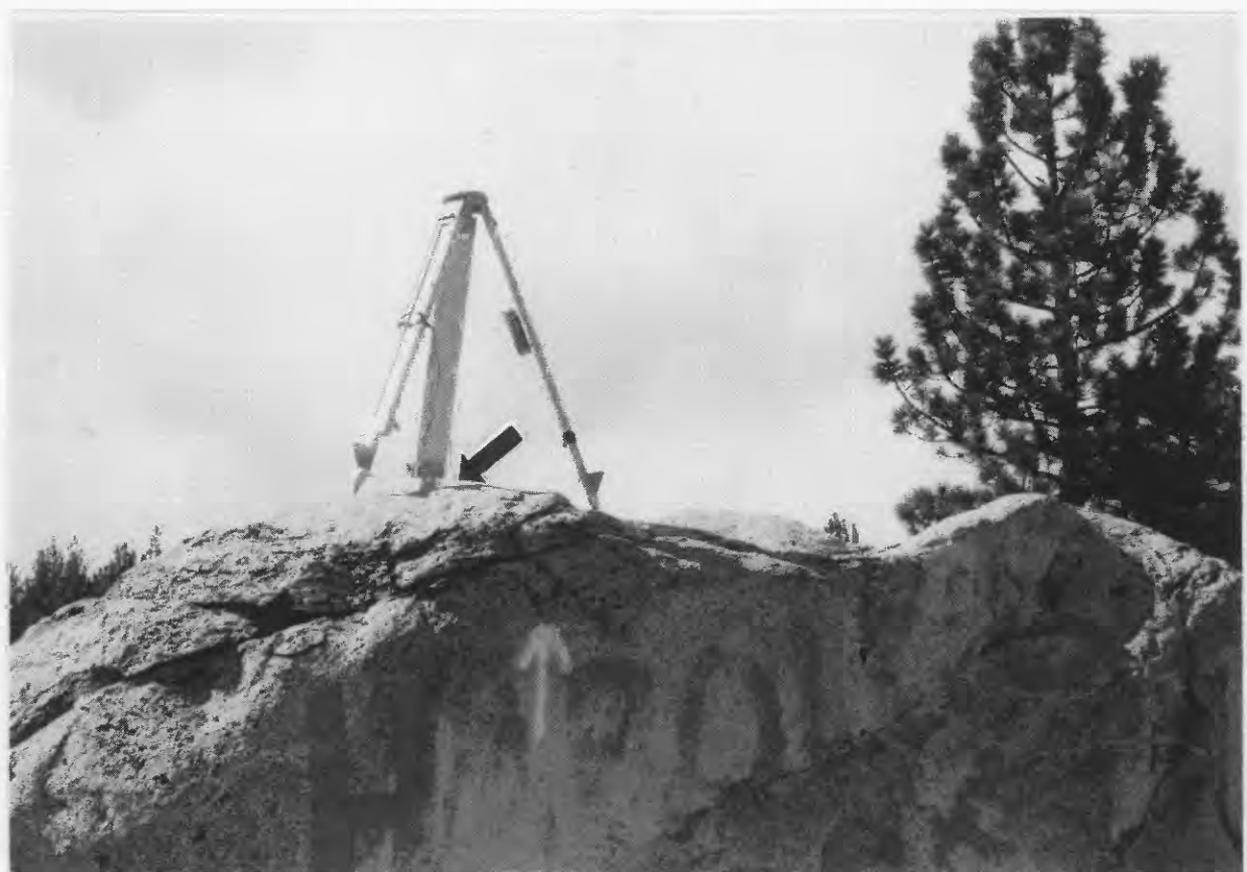
Figure 8

View looking west-southwest
Arrow at tripod points to bench mark

View looking south
Arrow at tripod points to bench mark

- 2 JCM 2.80 km (1.7 mi.) east along the east-bound lanes of State Highway 203 from the entrance to the post office at Mammoth Lakes. Bench mark is cemented on the east end of a 6 X 6 m (20 X 20 ft.) by 2.4 m (8 ft.) high granite boulder, 101 m (331 ft.) south of the centerline of State Highway 203, and approximately 23 m (75 ft.) west of a 3 m (10 ft.) high snow fence (See figure 7). Bench mark is stamped "2 JCM 1983". Note: New mortar was poured around the bench mark.

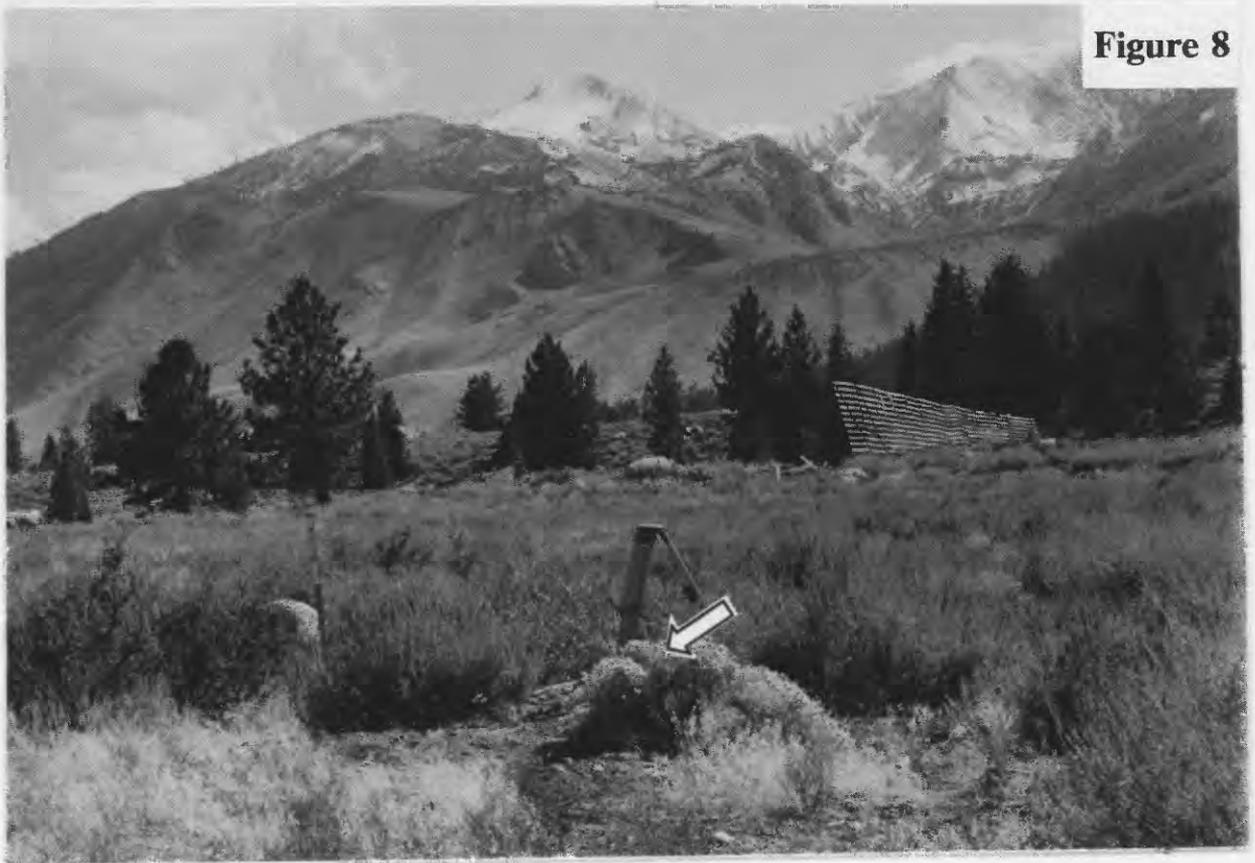
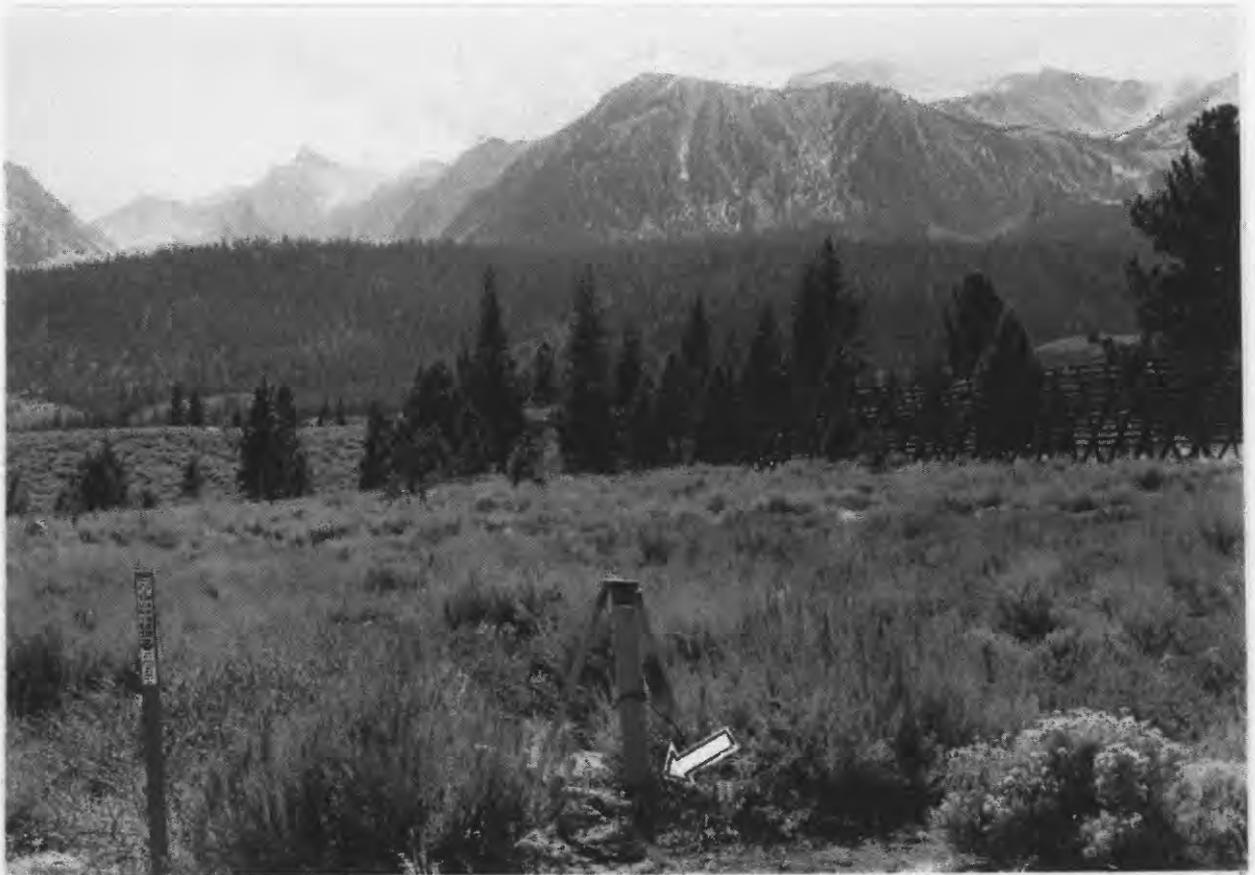
View looking south
Arrow at tripod points to bench mark

View looking southwest
Arrow at tripod points to bench mark

- 38 EGE 3.04 km (1.9 mi.) east along the east-bound lanes of State Highway 203 from the entrance to the post office at Mammoth Lakes. Bench mark is cemented on a 2 X 3 m (6 X 9 ft.) embedded boulder projecting 0.15 m (0.5 ft.) above the ground level, 13 m (43 ft.) south of State Highway 203, and 2.0 m (6 ft.) south of a witness post (See figure 8). Bench mark is stamped "38 EGE 1983". Note: New mortar was poured around the bench mark.

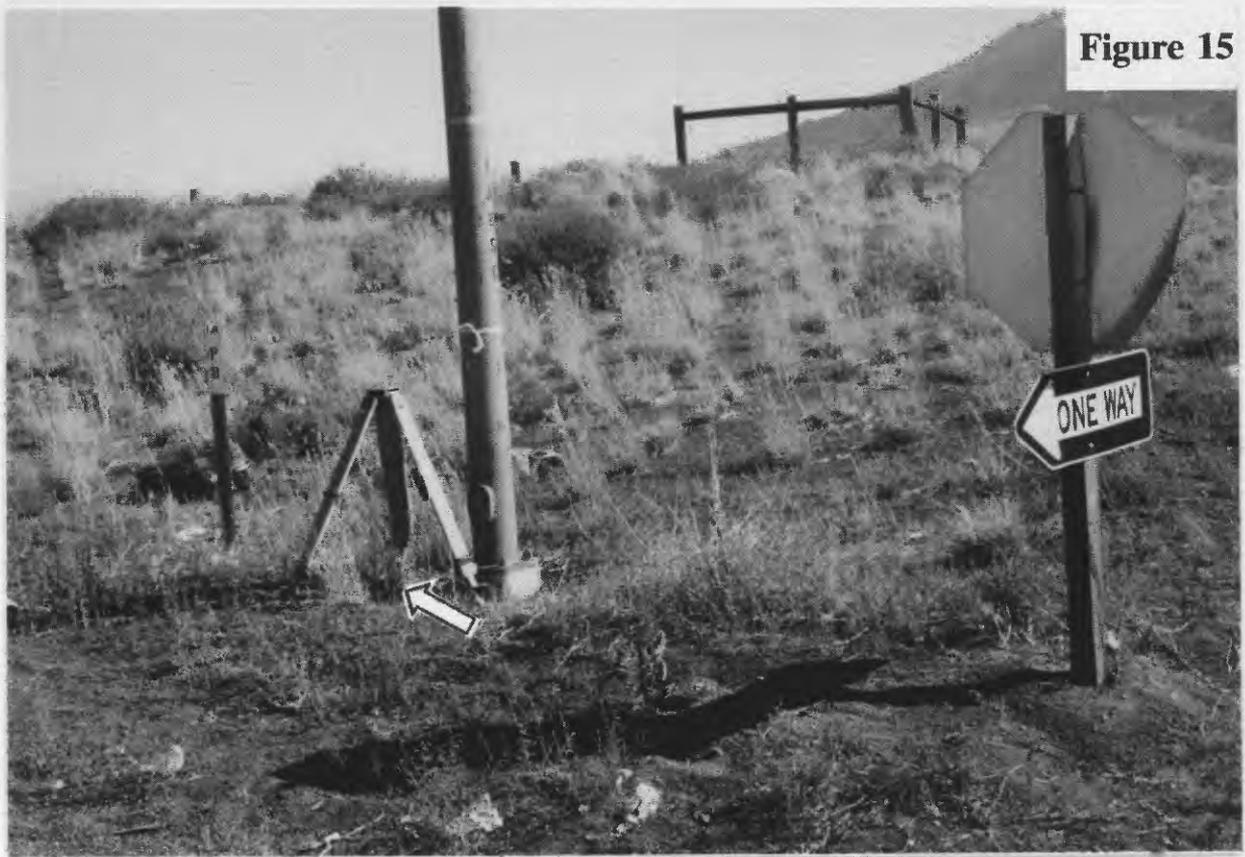
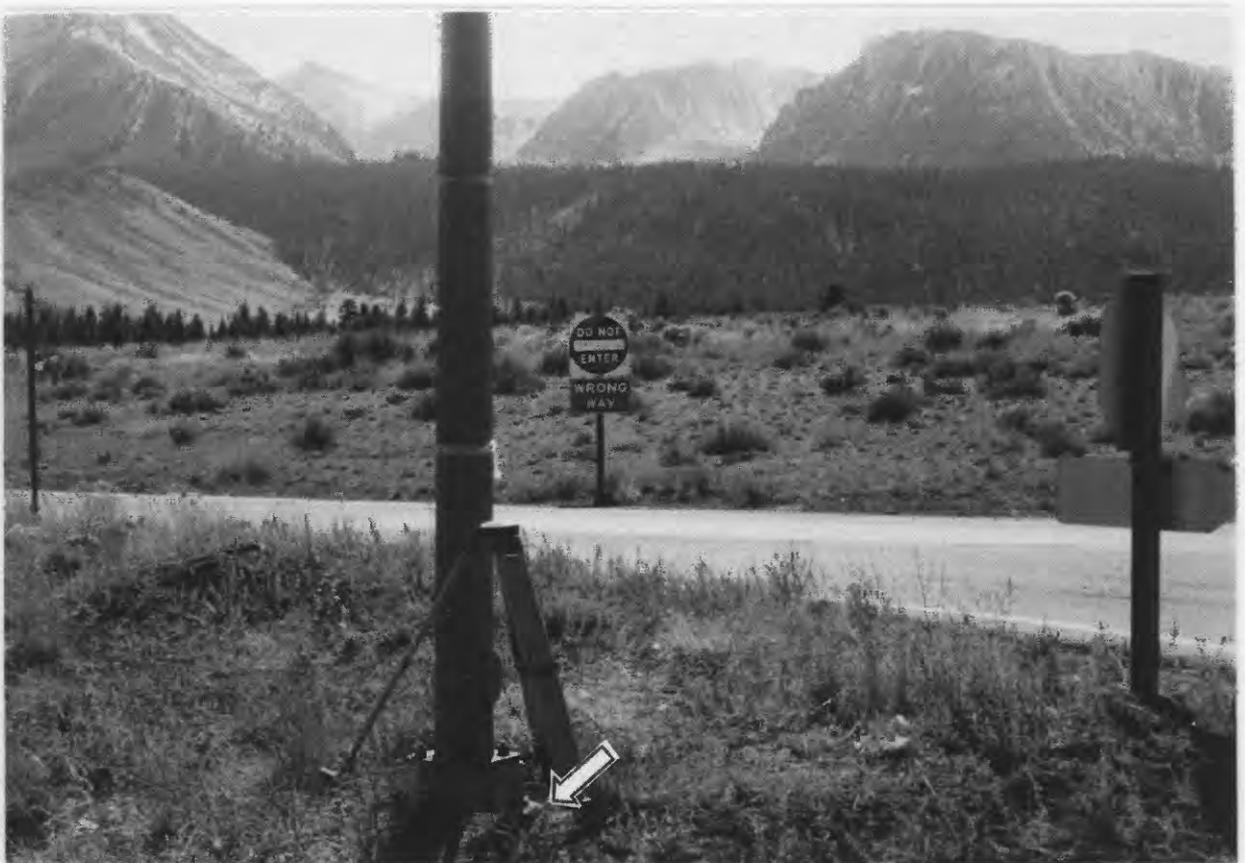
Figure 15

View looking east
Arrow at tripod points to bench mark

View looking southwest
Arrow at tripod points to bench mark

- DBR 21 5.58 km (3.45 mi.) east along State Highway 203 from the entrance to the post office at Mammoth Lakes. Bench mark is cemented on the concrete base of a highway lamp post on the southeast corner of the intersection formed by the exit ramp from U. S. Highway 395 and old Mammoth road, 11.5 m (38 ft.) south of old Mammoth road, 13 m (44 ft.) east of the "off ramp" from U. S. Highway 395, and 0.9 m (3 ft.) above road level (See figure 15). Bench mark is stamped " DBR 21 1983".

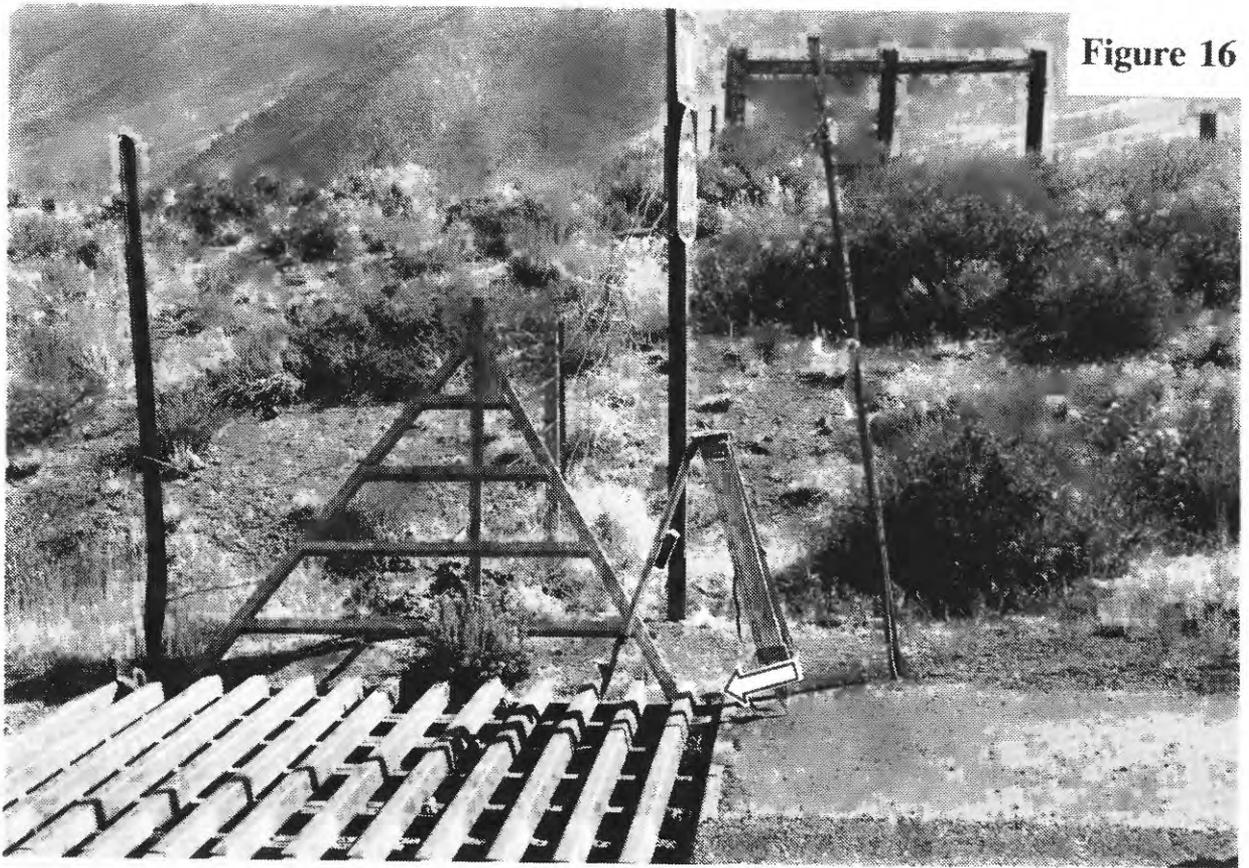
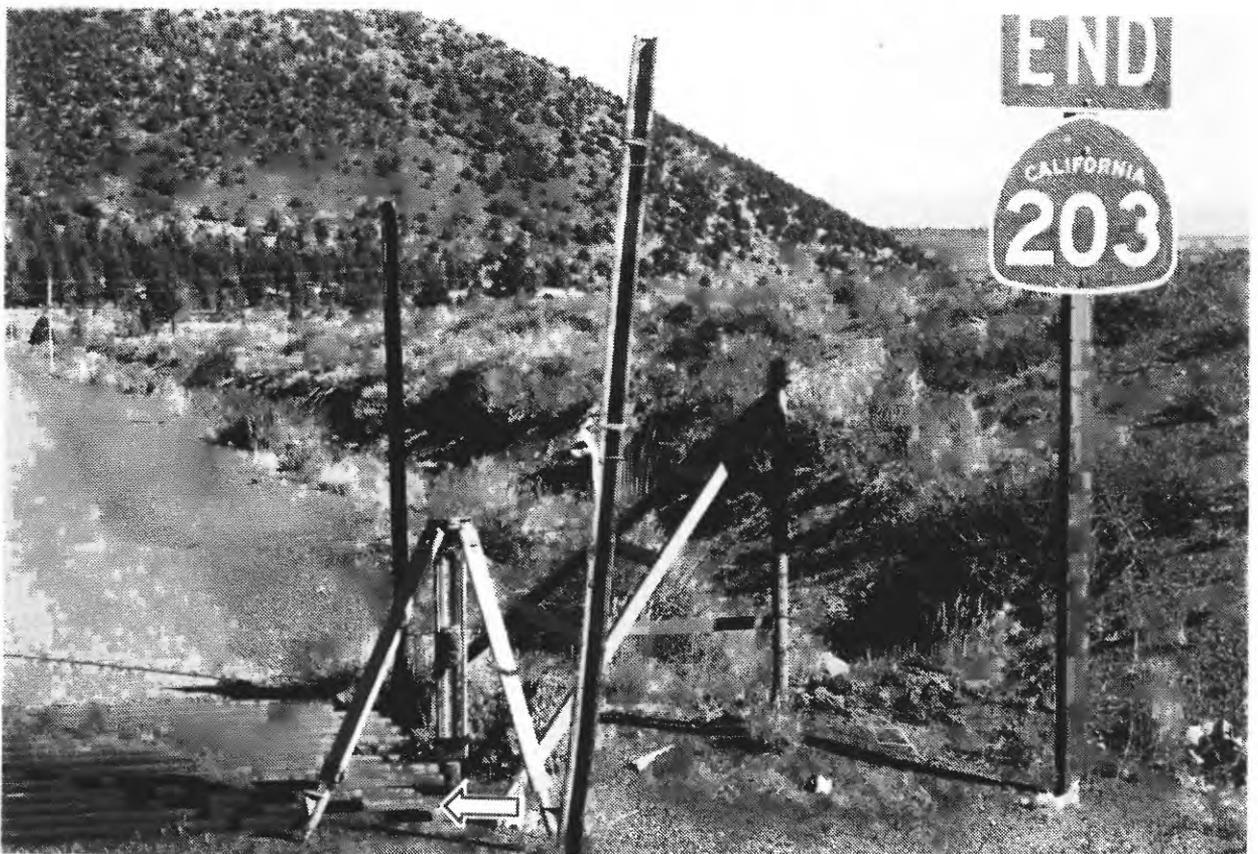
Figure 16

View looking southeast
Arrow at tripod points to bench mark

View looking northeast
Arrow at tripod points to bench mark

- DBR 20 5.65 km (3.5 mi.) east along State Highway 203 from the entrance to the post office at Mammoth Lakes, and 0.17 km (0.1 mi.) east of U.S. Highway 395 crossing. Bench mark is at the south end of a cattle guard, attached to a metal rod driven between the slates of the cattle guard and 6 m (20 ft.) south of the centerline of old Mammoth road (See figure 16). Bench mark

is stamped "DBR 20 1983".

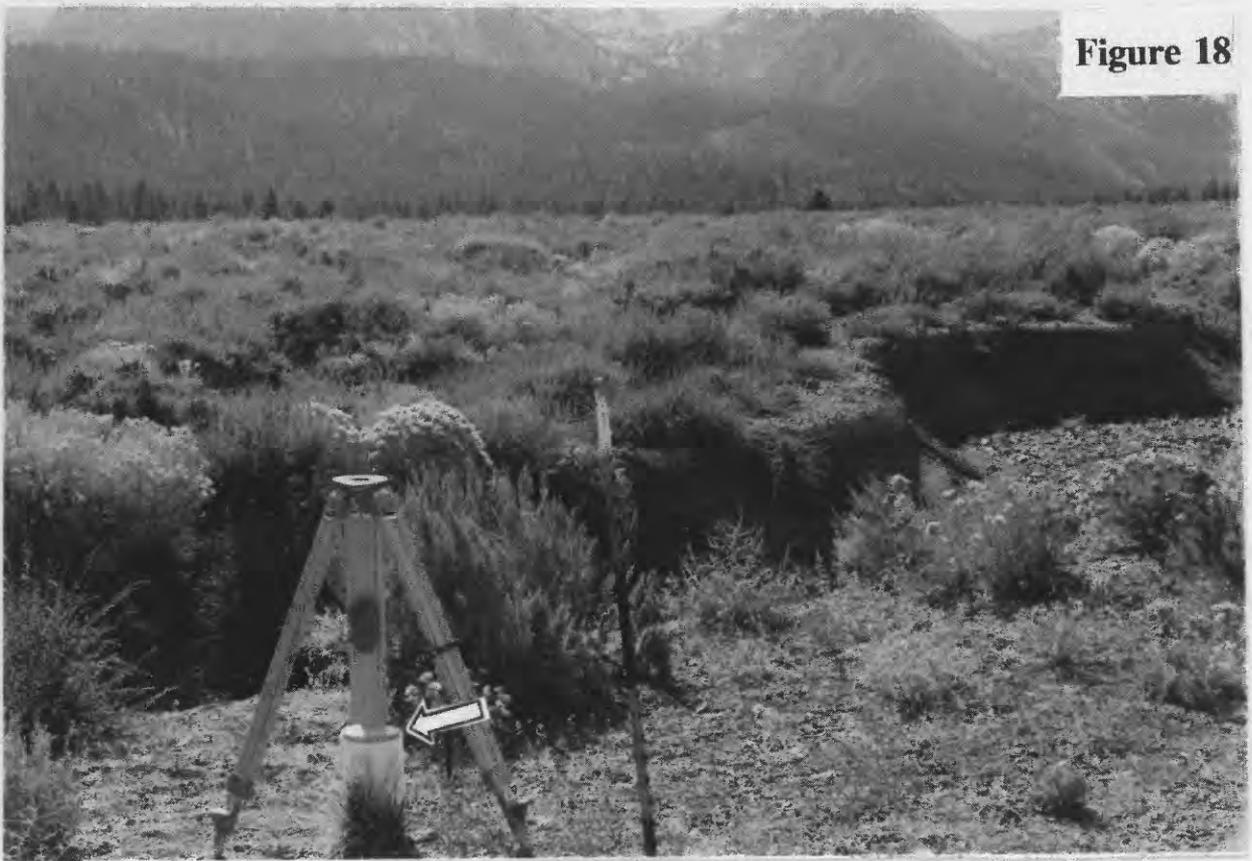
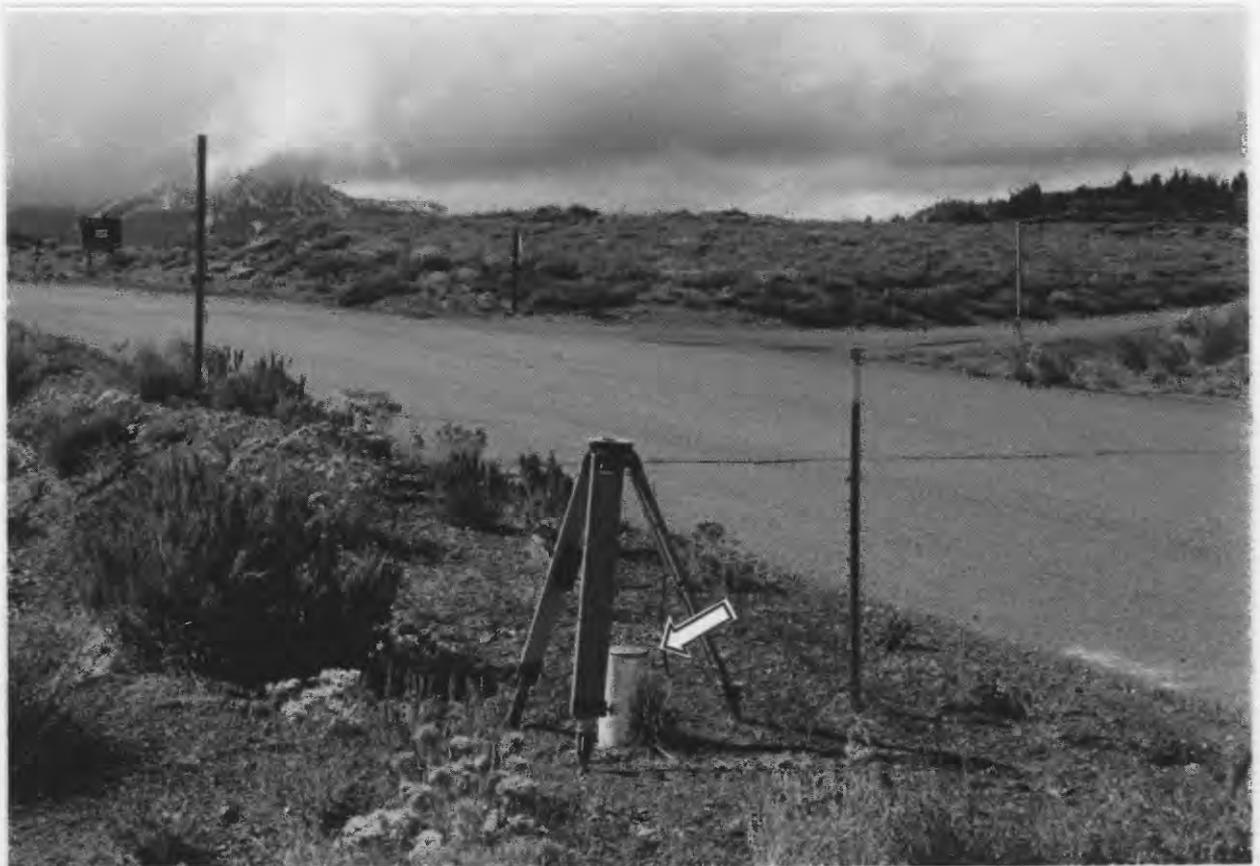
Figure 18

**View looking south west
Arrow at tripod points to bench mark**

**View looking west
Arrow at tripod points to bench mark**

- DBR 18 5.75 km (3.6 mi.) east along State Highway 203 from the entrance to the post office at Mammoth Lakes, and 0.35 km (0.2 mi.) east of U.S. Highway 395 crossing. Bench mark is attached to a metal rod enclosed in a 20 cm (8 in.) diameter PVC plastic pipe projecting 30 cm (12 in.) above ground level, 8 m (26 ft.) south of the centerline of old Mammoth road, and 1 m (3 ft.) south of a metal fence post (See figure 18). Bench mark is stamped "DBR 18 1983".

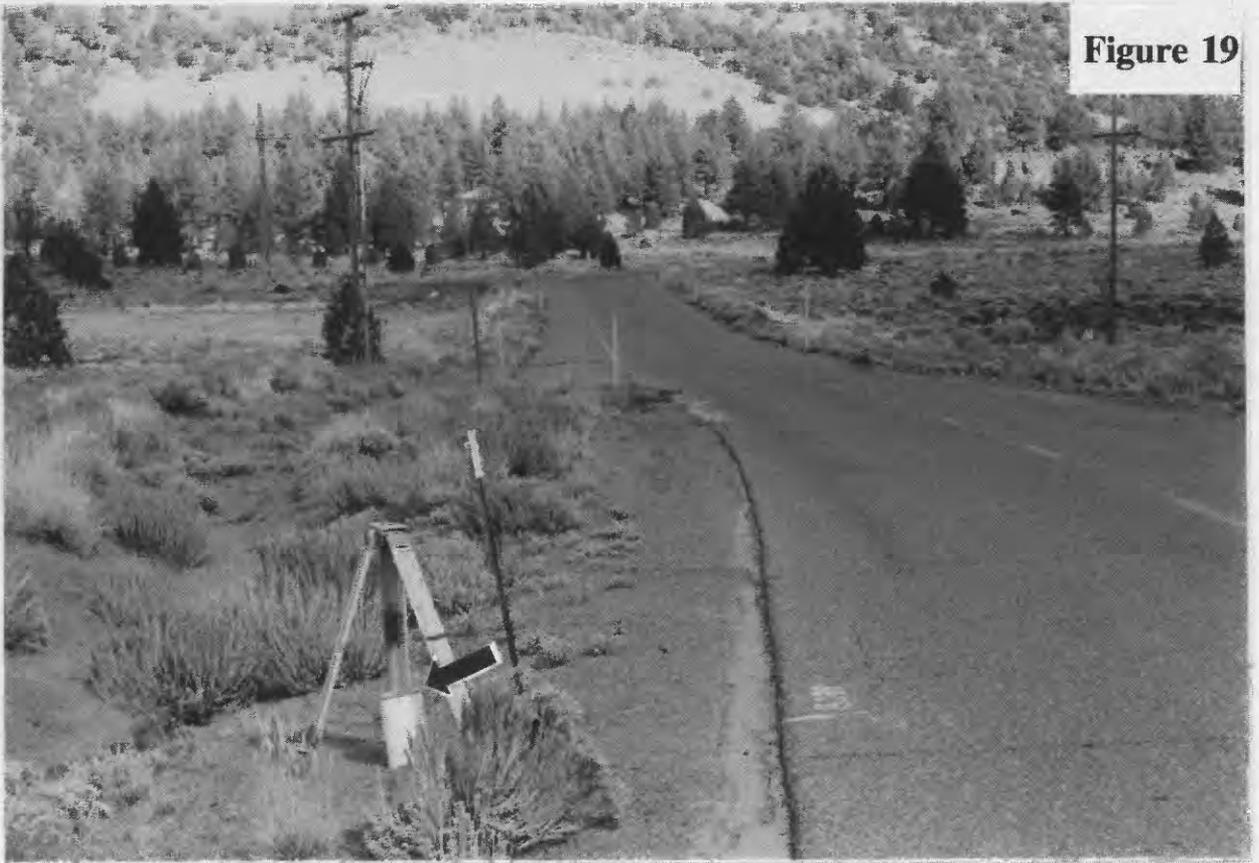
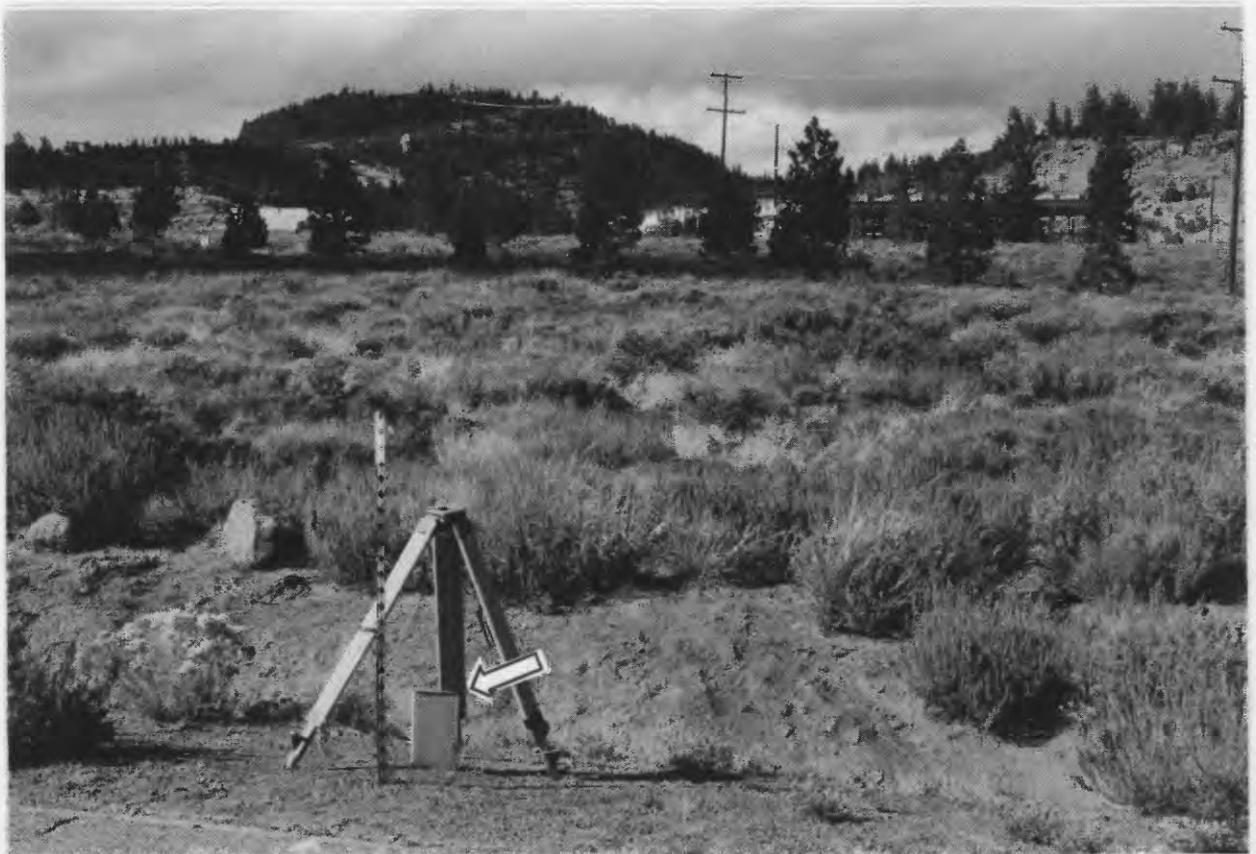
Figure 19

View looking east
Arrow at tripod points to bench mark

View looking north
Arrow at tripod points to bench mark

- DBR 15 5.91 km (3.65 mi.) east along State Highway 203 from the entrance to the post office at Mammoth Lakes, and 0.46 km (0.3 mi.) east of U.S. Highway 395 crossing. Bench mark is attached to a metal rod enclosed in a 20 cm (8 in.) diameter PVC plastic pipe projecting 0.3 m (12 in.), 4.6 m (15 ft.) north of the centerline of old Mammoth road, and 0.5 m (1.6 ft.) south of a witness post (See figure 19). Bench mark is stamped "DBR 15 1983".

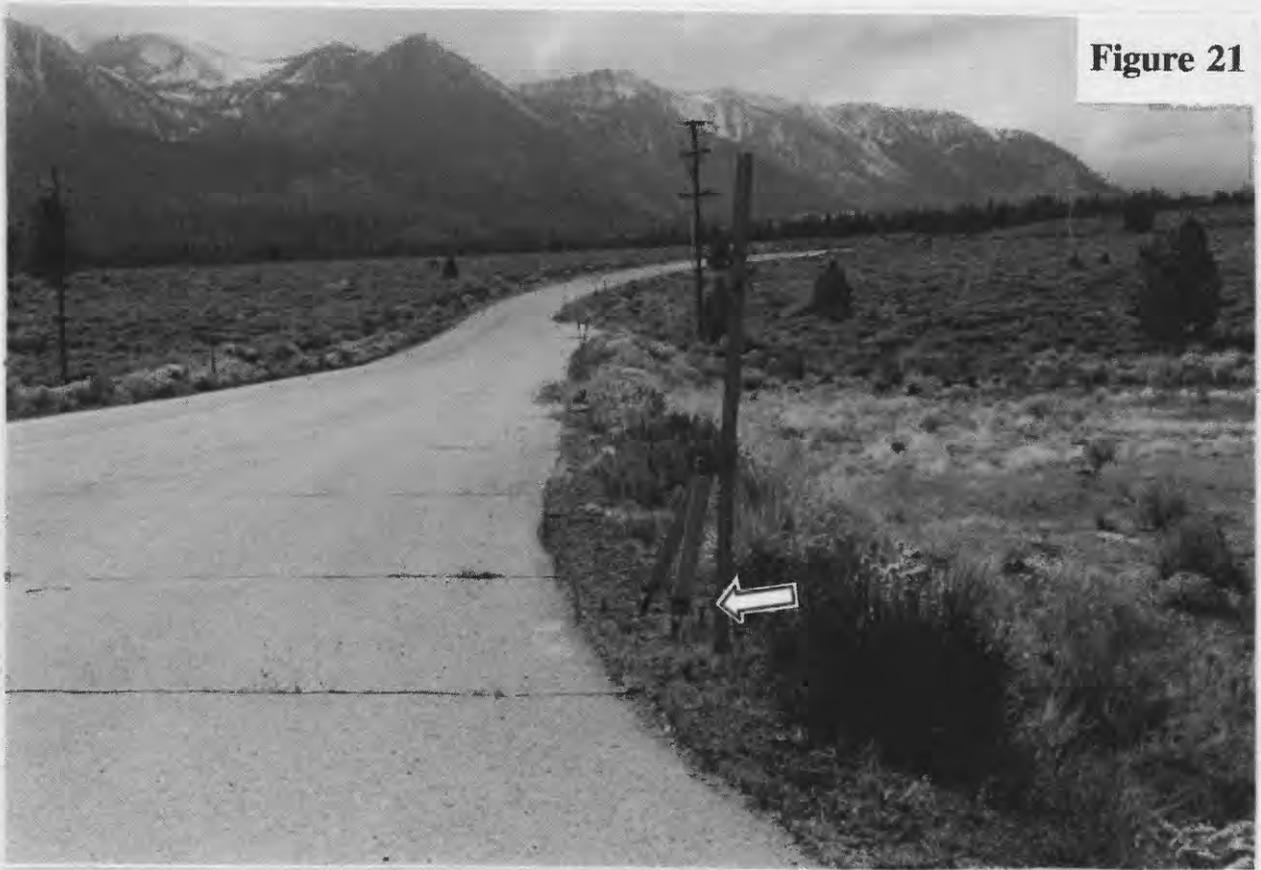
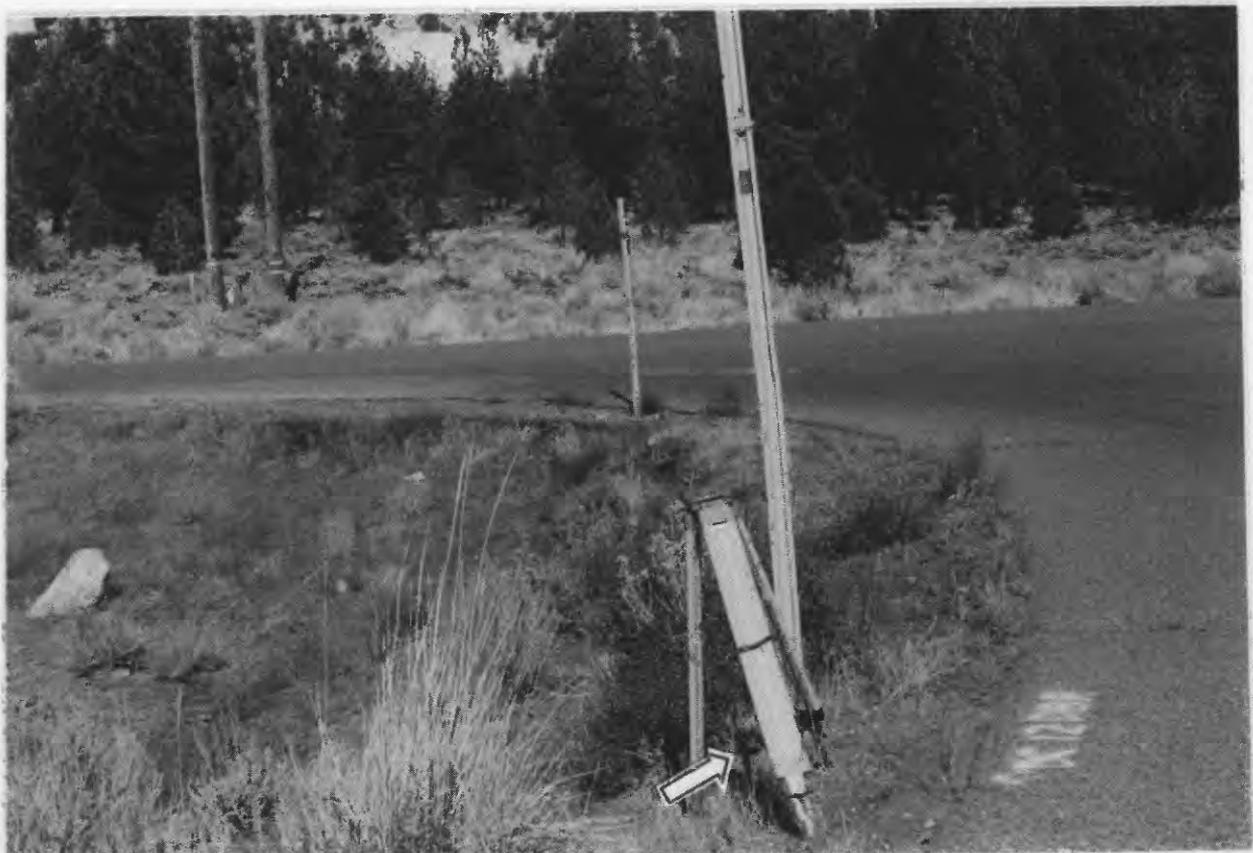
Figure 21

View looking west
Arrow at tripod points to bench mark

View looking north
Arrow at tripod points to bench mark

- DBR 12 6.11 km (3.8 mi.) east along State Highway 203 from the entrance to the post office at Mammoth Lakes, and 0.66 km (0.4 mi.) east of U.S. Highway 395 crossing. Bench mark is attached to a metal rod projecting 0.15 m (6 in.), 8.2 m (27 ft.) north of the centerline of old mammoth road, and 0.8 m (2.6 ft.) west of a metal fence post (See figure 21). Bench mark is stamped "DBR 12 1983".

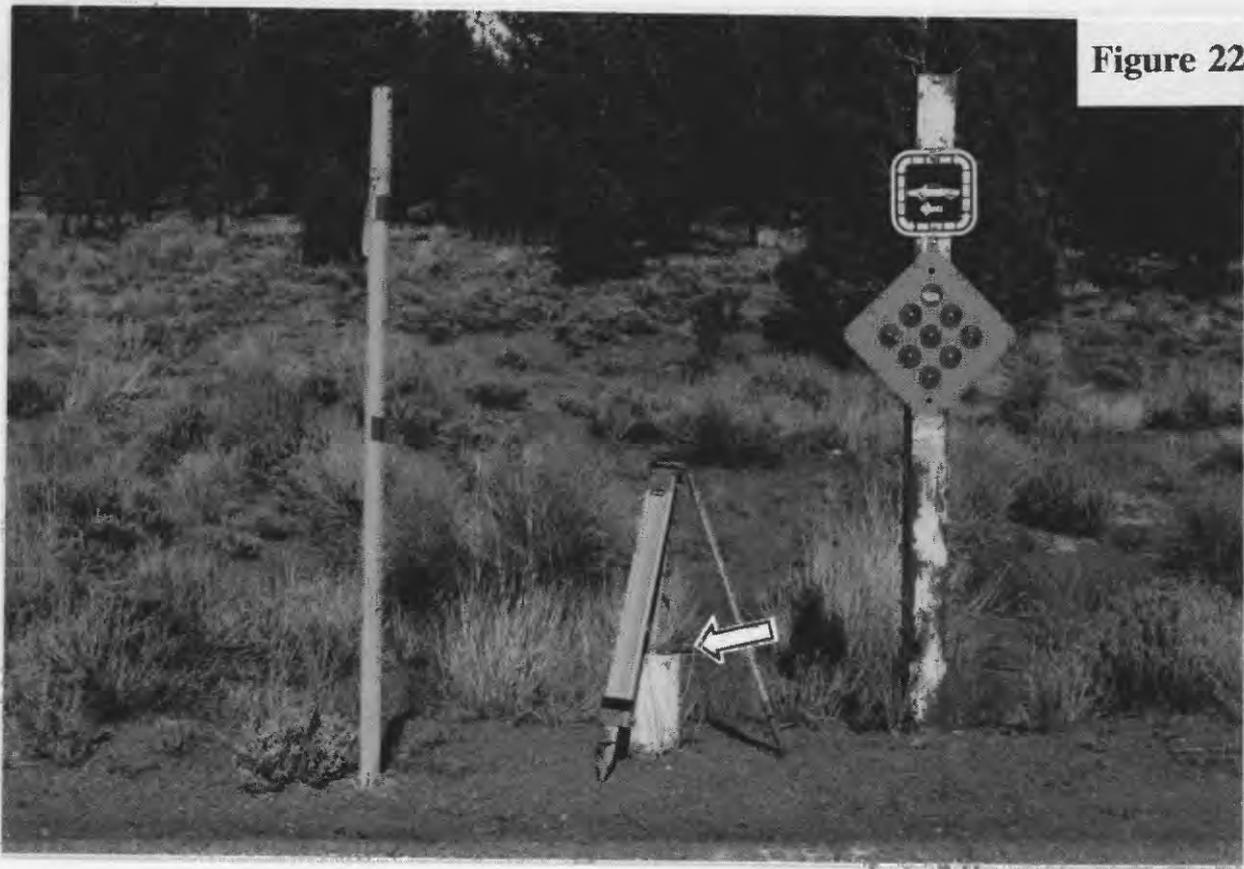
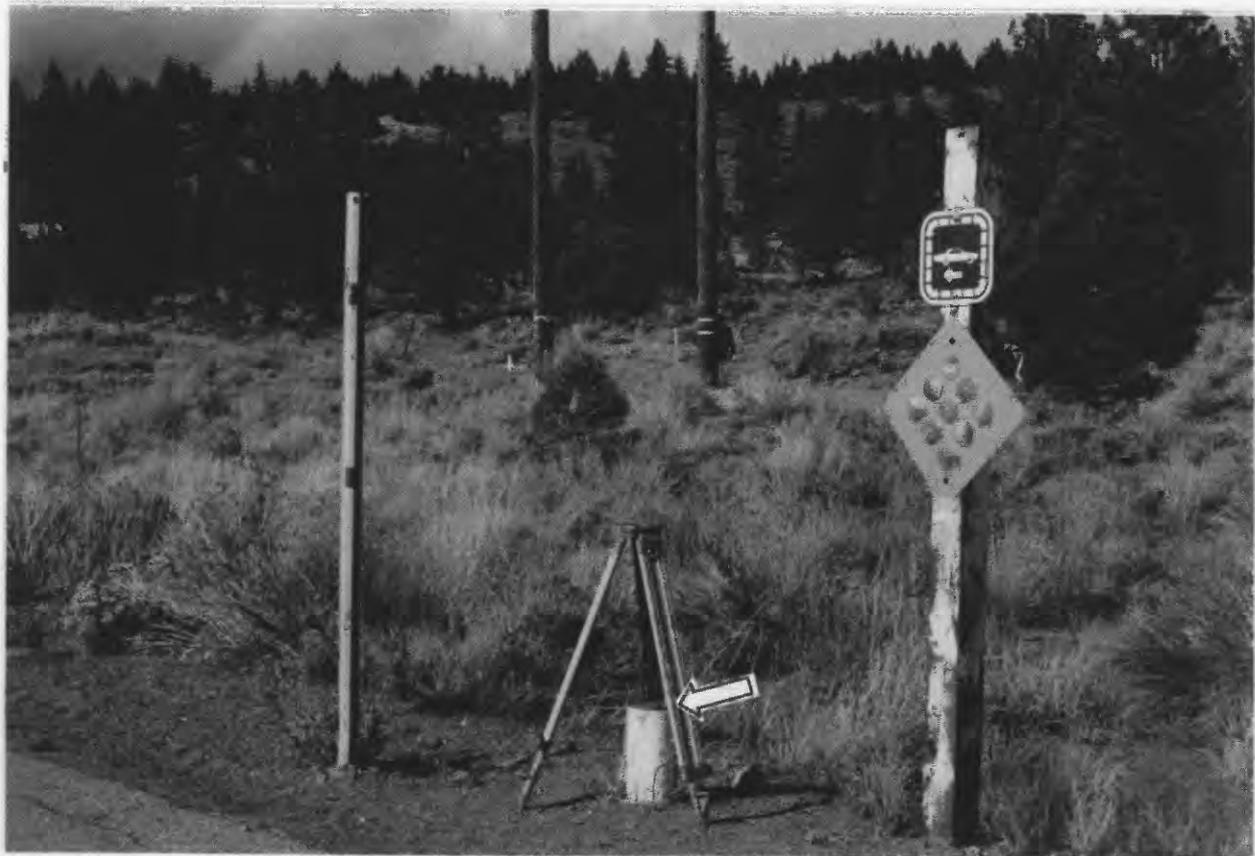
Figure 22

View looking east-northeast
Arrow at tripod points to bench mark

View looking north
Arrow at tripod points to bench mark

- DBR 11 6.15 km (3.8 mi.) east along State Highway 203 from the entrance to the post office at Mammoth Lakes, 0.69 km (0.45 mi.) east of U.S. Highway 395 crossing and at the "T" junction of old U.S. Highway 395. Bench mark is attached to a metal rod enclosed in a 20 cm (8 in.) diameter (broken) PVC

plastic pipe projecting 0.35 m (14 in.) above ground level, 4.8 m (16 ft.) north of the center of the "T" junction, and 1 m (3 ft.) west of a wooden sign post (See figure 22). Bench mark is stamped "DBR 11 1983".
