*Descriptions and Elevations for Bench Marks
at Mammoth Lakes, California*

Open-File Report 91-630

PURPOSE OF REPORT

This report describes new bench marks installed by the Cascades Volcano Observatory (CVO) leveling crew during the fall of 1989. In addition, improved descriptions are given for bench marks installed by the U.S. Geological Survey (USGS) in 1982, 1983, and 1985, and bench marks installed by the National Geodetic Survey (NGS) in 1986.

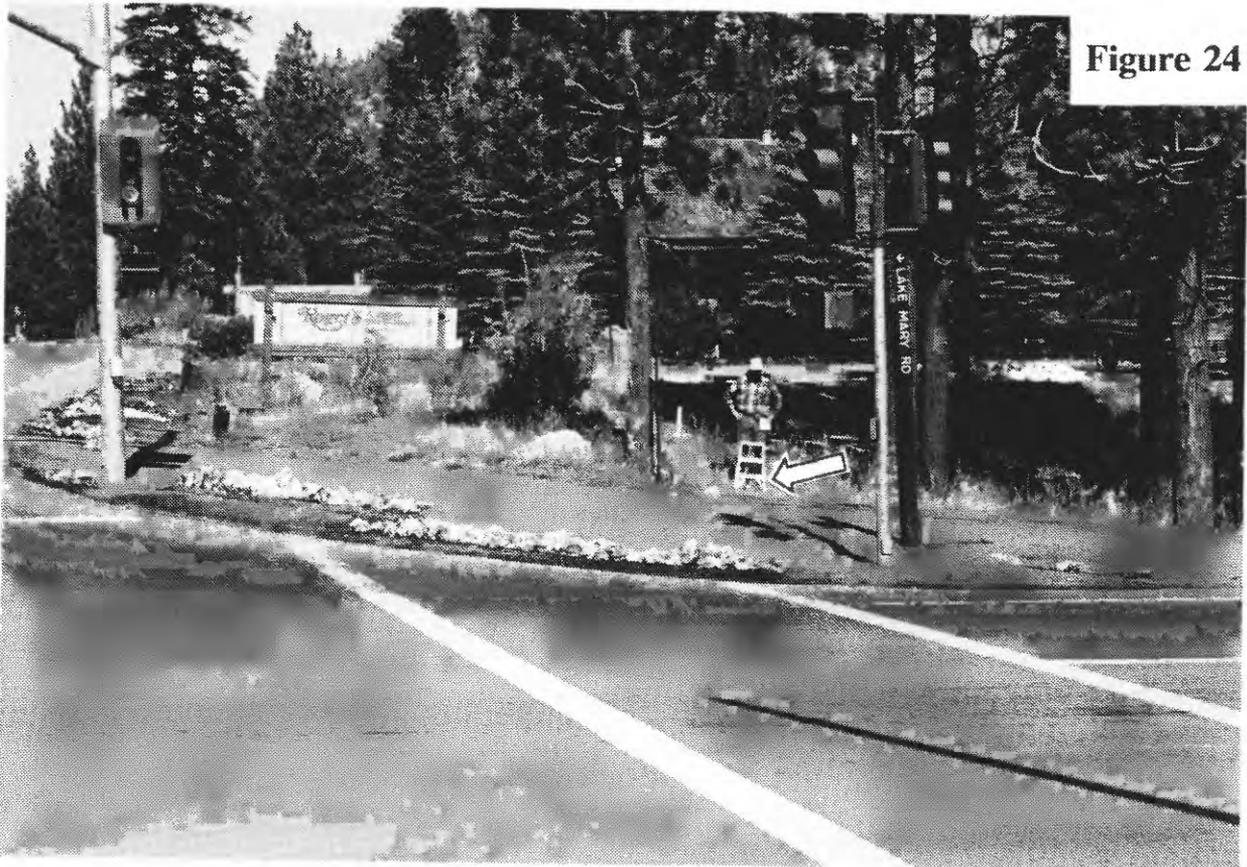
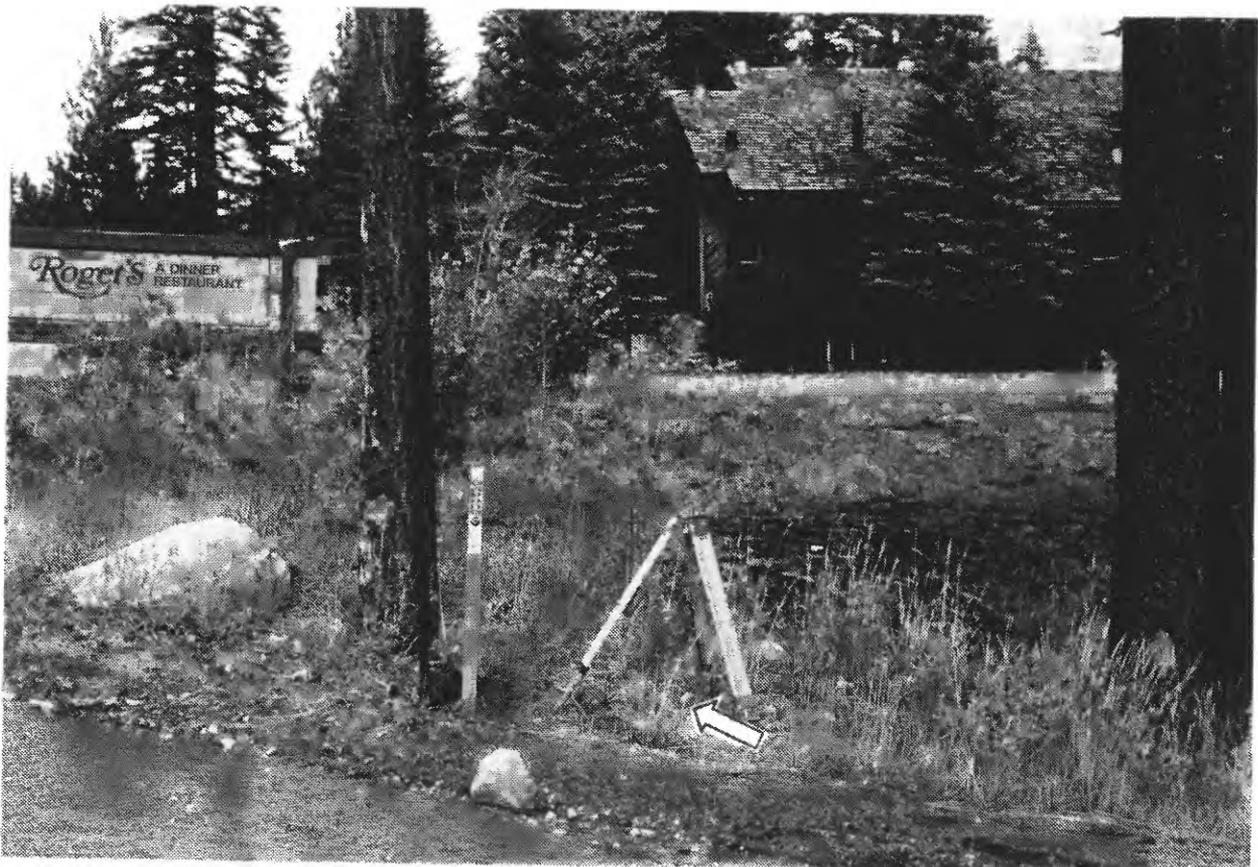
Figure 24

View looking northwest
Arrow at step ladder points to bench mark

View looking west
Arrow at tripod points to bench mark

- J 1383 1.05 km (0.65 mi.) west along State Highway 203 from the entrance to the post office at Mammoth Lakes to the intersection of Lake Mary, State Highway 203, and Minaret Summit roads. Mark is a stainless-steel rod enclosed in a 12.7 cm (5 in.) PVC pipe with a metal cap, in the northeast quadrant of the road intersection, 25 m (82 ft.) north from the double centerline of State Highway 203, 18 m (59 ft.) east of the centerline of the road to Minaret Summit, and 1 m (3 ft.) east of a witness post (See figure 24). Stamping on metal ring holding cap is "J 1383 1986".

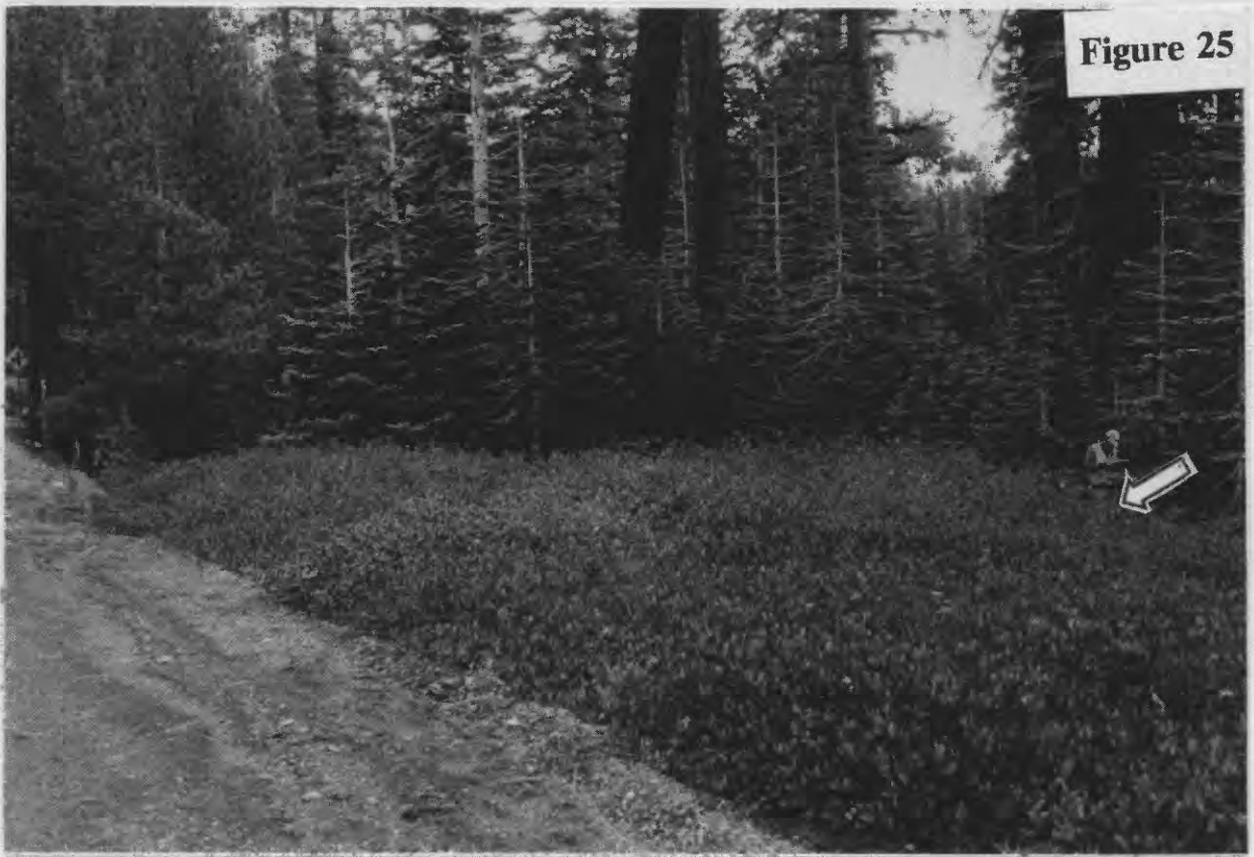
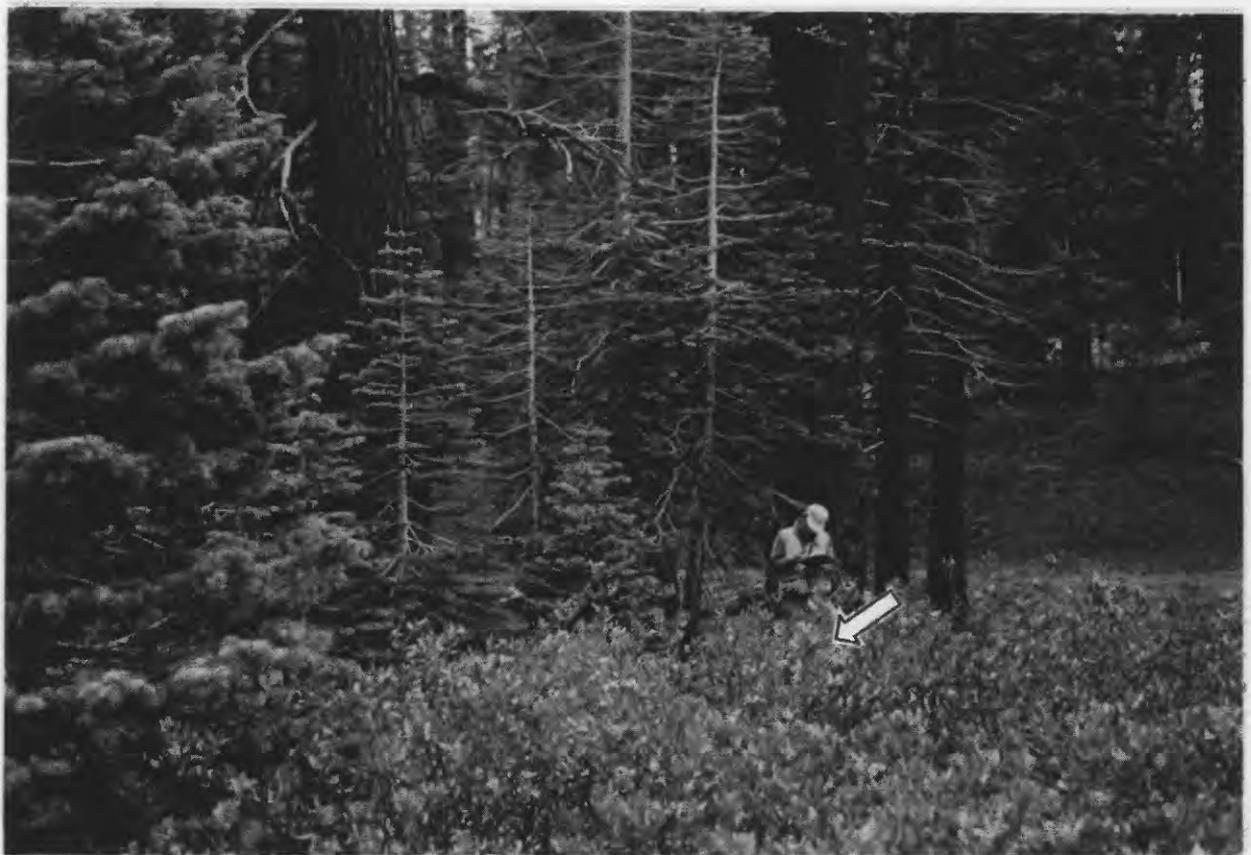
Figure 25

View looking south
Arrow points to bench mark

View looking southwest
Arrow points to bench mark

- H 1383 1.05 km (0.65 mi.) west along State Highway 203 from the entrance to the post office at Mammoth Lakes to the intersection of Lake Mary, State Highway 203, and Minaret Summit roads, then north along the road to Minaret Summit for 0.86 km (0.55 mi.). Bench mark is cemented on the east end of a 1 X 1.2 m (3 X 4 ft.) rock outcrop, projecting 0.3 m (1 ft.) above ground level, 20 m (65 ft.) south of the centerline of the road, approximately 1.8 m (6 ft.) lower than the road level, and 0.6 m (2 ft.) east of a witness post (See figure 25). Bench mark is stamped "H 1383 1986".

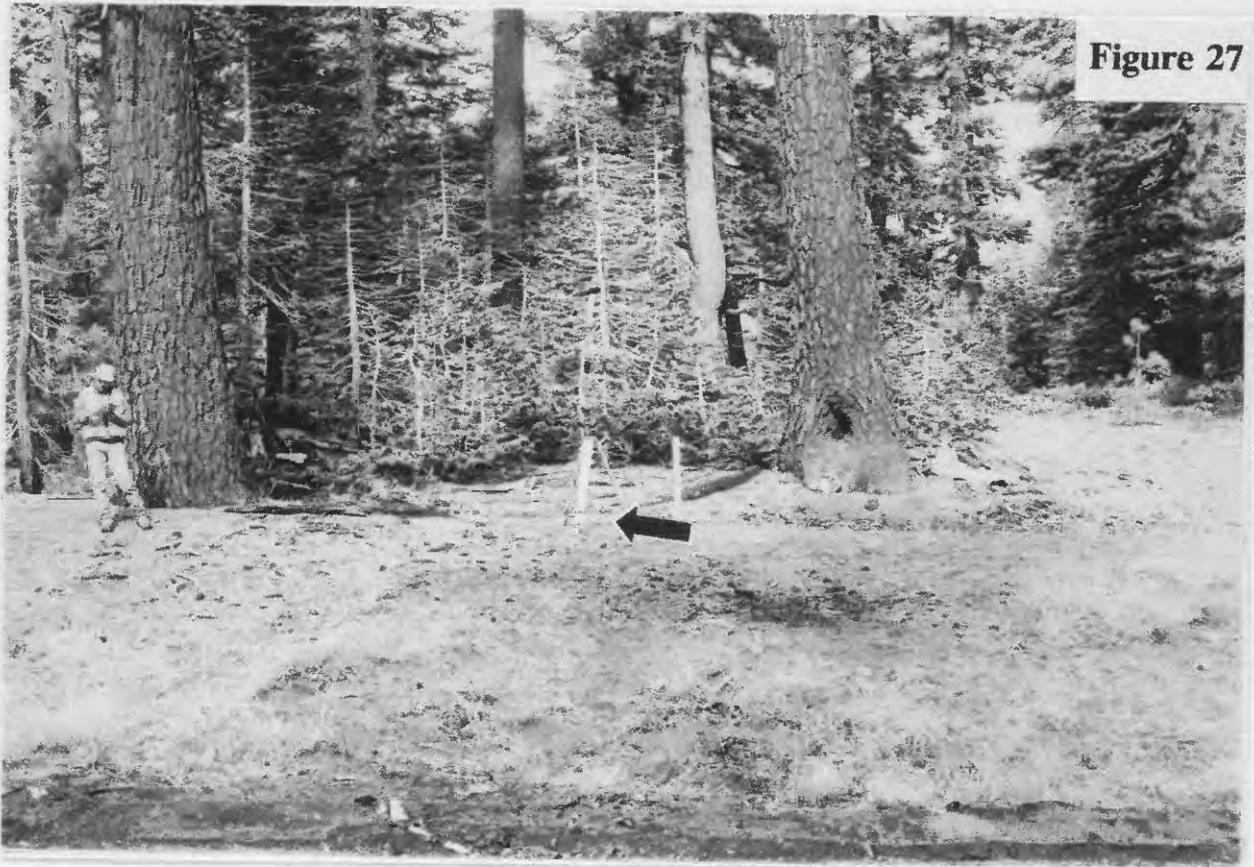
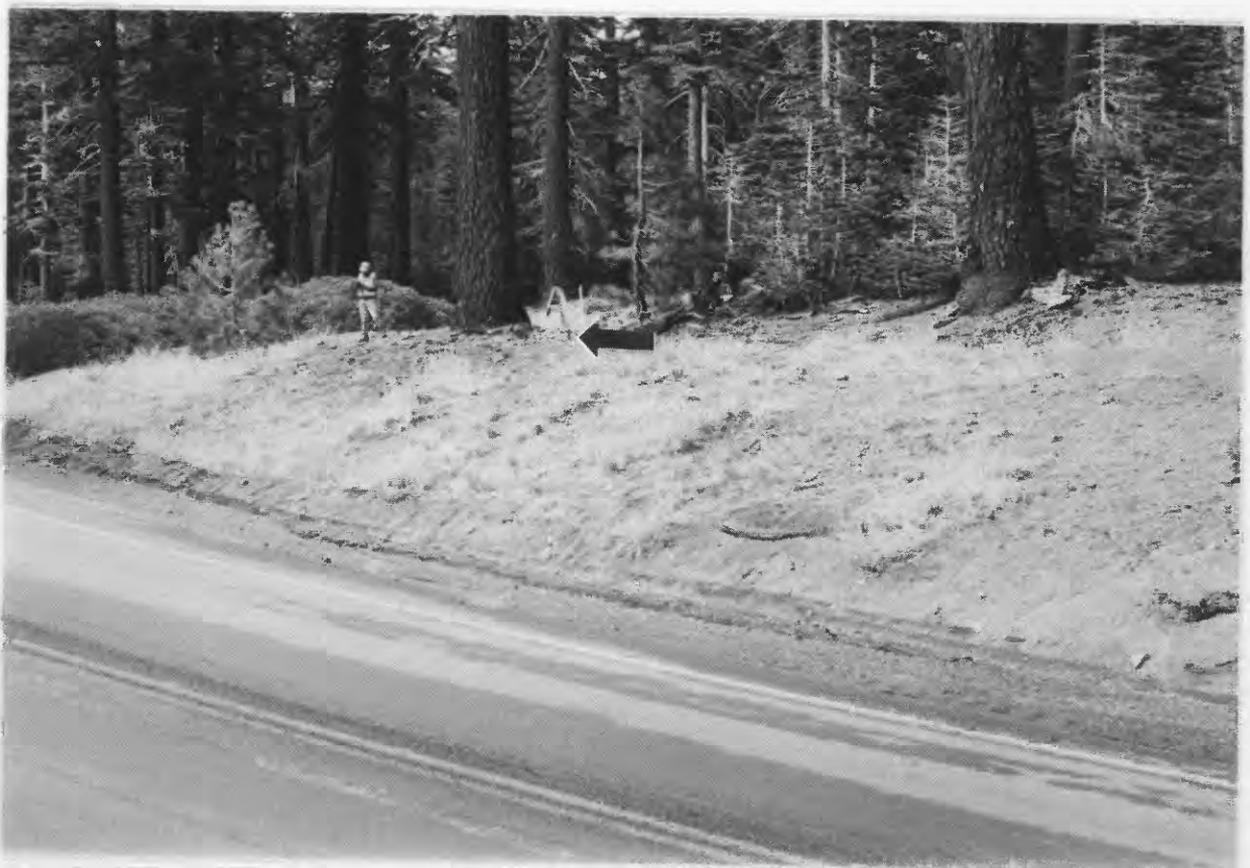
Figure 27

View looking northwest
Arrow at tripod points to bench mark

- G 1383 1.05 km (0.65 mi.) west along State Highway 203 from the entrance to the post office at Mammoth Lakes to the intersection of Lake Mary, State Highway 203, and Minaret Summit roads, then north along the road to Minaret Summit for 1.96 km (1.2 mi.). Mark is a stainless-steel rod

enclosed in 12.7 cm (5 in.) diameter PVC pipe with a metal cap, 16 m (52 ft.) northwest of the centerline of the highway, 40 m (130 ft.) southwest of a curve sign, approximately 3.7 m (ft.) above road level, and 1 m (3 ft.) south of a witness post (See figure 27). Stamping on metal ring holding cap is "G 1383 1986".

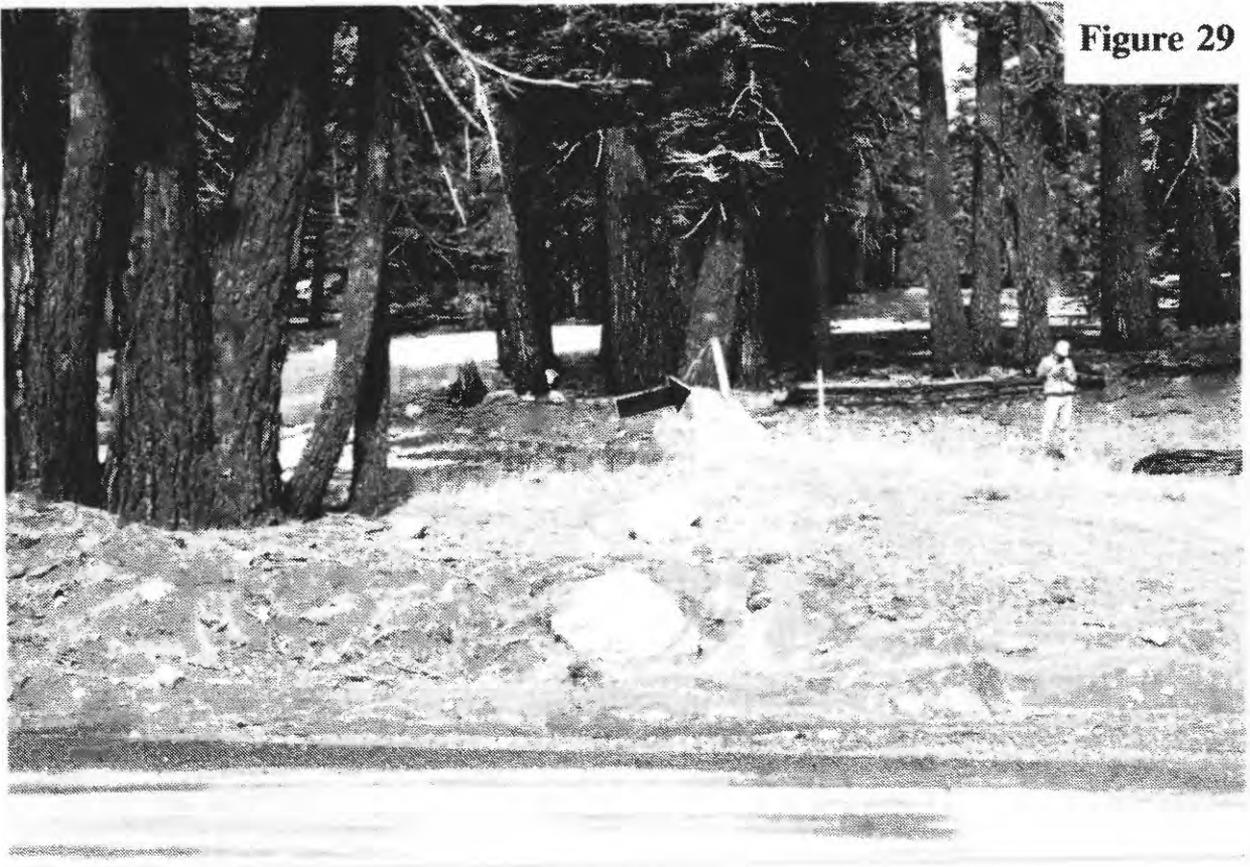
Figure 29

View looking north
Arrow at tripod points to bench mark

View looking northwest
Arrow at tripod points to bench mark

- 6 JCM 1.05 km (0.65 mi.) west along State Highway 203 from the entrance to the post office at Mammoth Lakes to the intersection of Lake Mary, State Highway 203, and Minaret Summit roads, then north along the road to Minaret Summit for 2.89 km (1.8 mi.). Bench mark is cemented on the top of a 1.5 X 1.8 m (5 X 6 ft.) boulder projecting 1.2 m (4 ft.) above the ground level, 29 m (94 ft.) northeast of the centerline of the highway, 13 m (42 ft.) northeast of the center of the road leading to "Earthquake Fault", and 1.5 m (5 ft.) southwest of a witness post (See figure 29). Bench mark is stamped "6 JCM 1982".

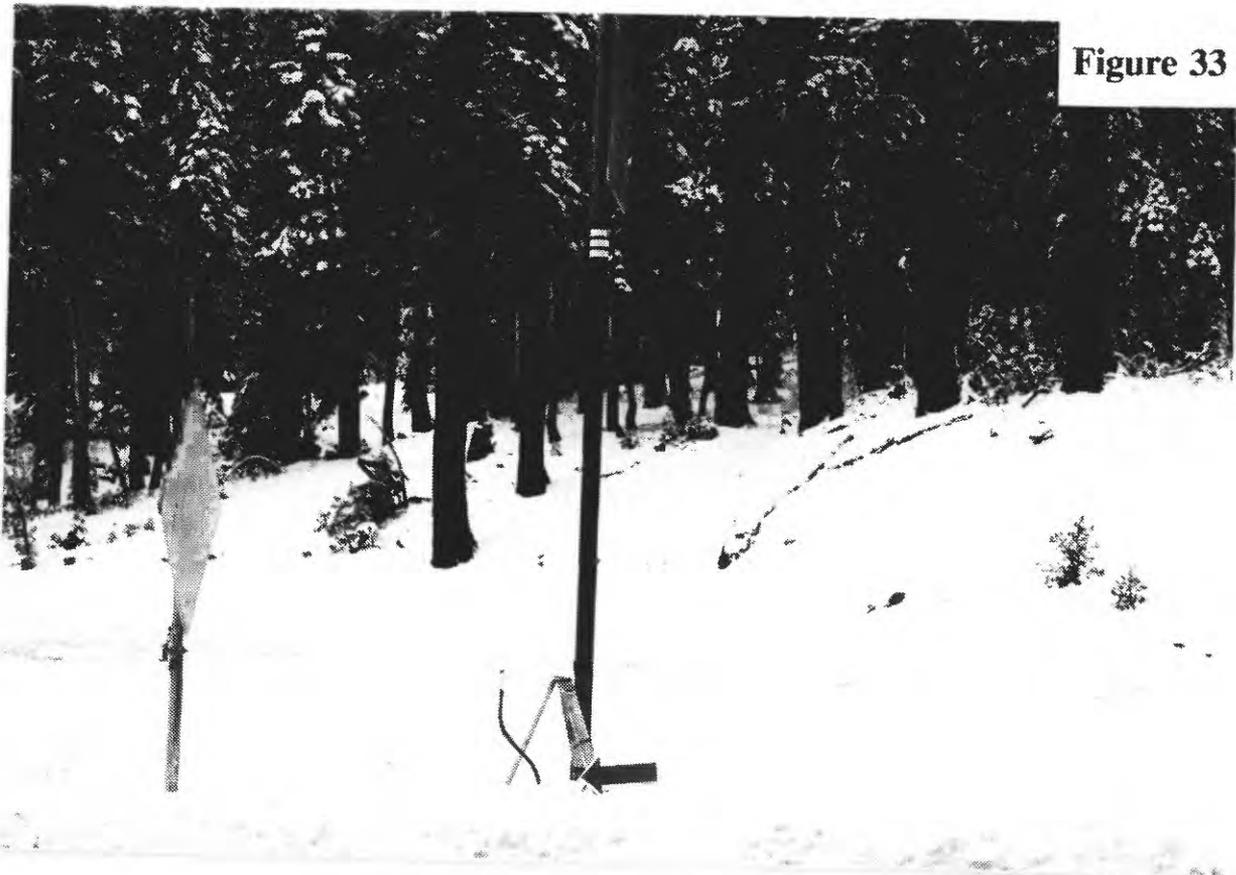
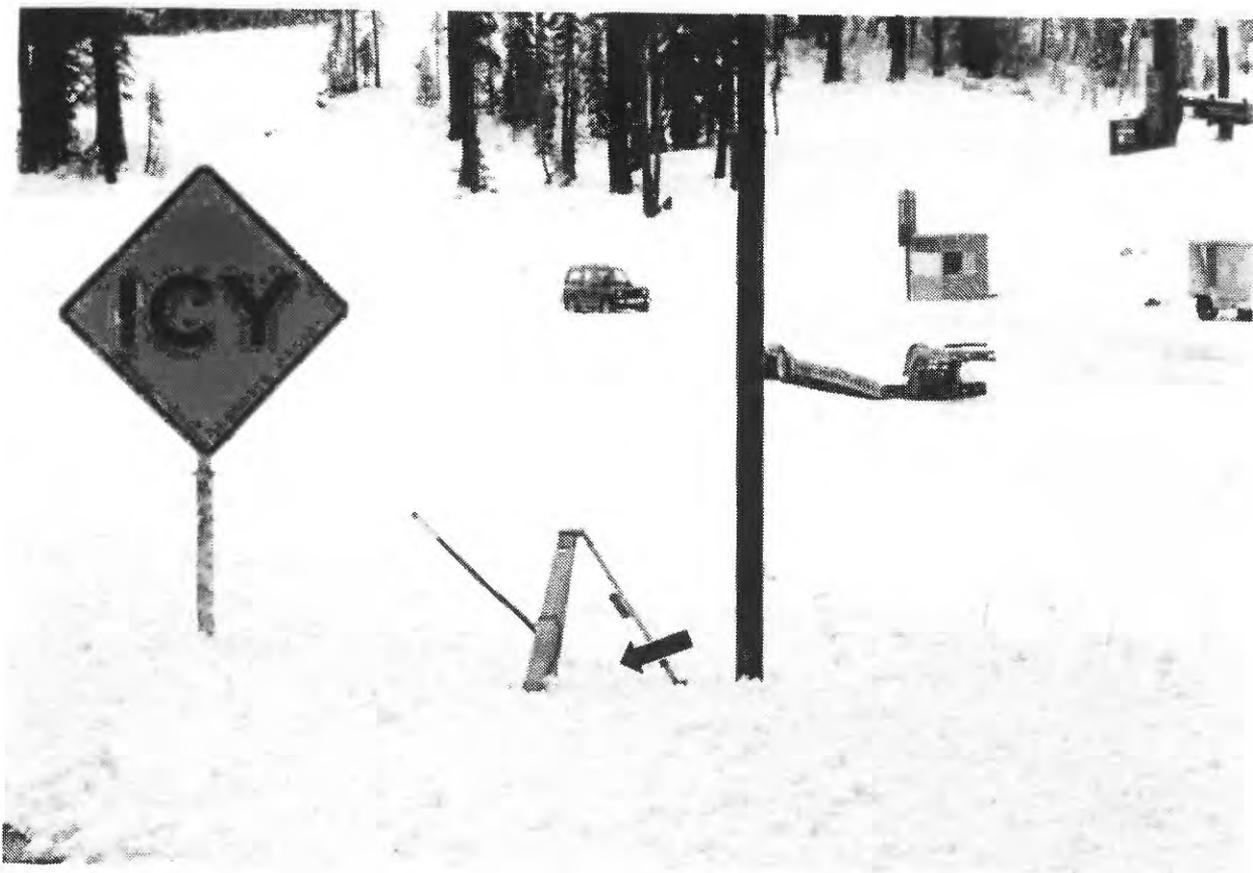
Figure 33

View looking south
Arrow at tripod points to bench mark

View looking southeast
Arrow at tripod points to bench mark

- JEE 3 1.05 km (0.65 mi.) west along State Highway 203 from the entrance to the post office at Mammoth Lakes to the intersection of Lake Mary, State Highway 203, and Minaret Summit roads, then north along the road to Minaret Summit for 5.79 km (3.6 mi.). Bench mark is attached to a metal rod enclosed in a 15 cm (6 in.) PVC pipe at the northern end of the same parking lot as JEE 1, near a "No overnight parking" sign, 2.1 m (7 ft.) southwest of a "ICY" sign, and 3.5 m (11.5 ft) from the west edge of road pavement (See figure 33). Bench mark is stamped "JEE 3".

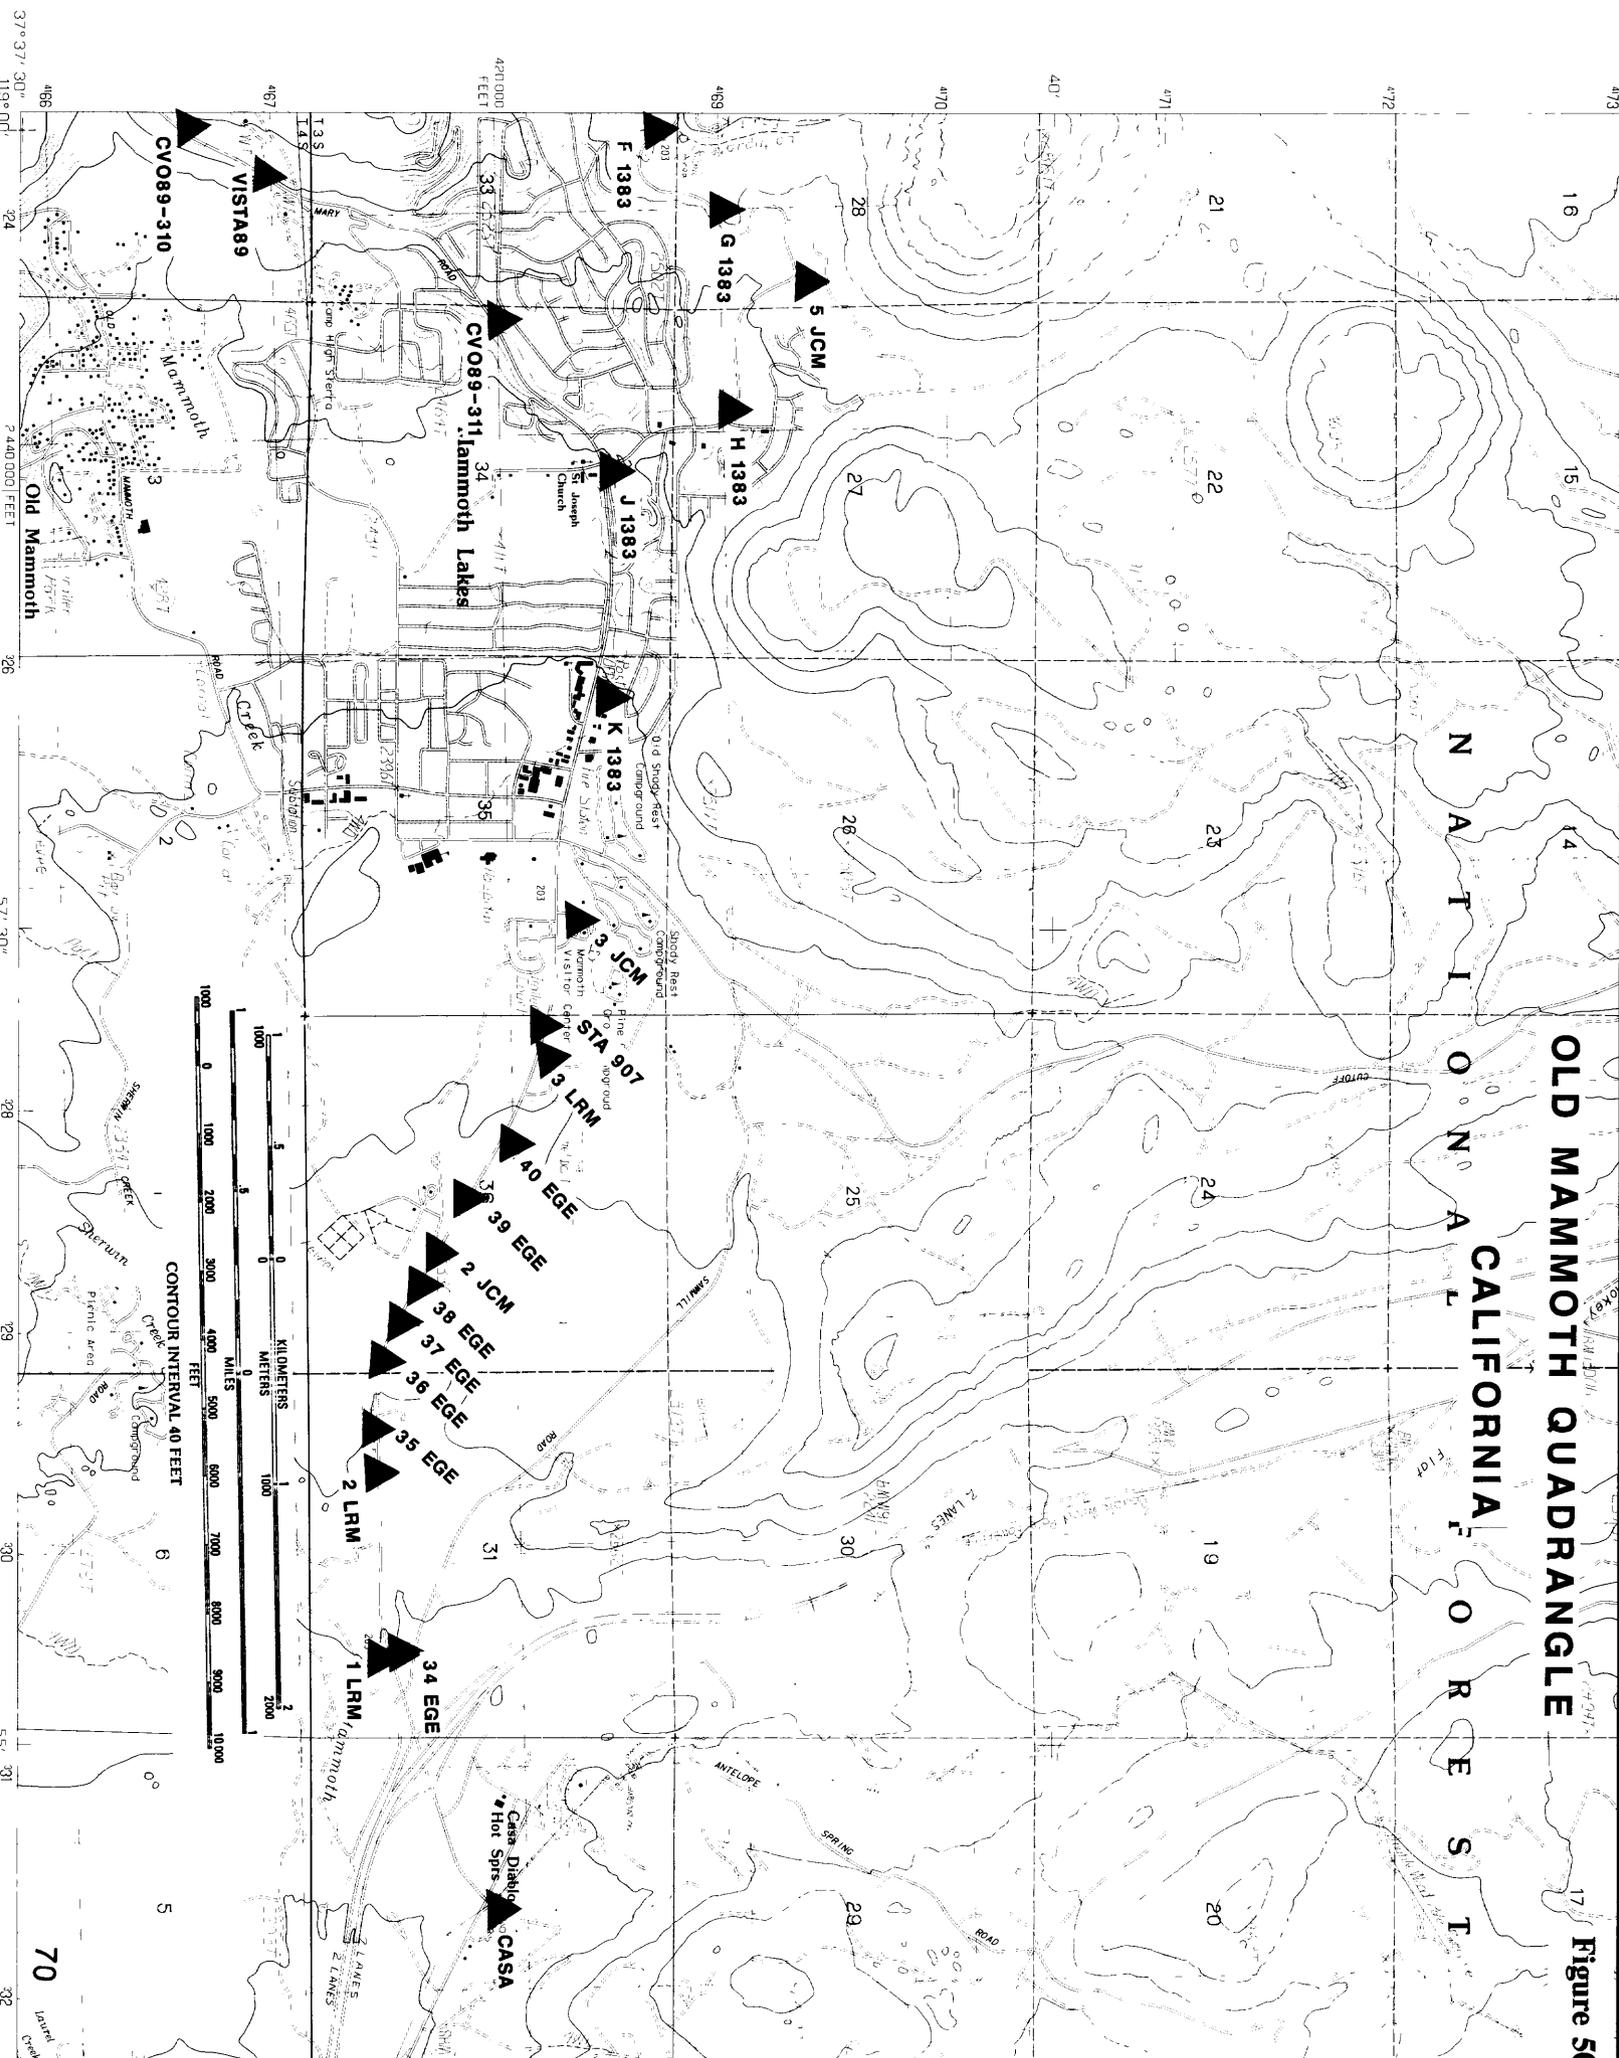
Figure 50

Also included is a partial reproduction of the U.S. Geological Survey topographic quadrangles, OLD MAMMOTH, CRYSTAL CRAG and MAMMOTH MTN, CA., with the locations of the bench marks plotted (figures 50 to 52).
