Channel Change on the Santa Cruz River, Pima County, Arizona, 1936–86

By JOHN T.C. PARKER

U.S. GEOLOGICAL SURVEY
Open-File Report 93—41

Prepared in cooperation with the
PIMA COUNTY DEPARTMENT OF TRANSPORTATION
AND FLOOD CONTROL DISTRICT

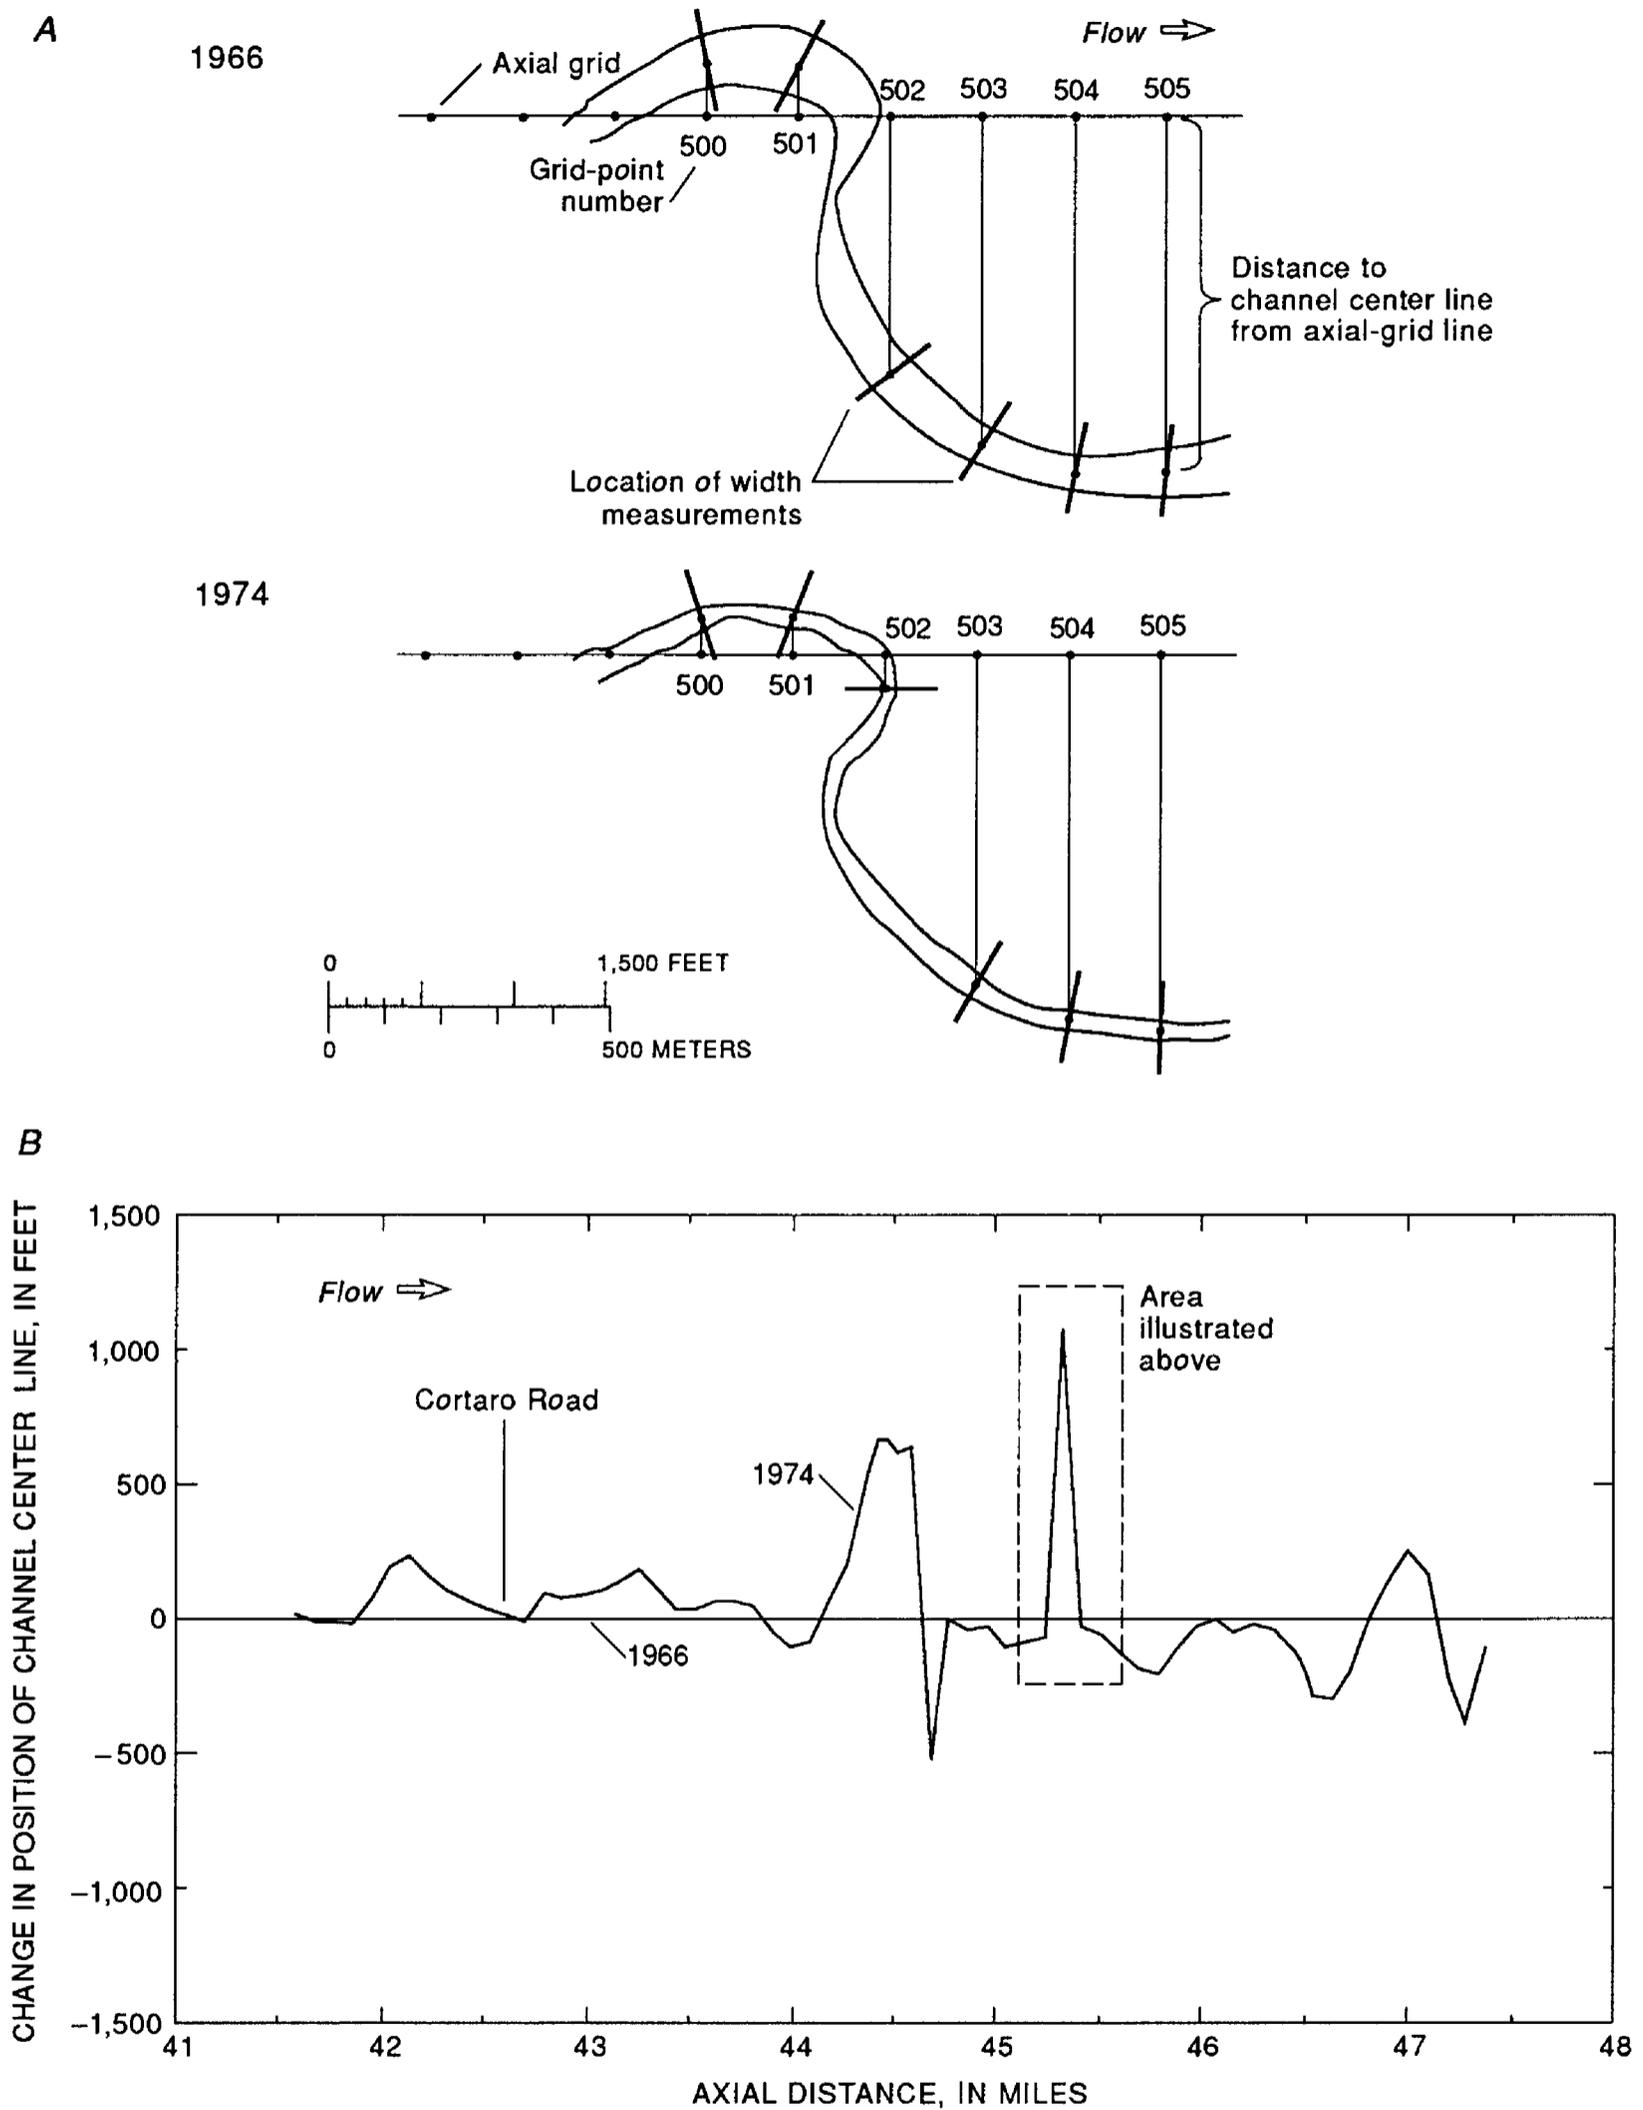
Figure 2. Method of relating channel change to axial reference system. *A*, Measurement of changes in width and channel position from 1966 and 1974. Note large shift in position relative to grid point 502 caused by rotation of meander axis. *B*, Change in position of channel center line with time. Positive values indicate shift in position toward left side of channel; negative values indicate shift toward right side.

new location of each channel center point relative to the channel axis (fig. 2B). Although plots such as figure 2B indicate lateral channel stability, the magnitude of shift in channel position is not a measure of bank retreat or meander migration, which is a vector quantity. Large shifts in position of the channel center line but minor amounts of channel movement can be caused by a change in channel orientation such as shown at grid point 502 in figure 2A and in the boxed area of figure 2B.

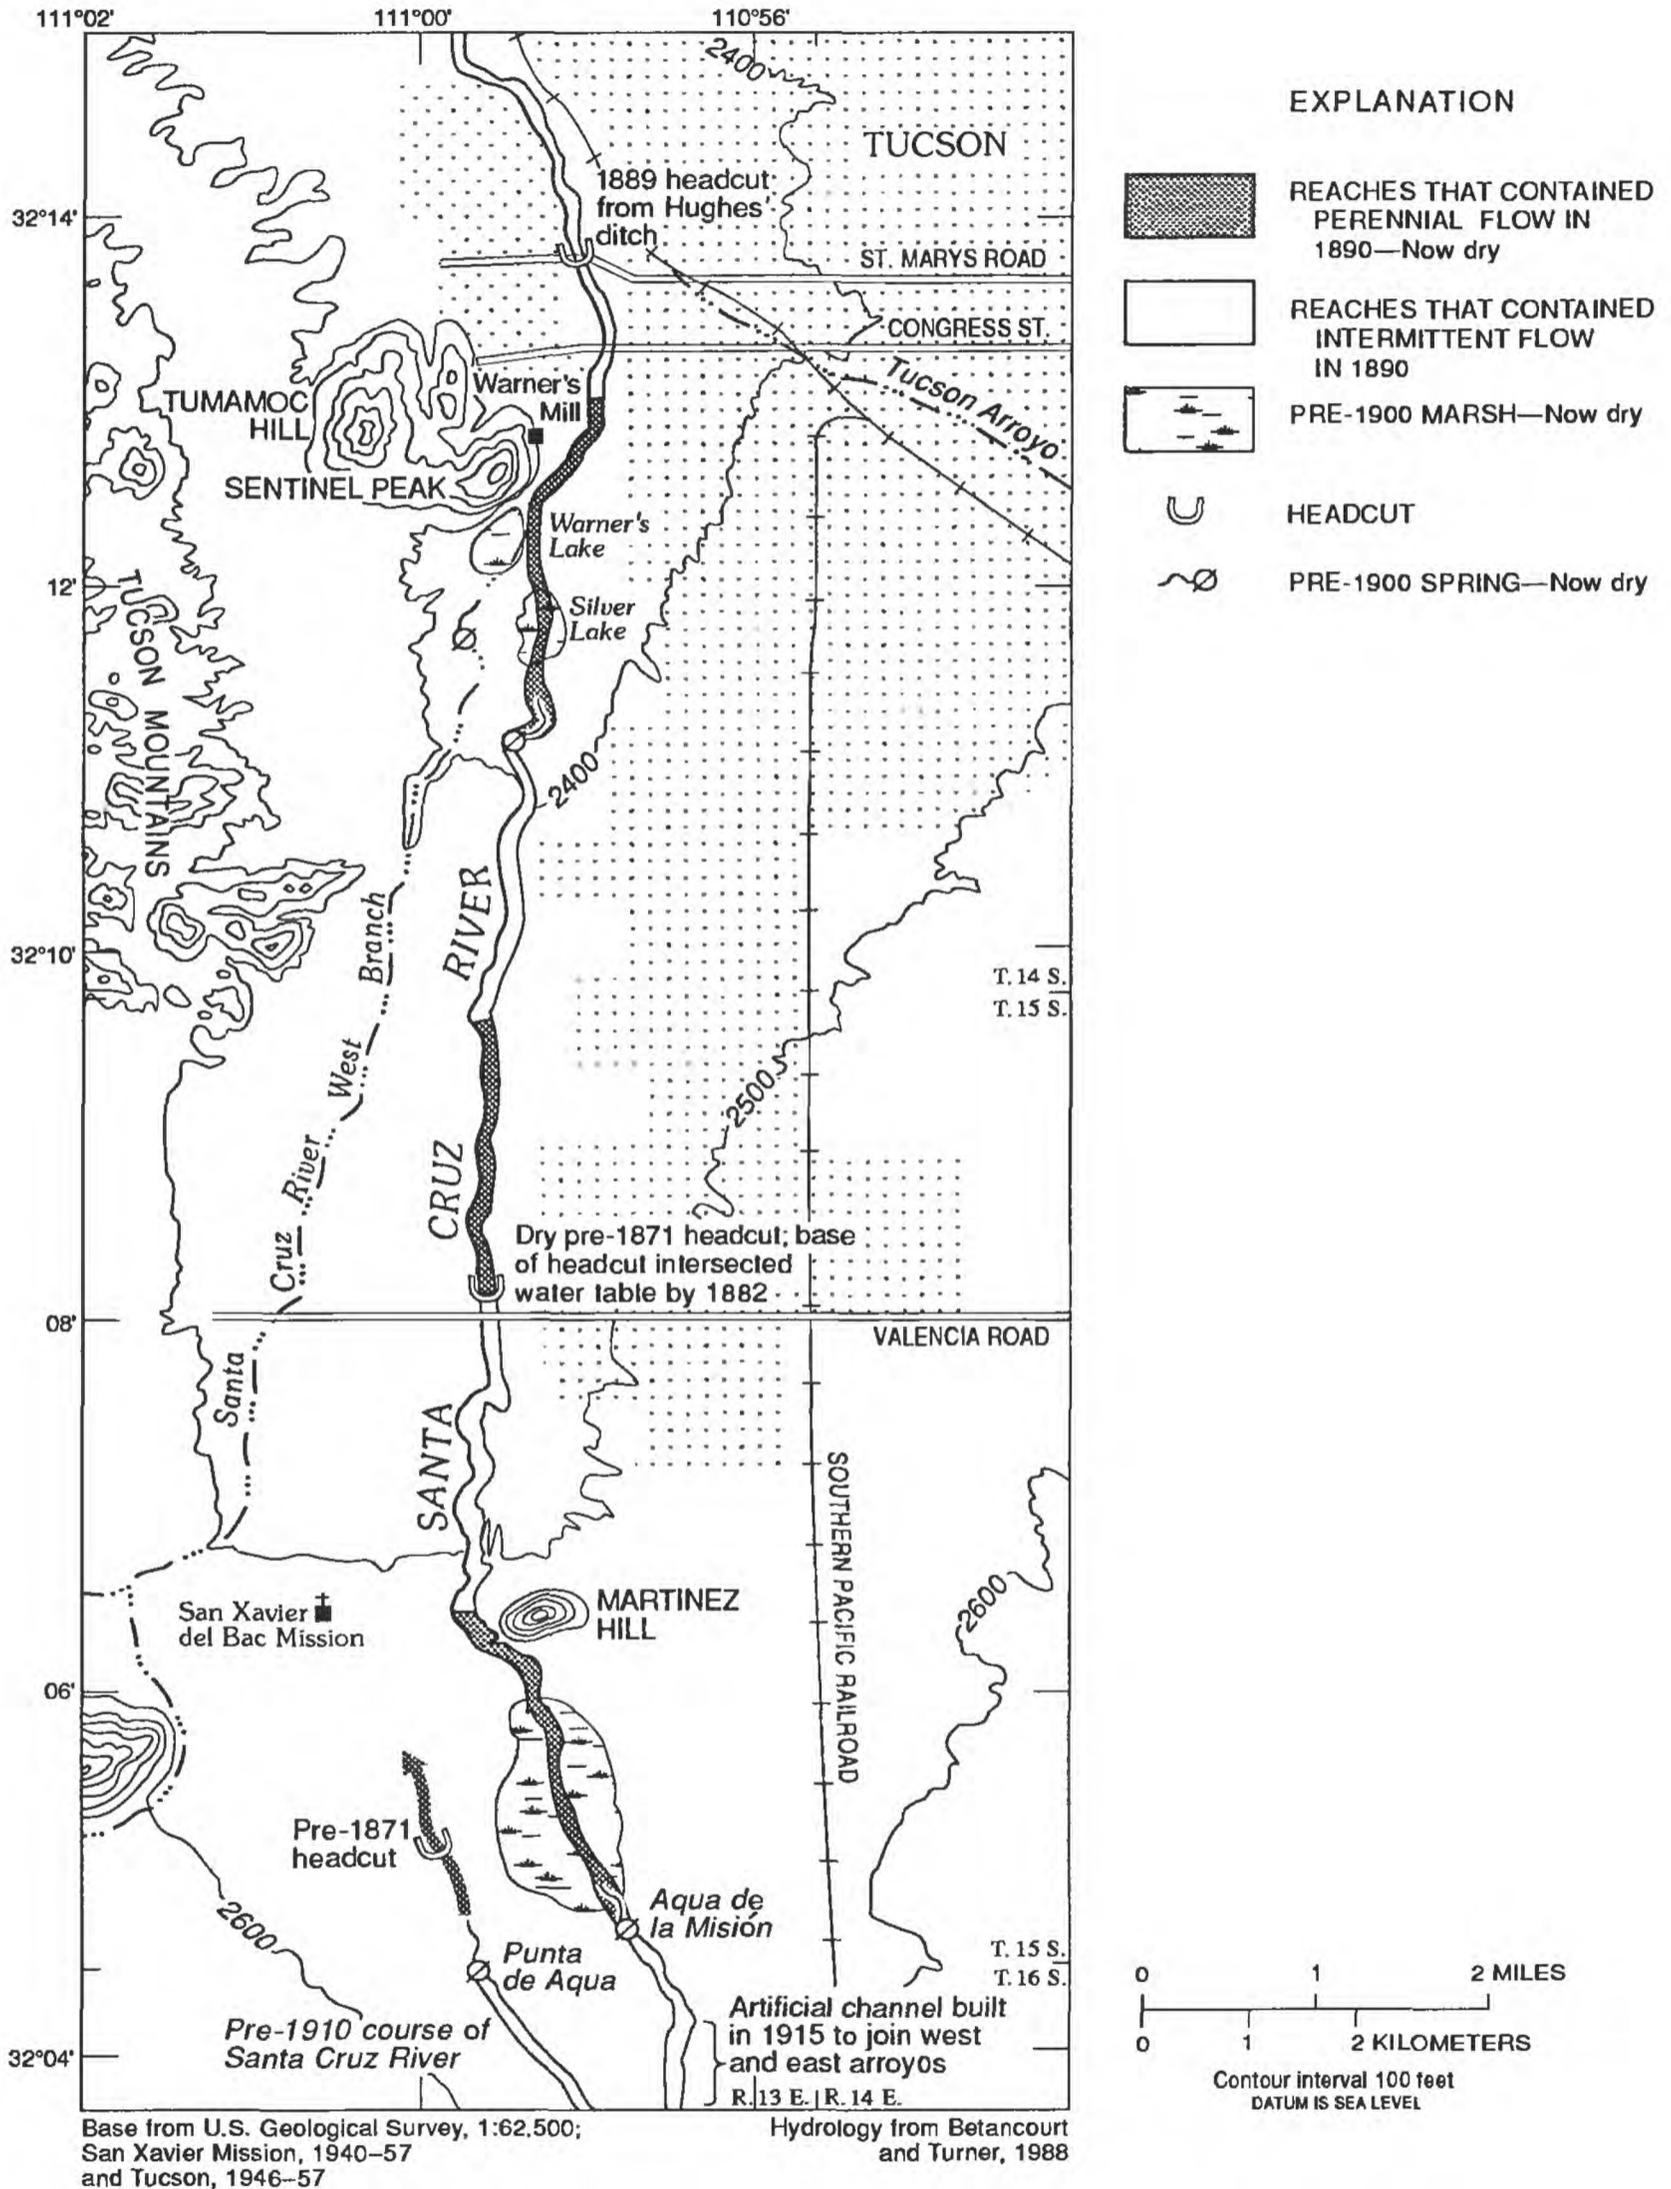
Figure 3. Santa Cruz River in 1988, perennial and intermittent reaches in 1890, and location of headcuts in relation to marshes in the late 19th century.

Headcuts signaling the onset of arroyo formation were first described in 1871 in the San Xavier area (fig. 3; Betancourt and Turner, 1988). In the late 1880's, extensive headcutting began through Tucson as a result of poorly engineered waterworks and high flows, particularly a series of summer floods in 1890. By 1910, the arroyo extended from Martinez Hill to Tucson. Winter floods in 1914-15 caused major channel widening and destroyed the bridge at Congress Street in Tucson. These floods also extended the headcutting through

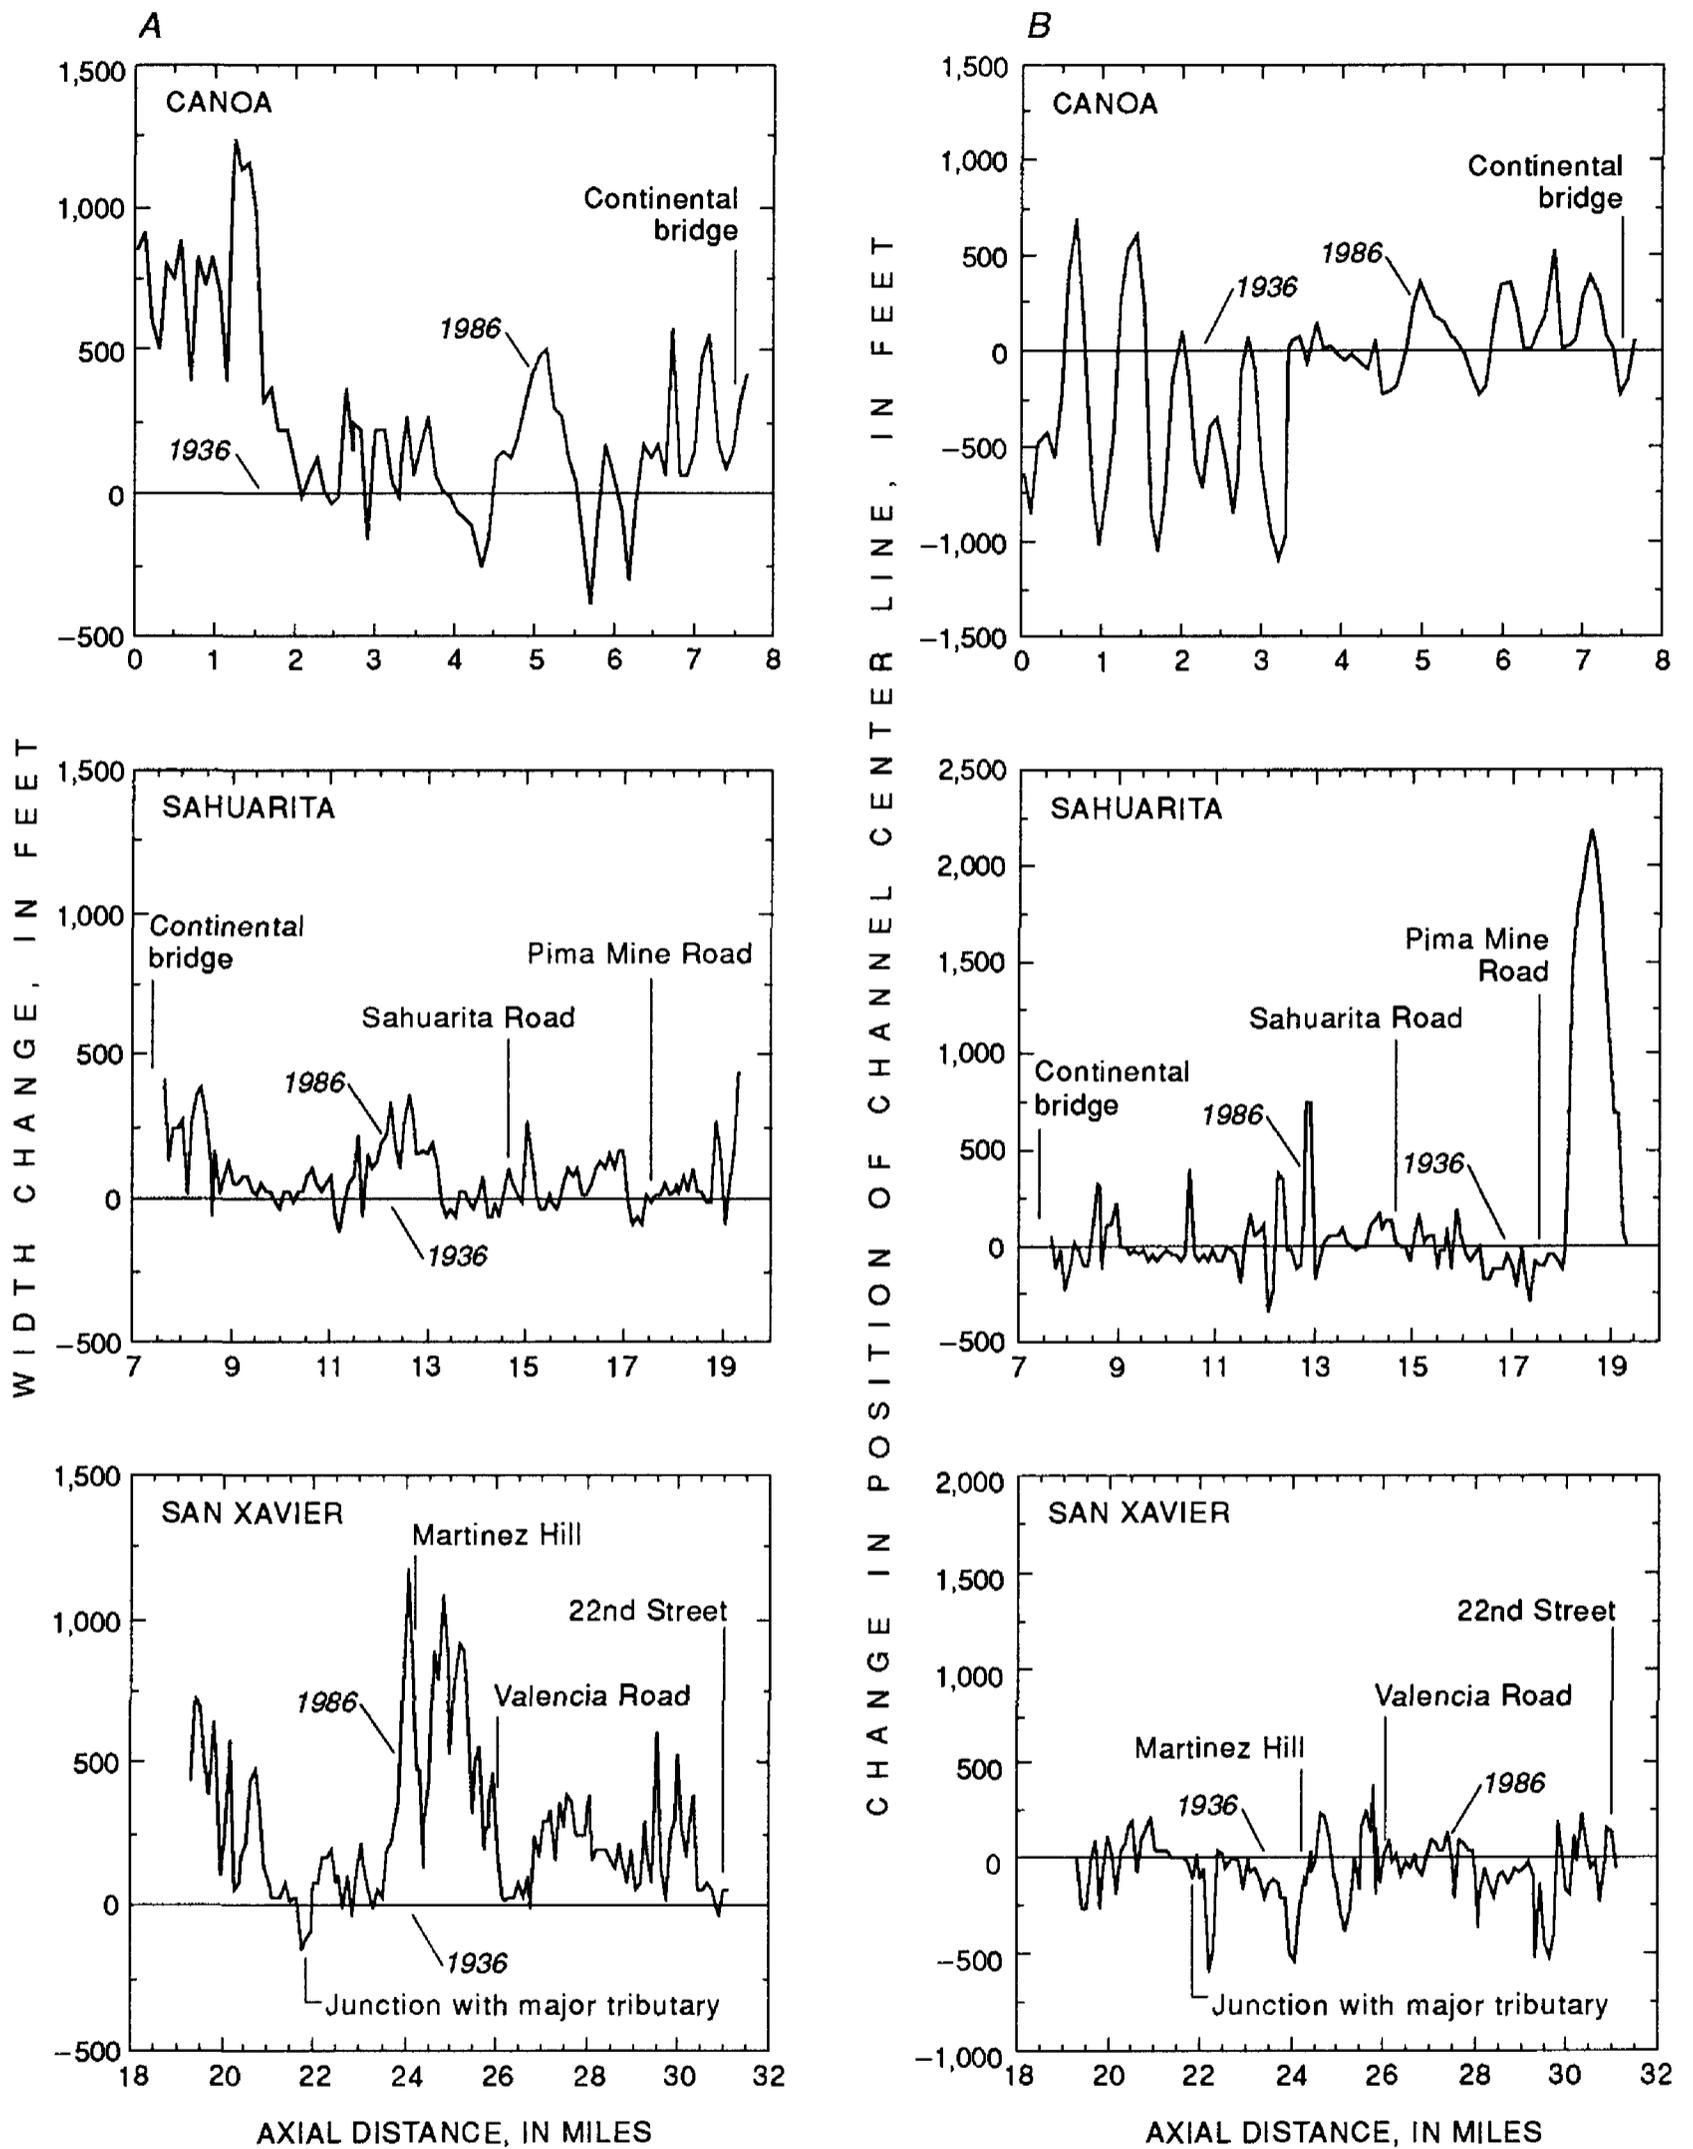
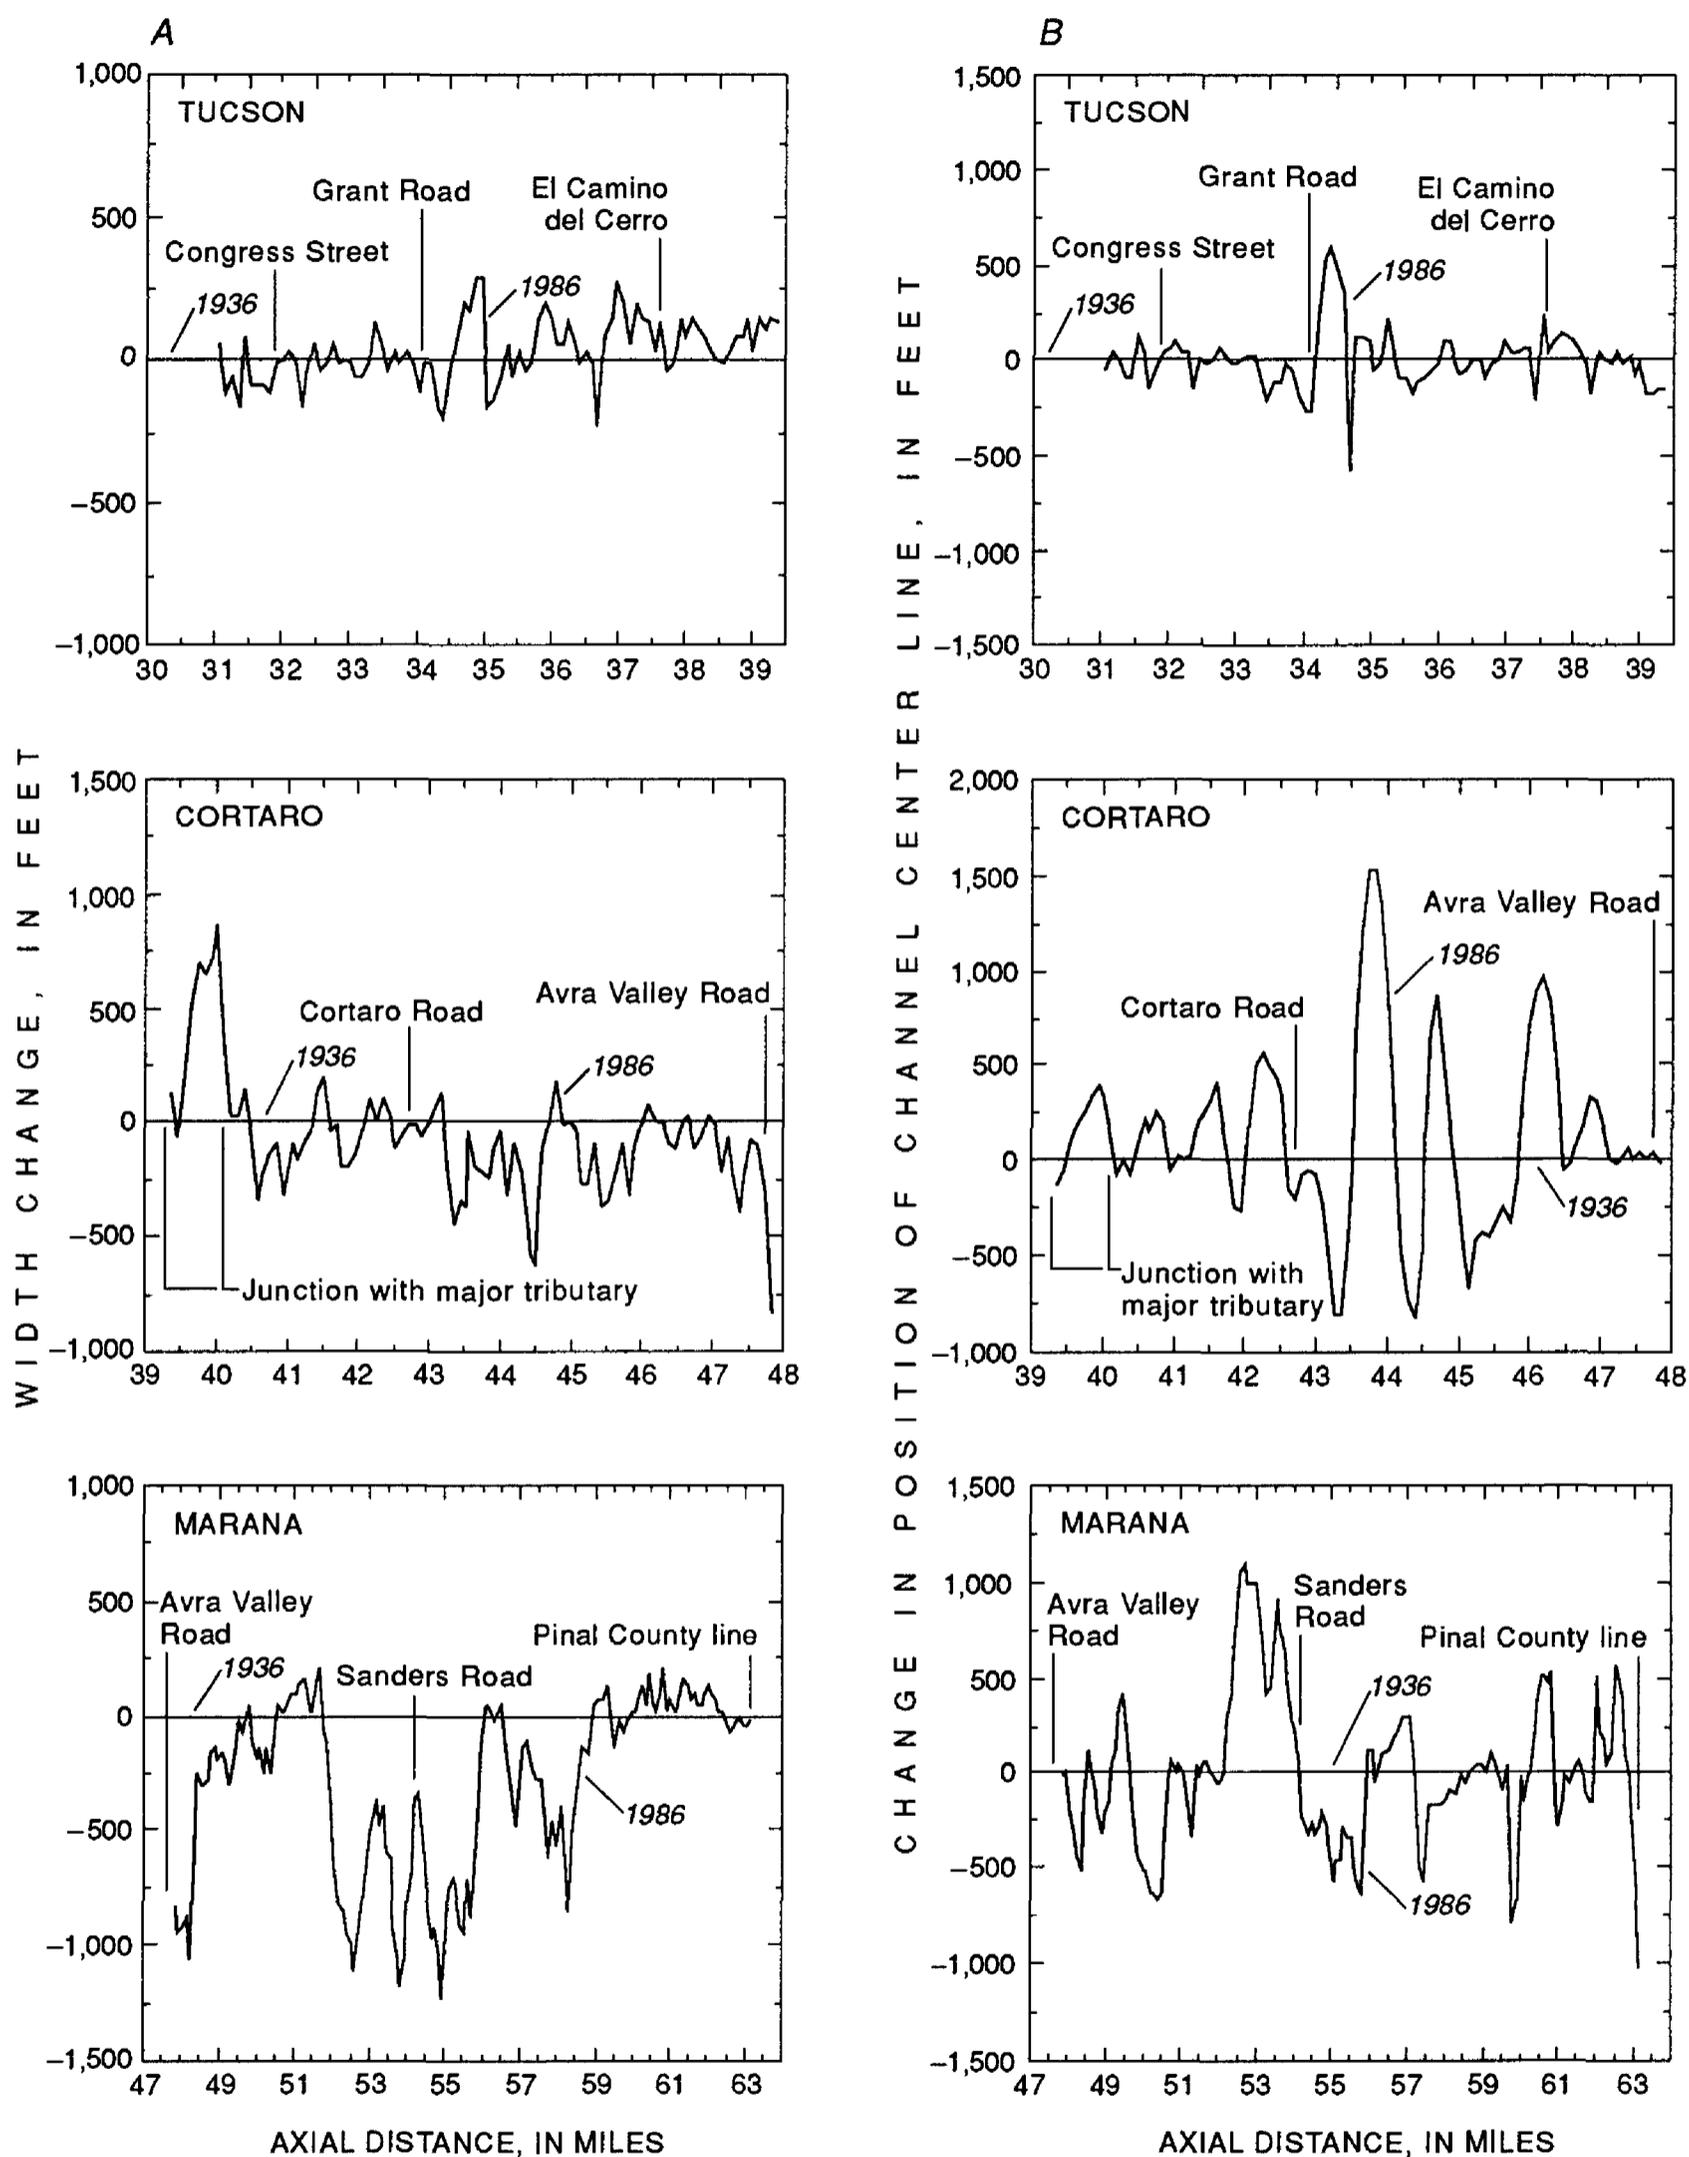
Figure 4. Channel changes on the Canoa, Sahuarita, San Xavier, Tucson, Cortaro, and Marana reaches, 1936-86. *A*, Width change. *B*, Change in position of channel center line. Positive values indicate shift in position toward left side of channel; negative values indicate shift toward right side.

From 1936 through 1986, channel change on the Santa Cruz River was characterized by an increase in width and a decrease in length throughout most of the study area (table 1 and fig. 4). Most of the reduction in length was the result of channelization. The increase in mean width would have been greater except for human intervention such as bank armoring, which inhibited channel widening, and landfill operations or channel maintenance, which narrowed channels artificially. Net vertical change in the same period was primarily degradational (fig. 5).

The Canoa reach is characterized by a generally unentrenched, sandy channel that occupies a 5,000-foot-wide active flood plain. The reach has undergone major channel widening (fig. 4A); however, little natural change occurred before the floods of 1977 and 1983. Much of the change in channel position and stream length (fig. 4B and table 1) resulted from artificial channelization that has been in place since at least the 1950's; 70 percent of channel widening during the study interval was caused by the 1983 flood.

The San Xavier reach was the most continuously unstable reach of the Santa Cruz River during the study period (fig. 4C). The channel is entrenched 20 to 30 ft into weakly indurated alluvium of Holocene age that fails readily when undercut during flows. The arroyo has widened continuously along most of the reach throughout the study period. Mean width increased 2.3 times, and median width increased by almost three times between 1936 and 1986. Downstream from Martinez Hill, sand and gravel operations and other activities, such as landfill operations, have altered the arroyo; however, upstream from that point, disturbance from human activity has been slight.

The Tucson reach has shown the least lateral instability during the study period (fig. 4D). Much of the apparent stability is artificial—either as a result of bank armoring, which has prevented channel change, or of artificial filling, which has obscured the record of change occurring between 1936 and 1986. Parts of the reach underwent about 15 ft of degradation between the 1950's and 1976 (fig. 5J).

The Cortaro and Marana reaches have had the most complex record of channel change since 1936 (fig. 4E-F). The Marana reach has changed from a wide, braided channel to a compound channel that is less than half the width of the channel in 1936. Both reaches were unstable before 1966 when they had sparsely vegetated ephemeral channels and would undergo large, frequent shifts in channel position. In 1970, when flow from sewage

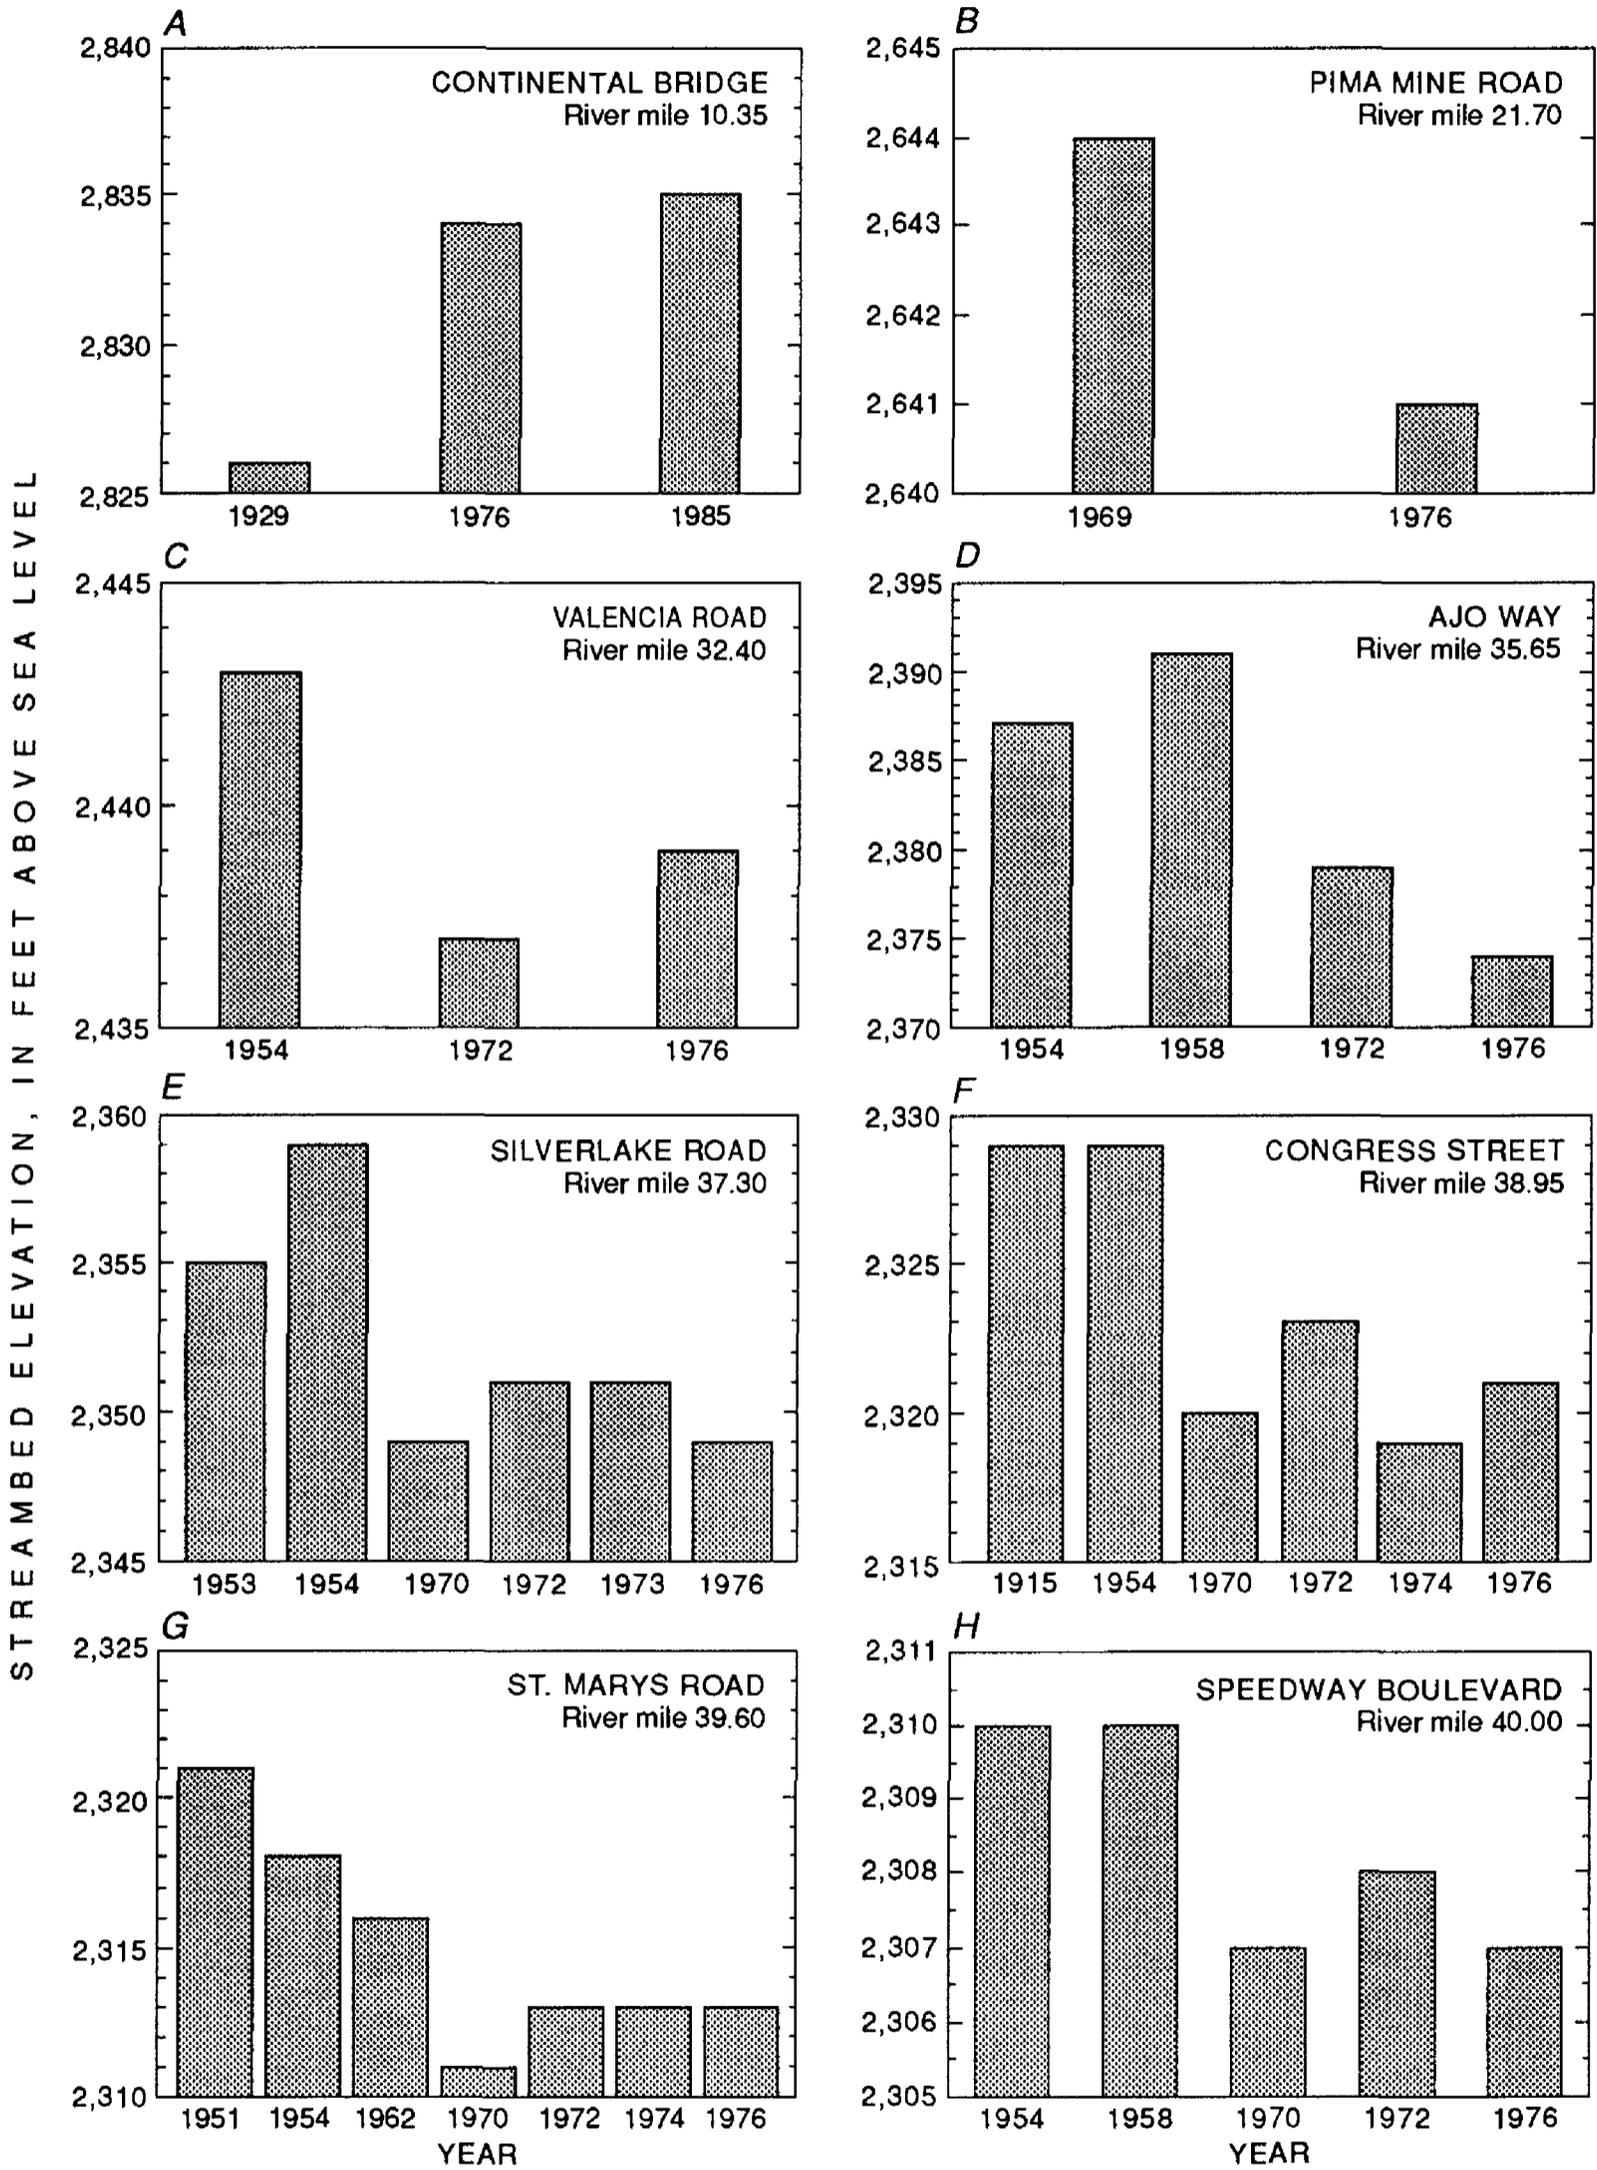
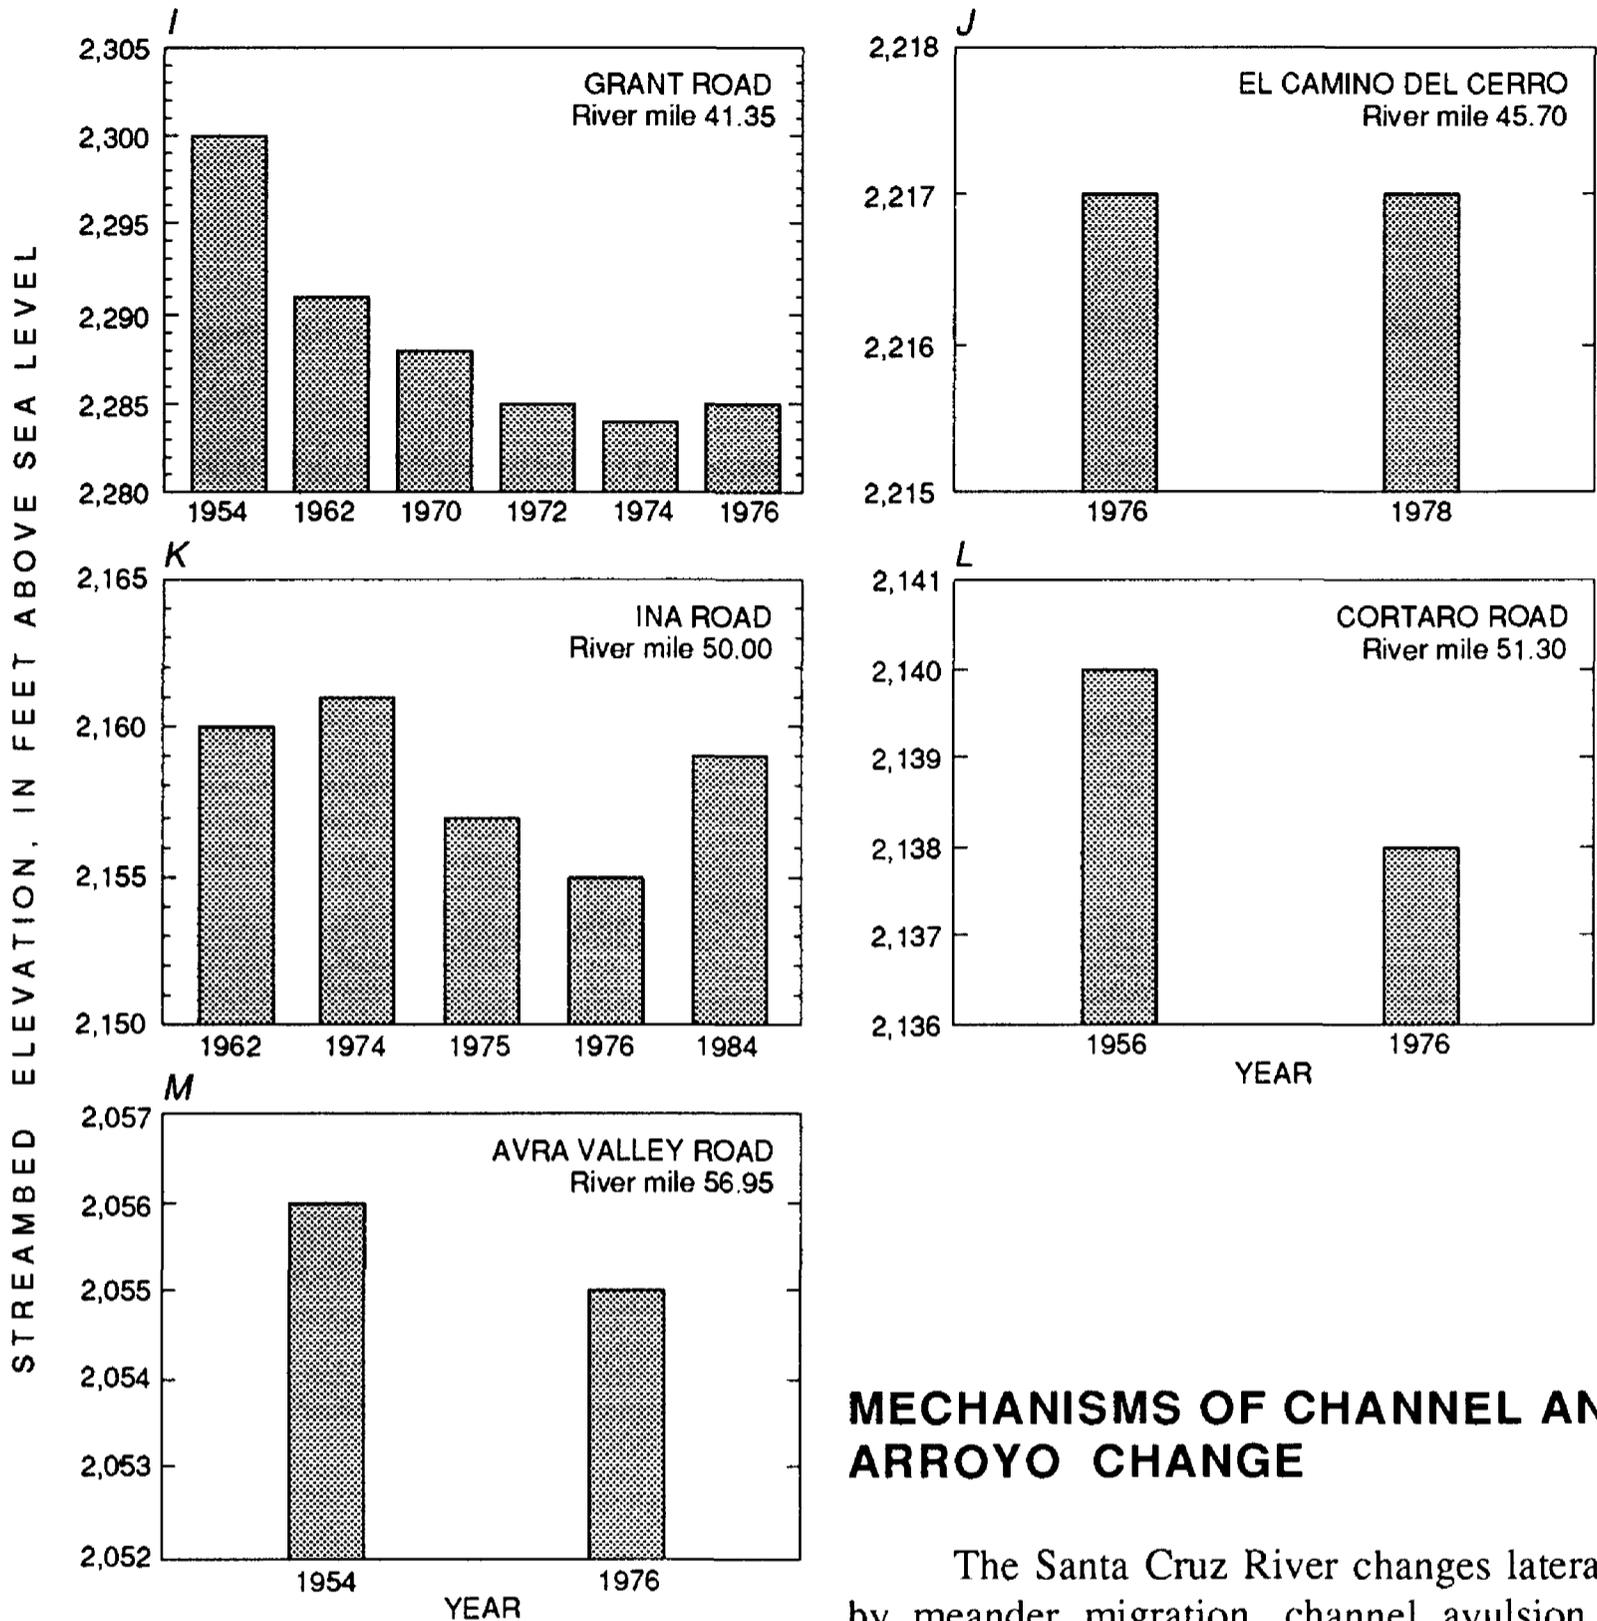
Figure 5. Changes in streambed elevations, Santa Cruz River. Note the vertical scale changes among various graphs. (Source: Data from Federal Emergency Management Agency, 1982, 1987, 1990; Pima County Department of Transportation and Flood Control District.)

Incision was apparently underway by 1962 (fig. 5G and I), and maximum degradation had occurred at most sites between Valencia and Grant Roads by 1970-74. Following maximum incision, minor fluctuations in streambed elevation occurred through the 1970's.
