Channel Change on the Santa Cruz River, Pima County, Arizona, 1936–86

By JOHN T.C. PARKER

U.S. GEOLOGICAL SURVEY
Open-File Report 93—41

Prepared in cooperation with the
PIMA COUNTY DEPARTMENT OF TRANSPORTATION
AND FLOOD CONTROL DISTRICT

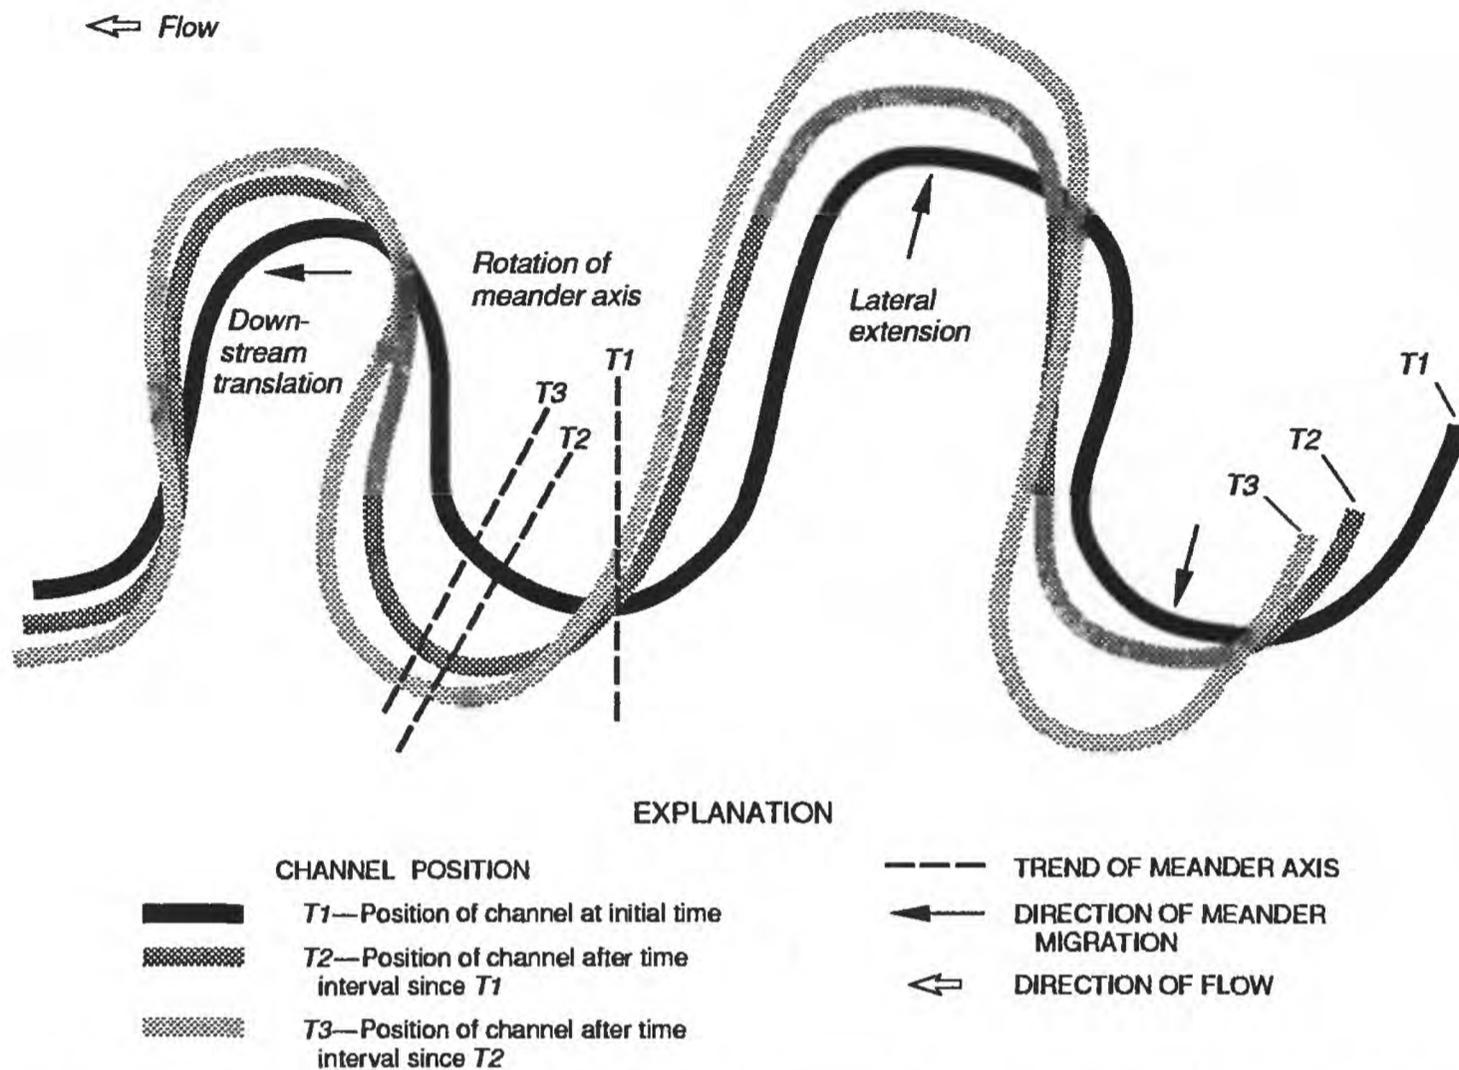
Figure 6. Channel migration caused by downstream translation of meander rotation of meander axis, and lateral extension of meander. Positive values indicate shift in position toward left side of channel; negative values indicate shift toward right side.

Meander migration refers to lateral shifts of center-line position associated with the inception of meanders and their subsequent downstream translation, lateral extension, or rotation of meander axis (fig. 6; Knighton, 1984). Meander migration involves the spatially continuous movement of channel position across a flood plain rather than a discrete, abrupt channel shift caused by avulsion or meander cutoff. Generally, meander migration increases sinuosity and lowers gradients. Where the channel is not confined within an arroyo, meander migration may be the dominant expression of lateral instability. Where the channel is confined within an arroyo, meander migration is a major component of arroyo widening. Meander migration on the Cortaro and Marana reaches is primarily a result of low to moderate flows that generally produce low rates of lateral channel movement. Moderate but prolonged flows having a peak discharge with a recurrence interval of 2 years or less, however, have caused hundreds of feet of erosion by meander

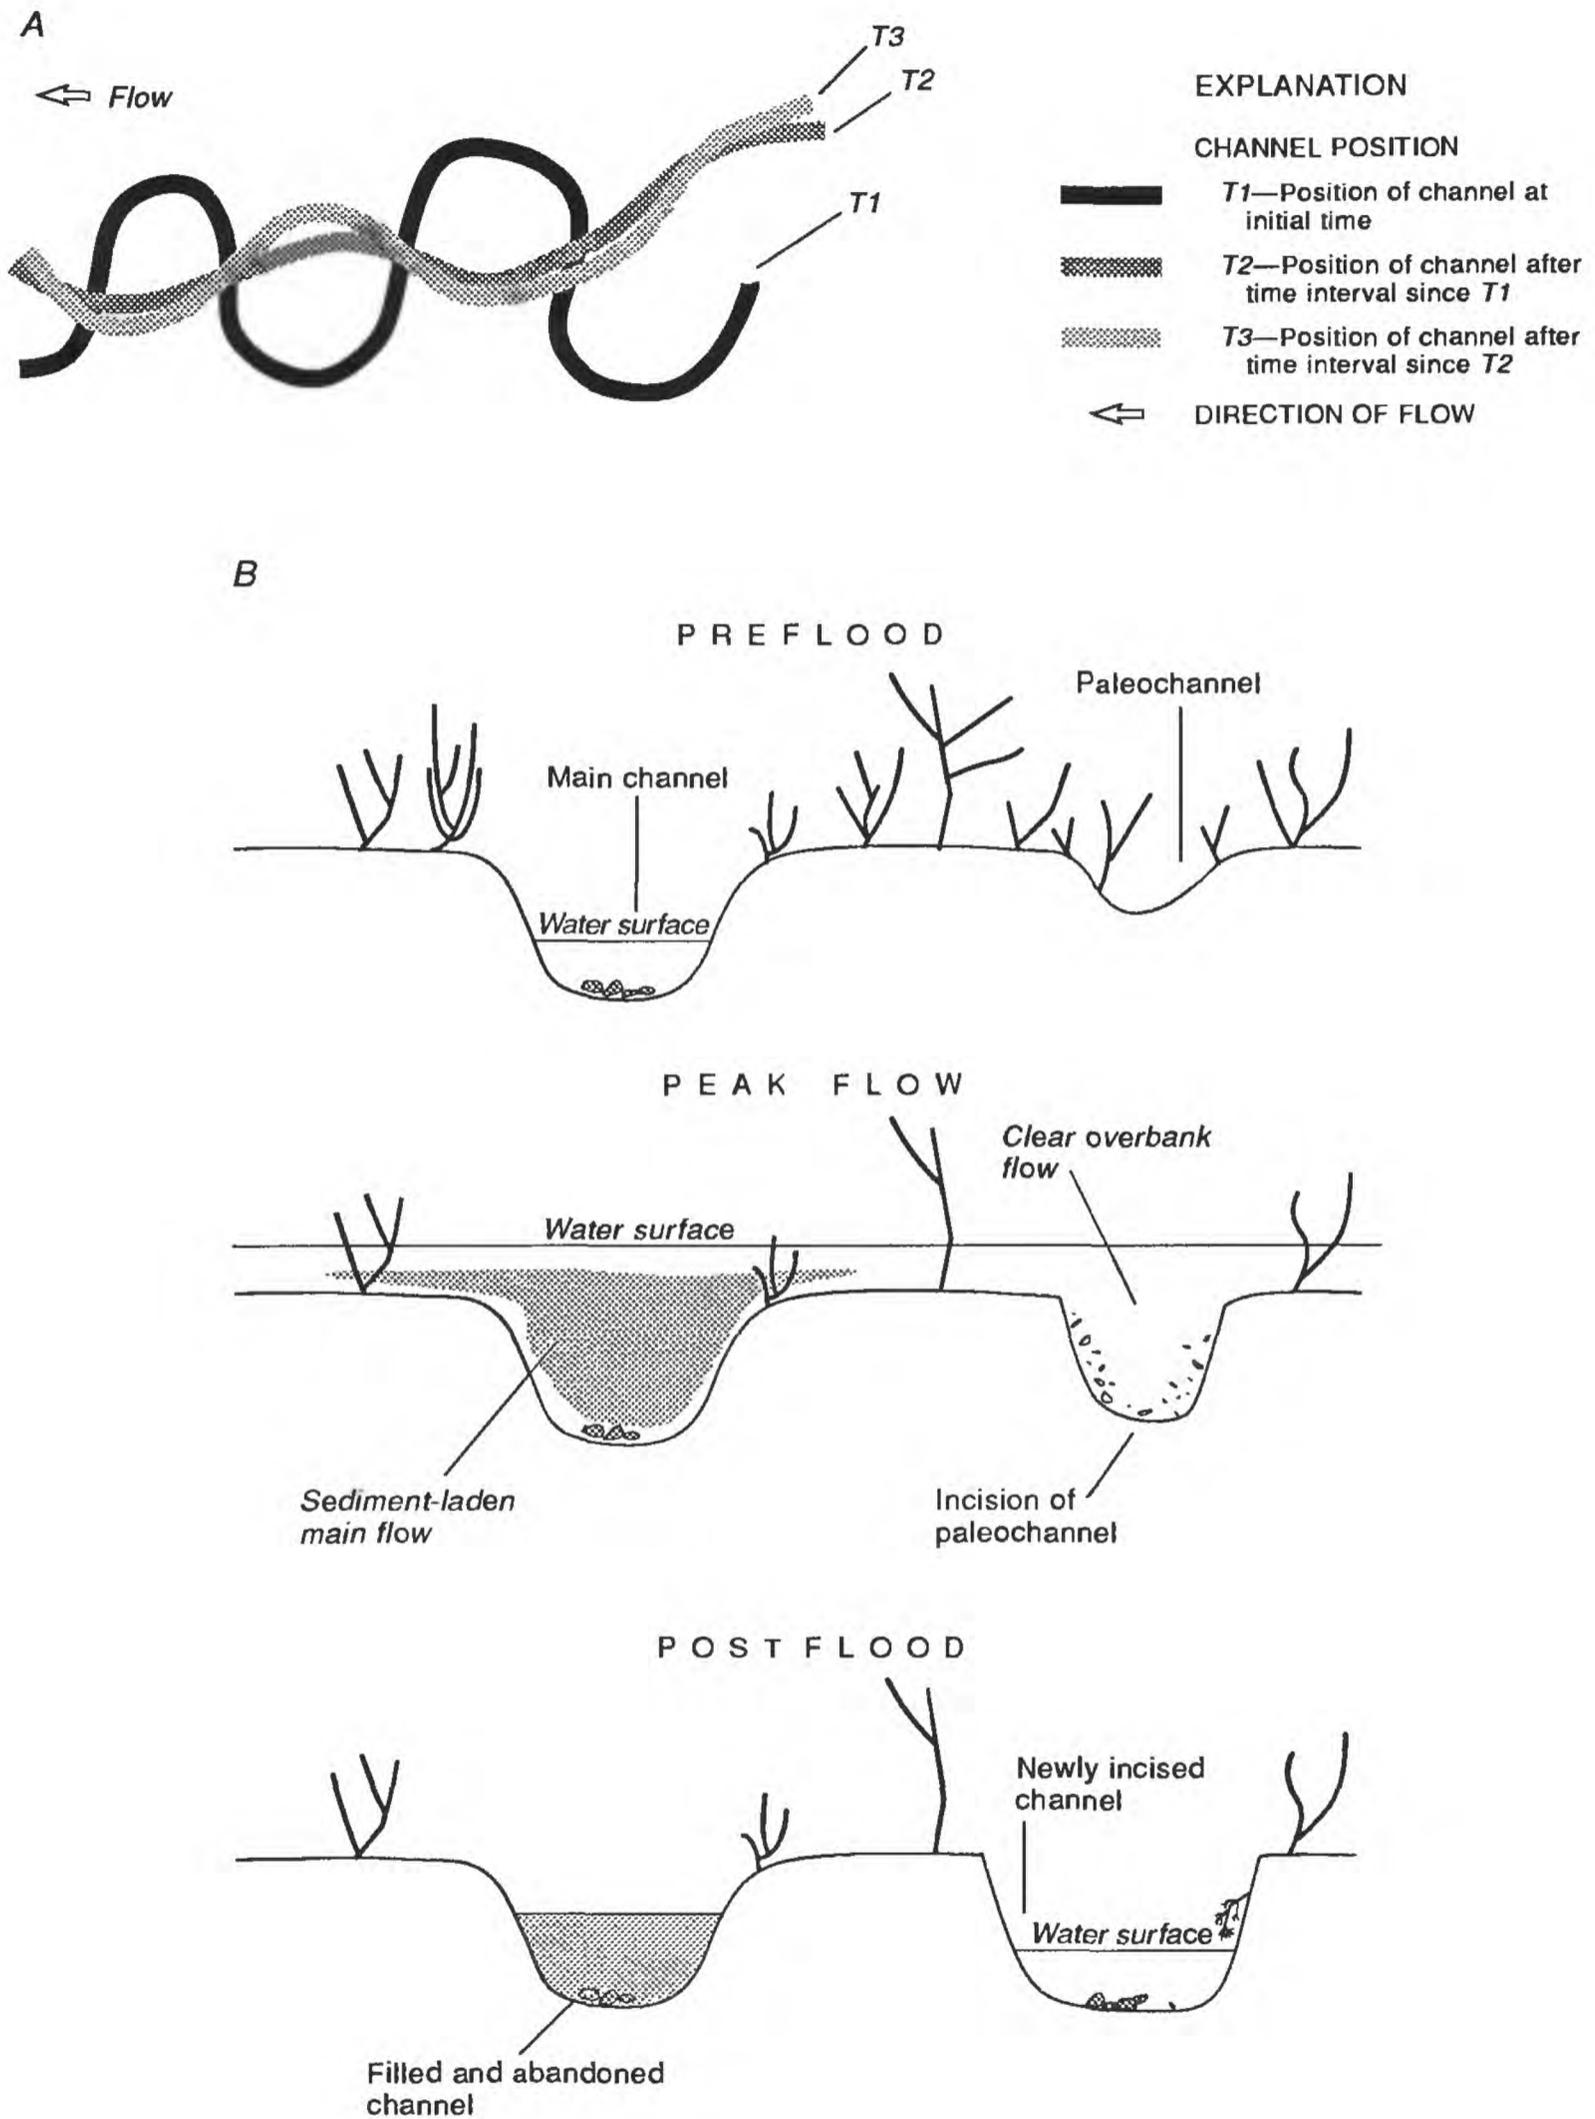
Figure 7. Avulsion and meander cutoff. *A*, Plan view of an initially sinuous channel at time 1 (*T1*) that changes course as a result of a flood (*T2*) and then is modified by subsequent meander migration during low flows (*T3*). *B*, Processes that produce a lateral shift in channel position by avulsion or meander cutoff.

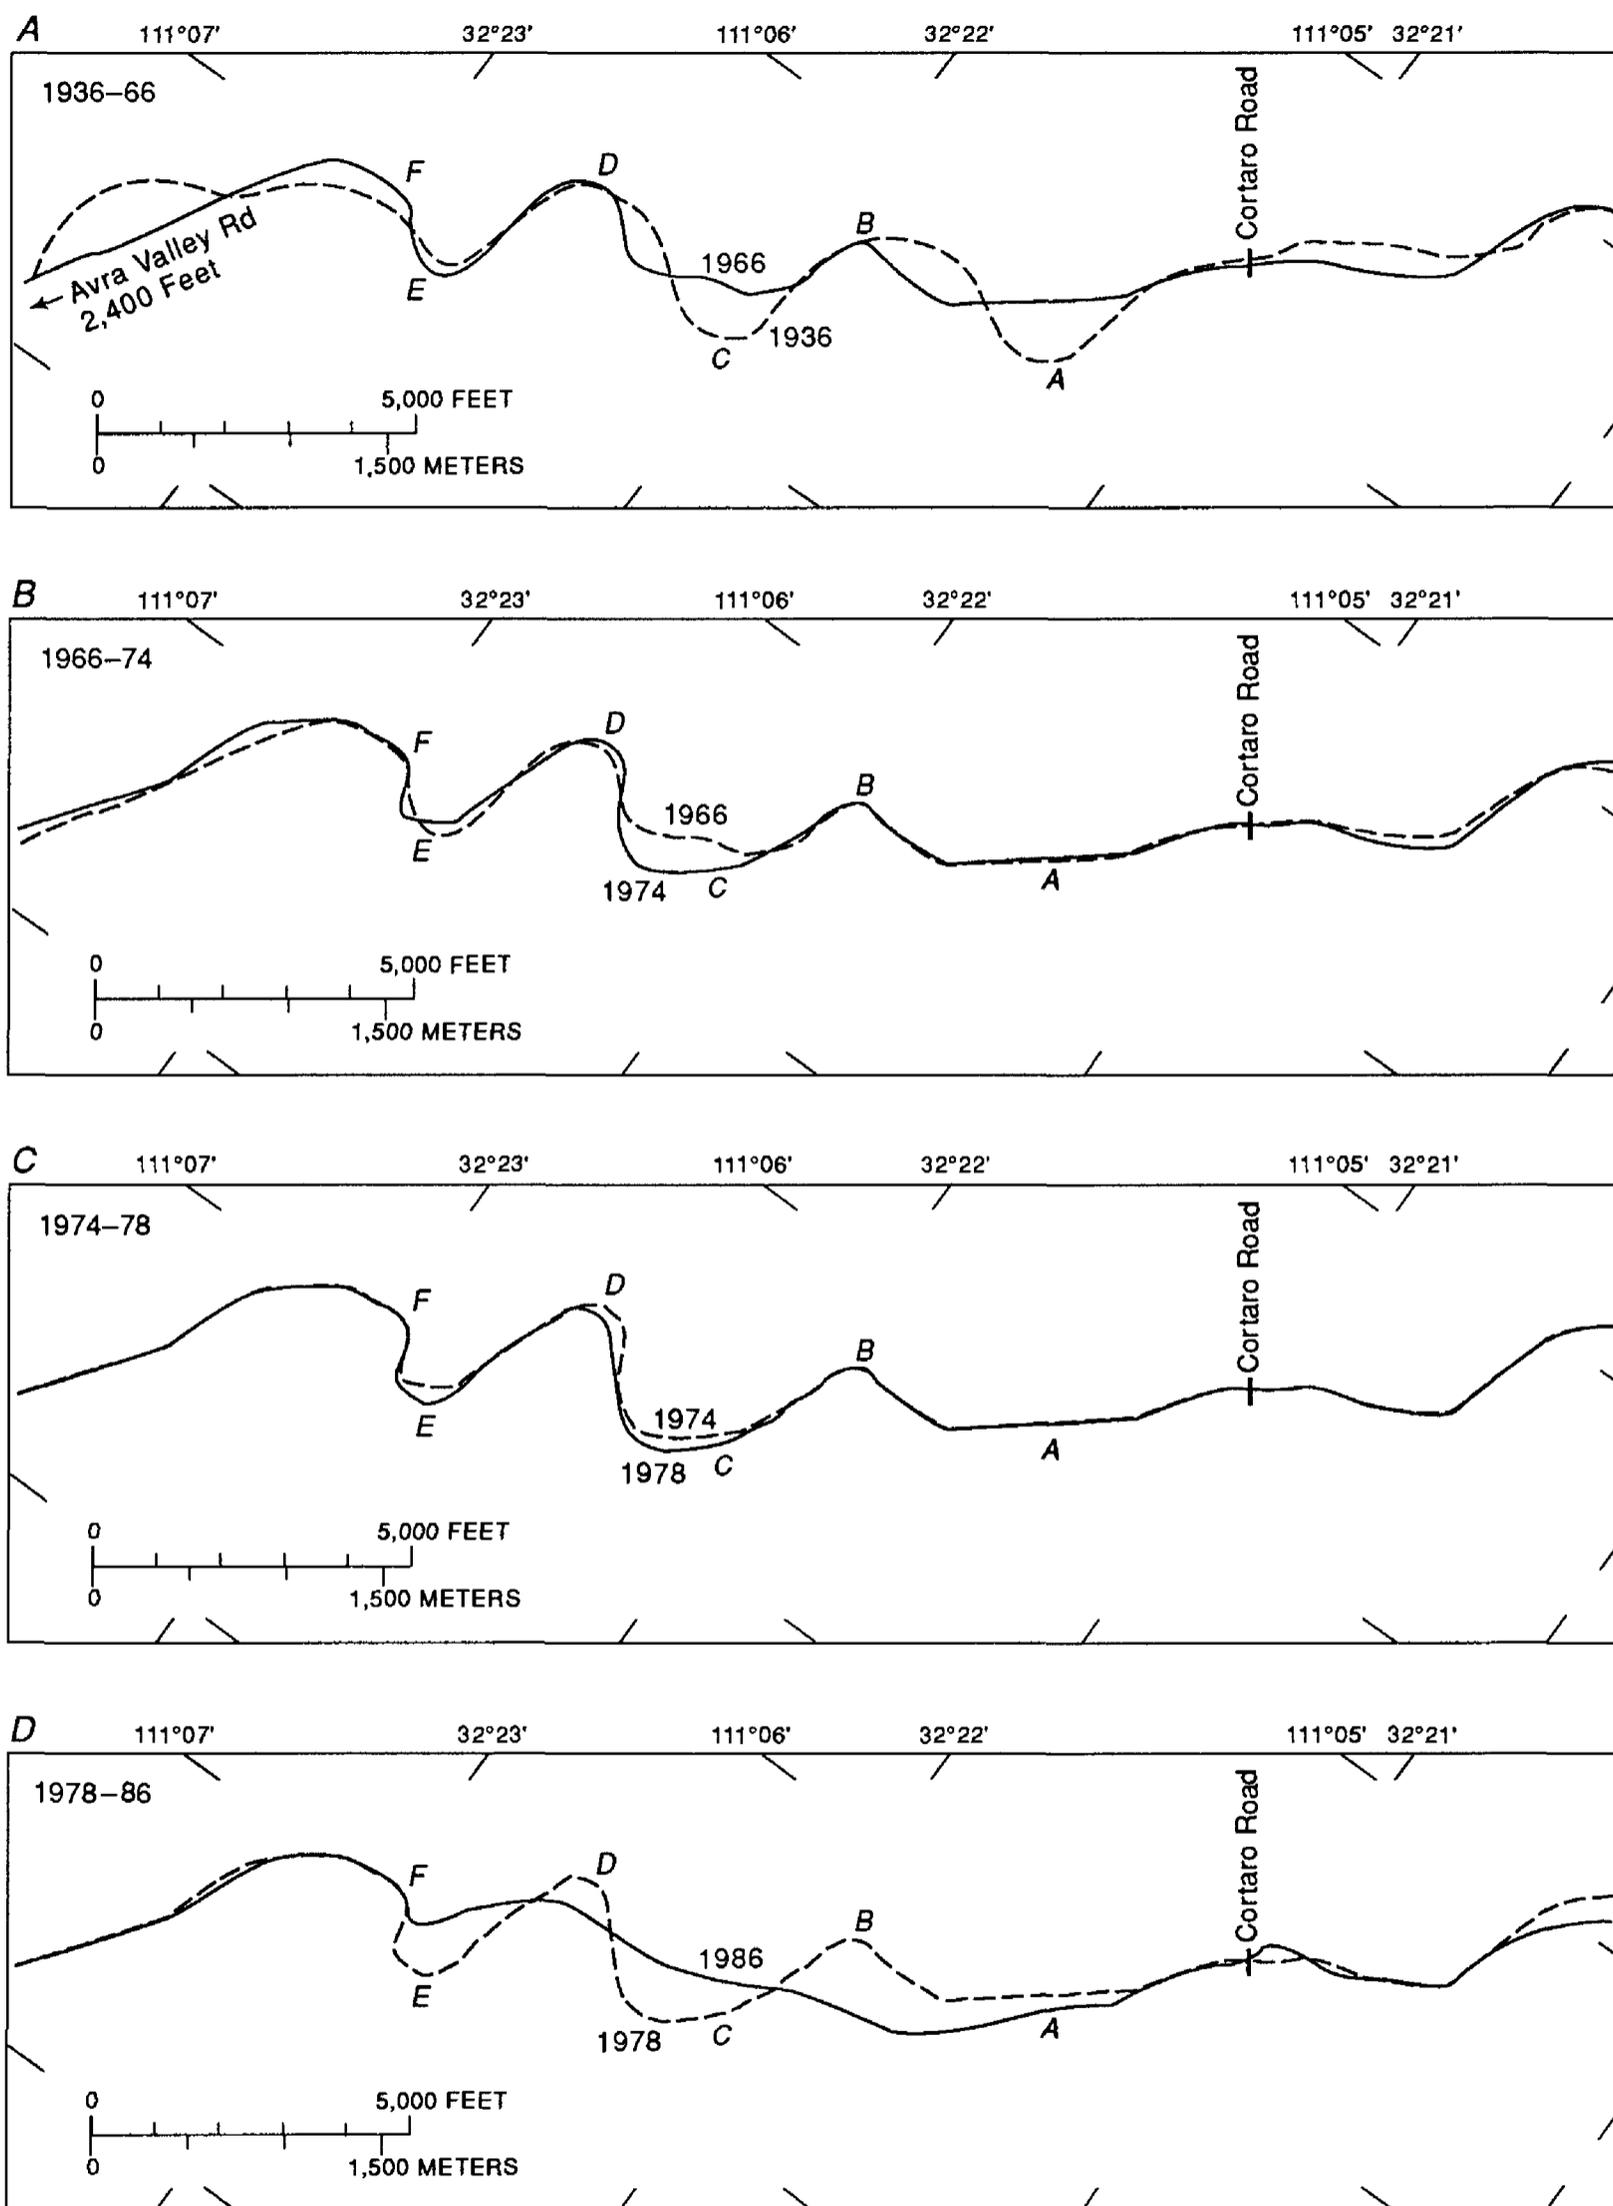
Figure 8. Meander development on lower Cortaro reach. Lines show location of channel center line.

Between 1936 and 1966, the lower Cortaro reach showed a high degree of channel instability (fig. 9) caused by meander migration (meanders B, D, E, and F, fig. 8) and meander cutoff (meanders A and C). The position of the channel center line shifted laterally as much as 900 ft because of cutoff at meander A.

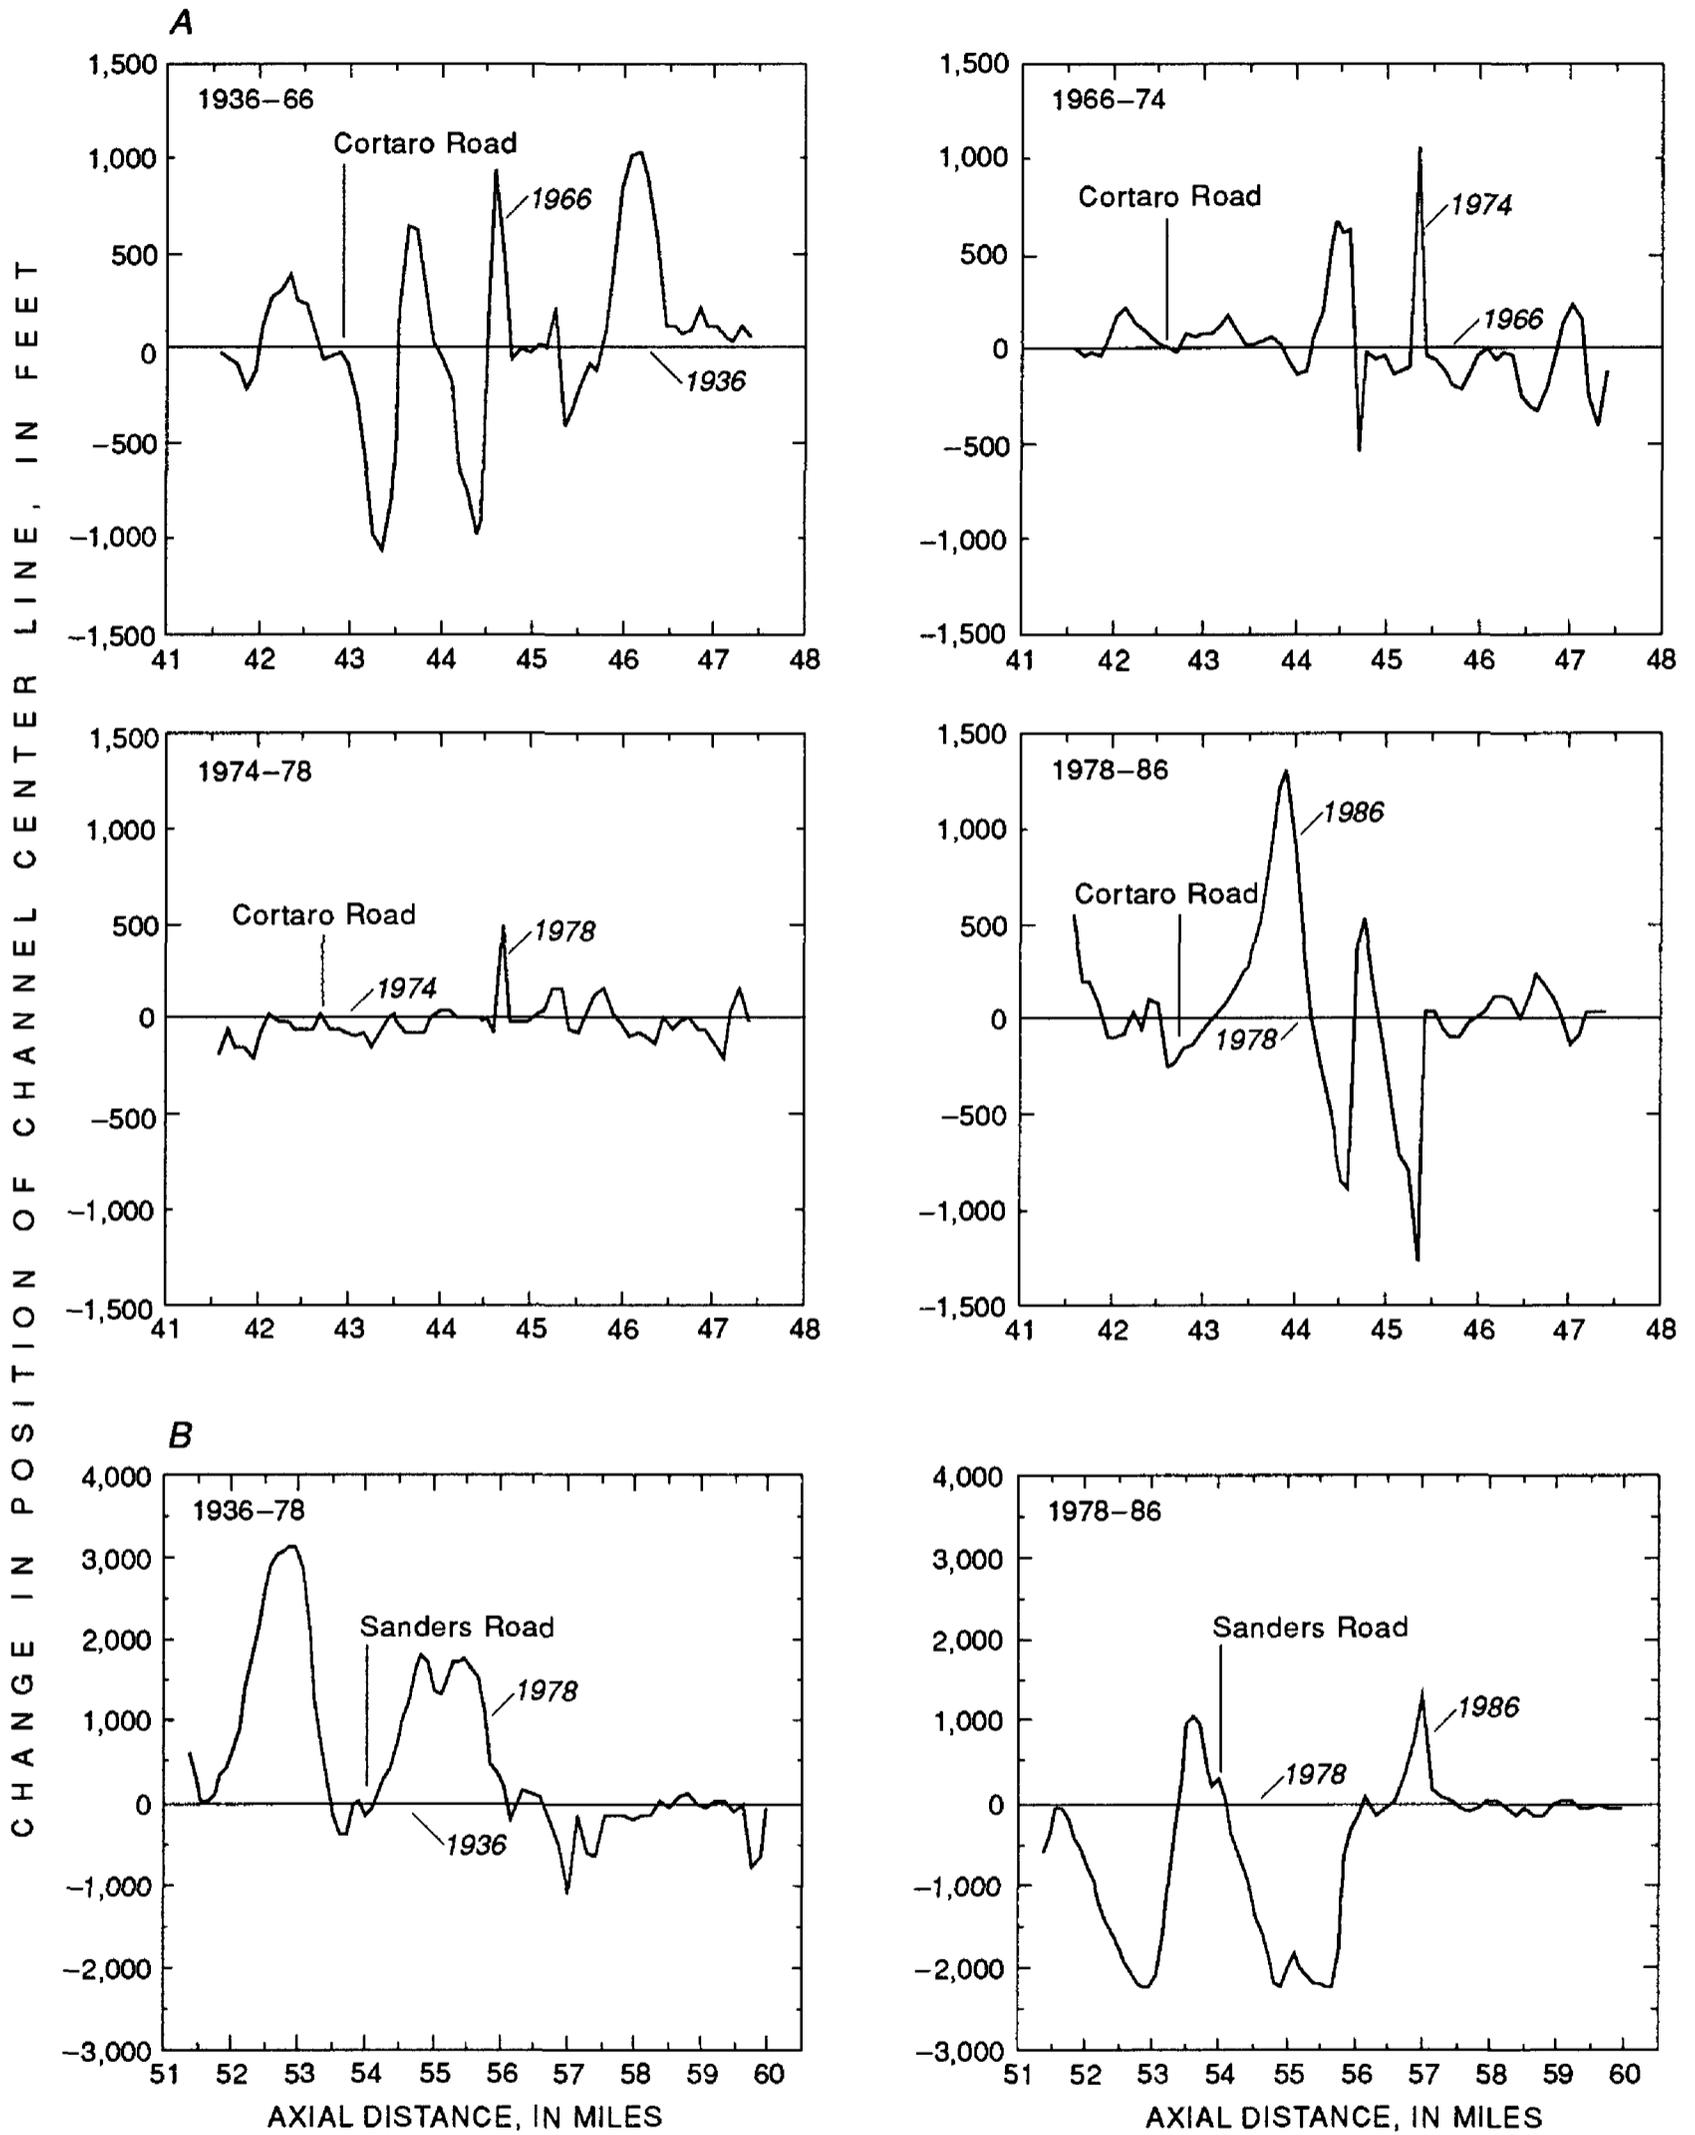
Figure 9. Changes in position of channel center line. A, Lower Cortaro reach. B, Upper Marana reach. Positive values indicate shift in position toward left side of channel; negative values indicate shift toward right side.

Between 1978 and 1986, all meanders between Cortaro and Avra Valley Roads except one were destroyed during the flood of 1983, which had a peak discharge of 65,000 ft³/s through the reach. On the Cortaro and Marana reaches, almost 23,000 ft of channel was abandoned 6 ft above the new channel bed, and channel position shifted laterally as much as 2,000 ft (fig. 9).

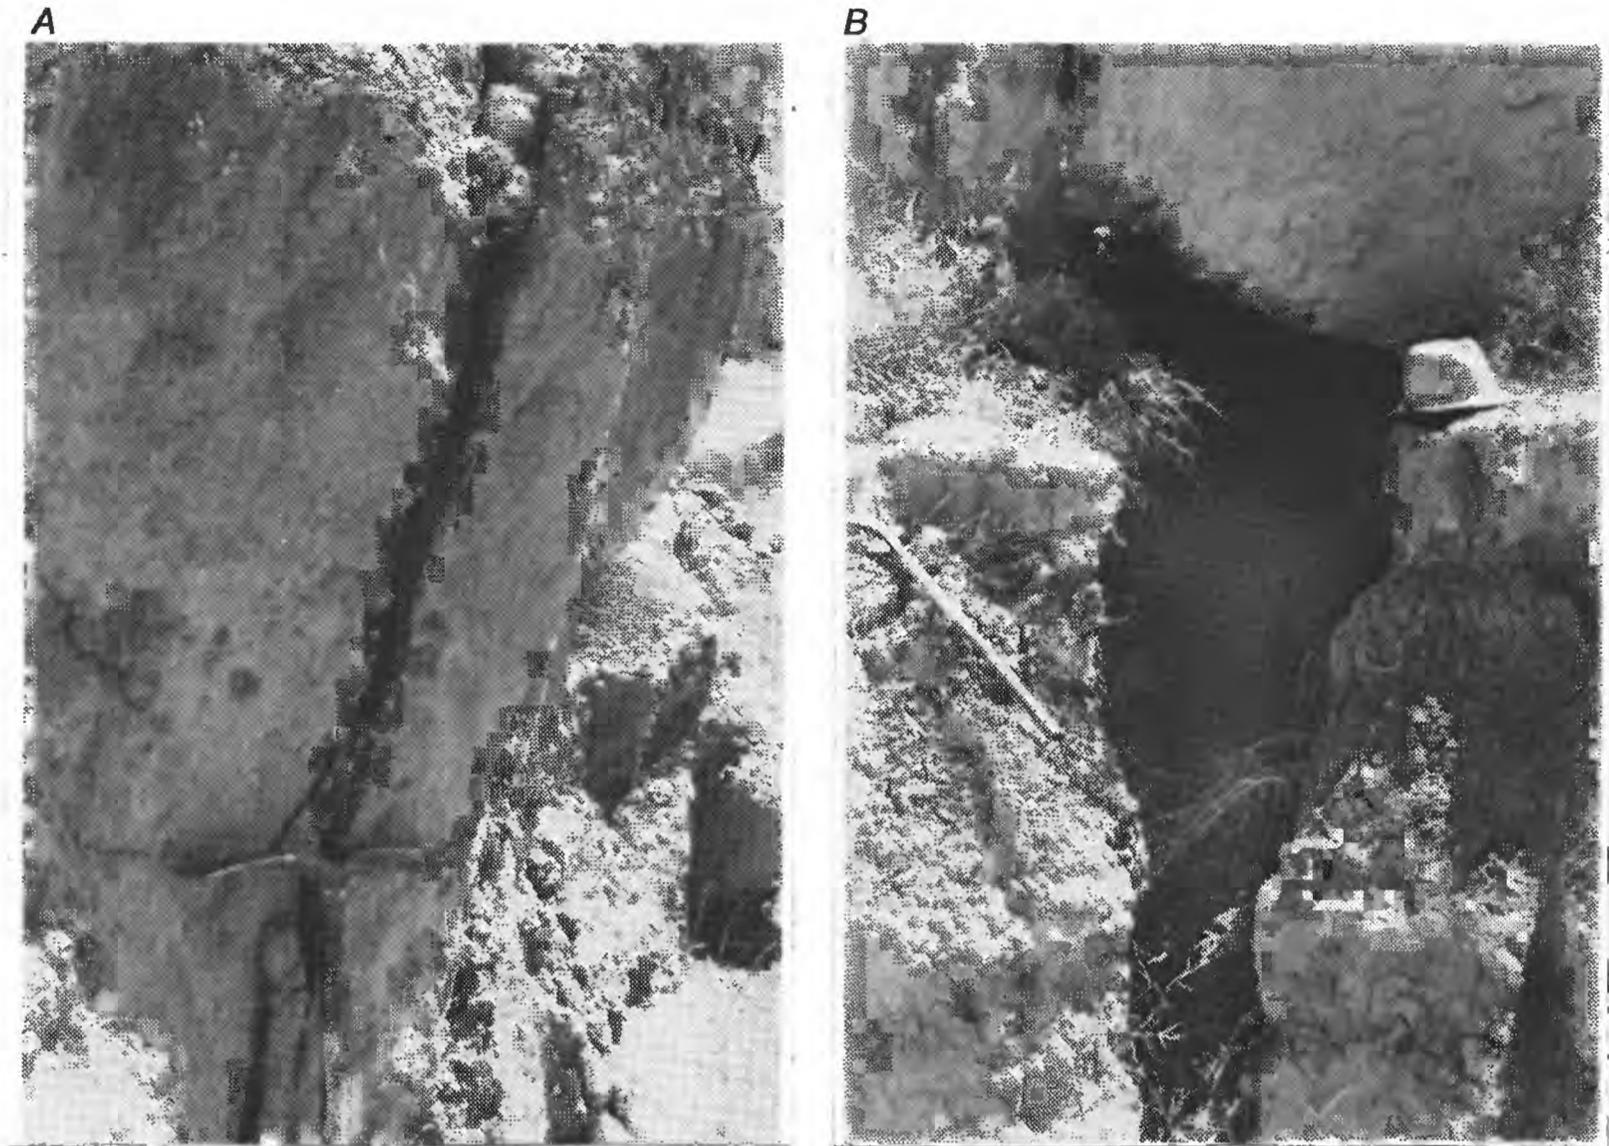
Figure 12. Structural weakening of arroyo walls, Santa Cruz River. *A*, Tension cracking leads to block failure of cohesive alluvium. *B*, Pipes enlarge and may produce cavernous discontinuities in alluvium.

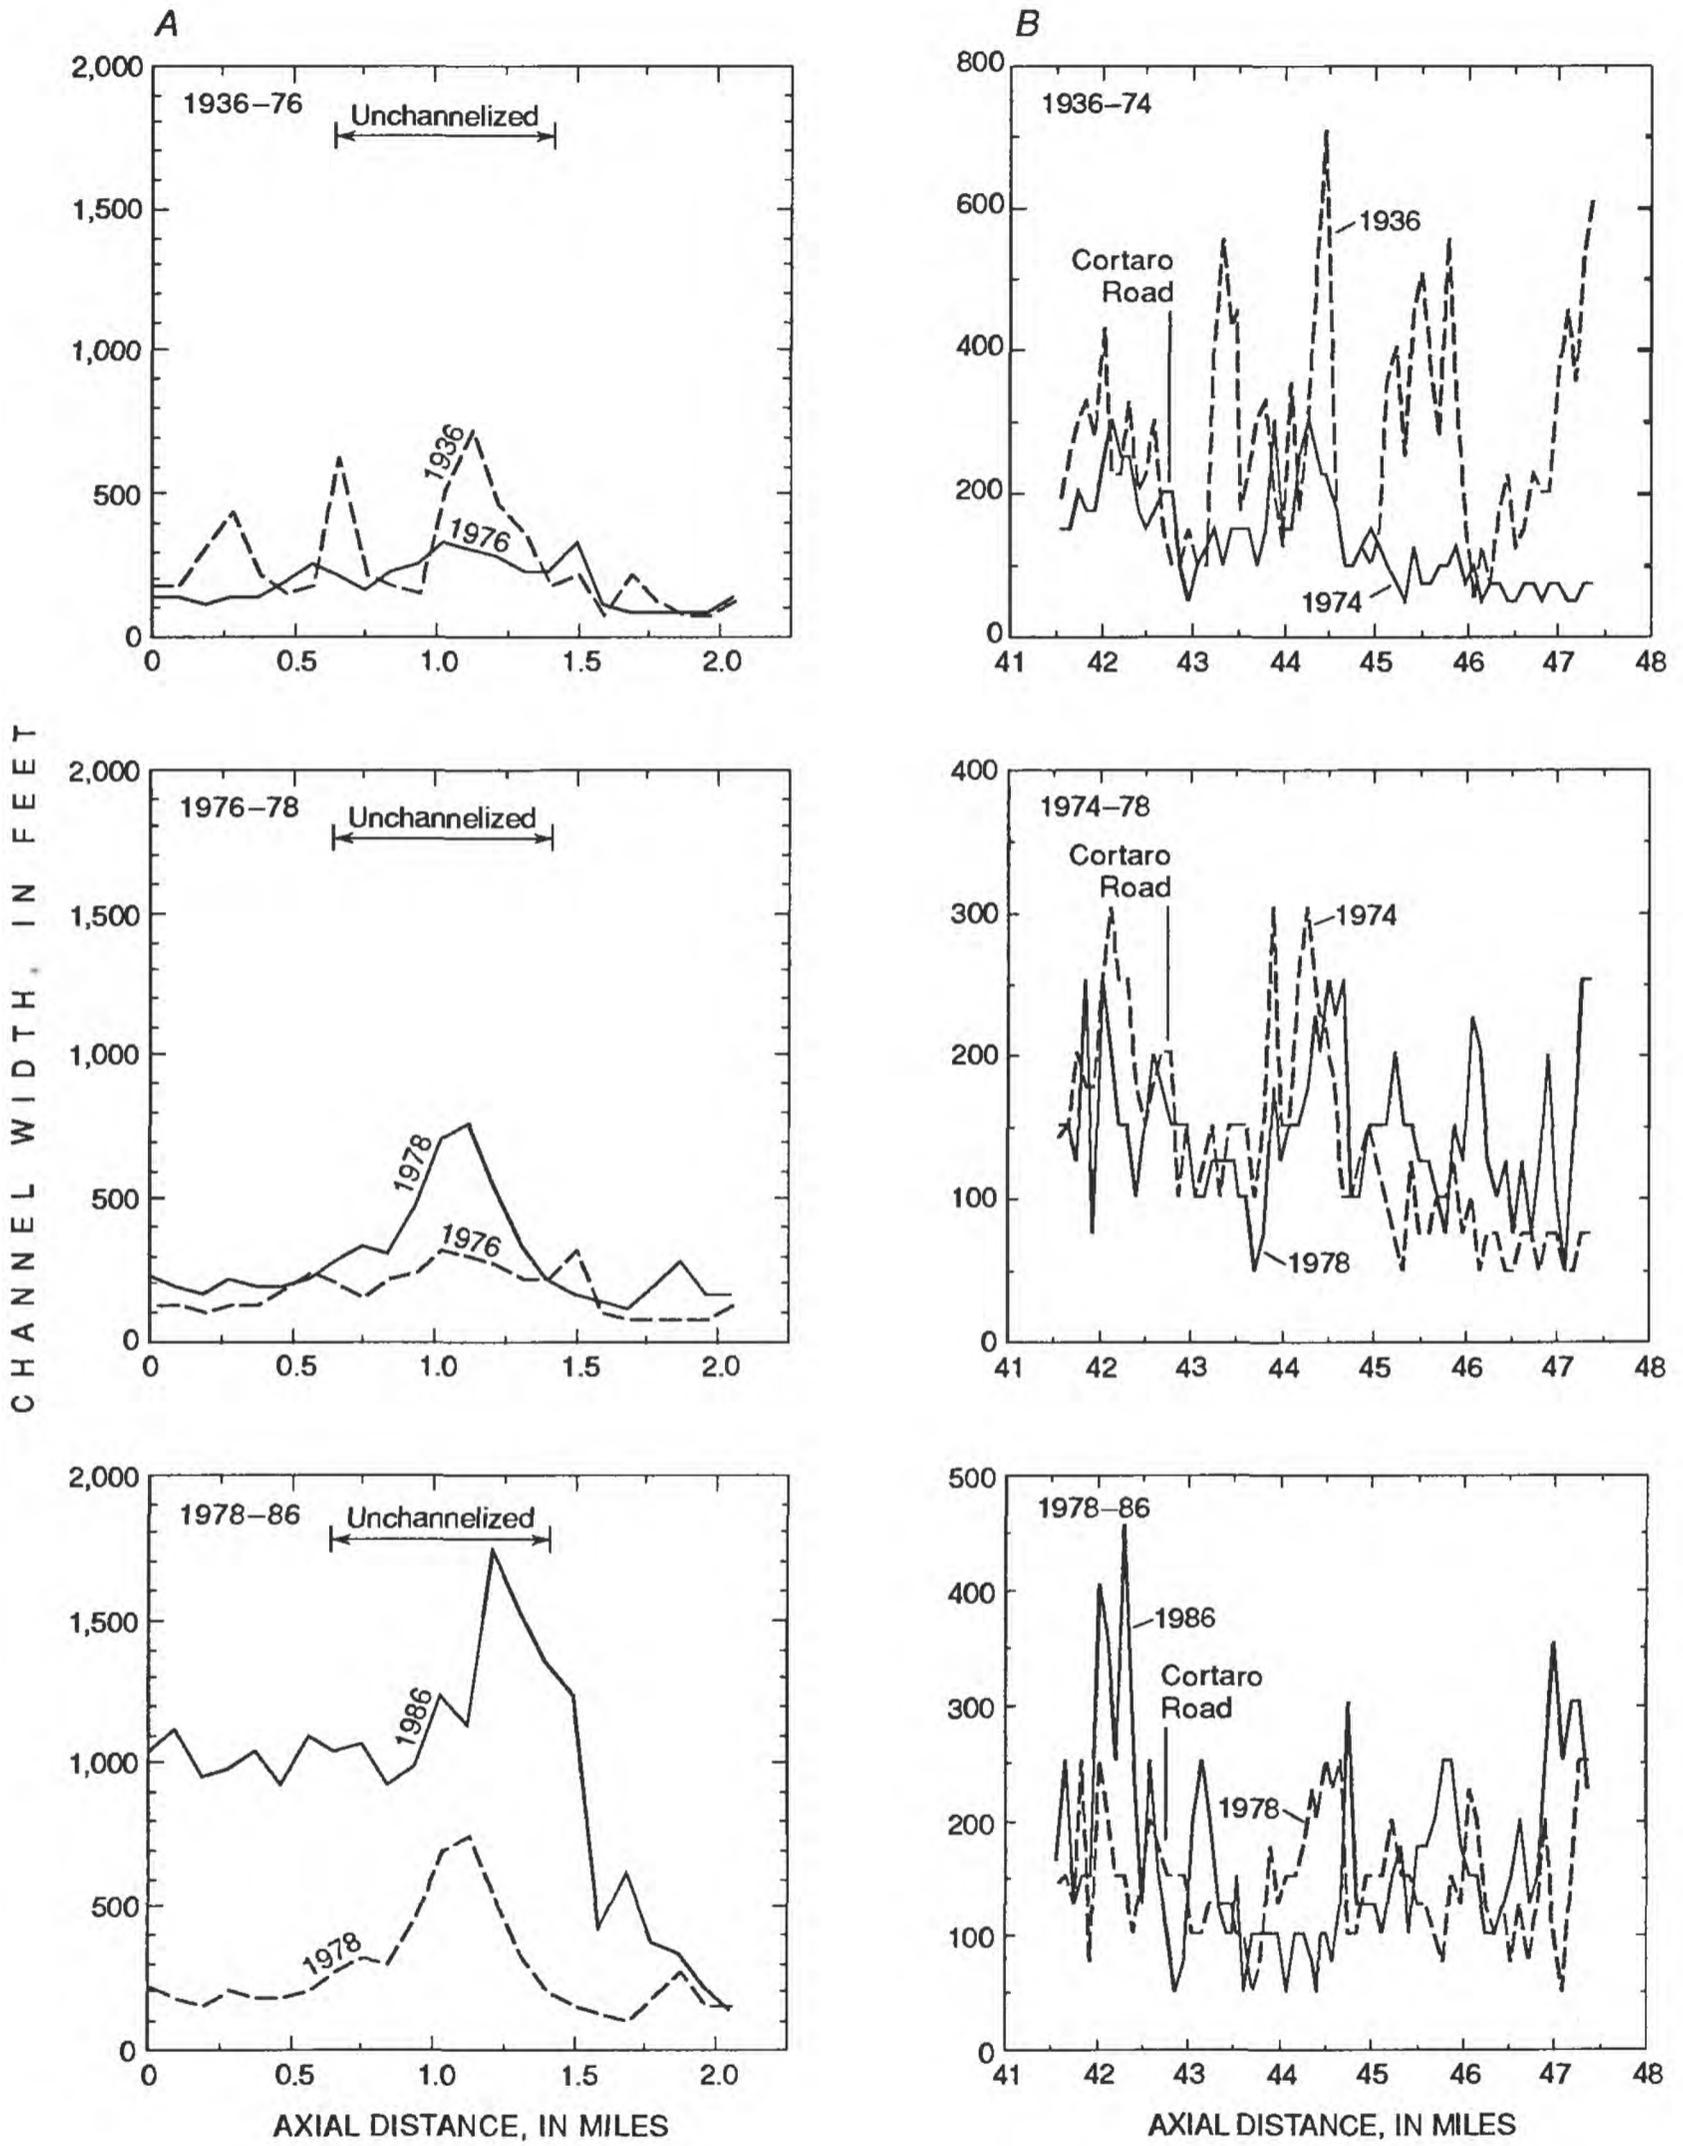
Figure 13. Channel-width changes on the Santa Cruz River. A, Upper Canoa reach. B, Lower Cortaro reach.

axial distance 0.7 mi (fig. 13A) was the result of lateral corrasion by high flow; widening in the unchannelized part of the reach between 0.7 and 1.6 mi was caused by channel widening on the outside of a meander as it migrated downstream. Migration of the meander on the Canoa reach was accompanied by almost complete point-bar removal, and only a coarse lag was left in its place.

narrowed after 1966 as a result of vegetation growth in response to perennial flow (fig. 13B; Hays, 1984), and in most of the reach the 1977 flood caused little widening. The 1983 flood stripped vegetation and eroded the generally sandy, gravelly banks. Hays (1984) reported an increase in mean width from 250 to about 450 ft on the Marana reach between Avra Valley Road and Trico-Marana Road after the 1983 flood. Aerial photographs taken in 1984 indicate that mean width on the Cortaro reach between Cortaro Road and Avra Valley Road increased from 150 to 270 ft as a result of the 1983 flood. By 1986, however, mean width of the Cortaro reach had declined to 170 ft as a result of subsequent low-flow incision, in-channel deposition, and revegetation.

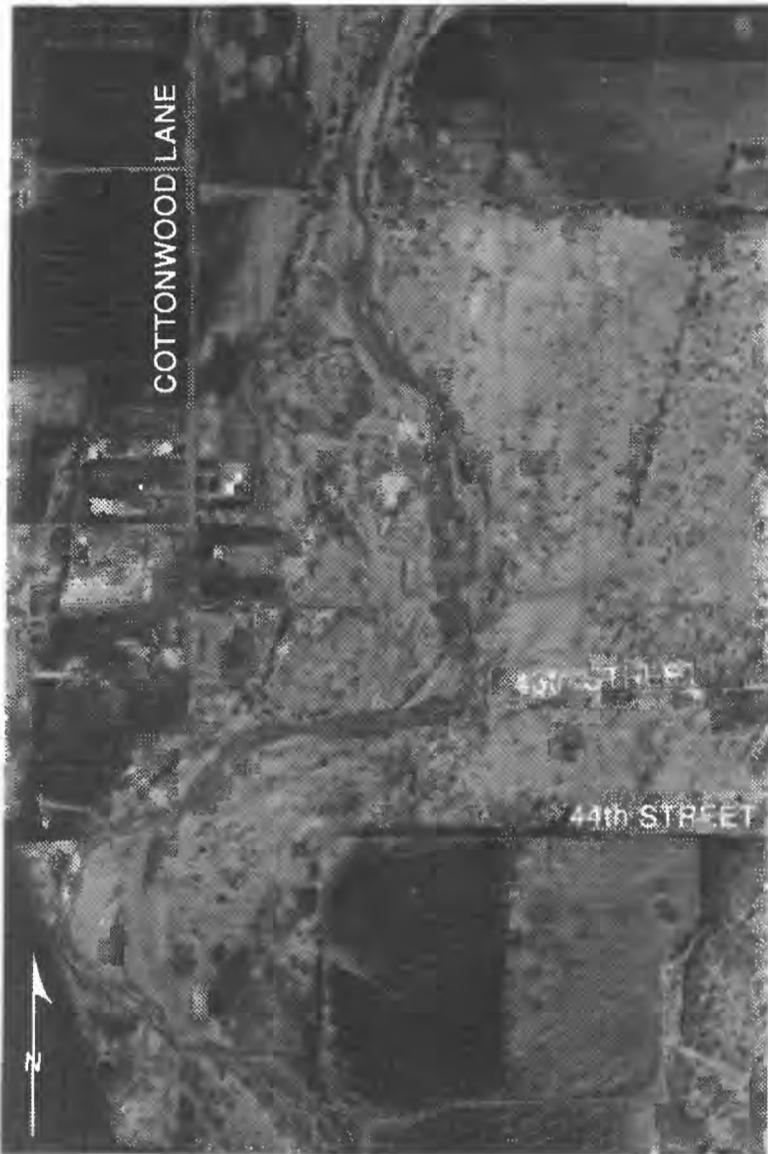
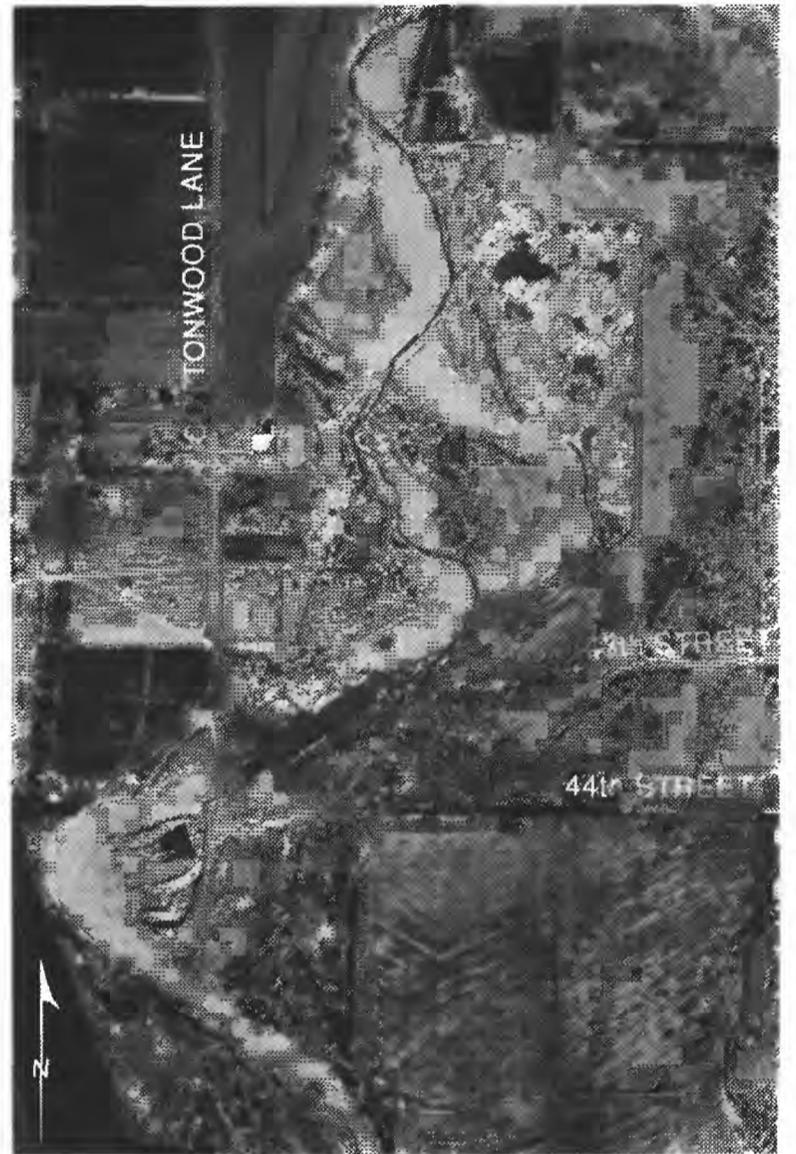
Figure 14. Avulsion within the arroyo in the lower San Xavier reach north of 44th Street, 1953–60. About 4 feet of aggradation occurred in the reach during that interval. (Source: Cooper Aerial Survey, 1953 and 1960.)
