Channel Change on the Santa Cruz River, Pima County, Arizona, 1936–86

By JOHN T.C. PARKER

U.S. GEOLOGICAL SURVEY
Open-File Report 93—41

Prepared in cooperation with the
PIMA COUNTY DEPARTMENT OF TRANSPORTATION
AND FLOOD CONTROL DISTRICT

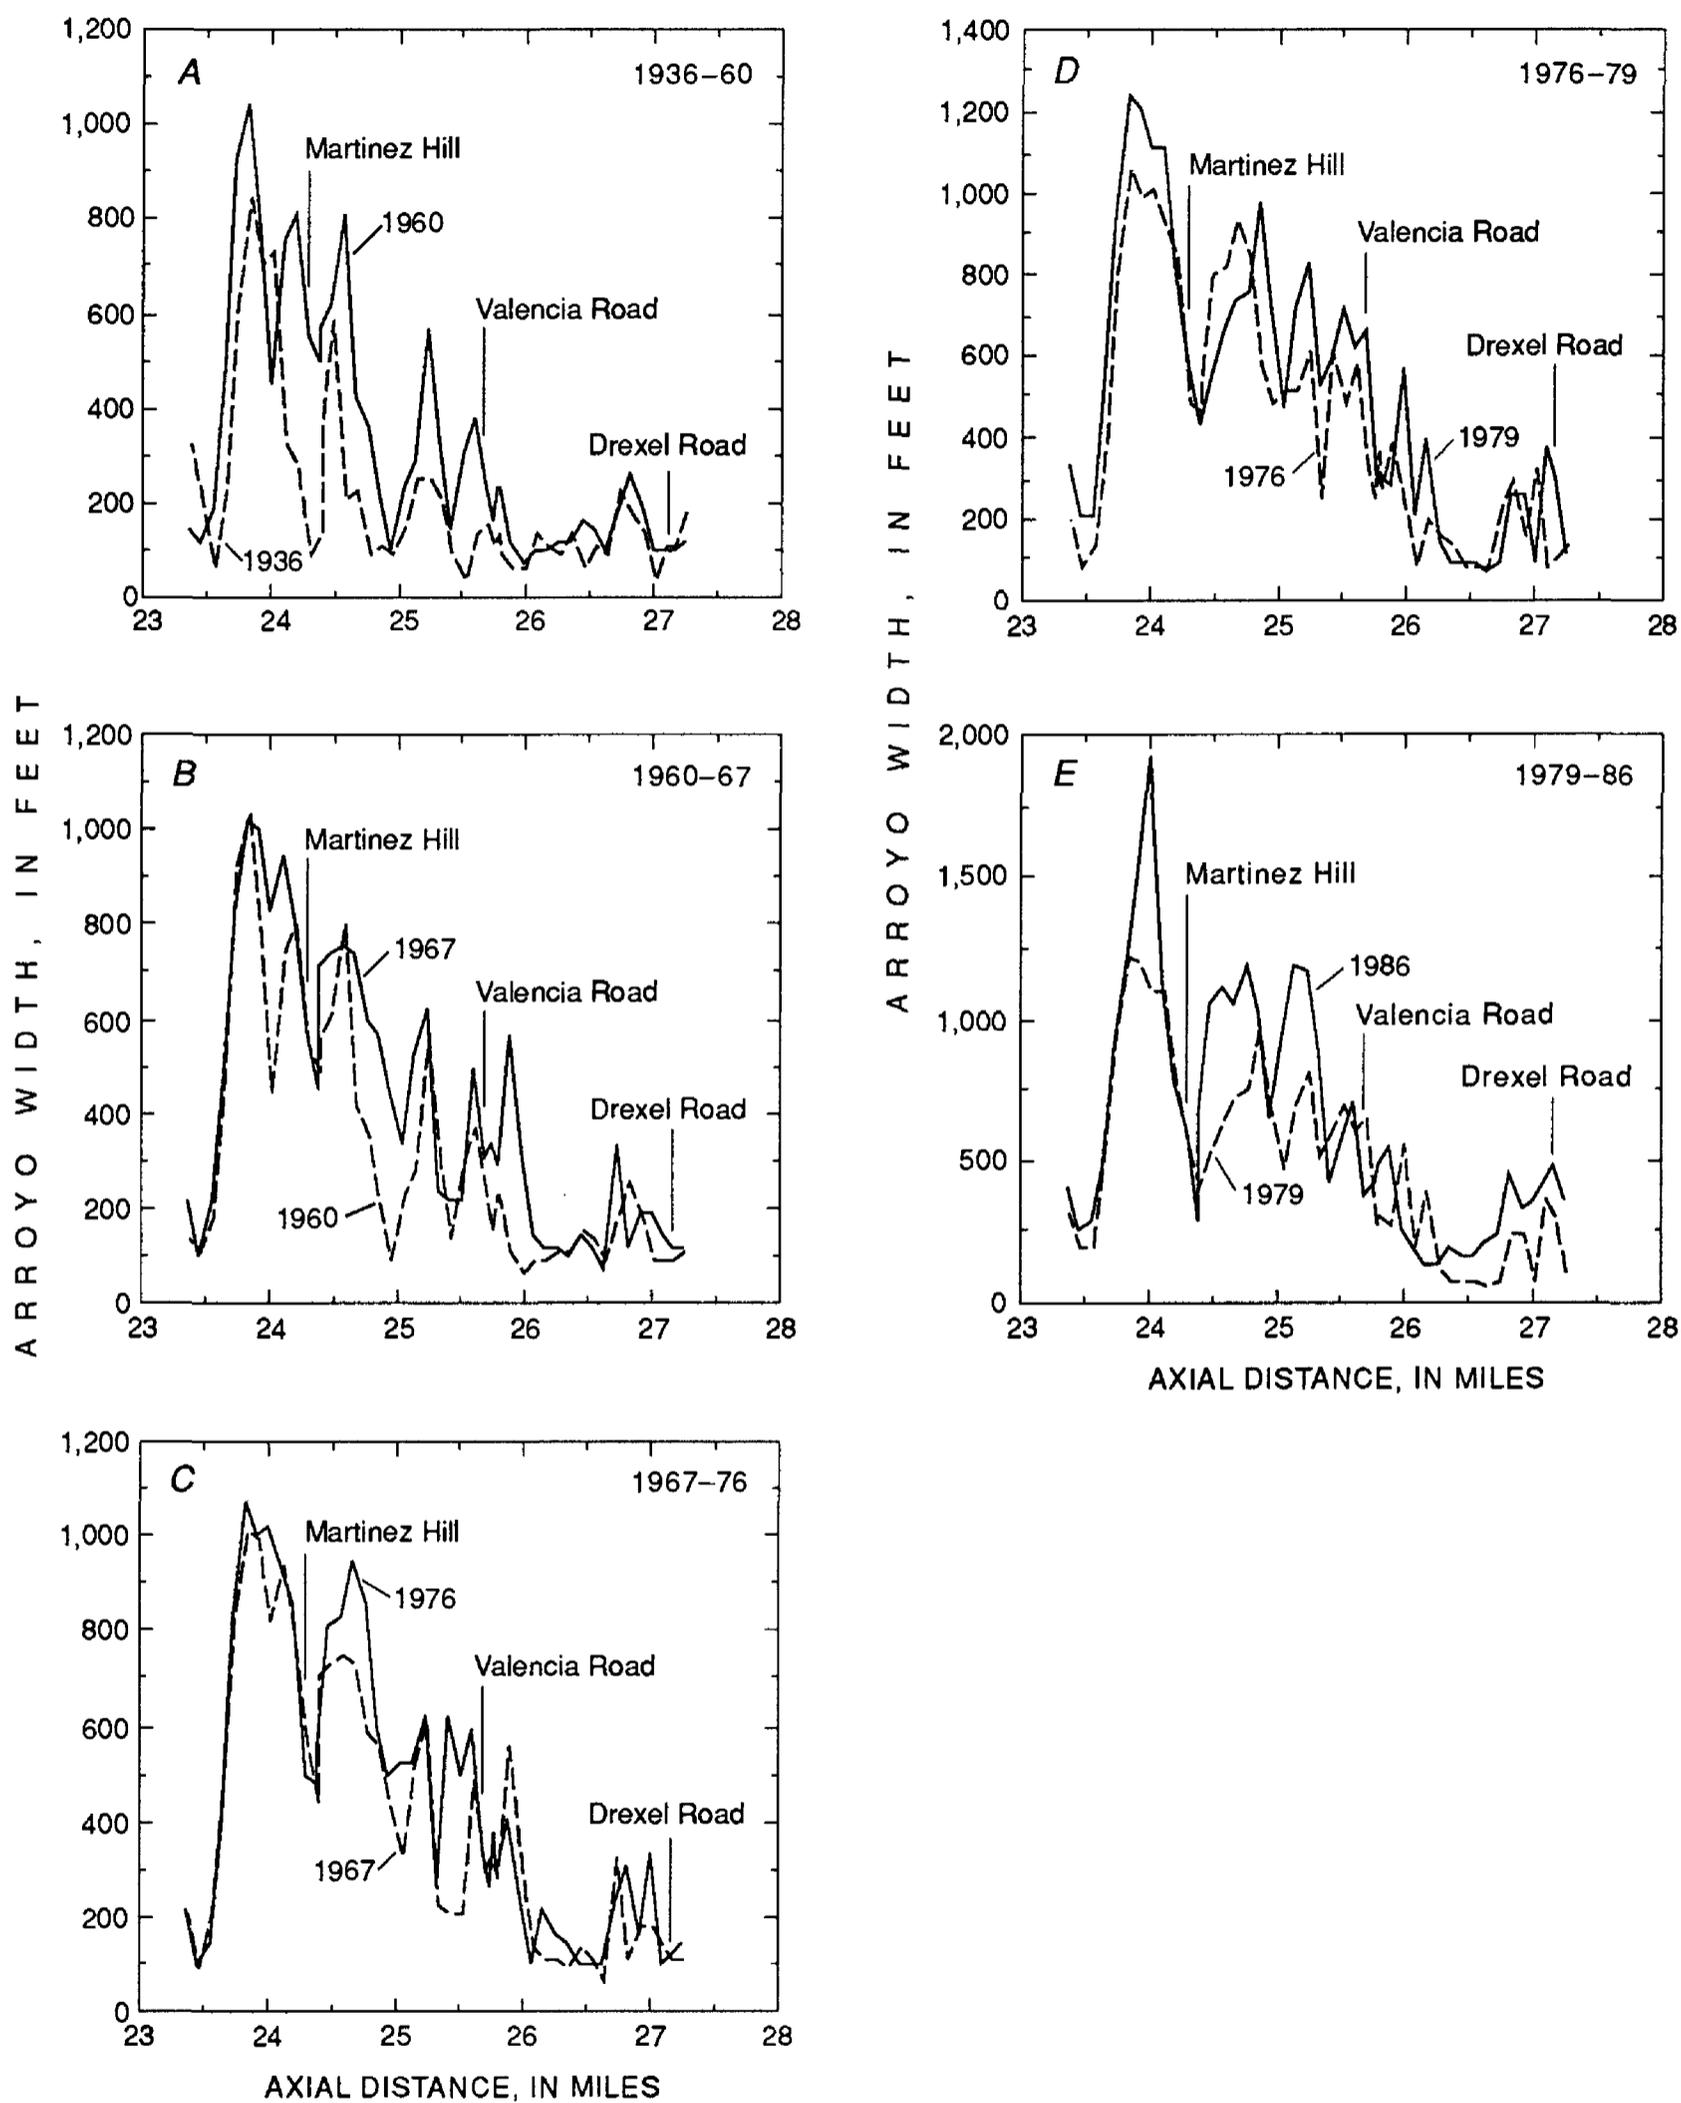
Figure 15. Arroyo widths on the lower San Xavier reach near Martinez Hill, 1936-86.

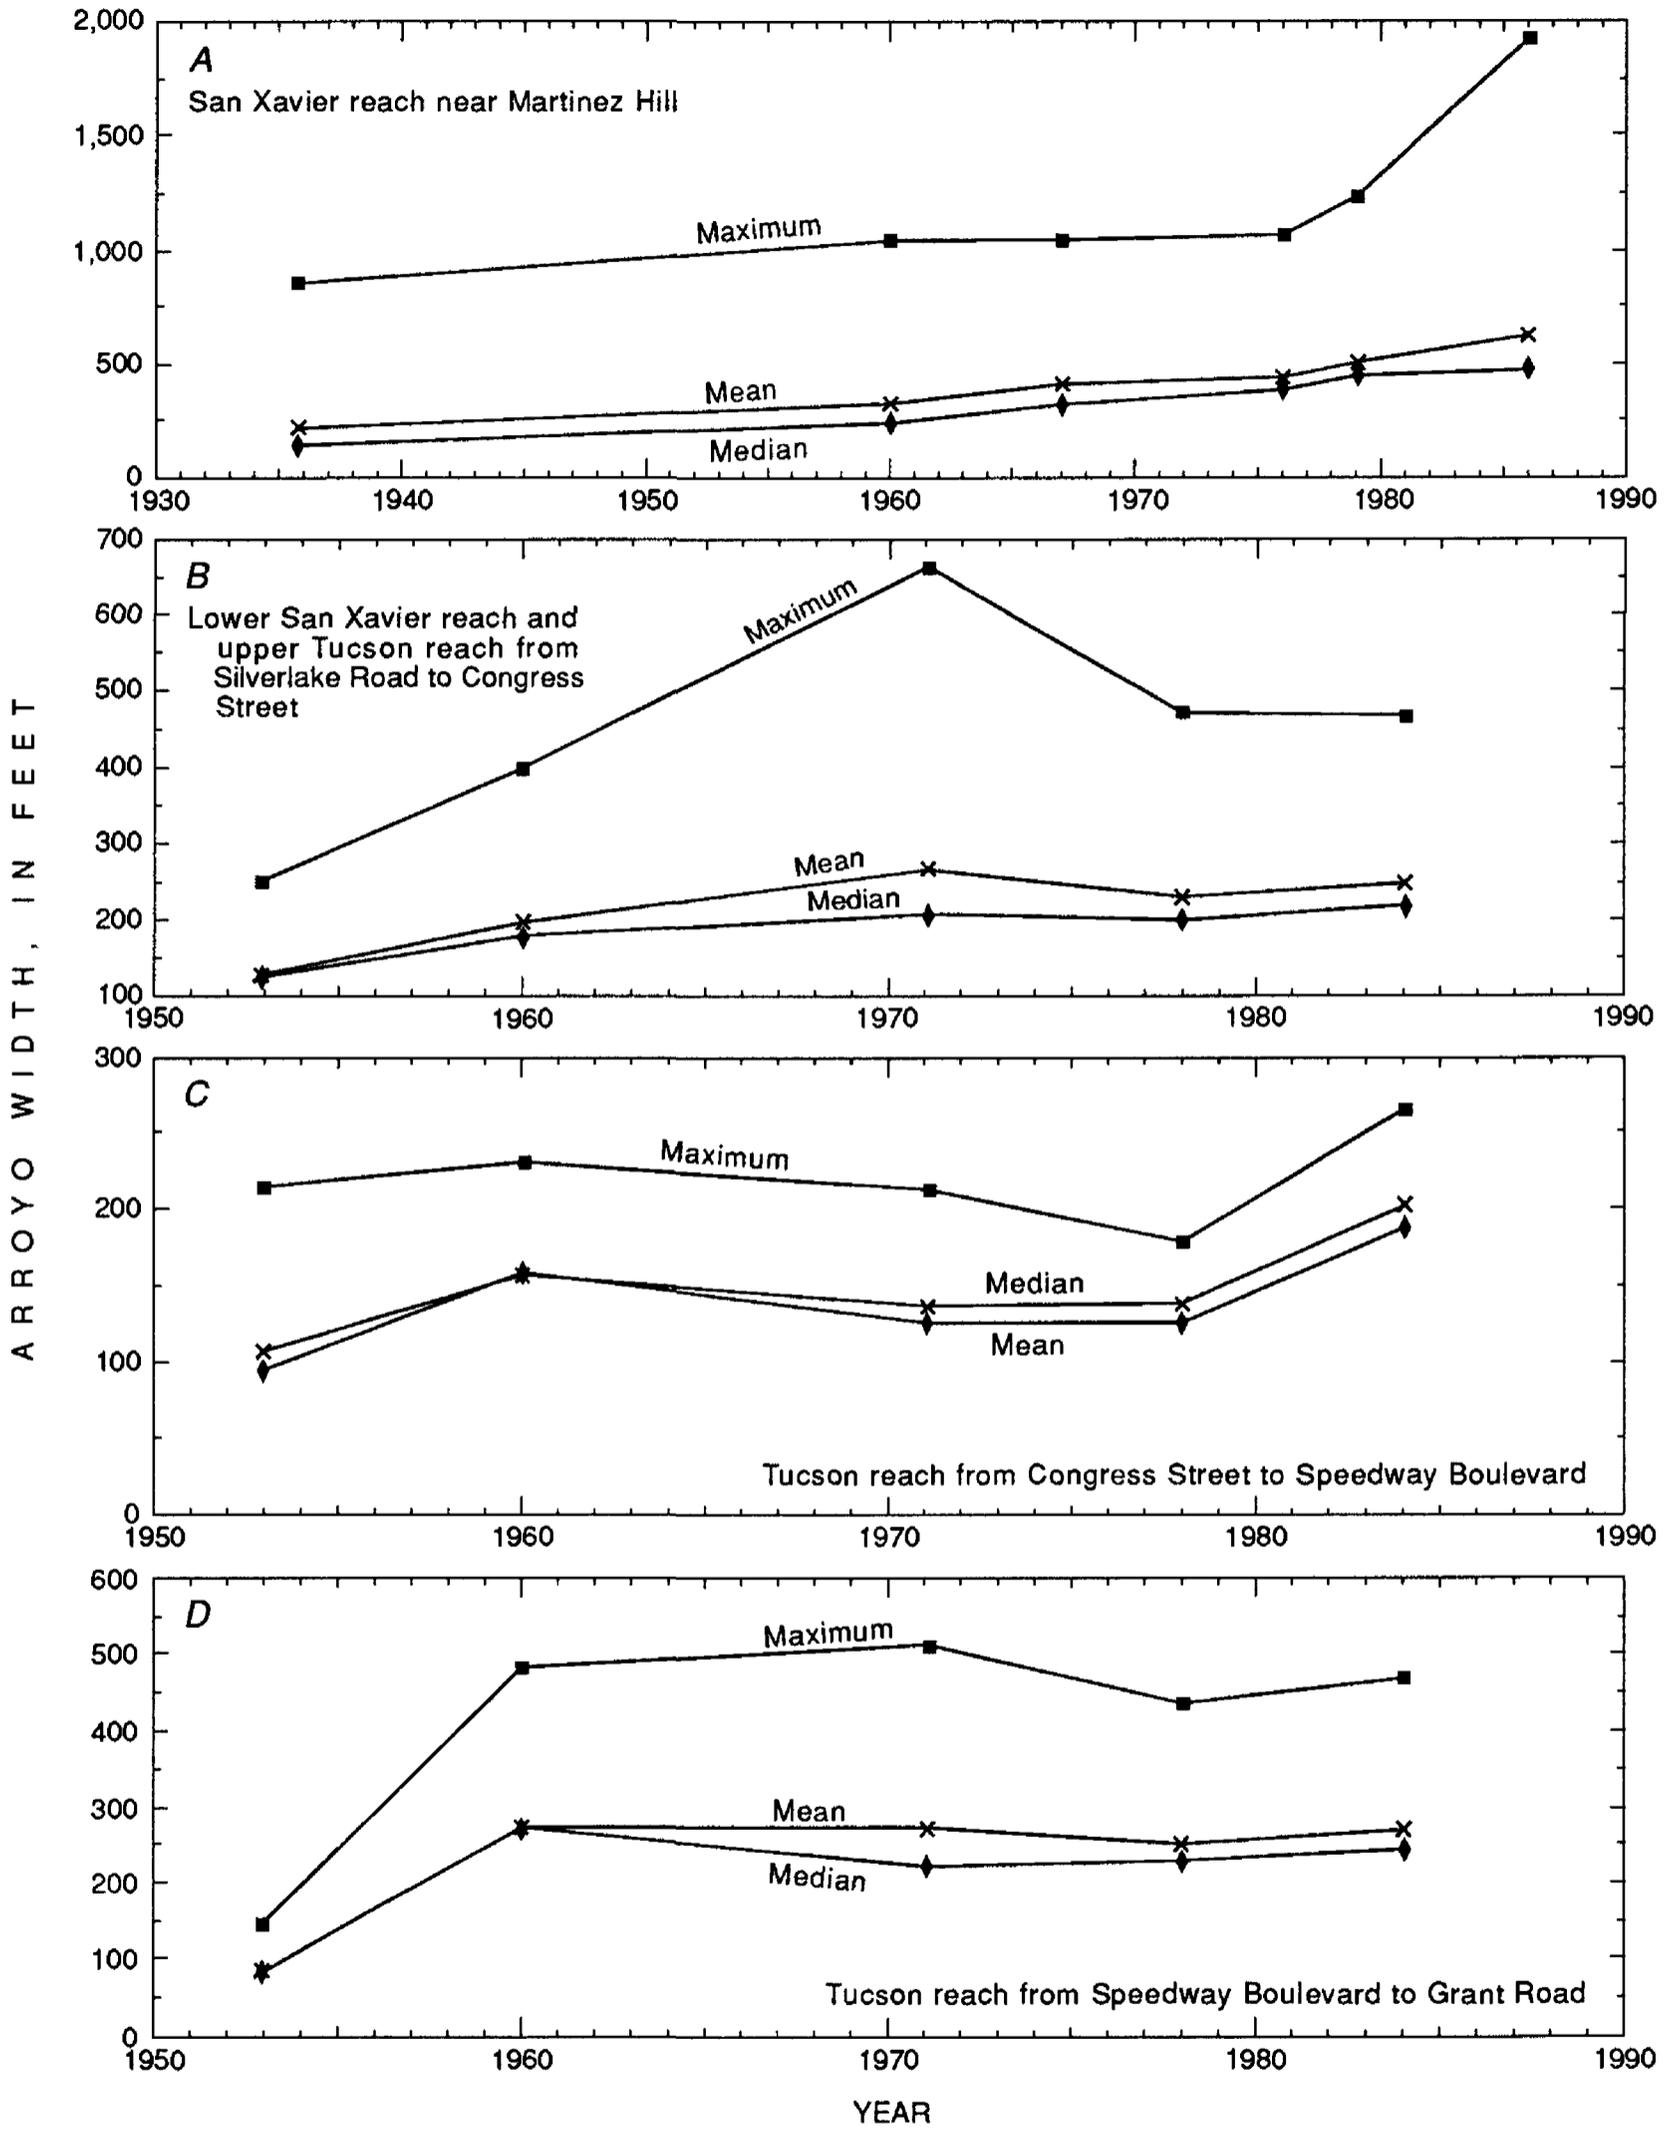
Figure 16. Arroyo-widening statistics for the San Xavier and Tucson reaches.

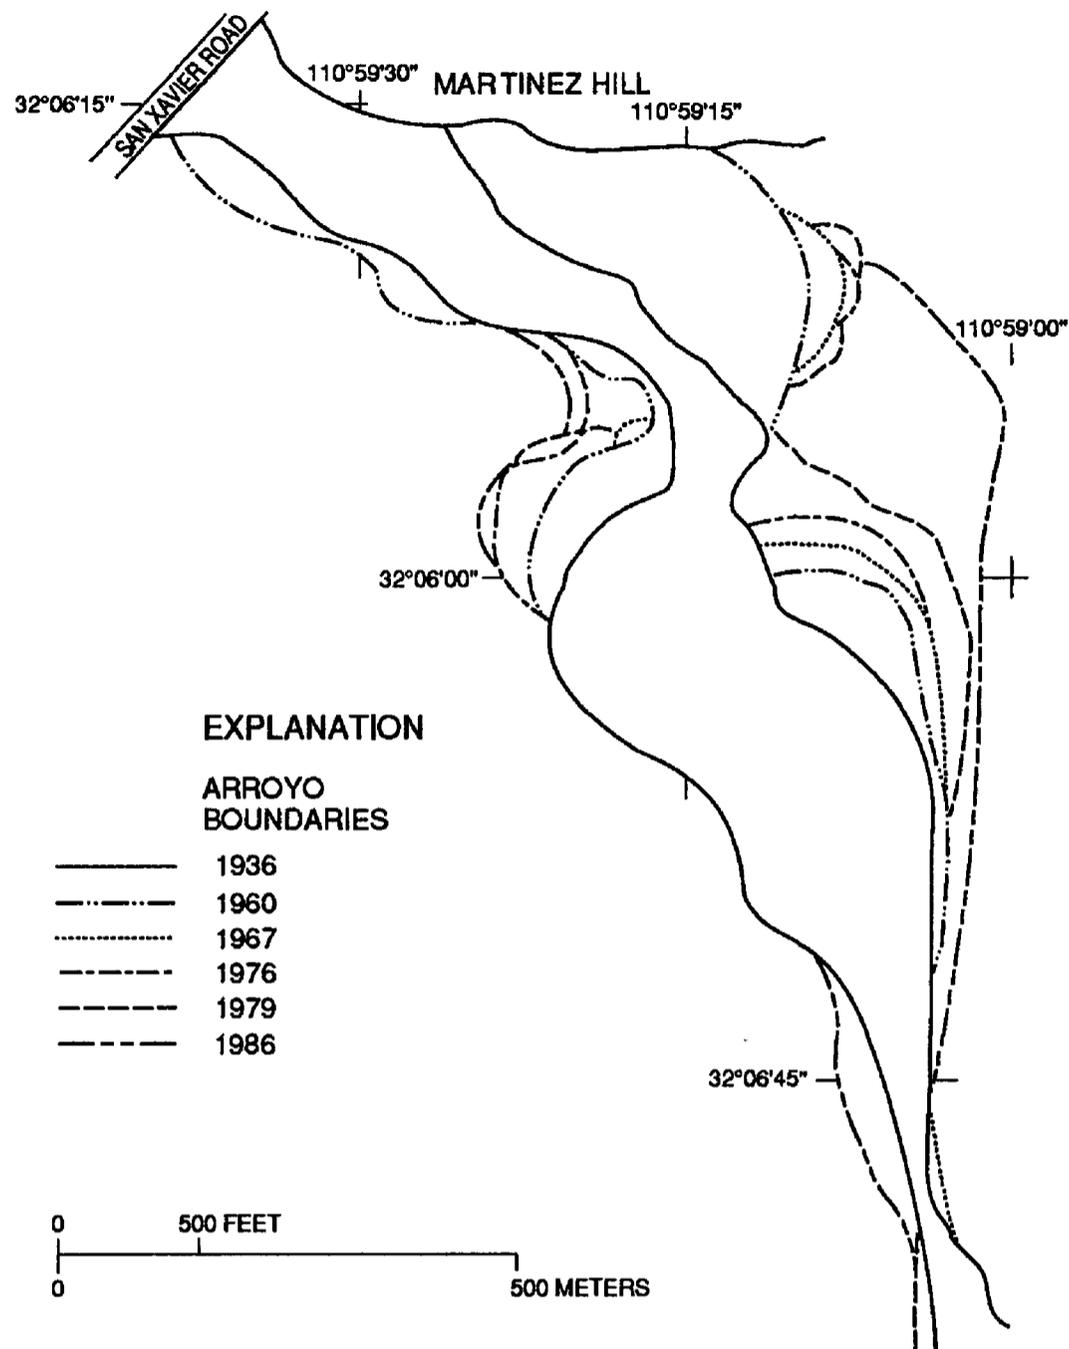
Figure 17. Arroyo widening caused by migration of entrenched meanders in the San Xavier reach at Martinez Hill, 1936–86. (Source: Data from National Archives, 1936; Cooper Aerial Survey, 1960, 1967, 1979, 1986; Kucera and Associates, 1976.)

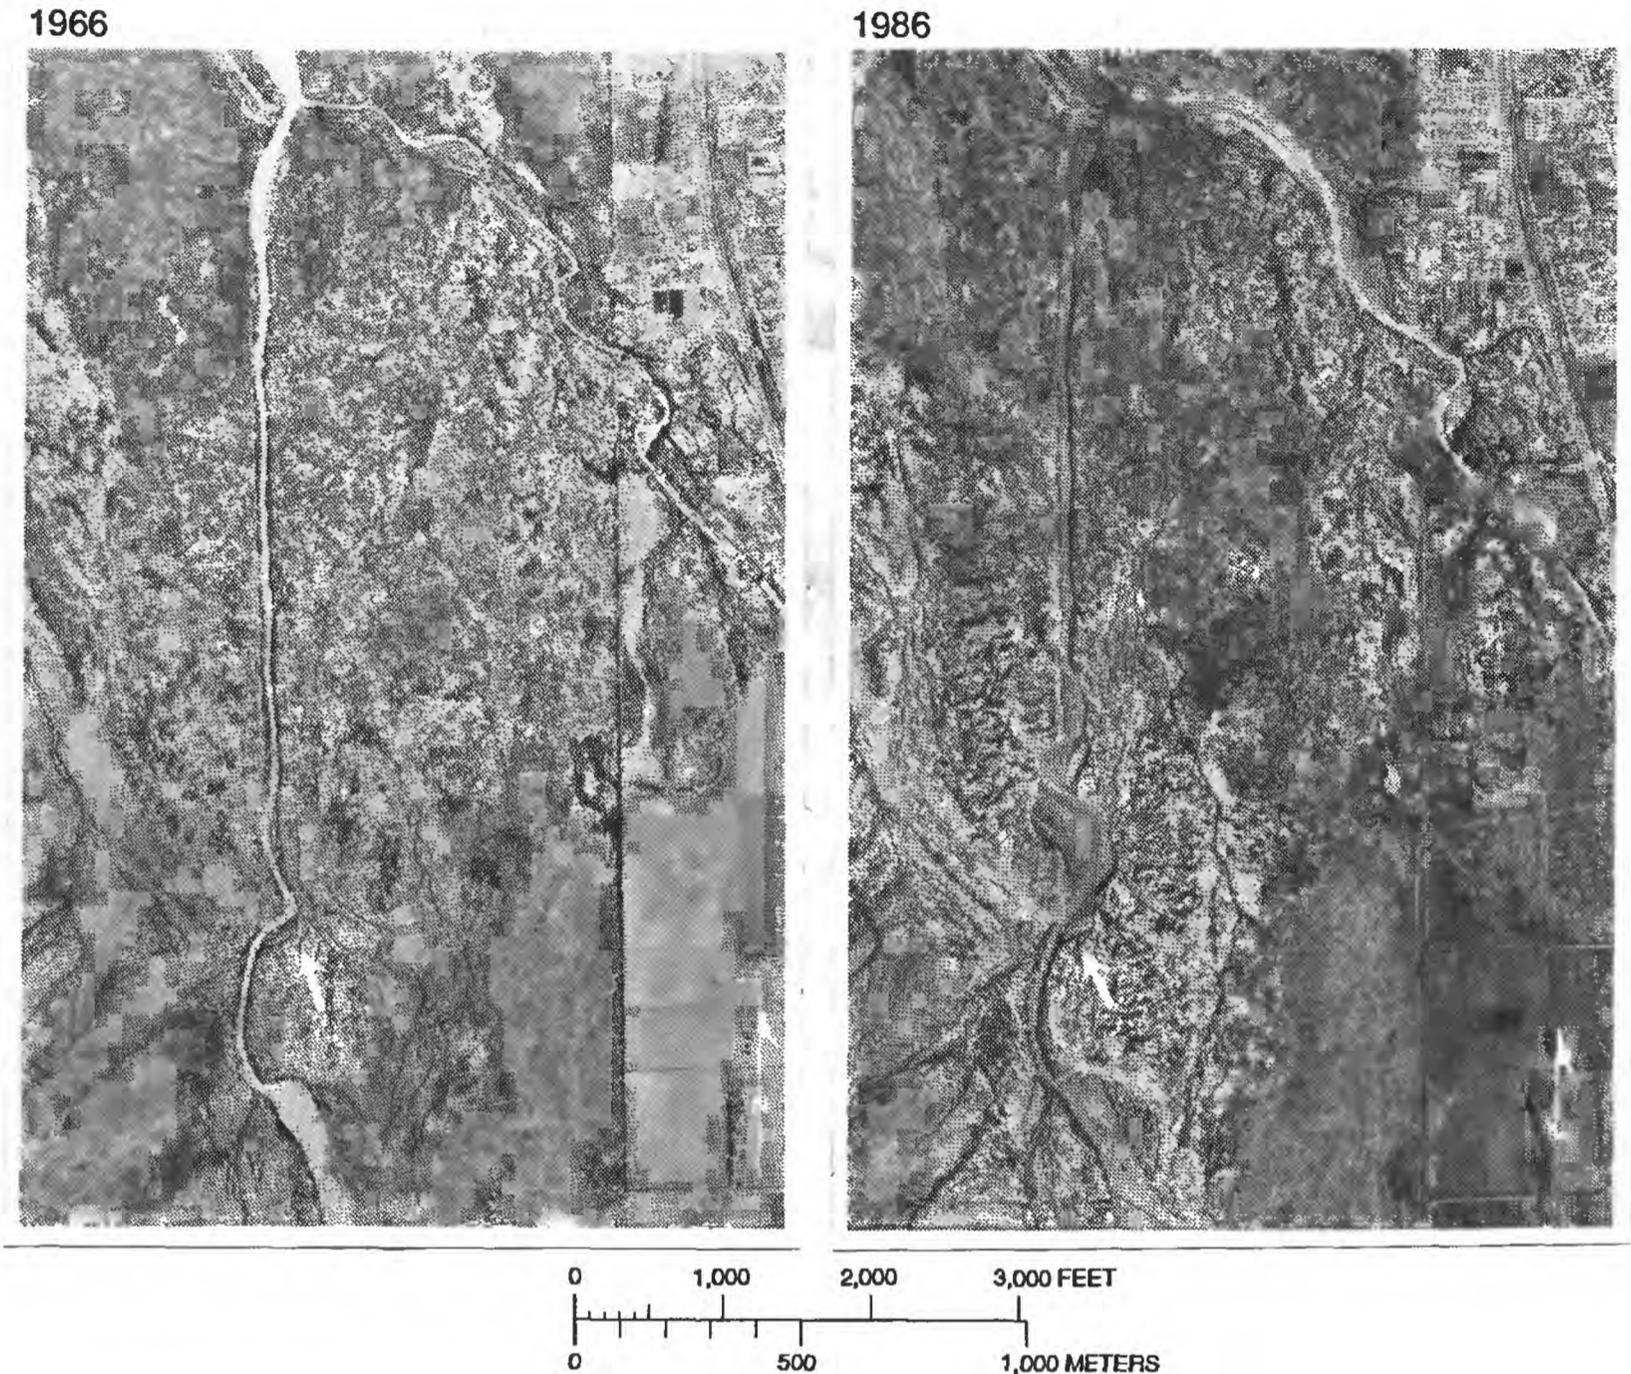
Figure 18. Changes on straight segment of the upper San Xavier reach, 1966–86. Arroyo width changed little except at the upstream end of the reach where an entrenched meander was migrating into the straight segment. Most of the change occurred during the flood of 1983. (Source: U.S. Geological Survey, EROS Data Center, 1966; Cooper Aerial Survey, 1986.)

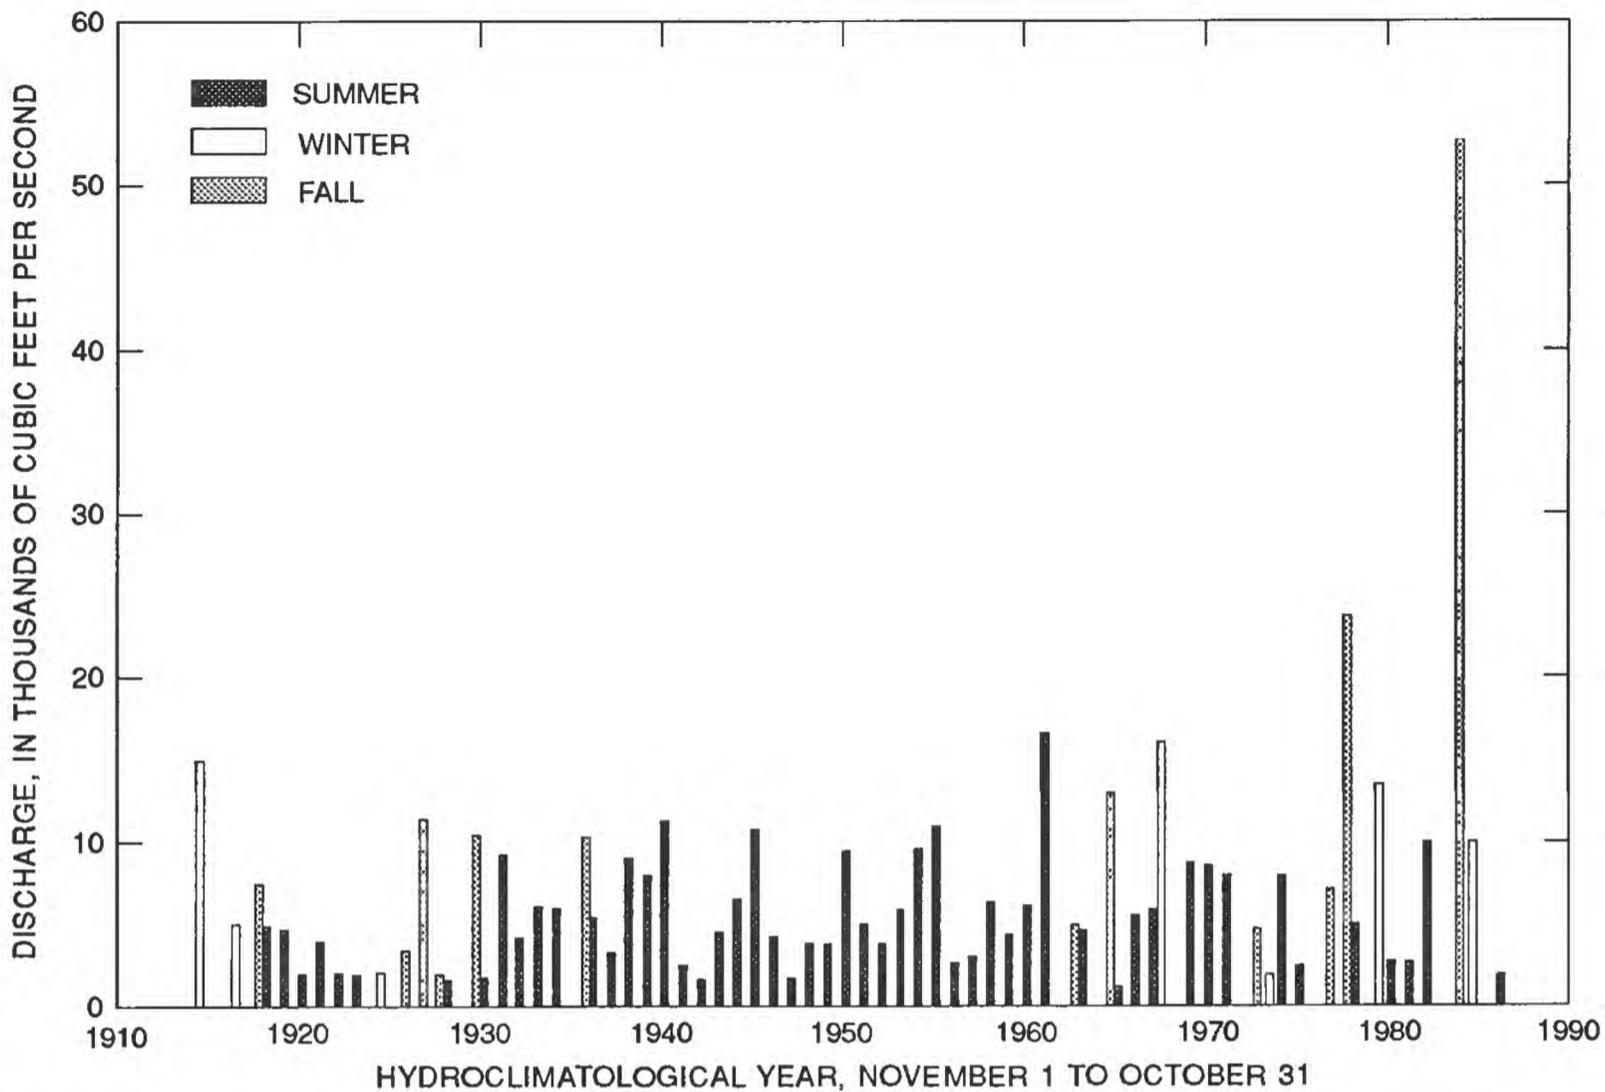
Figure 19. Annual flood series for the Santa Cruz River at Tucson. (Source: Data from Webb and Betancourt, 1992.)

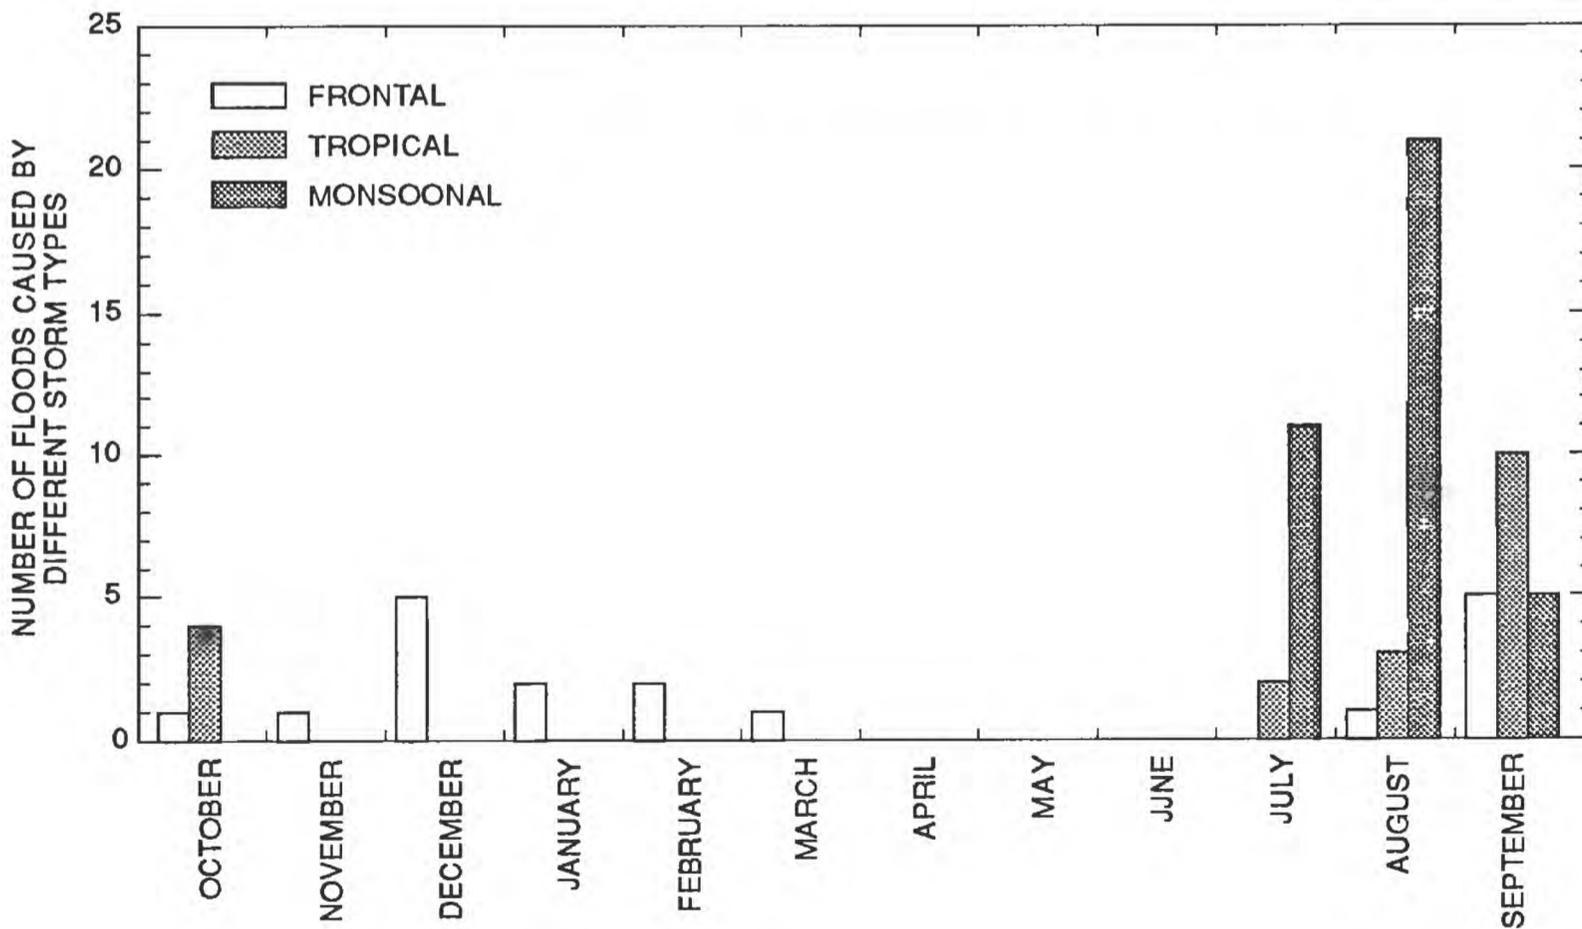
Figure 20. Seasonal occurrence of floods at Tucson caused by monsoonal thunderstorms, frontal systems, and dissipating tropical storms, 1914-84. (Source: Data from Webb and Betancourt, 1992.)
