Channel Change on the Santa Cruz River, Pima County, Arizona, 1936–86

By JOHN T.C. PARKER

U.S. GEOLOGICAL SURVEY
Open-File Report 93—41

Prepared in cooperation with the
PIMA COUNTY DEPARTMENT OF TRANSPORTATION
AND FLOOD CONTROL DISTRICT

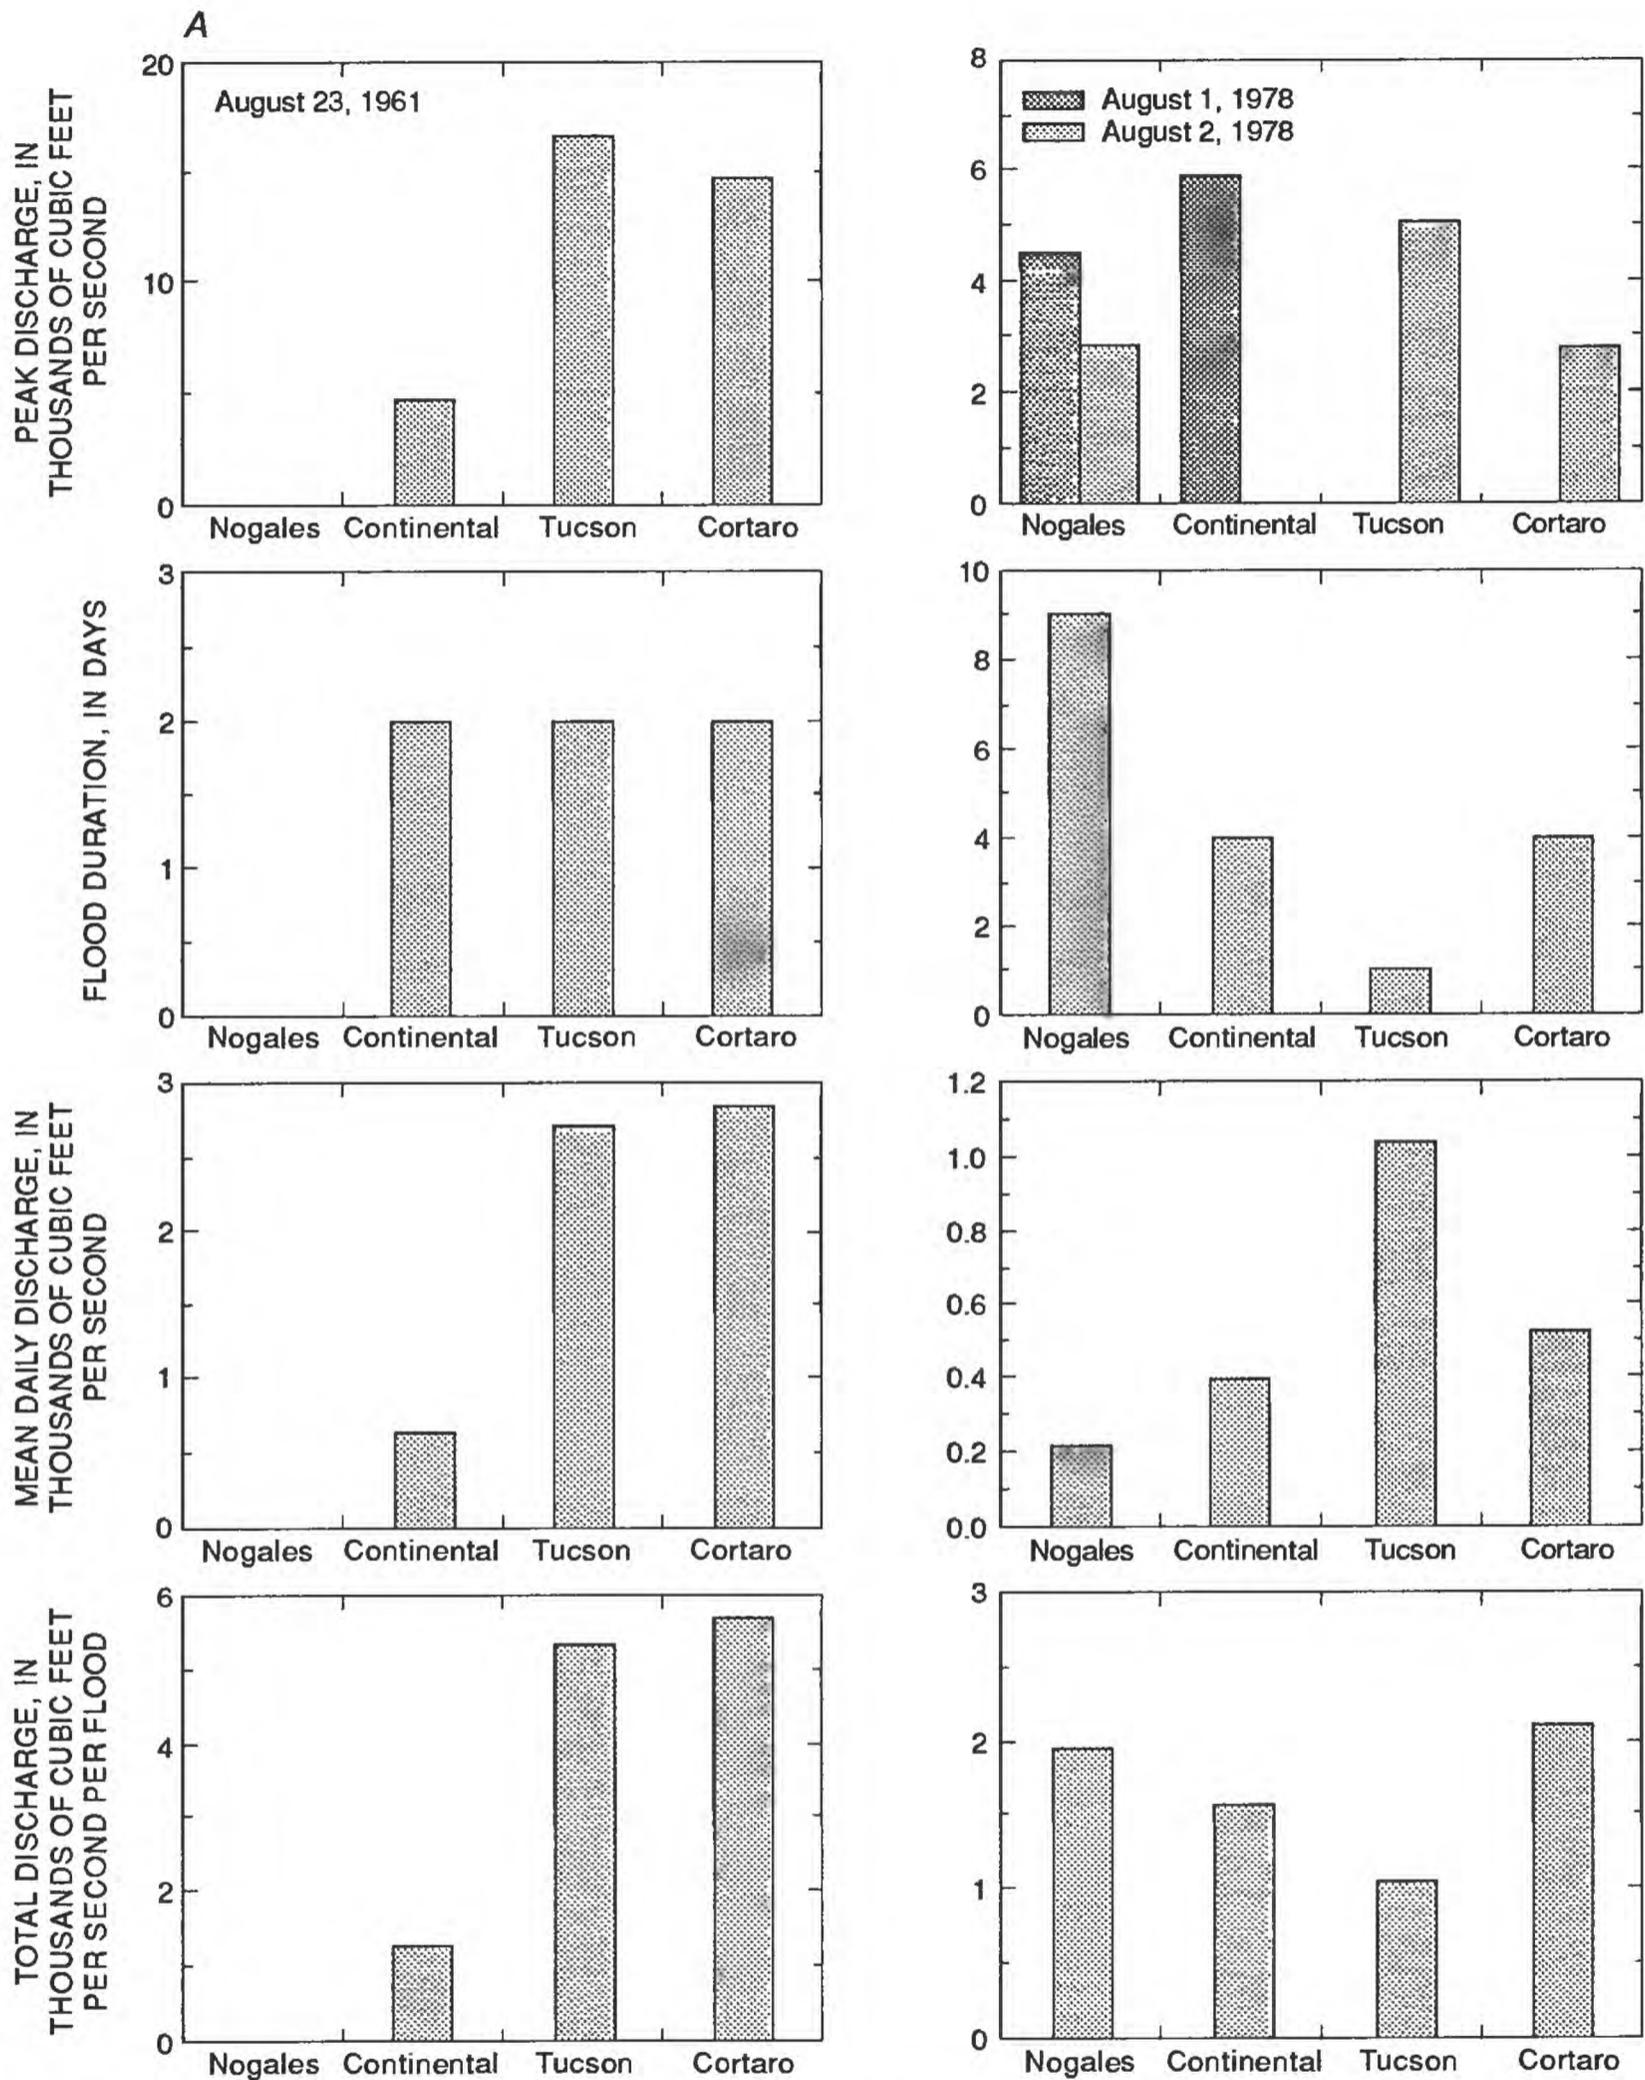
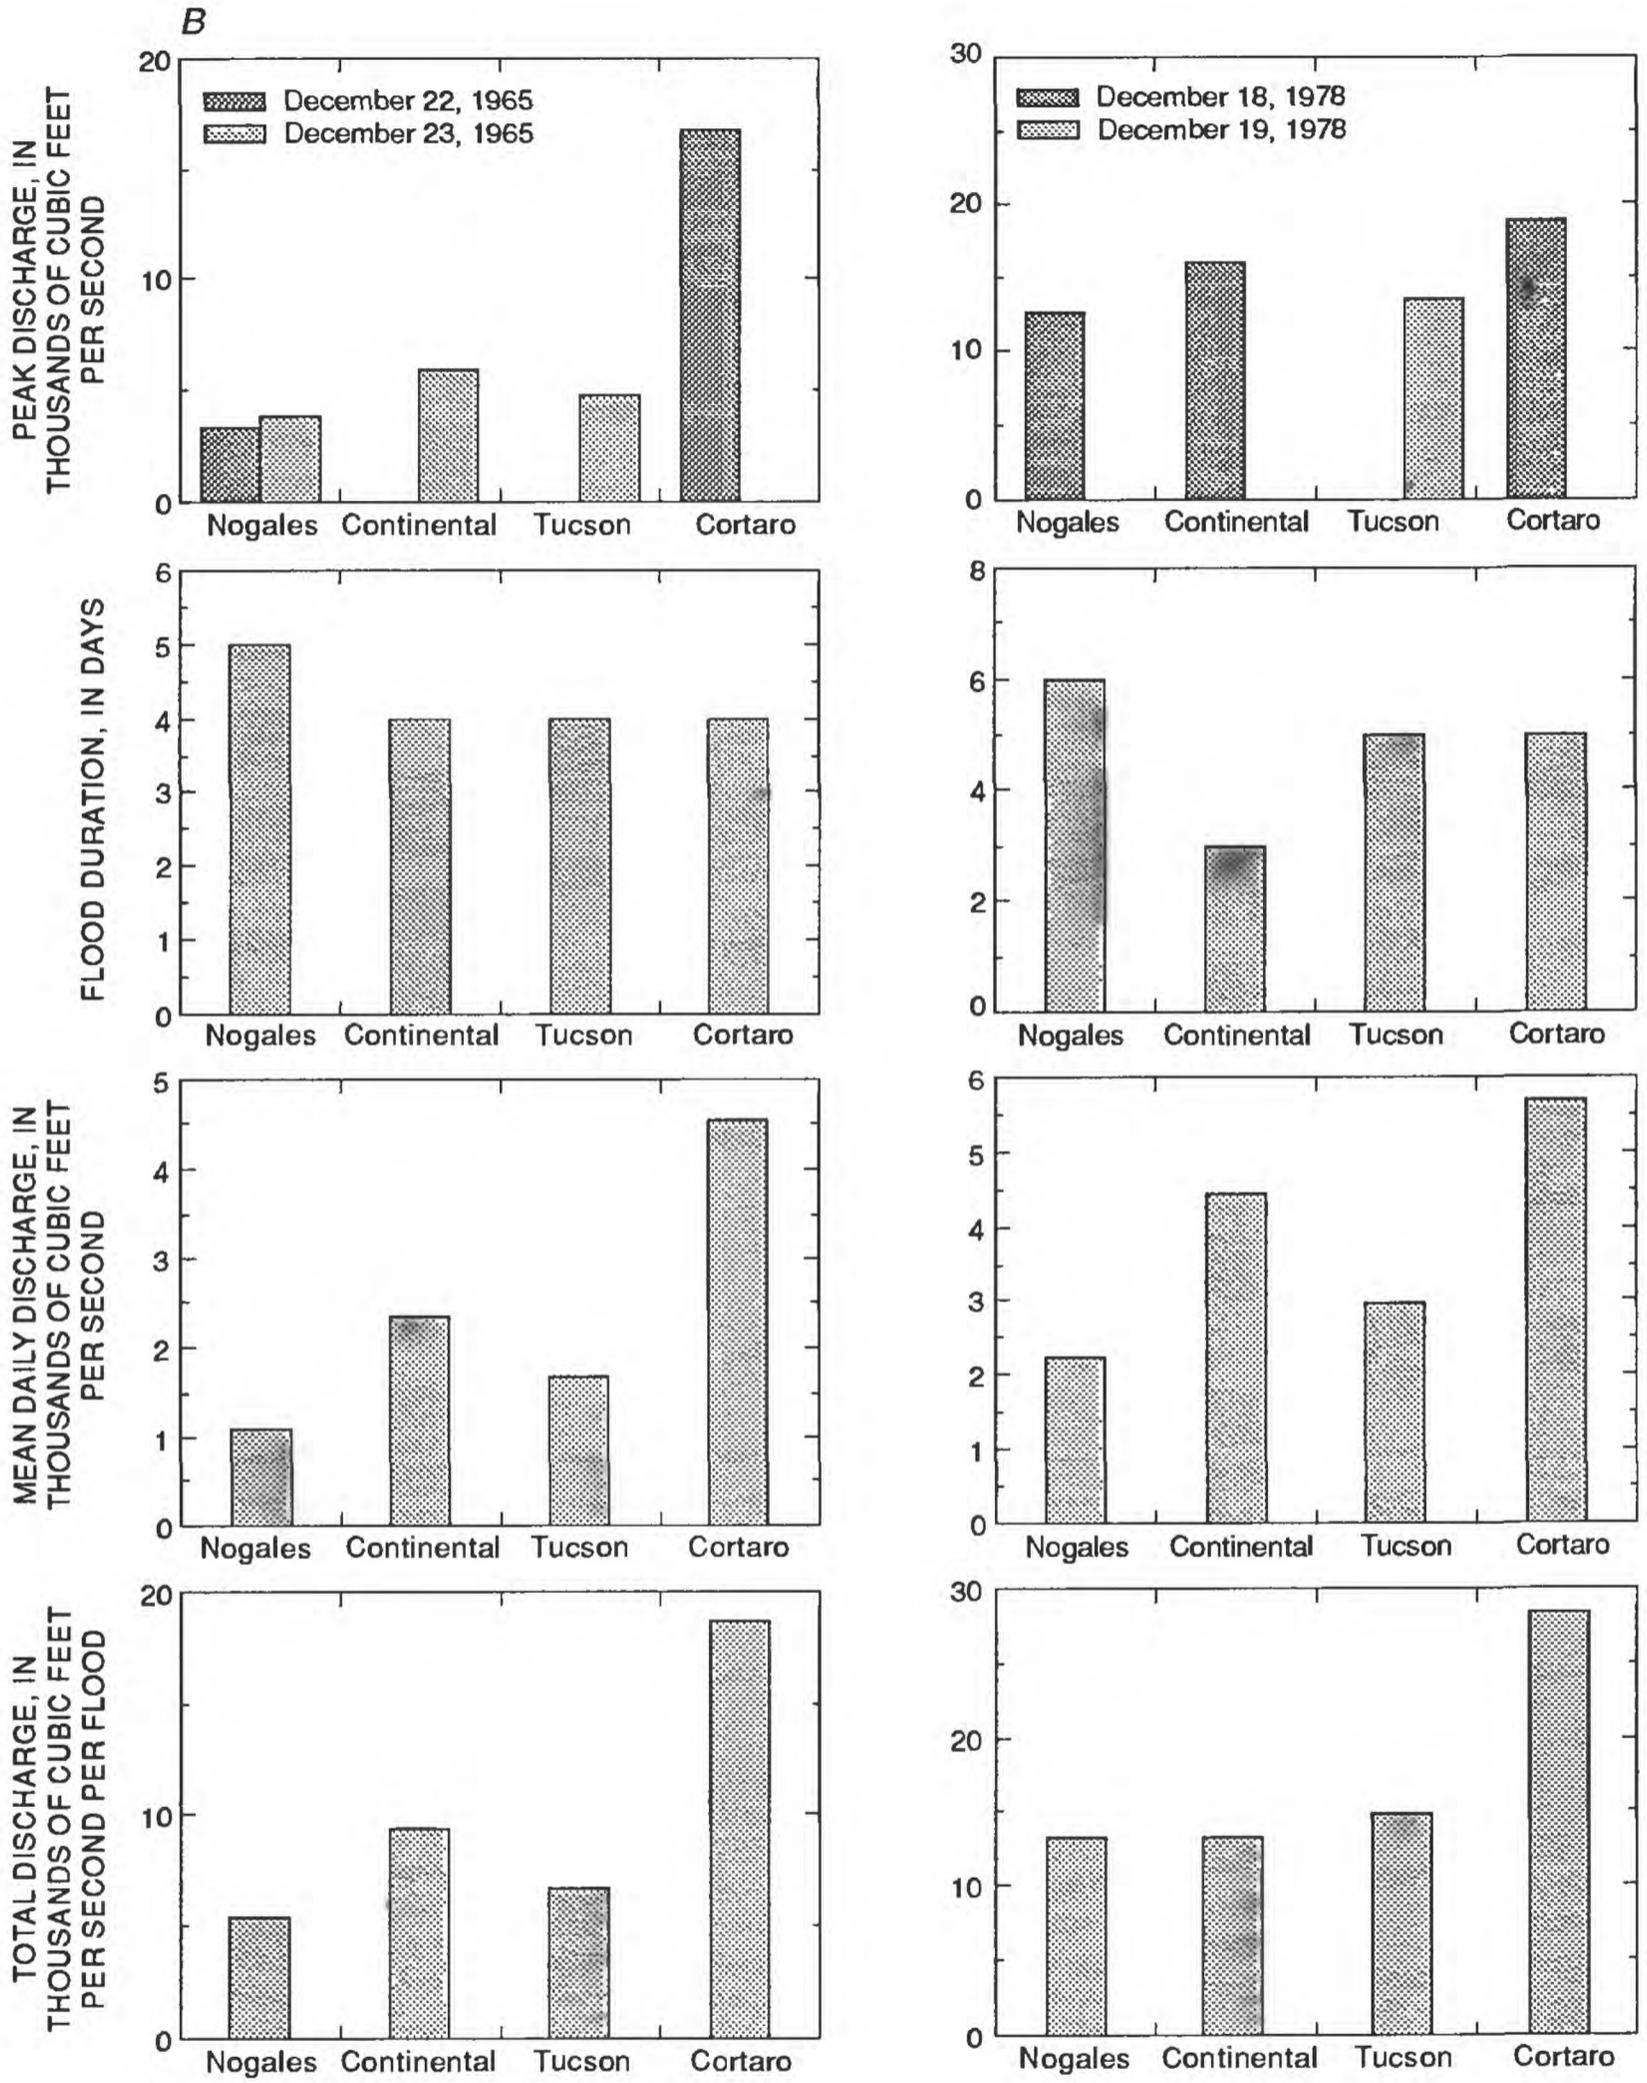
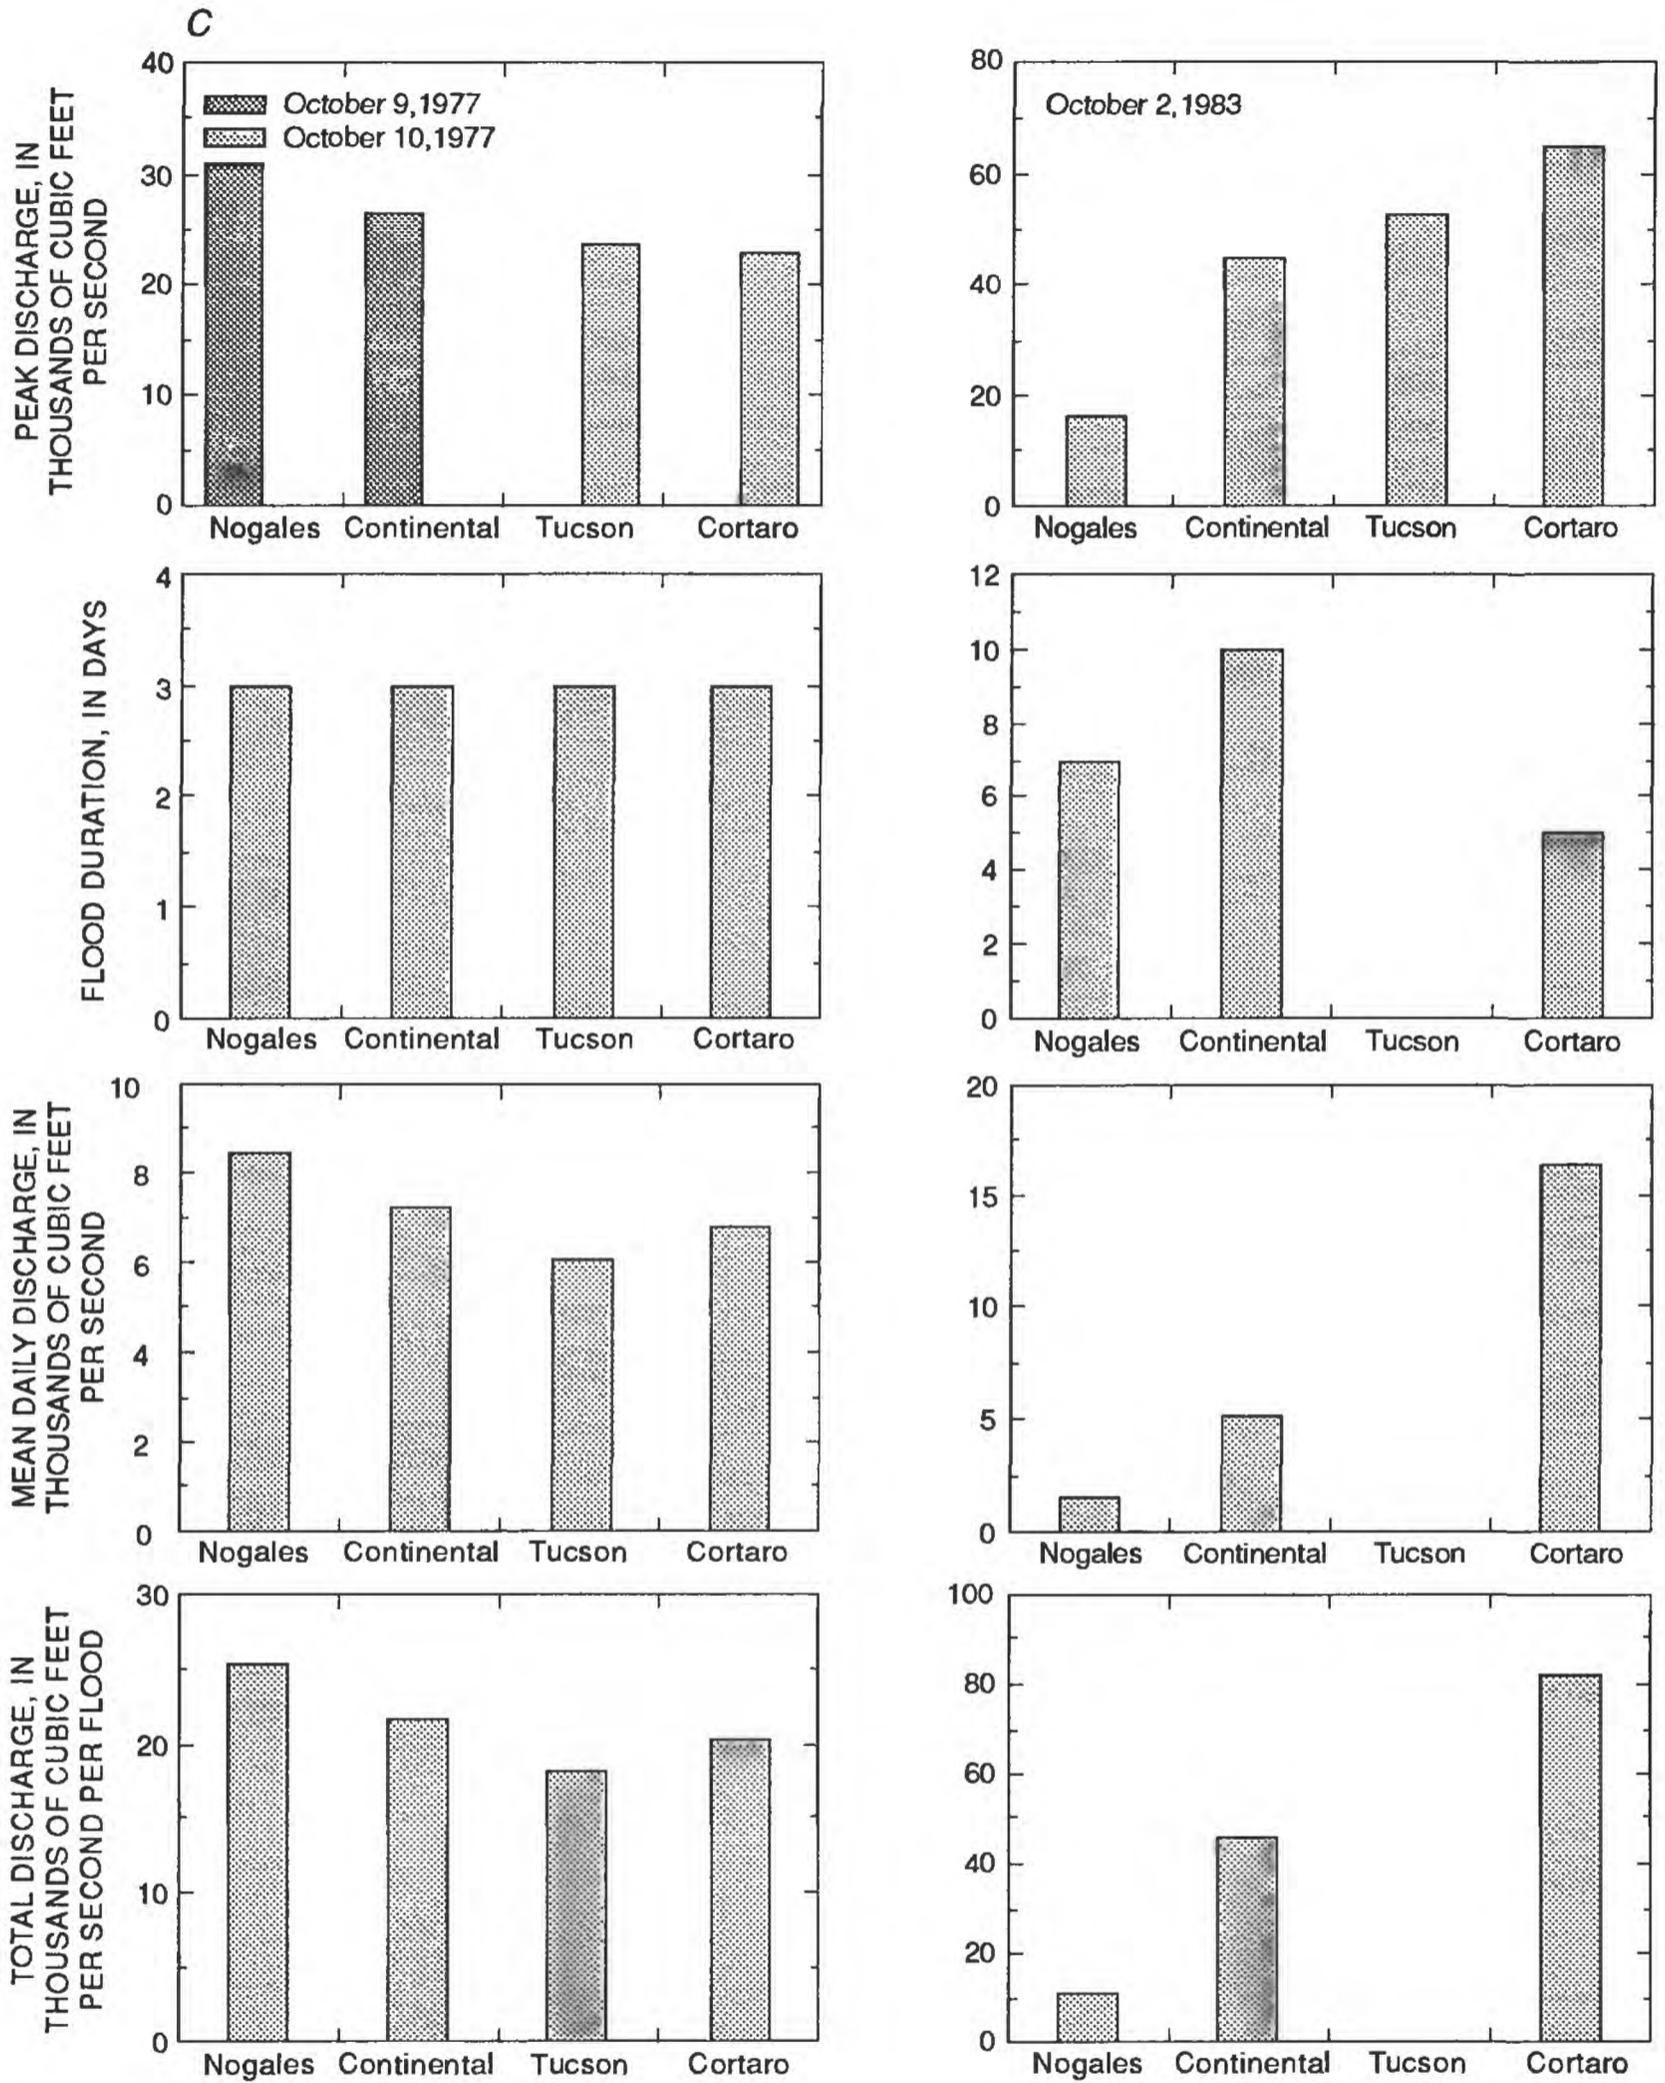
Figure 21. Flow characteristics of floods caused by different storm types at four stations on the Santa Cruz River. (Source: Data from Webb and Betancourt, 1992.) *A*, Floods of August 23, 1961 (no flow recorded at Nogales), and August 1–2, 1978, caused by monsoons. *B*, Floods of December 22–23, 1965, and December 18–19, 1978, caused by frontal storms. *C*, Floods of October 9–10, 1977, and October 2, 1983, caused by tropical storms. In 1983, the Tucson station was not in operation and peak discharge was determined indirectly.

The highly localized distribution of summer monsoonal precipitation is reflected in flood patterns of August 23, 1961, and August 1-2, 1978 (fig. 21A). The 1961 flood—the third largest of record at Tucson (table 5) and the eighth largest at Cortaro—produced a modest peak discharge at Continental and no flow at all at the Nogales streamflow-gaging station. Such a pattern is a product of the limited areal extent of intense precipitation during monsoonal thunderstorms. Spatial and temporal patterns of flow are more complex for the August 1978 flood. The timing and magnitude of peak discharge varied considerably among the four stations, and there was no direct relation between peak discharge and the other flow characteristics of duration and mean and total discharge (fig. 21A). Flow was considerably more flashy at Tucson where the flood lasted 1 day than at Nogales where the flood lasted 9 days but produced only twice the total flood volume. The variability among the four stations may reflect precipitation patterns but may be further influenced by different

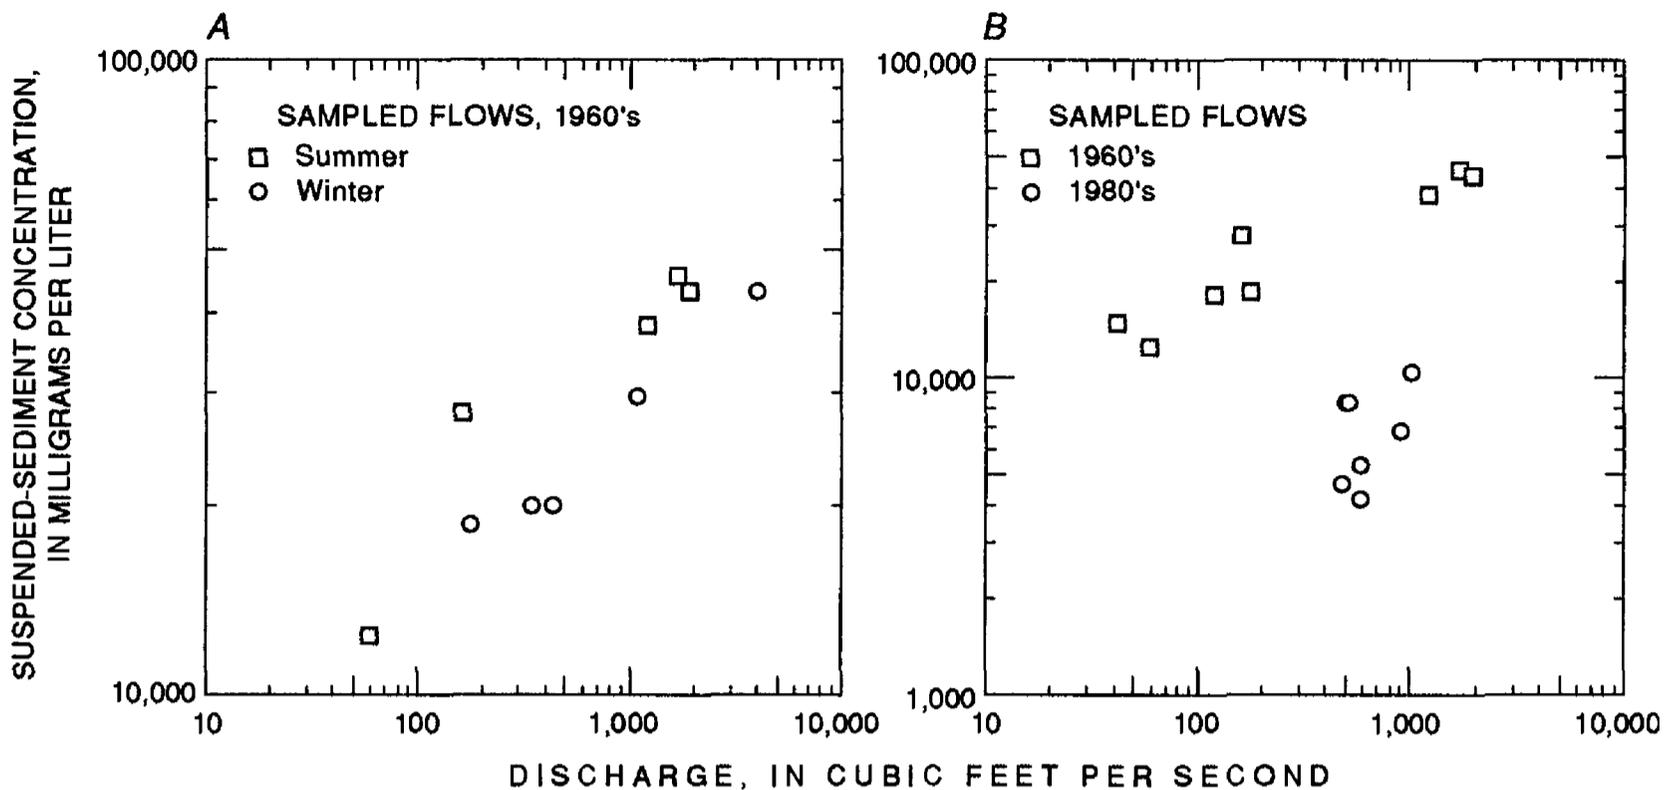
Figure 22. Relation of suspended-sediment concentration and discharge, Santa Cruz River at Tucson.

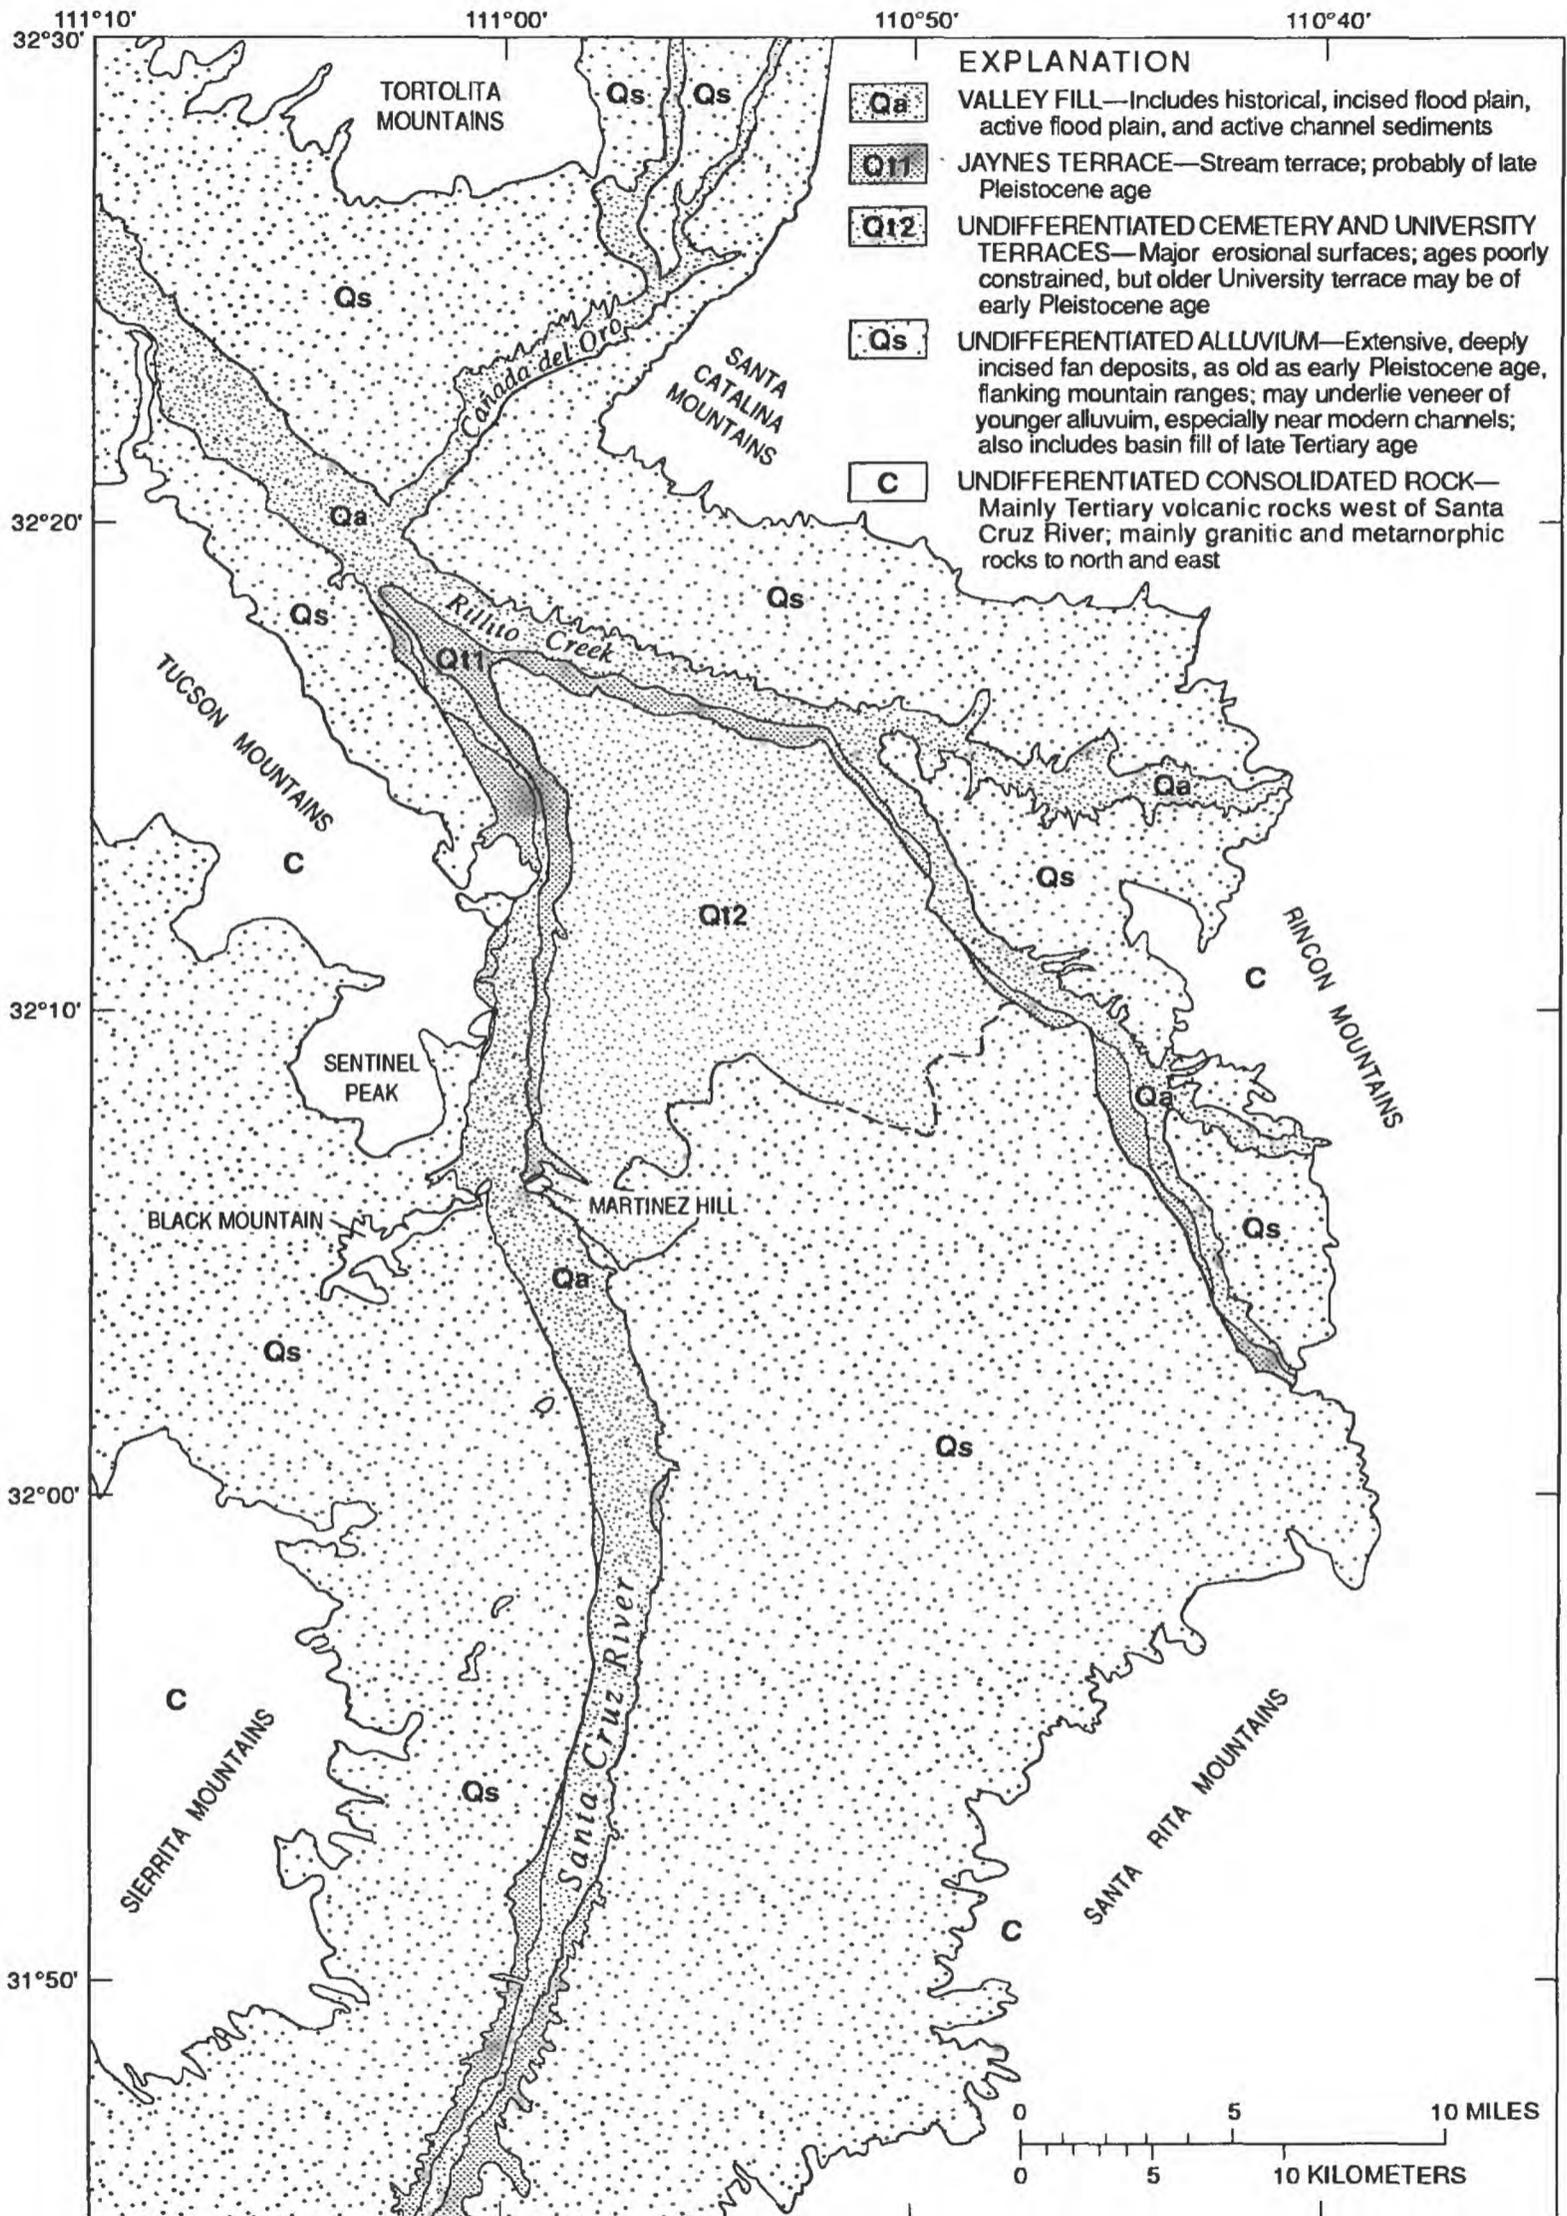
Figure 23. Geomorphology and surficial geology of the Tucson basin. (Source: Modified from Davidson, 1973; McKittrick, 1988; Jackson, 1989.)

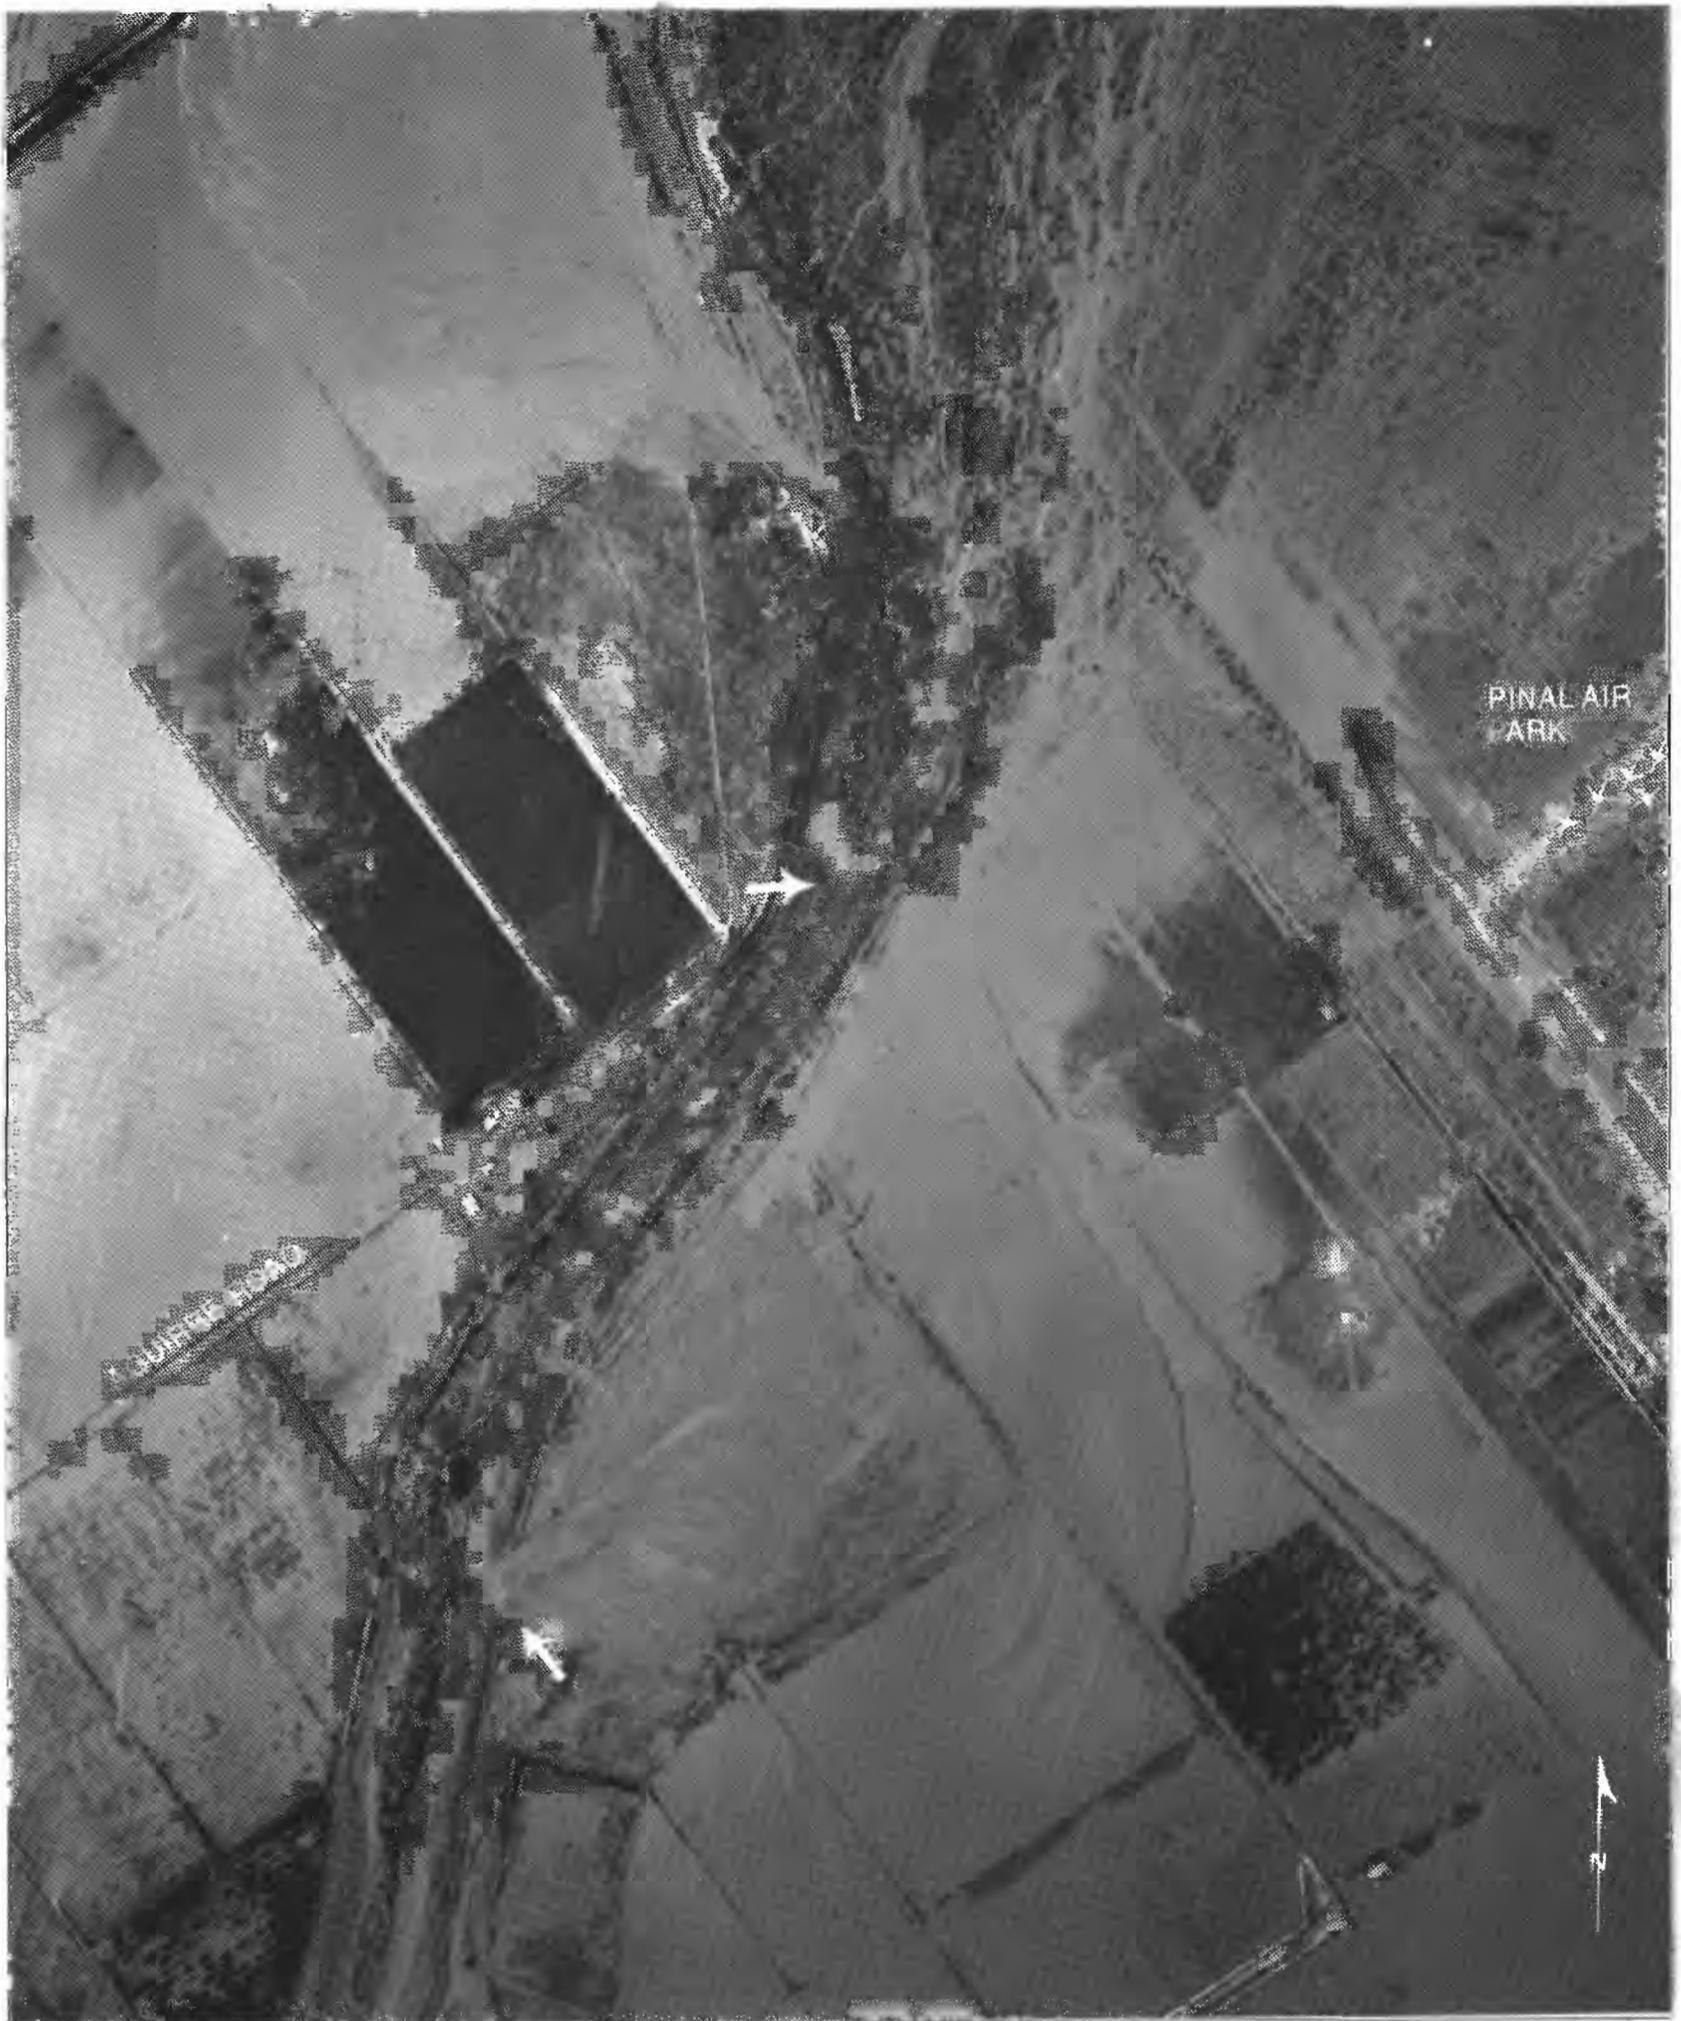
Figure 24. Floodwaters breaking through levees (indicated by arrows) on the lower Marana reach during the flood of October 1983. (Source: Cooper Aerial Survey, 1983.)
