**U.S. Department of the Interior
U.S. Geological Survey**

WINTER COASTAL OBSERVATIONS, LAKE ERIE, OHIO SHORE

Open-File Report 93-539

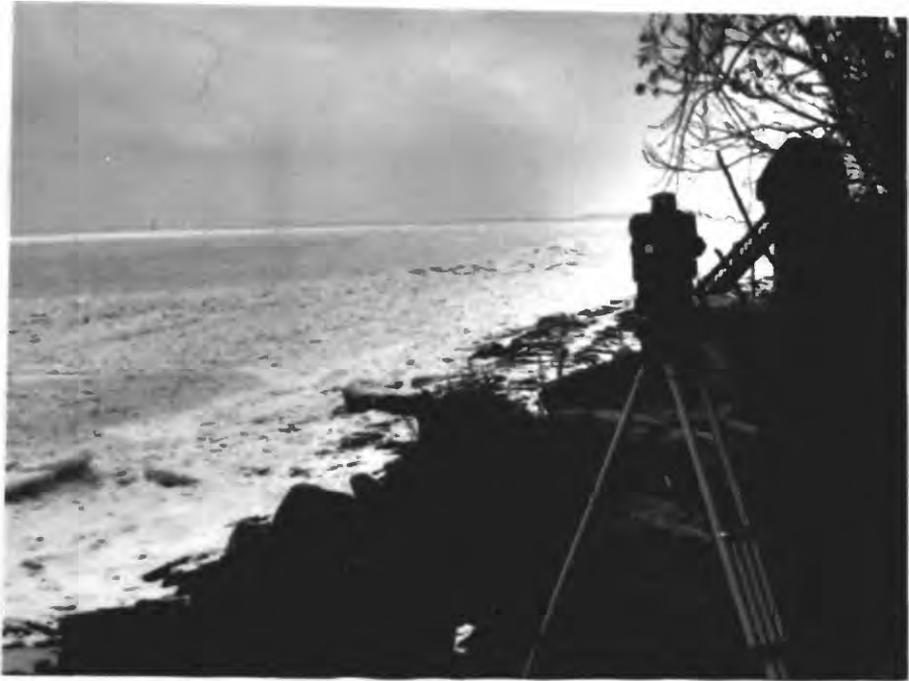
A very narrow (10m) beach backed by a 2m high ridge protected by rock rubble (Figure 2A). The EDM was located on the southwestern edge of a concrete 'patio' atop a ridge. Ice extended nearly to the horizon where a thin dark band of water was visible. The inner 26.5m of ice was typical of what we saw in Michigan with an icefoot extending out 10-20m from shoreline and a nearshore ice ridge between 20-40m from shoreline (Figure 2B), but the NIC was not well developed. The icefoot and ice ridges were grounded in less than a meter of water and were 1-2m high. Lakeward the ice consisted of pressured and rafted ice sheets (skim ice) and areas of refrozen slush and brash. The ice ridges seemed to be composed of ridged slabs that were pushed on top of each other rather than built by wave overwash as observed in Lake Michigan. Offshore profile stopped at 276m by the hip chain where the water was 360cm deep. Along the outer portion of the transect (from 26-276m) there were two or three areas of 'pressure' ridging of ice slabs with 30-50cm ridges. Ice thickness was 20-30cm where poked with rod but up to 120cm thick in rafted slabs forming the ridges. The slab ice must come from offshore.

Figure 2 - A) View of NIC at Cedar Point on February 15; **B)** Aerial view on February 19 showing NIC, offshore ice, and frozen lagoonal ice.

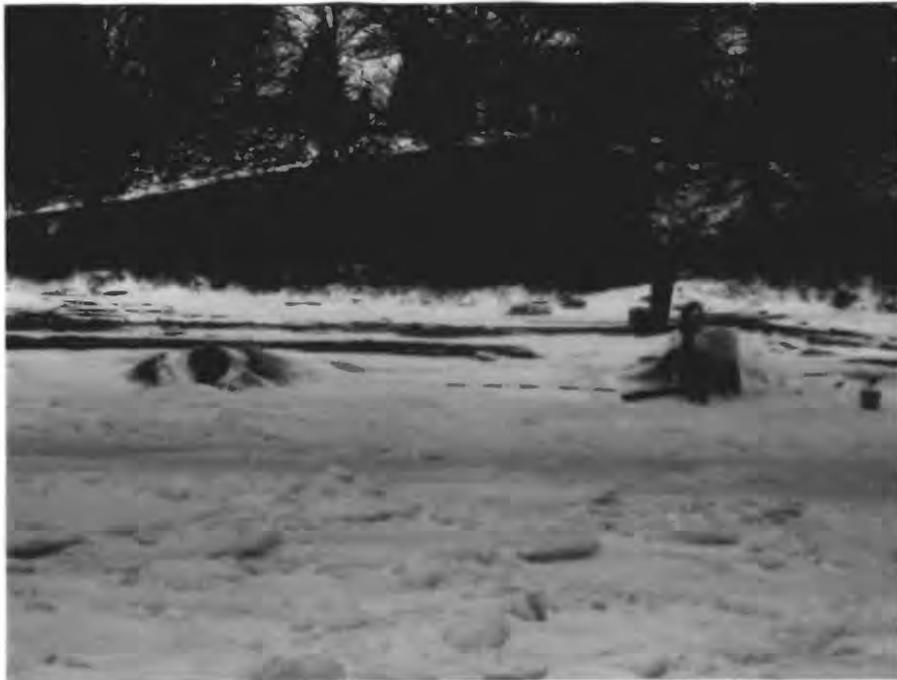
A

Narrow, 20m wide beach backed by steep slope to 10m height. Profile taken off groin at end of Indiana Street (Figure 3A). The icefoot, which averaged 5m wide, appeared to be composed of the remnants of ice volcanoes, judging from their conical nature and 'craters'. The sediment on these cones was coarser than sediment concentrated in the rest of the NIC, and had a lot of organic matter. The coarseness may result from the increased wave energy at the entrants to the craters. Samples were taken of the icefoot and of a nearshore ice ridge formed of rafted, shingled, clean-appearing slabs of thin ice about 30m offshore. From here inshore the ice was grounded. Five-cm thick ice lakeward of ridge forced a detour to get onto rafted ice (Figure 3B). No evidence of anchor ice on the lake bed was felt out to 175cm depth (the maximum depth of the traverse) where there were 1-5cm slabs, and thicker 10cm slabs and brash making up the ice. At several places, walking on the flat ice caused cracking. In areas of rafting offshore, there was evidence of sediment in the ice, primarily in the thicker slabs. The ice lakeward of the grounded ridges had an estimated average thickness of 10cm and was composed of the rafted and brash pieces. Areas of ridging had thicknesses up to 50 cm. Ice appeared hard on top and at bottom with a soft zone in between.

Figure 3 - A) View of Heidelberg Beach's NIC showing sediment covered ice volcano on February 15.

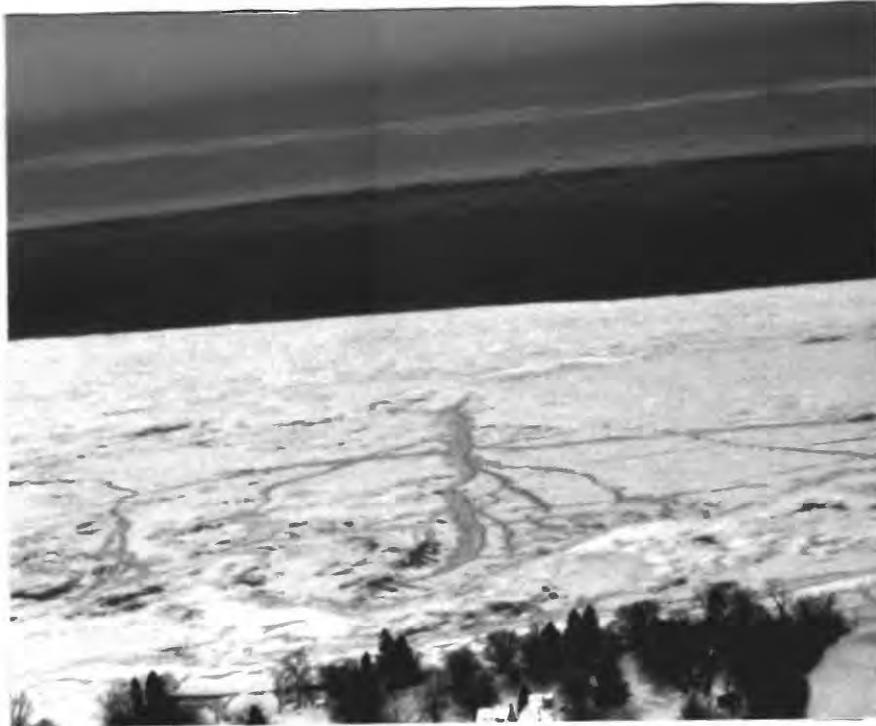
B

Figure 3 - B) Aerial view offshore ice and lead on February 19.

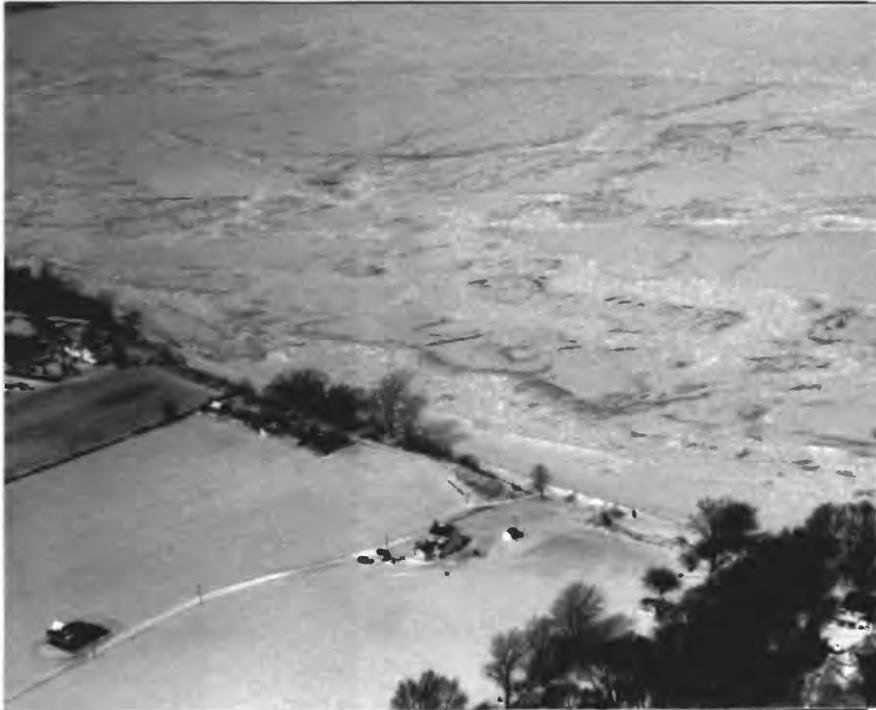
B

Figure 4B - Aerial view of offshore ice at Oberlin Beach on February 19.

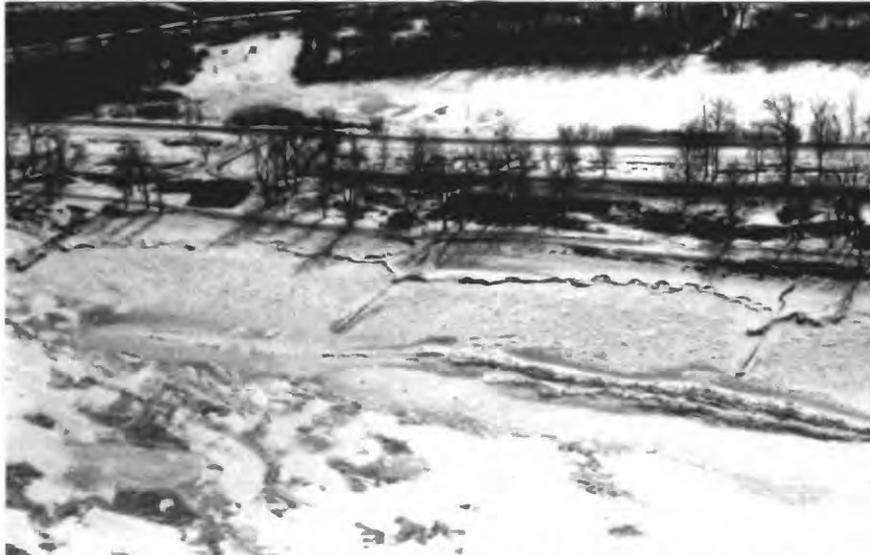
Wind from N and NE varies in intensity, and snow is drifting. Drive to Crane Creek State Park and sample nearshore ice where 20knt wind was blowing directly onshore. Ice extends as far offshore as we can see in blowing snow (at least 500m). There are patches of bare ice lakeward of groins that are spaced about every 100m and extend 50m lakeward of shoreline. Started at lakeward end of a line 70m offshore, beyond the groins in an area of snow-free ice that may represent much of the offshore ice at this end of the lake (Figure 5). Ice core (15) determined ice thickness of 14.5cm. After coring, water started flowing up through the hole indicating that lake level was rising due to NE winds. Other cores were taken inshore of a shore parallel 20cm high ridge just lakeward of the groins. The ridge was composed of rafted 3cm thick ice slabs. Ice inshore, between the groins, consisted of ruddled brash ice 10cm high, and a nearshore ridge and icefoot complex of overlapping volcanoes 70-100cm high within about 20m of the shoreline.

Figure 5 - Aerial view of NIC at Crane Creek State Park on February 19.

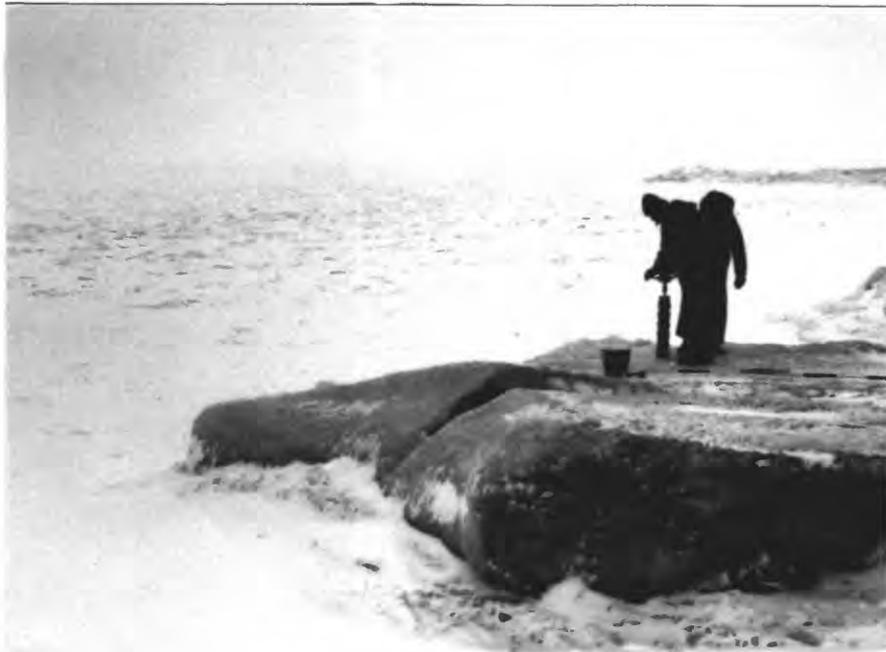
A

East facing shore south of Marblehead lighthouse had a pocket beach with a large NIC with ice volcanoes (Figures 6A & B). These features were 2 to 20 m wide and at least 2m high, with an estimated 3m thickness over a 150m section of the coast. These large coastal ice features were observed in pockets elsewhere along the northeast facing coast. Core of the ice showed turbid ice intermixed with 5-10cm blocks of clear skim ice that constituted about 30% of the core (Figure 6C). We also took a core of the 10 to 20cm high, granular brash and slush ice offshore of the ridge. The offshore ice morphology was caused by ice push rather than wave overwash processes.

Figure 6A - View of sediment laden icefoot at Marblehead on February 16.

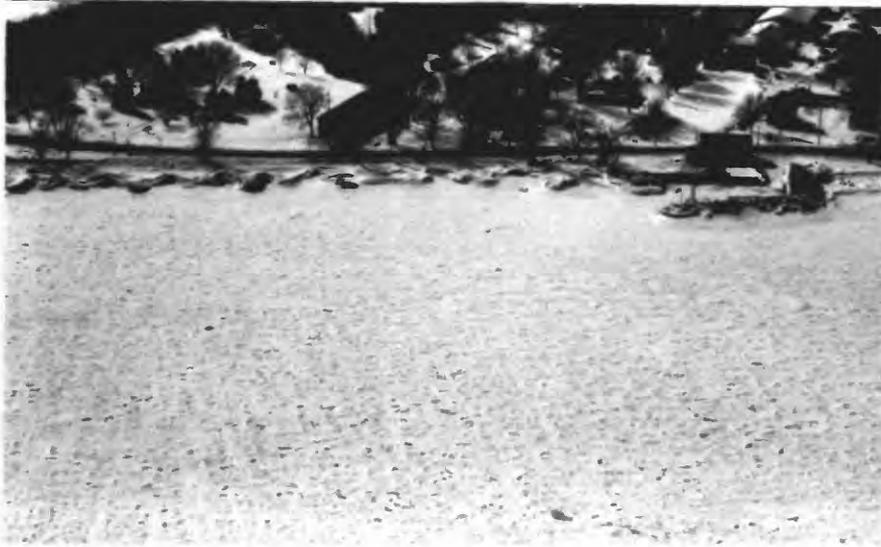
Figure 6 B - Aerial view of NIC and offshore ice at Marblehead on February 19.

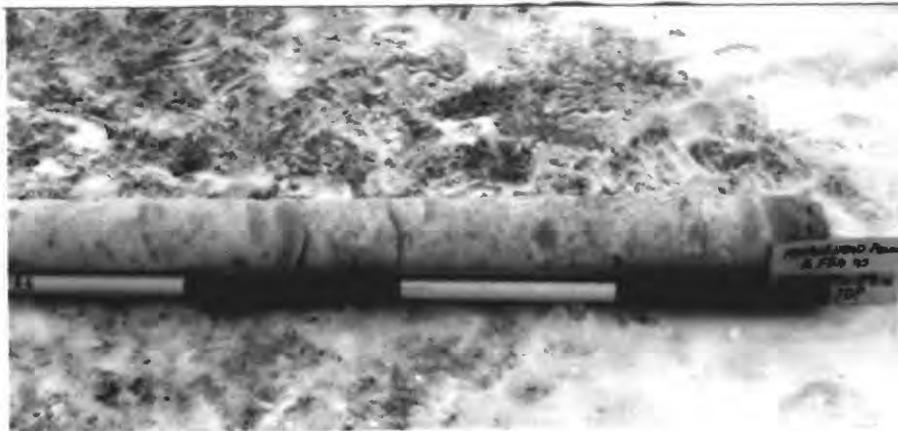
- 21 12x11cm ice core from icefoot - Sections taken from a core whose total length was 129cm (Figure 6C). Sections taken from 0-6cm and 89-95cm (top 1cm of core was covered with zebra mussels and was scraped off before measuring and sampling. Melted sample seemed to contain mostly organics.
- 22 5x11cm core of the rough (10-20cm relief) granular brash ice adjacent to the icefoot. Volume measurement is +/- 20%. Ice thickness greater than 50cm.

Figure 6 C - Core of icefoot at Marblehead showing large brash chips.

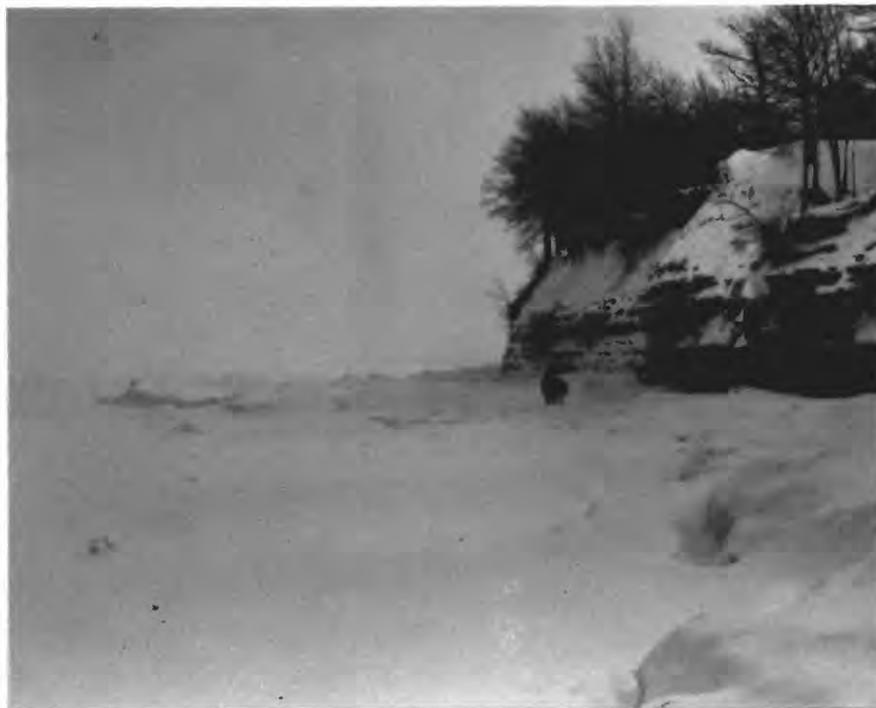
Calm winds and sunny skies at this location; temperature just below freezing. Shore ice at this site consisted of a 1 to 2m-high, 10m-wide icefoot and ice ridge at the shore (Figure 7A). Lakeward of the icefoot was a rubble brash ice region with 20cm surface relief, which was difficult to walk on. Lakeward of the rubble brash was a second ridged area 15m wide, 50cm high and up to a meter thick. About 50m offshore, ice was sampled that can be considered representative of the offshore ice located lakeward of the outer ice ridge. This offshore ice consisted of 20 to 40cm-high ridges of pressured skim and slush ice that extended to the horizon with an estimated average thickness of 40-50cm in the offshore area of the lake. The stream entering the lake at this location carried small quantities of anchor ice and frazil ice which may influence the local ice regime.

A
 Figure 7 A - View of icefoot and bluffs at Bay Village on February 17.

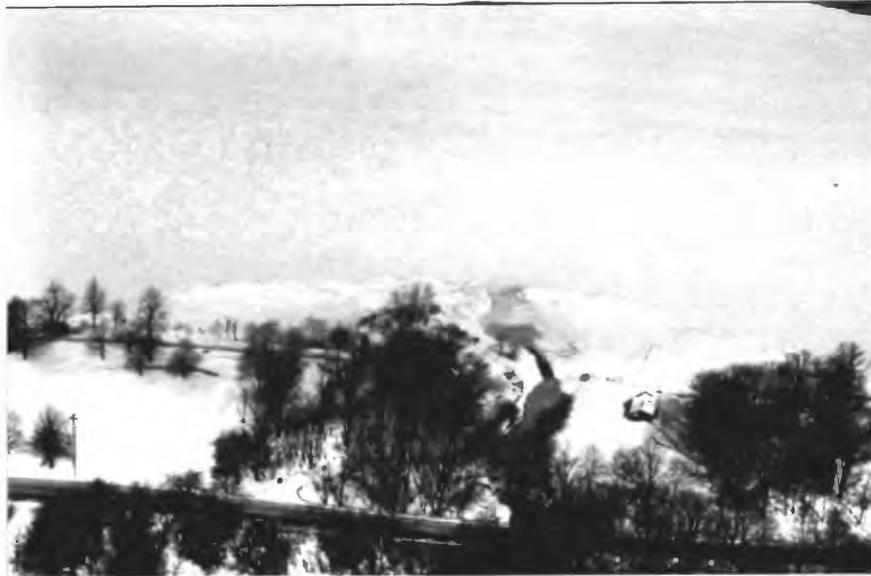
B

Figure 7 B) Aerial view of Bay Village showing NIC, offshore ice and open water (upper right).

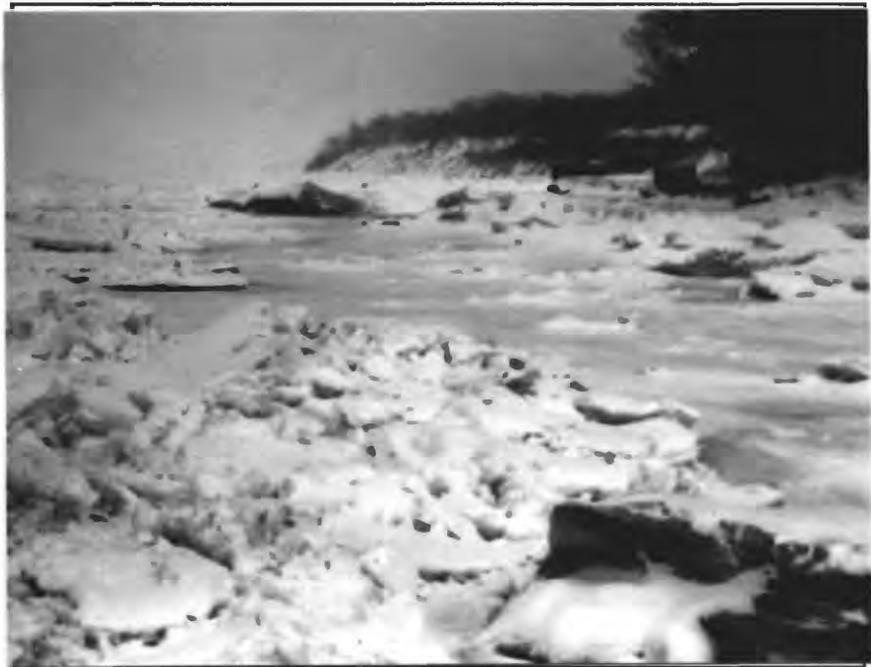
The bluff here is 10m to 15m high and the beach only a few meters wide (Figure 8A). The icefoot at this location is about 2m above the lake level which is the highest yet seen and consists of two ice ledges of different elevations, possibly the product of two different wave regimes. The NIC is formed into long tongues of poorly defined ridges, a meter or more in thickness, with an offshore area of rubbled brash, skim, and slush ice less than a meter thick except where ridged (Figure 8B). The NIC tongues extend up to 25m offshore but probably average slightly less at this location. Ice core of NIC is composed of frozen granular slush with less than 10% inclusion of clean skim ice (Figure 8C). Between snow squalls ice can be seen extending well offshore as mostly thin (~10cm) rubbled ice with small 20-40cm-high ridges, with an average thickness estimated to be between 15 and 20cm. A core taken here had a thickness of 50cm but this is in an area of thicker ice than the average. The ice lakeward of the NIC is a larger volume of ice than the NIC and estimating the sediment load relies on uncertain estimations of the ice volume for the vast areas offshore.

Figure 8 A - Rubbled offshore ice and NIC at Whitman Creek on February 17.

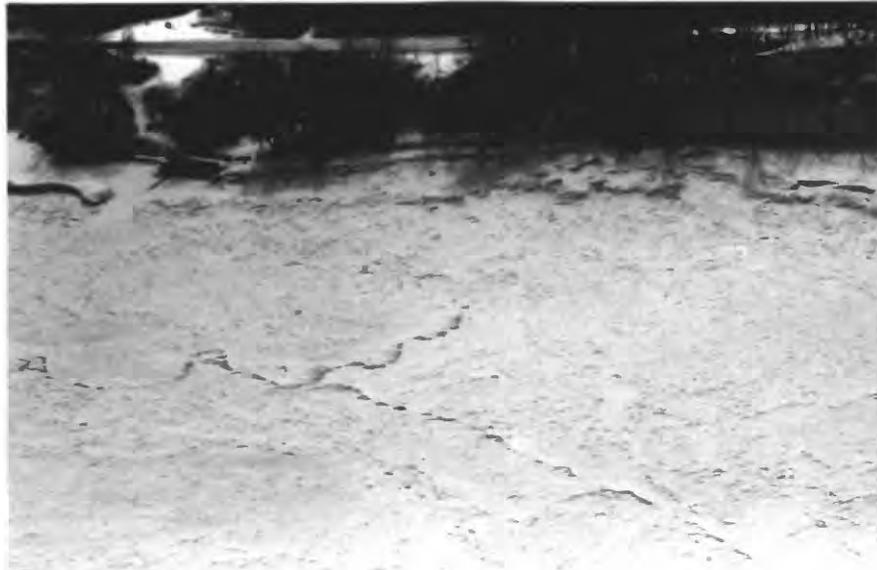
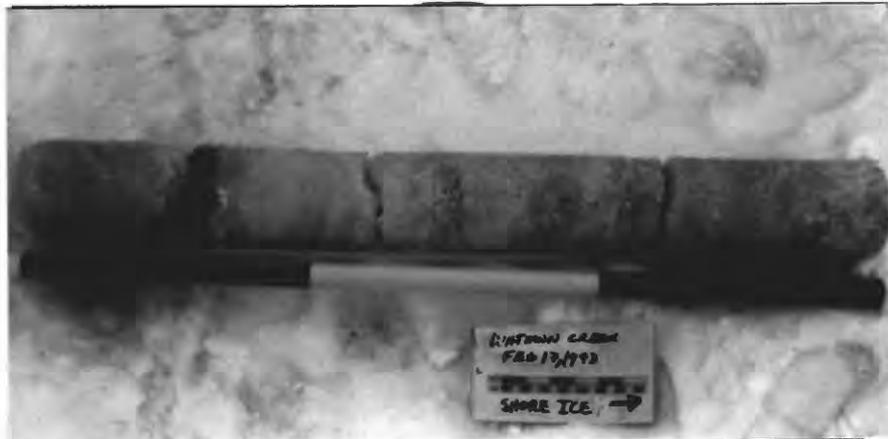
Figure 8 B) Aerial view of rubbled ice and NIC on February 19; **C -** Core of icefoot at Whitman Creek.

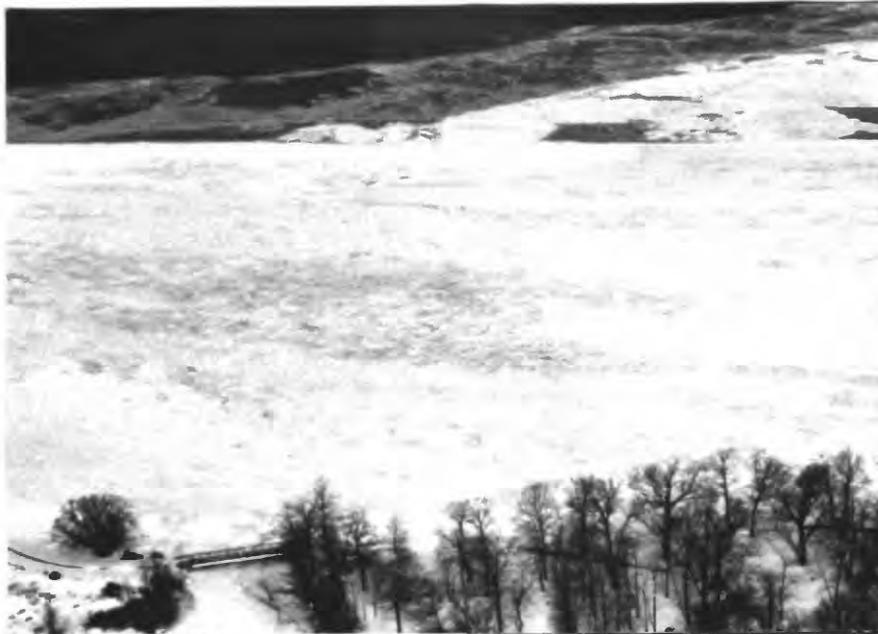
Profile location of State Geological Survey has undergone erosion (15m) in the 7 years following the 1987 installation of a marina breakwater to the west. A foot path and bridge have been damaged (Figure 9). The till bluffs are about 10m high above a 2-3m wide beach. Winds at this location were building from the west. When we arrived there was no open water but an hour later two coast-parallel but irregular leads were opening an estimated 500m and 1000m offshore. There was an icefoot raised more than a meter above lake level, similar to Whitman Creek. The large icefoot ridges and volcanoes formed on Feb. 12, 1993 according to the park ranger. The 40m of NIC ended in water depths of 1.5m (Figure 8). The offshore ice was composed of 80% snow-covered brash and 20% pancakes with raised rims. Snow 15-20cm deep was underlain by unconsolidated slush - treacherous walking - except on exposed ice ridges and hummocks 10cm high, and on the new 50cm high ridge piled against the NIC. The offshore ice was not as dirty as at Whitman Creek. The lake bed was solid bedrock at all but one location offshore of the NIC.

Figure 9 - Aerial view of offshore ice and open water at Geneva State Park on February 19.

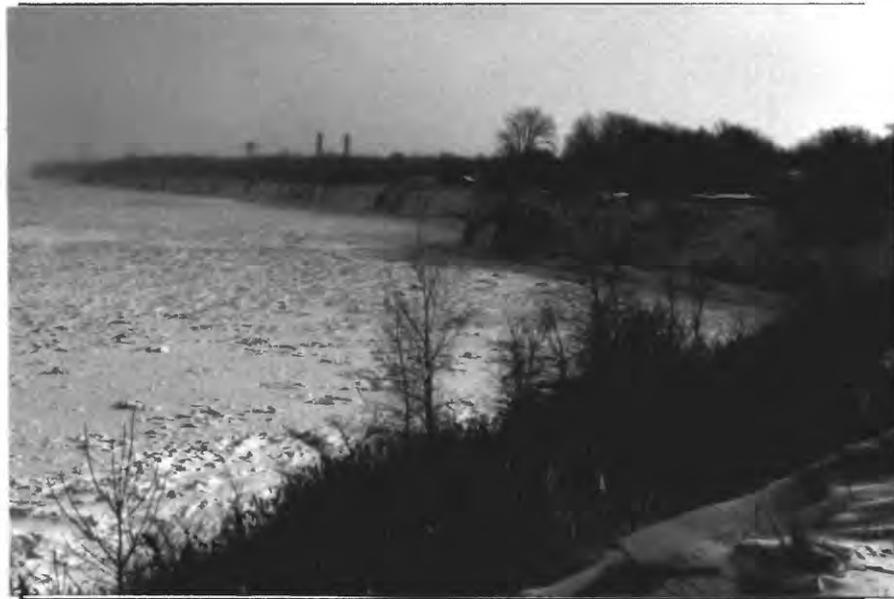
Figure 10 A - View of NIC, rubbled offshore ice and bluffs at Painesville on February 18.

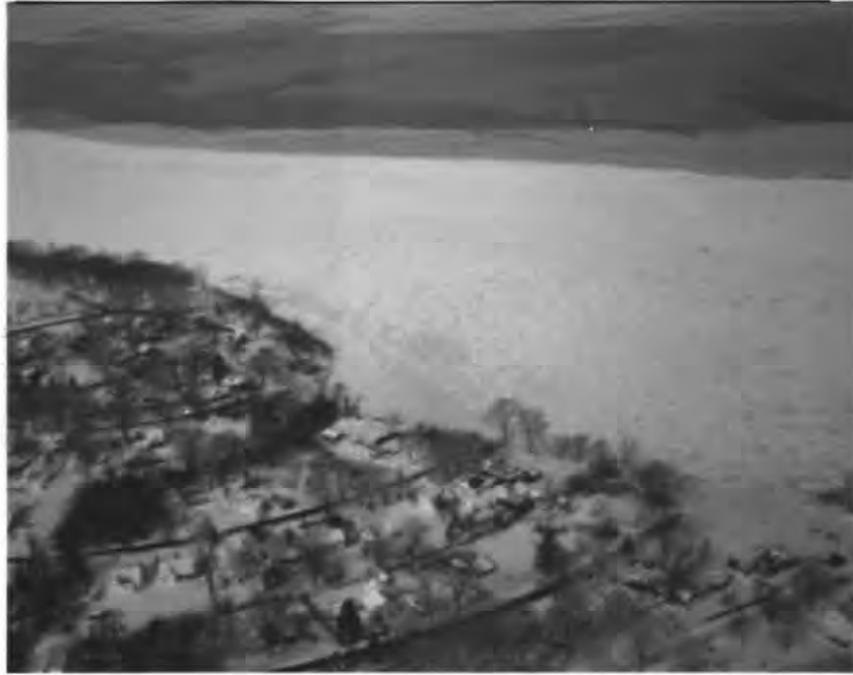
B

Figure 10 - Aerial view of offshore ice at Painesville-on-the-Lake on February 19.
