# **Overview of Environmental and Hydrogeologic Conditions on Hinchinbrook Island, Alaska**

U.S. GEOLOGICAL SURVEY

Open-File Report 95-176

FEDERAL AVIATION ADMINISTRATION

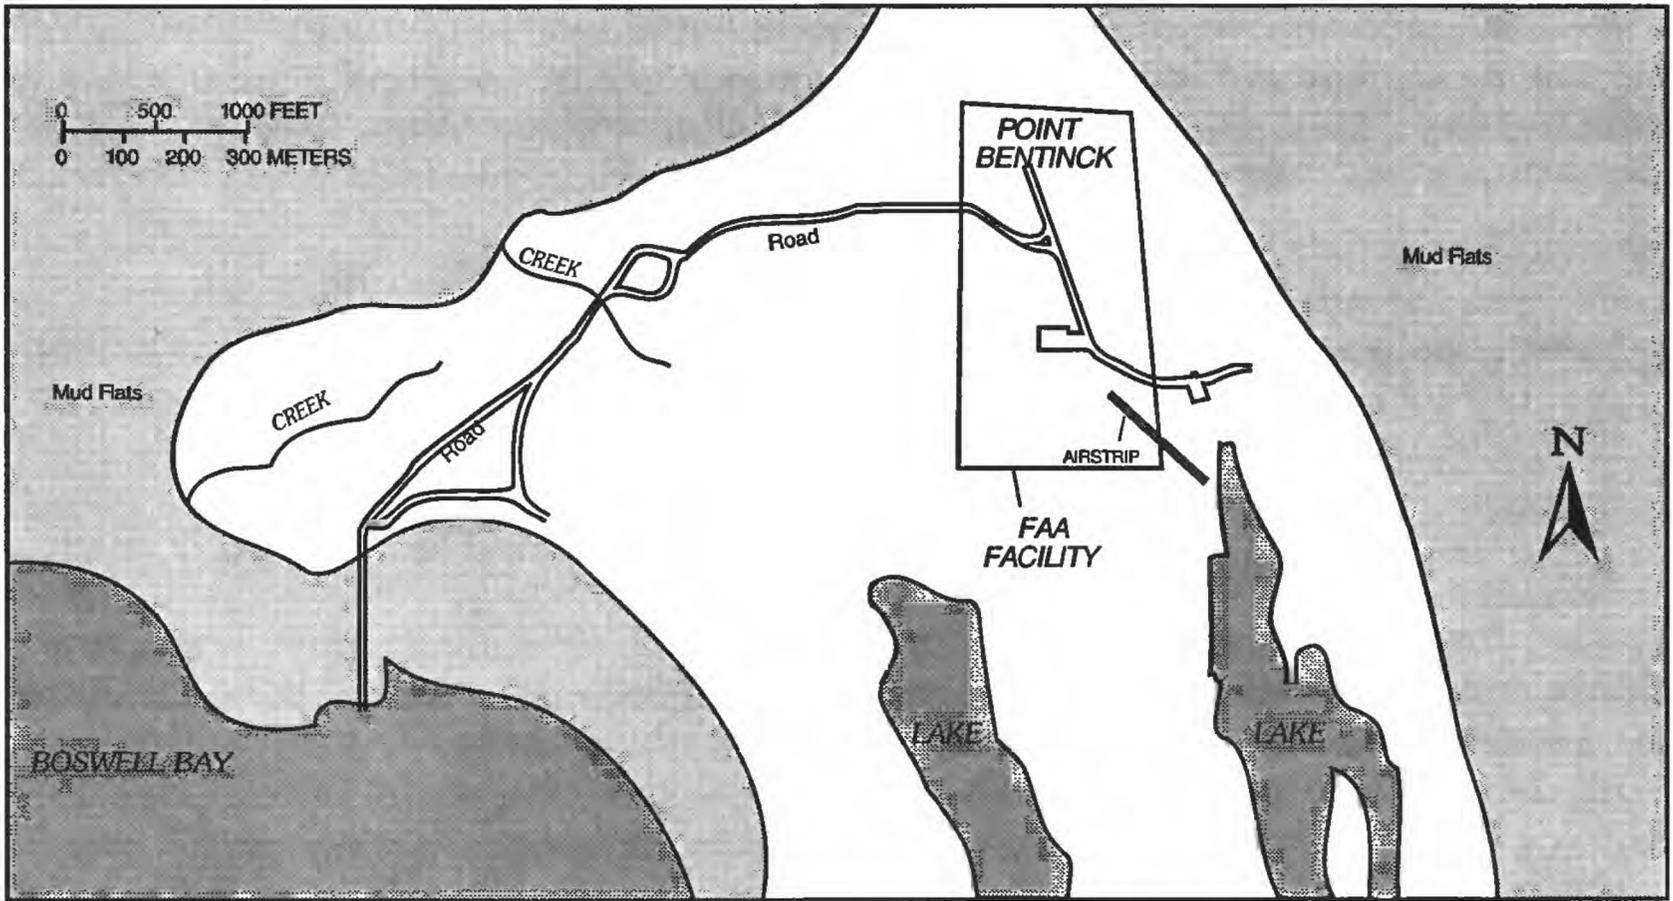
**Figure 2.** Location of Point Bentinck Federal Aviation Administration facility. [Modified from Ecology and Environment, 1992a.]

The Point Bentinck FAA facility (fig. 2) was established in December 1946 and the Johnstone Point facility (fig. 3) was established in 1964 (Ecology and Environment, 1992a, b). The FAA facility at Point Bentinck includes navigation equipment, a small aircraft runway, and numerous support structures. The Johnstone Point FAA facility includes a small aircraft runway, several support structures, and air navigation equipment. A detailed description of both the Point Bentinck and Johnstone Point FAA facilities and an investigation of potential sources of contamination are included in reports by Ecology and Environment (1992a, b).

The Point Bentinck FAA facility is on an abandoned beach ridge about 15 m in elevation. The facility is more than 15 km from the nearest hills, which are higher than 500 m in elevation. Extensive wetlands near the facility preclude accurate definition of the local surface-water drainage. Major streams in the area drain into Boswell Bay north of the airstrip, and smaller streams—not visible on maps of the area but identified by Ecology and Environment (1992a)—also are north of the facility.

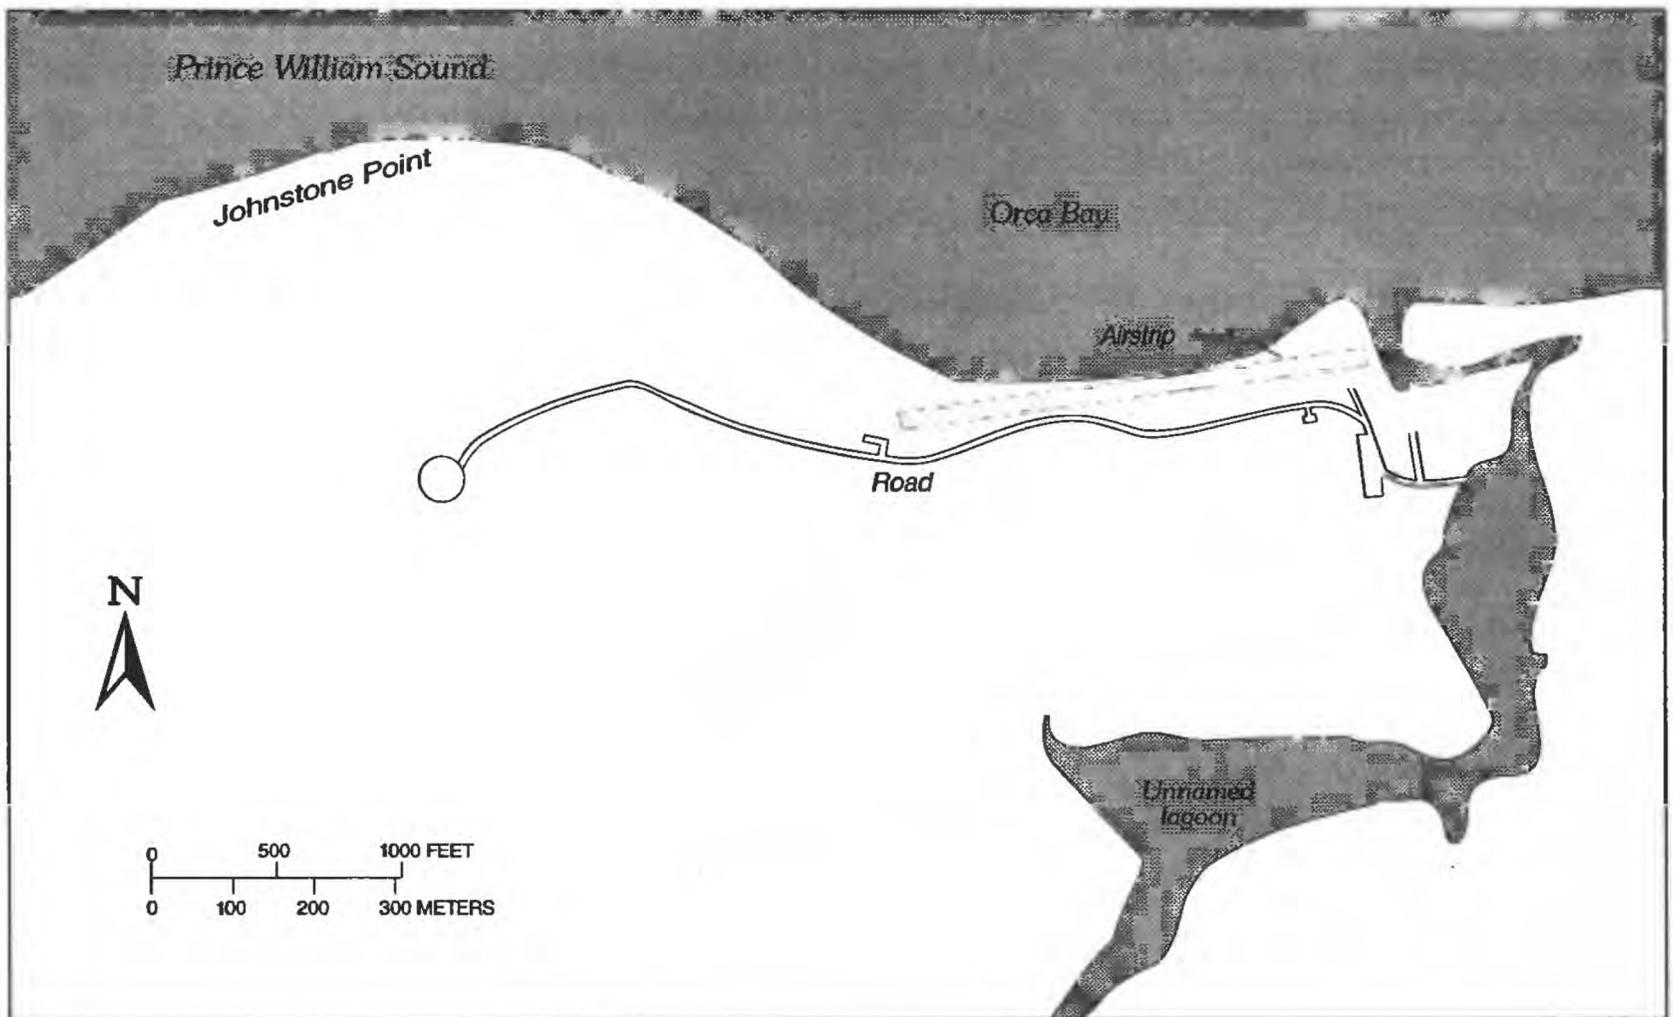
**Figure 3.** Location of Johnstone Point Federal Aviation Administration facility. [Modified from Ecology and Environment, 1992b.]

The northern tip of the island near the FAA facility at Johnstone Point is about 8 km northwest from the closest hills. The facility is at an elevation of about 15 m, and the hills are about 800 to 900 m higher. Surface water drains from these hills toward the northeast and northwest into Prince William Sound and does not reach the FAA facility. Numerous small lakes between the hills and the tip of the island store some of the surface runoff, thereby attenuating streamflow response to storms.
