U.S. DEPARTMENT OF THE INTERIOR
U.S. GEOLOGICAL SURVEY

REVIEW OF SLOPE STABILITY ISSUES AT THE PROPOSED CARLOTA COPPER PROJECT, PINAL AND GILA COUNTIES, ARIZONA

OPEN-FILE REPORT 95-617

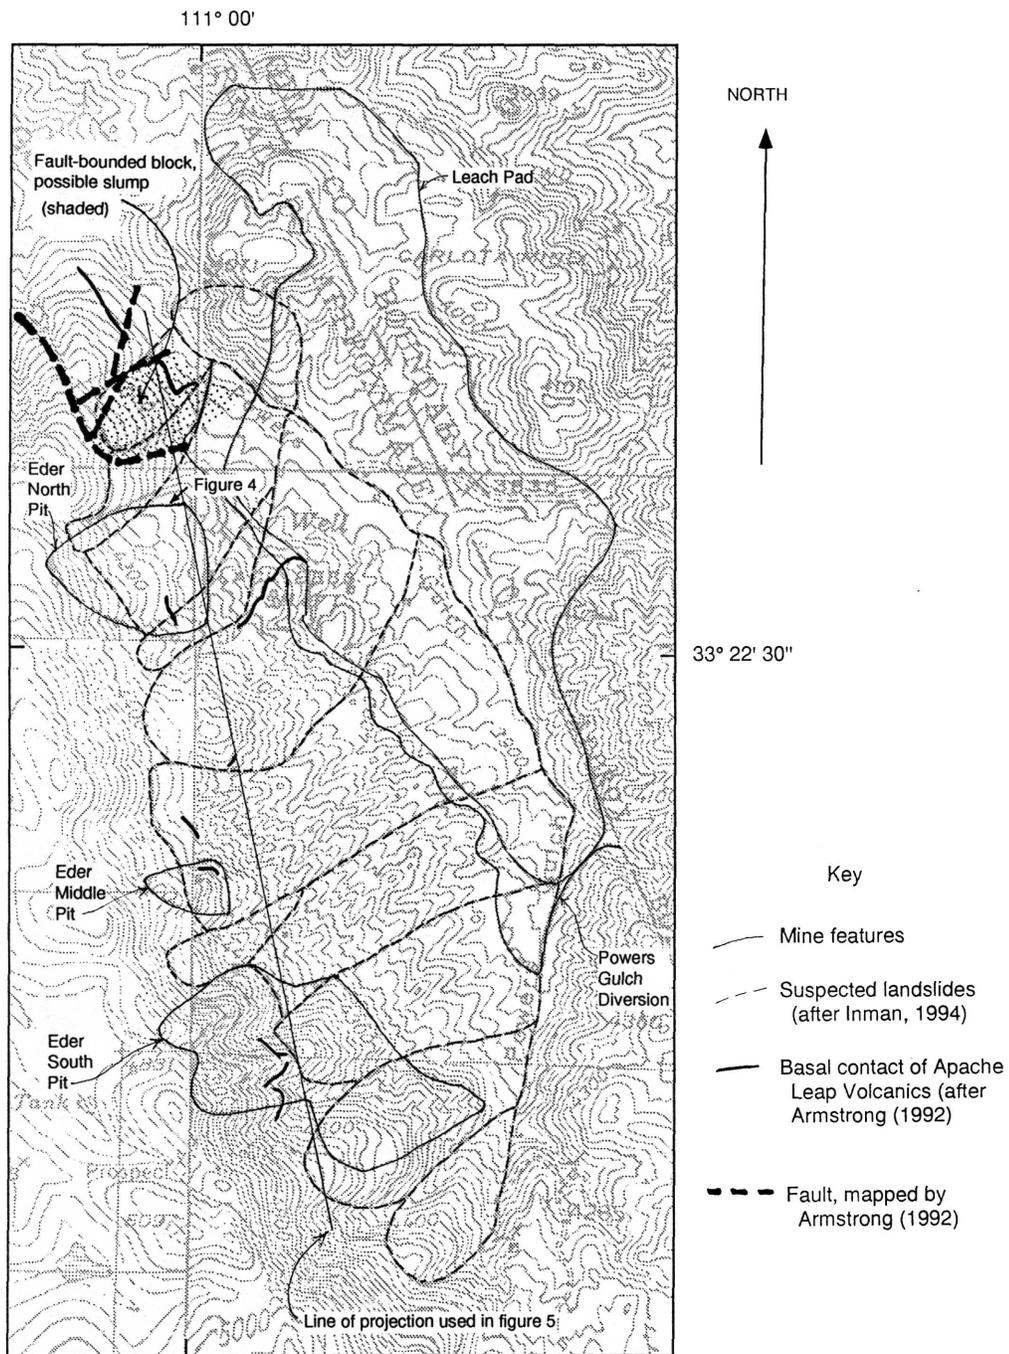
Figure 3. Map of the Eder slope and Powers Gulch area. Base from U.S. Geological Survey, 7-1/2-minute quadrangles: Inspiration (1945, photorevised 1982) Pinal Ranch (1948), Haunted Canyon (1949) and Superior (1948) photorevised 1981).

Much of the concern for stability of slopes near the Eder pits and the Powers Gulch diversion resulted from interpretation of aerial photographs (Inman, 1994). The slope where the Eder Pits are planned (fig. 3) was interpreted as a "nested landslide complex." In that area, the Apache Leap Volcanics support a rugged 500-ft-high cliff, and the Precambrian diabase and Pinal Schist support rolling, gently sloping topography. Five diamond drill holes sunk along the rim of the volcanics (400-1000 ft from the edge), in 1930 and 1931, passed through 500-1235 ft of dacite and tuff (Apache Leap Volcanics) and 70-410 ft of the underlying schist and granite (Peterson, 1962). Annotated aerial photographs, maps, and cross sections (Inman, 1994) interpret the dacite cliff as the adjoining scarps of the landslide complex and the flatter slopes below as the landslide deposits (fig. 3). Given this interpretation and the dacite's resistance to weathering and erosion, we expected to find huge blocks of dacite below the cliff and abrupt offsets in the basal contact of the Apache Leap Volcanics at the edges of such blocks. We also expected Pinal Schist and diabase to be obscured by the dacite blocks within about 1000 ft of the base of the cliff.

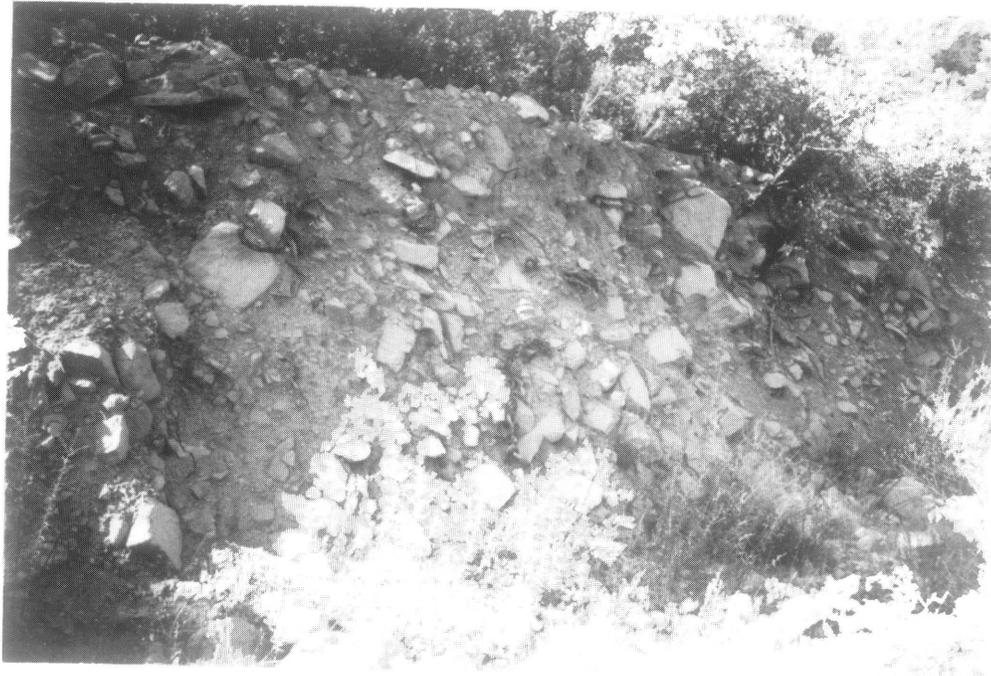
Figure 4. Debris-flow or debris-avalanche deposit exposed in road cut near Eder North Pit. Note angular blocks of dacite in fine-grained matrix. See figure 3 for location.

We observed little evidence of large-scale landslide deposits, rather we found small debris-flow or debris-avalanche deposits. The Pinal Schist, although badly weathered, showed little evidence of shearing or of compression parallel to the slope. Outcroppings of Pinal schist were present at the base of the cliff and at many locations between there and Powers Gulch. No huge blocks of dacite exist below the cliff; we observed dacite only in blocks as large as 10 ft. The angular, randomly oriented, dacite blocks occur in heterogeneous, matrix-supported deposits (fig. 4). Surficial deposits including dacite are less than 30 ft thick and are locally absent; thus the total volume of displaced dacite is much smaller than would be expected if large-scale failures had occurred.

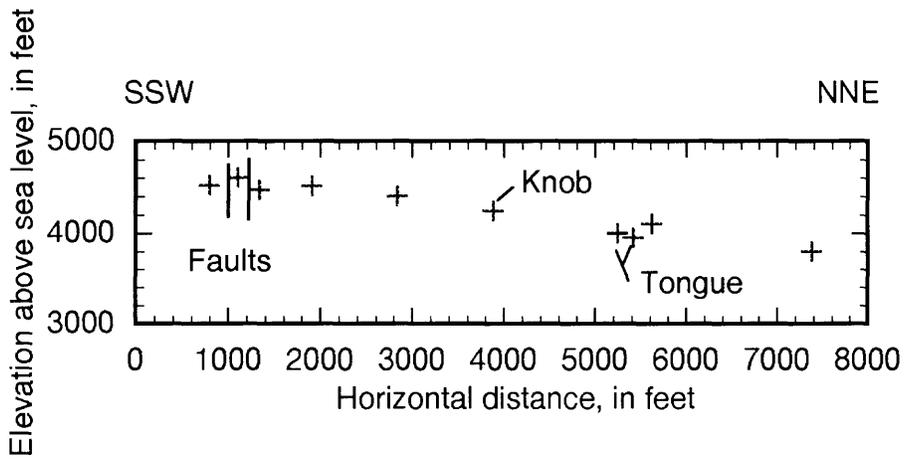
Figure 5. Outcrop elevation of the basal contact of Apache Leap volcanics on the Eder slope. Projected to line shown on figure 3.

The contact between the basal tuff and vitrophyre unit of the Apache Leap Volcanics and the underlying schist or diabase dipped fairly uniformly toward the north (fig. 5). Slight variations occur near small faults in the Eder South Pit area and near the Eder North Pit. The faults near the Eder South Pit strike east or northeast, are roughly perpendicular to the contours, and are evidently discontinuous (Armstrong, 1992); their pattern does not seem consistent with slumping because they do not define discrete blocks that are down relative to the surrounding bedrock. A prominent knob near the Eder North Pit is the only area that topographically resembles a slide block; however, the contact elevation is on a consistent trend with points to the south (fig. 5). The basal contact dives abruptly in the Eder North Pit area where a narrow finger of tuff and vitrophyre blankets the Pinal Schist. This narrow finger is consistent with known relief on the basal contact of the Apache Leap Volcanics (Peterson, 1962) and appears to be in normal contact with the underlying schist. A fault-bounded block north of the North Eder Pit may be a slump block. The block lacks topographic features of a slide block, but the fault pattern mapped by Armstrong (1992) is consistent with movement as a slide. Regardless of the block's origin, excavation at its toe during construction of the Powers Gulch Diversion may destabilize the block and allow it to move on the faults. Stability of the block should be thoroughly studied during the planned geotechnical investigation for the Powers Gulch Diversion.

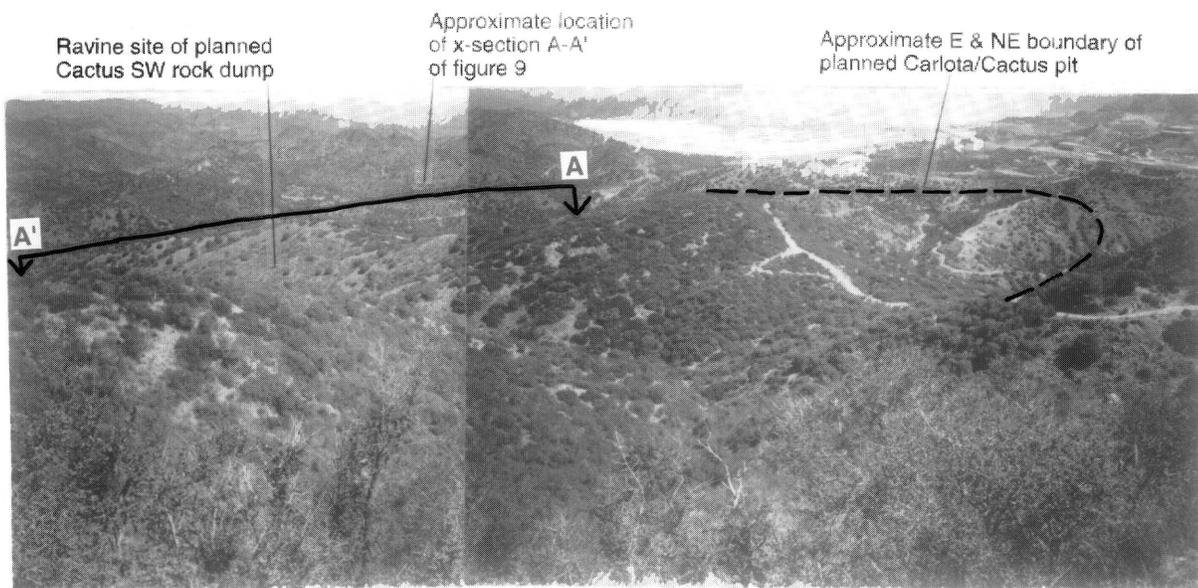
Figure 6. View looking northward of the planned ravine site of the Cactus Southwest Rock Dump. Carlota/Cactus pit will be located to right, behind ridge line. Section A'-A is shown in figure 8.

The planned location for the Cactus SW rock dump is a ravine approximately 2800 ft south-southwest of the center of the Carlota/Cactus pit (figures 2 & 6). The ravine is at a mean elevation of approximately 4125 ft, and the top of the dump will ultimately reach an elevation of 4360 ft. The proximity of the dump to the southern boundary of the Carlota/Cactus pit, and its ultimate surface elevation 1400 ft above the bottom of the Cactus pit, has focused some concern on the issue of stability of the southern pit wall.

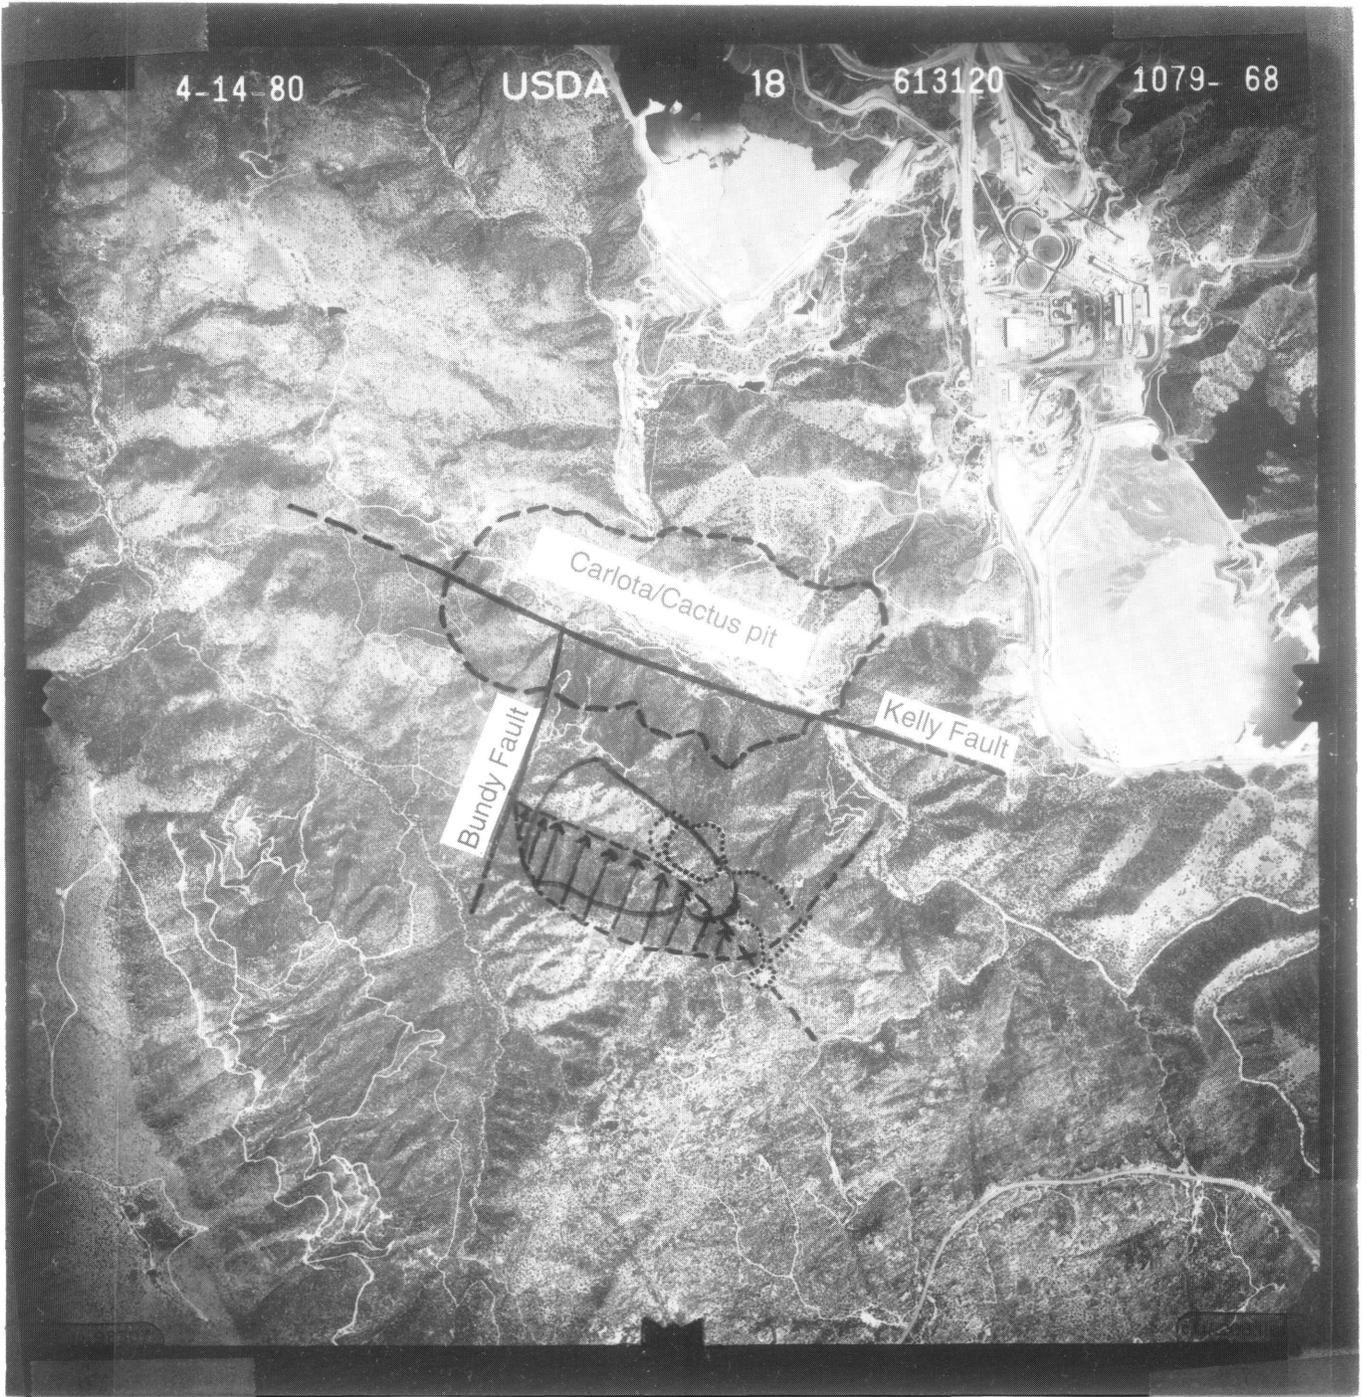
A major question regarding the southern pit wall stability was raised by Inman (1994). Based on aerial-photo analysis, he concluded that the ridge between the pit and the Cactus dump ravine is a large block slide (figure 7). In this interpretation, the southern slope of the ravine represents a remnant slide surface dipping approximately 20° toward the pit, with about 1700 ft of down-dip displacement (1500 ft of lateral displacement) of the hypothesized slide block (figure 8). Mining of the Cactus pit would expose the slide surface in the pit wall or near the bottom of the pit, effectively removing any lateral restraint from the base of the hypothesized slide block. This removal of lateral restraint, coupled with increased vertical loading of the slide block from the Cactus SW dump, was interpreted to pose potentially serious concerns for the pit-wall stability Inman (1994).

Figure 7. Aerial photograph showing outline of planned Cactus SW dump site and Carlota/Cactus pit location. Arrows and dashed lines indicate location of hypothesized shear surface from previous air-photo interpretation. Dotted lines show locations of foot traverses referred to in text and in figure 9. Approximate locations of Kelly and Bundy faults are also indicated.

The field reconnaissance focused along the top and sides of the ridge where the hypothesized shear surface would intersect the ridge (figure 7), and also along the north side and bottom of the ravine, where we looked for evidence of shear deformation in the exposed schist and granite. No evidence of offset or shear failure was found in the rocks along the eastern side of the ridge (traverses 1,2,&3, figure 9) where the slide surface was projected to extend. Here, the predominantly granite rocks were observed to be unaltered and relatively unfractured. Some minor slickensides were found on a few small pieces of granite (<1 ft³) near the ridge top (S in figure 9), but no evidence of large scale shearing was apparent.

In his air-photo analysis, Inman (1994) shows the northwest side of the suspected block slide (fig. 7) terminating on the Bundy fault, where schist on the southeast is in contact with diabase on the northwest side of the fault. If the ridge to the southeast of the Bundy fault were emplaced as a result of displacement on a low-angle shear surface, then some offset in the ridge line and drainage at the Bundy fault would be expected. The ridge line and drainage, however, continue northwestward across the Bundy fault without any significant offset in alignment.

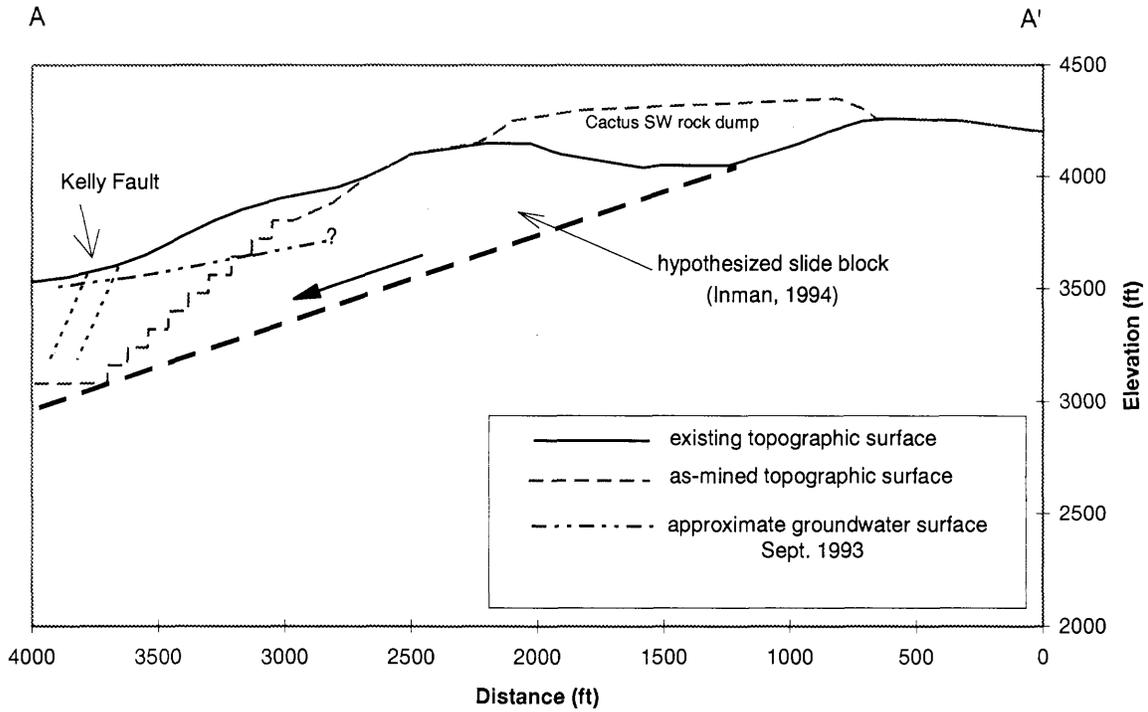
Figure 8. Cross-section A-A' of proposed Cactus SW rock dump and Cactus pit showing both existing land surface and as-mined surface. Heavy dashed line represents hypothesized shear surface from previous aerial-photo interpretation.

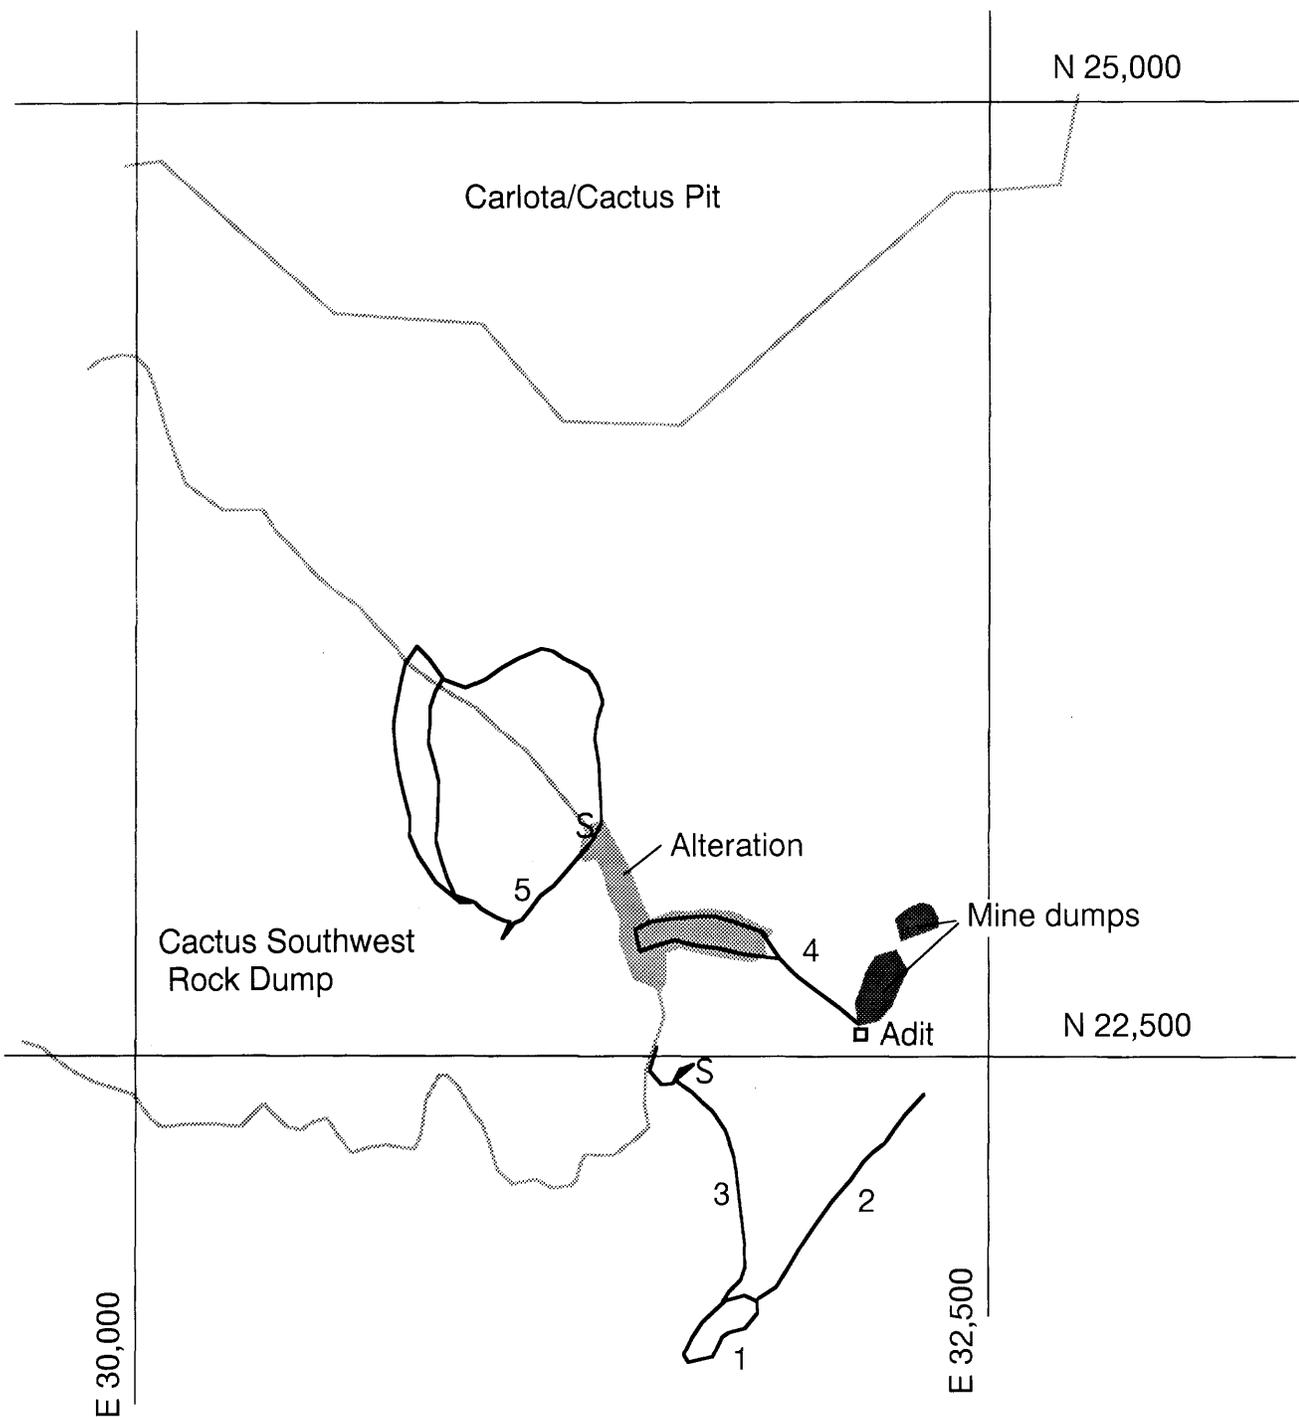
Slightly altered granite was present at a lower elevation in a saddle along the ridge top (traverse 4, figure 9), but the alteration appeared to be localized to the saddle area. An old mine adit and rock dump near the saddle and zone of alteration indicate the presence of mineralization. The old mine workings are located on a contact between the Pinal schist and the intrusive "Granite on Manitou Hill", and no faulting was mapped in the area (Armstrong, 1992).

Traverse 5 (figure 9) into the ravine west of the saddle did not reveal any evidence of alteration or shearing. The granite in the flank and bottom of the ravine was weakly foliated and jointed, and locally covered by a thin residuum. The contact between the granite and schist is transitional. The schist, locally covered by a thin residuum, is jointed but appears relatively competent.

Figure 9. Sketch of Cactus Southwest rock dump area showing outline of planned dump, (shaded line) southern boundary of Carlota/Cactus pit (shaded line), and details of foot traverses made during field reconnaissance for this investigation (heavy solid lines, referred to by numbers 1-5 in text). Light shading indicates area where alteration observed, dark shading indicates old mine dumps, open square indicates location of adit. Locations are approximate.
