U.S. GEOLOGICAL SURVEY

**DEBRIS FLOWS AND LANDSLIDES
RESULTING FROM THE JUNE 27, 1995, STORM
ON THE NORTH FORK OF THE MOORMONS RIVER,
SHENANDOAH NATIONAL PARK, VIRGINIA**

OPEN-FILE REPORT 96-503

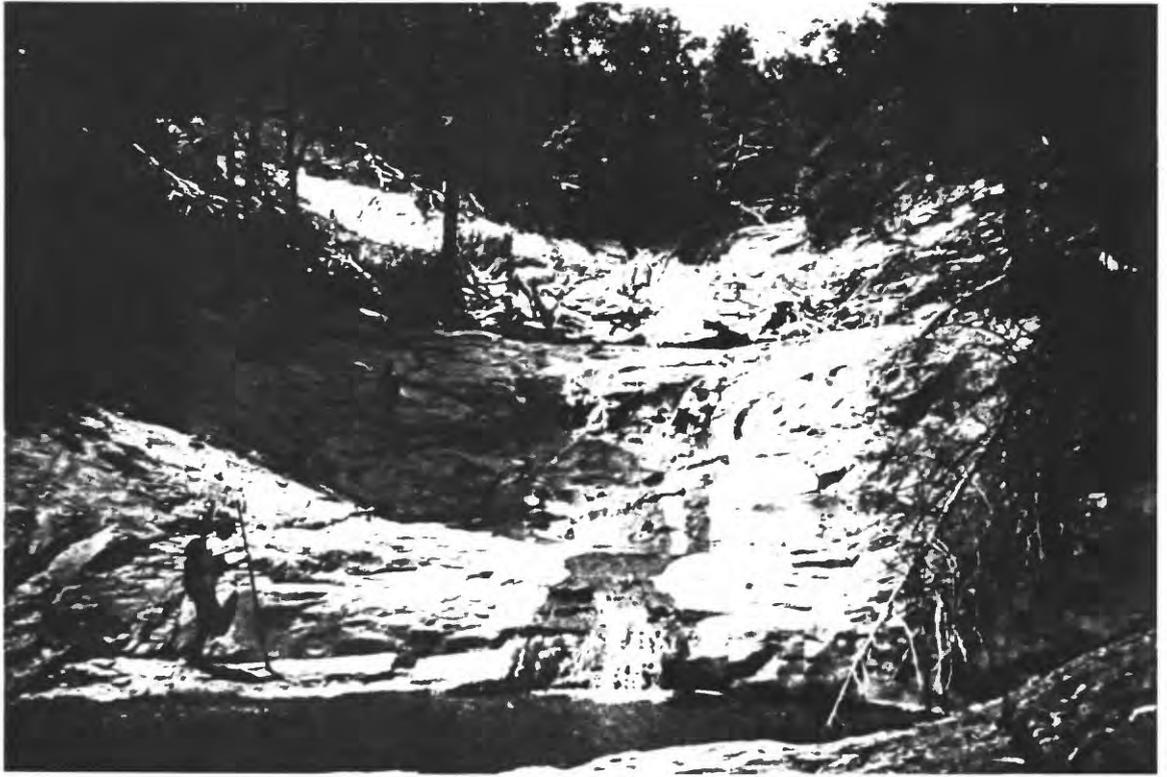
FIG. 3

Figure 3. Waterfalls at Big Run showing stripping of regolith and vegetation. Photograph taken August 2, 1995.

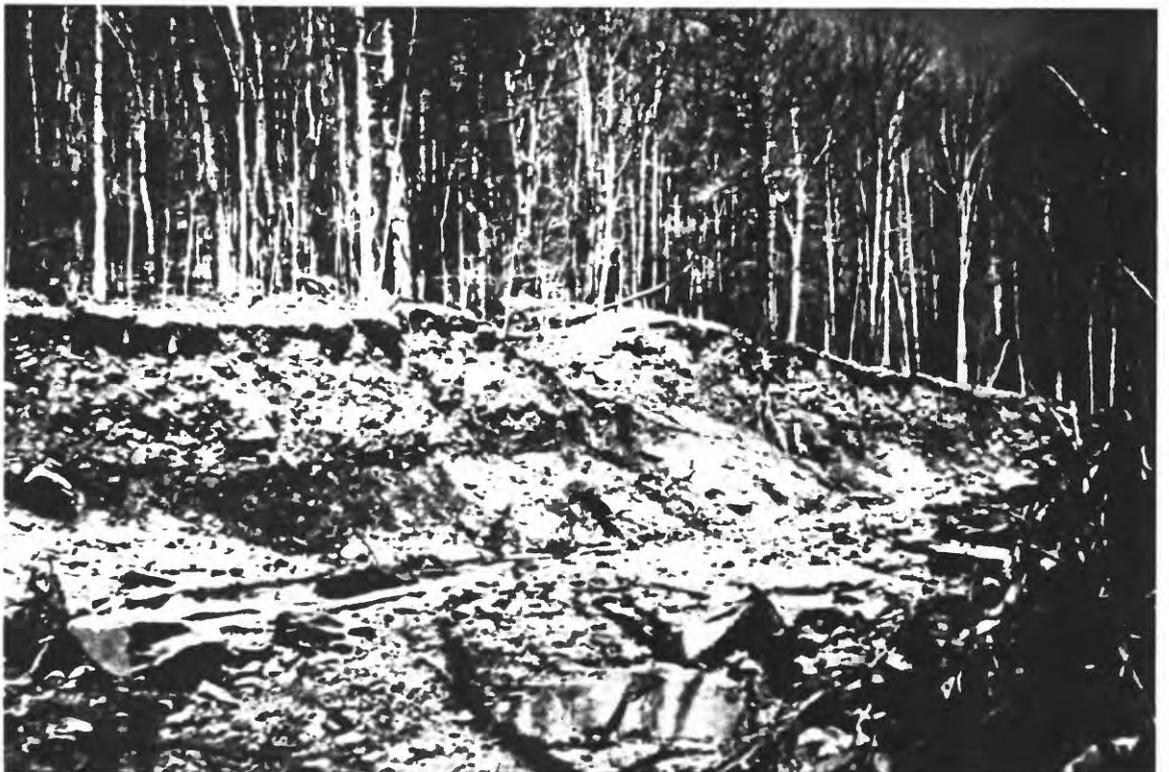
FIG. 4

Figure 4. Bluffs on North Fork of Moormans River created by the June 27 storm revealing two large prehistoric debris-flow deposits separated by a fossil soil horizon. Photograph taken March 15, 1996.

Debris flows moved down the Moormans River widening the channel, destroying portions of the road alongside the stream as well as bridges and trails. The steepened stream banks reveal older, pre-historic debris-flow deposits along the valley floor, which predate the establishment of the Shenandoah National Park in the early 1930's. Several bluffs reveal a sequence of two older debris flow deposits that are 15 feet thick each with an intervening fossil soil horizon (figure 4).

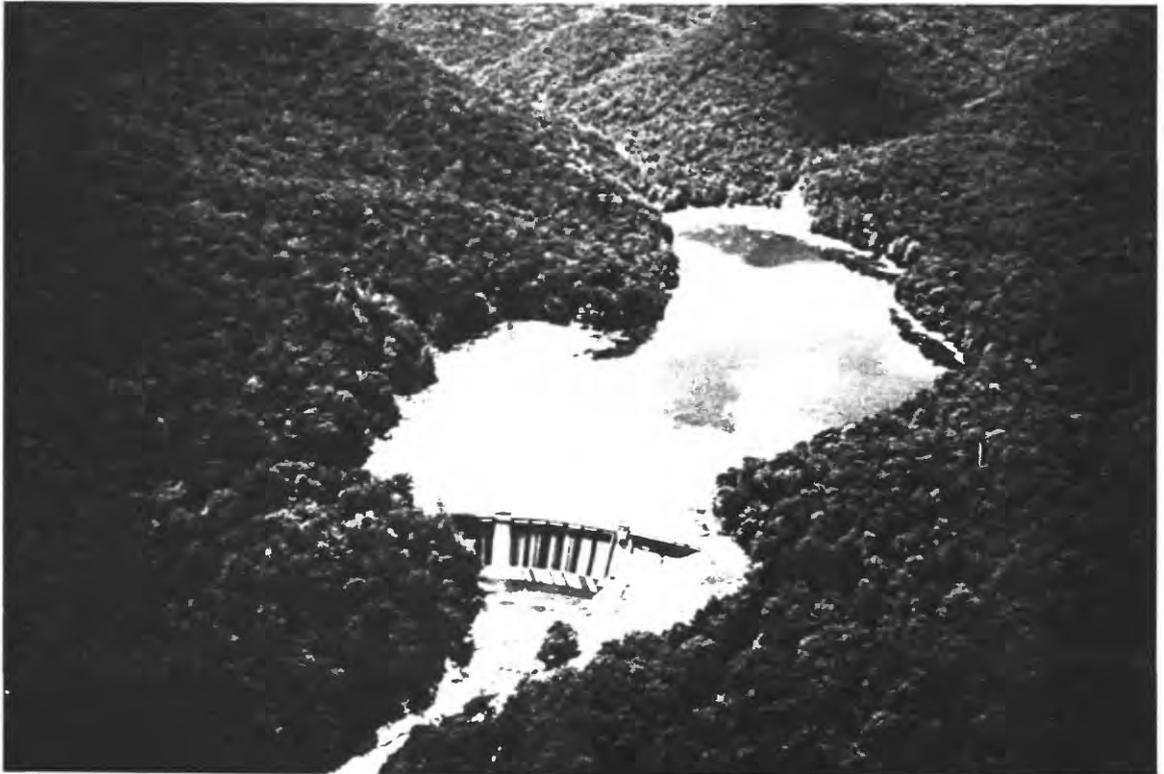
FIG. 5

Figure 5. Sugar Hollow Reservoir showing the dam and floating logs. Delta created by debris flows is in the distance. Photograph taken by National Park Service, July 19, 1995.

the dam. Between 9 and 11 pm the water rose rapidly and Mr. Frazier successively opened the remaining crest gates. By 11 pm all gates were open and the water stood only 18 inches below the crest of the dam. Figure 5 is a photograph taken July 16, 1995 of the Sugar Hollow Reservoir showing the dam, the tree debris floating in the water and the delta of sediment and debris at the far end of the reservoir.

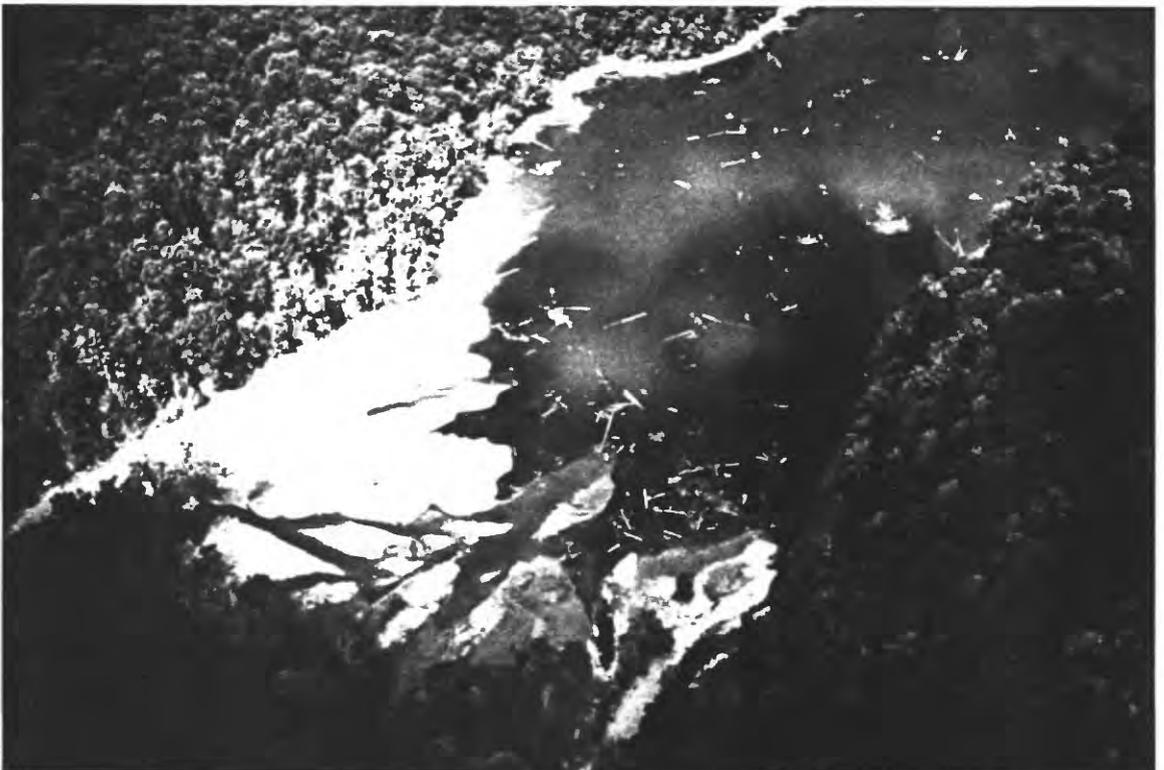
FIG. 6

Figure 6. Delta produced by debris flows in the Sugar Hollow Reservoir. Photograph taken by National Park Service, July 19, 1995.

Surges of muddy debris moved downstream into the Sugar Hollow Reservoir and deposited a substantial delta of boulders and cobbles over an older delta of mud and gravel that has been built up over the 50-year life of the reservoir. Figure 6 is a photograph of the delta taken on July 19, 1995. The delta now extends underwater covering about one third of the floor of the reservoir. The new delta is a composite of discrete lobes about 30 feet in width with crude size sorting of larger fragments within each lobe and with a fine matrix supporting the fragments. The lobes apparently were built by successive surges of the debris-laden fluid. Evidence for deposition from a viscous slurry includes lack of imbrication of larger cobbles, matrix support of rock clasts, and the transport of boulders up to three feet in diameter onto the nearly flat surface (less than 2 degrees) of the delta.
