Baseline Characteristics of Jordan Creek, Juneau, Alaska

Open-File Report 2004-1220

U.S. Department of the Interior
U.S. Geological Survey

By Randy H. Host and Edward G. Neal

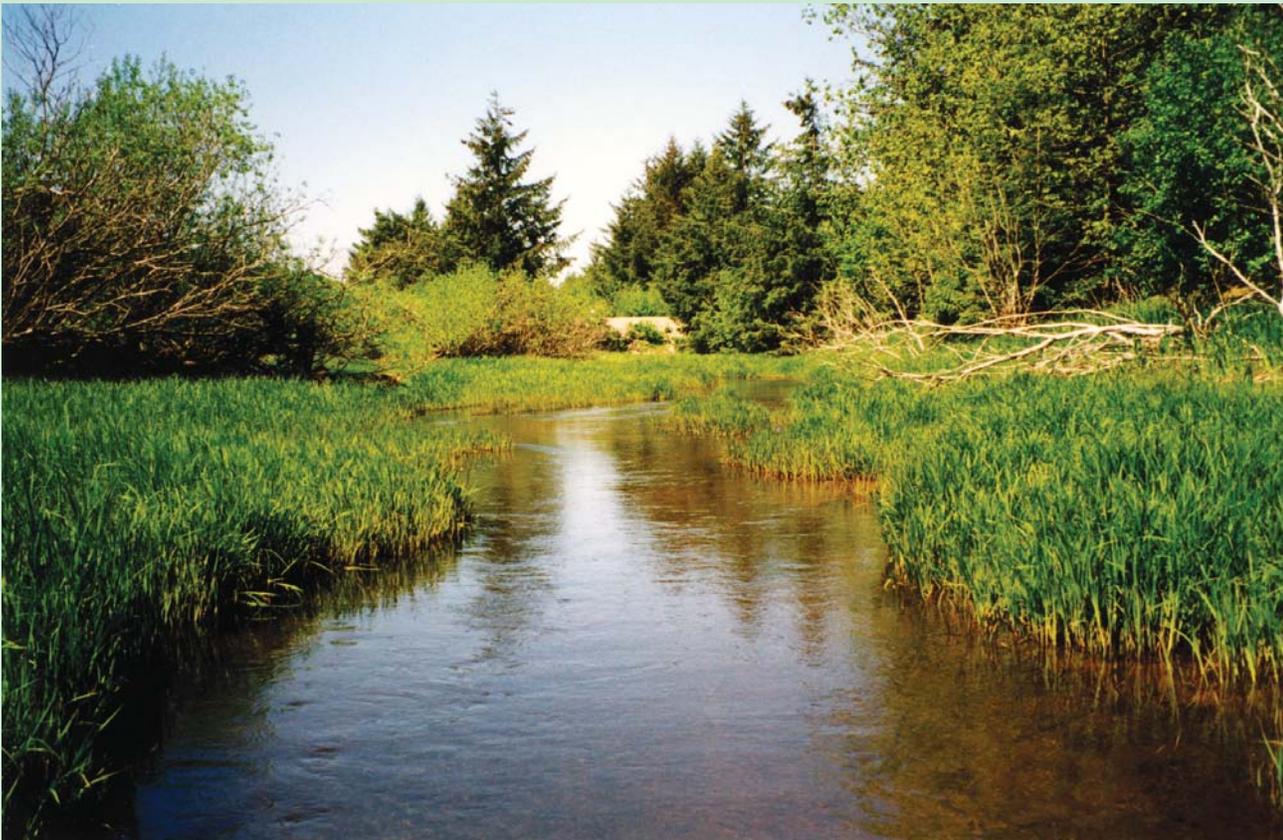
Cover. Jordan Creek at the Juneau Airport study reach, June 1999. View is looking upstream from transect 6. Photograph taken by Randy Host, U.S. Geological Survey

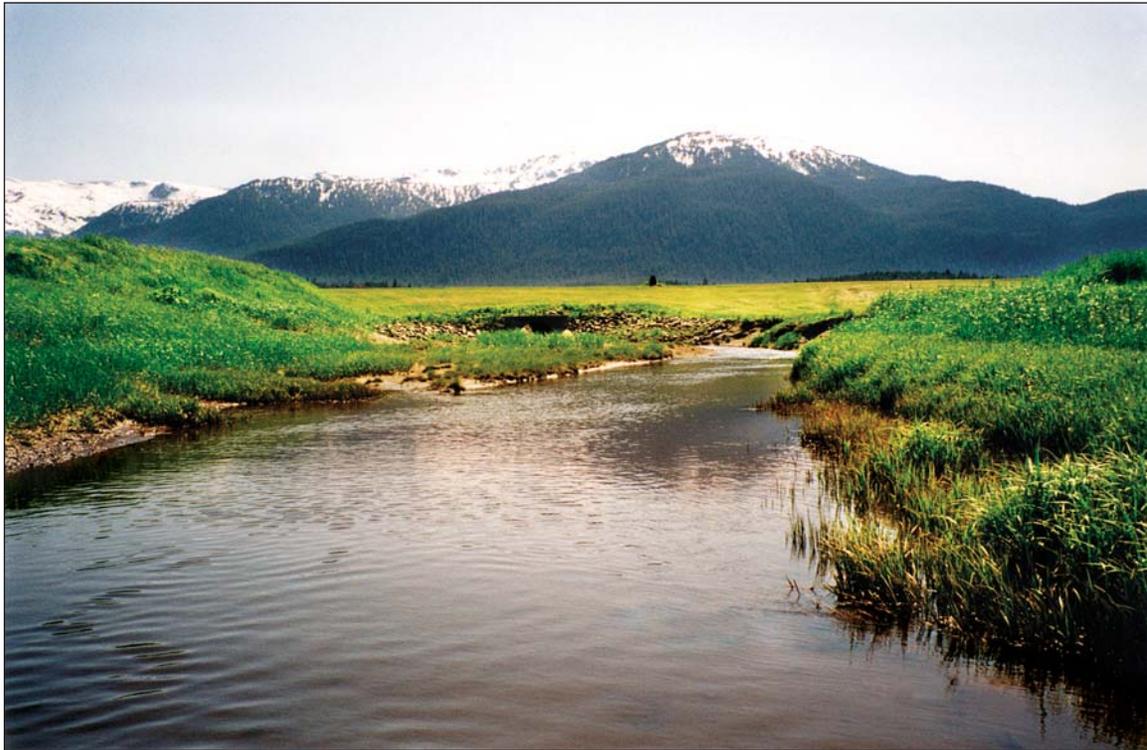
Figure 9. Jordan Creek at the Juneau Airport study reach, June 1999. View is looking downstream from transect 9. Photograph taken by Randy Host, U.S. Geological Survey.

a stable bank. Bank substrate was predominately silt, organic detritus, and sand (0.063-2 mm) from transects 1 to 10. The bank material at transect 11 consisted of large boulders. Transect 11 is just upstream of a culvert that runs underneath the taxiway. The approach of the culvert was riprapped to minimize erosion around the culvert entrance. In the spring of 2001, all trees remaining along this reach were cut down.

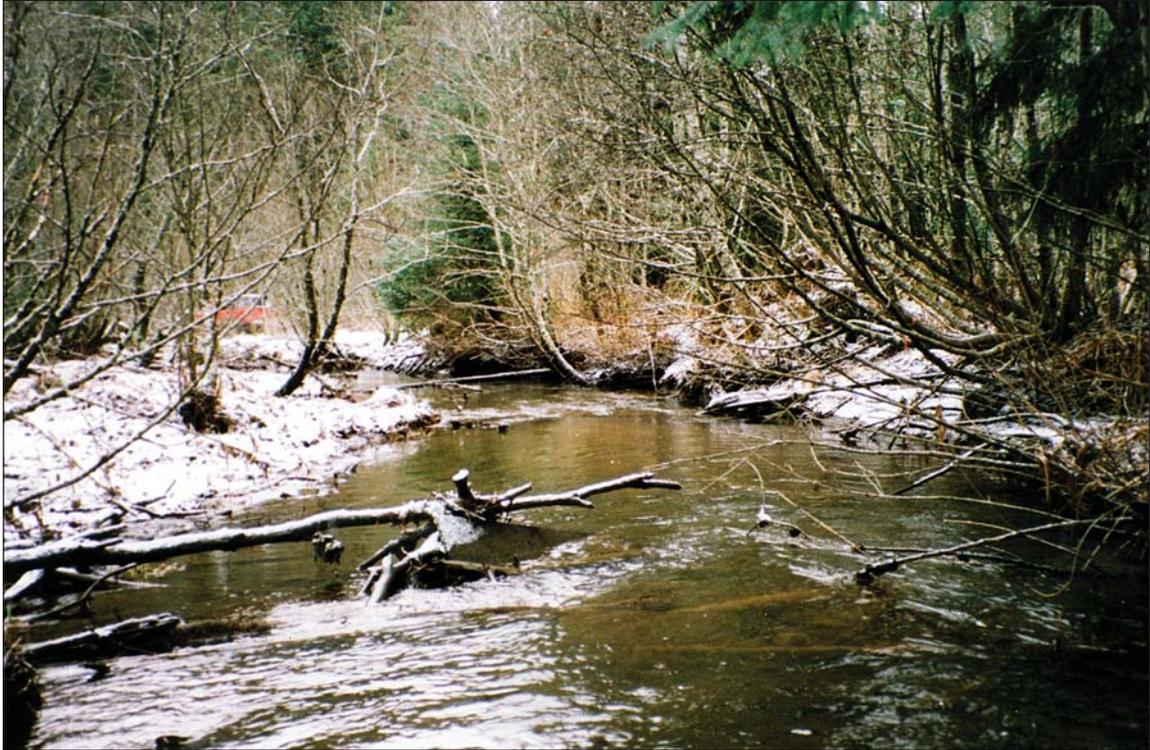
Figure 12. Jordan Creek at the Nancy Street study reach. View is looking downstream from transect 1. Photograph taken by Randy Host, U.S. Geological Survey.

rial composed primarily of silt, organic detritus, and sand. Bank erosion was noted at all transects except transects 9 and 10. There was one all-terrain vehicle (ATV) or four-wheel drive dirt road crossing located between transect 6 and 7. Bank degradation appeared to be accelerated between these two transects. Undercut banks, overhanging vegetation, and submerged woody debris provided potential fish habitat. The bed substrate consisted predominately of sand (0.063-2 mm) and coarse gravels (16-32 mm).

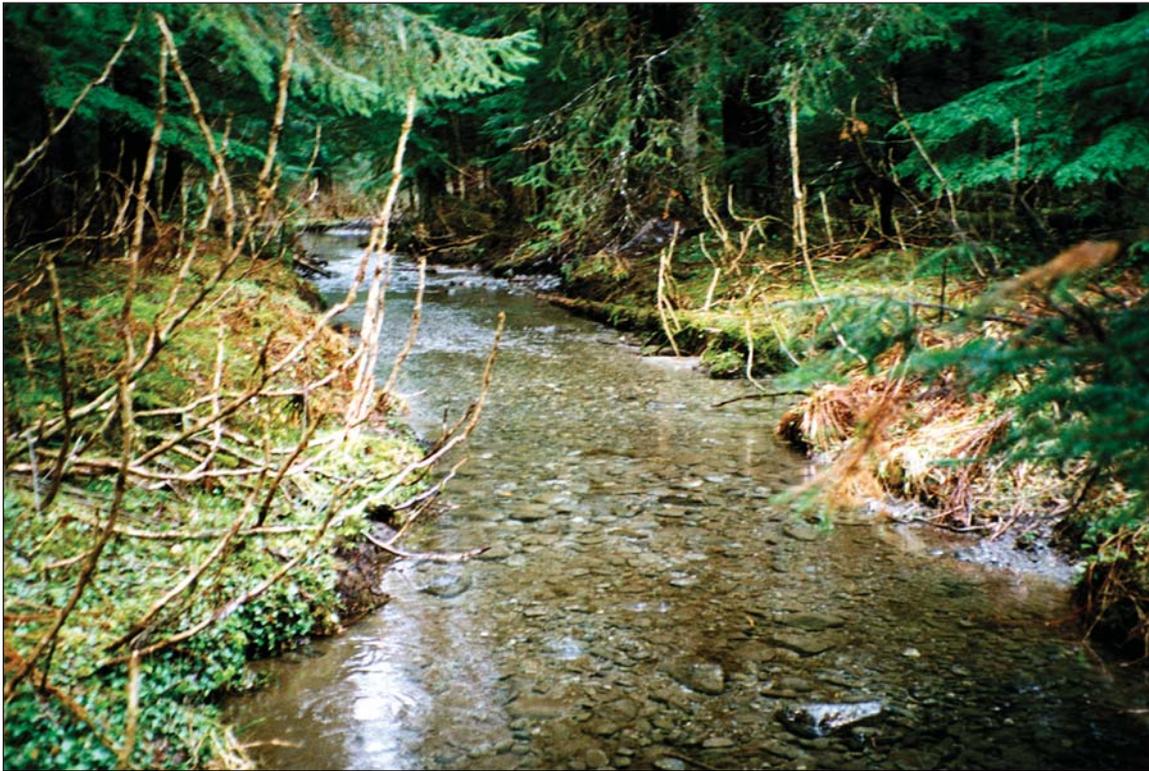
Figure 14. Jordan Creek at Thunder Mt. Trailer Park study reach. View is looking downstream from transect 1. Photograph taken by Randy Host, U.S. Geological Survey.
