# **Hazard Analysis of Landslides Triggered by Typhoon Chata'an on July 2, 2002, in Chuuk State, Federated States of Micronesia**

By Edwin L. Harp, Mark E. Reid, and John A. Michael

U.S. Geological Survey Open-File Report 2004-1348

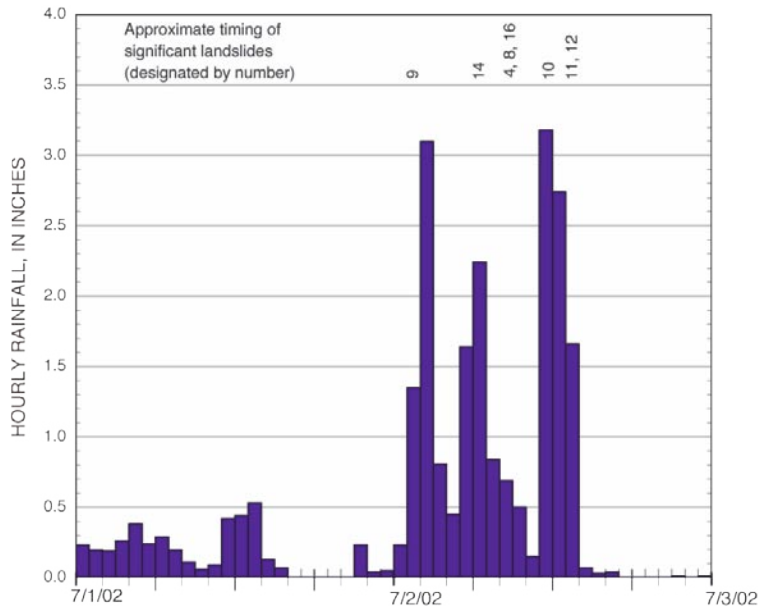
Figure 3. Bar graph of hourly rainfall from tropical storm Chata'an at Weno airport (WSO) station. Time of occurrence of significant landslides obtained from local residents. Table 2 contains more information about the significant landslides (by number).

According to local residents, most of the landslides occurred between 7 a.m. and 2 p.m. on July 2. At the airport on the island of Weno, 19.74 inches of rain fell on July 2, with several rain bursts having hourly intensities greater than 3 inches per hour (fig. 3). Although the timing and amounts of rainfall likely varied between islands, many of the landslides appear to have been triggered during or immediately following intense rain bursts (fig. 3). Residents experienced prolonged thunder and lightening during the storms, often during the time when landsliding occurred. Hundreds of people evacuated their homes in fear of future landsliding, and many remained evacuated more than a month later.

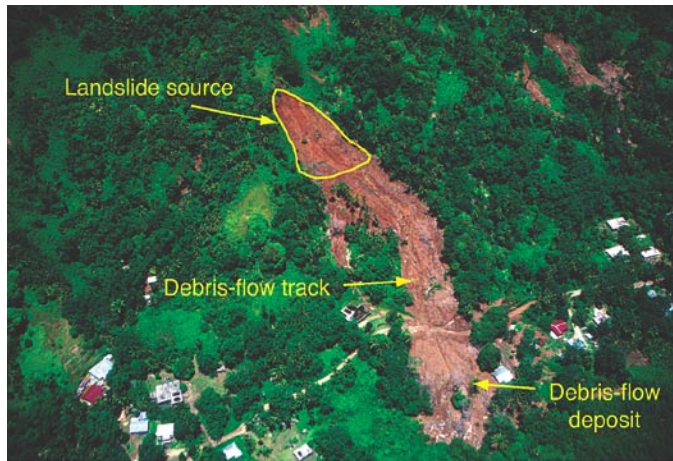
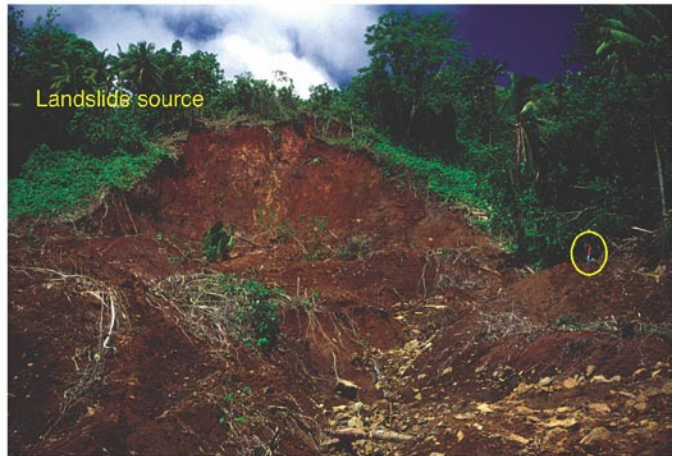
Figure 4. A. Oblique aerial photograph of Mwan slump/debris flow showing the location of the landslide source, debris-flow track, and debris-flow deposit. B. Landslide source (slump) for the Mwan debris flow. Yellow circle locates person for scale.

triggered by rainfall infiltrating into the ground, increasing ground-water pressures, and weakening the slopes. Most of the initial landslides occurred on slopes steeper than 20°. Many saturated or nearly saturated slumps then transformed into debris flows, raced down steep slopes, traveled across the coastal flats, and came to rest leaving thick deposits of saturated mud, boulders, and debris. Figure 4 shows a slump (landslide source), debris-flow track, and debris deposit at Mwan (no. 2, pl. 1) on the island of Weno.

This slump/debris flow occurred inland from the village of Mwan on the island of Weno (fig. 4) and resulted in one fatality. As with the Nepukos landslide, the Mwan landslide began as a slump in weathered volcanic rocks on a 35° slope and transformed into a rapidly moving debris flow. The flow traveled about 100 m downslope along a stream channel and buried a road and water well at the base of the slope. The debris flow also may have incorporated additional material from the stream channel. It then flowed onto flatter ground, destroyed a house, and stopped about 60 m downslope of the road. The initial slump, about 50 m high, had an approximate volume of 10,000 m<sup>3</sup>. Clay-, sand-, and boulder-rich landslide deposits remain along the sides of the stream channel and in the depositional area downslope of the buried road. Drainage channels have been eroded into remnants of the landslide debris in the slide scar. Two small incipient slumps remain adjacent to each side of the initial headscarp; they have volumes of about 1,000-2,000 m<sup>3</sup> each. Both incipient slumps have undergone about 3 to 4 m of displacement. Future heavy rainfall may reactivate these incipient slumps; however, it is doubtful that they will cause additional damage in the short term. Any newly mobilized materials likely will be small and will be impeded by the rough, irregular slide surface.

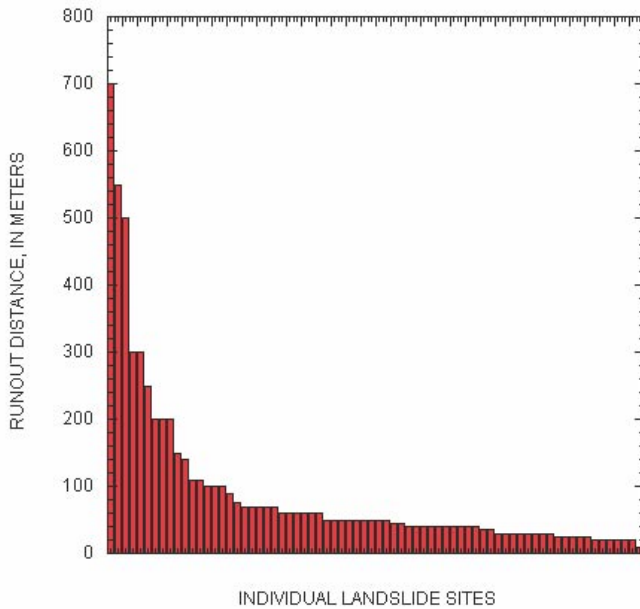
Figure 5. Bar graph showing horizontal runout distances of 72 individual debris flows triggered by tropical storm Chata'an. Distances were determined from the topographic base map used for Plate 1.

The distance debris flows travelled across gently sloping ground and the coastal flats was extremely important in causing damage to people and property during Chata'an. Most of the population of the volcanic islands reside on the flat coastal shorelines of the islands. The degree of damage wrought by landslides was linked directly to the runout length of debris flows that invaded these areas of highest population density. Runout distances depended on the volume of the source landslide and the slope steepness below the source areas; large initial volumes and steep slopes resulted in longer runouts. Using the landslide-inventory map (pl. 1), we measured and compiled runout distances for all debris flows that had significant runout. Runout was defined as the distance a debris flow traveled after it reached a distinctive break in slope below its source, identifiable on the topographic base of plate 1. For longer flows, part of this runout is across the coastal flats. Figure 5 shows a bar graph of the runout distances of 72 debris flows that had a flow path that could be measured. The range of runout distances varied from a low of 10 m to a maximum of about 700 m. The average runout distance was 89 m.

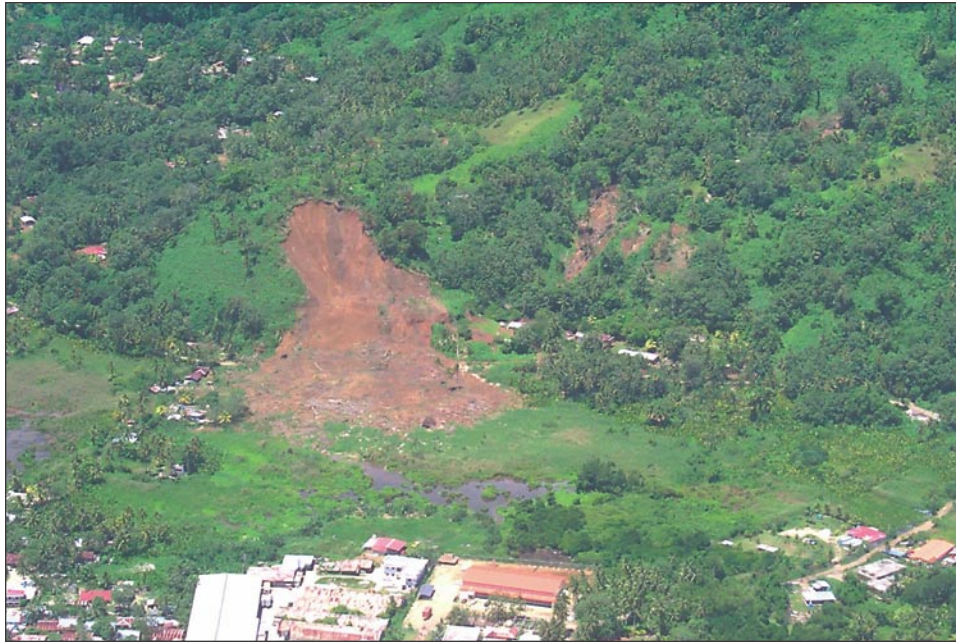
Figure 6. Oblique aerial photograph of Nepukos slump/debris flow on the island of Weno.

Above Nepukos village on the western side of Weno Island, Chata'an triggered a slump that transformed into a debris flow; this flow overran five houses, a road, and powerline at the base of the slope, caused three fatalities, and continued about 70 m out onto coastal flats and into mangrove swamps. The initial slump of about 20,000 m<sup>3</sup> occurred on a knoll with a slope of about 35° at the end of a ridge (fig. 6). The headscarp of the slump was about 10 m high and 30 m wide at its base. The slump occurred in weathered, clay-rich volcanic rocks. The landslide scar and remaining debris are now well drained and eroded so that water emanating from the headscarp flows in a well-developed channel. Future rainfall could generate some smaller failures from the headscarp; however, such failures are not likely to travel beyond the immediate headscarp area.

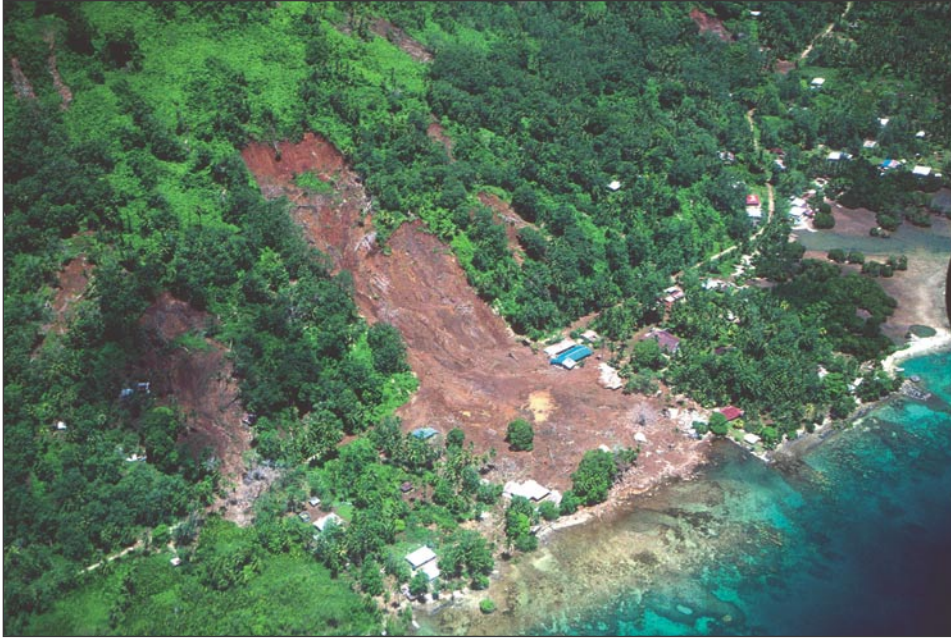
Figure 7. Oblique aerial view of Nechap slump/debris flow on the island of Tonoas.

One of the largest landslide disasters transpired in the village of Nechap on the island of Tonoas. Here, residents reported that debris flows caused 14 fatalities and destroyed 31 dwellings, a water-supply system, and powerlines (fig. 7). Concrete water tanks were transported more than 100 m out to the ocean's edge by the flows. The damaging landsliding began as two slumps in weathered volcanic rocks, with a combined volume of more than 100,000 m<sup>3</sup>. These slumps mobilized into rapid debris flows; deposits from these flows cover a road and extend across the flat coastal lowland for about 175 m and into the ocean (figs. 8 and 9). The lower slump of approximately 75,000 m<sup>3</sup> has a slope width of about 90 m, a scarp height of 120 m, and an average thickness of 7 m. The upper slump mass has a width of about 70 m, a scarp height of 50 m, and a thickness of about 7 m. The upper slump mass initially impounded water draining from the landslide scarp and formed a rapidly moving slurry of soil and weathered rock (debris flow) as the impounded water breached the slump mass. The debris flow from the upper slump evidently occurred after the debris flow from the lower slump mass, because it forms a lobate deposit that overlies the debris deposit from the lower slump.

Both of the slumps failed completely, meaning that most or all, of the slide material within the source areas underwent many meters of displacement. Much of the slump material was remobilized into a debris flow, and the scarp area now is well drained. The likelihood of additional large failures from these scarps is low. Remaining debris-flow material, which extends to the ocean, likely will be eroded by future rainfall

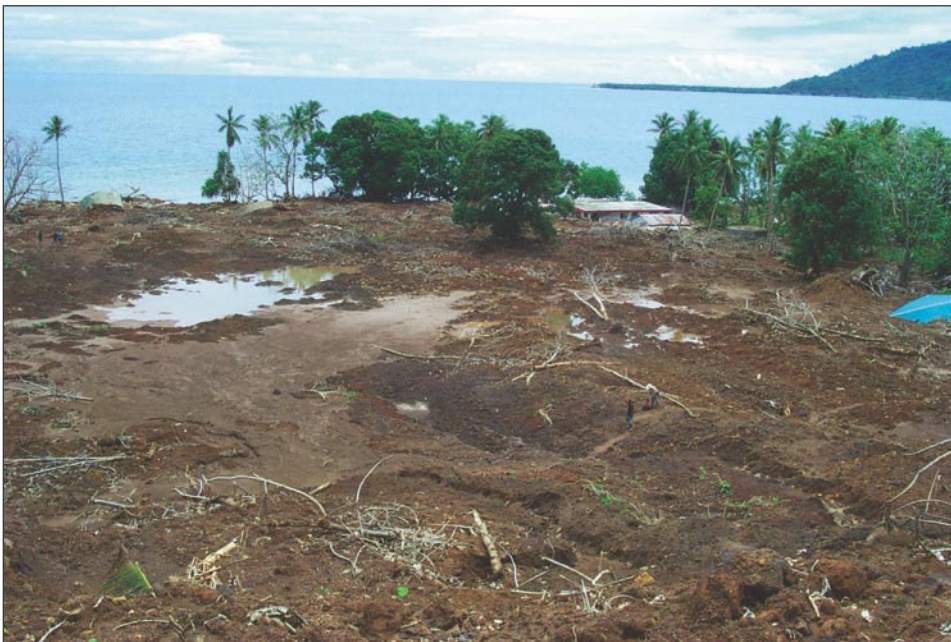
Figure 8. Deposits from Nechap debris flow showing destroyed homes and displaced concrete water tanks (upper left in photo near shoreline).

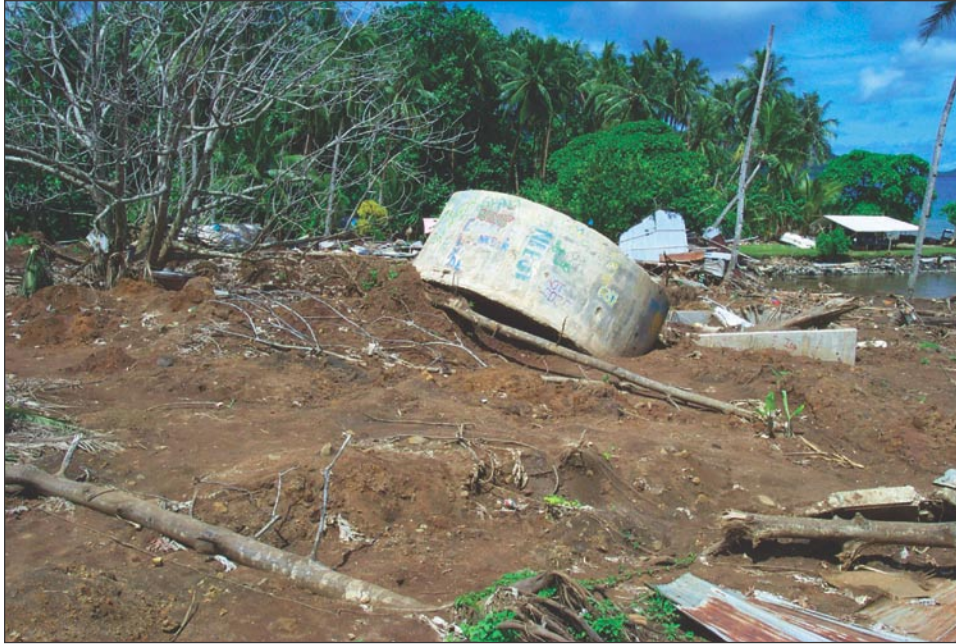
Figure 9. Distal part of Nechap debris flow, near the ocean, showing debris from destroyed houses and closeup of water tank.

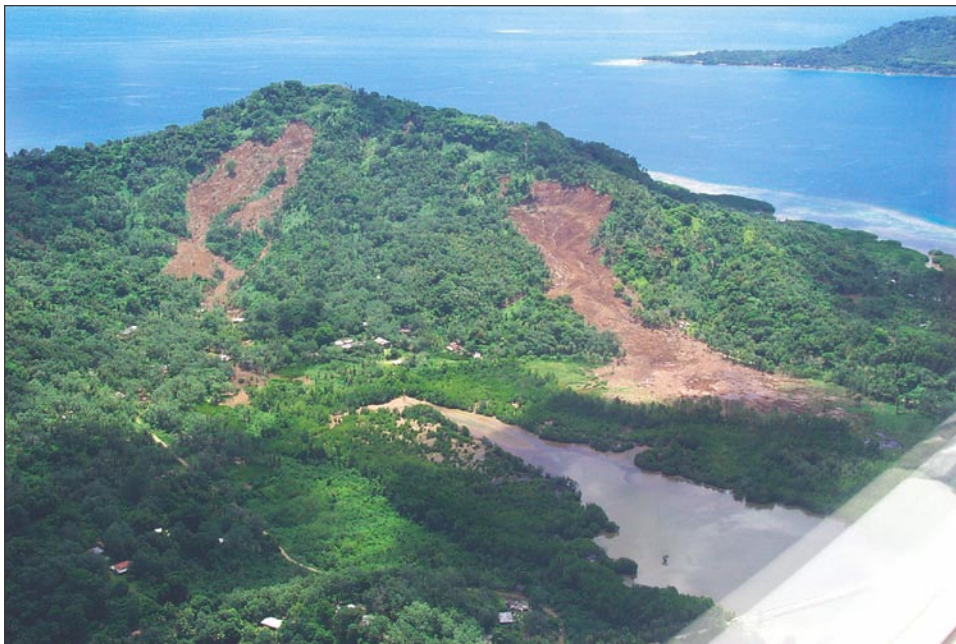
Figure 10. Oblique aerial view of Kuchua slump/debris flow (right) and Roro debris slide/flow (left) on the island of Tonoas.

This landslide is one of the largest triggered by tropical storm Chata'an (fig. 10). The landslide and resulting debris flows resulted in five fatalities and six homes destroyed. The headscarp of the source slide is about 150 m wide, 150 m long in the downslope direction, and 10 m in average thickness, resulting in a total volume of approximately 200,000 m<sup>3</sup>. The slope of the headscarp area, prior to failure, was approximately 30°-40°. The failure surface is arcuate in cross section, and initial movement of this mass apparently resulted in the temporary impoundment of a large volume of water draining from the scarp and possibly surface gullies. In addition to impounded water infiltrating the slump mass, catastrophic failure likely resulted from overtopping of the slump mass by the impounded water, and/or from piping and subsequent rapid failure. The catastrophic failure mobilized much of the slump material, and the resulting flows cut a deep erosion channel through the slump. This channel exits at the east side of the source area and indicates where mixed water and debris flowed out of the source area. According to Chester Gustav, who lives near the distal end of the debris flow, the first wave of debris and water arrived at 10:00 a.m. on July 2, followed by two more waves of debris. The entire debris-flow activity took place over 26 minutes. The distal end of the debris flow

extended about 500 m into the taro field beyond the break in slope at the base of the flow path (figs. 10 and 11). The overall length of the flow is greater than 700 m. The headscarp area has relatively low continuing landslide hazard. Farther down the flow path, considerable debris remains along the west side of the main channel of flow. These slopes are relatively gentle ( $\sim 15^\circ$ ), however, and are unlikely to remobilize into massive debris flows.

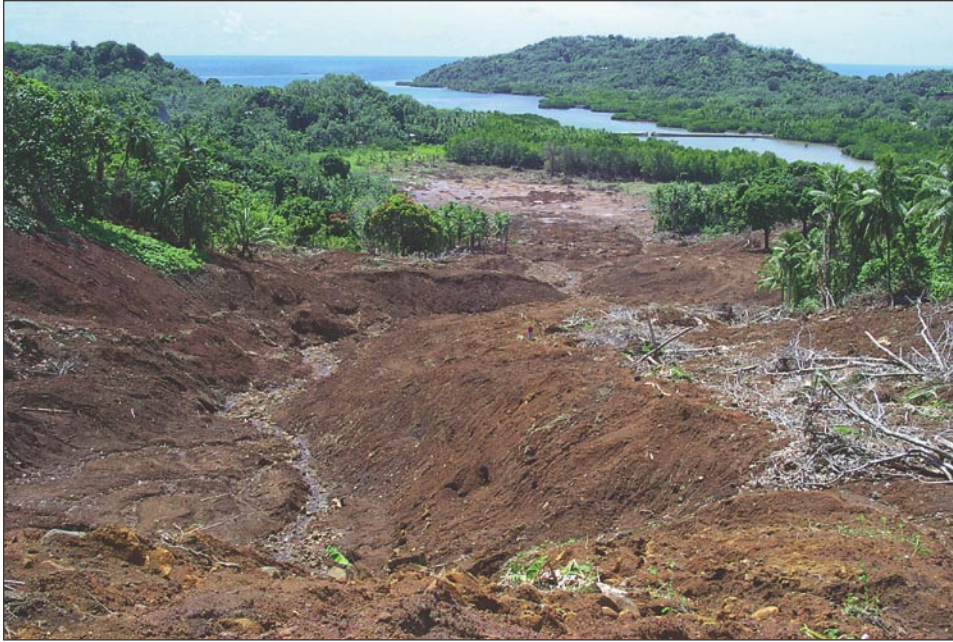
Figure 11. Downslope view of Kuchua slump/debris-flow path. Deposits from this flow covered taro fields at the distal end of the deposit.

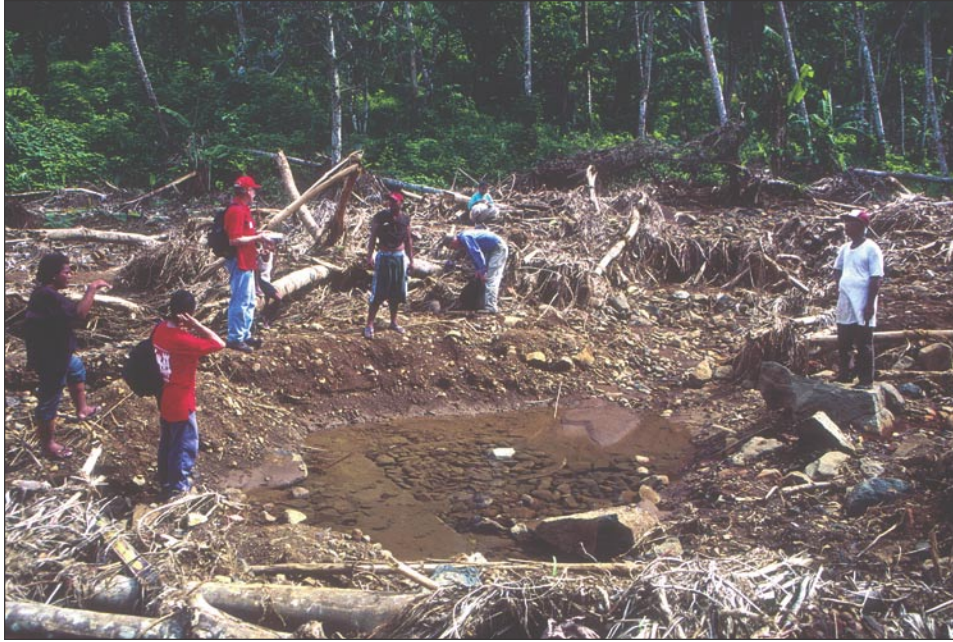
Figure 12. Water catchment basin inundated by debris from the Roro debris slide/flow. Part of the basin wall (in the small pond) has been exposed by digging after the debris flow event.

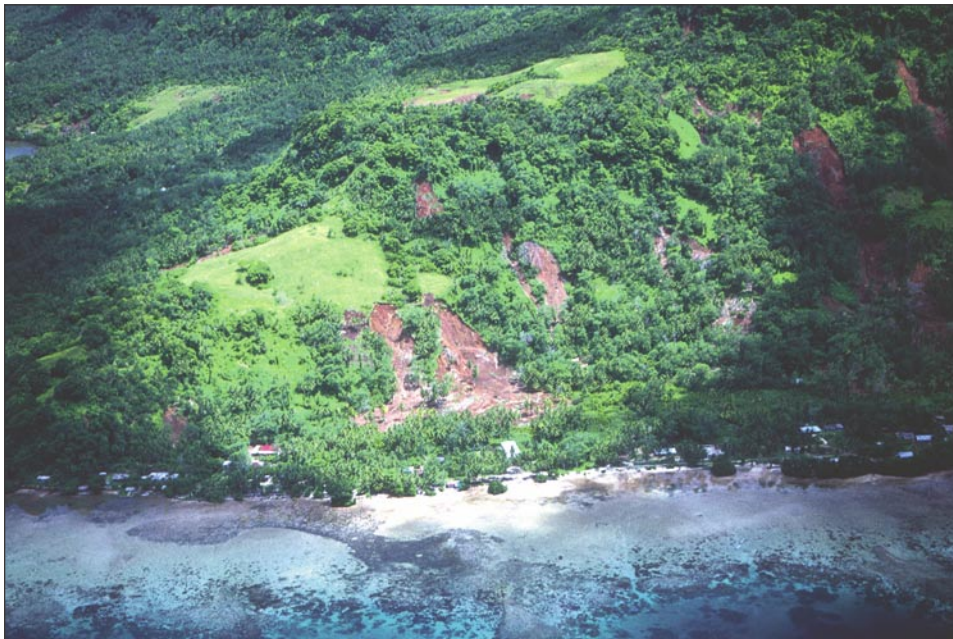
Figure 13. Aerial view of Pwene slump/debris flow on the island of Fefan. This site shows a debris-flow doublet (center of photo) with a downslope line of trees located on a ridge between the two debris flows that coalesced.

Near the school in the village of Pwene (Wininis), two children were killed by a debris flow on the afternoon of July 2. Here, two slumps failed from a 30° slope above the school

and coalesced to produce a 28,000 m<sup>3</sup> debris flow (figs. 13 and 14). A 50-m-wide tree covered ridge that did not fail during the storm separates the two slump sources. The debris flow spread out across a nearly flat field behind the school. The slumps underwent extensive mobilization into debris flows, and little material remains in the headscarp area.

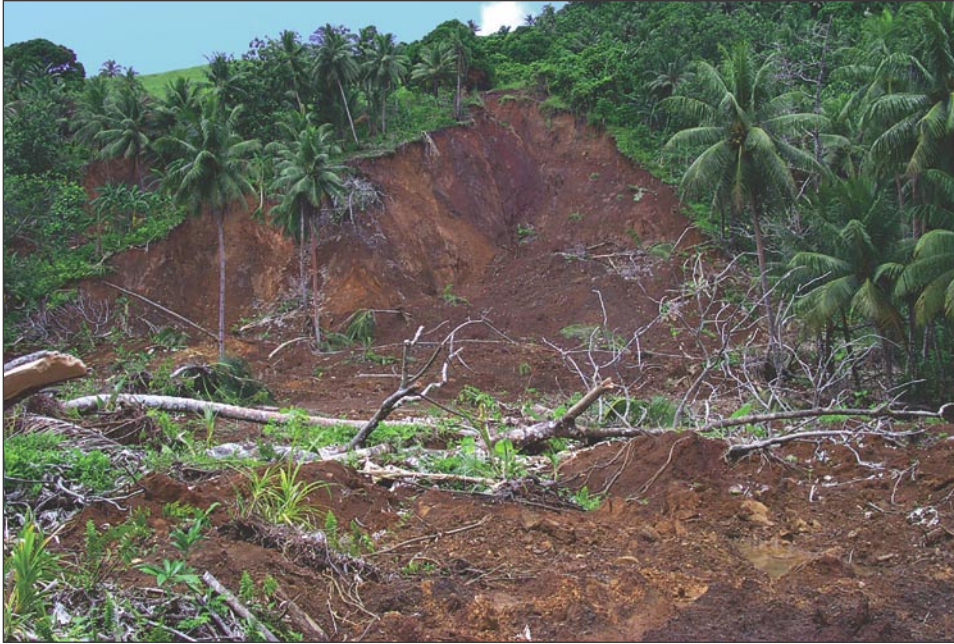
Figure 14. Head scarp of the northern Pwene slump/debris flow.

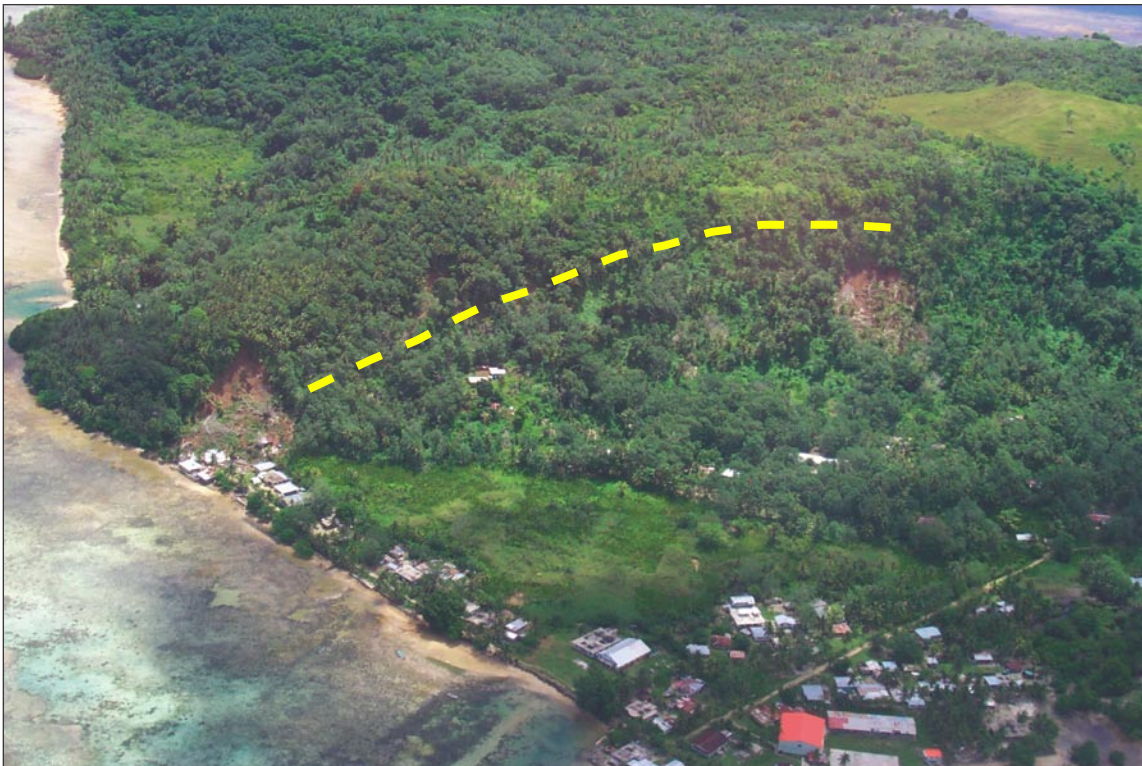
Figure 15. Oblique aerial view of Sapore slump/debris flow (left center) on the island of Fefan. Dashed line indicates approximate position of reactivated head scarp of preexisting large incipient slump. Preexisting slump mass is below and to the right of dashed line.

On the southern end of the island of Fefan, a slump/debris flow buried a road, destroyed nine homes, and killed four people during Chata'an (figs. 15 and 16). The slump originated on slopes of 35° and moved about 10,000 m<sup>3</sup> of weathered volcanic rock before transforming into a debris flow. Most of the slump material has undergone 5-10 m of displacement, and any additional movement likely will be small and confined to the source area. The headscarp of a large incipient slide extends from this slump scar northward along the hillslope for at least 500 m. This scarp has recent vertical displacement of 2-3 m (Figure 17), although older roots near the slump scar suggest that at least part of the scarp was preexisting. A 15 m-long toe is present below this scarp about 300 m from the slump where the slump mass has overthrust the ground surface by about 0.5 m. Several houses are located near and downslope of the toe. Future behavior of this large incipient landslide is uncertain. It may undergo renewed movement with future rainfall. However, the depth of this slump is estimated to be 15-25 m, and such a deep-seated landslide of this volume would be unlikely to move in response to light or moderate rainfall. Reactivation of this landslide may require abnormally high rainfall intensities and longer durations such as that provided by tropical storm Chata'an.

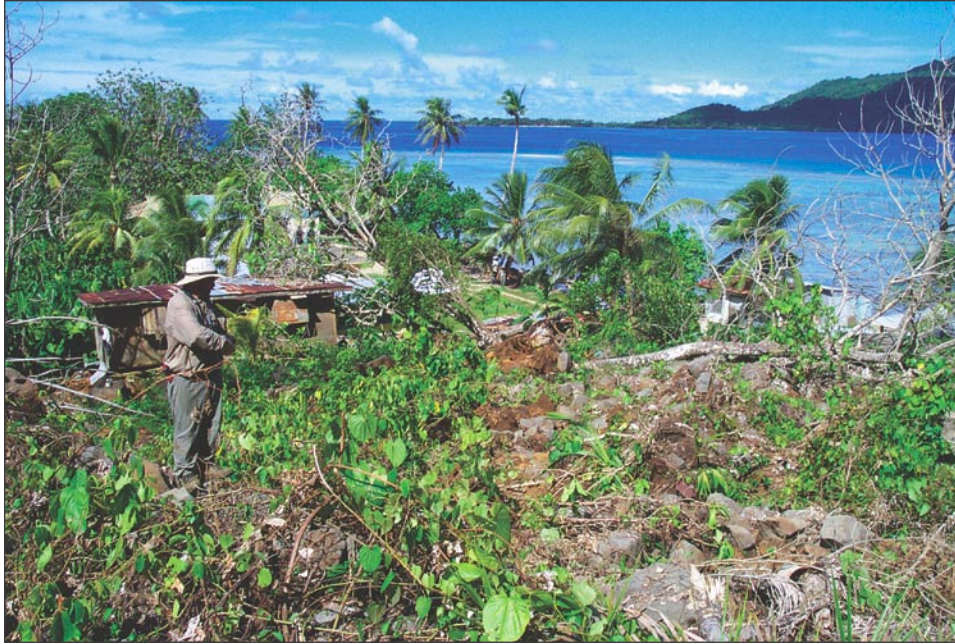
Figure 16. Downslope view of Sapore debris flow showing area where nine houses were buried or destroyed by the deposit.

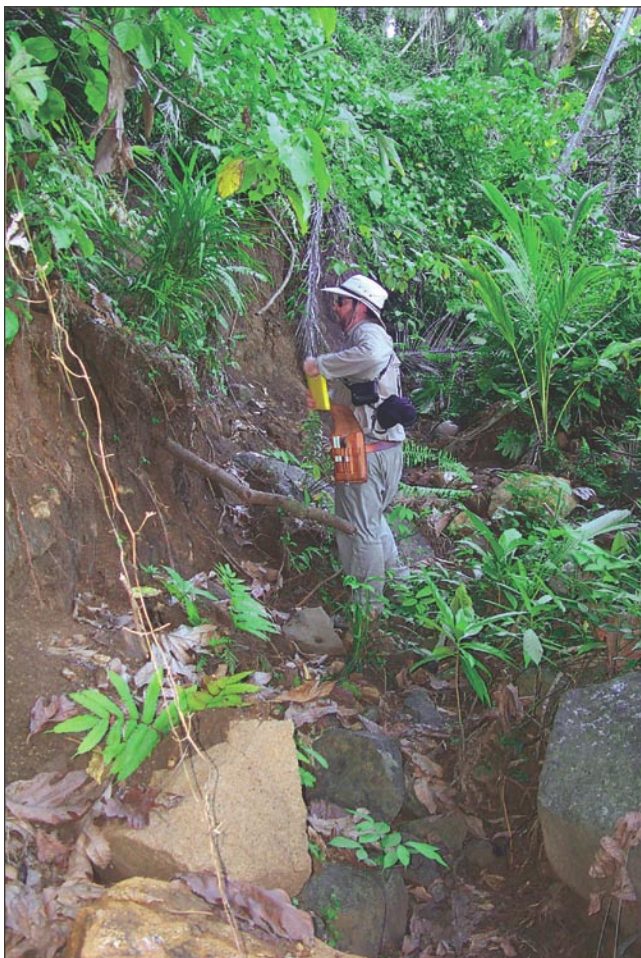
Figure 17. Scarp of reactivated large incipient slump (see fig. 15) near Sapore produced by rainfall from tropical storm Chata'an.

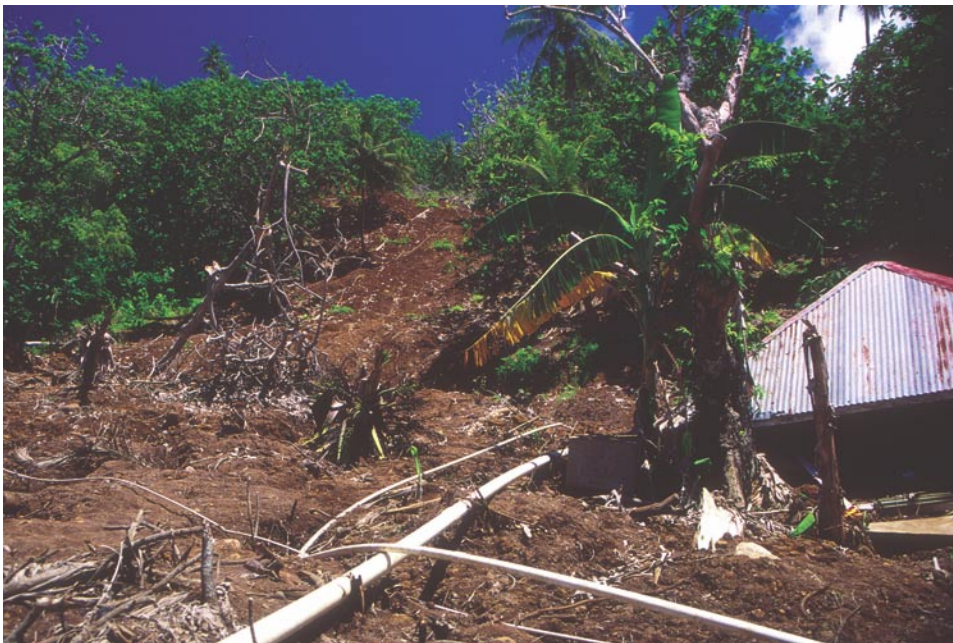
Figure 18. Lower portion of a slump/debris flow at the village of Sanuk on the island of Uman that destroyed 13 homes and a community center.

On the northeastern coast of the island of Uman in the village of Sanuk, another slump that transformed into a debris flow traveled across relatively narrow coastal lowlands. The debris flow buried 13 homes, a community center, a road, and caused one fatality. The 50-m high, 6,000 m<sup>3</sup>- slump initiated on slopes of about 30° in highly weathered volcanic rocks (fig. 18). After transforming into a debris flow, it traveled about 140 m downslope to the coastal lowlands and incorporated about 4,000 m<sup>3</sup> of colluvium and weathered bedrock along its travel path. The resulting total volume of the flow deposit is about 10,000 m<sup>3</sup>. Some of the slump debris still remains in the slide source area; however, this material is unlikely to travel beyond the original source area due to small source volumes and roughness of the existing flow path.

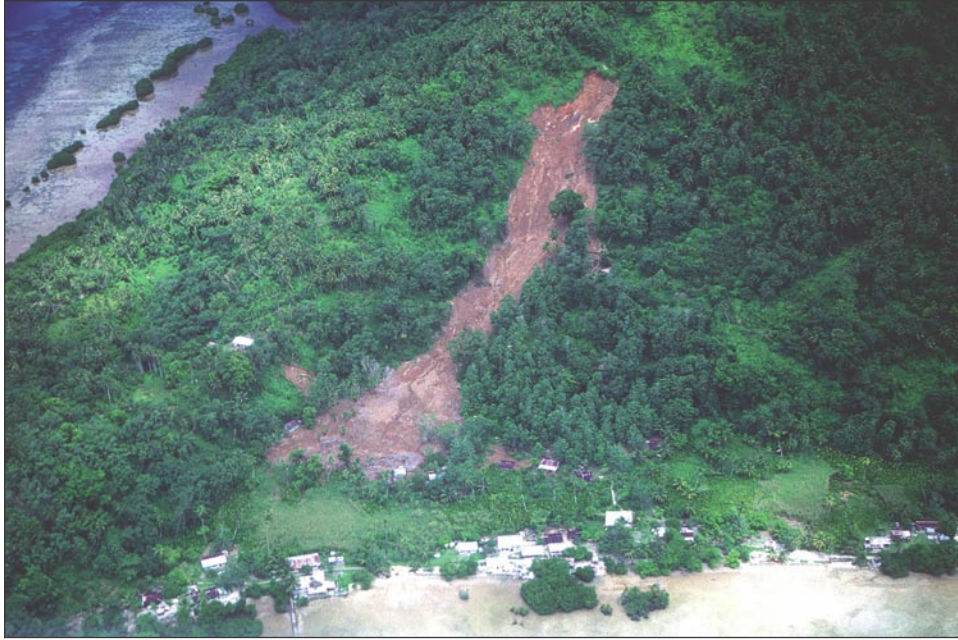
Figure 19. Aerial oblique view of slump/debris flow at the village of Penia on the island of Udot.

A slump located on the northwestern side of the island of Udot mobilized into a debris flow, traveled about 220 m downslope to the coastal flats, and caused four fatalities. The initial slump source had an 80 m-high scar and an estimated volume of 10-15,000 m<sup>3</sup> (fig. 19). As with most of the other larger landslides triggered by Chata'an, the source area is located in deeply weathered, basaltic-volcanic rocks. According to local residents, this event occurred at about 7:00 or 8:00 a.m. on July 2. Small remnants of the original

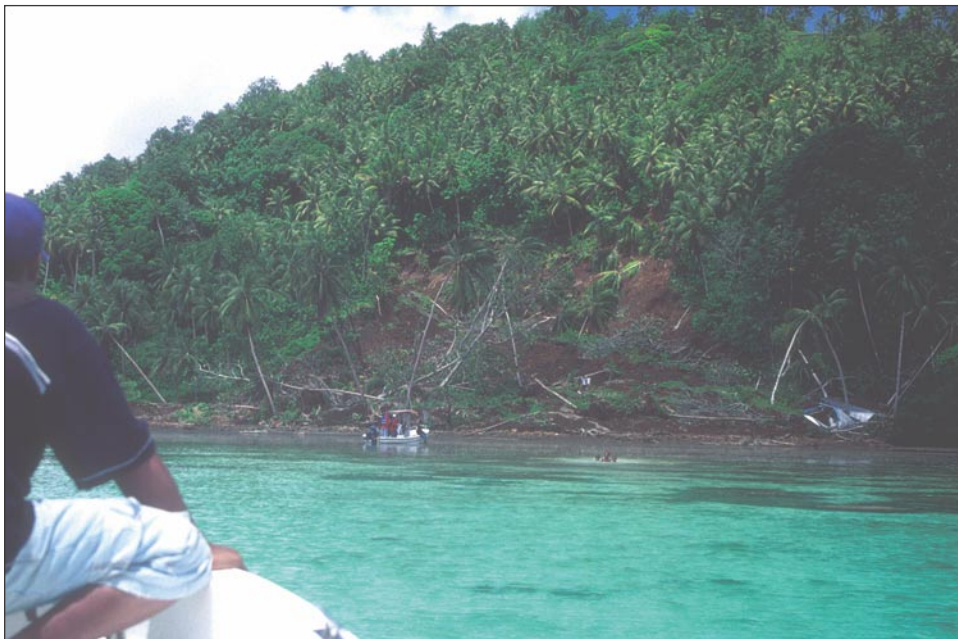
Figure 20. Faia slump/debris flow and incipient slumps that destroyed 15 homes and a dispensary on the island of Fanapanges.

On the eastern coast of the island of Fanapanges, a continuous series of slumps and incipient slumps were triggered during Chata'an, again within highly weathered, basaltic-volcanic rocks. The entire complex affects at least 250 m of trail along the coastline. The northernmost of these slumps, 50 m in height, with a volume of about 8,000 m<sup>3</sup>, transformed into a debris flow and traveled about 100 m to the shoreline (fig. 20). This flow destroyed 15 homes, a water basin, and a dispensary in the village of Faia. According to local residents, this event occurred about 10:00 a.m. on July 2. Incipient cracking, with a vertical displacement of about 0.5-1.5 m, extends southward from the headscarp of this slump (A, fig. 21). Adjacent to this slump and below the incipient cracking is a relatively intact, wedge-shaped incipient slide, 60 m wide along the trail (B, fig. 21). South of this, shallow blocky failures from the toe of a larger slump extend for about 90 m along the trail and reach the coastline (C, fig. 21). According to residents, this slump occurred a few minutes after the destructive northern debris flow. To the south of this feature, incipient cracks curve and step shoreward, crossing the trail about 70 m south of recent slumps (D, fig. 21). During very wet periods, this entire area (about 250 m long) may be subject to renewed slumping and possibly debris-flow activity. This extensive area remains potentially hazardous and would be a relatively poor site for relocating a dispensary.

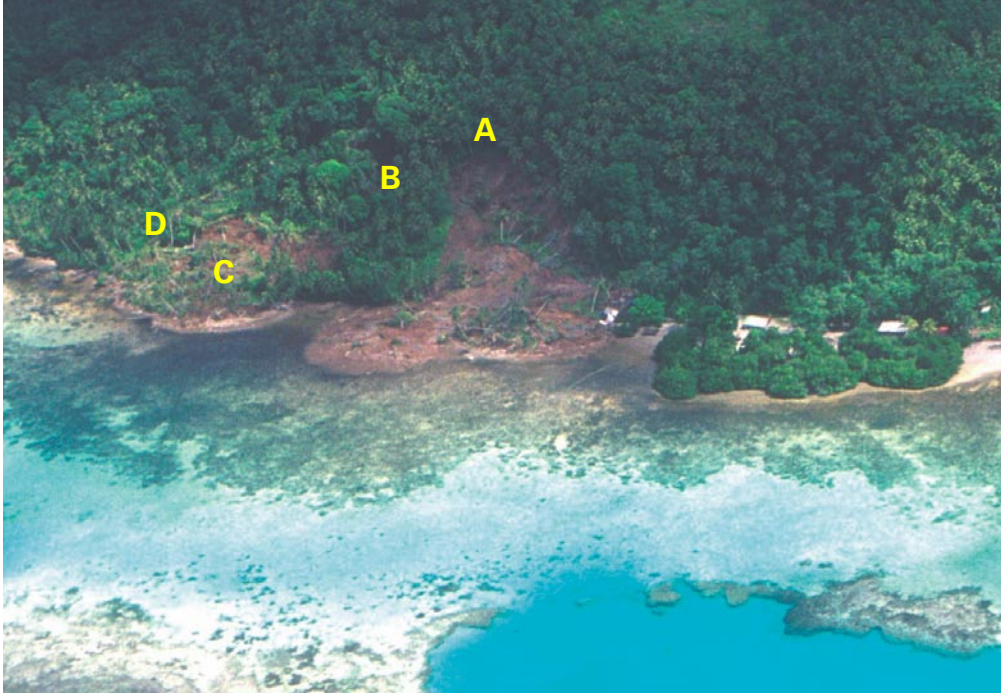
Figure 21. Aerial view of the Faia landslide and incipient slumps. Letters denote locations described in text.

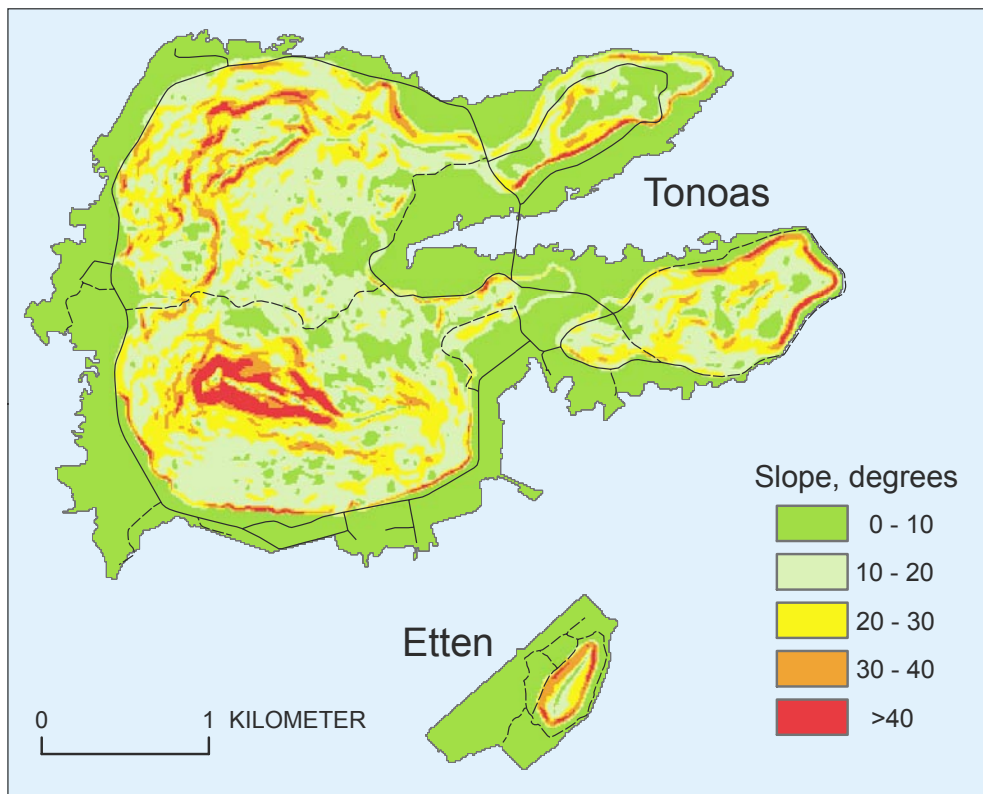
Figure 22. Slope map of the island of Tonoas prepared from a 10-m digital-elevation model (DEM).

a slope map for the island of Tonoas is shown in figure 22. The thickness of the potential sliding block ( $t$  in equation 1) at each cell was estimated at a constant 3.5 m, reflecting an average thickness of Chata'an-triggered landslides. For ground-water conditions during intense rainfall similar to tropical storm Chata'an, we assumed a fully saturated soil column with slope-parallel ground-water flow within all cells ( $m = 1$  in equation 1). Ground-water conditions undoubtedly varied from place to place and over time during Chata'an; nevertheless this assumption provides a relative "worst case" condition for computing slope stability.

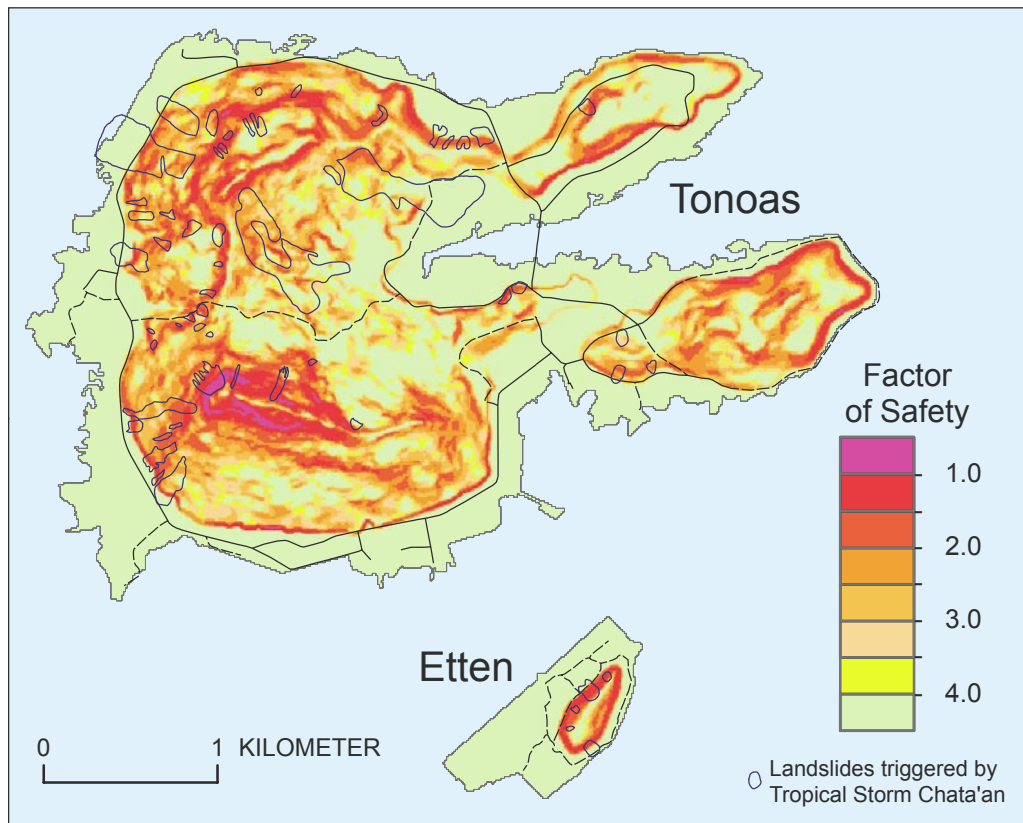
Figure 23. Factor-of-safety (susceptibility) map of the island of Tonoas using the slope-stability analysis described in text.

Using equation 1, we computed the static factor of safety,  $FS$ , for each 10-m grid cell of the affected Chuuk islands. The resulting slope-stability (factor-of-safety) map was then used to construct the debris-flow hazard map described in the next section. An example of the factor-of-safety map for the island of Tonoas is shown in figure 23. Factor-of-safety categories are portrayed on the map as different colors, ranging from magenta and red for the lowest values or least stable slopes to green for the highest values or most stable slopes. These colors indicate the general susceptibility of a given slope to landsliding in a storm similar to Chata'an. Overall, most of the debris flows initiated within slopes

shown as magenta, red, or orange colors in figure 23, indicating a generally good agreement between the actual locations of landslide-source areas and those slopes predicted to be highly susceptible. There are, however, debris flows that initiated on slopes containing a significant number of cells of intermediate susceptibility. Notably, some of the larger debris flows on Tonoas, including those at Nechap, Kuchua, and Roro, initiated on slopes such as these. These debris flows began as complex deep-seated failures (greater than 10-m thick and much larger than a 10-m grid cell) with complex failure mechanisms (see discussions above). They are poorly represented by the slope-stability analysis described by equation 1. In general, the smaller, thinner, and more numerous debris flows more closely approximate the assumptions of our stability analysis, for example, a simple sliding block of constant thickness. For these more common debris flows, our analysis performed well.

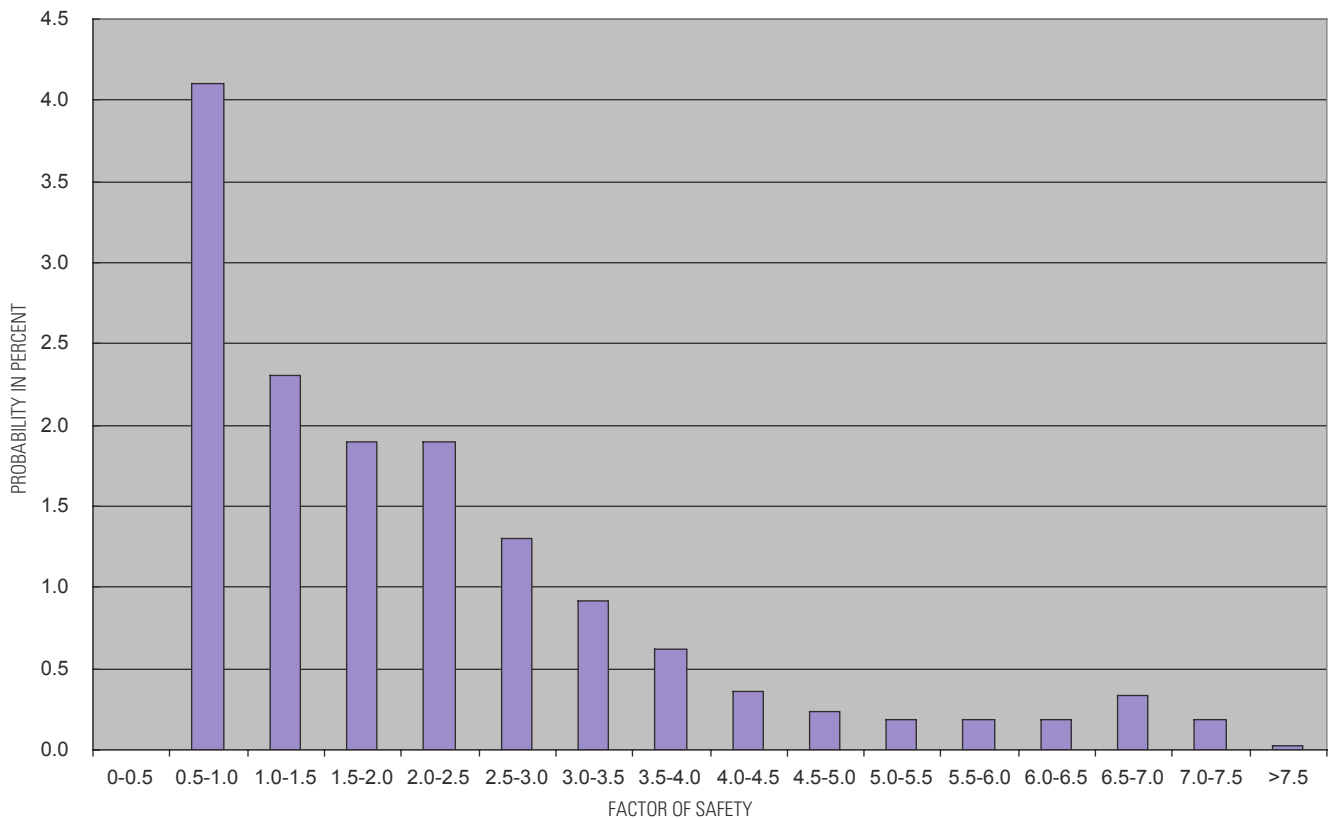
Figure 24. Histogram of debris-flow source probability versus factor-of-safety based on slope stability analysis of the islands of Weno, Tonoas, Fefan, Etten, Uman, Udot, Eot, and Fanapanges. Larger probabilities indicate an increased likelihood that a Chata'an-triggered landslide (debris-flow source) occurred on hillslopes with the corresponding factor-of-safety.

having  $FS$  values of between 1.0 and 1.5 had a 2.3 percent probability of sliding, and the pattern of decreasing percent probability continues with increasing  $FS$  (fig. 24). With debris-flow source probability plotted versus  $FS$  in figure 24, we were able to establish debris-flow hazard categories in terms of  $FS$ .

yellow, and green, respectively, on plate 2. Figure 24 shows that  $FS=0.5-1.0$  stands out noticeably from the rest of the data (highest probability), but the areal extent of this category is small. For this reason, we combined this FS category with the three adjacent bins,  $FS=1.0-2.5$ , that have similar values, to form the “high” hazard category. The limits of the “moderate” category are somewhat more arbitrary ( $FS=2.5-4.0$ ), although the probabilities in these two bins are significantly higher than in the rest of the bins ( $FS > 4.0$ ). The bins with low probabilities form the “low” hazard category. In summary, areas of “high” hazard have a 2 percent probability, areas of “moderate” hazard have a 1 percent probability, and areas of “low” hazard have a 0.1 percent probability of producing slump/debris flows during rainfall conditions similar to those of tropical storm Chata’an in the eastern islands of Chuuk State.
