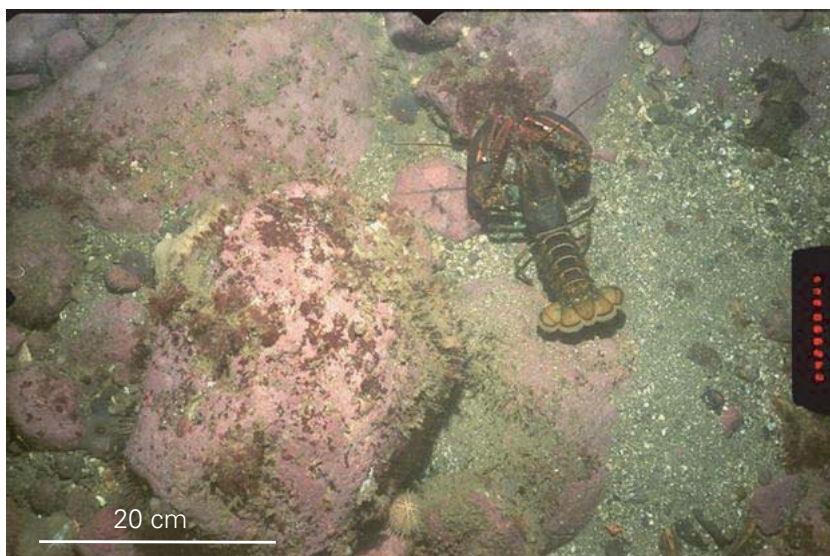
Figure 2.6a. Photograph of the sea floor on the crest of the ridge south of the new ocean outfall at a water depth of about 24 m (see Figure 2.5b for location). The pink on the boulders is calcareous algae. The sea floor at this location is devoid of any fine-grained sediments.

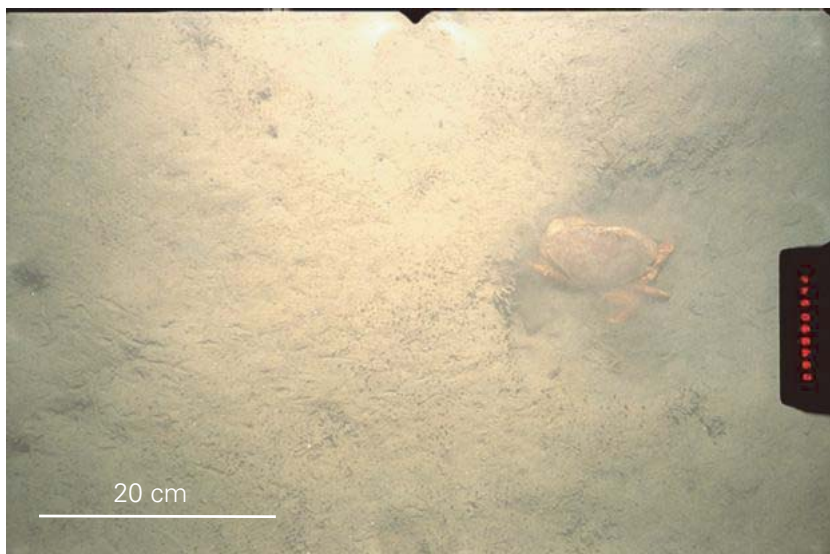
Figure 2.6c. Photograph of the sea floor to the west of the new ocean outfall at a water depth of about 33 m in an area of muddy sediments (see Figure 2.5b for location). A cancer crab is burrowing in the sediment. This is the location of long-term sediment sampling (see Section 7).
