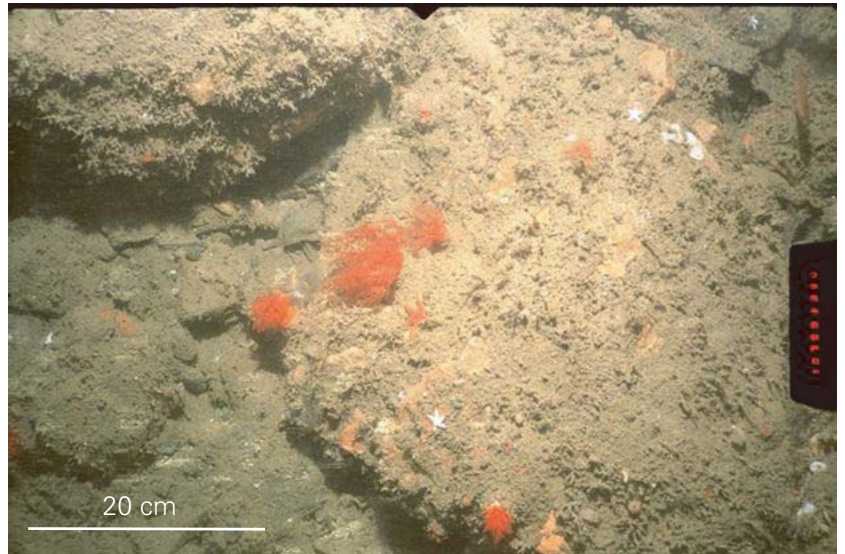
**Figure 2.6d.** Photograph of the sea floor to the northwest of the new ocean outfall in an old dumpsite area at a water depth of about 28 m (see Figure 2.5b for location).

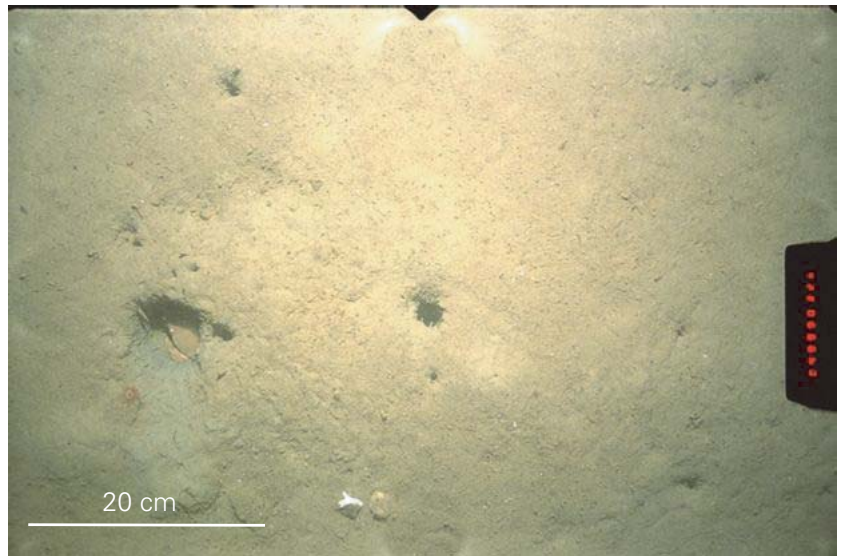
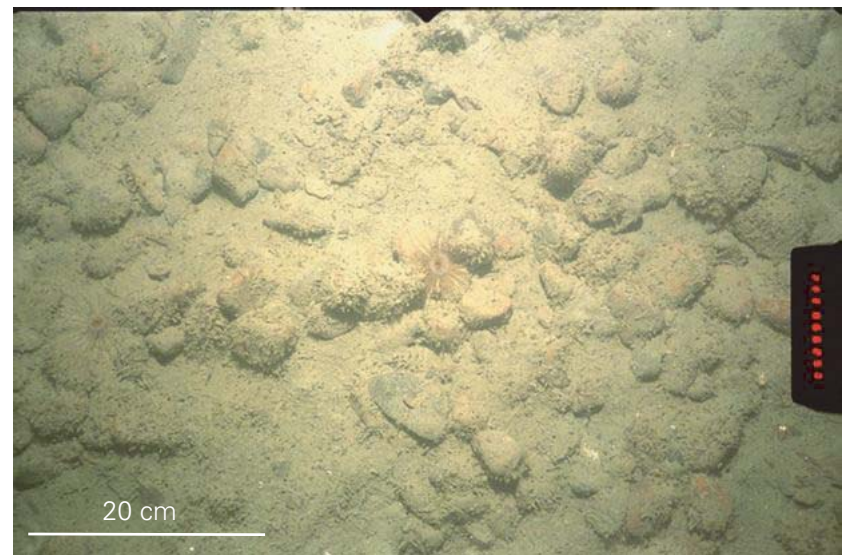
**Figure 2.6e and f.** Two photographs of the sea floor in a depression to the south of the new ocean outfall at a water depth of about 34 m (see Figure 2.5b for location). These photographs, taken about 80 m apart, illustrate the changes in bottom characteristics that occur over short distances. One photograph (**2.6e, top**), obtained in an area characterized by low-backscatter intensity material (blue in Figure 2.5b) shows fine-grained sediments burrowed by a cancer crab. The second photograph (**2.6f, bottom**) is from an area characterized by moderate-backscatter intensity material (green to yellow in Figure 2.5b) and shows the sea floor covered by pebbles and cobbles.
