Flood of July 27–31, 2006, on the Grand River near Painesville, Ohio

Open-File Report 2007–1164

By Andrew D. Ebner, James M. Sherwood, Brian Astifan, and Kirk Lombardy

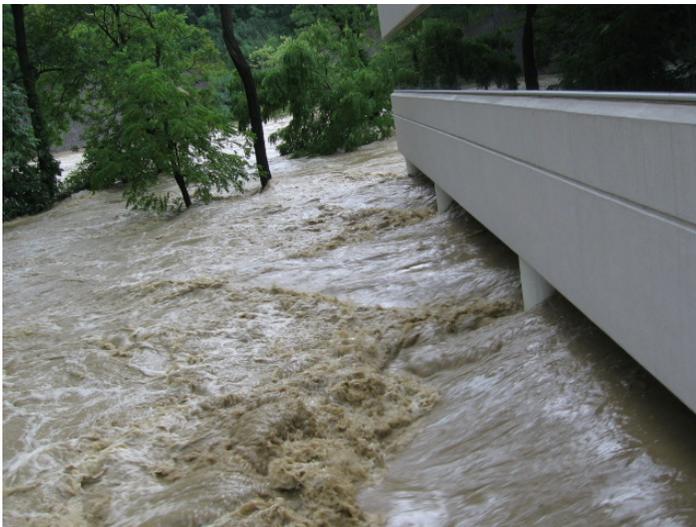
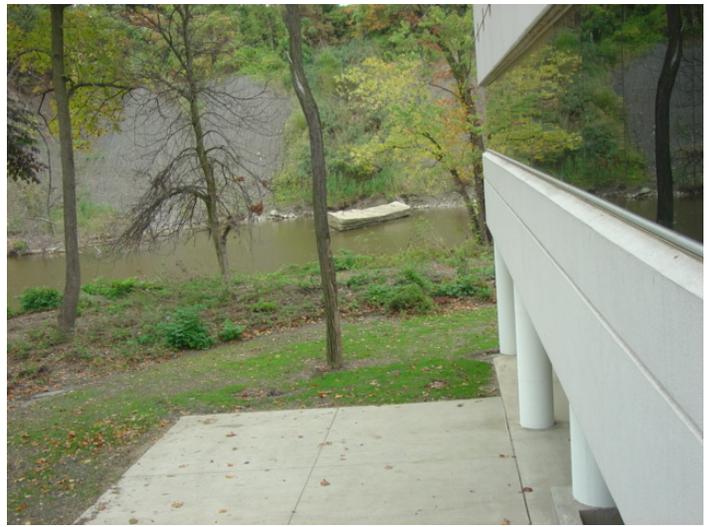
Cover: (Left) Floodwaters from the Grand River on July 28, 2006, rushing through the parking area below the Eckart Building in Painesville, approximately 6 miles upstream from the river mouth (photo by Barbara Petersen, Eckart America Corporation, reproduced with permission). (Right) A photo taken from about the same vantage point after the flood, on October 11, 2006 (photo by Andrew Ebner, U.S. Geological Survey).

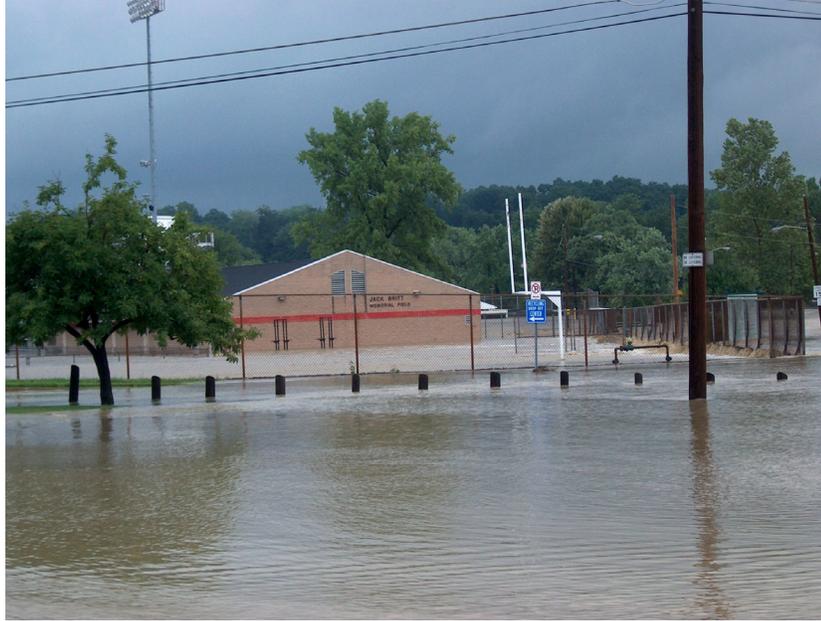
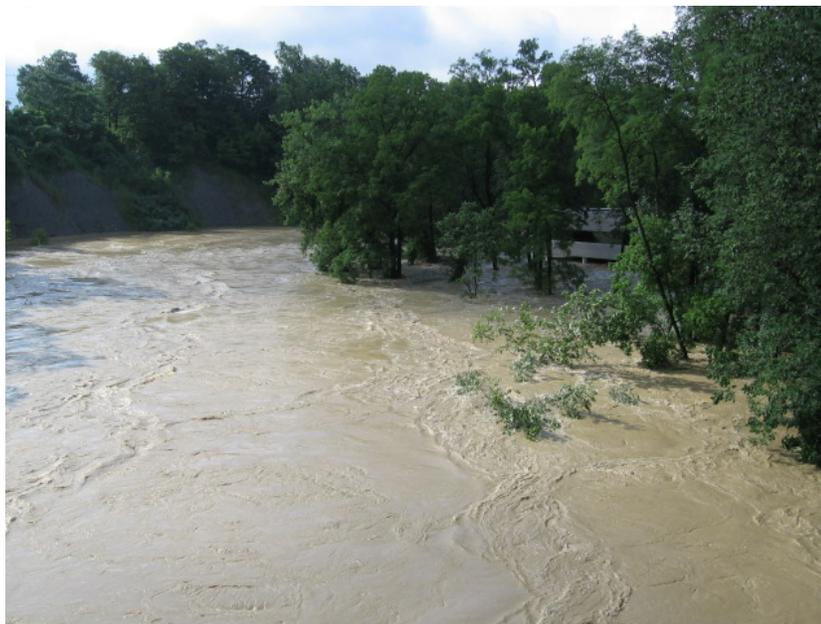
Above: Photographs of the July 27–31, 2006, flood on the Grand River near Painesville, Ohio. *Top*, Photograph showing flooding from the Grand River at Jack Britt Memorial Field, Painesville, Ohio. *Bottom*, Photograph showing the Grand River on July 28, 2006, viewed from the U.S. Route 20 bridge in Painesville, Ohio. Building shown behind trees in right of picture is the same office pictured on cover.
