Thatcher Bay, Washington, Nearshore Restoration Assessment

Open-File Report 2008-1369

Prepared for:

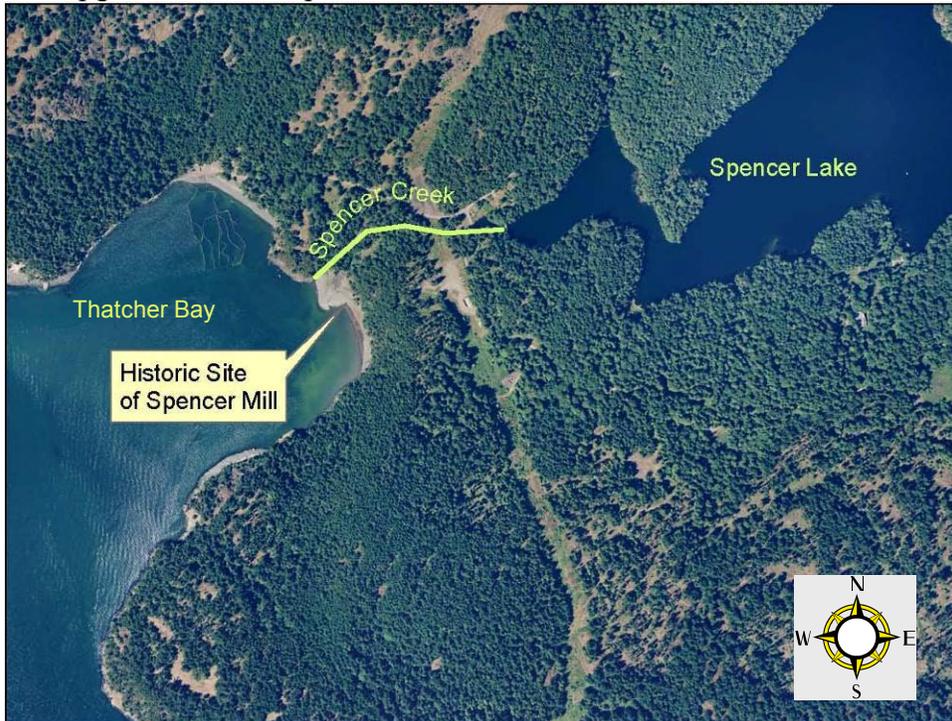
Figure 2. Aerial photograph showing the location of the Spencer Mill in relation to Spencer Creek and Lake.

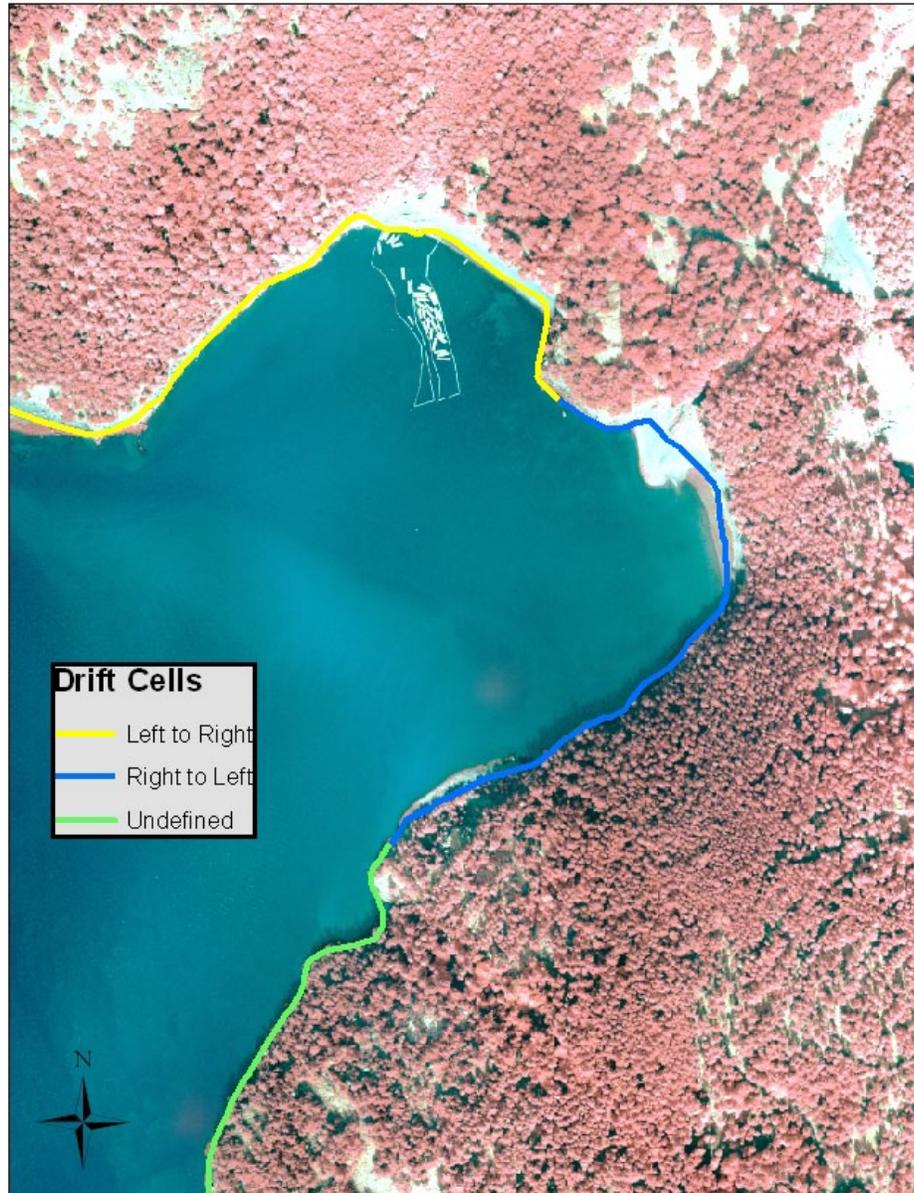
Figure 4. Annotated color infrared photograph showing prevailing drift-cell patterns in Thatcher Bay, Washington.

Given the water current and drift-cell patterns within Thatcher Bay, transportation of the wood-waste off site is unlikely (Figure 4). Drift cells are erosion and depositional patterns influenced by tidal movement, prevailing winds, and geography of the region (Shoreland and Environmental Assistance Program, 2002). The convergence of the prevailing drift-cells near the project site would result in minimal transportation of wood-waste from the impacted area. It is more likely that persistent wave and tidal action has caused settling of the wood-waste in the sediment matrix. This theory is supported by the coring done in August 2007 as part of this project; findings are discussed in the Assessment of Wood-waste Distribution and Abundance section.

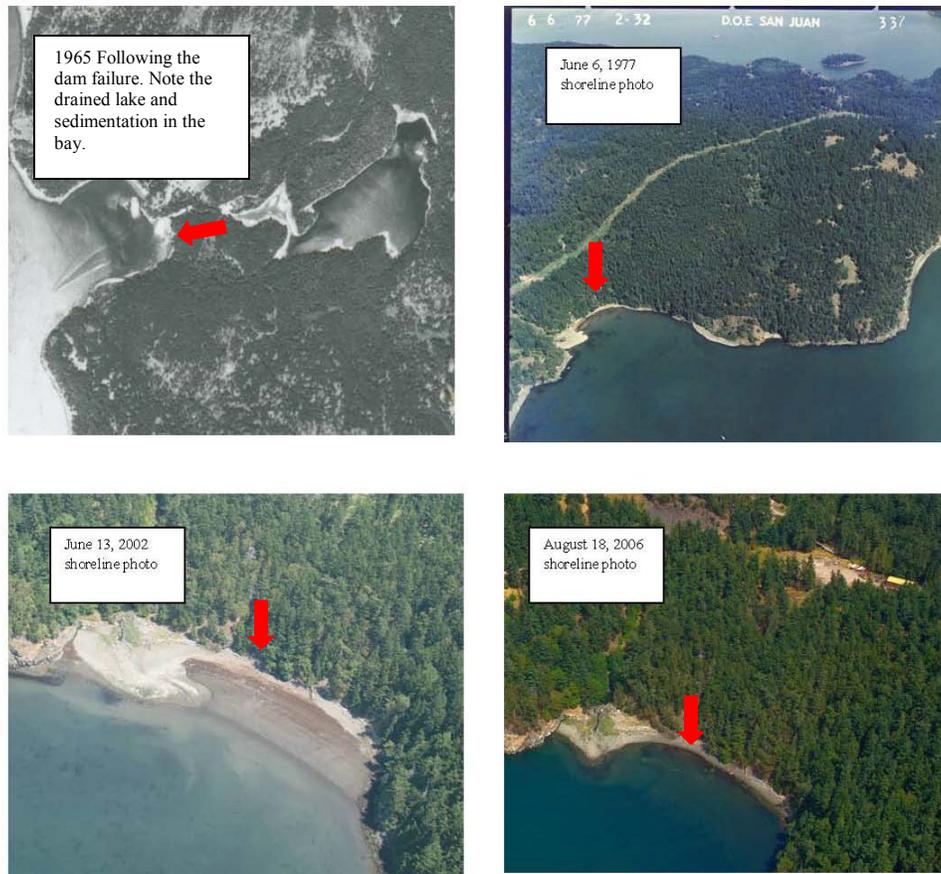
Figure 5. Photographs showing the persistence of wood-waste (red arrows) in Thatcher Bay since 1965.

There are several series of aerial photographs of the Thatcher Bay area from 1965 to present (Figure 5) courtesy of the Washington Coastal Atlas (http://www.ecy.wa.gov/programs/sea/sma/atlas_home.html). While it is not possible to determine the movement of the wood-waste over time by using these photos, the signature of the wood-waste remains visible. The failure of the Spencer Lake dam in 1965 caused significant movement of upland rocky sediments into the nearshore. The persistence of this rocky substrate and wood-waste are visible in the aerial photographs.

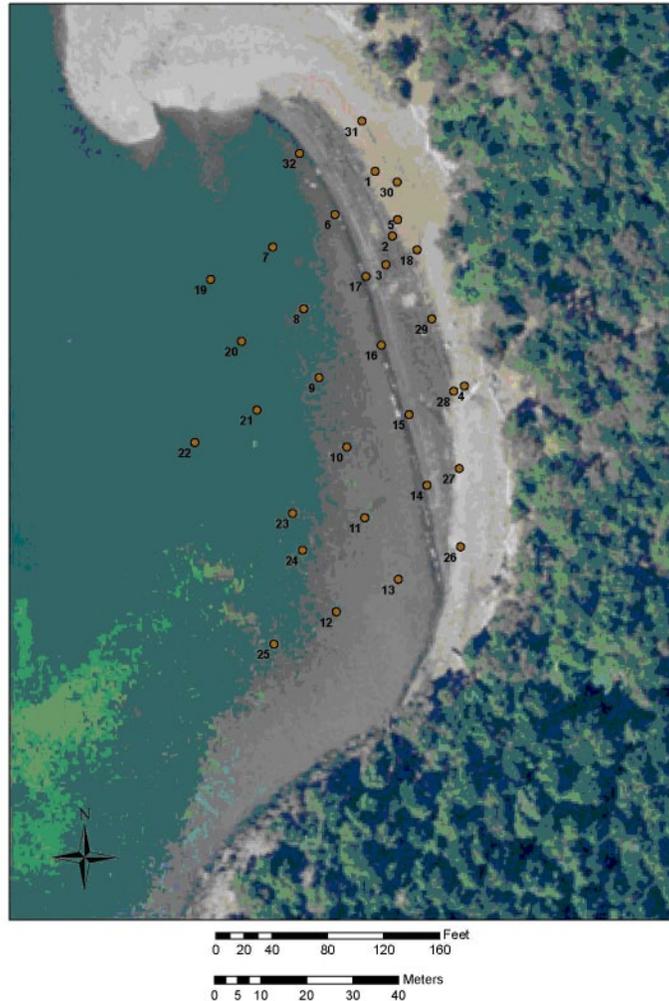
Figure 6. Location of the sediment cores in Thatcher Bay, Washington.

On August 23, 2007, sediment cores were obtained by using a split-core auger system. Thirty-two sediment cores were taken every fifty ft. along six predefined transects perpendicular to shore (Figure 6). Several pilot cores, outside the six predefined transects, were included in the analysis of wood-waste distribution. All cores were measured, and segments were assigned to one of five categories: surface sediment, wood, sediment/wood, dense sediment wood and basal sediment. Precautions were taken to ensure that the core remained intact for measurement purposes. Due to the compaction of the wood-waste and sediment inherent to the coring process, some cores may underestimate the amount of wood-waste within individual sampling locations. An estimate of compaction levels for each core appears in Appendix A.

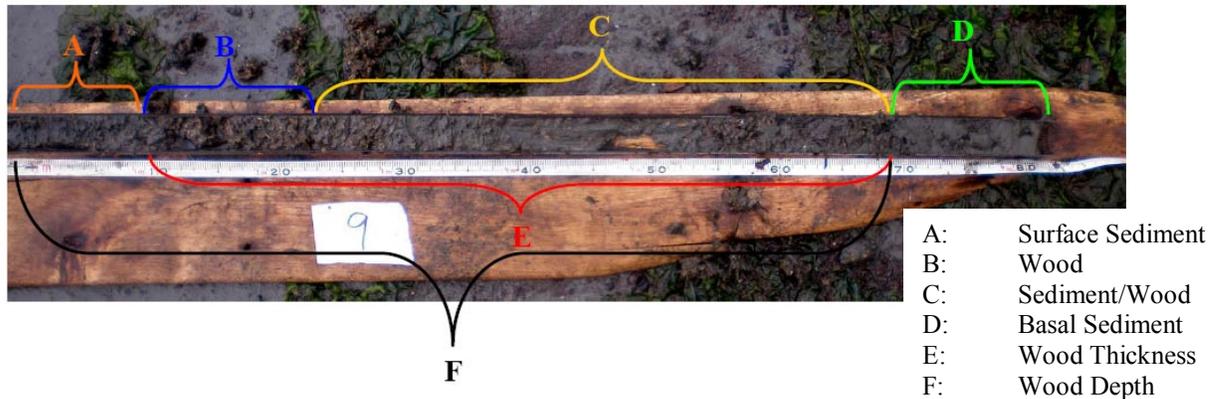
Figure 7 shows the process of measuring the core. Surface sediment (A) was defined as any sediment located above wood-waste. Wood (B) was used to define any portion of the core where the composition was found to be mostly wood-waste. Sediment/wood and dense sediment wood (C) were two categories used to describe any portion of the core where sediment and wood-waste were visibly intermixed. Dense sediment wood was used to describe core segments where wood-waste composed less than 20 percent of the sediment. Basal sediment (D) was all sediment found below the last visible wood-waste in the core. All cores were labeled and photographed at high resolution for future reference. If the basal sediments were not reached, a second core was taken to determine the maximum depth of wood-waste deposition.

Figure 7. Photograph showing visual representation of sediment categories, taken from Thatcher Bay, Washington. See text for explanation.

Maximum wood depth and thickness were calculated for all cores as shown in Figure 7. Maximum depth (F) was calculated by combining the surface sediment, wood, sediment/wood, and dense sediment wood categories. The result is the maximum depth, in meters, that wood-waste was observed. The same method was used to determine wood thickness (E) with the exclusion of the surface sediment category. Locations and details of core measurements are listed in appendix A.

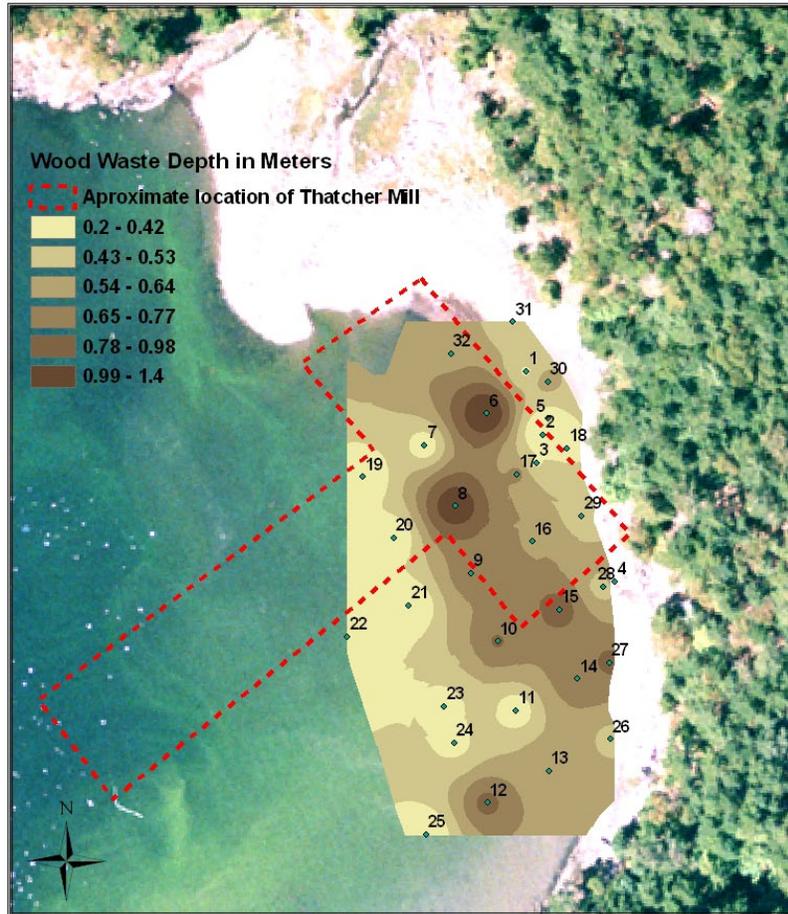
Figure 8. Map of the maximum depth of wood-waste observed in Thatcher Bay and approximate extent of historic mill house (red dashed line). Color is indicative of depth below the sediment surface. Darker colors indicate deeper depths. A general trend of decreasing depth along transects perpendicular to shore was observed.

Figures 8 and 9 display the spatial interpolation of the data obtained from core samples (see appendix A). Figure 8 illustrates a concentration of wood-waste in the center of the project site at approximately 1-2 ft below Mean Lower Low Water (MLLW). This concentration of wood-waste corresponds with cores 6 and 8. By using landmarks in the historical photos of the Spencer Mill (Figure 3), it can be estimated that cores 6 and 8 correspond with the historical location of the mill, the concentration of wood-waste shown in Figure 9 supports this observation, as well. The distribution determined by the IDW analysis indicates that there is a trend of reduced wood-waste thickness and depth with distance from the shore and site of the mill. Assuming a conservative 0.55 m (1.8 ft) for average depth of the wood-waste and contaminated sediments, there are approximately 3,792 m³ of wood-waste and wood-waste contaminated sediments in the impacted area.

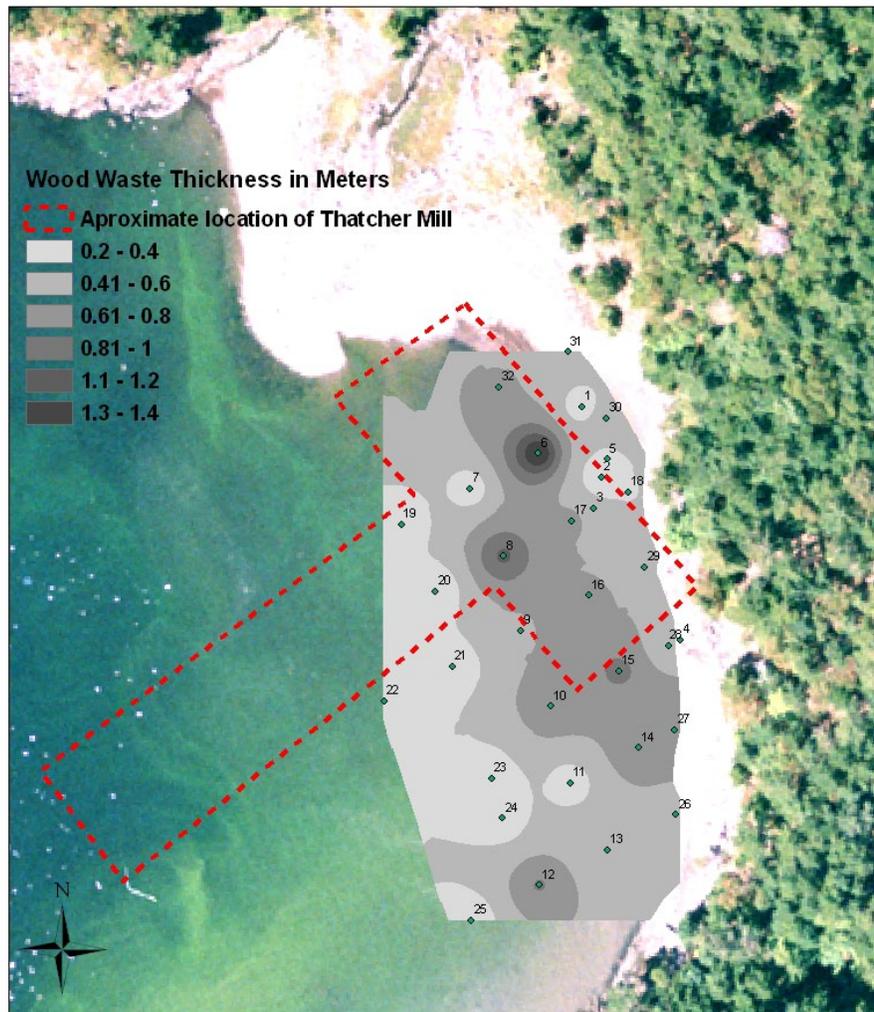
Figure 9. Map of the maximum thickness of wood-waste observed in Thatcher Bay and approximate extent of historic mill house (red dashed line). Color gradient represents thickness of wood-waste deposit. Wood thickness distribution is strongly correlated to wood depth.

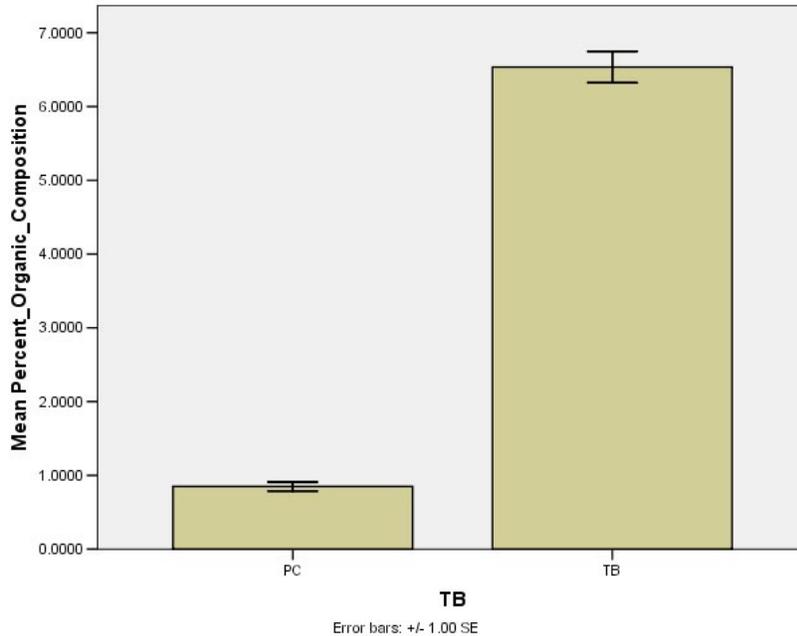
Figure 11. Plot of average percent organic matter (and +/- 1 SE) in Thatcher Bay (TB) and Picnic Cove (PC) sediments determined by using loss on ignition.

Thatcher Bay sediments returned an average organic composition of >6 percent (fig. 11). Picnic Cove, which supports a *Z. marina* population, returned an average organic composition of <1 percent, well below the levels found in Thatcher Bay. The elevated organic composition of the Thatcher Bay sediments informs our understanding of the ongoing impacts of wood-waste within Thatcher Bay.

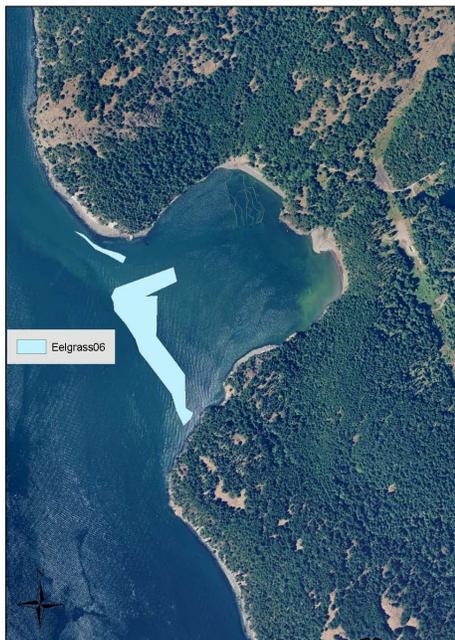
Figure 12. Photograph showing the extent of the eelgrass present in Thatcher Bay, Washington, in 2006.

Maps created from video data collected during 2006 and 2007 are displayed in Figure 12 Figure 13. The data show that the current distribution of *Z. marina* is limited to the mouth of Thatcher Bay. The extant population remained in a relatively similar position during the two years of sampling.

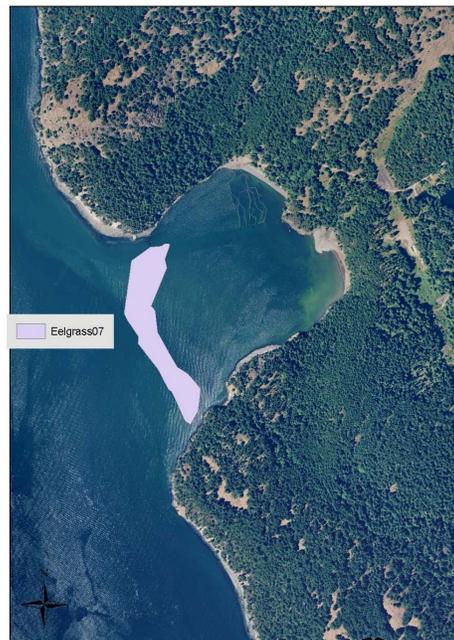
Figure 13. Photograph showing the extent of the eelgrass present in Thatcher Bay, Washington, in 2007.

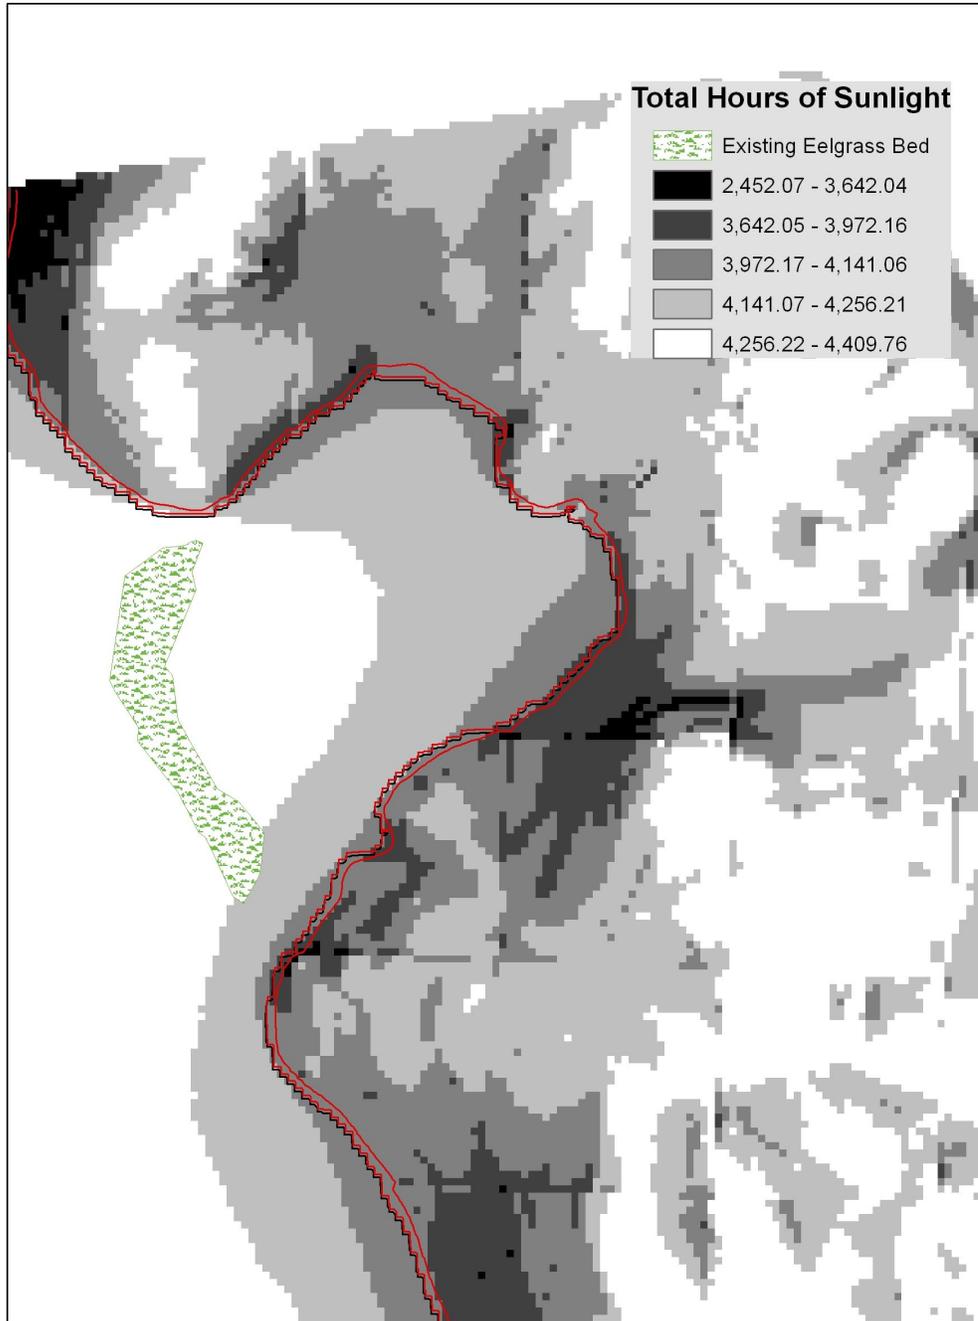
Figure 14. Map of total hours of direct sunlight for 2007 in Thatcher Bay and 2007 eelgrass cover (green stippling). Darker areas correspond to decreased total light availability.

Figure 14 displays the total hours of direct sunlight received by each region in the bay as a proxy of available atmospheric PAR relative to the distribution of *Z. marina* in 2007 from Figure 13. The darker colors correspond to fewer hours of direct sunlight exposure.

This modeling exercise demonstrates that the topography of Thatcher Bay may have an effect on the light availability of atmospheric PAR for the inner portions of the Bay. In turn, this will influence the amount of submarine PAR available in the *Z. marina* zone. Further study is needed to determine the actual light requirements of *Z. marina* in an elevated sulfide environment, but this analysis suggests that light in conjunction with elevated sulfide levels could be limiting the current distribution of *Z. marina* in Thatcher Bay.

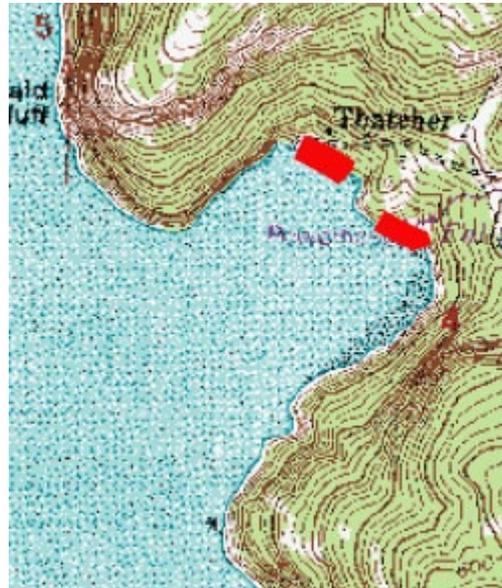
Figure 15. Surf smelt spawning in Thatcher Bay, Washington, adjacent to the wood-waste impacted area (Friends of the San Juans, 2004).

Friends of the San Juans (FOSJ) conducted forage fish spawning habitat surveys in 2004; both Surf smelt and Sand lance were found to spawn on beaches in and around Thatcher Bay. Surf smelt spawning was documented in the areas adjacent to those covered by wood-waste in Thatcher Bay (Figure 15; Friends of the San Juans, 2004). Surf smelt and sand lance share similar spawning habitat requirements, although sand lance prefer sandy substrate (1 - 3mm), while surf smelt prefer sand to small gravel substrate (1 - 7mm; Washington Department of Fish and Wildlife Fish Management Program, 1997a, b). The nature of the fine wood-waste found in the southeastern corner of Thatcher Bay is not consistent with these spawning requirements.
