# National Assessment of Historical Shoreline Change: A Pilot Study of Historical Coastal Bluff Retreat in the Great Lakes, Erie, Pennsylvania

By Cheryl J. Hapke, Shamus Malone, and Meredith Kratzmann

Open-File Report 2009–1042

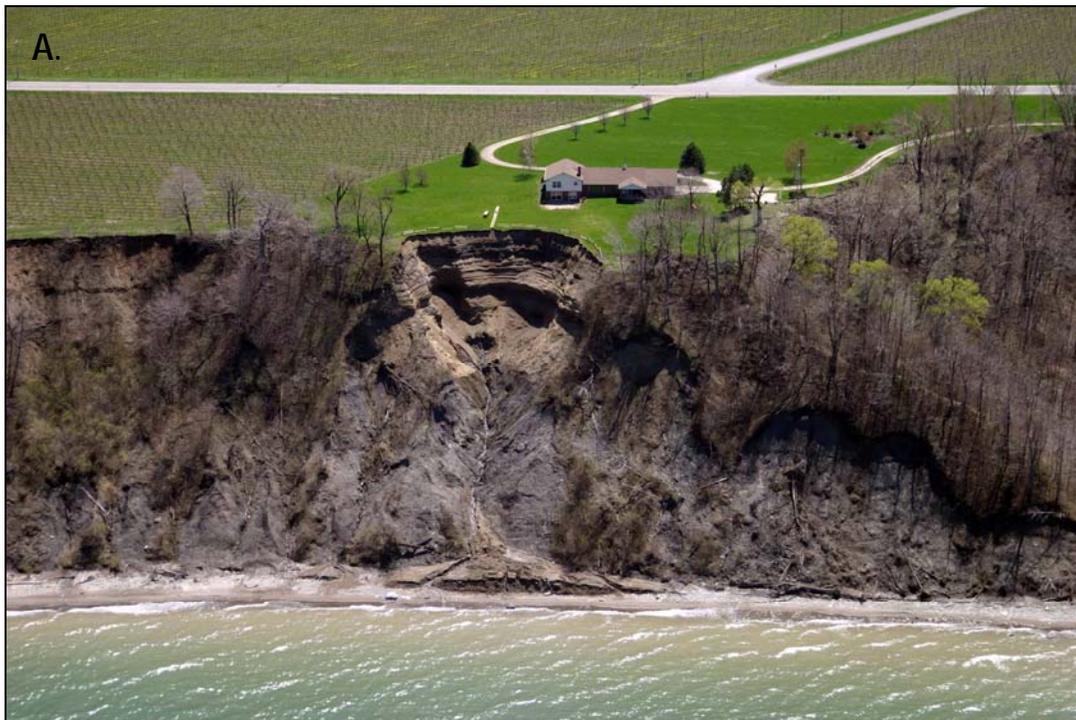
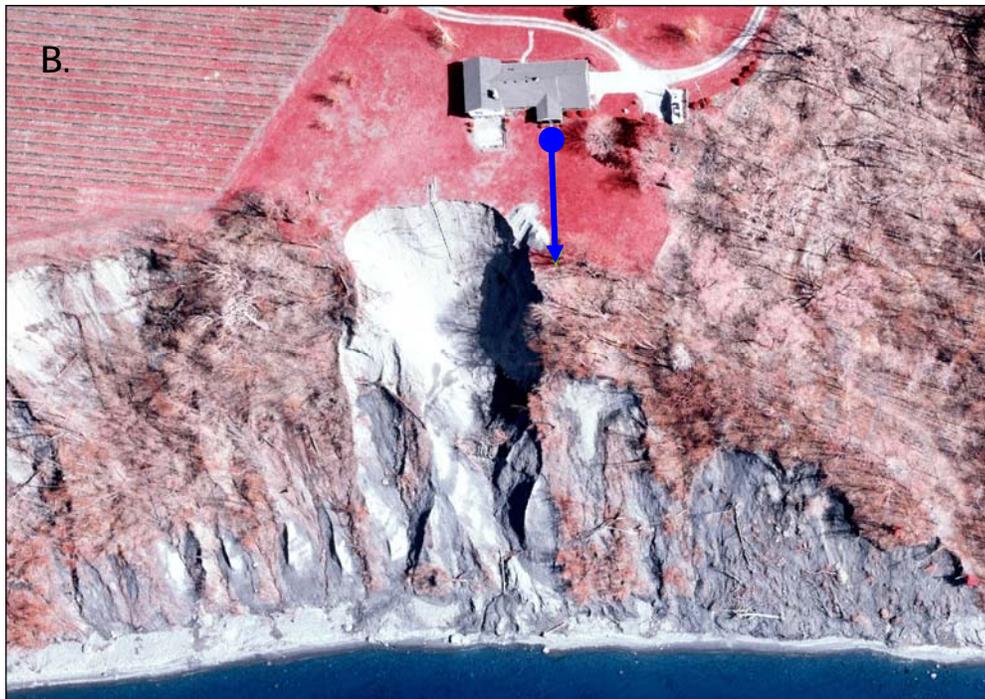
**Figure 1. (A)** This low-angle oblique aerial photograph shows an area of high recession along Lake Erie, Pennsylvania, bluffs that is not documented in a State Coastal Resources Management Program monitoring study as a result of the original location of the control point from which distance to the bluff edge is measured. **(B)** This low-altitude vertical aerial photograph of the same area shows the location of the control point (blue dot) and the azimuth (blue arrow) along which the transects are measured. Photographs from Pennsylvania Coastal Resource Management Program.

Long-term (25-year) average retreat rates as high as 1.0 m/yr at specific control-point locations and bluff recession up to 11.3 m between monitoring cycles have been documented as part of the monitoring program. Some control points are in stable bluff areas and show no measurable recession. Although the long-term average recession rate based on all the control points for the Lake Erie Coastal Zone is 0.23 m/yr, recession tends to be spatially variable and temporally episodic. Additionally, the control-point measurement sites were chosen independently of known erosion hazard areas; therefore, in some cases, very low retreat rates were measured as part of the study when rates in immediately adjacent areas were much higher. The location of a control point at which the long-term recession rate is 0.04 m/yr is

shown in figure 1. The control-point location does not accurately reflect the high rates of retreat and high hazard in the area. In contrast, a long-term recession rate of 1.0 m/yr was documented at an adjacent control point (fig. 2), located in what was found to be a rapidly receding stretch of coastline. Because the control points are randomly located with respect to coastal processes, recession hazard is adequately monitored at some locations but not at others.

Along most of the Lake Erie, Pa., coast, the bluff is a flat-topped, elevated terrace with a distinct lakeward edge (see figs. 1, 2, and 5). In some areas, however, there is no well-defined break in slope, or the break is obscured by dense vegetation. In these situations, the interpretation of the bluff edge from the lidar data reverted to the same feature that was surveyed on the historical maps, as determined by superimposing the two data sets. Aerial photographs and the orthophotographs were frequently utilized when digitizing the bluff edges from the hillshades to resolve ambiguities in the identification of the bluff edge.

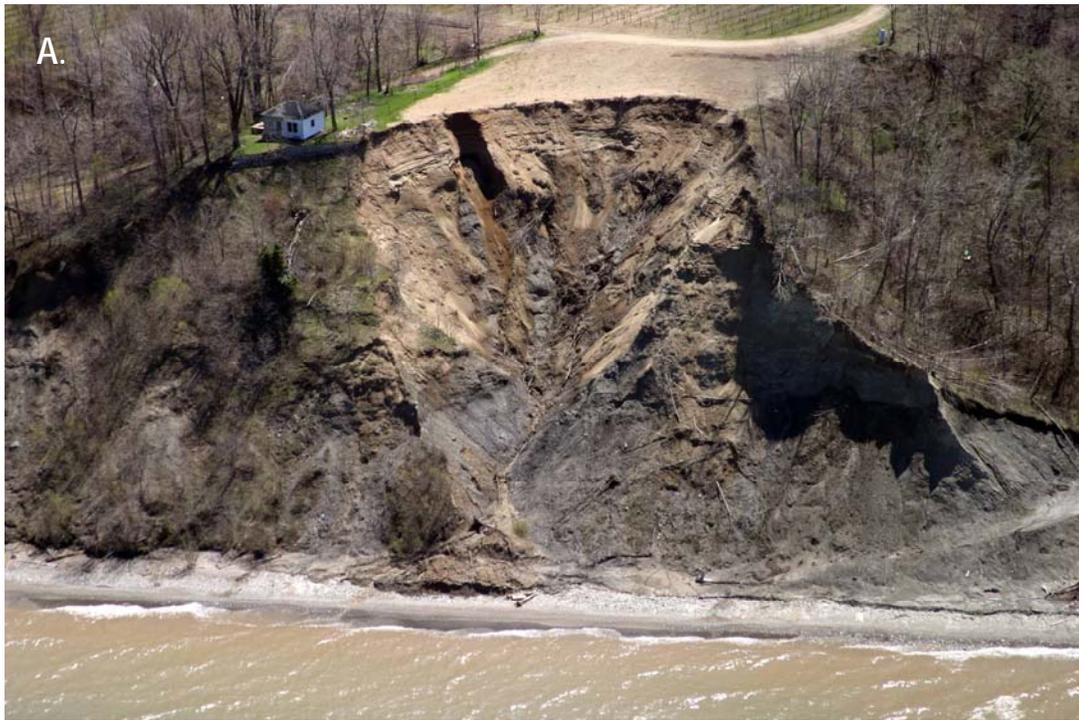
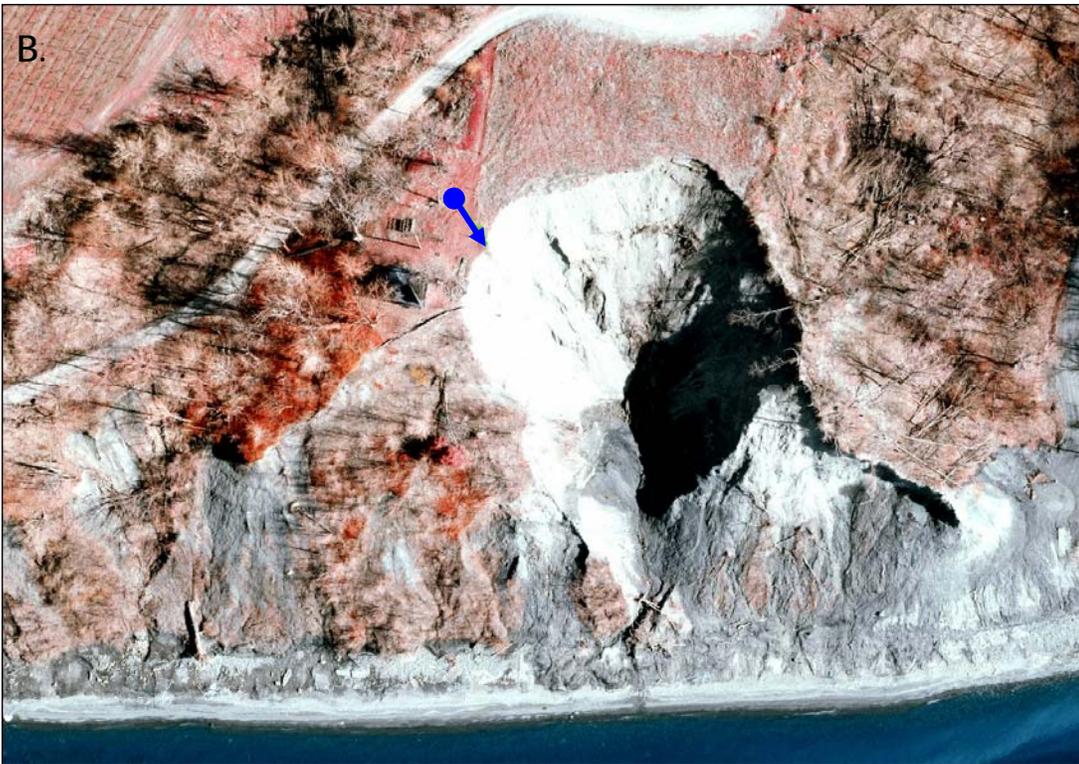
**Figure 2. (A)** This low-angle oblique aerial photograph shows a location along the coast of Lake Erie, Pa., where high bluff recession was accurately documented in a Pennsylvania Coastal Resources Management Program monitoring study because the location of the control points along which bluff retreat is measured captured the large landslide. **(B)** This low-altitude vertical aerial photograph of the same area showing the location of the control point (blue dot) and the azimuth (blue arrow) along which the transects are measured. This is also the area of the highest measured retreat rate (1.0 m/yr) assessed in this pilot study. Photographs from Pennsylvania Coastal Resource Management Program.

along a concavely curved rupture (see fig. 2). The resulting slump surface is spoon-shaped and is rotational about an axis that is parallel to the slope (Varnes, 1978). The classic slump is common in homogeneous materials. Rotational slumps tend to occur in clayey soils and not in sands.

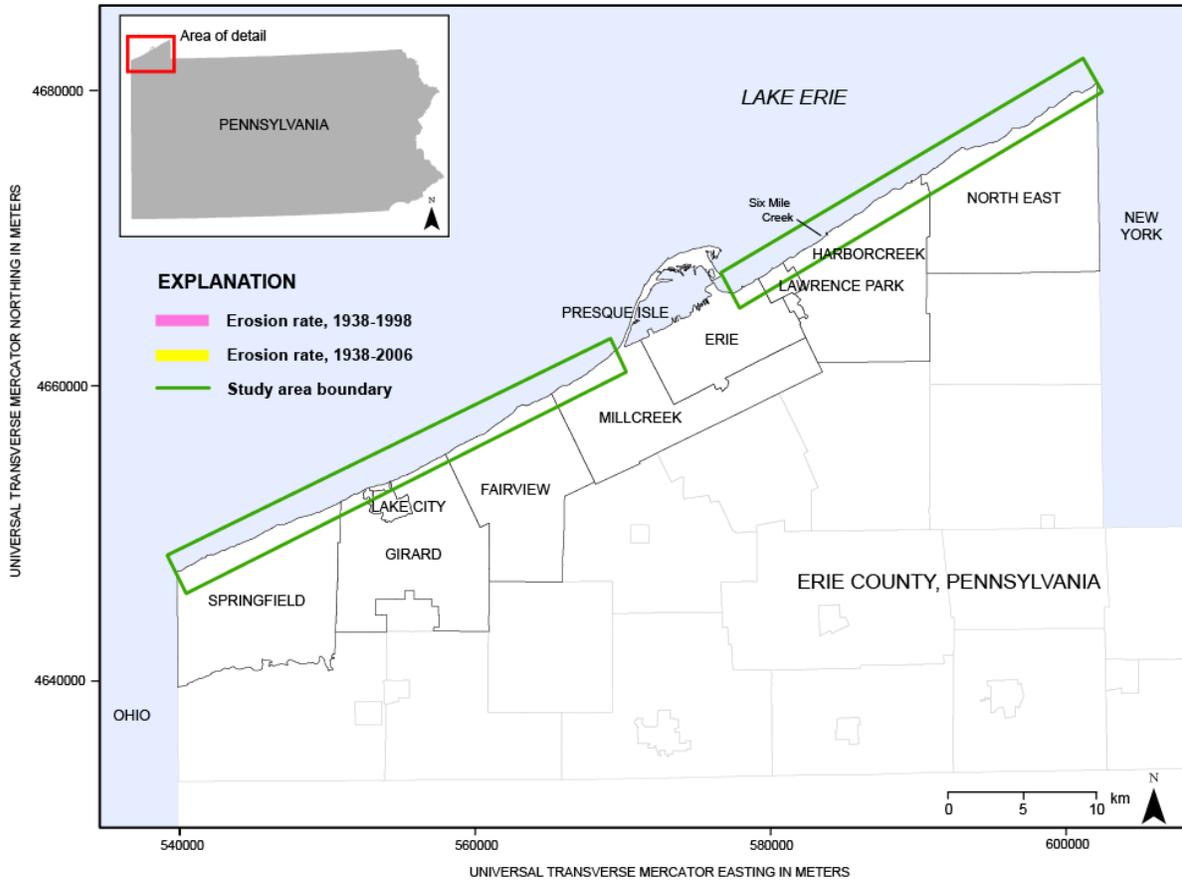
Figure 3. Location map of the Lake Erie, Pa., Coastal Zone including the study areas along which recession rates were calculated.

The coastal bluffs along Pennsylvania's Lake Erie shoreline in Erie County (fig. 3) are located in the Eastern Lake Section of the Central Lowland Province (Knuth and others, 1981; Pennsylvania Department of Conservation and Natural Resources, 2000) (fig. 4). The region is north and west of the Appalachian Plateau Province. The escarpment marking the division between the provinces is visible from most areas of the coastal zone (fig. 5). Surface drainage is from the lowland north to Lake Erie and is locally controlled by glacial deposits. The physiography and topography are a function of geologic structure, bedrock strata, and Pleistocene glaciation (Knuth and others, 1981).

Bedrock exposures at the base of the bluffs in the coastal reach east of Presque Isle and locally west of Presque Isle (figs. 6 and 7) are of the Canadaway Formation, Middle Upper Devonian in age (Pennsylvania Department of Conservation and Natural Resources, 1990). The bedrock along the base of the bluff influences coastal processes in three ways. First, in areas of sand deficiency, precluding beach development, the bedrock exposures act as a natural seawall with respect to wave energy. The reflection of wave energy removes sediment from the nearshore and deposits it farther offshore (Knuth and others, 1981). As a result, sediment that might have been available is removed from the longshore transport system, exacerbating sediment deficits and precluding beach development. Second, exposures of bedrock in the zone of breaking waves promotes "plucking," which produces shingles from a few centimeters to 1 m in size. This eroding bedrock is an important source of siltstone gravels (Clemens, 1976). The capacity of the littoral transport system to move those shingles substantial distances is evidenced by the volume of shingles seen on Presque Isle Beaches, as much as several kilometers downdrift from the nearest bedrock exposures. The shingles tend to remain in the nearshore (fig. 7) as a result of the large grain size, providing material for beach building as they weather. Third, linear joints in the bedrock that are exposed to storm waves expand by hydraulic force to produce the incised or cusped morphology seen in the bluffs east of Presque Isle (fig. 8). On a larger scale, these incisions produce headland-cove morphology, and pocket beaches tend to form in the sheltered areas (Knuth and others, 1981). In most cases, the small pocket beaches are the only beaches along the reach from the City of Erie east to Six Mile Creek (fig. 3).

In this study bluff-retreat rates were averaged over a 68-year time period for the western portion of the area and over a 60-year time period for the eastern portion (fig. 3). Averaged rates of coastal change are frequently used in coastal-zone management and can provide information on the spatial distribution of regional bluff-retreat trends, but they provide little information on specific hazard zones because of the highly variable nature (both spatially and temporally) of coastal bluff-retreat process and response. The dominant influences on the temporal variation of coastal bluff retreat are related to weather variations (storm intensity and frequency), climate variations, and fluctuations in lake-water levels. Spatial variations in bluff retreat are related to the physical characteristics of the bluff-forming material (lithology and geologic structure) and anthropogenic impacts such as irrigation and the emplacement of protective structures. Because bluff retreat and rates of bluff retreat vary substantially in space and time, the averaged data presented in this report are not a good predictor of future annual change.

The coastline of Lake Erie is divided politically into seven townships and the City of Erie (fig. 3), which extend from Springfield Township in the west to North East Township on the east, next to the Pennsylvania-New York border. For the pilot study, bluff-retreat rates were assessed separately for two sections of coast, defined by the availability of 2006 versus 1998 lidar data. Wherever possible, the most recent data were used. However, no lidar data are available for 2006 for most of Harborcreek Township (8 of 11 km) and all of North East Township. This portion of the coastline is referred to in the discussion as the “eastern section,” and the rates presented are 60-year assessments, from 1938 to 1998. The end-point rate was used because there were only two dates of bluff edges available. The bluff-retreat rates for the western section, composed of the remaining five townships (Springfield, Girard, Fairview, Millcreek, and Lawrence Park) and 3 km of Harborcreek Township, are assessed over a 68-year time period, from 1938 to 2006. No bluff retreat data are presented for the City of Erie, as it is a heavily developed and engineered coastline with few measurable bluffs.

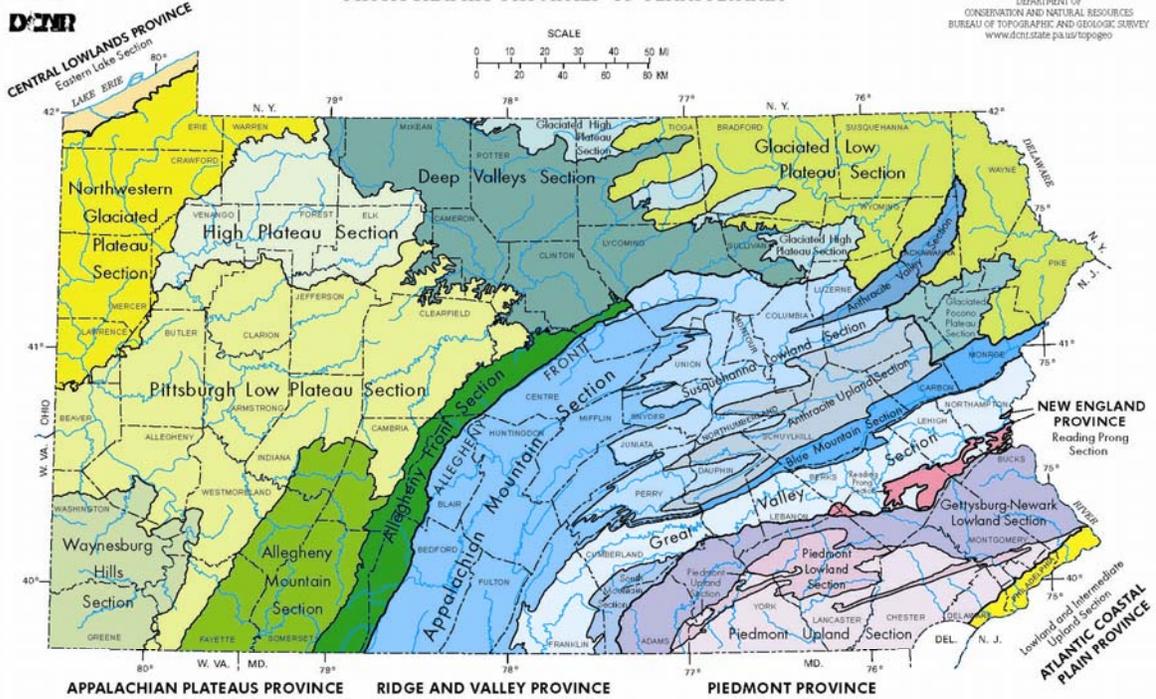
Figure 4. Map showing physiographic provinces of Pennsylvania. The bluffs of Lake Erie are in the upper northwestern corner of the state, in the Central Lowlands Province. (From Sevan, 2000)

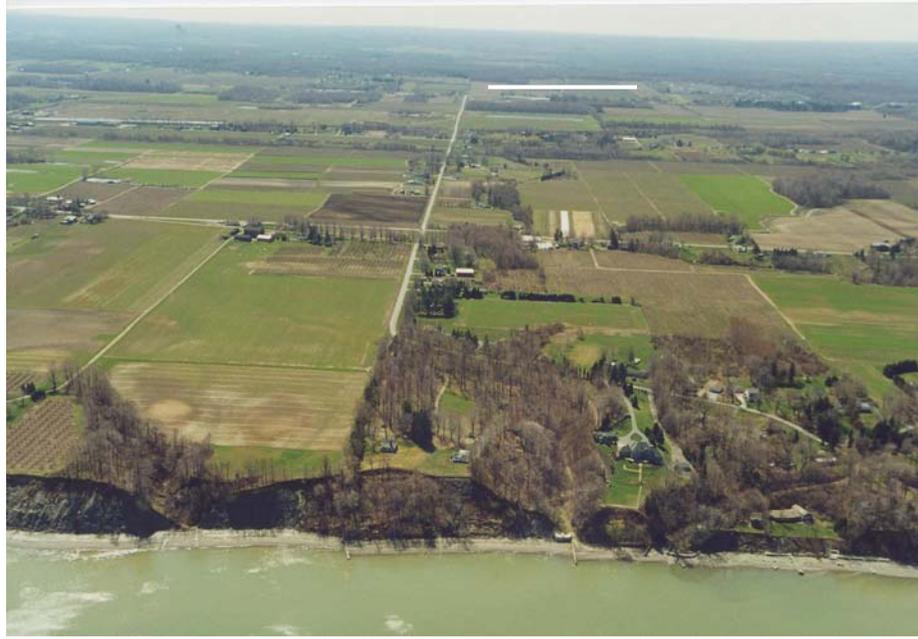
**Figure 5.** Oblique aerial photograph looking south from Lake Erie, Pa. The division between the Central Lowland Province and the Appalachian Plateau Provinces is demarcated by the dark tree line near the top of the photo (indicated by white line). Photograph from Pennsylvania Coastal Resource Management Program.

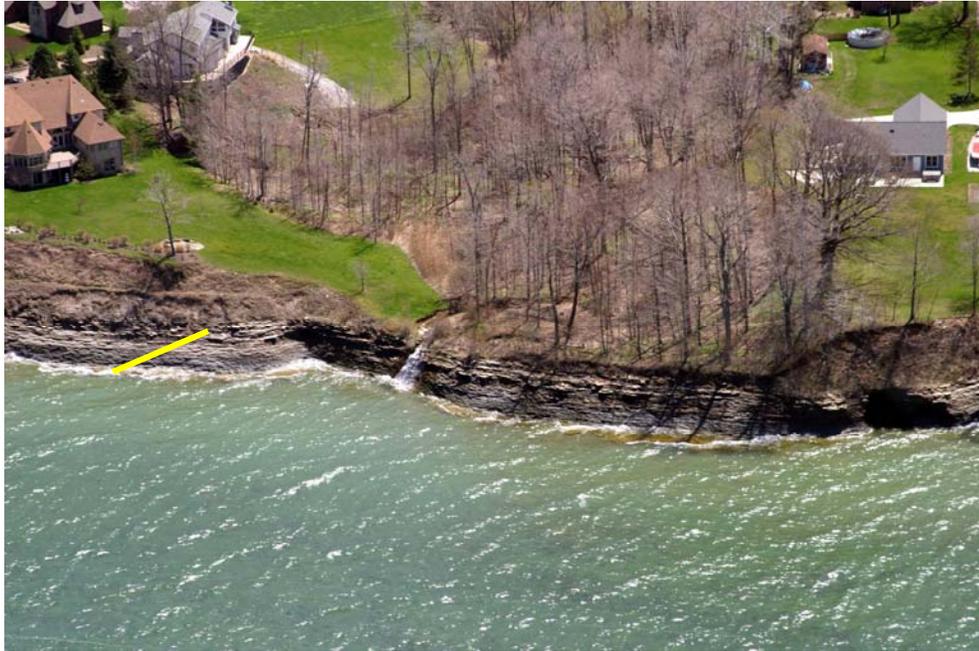
**Figure 6.** Oblique aerial photograph of bluffs in Harborcreek Township, Pa. (see fig. 3 for location). The base of the bluff in this location is exposed Devonian sandstone and shale, which is overlain by unconsolidated glacial deposits (contact indicated by yellow line). Bluff recession rates tend to be lower where the basal exposures are bedrock. Photograph from Pennsylvania Coastal Resource Management Program.

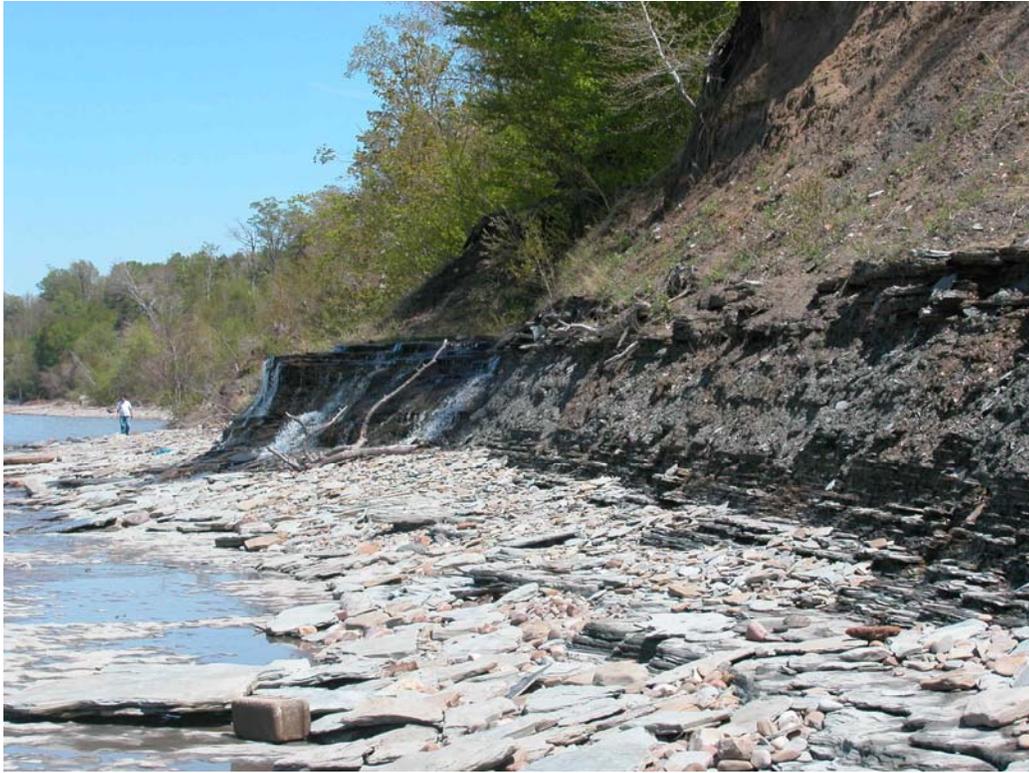
**Figure 7.** Photograph showing bedrock exposure in base of bluff and shingle beach near Presque Isle, Pa. Photograph from Pennsylvania Coastal Resource Management Program.

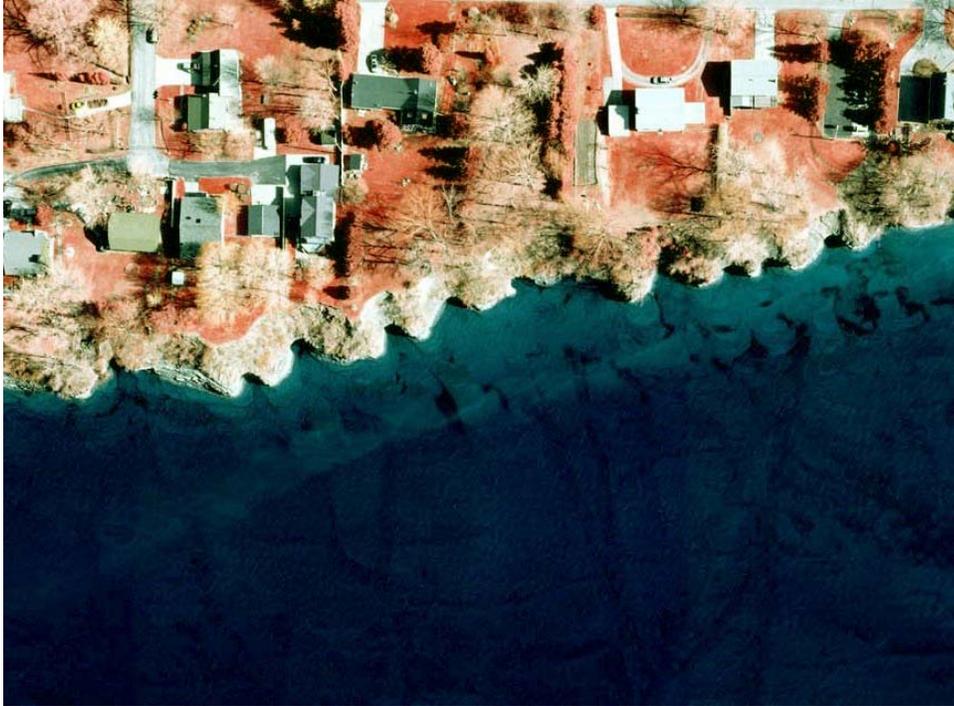
**Figure 8.** Aerial photograph showing headland-cove morphology formed in portions of the Lake Erie, Pa., bluffs in areas where jointed bedrock makes up the bluff face. The morphology can also be seen in the submerged portion of the bluff, where the jointing in the bedrock is also visible. Photograph from Pennsylvania Coastal Resource Management Program.

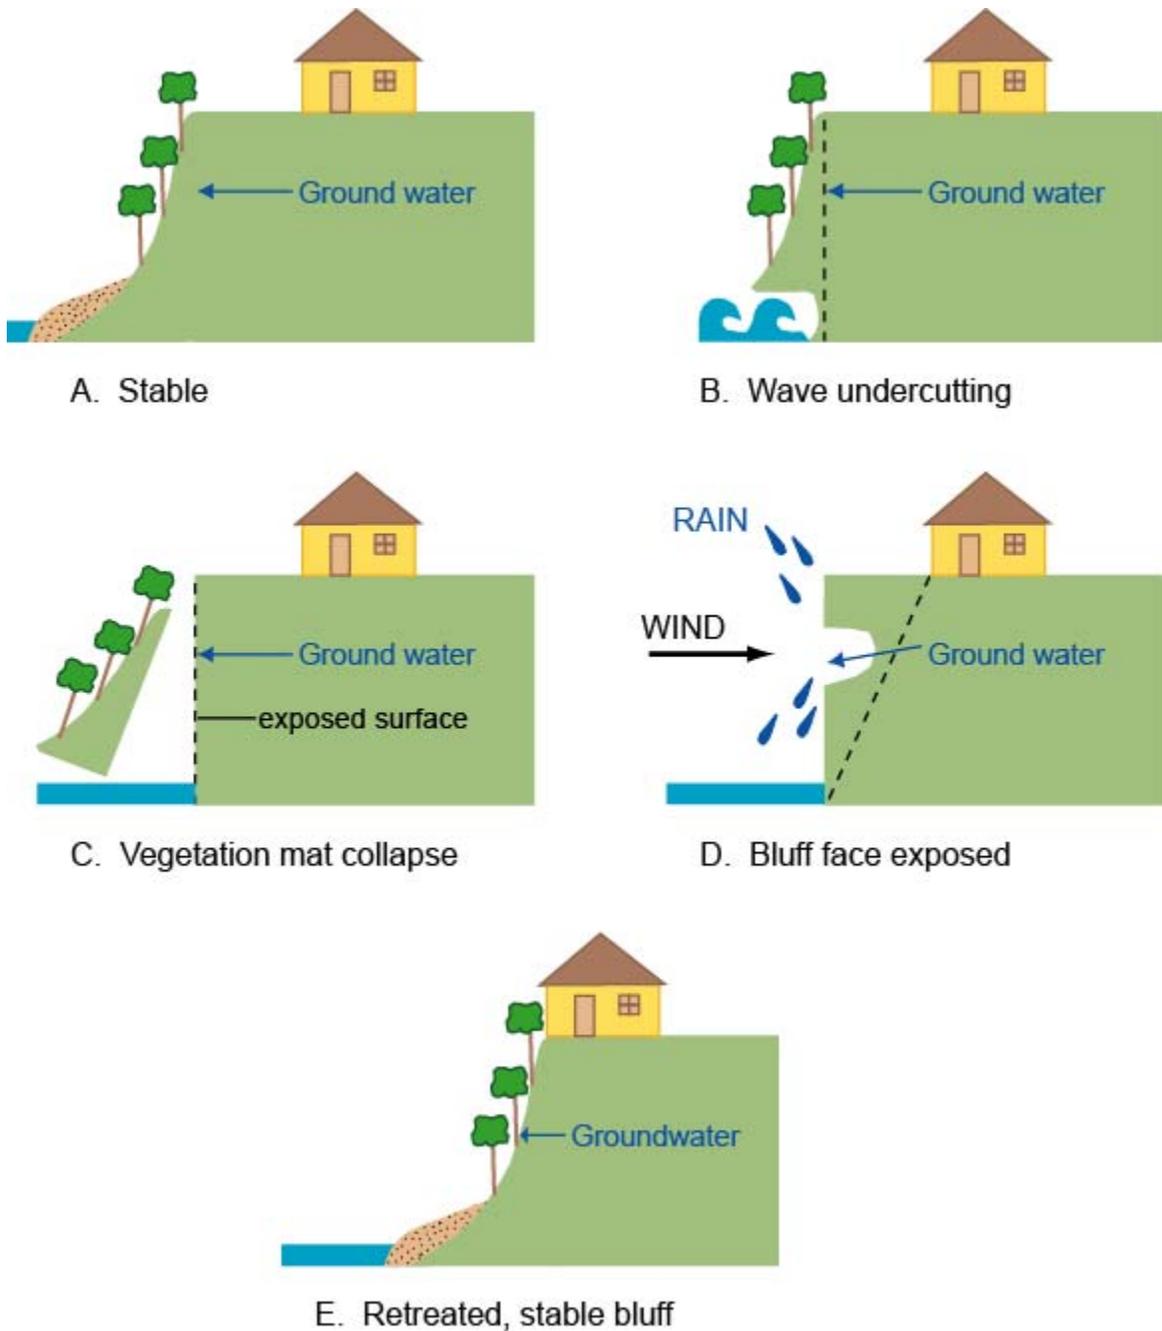
**Figure 9.** Schematic diagrams showing stages of bluff retreat unique to the Lake Erie, Pa., bluffs. **(A)** Bluff is in a stable condition; steep slopes are fully vegetated and vegetation is nourished by ample ground-water flows; residential structure is a safe distance from the bluff crest. **(B)** Wave contact at the base of the bluff undercuts the bluff face and creates instability for the now-unattached vegetation mat higher on the bluff face. **(C)** The bluff face, stripped of a protective vegetative mat, is increasingly susceptible to further erosion. **(D)** The unprotected and over-steepened bluff face is susceptible to the erosion processes of wind, rain, and ground-water flow. **(E)** The bluff slope retreats to an angle of repose, vegetation returns, and the bluff face is stabilized. However, bluff recession now has encroached close to the residential structure.

Pennsylvania's bluffs range in height from 1.5 to 60 m. Without wave contact at the base, bluffs are inherently stable, with only minimal loss of soil due to gravity-induced bluff creep, usually visible only at the bluff crest. Heavy ground-water flows exiting the bluff face between the lakeward tilted glacial till (clay) layer and permeable lacustrine sands and gravels supply adequate moisture to support trees and a dense mat of vegetative cover. The bluff consists mostly of a clay-rich glacial till and because the roots of the forested vegetation mat are unable to penetrate the clay substrate, the mat simply lies on the bluff face as a mat of roots and organic mass. There is a delicate balance between the root mat and the ground water, which exits the upper bluff face above the glacial till. The ground water moves down through the mat, nurturing vegetative growth. Within a healthy stabilized bluff, the ground water is completely absorbed into the root mat and the system is balanced (fig. 9a). When lake levels are high or during large storms, waves can reach the base of the bluff, causing extensive erosion of the unconsolidated soils and unprotected vegetation mat (fig. 9b). When the vegetation mat is removed from the base of the bluff, the upper areas of the bluff face become unstable, causing the upper vegetation mat to break apart, slip, and collapse in sections to the base of the bluff (fig. 9c). Wave erosion will continue to remove collapsed vegetation-mat sections until all debris is eroded from the base of the bluff. Steep bluff slopes denuded of vegetation are further susceptible to other erosion processes (ground-water flow, surface-water flow, wind, and rain) (fig. 9d) and will continue to recede landward until an angle of repose is established (fig. 9e).

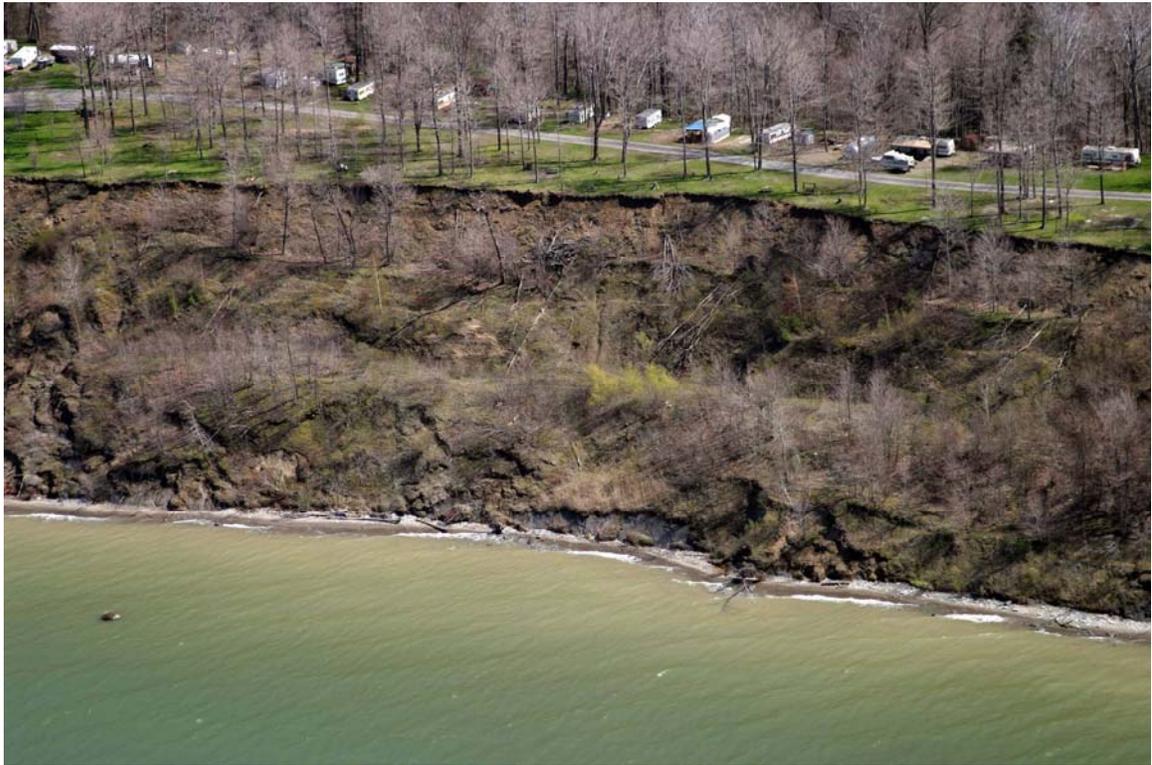
**Figure 10.** Photograph showing area of classic translational slope failure along coast of Lake Erie, Pa., where a relatively linear mass of bluff material separates and slides downslope. This type of slope failure is most common in bluffs composed of sand and silt. Photographs from Pennsylvania Coastal Resource Management Program.

In translational slides, the mass of soil progresses down and out along a more or less planar surface and shows no rotational or backward tilting characteristics of a slump (Varnes, 1978). Translational slides (fig. 10) tend to move as one mass, and the separation line is somewhat linear in appearance.

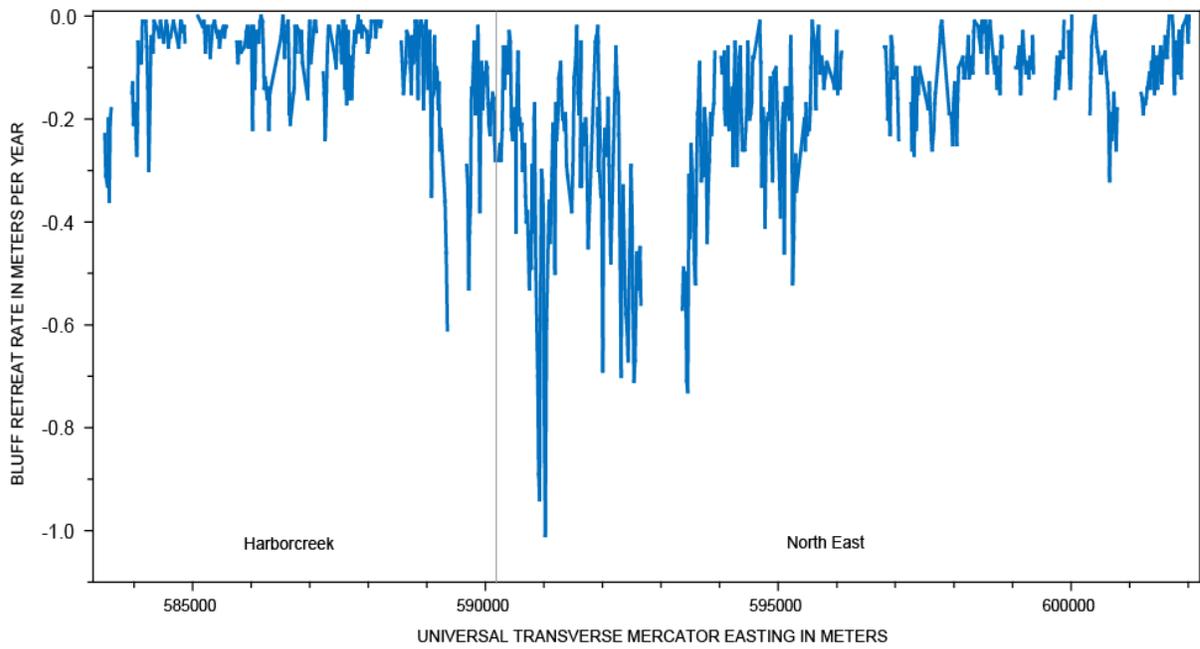
**Figure 11.** Bluff-retreat rates in the Eastern study section of the Lake Erie, Pa., coast, 1938-98. The average rate of recession in this section was  $0.2 \pm 0.1$  m/yr. The highest rate,  $1.0 \pm 0.1$  m/yr, was measured in the central portion of the section in a predominantly agricultural area.

For the eastern section of the Lake Erie, Pa., coastline, the average bluff-erosion rate was  $-0.2 \pm 0.1$  m/yr, which is equal to an average retreat of 12 m over the 60-year time period of the analysis (table 1). The eastern section is 22 km in length but because there are many data gaps, retreat rates were calculated along only 4.7 km. The rates of bluff retreat are highest in the central portion of the section, where the maximum rate of  $-1.0 \pm 0.1$  m/yr was measured (fig. 11). The highest rates are found along a stretch of coast in the western 6 km of North East Township. The actively eroding bluffs (fig. 2) are in areas where the land use on the top of the bluff is predominantly agricultural, suggesting that irrigation may, in part, be responsible for the higher rates. The active bluffs, slump deposits, and headscarps are readily visible on Google Earth satellite imagery (<http://earth.google.com/>).

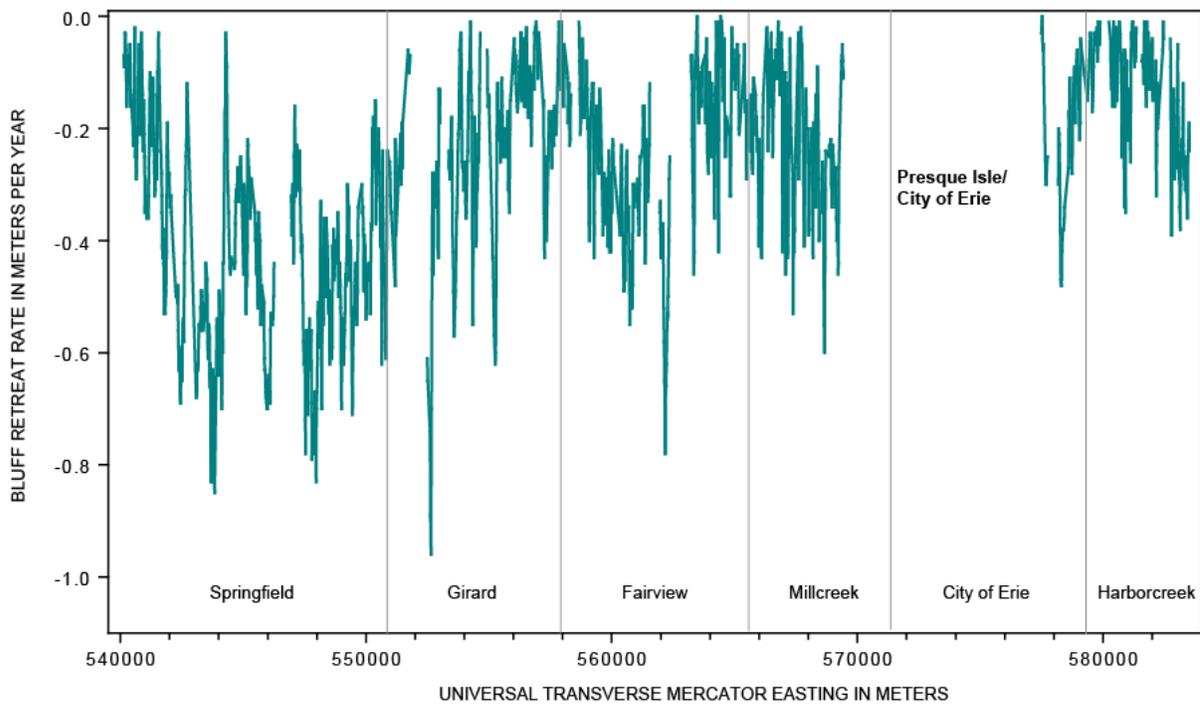
**Figure 12.** Bluff-retreat rates in the Western study section of the Lake Erie, Pa., coast, 1938-2006. The average rate of recession in this section was  $0.3 \pm 0.1$  m/yr. The highest rate,  $1.0 \pm 0.1$  m/yr, was measured in the central portion of the section in a predominantly agricultural area.

The western section is a total of 40 km in length along which 68-year bluff-retreat rates were generated for 27 km of coast. There is a large data gap extending from Presque Isle in Millcreek Township to the eastern boundary of the City of Erie (fig. 3). The average rate of bluff retreat in the western section is  $-0.3 \pm 0.1$  m/yr (table 1), and rates are consistently higher west of Presque Isle (fig. 12). The highest rate in the western section,  $-1.0 \pm 0.1$  m/yr, is in western Girard Township just east of several groins. Additionally, a large portion of the Springfield Township bluffs has high rates of retreat (0.6–0.8 m/yr). Predominant littoral transport rates along the Lake Erie, Pa., coast are east to west. The higher rates of erosion in these areas are likely related to the impoundment of littoral sediment behind the nearby upcoast Conneaut Harbor jetties and, more locally, groin fields. The trapping of these sediments essentially eliminates the source of protective beach material for the downcoast bluffs. The trend of lower erosion rates with distance from the harbor jetties is additional support for the influence of the jetties on the coastal system.
