# Geological Impacts and Sedimentary Record of the February 27, 2010, Chile Tsunami—La Trinchera to Concepcion

Open-File Report 2010–1116

U.S. Department of the Interior  
U.S. Geological Survey

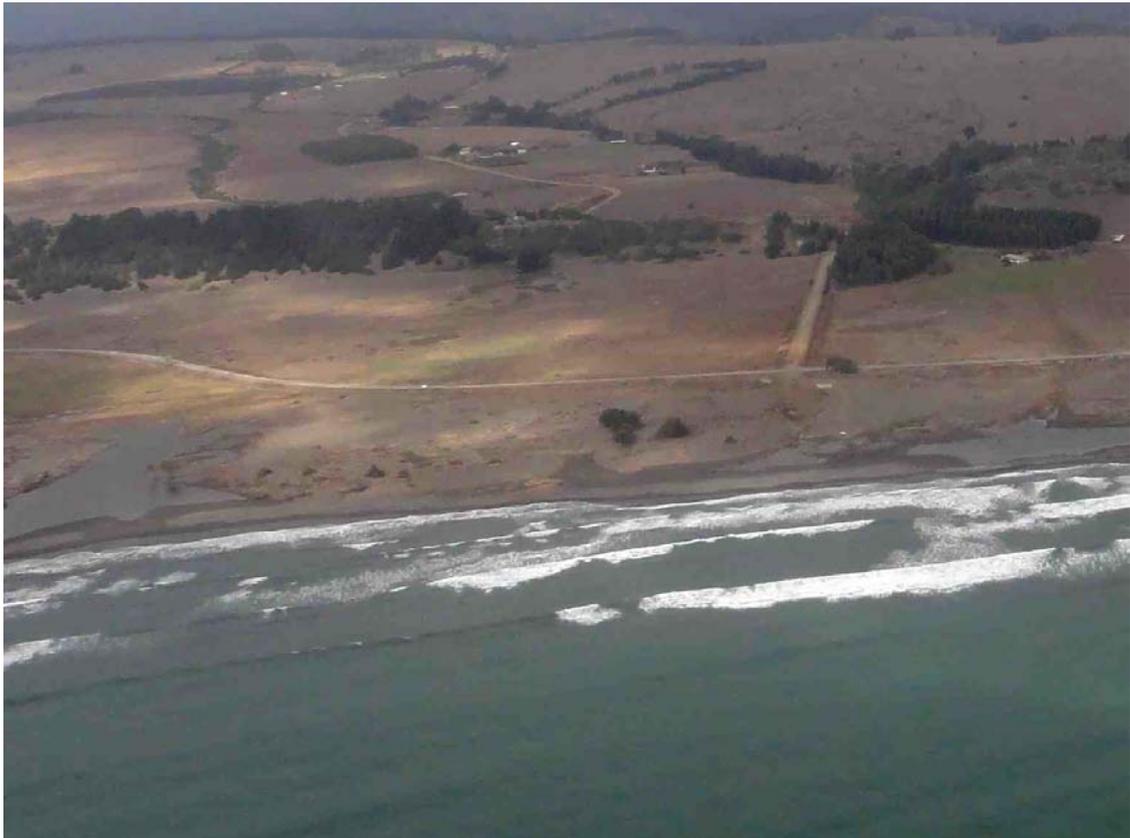
**Figure 2** Post-tsunami oblique photograph of the La Trinchera study site taken on April 5, 2010, by the UNESCO team.

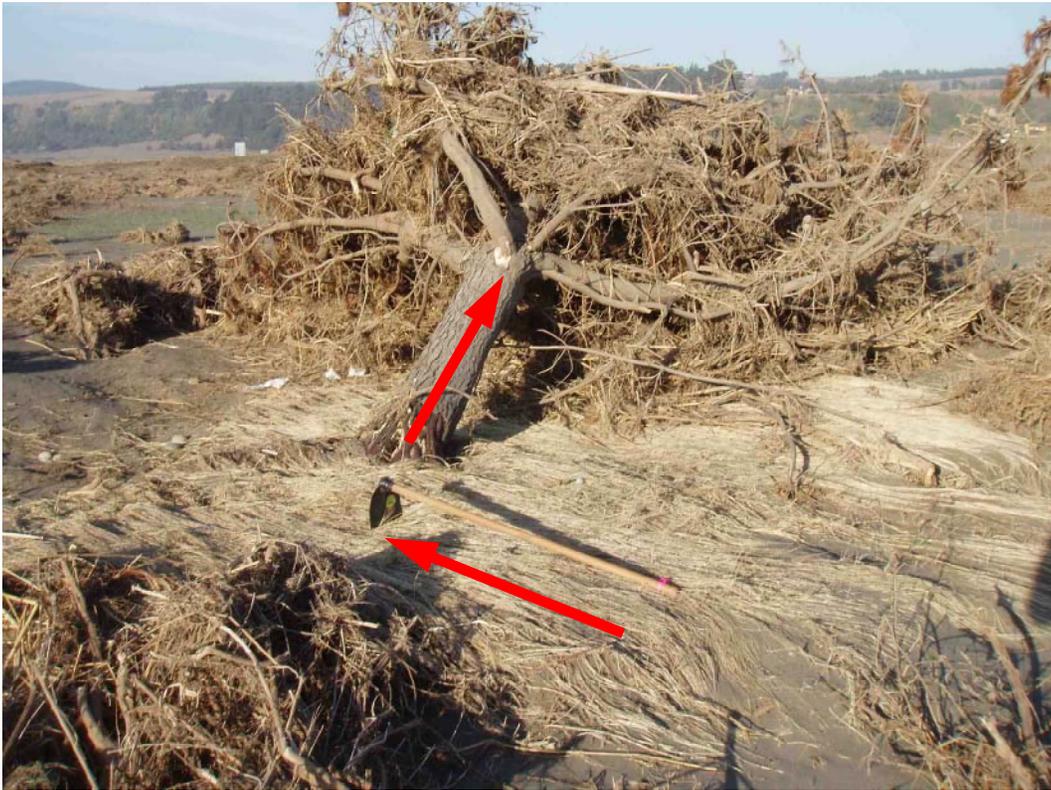
**Figure 3.** Sequential flow directions (red arrows) at La Trinchera indicate multiple strong onshore flows from waves approaching from different directions. View toward the east

*Significant Observations.*—The superposition of bent but still rooted trees, bushes, and grass, plus the distribution of trapped debris, indicated multiple strong onshore flows from waves approaching from different directions (fig. 3). An eyewitness interviewed by another team reported that the first wave came from the west, whereas a later wave came from the southwest (Patricio Winckler, oral commun., 2010). The flow-direction history derived from superposition of bent vegetation is consistent with the eyewitness account. An extremely large volume of sand was eroded from the subaerial sand bar, greatly reducing its width. After the tsunami, the shoreline was located near the former seaward edge of the lagoon. Trees along a low sand ridge were excavated around the roots and removed from the ridge, leaving an irregular erosional scarp on the landward side of the ridge (fig. 4). The limit of inundation was on a low slope near the landward margin of the coastal plain. The inland limit of sand deposition was substantially less than the limit of tsunami inundation.

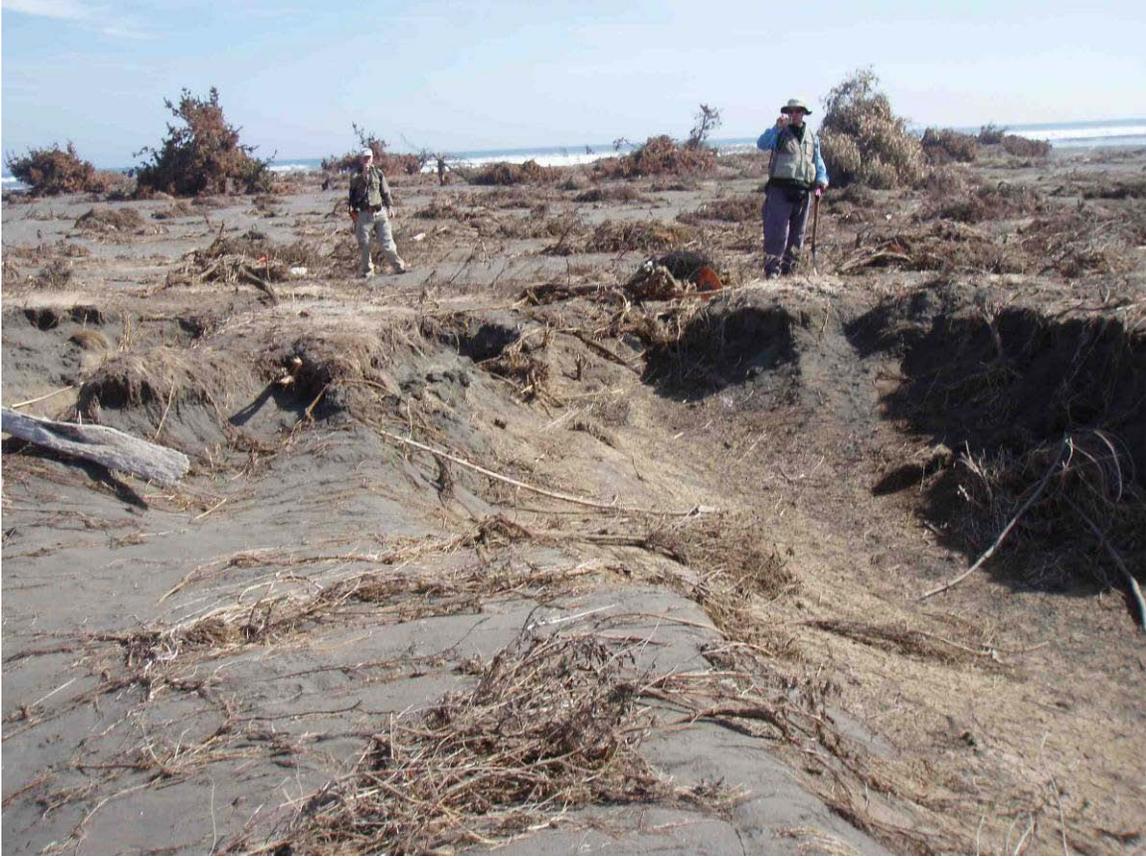
**Figure 4.** Landward side of a coastal dune ridge at La Trinchera, showing the erosional scarp left after the tsunami removed entire trees from the ground, leaving only a few roots as evidence. Maximum vertical erosion of the surface was 1.2 m.

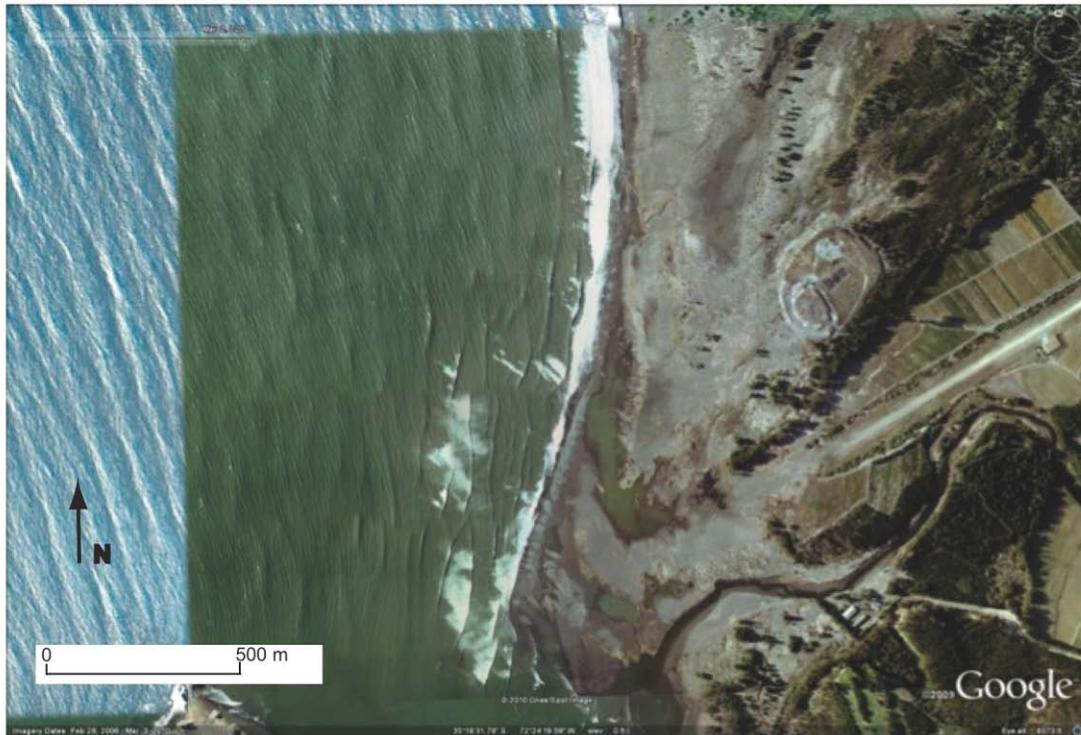
**Figure 5.** Google Earth image of the Constitución study site near Rio Maule taken 3 days after the tsunami.

*Geologic Setting.*—The mouth and delta plain of Rio Maule (fig. 5), where sediment supply was abundant. Prominent morphological features included a broad gravel and sand beach, a wide ramp that was covered with planted trees before the tsunami, and, farther inland, vegetated sand-dune ridges forming the highest elevations near the shore.

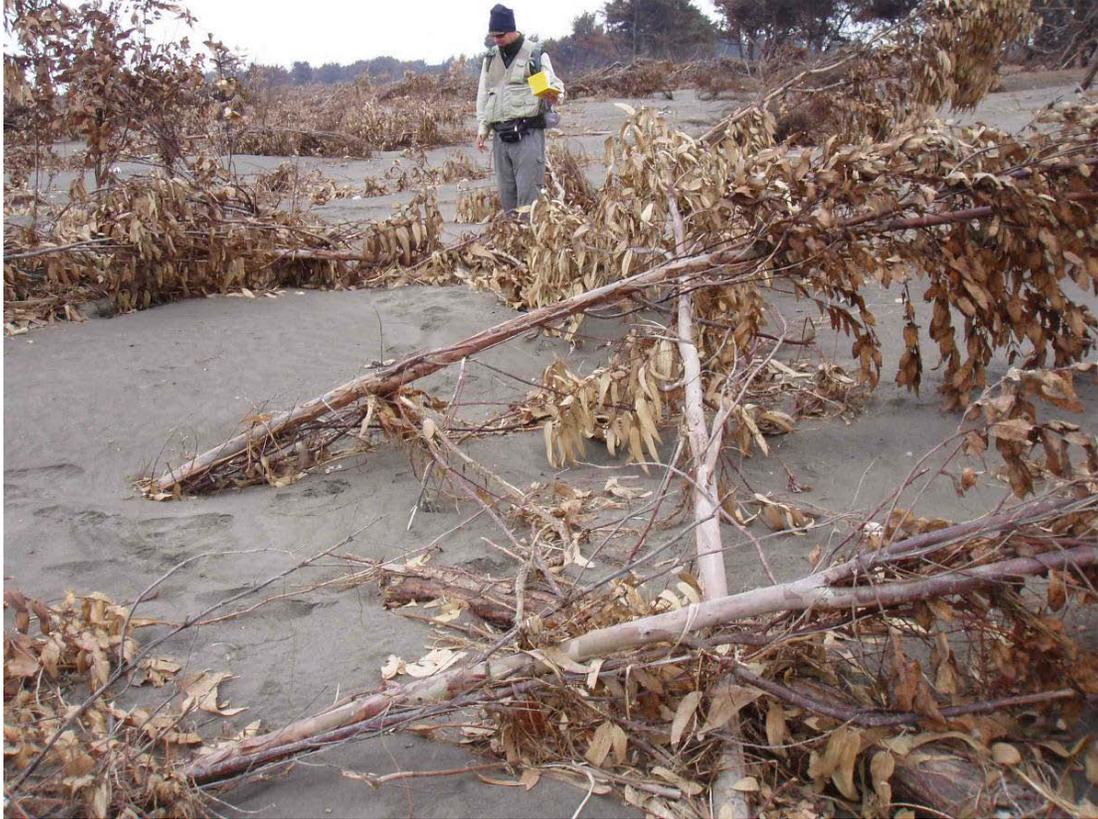
**Figure 6.** Field evidence at Constitution indicates flow during multiple waves approaching from different directions. View is toward the northeast.

*Significant Observations.*—Flow-direction indicators show that tsunami flow patterns were complex and included strong onshore flow from multiple waves (fig. 6). There were large changes in land elevation due to vertical erosion (110 cm maximum, fig. 7) and deposition (93 cm maximum, fig. 8). Mud boulders, as large as 70 cm in diameter, were excavated and deposited inland more than 350 m from the shore. A broad zone of

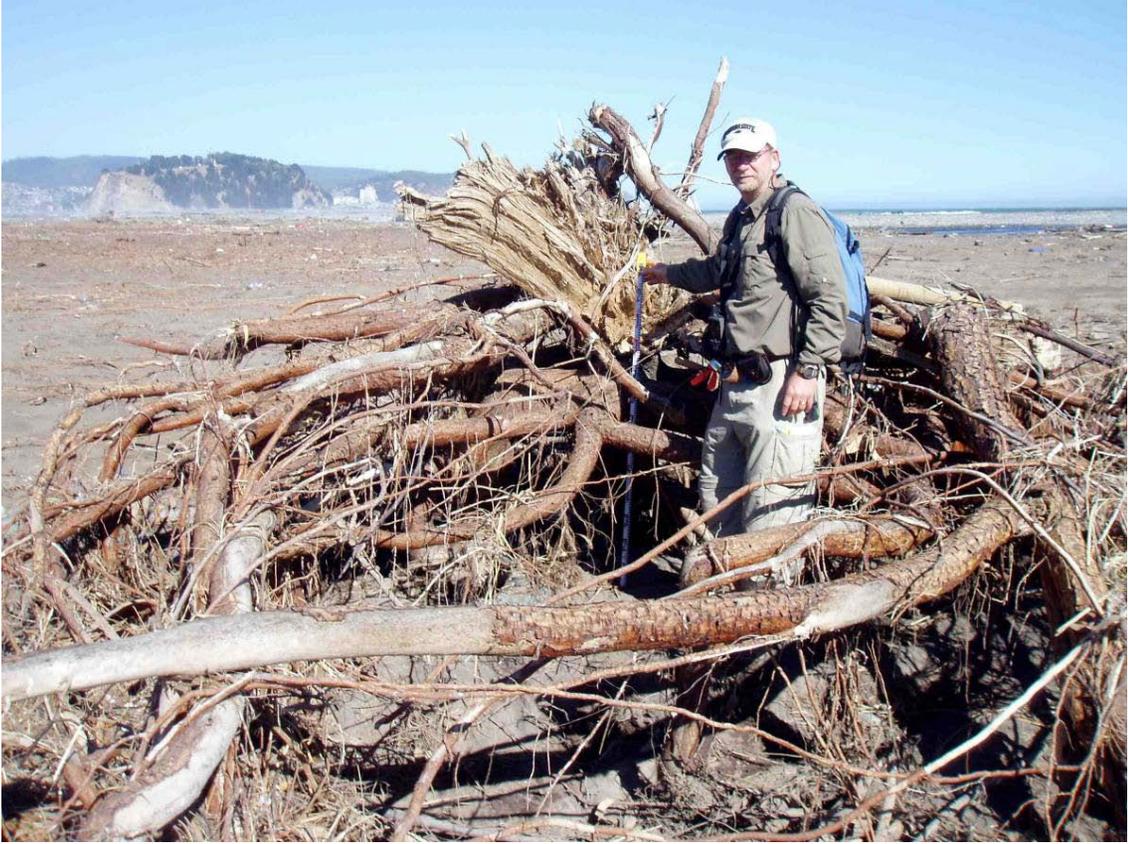
**Figure 7.** Exposed roots of this former pine tree show that the tsunami caused at least 110 cm of vertical erosion of the coastal plain at Constitucion.

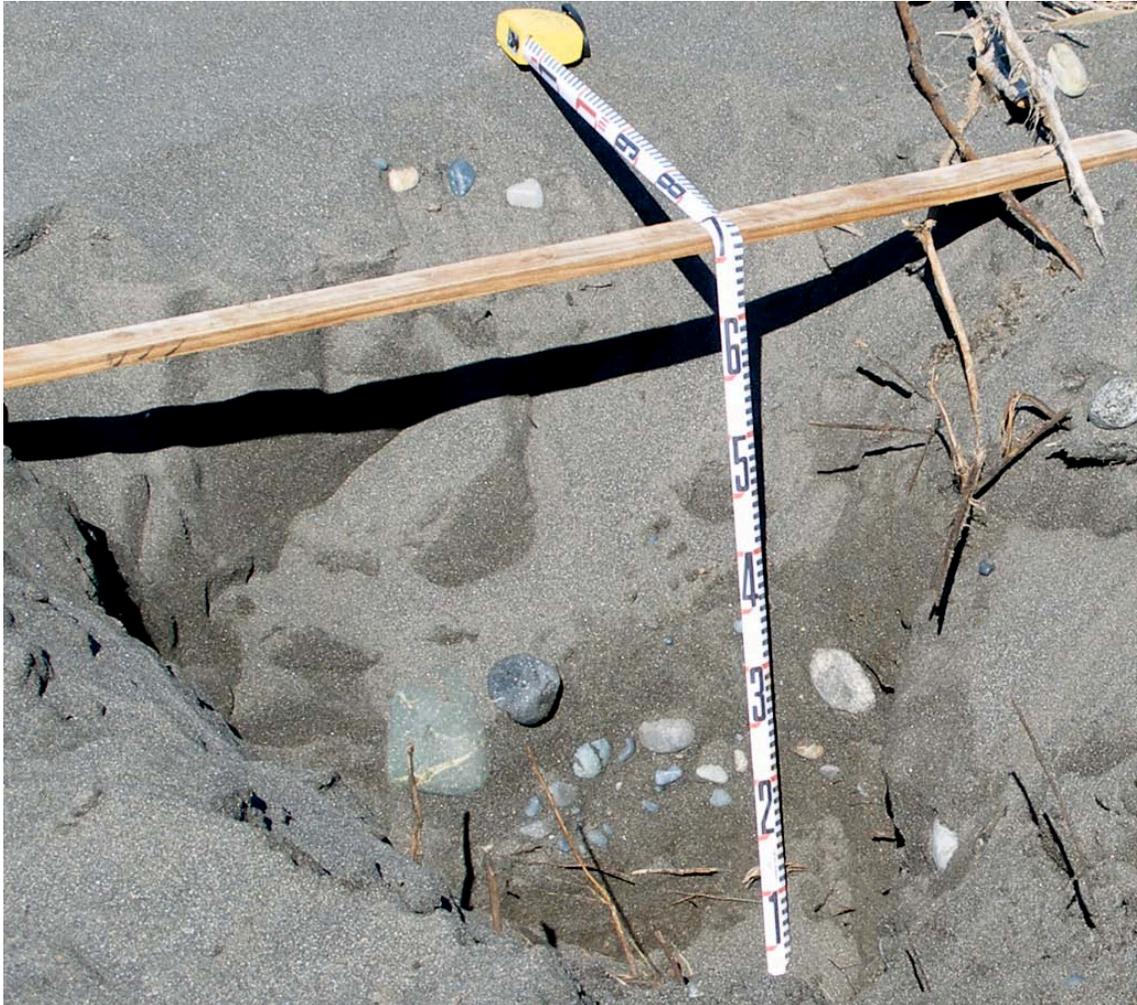
**Figure 8.** Tsunami sand and cobble deposit 73 cm thick at Constitution.

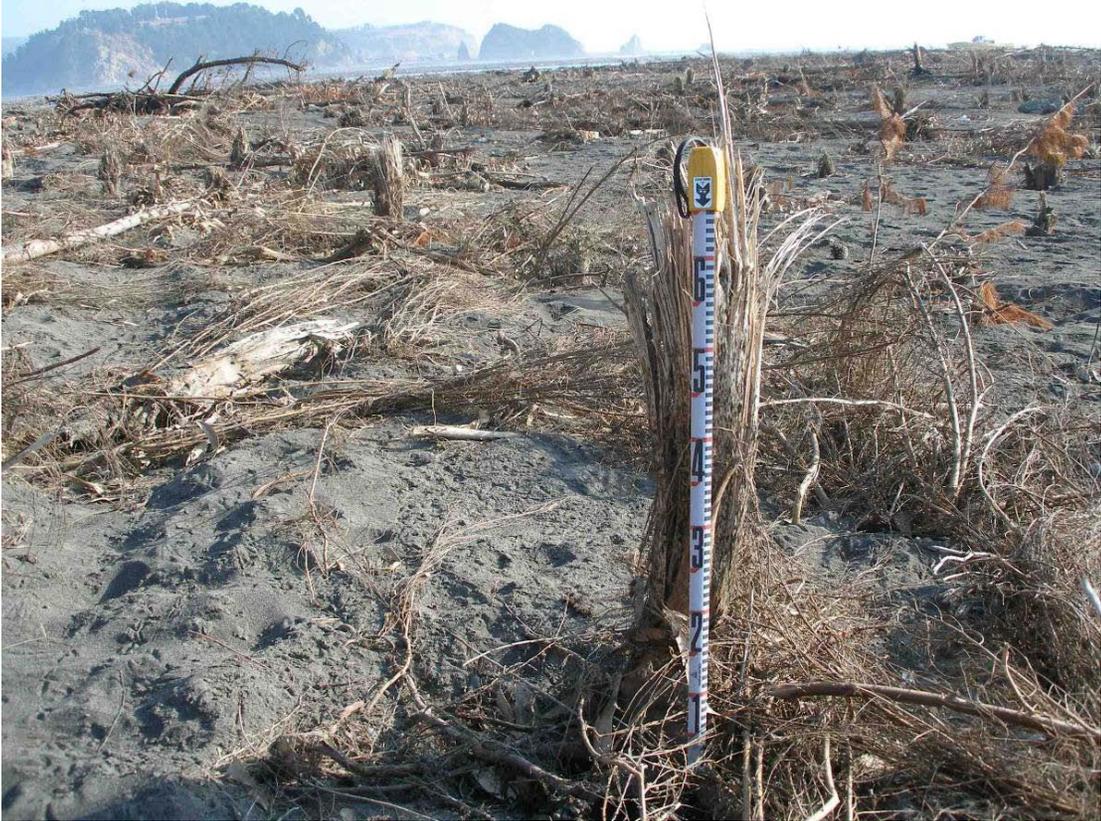
**Figure 9.** Splintered stumps of planted eucalyptus and pine trees destroyed by the tsunami at Constitucion. View is south toward the mouth of Rio Maule.

sand deposition extended inland to the limit of tsunami inundation. Where it was unprotected by vegetation, eolian processes were modifying the surface of the tsunami sand deposit. Sedimentary structures in a small field of large (6 to 8 meter wavelength) low-amplitude bedforms were constructed on the northern margin of a low ridge, indicating that some deposition occurred during the return flow. The basal contact of the tsunami deposit was variable and at some trenches included delta-plain mud and at others a soil with in-place grass. The limit of inundation was influenced by steep slopes and dense vegetation, with the greatest inundation limit near the landing strip where there were no dunes. The tsunami destroyed planted areas of eucalyptus and pine trees that occupied much of the area seaward of the sand-dune ridges (figs. 6, 7, and 9).

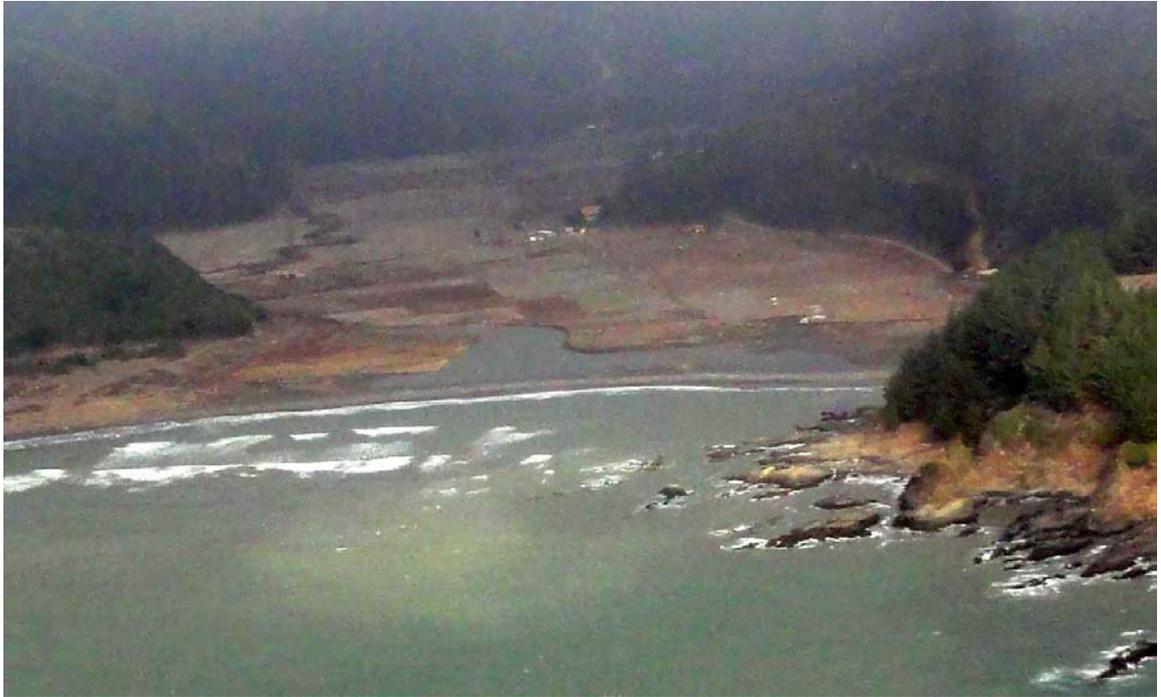
**Figure 10.** Post-tsunami oblique photograph of the Purema study site taken on April 5, 2010, by the UNESCO team.

*Geologic Setting.*—A coastal embayment and pocket beach bounded by rocky headlands and fronting an alluvial valley that is partly filled by a small meandering stream (fig. 10).

*Significant Observations.*—There was a broad zone of beach and coastal plain erosion extending inland from the shore (fig. 10). Sand deposits near the inland limit of erosion were relatively thick (15 cm, fig. 11). The tsunami deposits contained multiple layers of laminated sand with both coarse and fine textures (fig. 11). The surface of the tsunami deposit was unprotected and undergoing modification by eolian processes driven by strong winds. The limit of tsunami inundation was on a low gradual slope.

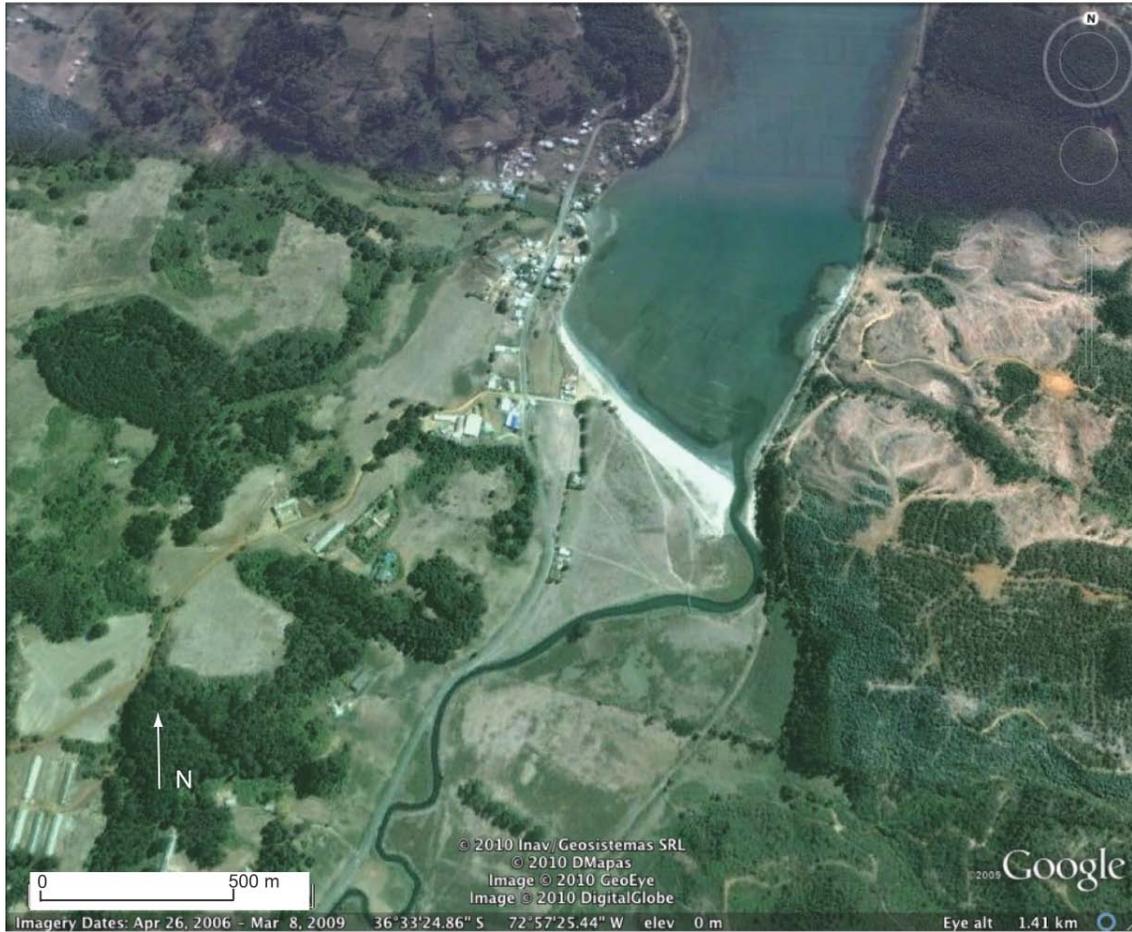
**Figure 12** Pre-tsunami Google Earth image of the deeply embayed Coliumo study site. The open coast is approximately 3 km to the north-northeast of the top of the figure.

*Geologic Setting.*—A moderately deep coastal embayment containing a pocket beach bounded by rocky headlands and fronting an alluvial valley that is partly filled by a small river (fig. 12).

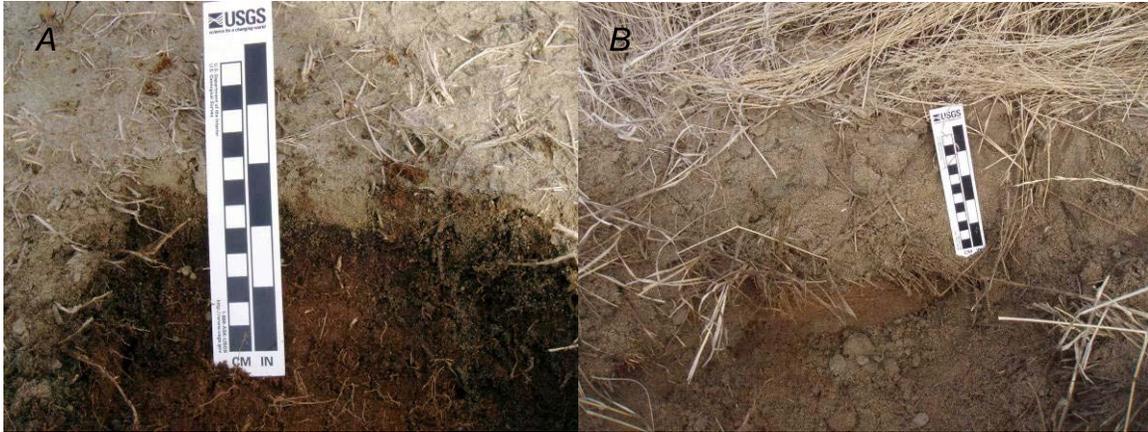
**Figure 13.** Comparison of thicknesses of tsunami sand deposited in (A) low, thin, sparse, vegetation and in (B) tall, thick clumps of dense vegetation at the Coliumo site.

tsunami sand deposits were partly controlled by vegetation density and flow depth. In general, sand was thinner where vegetation was low or sparse (fig. 13A) and thicker where vegetation was high and dense (fig. 13B). Also, sand thicknesses increased along the valley margin, where flow depths decreased and flow decelerated. Sand deposits extended inland to near the limit of inundation. Major bank failure along the small river increased the stream width (fig. 14) and, in conjunction with the tsunami removing failed banks, altered the channel morphology (width/depth ratio).

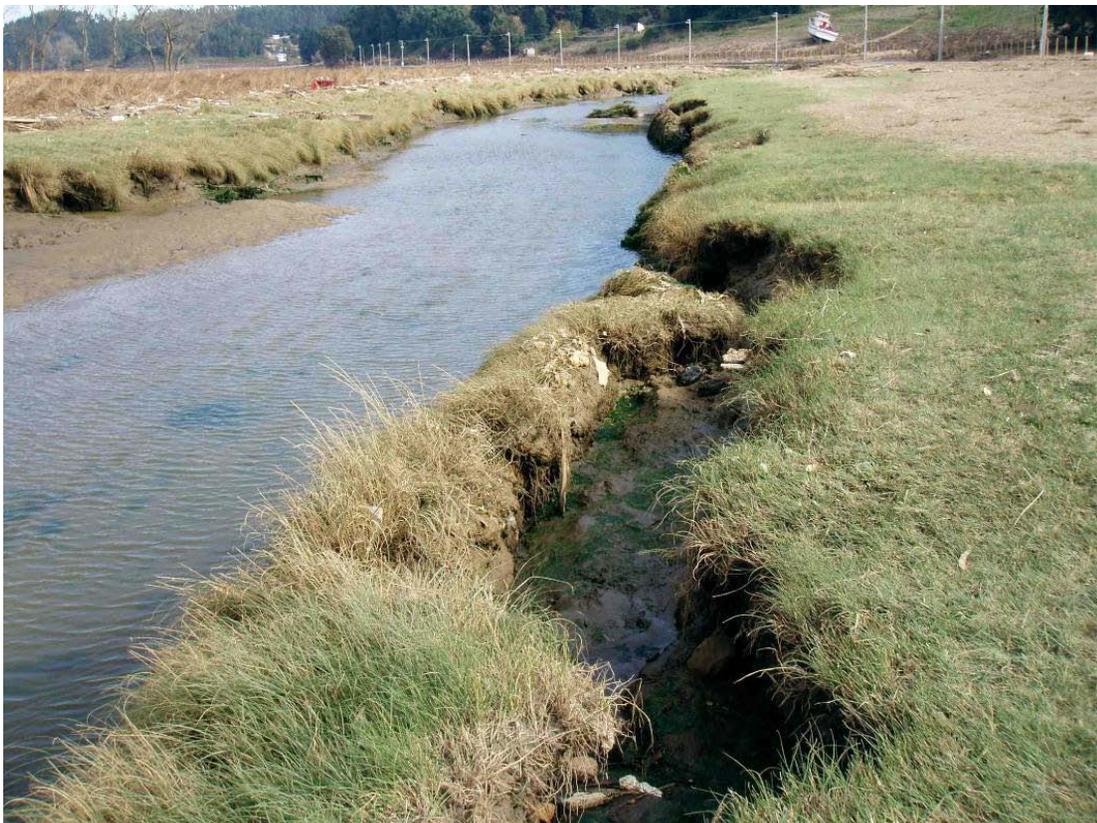
**Figure 14.** Bank failure abruptly widened the small river at Coliumo.

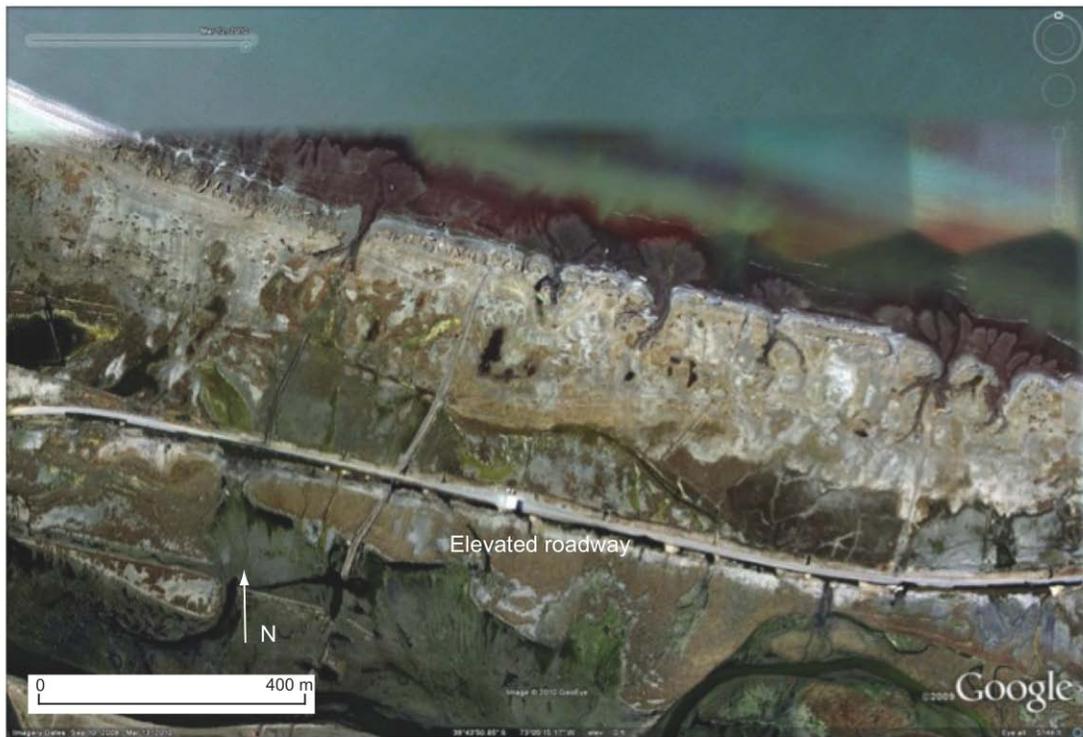
**Figure 15.** Google Earth image of the Talcahuano study site taken 13 days after the tsunami. Note large return-flow incised channels and ebb-flow deltas.

*Human Modifications.*—An unpaved road and landfill where the dunes would naturally form at the shore artificially increased elevations, partly blocking the tsunami inundation and increasing the depth of channel incision by the return flow (figs. 15 and 16). An elevated roadway (fig. 15) caused a flow disturbance, possibly a hydraulic jump on the landward side, that scoured a road-parallel trench that was the source of mud boulders deposited in the adjacent marsh (fig. 17).

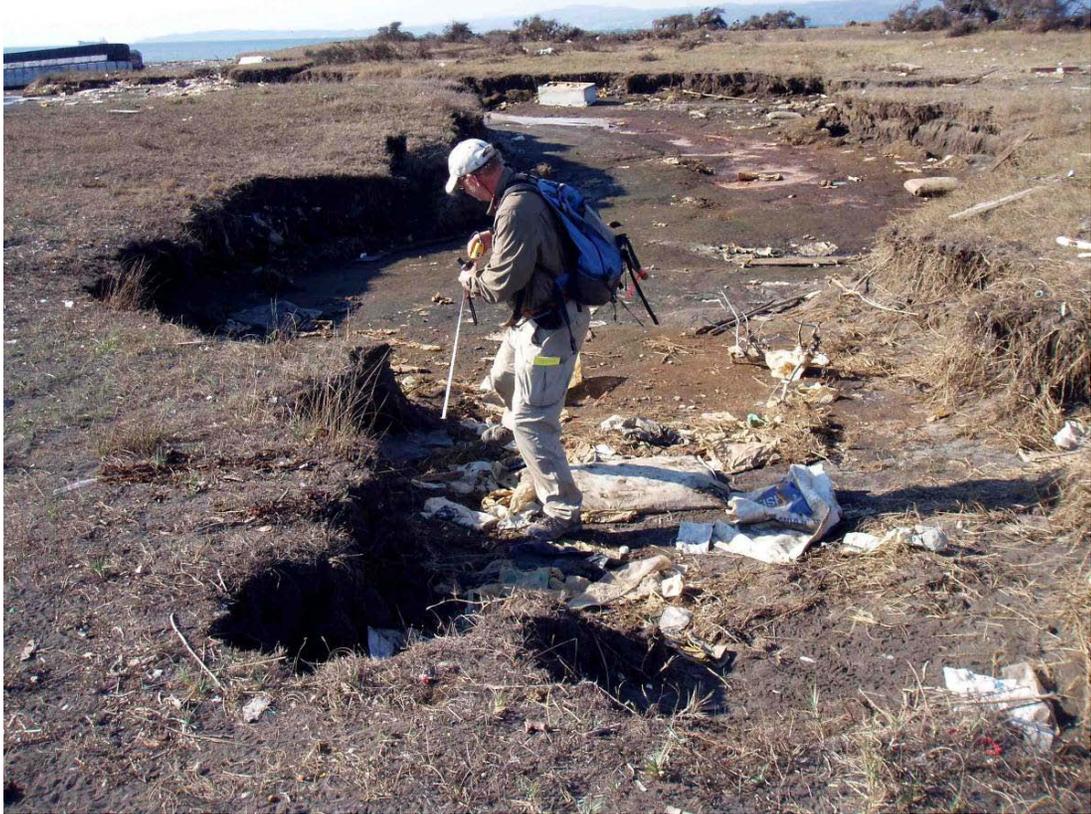
**Figure 16.** Inland limit of erosion of return-flow incised channel at Talcahuano.

*Significant Observations.*—An erosional scarp formed along the dune/unpaved road berm, but retreat of the shoreline was not significant. The headward erosion of the return-flow channels (fig. 16) extended landward about 100 m from the shore. At the time of field observations, the small ebb deltas deposited at the mouths of the return-flow channels (fig. 15) were being reworked and eliminated by normal wave action in Bahia de Concepcion. Landward of the artificial berm was a broad zone of thin sand deposits that coincided with a prior overwash zone. The thickest tsunami sand deposits were landward of the elevated roadway, and sand deposits extended to near the limit of inundation. Some cobbles were transported far inland and deposited on the marsh vegetation of the pre-tsunami surface and at the base of the tsunami sand deposit (fig. 18).

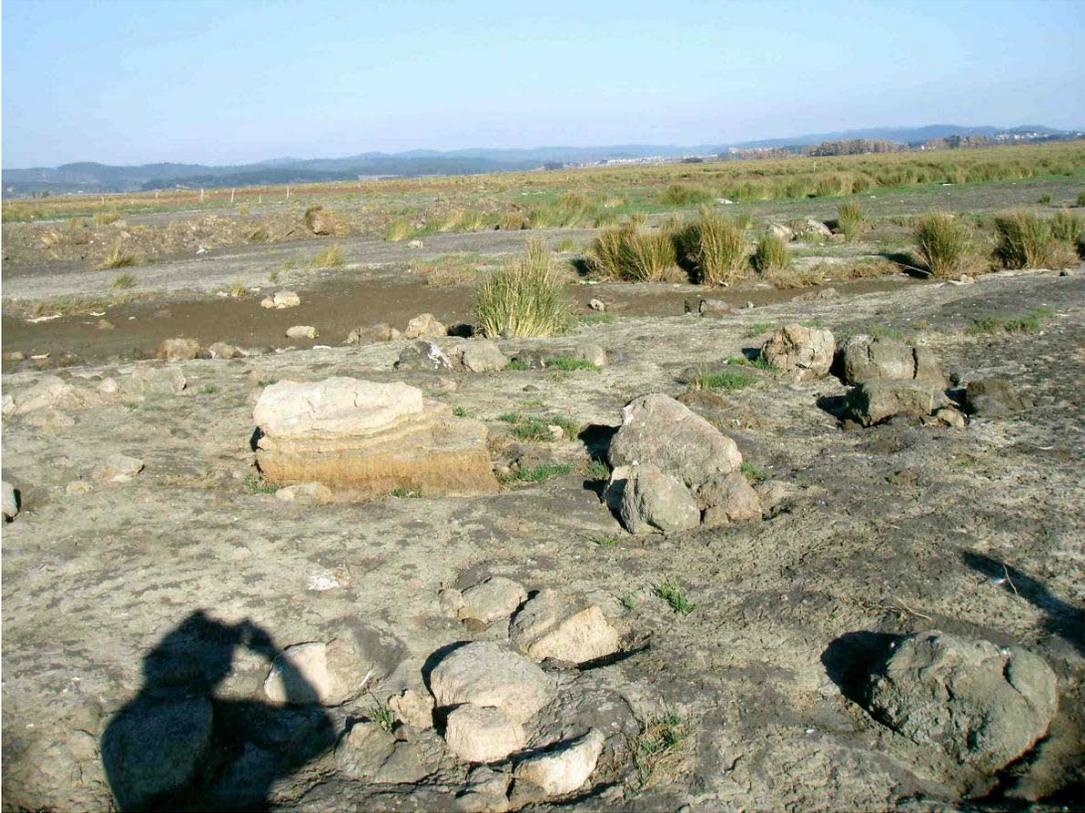
**Figure 17.** Field of small mud boulders at Talcahuano excavated from a scour trough on the landward side of the elevated highway (out of view to the rear). The trough was eroded by accelerated flow over the roadway during tsunami inundation. View looking inland.

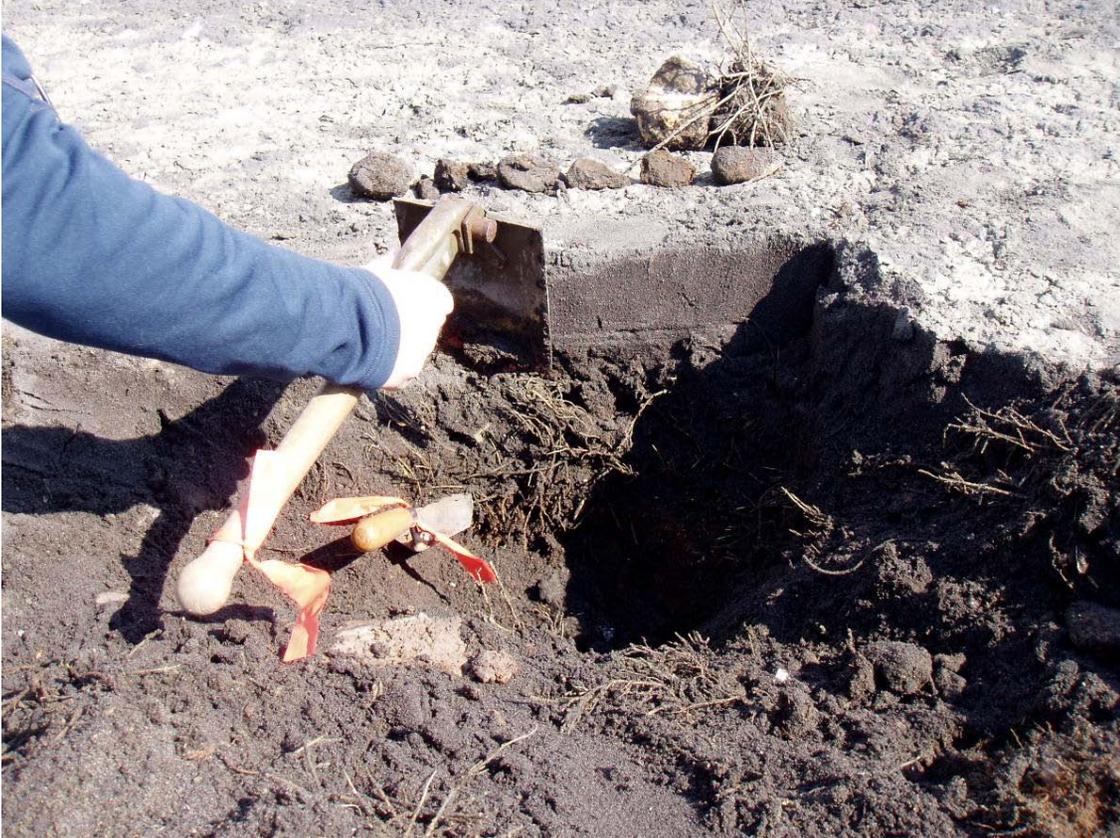
**Figure 18.** Tsunami deposit at Talcahuano 24 cm thick, consisting of sand with cobbles at the base, overlying the grass and soil of the pre-tsunami surface (trowel).
