Prepared in cooperation with Hinsdale County, Colorado

Postwildfire Debris-Flow Hazard Assessment of the Area Burned by the 2013 West Fork Fire Complex, Southwestern Colorado

Open-File Report 2013–1259

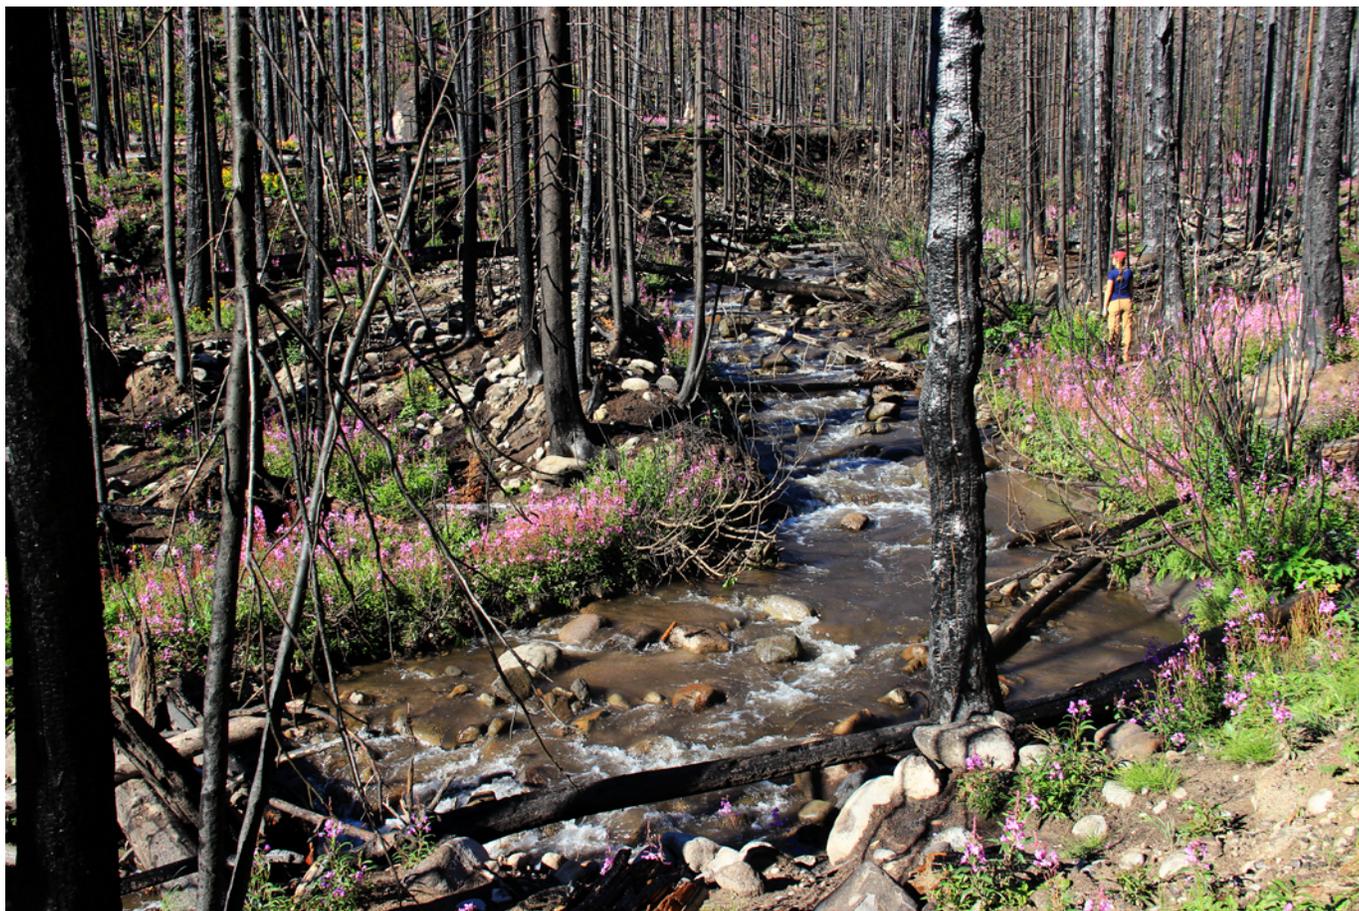
Cover photograph: Hope Creek, looking upstream, about 0.40 kilometers upstream from forest road crossing. (photograph by Michael Stevens, U.S. Geological Survey, September 2013)

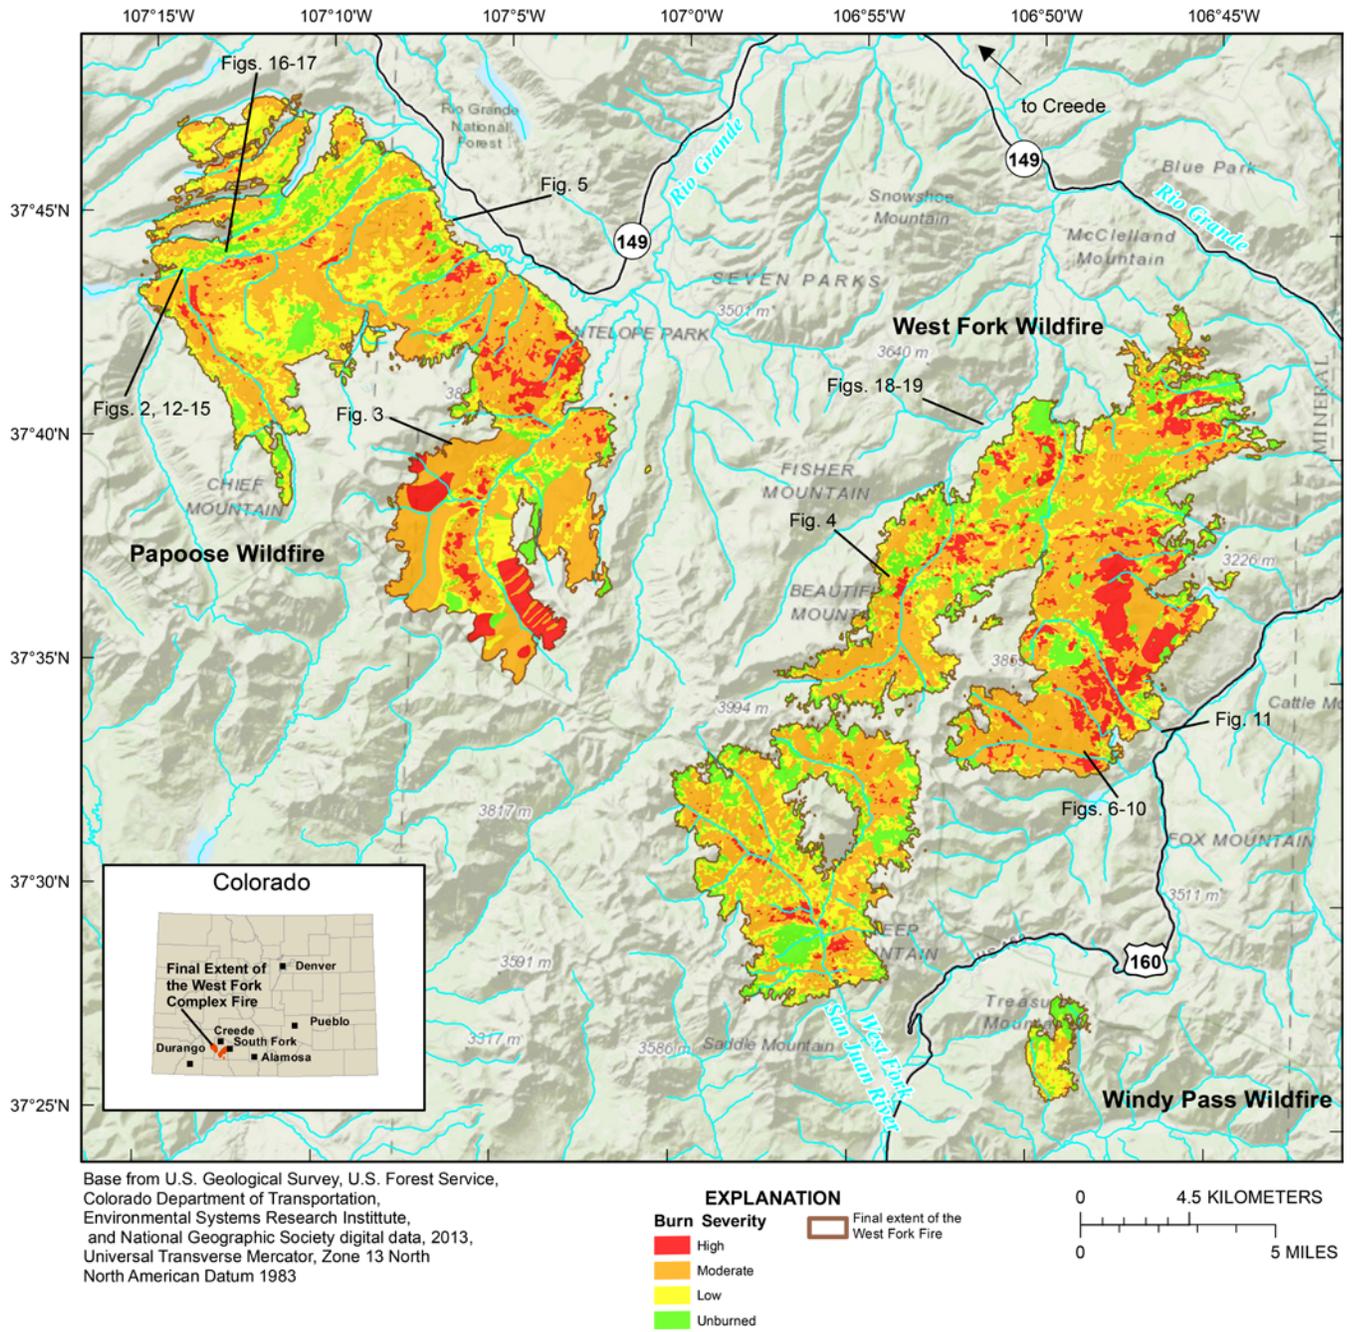
Figure 1. Location map with burn severity and locations of photographs in figures 2 through 19.

Areas where field reconnaissance was not possible were evaluated using prewildfire aerial photography and are shown in figures 2–5 and identified on figure 1. Figure 2 shows fan structures at the mouth of both Squaw and Little Squaw Creeks at the Rio Grande. Figure 3 shows a reach of upper Trout Creek and basin 19 and sediment erosion areas, which has an estimated debris-flow probability of 64 percent and debris-flow volume of 14,000 cubic meters in response to a 25-yr recurrence storm. Two fan structures, which may be alluvial or debris-flow deposits also are shown on figure 3. Figure 4 shows a reach of Goose Creek upstream from Lake Humphreys (plates 1–3) that contains erosion source areas for the fan deposits at the mouths of small tributary drainages. Figure 5 shows several fan deposits at the mouths of various watersheds between the mouths of Texas and Workman Creeks. Again, there is no direct evidence that wildfire was involved in the events that created these fan deposits.

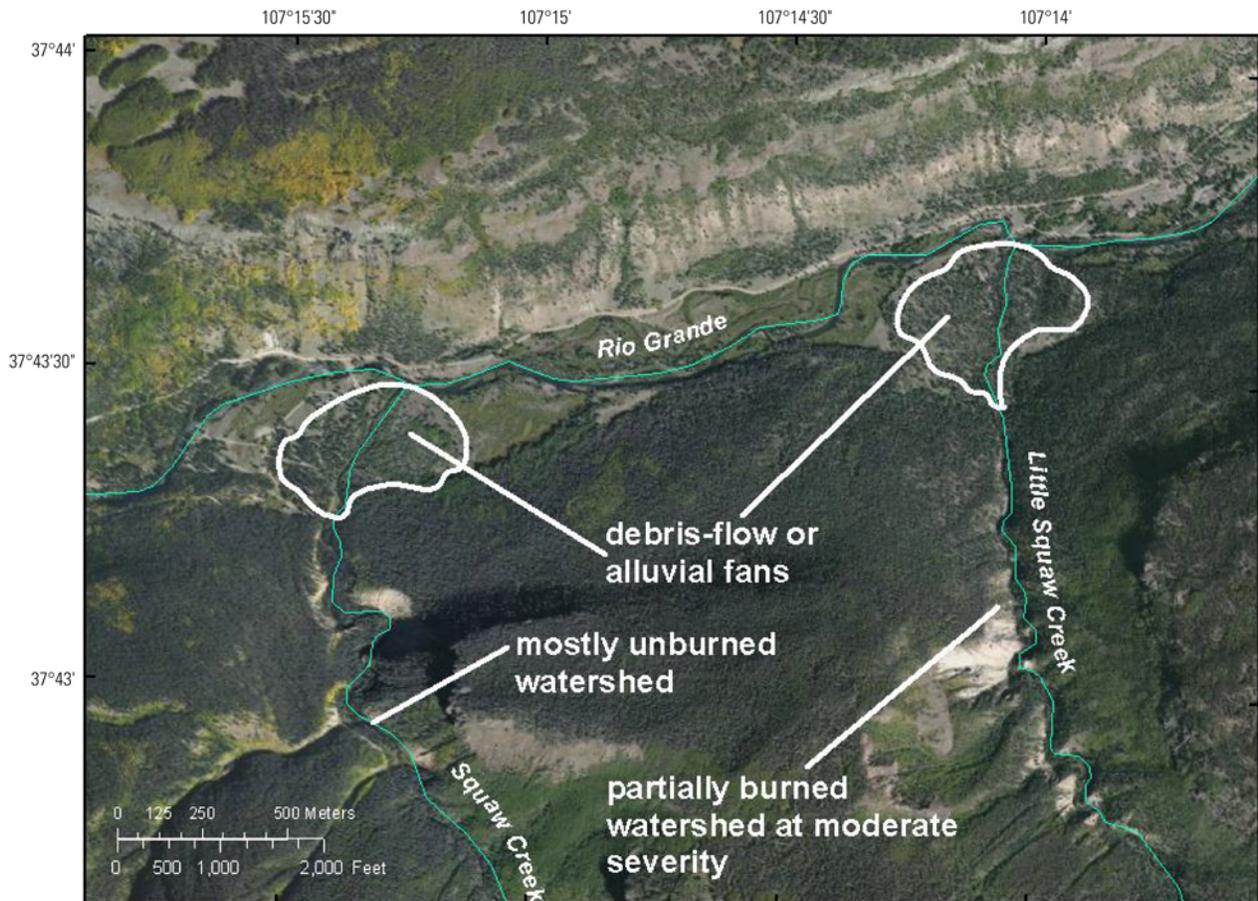
Figure 2. Aerial prewildfire photograph (NAIP Imagery, U.S. Department of Agriculture, Farm Service Agency, 2011) of lower reach of Little Squaw Creek and Squaw Creek (fig. 1) which flows from bottom to top of the image (south to north) into the Rio Grande west of Creede, Colo. Erosive areas are prominent in the lower part of the photograph, and a debris-flow fan is evident at the mouths of the watersheds at the Rio Grande.

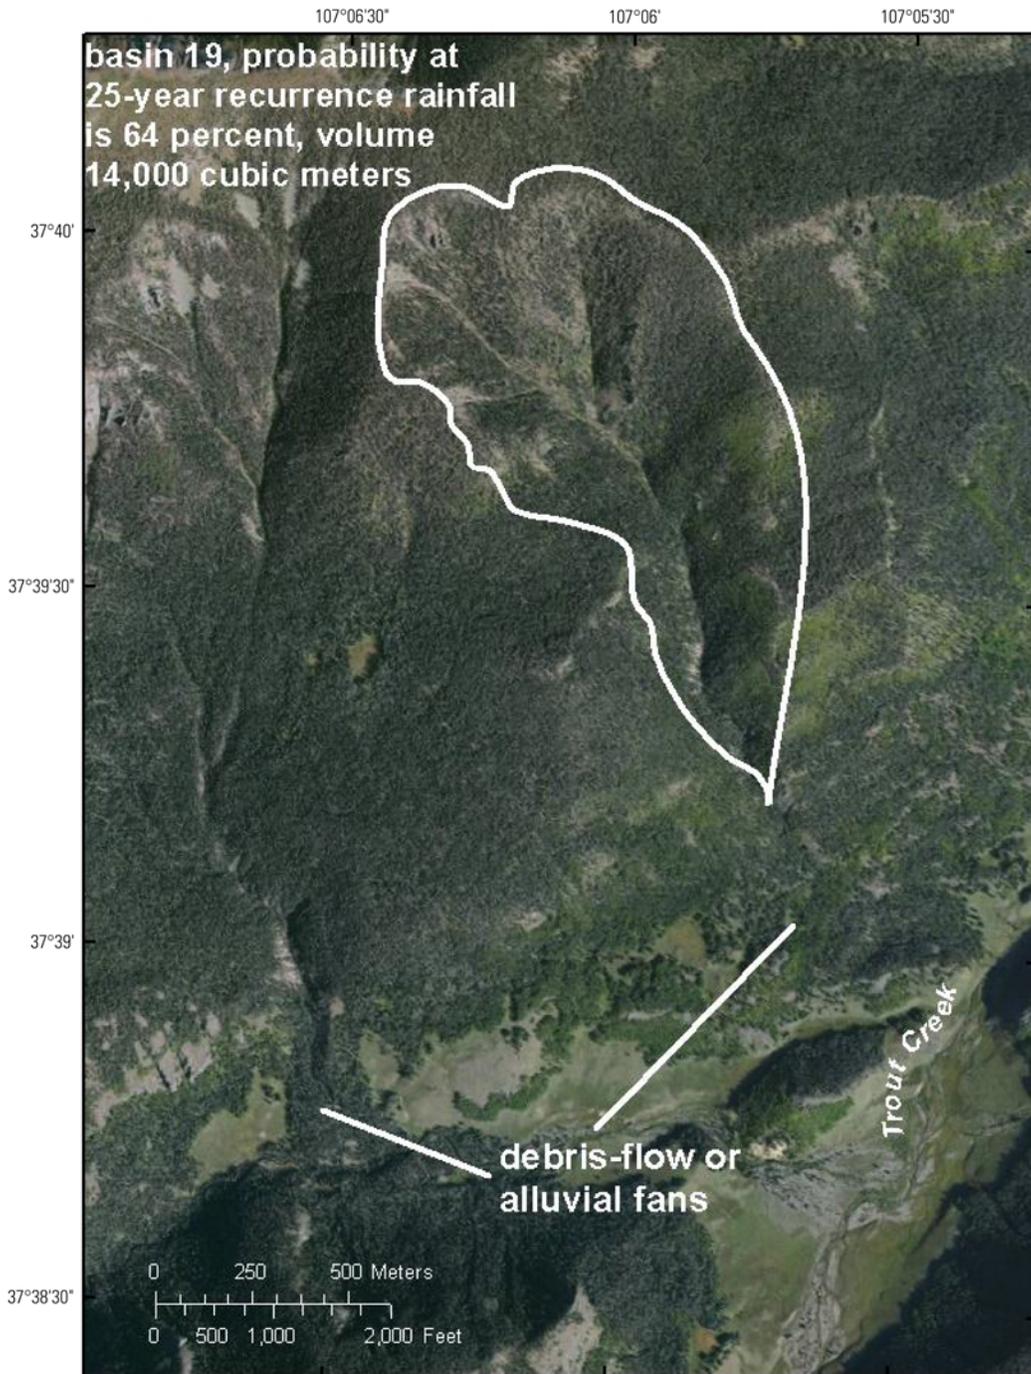
Figure 3. Aerial prewildfire photograph (NAIP Imagery, U.S. Department of Agriculture, Farm Service Agency, 2011) of upper Trout Creek (basin 19, fig. 1) which flows from bottom to top of the image (south to north) and then discharges into the Rio Grande west of Creede, Colo. Sediment erosion areas are prominent adjacent to beetle-killed spruce which burned in the West Fork Complex fire (Papoose burn).

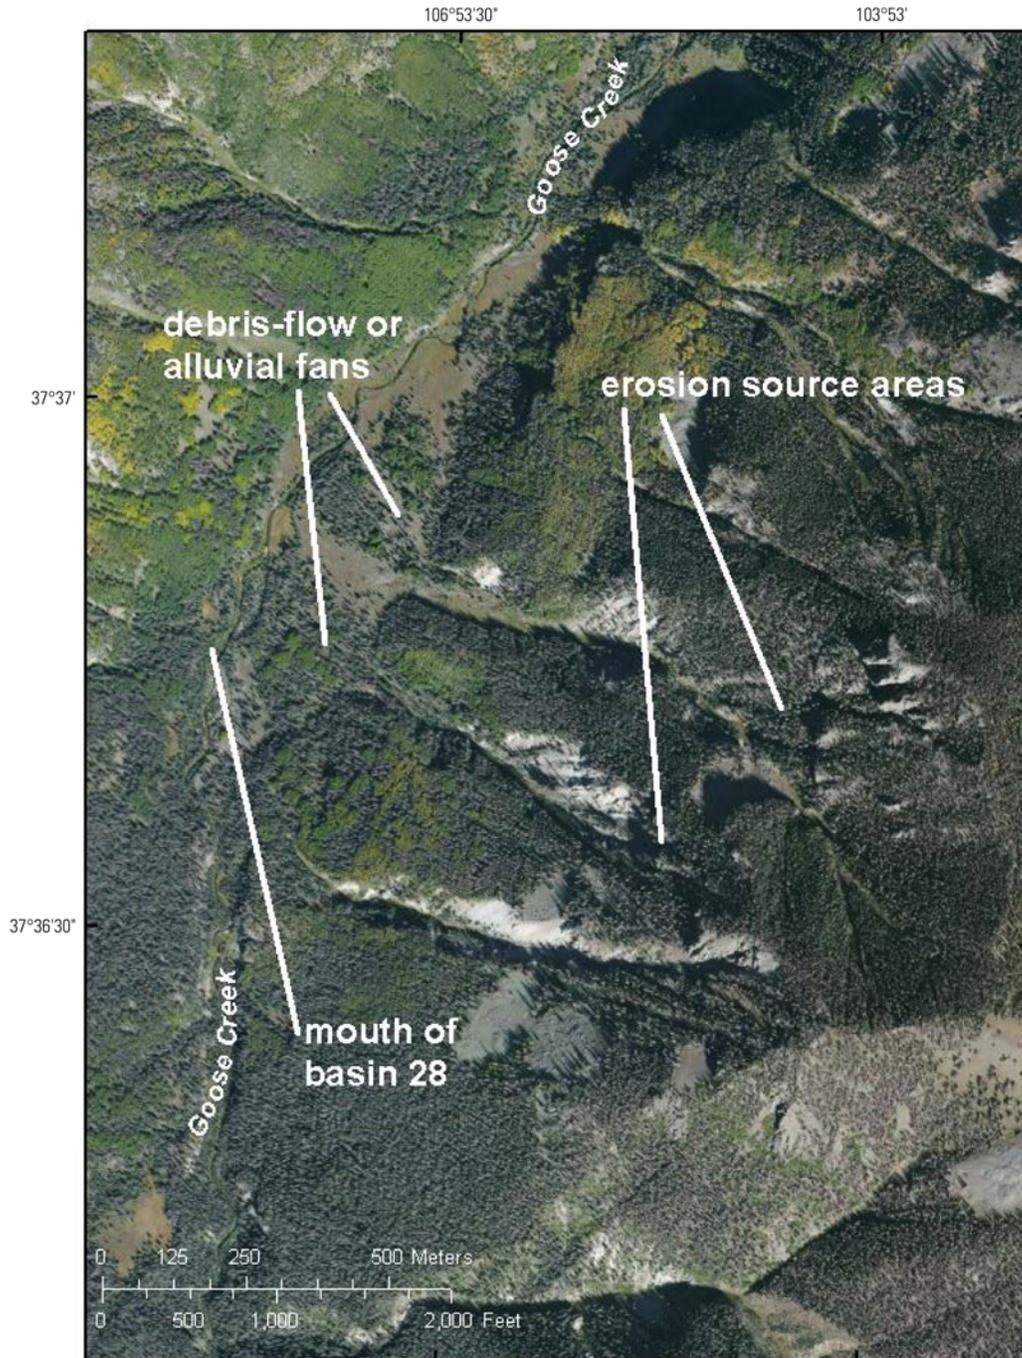
Figure 4. Aerial prewildfire photograph (NAIP Imagery, U.S. Department of Agriculture, Farm Service Agency, 2011) Goose Creek (fig. 1) which flows from bottom to top of the image (south to north) and eventually discharges into the Rio Grande east of Creede, Colo. Sediment erosion areas (located near basin 28 on plate 1) are prominent adjacent to beetle-killed spruce which burned in the West Fork Complex fire (West Fork burn).

Goose Creek is a large basin that drains north to the Rio Grande near Wagon Wheel Gap and was partially burned in the West Fork Fire Complex (figs. 1 and 4, plates 1–3). The upper part of the drainage basin was burned, particularly the area upstream from Lake Humphreys (fig. 18), a reservoir formed by a large concrete arch dam with hydropower generation capacity (fig. 19). Figure 18 shows an alluvial fan at the Goose Creek inlet to Lake Humphreys (fig. 1). The burned slope in the background (top right) is basin 32 (debris-flow probability of 30 percent and debris-flow volume of 8,700 cubic meters in response to the 25-year storm), which could flow into the inlet area if triggered. Figure 19 is a photograph of the siphon for hydropower generation at Lake Humphreys that would likely be affected by floating debris flowing into the lake from upper Goose Creek.

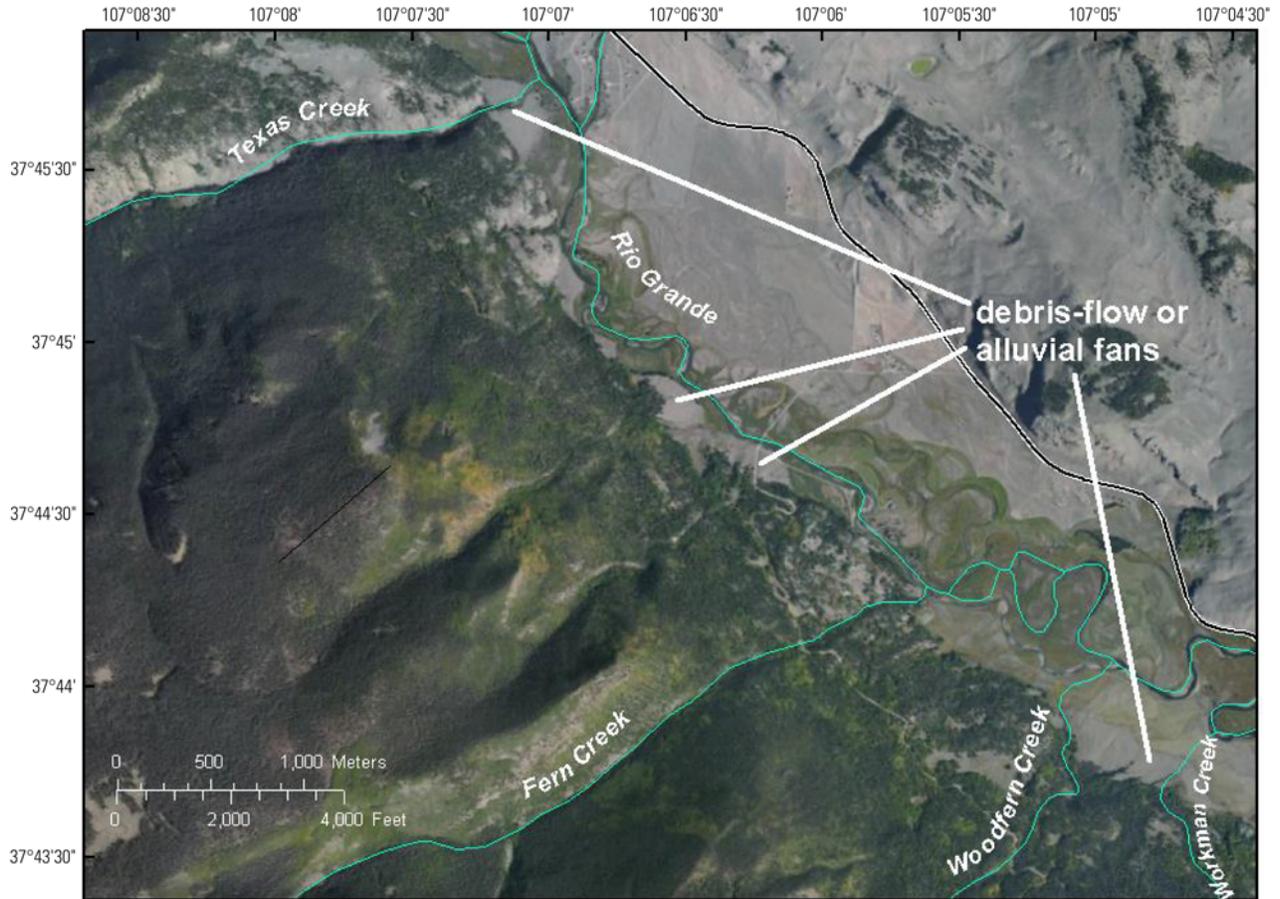
Figure 5. Aerial prewildfire photograph (NAIP Imagery, U.S. Department of Agriculture, Farm Service Agency, 2011) of area between the mouths of Texas Creek and Workman Creek along the Rio Grande (fig. 1). Fan structures of debris-flow, alluvial, or mixed origin are visible at the mouths of several creeks.

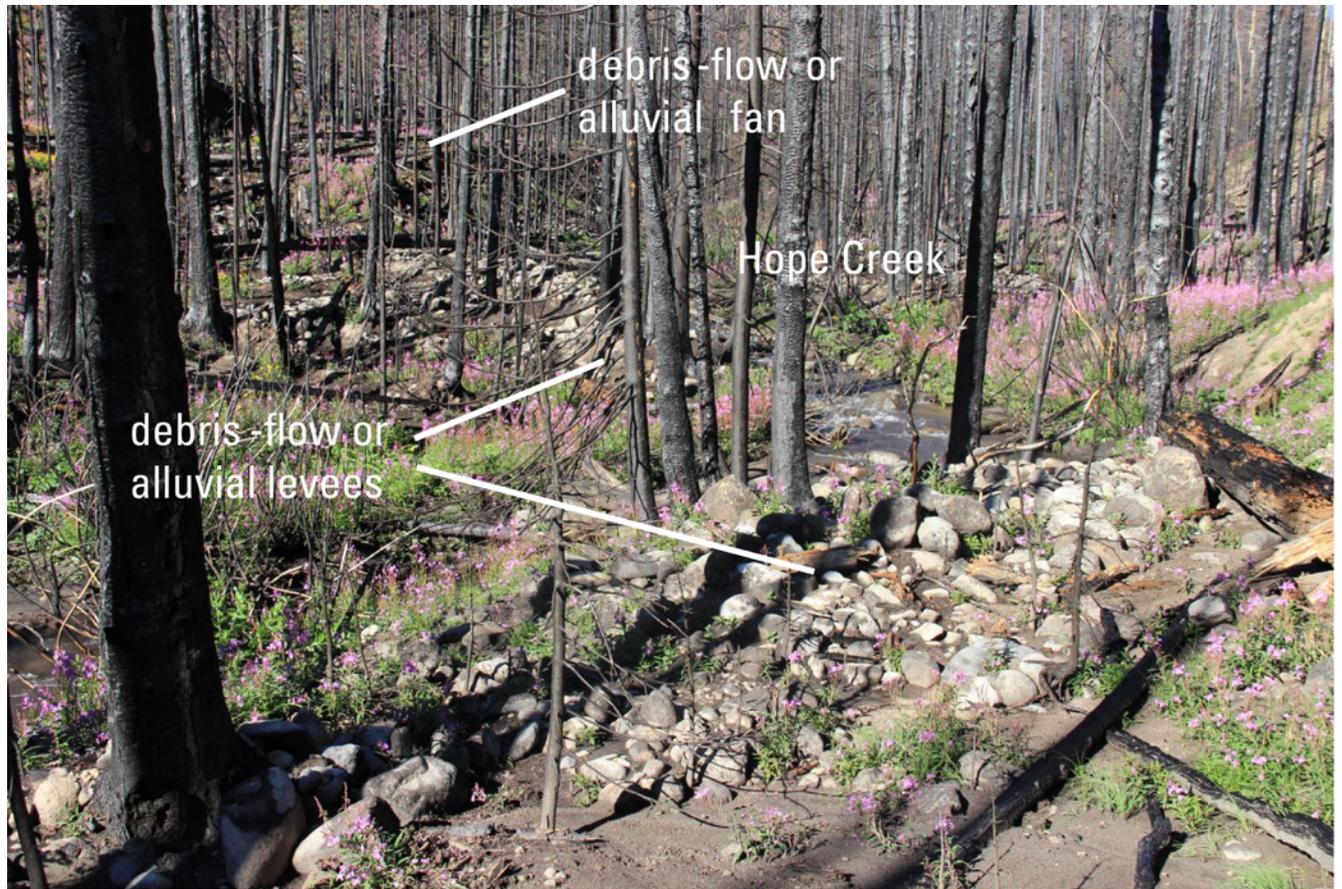
Figure 6. Debris-flow or alluvial fan and levees in the Hope Creek watershed (basin 41), view upstream (fig. 1).
(photograph by Michael Stevens)

One of the sites visited in the field was at Hope Creek (figs. 6–10), located about 3 miles east of U.S. Highway 160 where the forest road crosses Hope Creek. Figures 6–8 show evidence of debris-flow or alluvial deposits along Hope Creek including a fan structure and levees along the stream. Figure 9 shows erosion on a side-slope along Hope Creek that occurred in response to summer rains in 2013 after the West Fork Complex wildfire. Figure 10 shows the culvert at the forest road crossing Hope Creek. Culverts and bridges may become blocked during high streamflows and could back up water and cause failure of road embankments. The next drainage basin to the north is Lake Creek; figure 11 shows a debris-flow or alluvial fan cut by U.S. Highway 160 at the mouth at South Fork Rio Grande (fig. 1, plates 1–3).

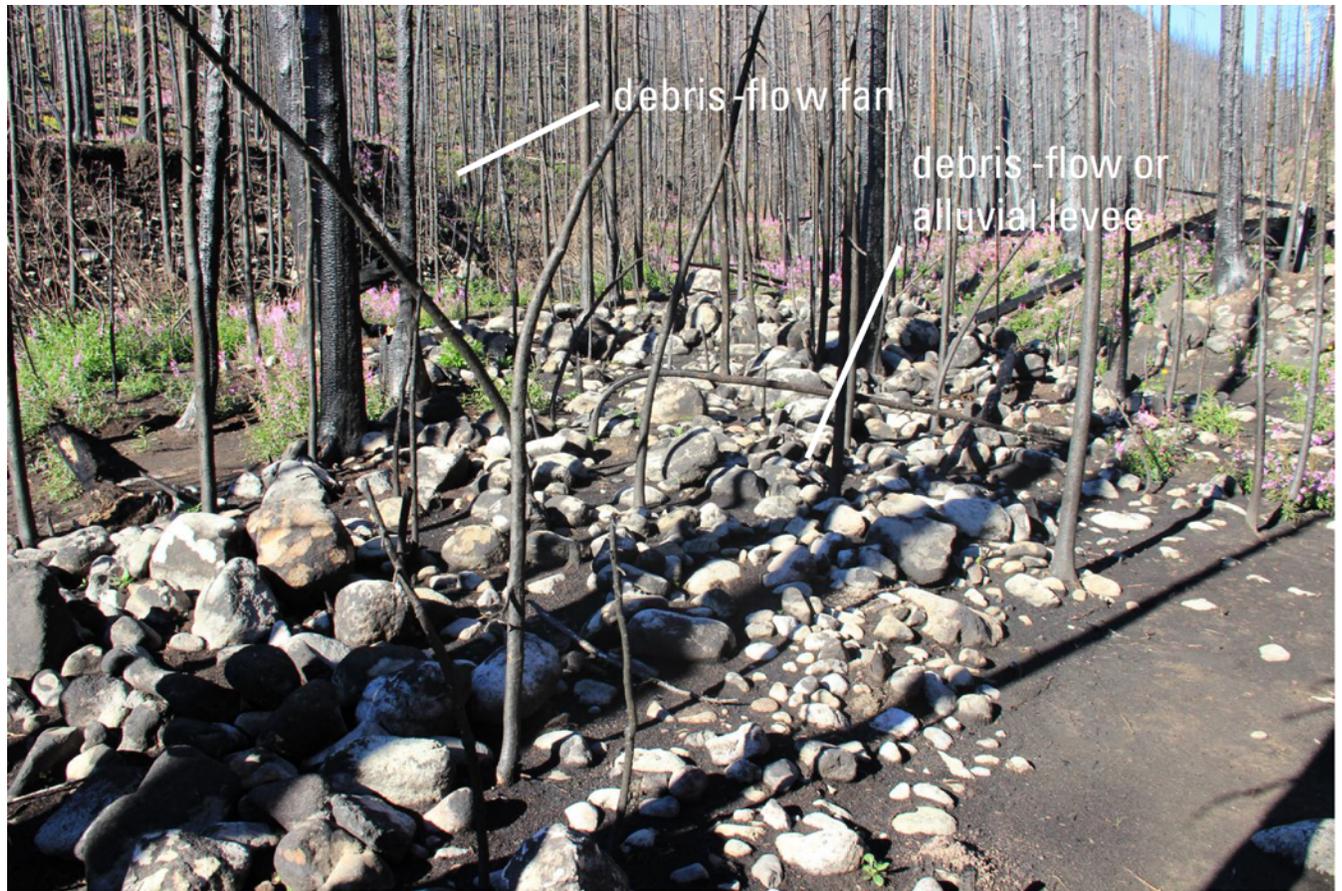
Figure 7. Debris-flow or alluvial fan and debris-flow or alluvial levees in the Hope Creek watershed (basin 41) (fig. 1), taken a short distance upstream from figure 6. (photograph by Michael Stevens)

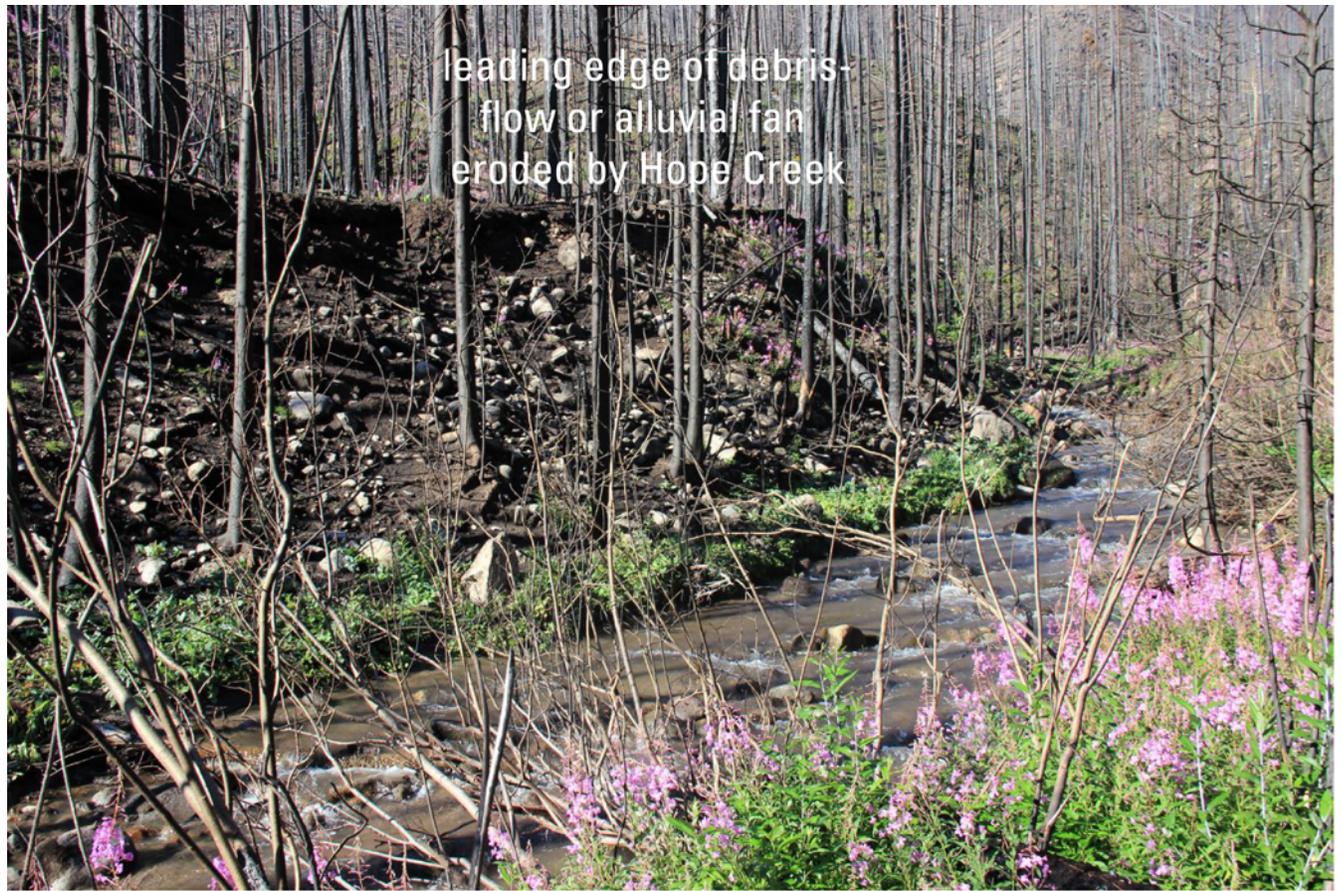
Figure 8. Leading edge of debris-flow or alluvial fan eroded by Hope Creek (fig.1). (photograph by Michael Stevens)

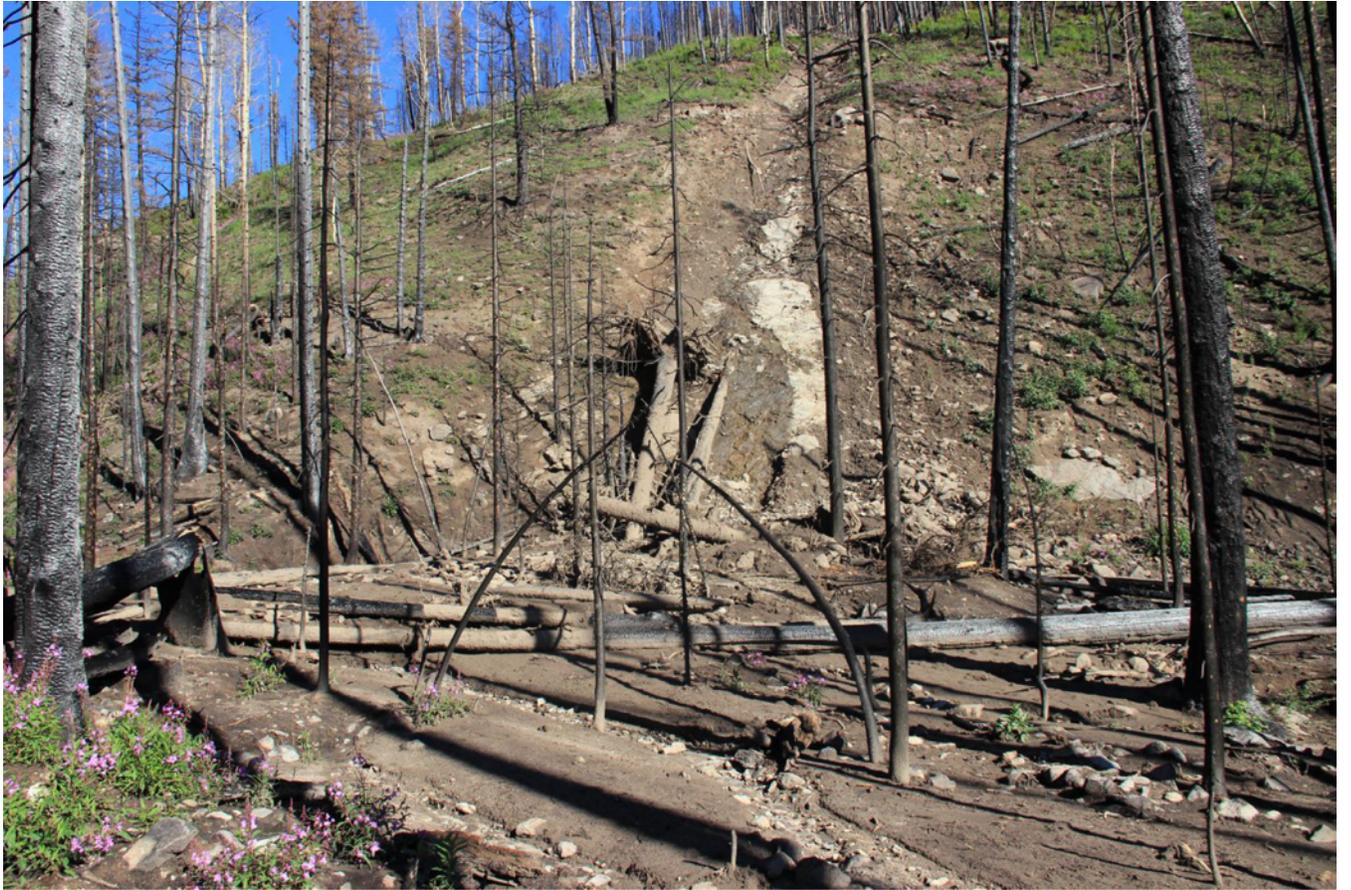
Figure 9. Erosion of slope colluvium from late summer postfire rainfall in 2013 on slope adjacent to Hope Creek (fig.1). (photograph by Michael Stevens)

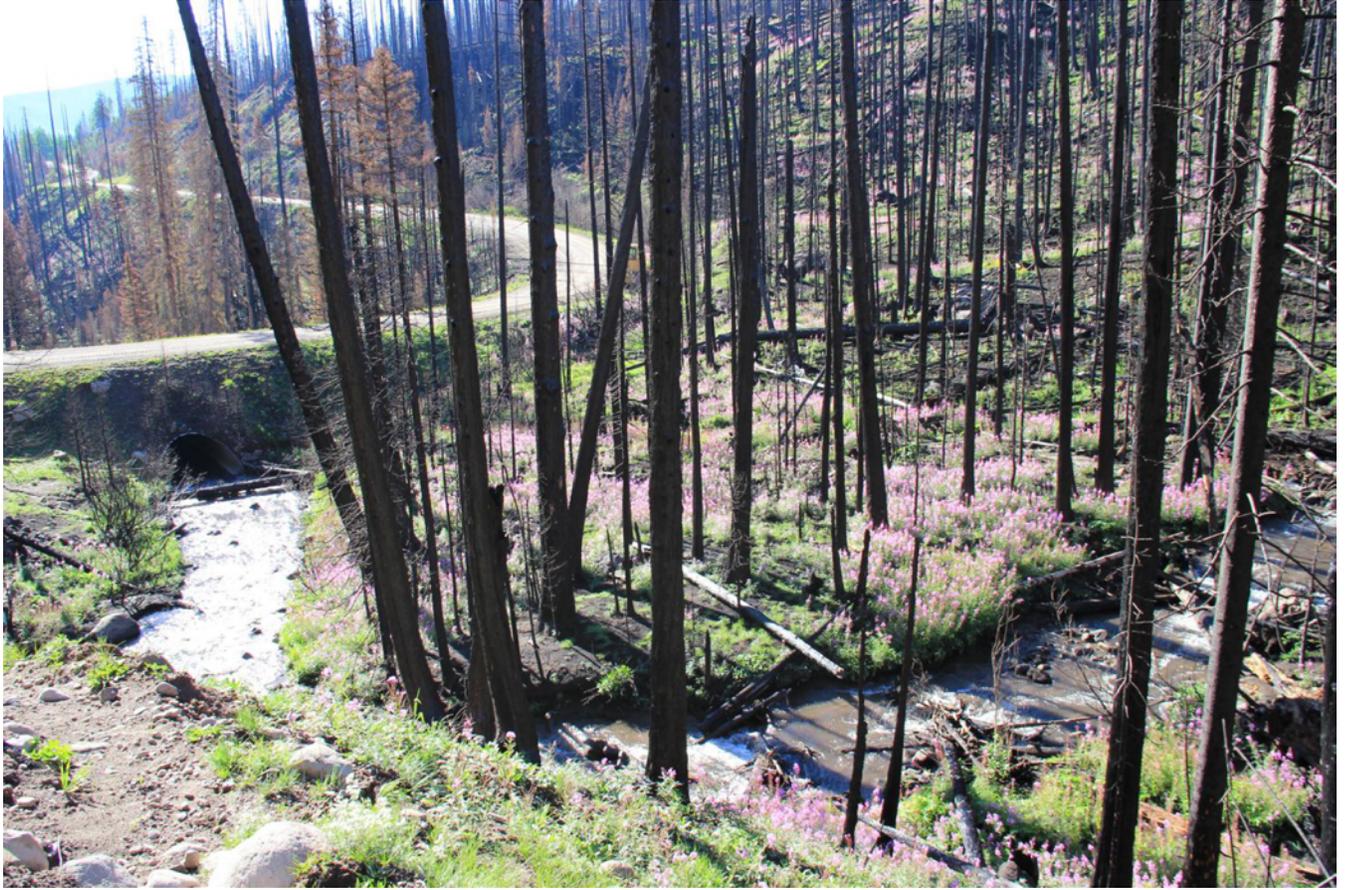
Figure 10. Hope Creek (fig. 1) could transport debris that could obstruct the culvert at the forest road crossing and cause backup of water and possible failure of the road embankment. (photograph by Michael Stevens)

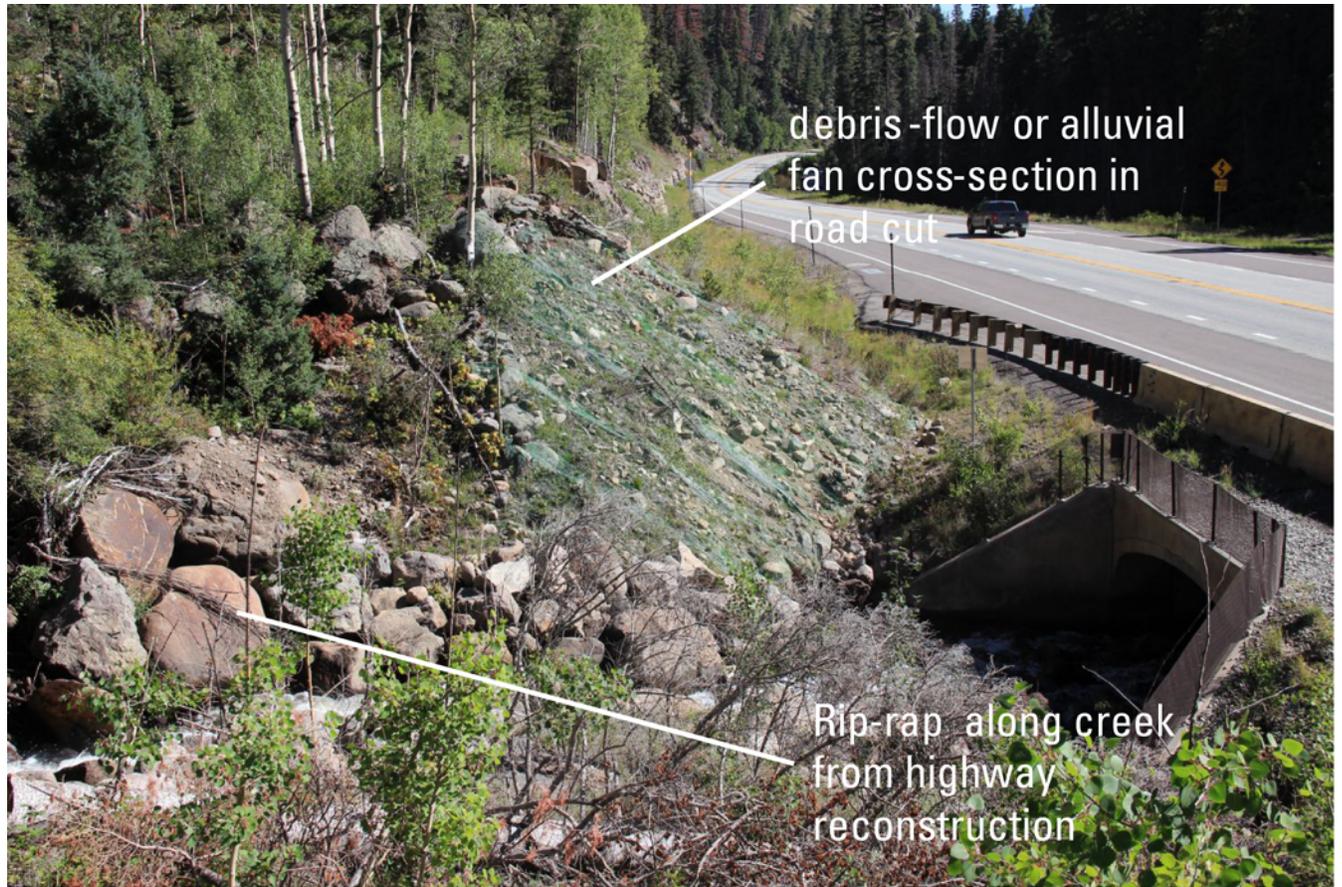
Figure 11. Road cut through debris-flow or alluvial fan deposit at the mouth of Lake Creek at U.S. Highway 160 (fig. 1). (photograph by Michael Stevens)

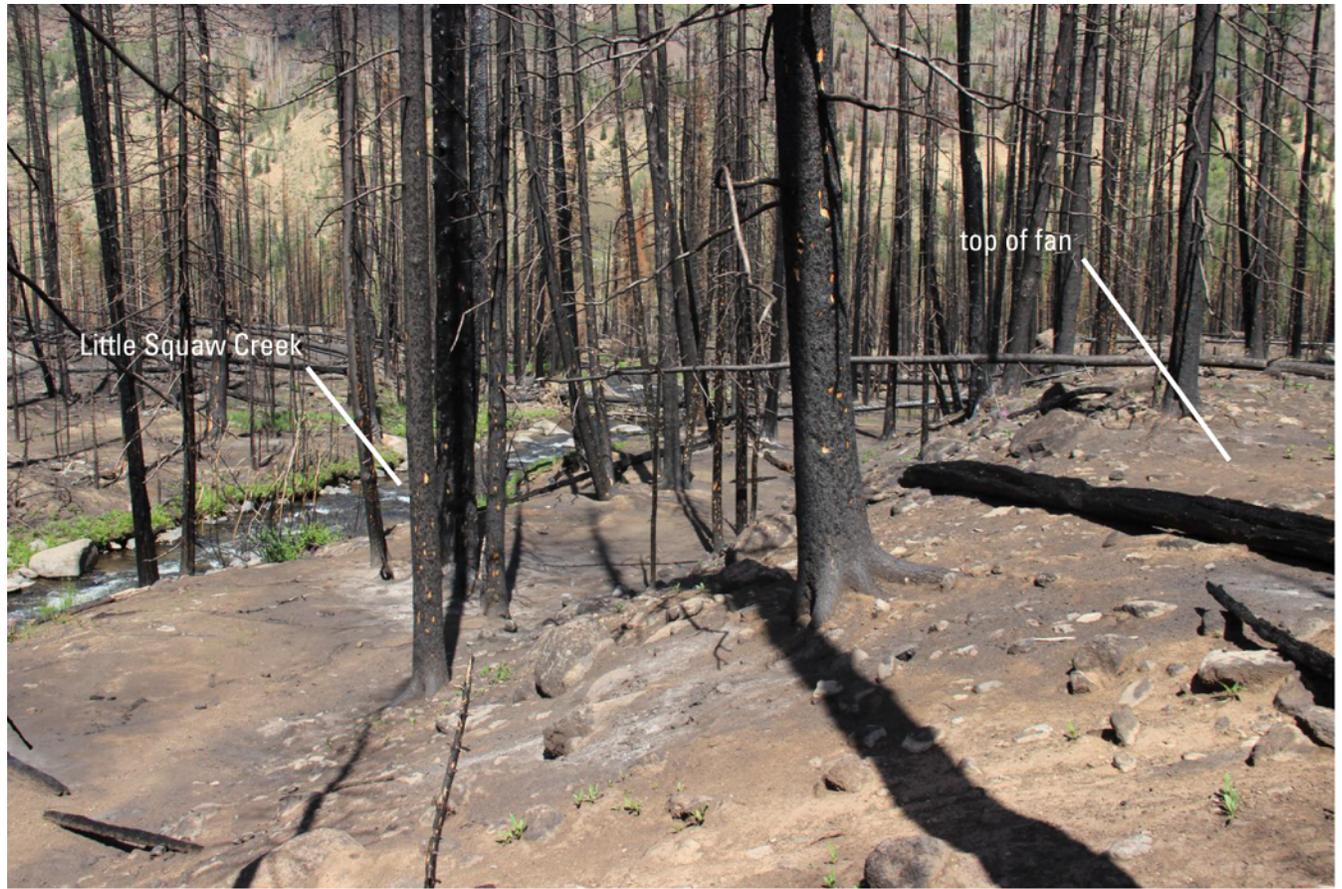
Figure 12. Little Squaw Creek (basin 4, plates 1-3) cutting through debris-flow or alluvial fan at the mouth at the Rio Grande (fig. 1). (photograph by Michael Stevens)

Squaw Creek and Little Squaw Creek flow into the Rio Grande just downstream from Rio Grande Reservoir near Creede, Colorado. During a site visit to the mouth of Little Squaw Creek at the Rio Grande (fig. 1, plates 1–3), evidence of a large debris-flow or alluvial fan was identified (fig. 2). Unsorted deposits with large cobbles, boulders, and deformed trees on the surface of the fan are shown in figures 12–15 and small erosion channels were observed throughout the burned and unburned

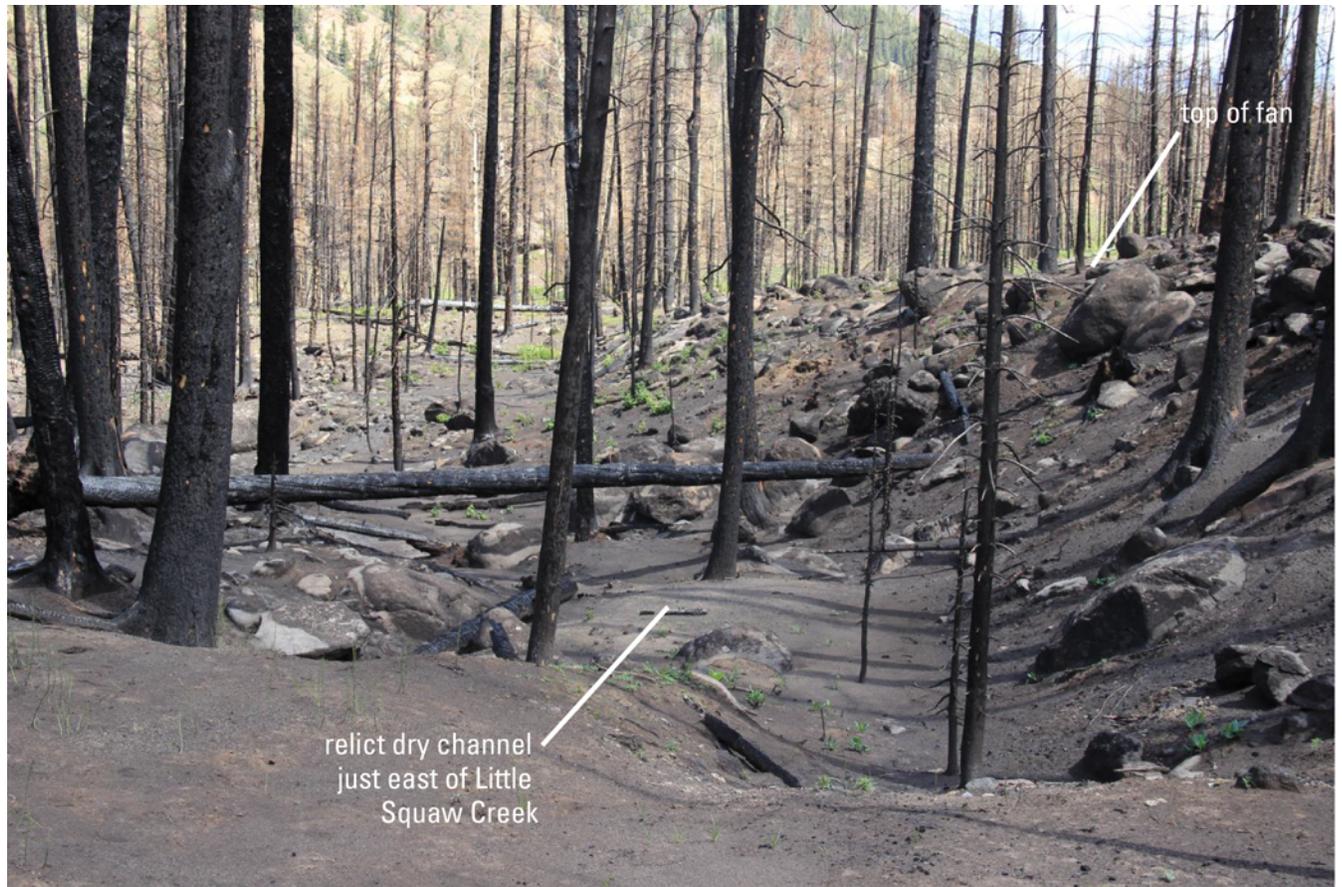
Figure 13. Relict dry channel through debris-flow or alluvial fan just east of active channel of Little Squaw Creek at the mouth at the Rio Grande (fig. 1). View downstream toward Rio Grande. (photograph by Michael Stevens)

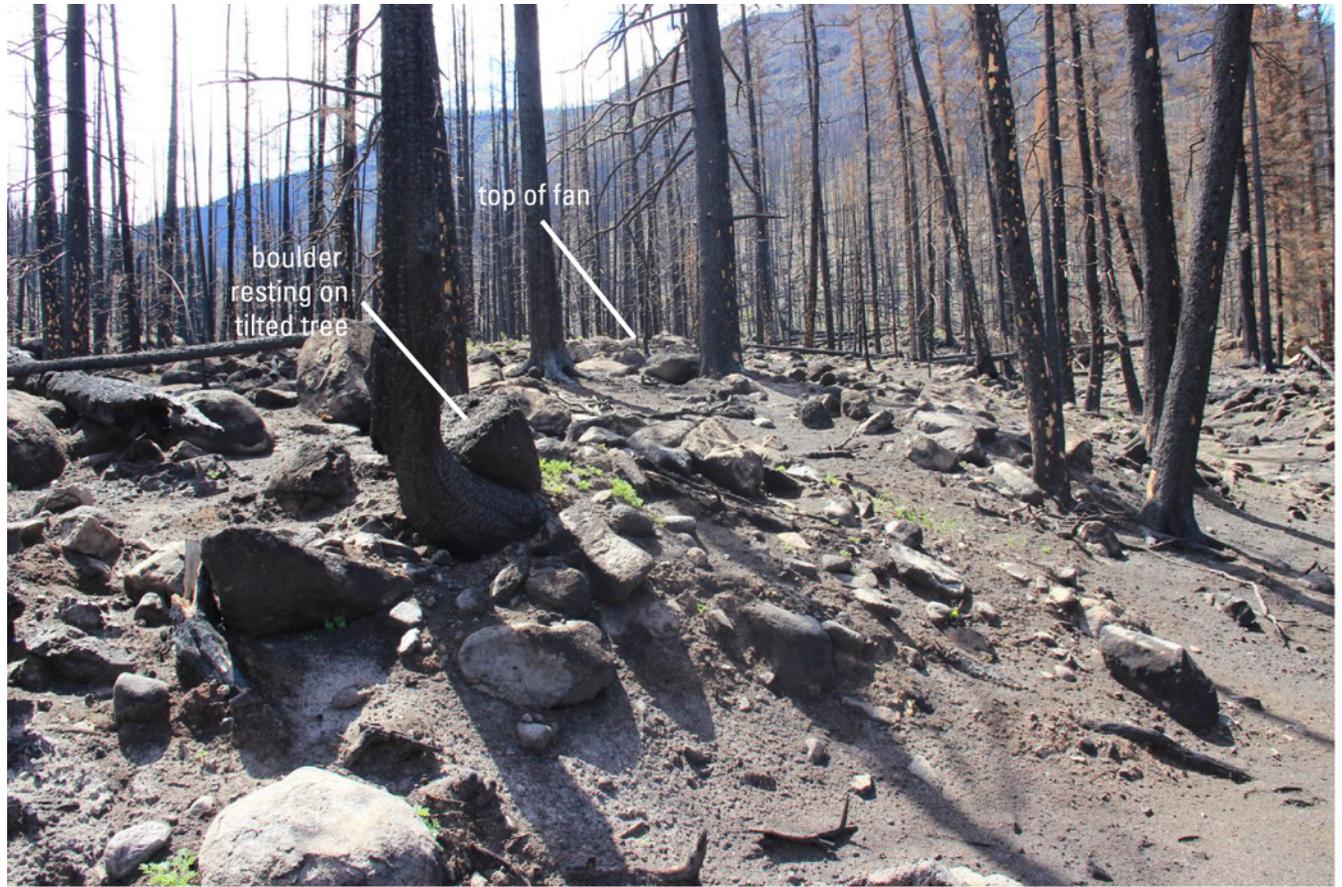
Figure 14. Debris-flow or alluvial levee on fan feature at mouth of Little Squaw Creek at the Rio Grande (fig. 1)
(Note rock resting on tree trunk). (photograph by Michael Stevens)

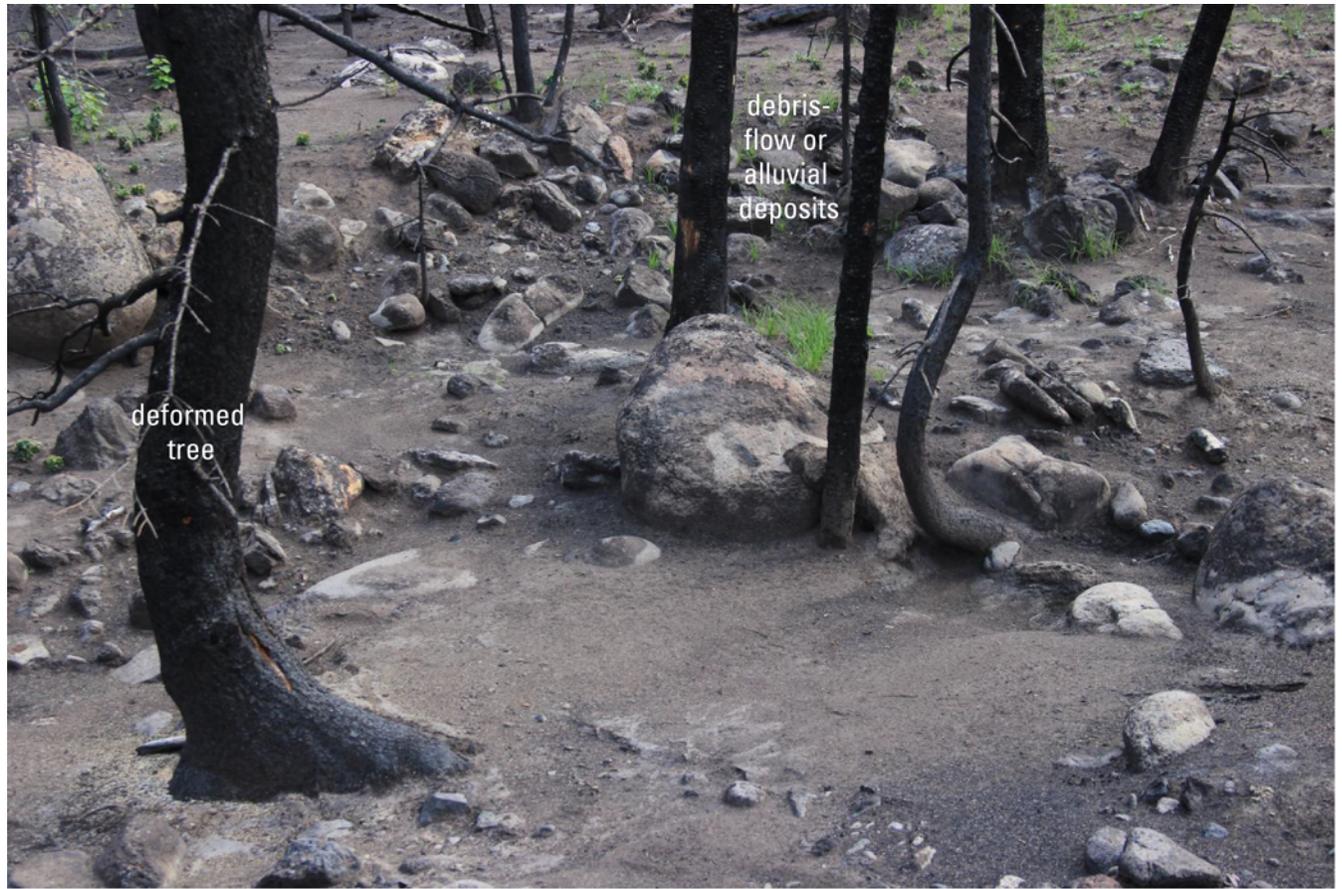
Figure 15. Trees possibly deformed by debris-flow or alluvial material on Little Squaw Creek fan at the Rio Grande (fig. 1). (photograph by Michael Stevens)
