Prepared in cooperation with Hinsdale County, Colorado

Postwildfire Debris-Flow Hazard Assessment of the Area Burned by the 2013 West Fork Fire Complex, Southwestern Colorado

Open-File Report 2013–1259

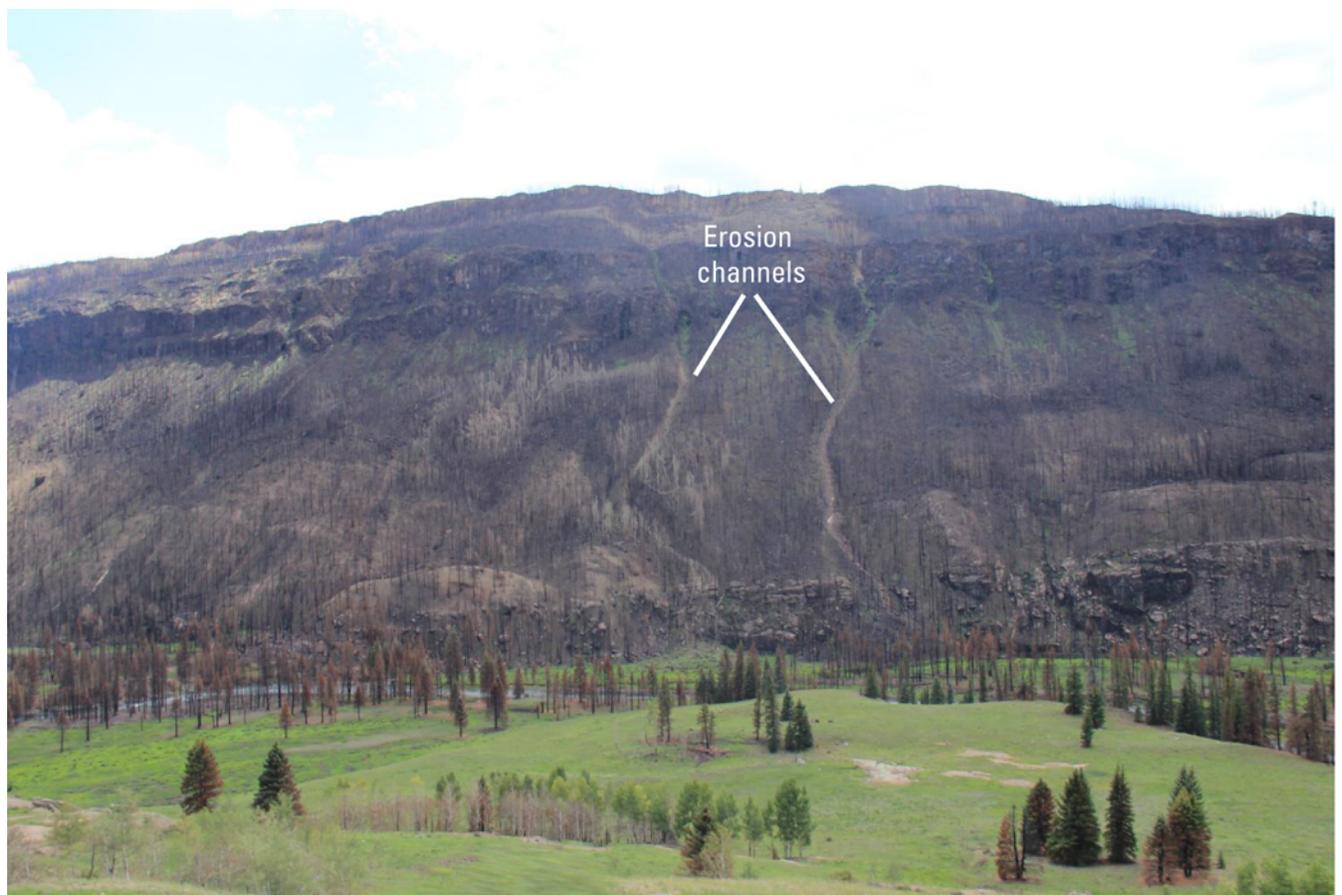
Figure 16. Narrow channels (fig. 1) with small drainage areas on steep slopes above the Rio Grande (flows right to left) that may be affected by avalanche, dry ravel, alluvial (water dominated) erosion, and debris-flow processes. (photograph by Michael Stevens)

watershed in the study area. Figures 16 and 17 (location in fig. 1) provide examples of these channels along the Rio Grande downstream for a few miles below Rio Grande Reservoir (plates 1–3). The narrow channels with small drainage areas on steep slopes above the Rio Grande may be affected by avalanches, dry ravel, alluvial (water dominated) erosion, and debris-flow processes (fig. 16). The channels, while apparently active, do not contain large accumulations of debris or significant fans.

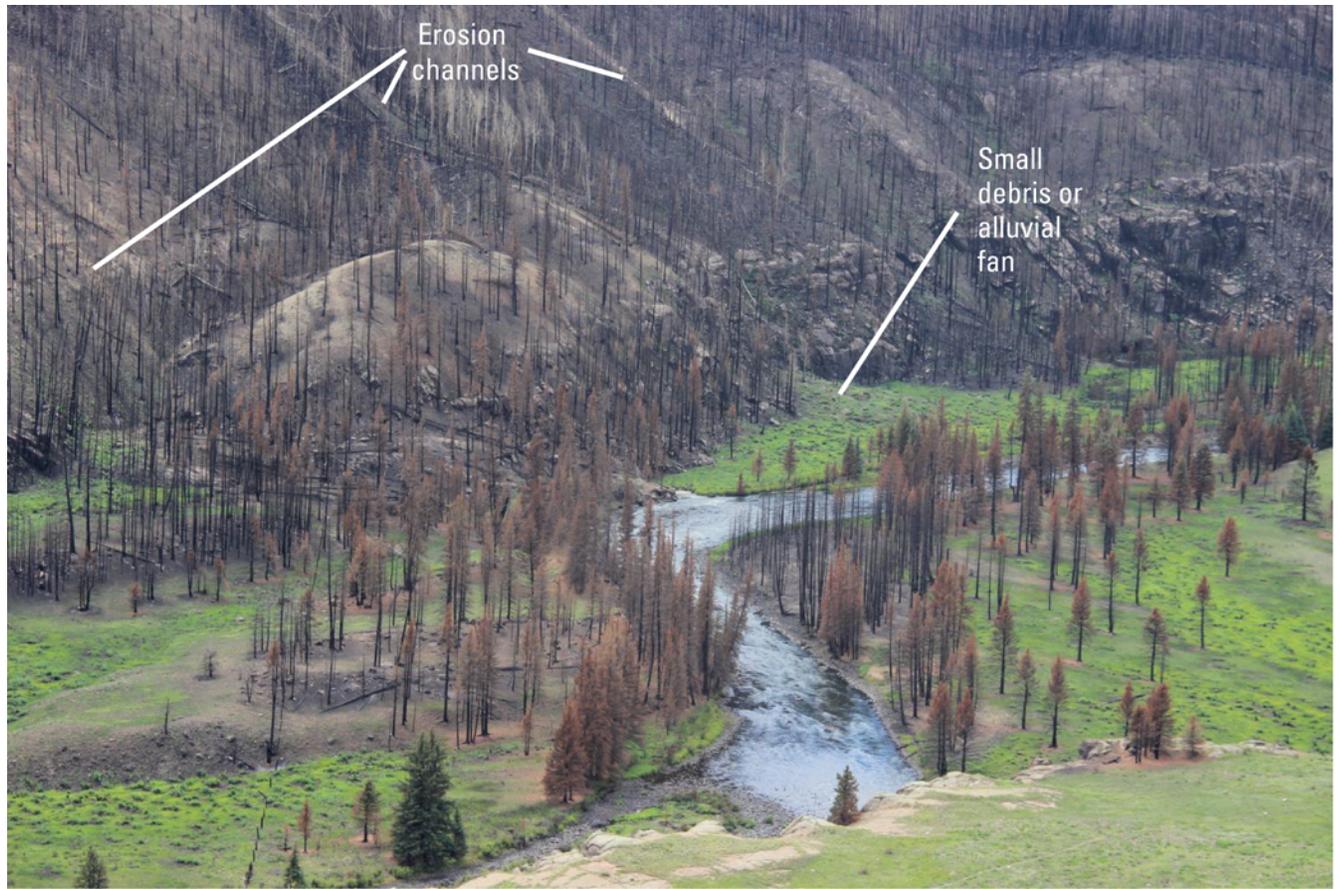
Figure 17. Erosion channels at base of steep slope at Rio Grande downstream from Little Squaw Creek (fig. 1), while apparently active, do not have large accumulations of debris or significant fans, possibly indicating relatively small potential debris-flow volumes. (photograph by Michael Stevens)

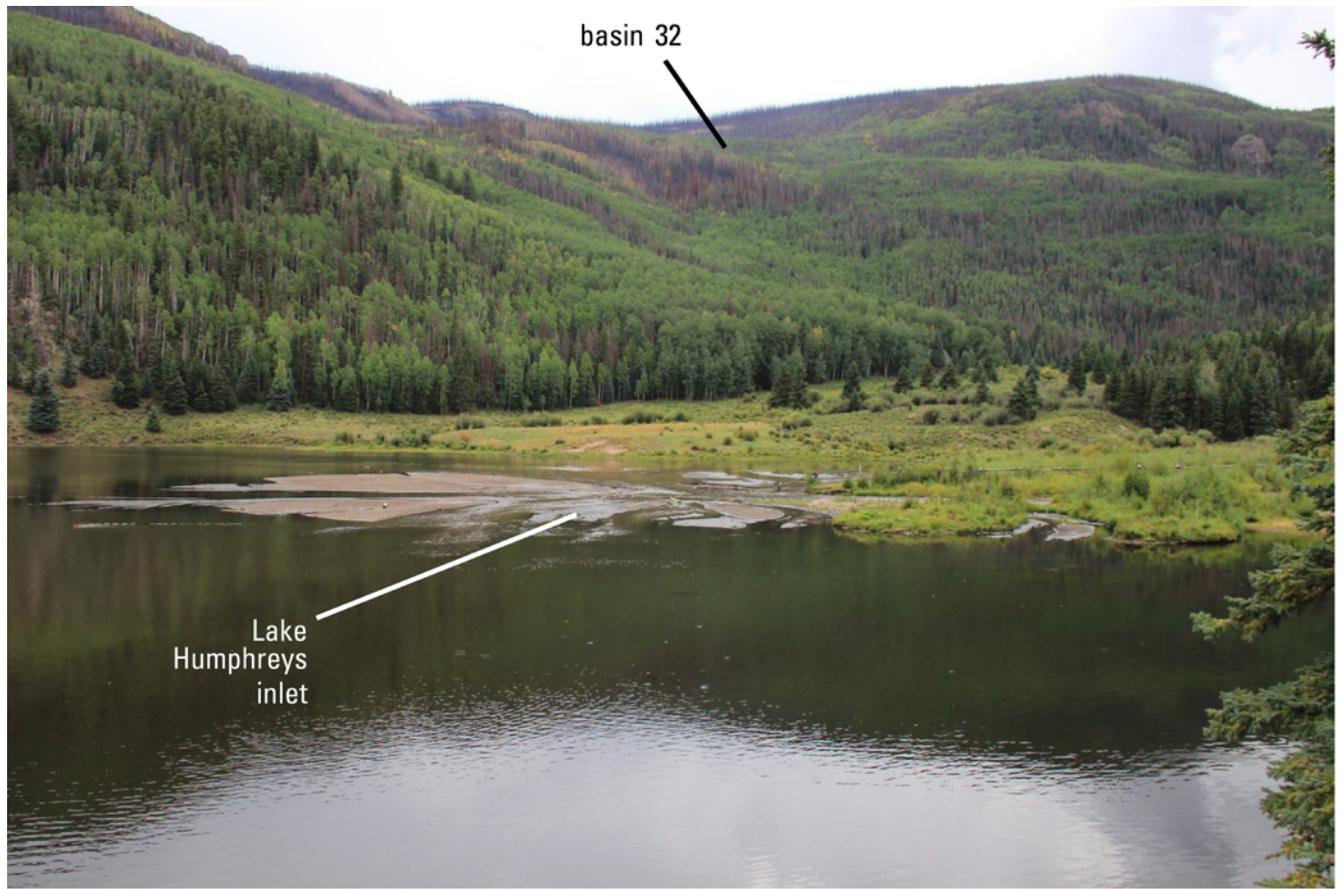
Figure 18. Alluvial fan at inlet to Lake Humphreys on Goose Creek (fig. 1). Burned slope in the background (top right) is basin 32 (probability of 30 percent and volume of 8,700 cubic meters with the 25-year recurrence 1-hour rainfall) which could flow into the inlet area if triggered. (photograph by Michael Stevens)

Goose Creek is a large basin that drains north to the Rio Grande near Wagon Wheel Gap and was partially burned in the West Fork Fire Complex (figs. 1 and 4, plates 1–3). The upper part of the drainage basin was burned, particularly the area upstream from Lake Humphreys (fig. 18), a reservoir formed by a large concrete arch dam with hydropower generation capacity (fig. 19). Figure 18 shows an alluvial fan at the Goose Creek inlet to Lake Humphreys (fig. 1). The burned slope in the background (top right) is basin 32 (debris-flow probability of 30 percent and debris-flow volume of 8,700 cubic meters in response to the 25-year storm), which could flow into the inlet area if triggered. Figure 19 is a photograph of the siphon for hydropower generation at Lake Humphreys that would likely be affected by floating debris flowing into the lake from upper Goose Creek.

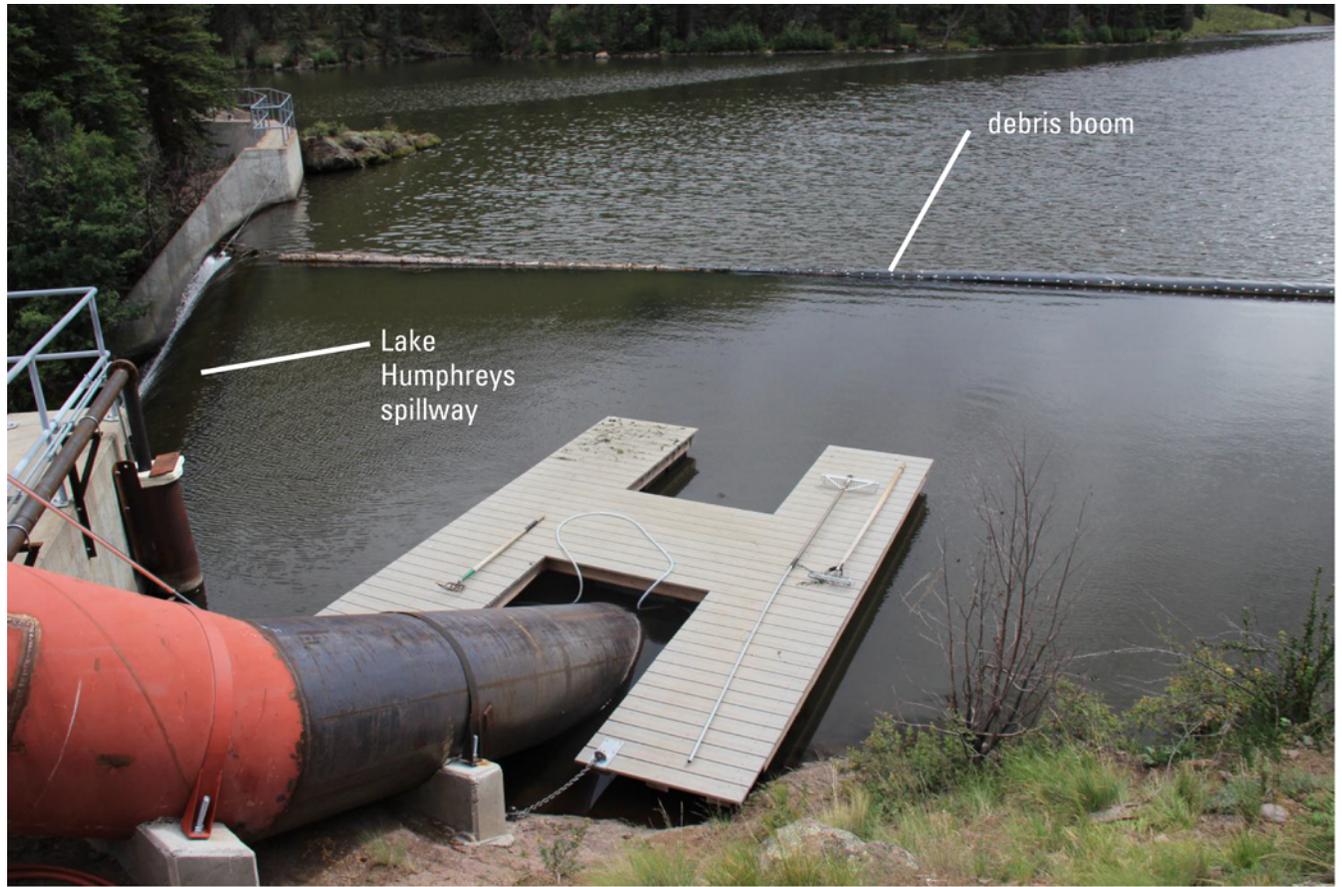
Figure 19. Siphon for hydropower generation at Lake Humphreys (fig. 1) could be affected by floating debris flowing into the lake from upper Goose Creek. (photograph by Michael Stevens)
