Flood-Inundation Maps of Selected Areas Affected by the Flood of October 2015 in Central and Coastal South Carolina

Open-File Report 2016–1019

By Jonathan W. Musser, Kara M. Watson, Jaime A. Painter, and
Anthony J. Gotvald

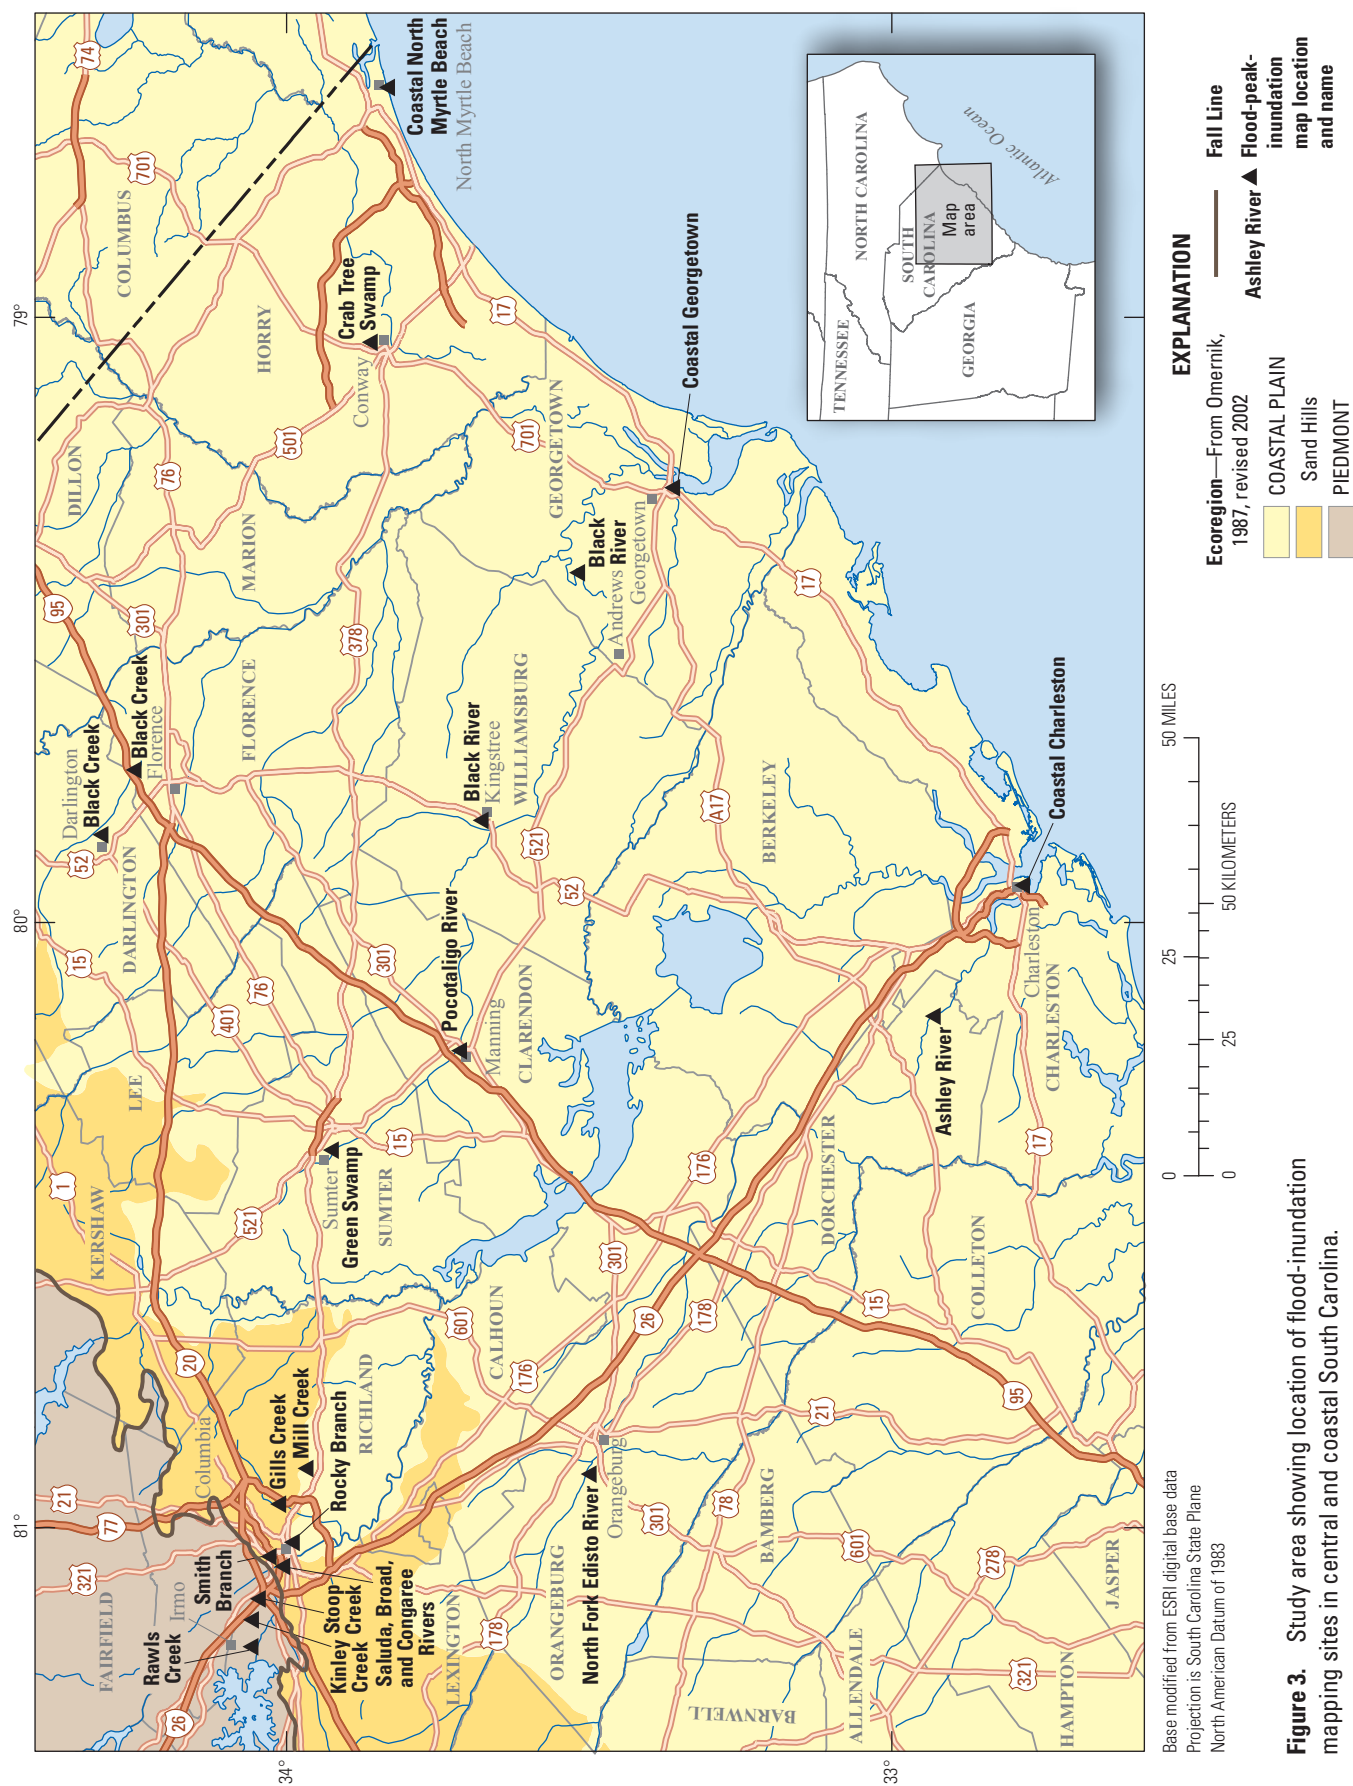
Figure 3. Study area showing location of flood-inundation mapping sites in central and coastal South Carolina.

South Carolina is located in the southeastern United States, adjacent to the Atlantic Ocean, and has an area of 31,055 square miles. Most of the State is within two physiographic regions: Piedmont and Coastal Plain (Cooke, 1936; fig. 3). The Piedmont is characterized by rolling hills, elongated ridges, and moderately deep to shallow valleys. Piedmont land-surface elevations range from about 1,000 feet (ft) above sea level at the Blue Ridge foothills to about 400 ft above sea level at the Fall Line, which is the name given to the boundary between the Piedmont and Coastal Plain regions (fig. 3; Feaster and others, 2015).

flood-inundation map identification name associated with each streamgage is listed in table 4. The streamgage locations are shown in figure 3 as well as in the flood-inundation maps in appendix 2. The data listed in table 4 currently (January 2016) are considered provisional until final approval of the data. New gage-height records were set at six of the nine USGS streamgages listed in table 4. The peak discharge currently (January 2016) is not available for four of the six streamgages with peak gage height of record, so the AEPs were not
