Description of Chronostratigraphic Units Preserved as Channel Deposits and Geomorphic Processes Following a Basin-Scale Disturbance by a Wildfire in Colorado

Open-File Report 2017–1090

U.S. Department of the Interior
U.S. Geological Survey

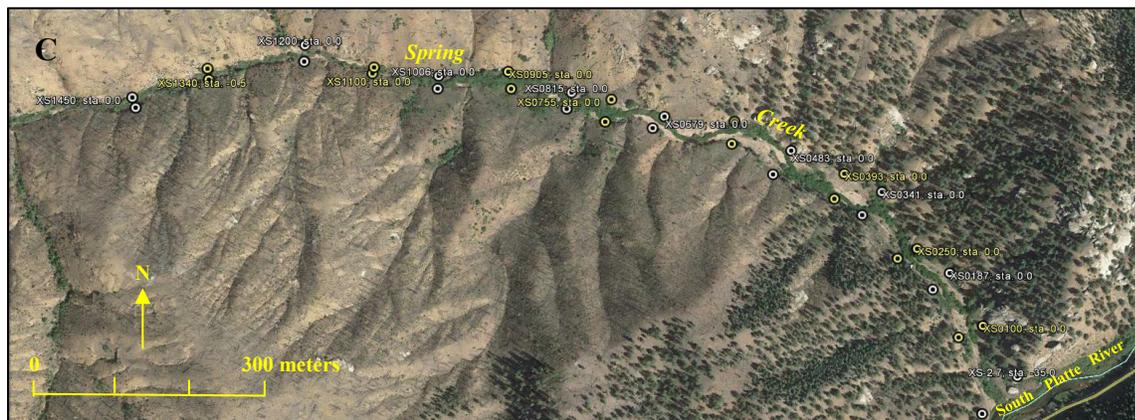
Figure 1. Area near Denver, Colorado, USA, that was burned by the 1996 Buffalo Creek fire and subsequently modified by flooding. *B*, Modified Google Earth image (October 4, 1999) showing the burned area of Spring Creek. Image was taken three years after the major flood on July 12, 1996, and the landscape still shows the burn scar and the extent of the sediment superslug consisting of white sand, gravel, and rocks occupying the main channel and most of the major tributary channels of the Spring Creek basin (especially the tributaries upstream from the location of cross section [XS] 4850). The primary study reach extends from the confluence of Spring Creek and the South Platte River to a rain and streamgage 1,500 meters (m) upstream. Data from the rain gage were used to determine rainfall-discharge relations (Moody, 2001; Moody and Martin, 2001a, b, c). Five of 18 channel cross section locations are shown. In each section label, the number following the “XS” is the distance in meters upstream from the confluence. Box with yellow dashed lines shows the approximate area of figure 1C. *C*, Google Earth image (September 8, 2016) showing close-up view of the primary study reach of Spring Creek shown in figure 1B. Flow in the creek is from west to east. Seventeen channel cross sections are shown. The most upstream cross section (XS4850, not shown) is about 3,000 m upstream from XS1450. The 0.0 station for each cross section is on the left bank of Spring Creek. Base map data from Google, DigitalGlobe 2015.—Continued

During 2010, additional discharge measurements were made by using a 9-inch modified Parshall flume located 10 m downstream from XS0815 (fig. 1B). Stage was measured with a Global Water sensor (Model WL15-015) every 15 minutes, and discharge measurements were made approximately every month (with a Pygmy, open-cup current meter) to check the theoretical calibration of the flume (Grant, 1991).

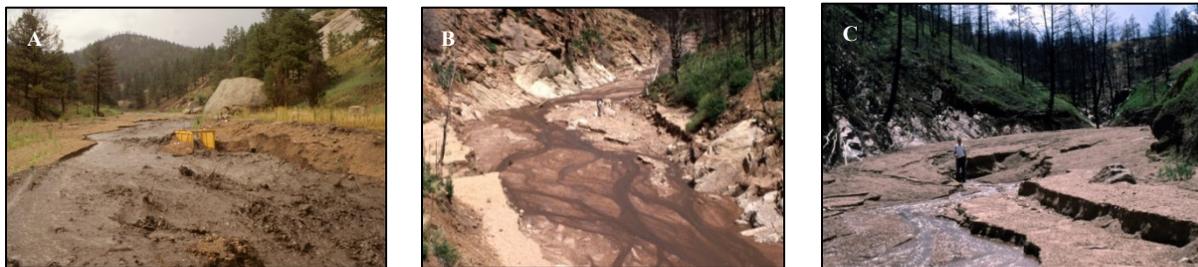
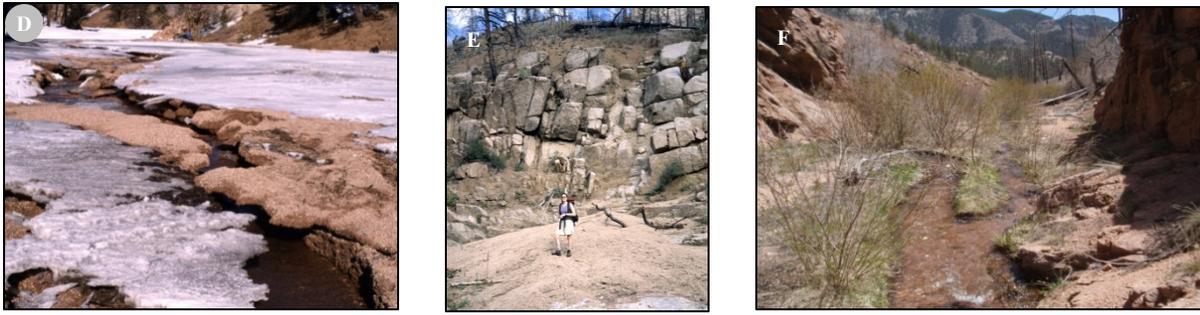
Figure 4. Photographs showing six geomorphic processes that eroded, transported, and deposited sediment. These processes modified the initial form of the sediment superslug deposited in Spring Creek. A, Floods. View is looking upstream from a vantage point at the mouth of Spring Creek during the flood on July 29, 1997. B, Braided flow. View is looking downstream, with XS1200 across the center of the photograph. The width of the sand and gravel surface is about 20 meters (m). C, Percolation. View is looking upstream. This process was common where water transporting sediment percolated into the channel bed, leaving behind sediment and forming thick sediment deposits, sometimes referred to as in-channel fans. The downstream end of an in-channel fan is shown behind D. Wolf (about 1.8 m tall) in the photograph. Surface flow from upstream completely disappears into the fan and reappears downstream at approximately the location where D. Wolf is standing.

Figure 4. Photographs showing six geomorphic processes that eroded, transported, and deposited sediment. These processes modified the initial form of the sediment superslug deposited in Spring Creek. *D*, Winter aggradation. View is of an area upstream from XS0187, January 20, 1998. Sediment particles in the photograph are typically 2–4 millimeters in diameter and are derived from the weathered granite that underlies most of the Spring Creek basin (Blair, 1976). The channel is about 0.3 m wide. *E*, Dry ravel. Photograph shows a fan at the base of a hillslope between XS1340 and XS1450. The sediment in the fan was deposited in the bedrock channel by dry ravel during the summer, by the freeze-thaw process during the winter, and some hillslope runoff after a rain storm on August 13, 2001. The person in the photograph is about 1.8 m tall. *F*, Vegetation trapping and armoring. Photograph was taken on May 8, 2010 of the channel at XS0679. View is looking downstream and the water surface is about 1 m wide. The effects of vegetation trapping and armoring have produced an anabranching channel as the willows re-colonized the reach.—Continued

Six geomorphic processes (floods, braided flow, percolation, winter aggradation, dry ravel, and vegetation trapping and armoring) were observed to alter the initial form of the superslug, which first underwent vertical aggradation and, later, incision (fig. 3). Flash floods (fig. 4A) were a primary geomorphic process in the first years after the deposition of the superslug when they were more frequent, had greater magnitudes, and transported substantial amounts of sediment. Each extreme and major flood generally resuspended the bed sediment, eliminating any channelization and vegetation regrowth, and redeposited the sediment as a level, planar cross-channel surface (fig. 4B) with a relatively steep down-channel slope (0.03–0.05; Moody, 2001). These conditions were ideal for braided, shallow (0.02–0.05 m) flow (fig. 4B), which tended to be steady but spatially discontinuous. Flow was often observed to transport larger sediment particles (about 10 mm) by rolling them on the relatively uniform bed surface composed of 1–2-mm particles. Surface flow was observed to percolate into the bed sediment in some channel reaches and to leave behind the sediment it had been transporting. This process formed in-channel fans (fig. 4C), but also caused sediment aggradation upstream from the in-channel fan where the bed slope was less. Aggradation was usually during late fall, winter, and early spring, when the bank sediments were frozen and, thus, cohesive, and is termed “winter aggradation”. Flowing water was then only able to erode narrow, slot-like channels, and at times some winter and early spring flows exceeded the capacity of the small incised channels, spread onto the adjacent surface, and deposited sediment which refroze (fig. 4D). Dry ravel (Anderson and others, 1959; Gabet, 2003; Jackson and Roering, 2009; Lamb and others, 2011) supplied sediment from the adjacent hillslopes (fig. 4E). The dry ravel originated from the equatorial (south)-facing hillslopes in summer and also during the late fall, winter, and early spring when the freeze-thaw process was observed to deliver substantial quantities of sediment to the channel from equatorial-facing slopes but not from frozen, polar-facing hillslopes. Vegetation trapping increased as the frequency of major floods decreased and steadier flow conditions prevailed such that the riparian vegetation (for example sedges, grasses, willow species, and cottonwood trees) was able to reestablish itself (fig. 2B inset, fig. 4F). Multi-stemmed willows reduced the bed shear stress available for transporting sediment (Griffin and others, 2014). Their roots were observed to grow just under the bed surface and formed a root mat that essentially armored the bed surface and thus increased the bed shear stress required to erode the sediment (Prosser and others, 1995).

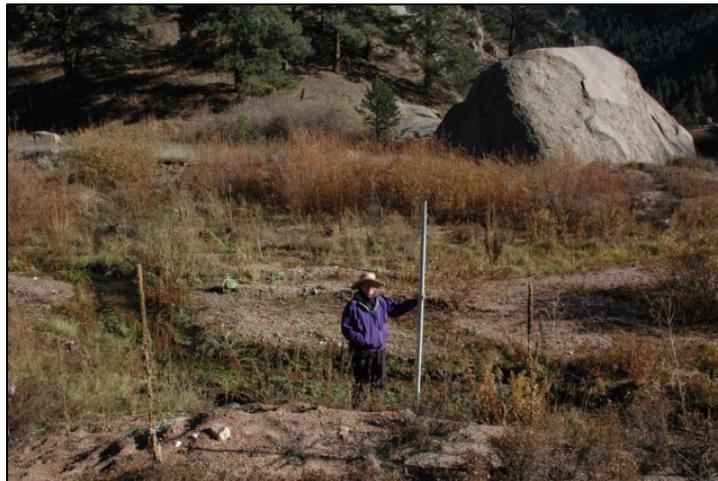
Figure 9. View from the right bank along the line of section for cross section -2.7 (XS-2.7), 2007. Photograph of D. Martin (1.7 meters tall) standing on the right-bank flood plain of Spring Creek, taken on October 25, 2007. Line of section passes through the leveling rod and between the small ponderosa pine tree and the large bedrock boulder on the left bank (background). The right-bank terrace is in the foreground.

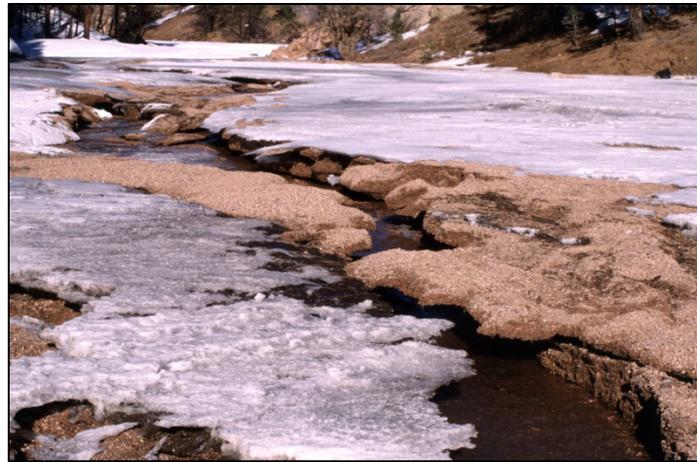
Figure 13. Winter aggradation process near the location of cross section 187 (XS0187), 1998. Photograph was taken on January 20, 1998, looking upstream. During the winter, the sediment composing the channel banks was frozen and, thus, cohesive. Flowing water was then only able to erode a narrow, slot-like channel, and at times, some winter and early spring flows exceeded the capacity of the small, incised channel, spread onto the adjacent surface, and deposited sediment, which refroze. Sediment particles in the photograph are typically 2–4 millimeters in diameter and are derived from the weathered granite that underlies most of the Spring Creek basin. The channel is about 0.3 meters wide.

Other chronostratigraphic units (ascending-diagonal, white sparsely stippled, and grey densely stippled polygons), especially on the left bank, were deposited during braided-stream conditions, by percolation, and during winter conditions when frozen, or cohesive, sediment filled the channel. Braided-stream deposits were observed to form when multiple threads of shallow water deposited bedload as levees. These levees caused flow paths to alter directions, leaving the deposits to accumulate (fig. 32). Percolation deposits formed when surface water, transporting bedload, percolated into the sediment and left behind stranded bedload particles, which with time developed into relatively large deposits (fig. 26). Additionally, any water from upstream that was transporting sediment spread out and lost velocity where the channel slope decreased (0.025–0.040). Frequently during the winter, the sediment filling the braided channel was frozen, or cohesive. Flowing water was then only able to erode narrow, slot-like channels, and, at times, some winter and early spring flows exceeded the capacity of the small, incised channels, spread onto the adjacent surface, and deposited sediment, which refroze (figs. 13, 41, 45).

Interspersed between the flood deposits are braided, percolation, and winter deposits. Braided-stream deposits were observed to form when multiple threads of shallow water deposited bedload as levees. These levees caused flow paths to alter directions, leaving the deposits to accumulate (fig. 36A). Percolation deposits formed when surface water, transporting bedload, percolated into the sediment and left behind stranded bedload particles, which with time accumulated to form relatively large deposits (fig. 26). Frequently, during winter, sediment filling the braided channel was frozen and, thus, cohesive. Sometimes during the winter flow exceeded the capacity of small (0.2–1.0 m wide), shallow channels, and sediment-bearing water spread out from the small channels, deposited sediment on the surface, and refroze (figs. 13, 41, 45).

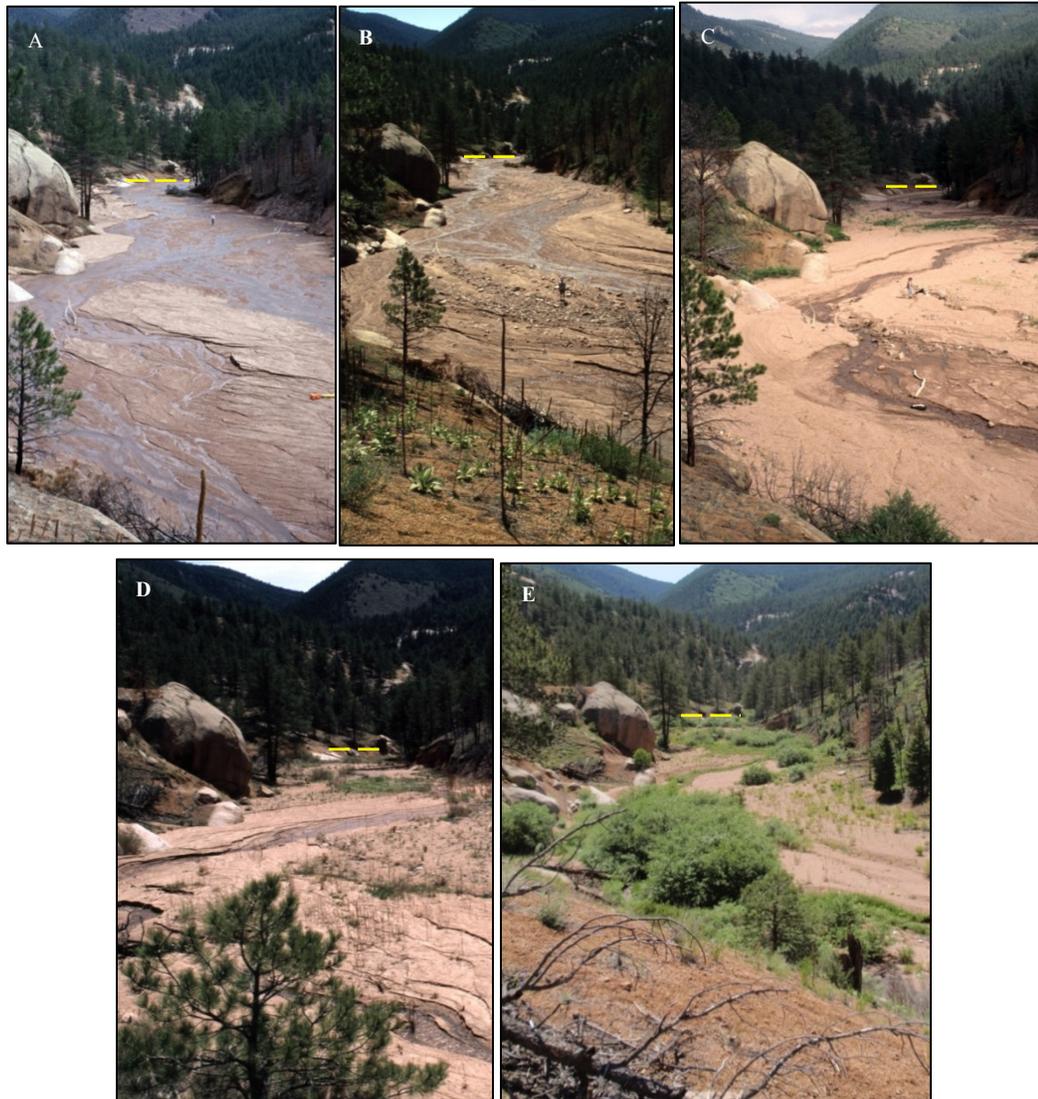
Figure 15. Repeated views of the Spring Creek channel that include the location of cross section 341 (XS0341), 1998–2009. All views are looking downstream. The yellow dashed line in each photograph indicates the approximate location of XS0341. A, May 3, 1998. Yellow-and-orange tripod and level are near XS0555. B, Barkett (about 1.8 meters [m] tall) is standing near XS0470. B, Photograph was taken on July 11, 1998, after the flood on July 9, 1998 (48–58 cubic meters per second). D, Kinner (about 1.8 m tall) is standing at XS0555 on cobble-and-boulder bar left by the flood. C, May 30, 2000. D, Martin (1.7 m tall) is standing near XS0520. D, May 18, 2005. E, June 2009.

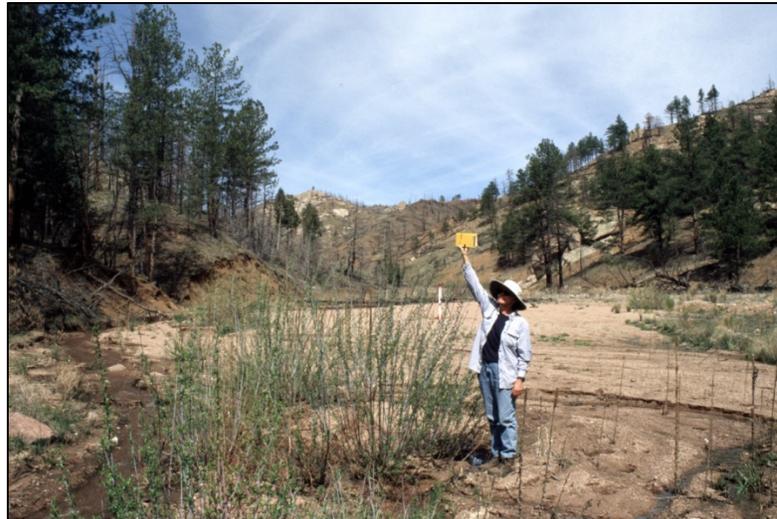
Figure 17. Photograph showing willows approximately 1.5 meters (m) tall at the location of cross section 341 (XS0341), 2005. Photograph was taken on May 18, 2005, looking upstream, and the willows are about 3 m downstream from station 34 on XS0341. D. Martin is 1.7 m tall from head to toe.

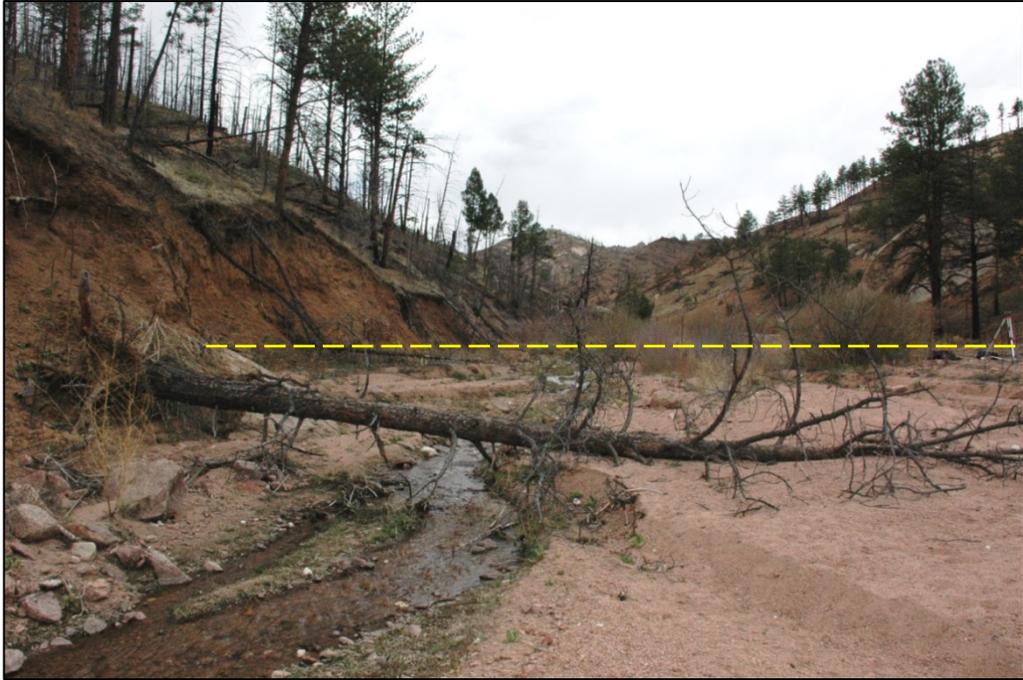
Figure 20. Photograph showing the reach of Spring Creek where cross section 393 (XS0393) was measured, 2008. Photograph was taken on May 5, 2008, looking upstream. The yellow dashed line indicates the approximate location of XS0393. Tripod in the center right of the photograph is about 1.4 meters tall.

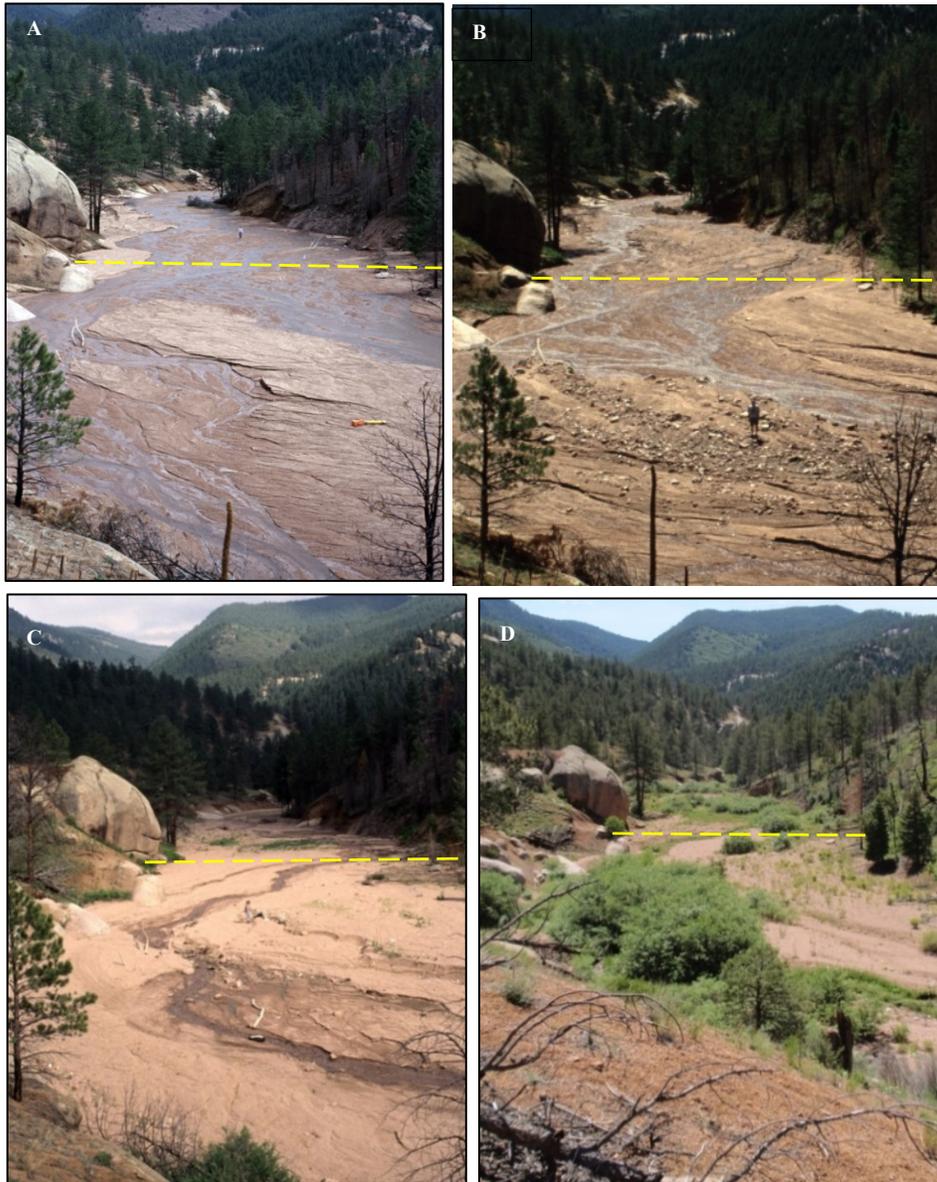
Figure 21. Repeated views of the Spring Creek channel that include the location of cross section 483 (XS0483), 1998–2009. All views are looking downstream. The yellow dashed line in each photograph indicates the approximate location of XS0483. A, May 3, 1998. Yellow-and-orange tripod and level are near XS0555. B, Barkett (about 1.8 meters [m] tall) is standing near XS0470. B, Photograph was taken on July 11, 1998, after the flood on July 9, 1998 (48–58 cubic meters per second). D, Kinner (about 1.8 m tall)

when multiple threads of shallow water (fig. 21A–C) deposited bedload as levees. These levees caused flow paths to alter directions leaving the deposits to accumulate. This chronostratigraphic unit is small in area at the location of this cross section but much larger at other cross-section locations (for example, downstream at XS0100, and upstream at XS0567 through XS1200). This deposit and an earlier deposit left by a major flood on July 29, 1999, ($6.4 \text{ m}^3/\text{s}$) (blue polygon in figure 22) are only preserved within the flood plain sediments and not in the terraces on the left and right banks or in the alluvial fan deposits from the tributary. The channel thalweg in 2014 was only about 0.1 m lower than the elevation of the thalweg after the extreme flood in 1996 (1,892.4 m) (fig. 22).

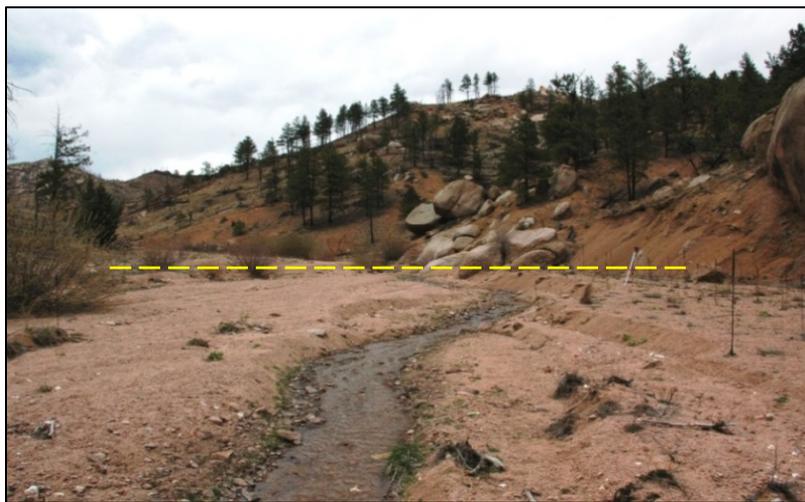
Figure 23. Photograph showing the reach of Spring Creek where cross section 483 (XS0483) was measured, 2008. Photograph was taken on May 5, 2008, looking upstream. The yellow dashed line indicates the approximate line of section. The right end of the yellow dashed line is on a 1-meter-diameter boulder. The edge of the large bedrock outcrop seen in figure 21 is on the right edge of the photograph. The tripod is on the left-bank terrace. No willows are growing along the channel margin in this photograph, but by 2009 (fig. 21D) willows had colonized both edges of the water and were about 1.5 meters tall.

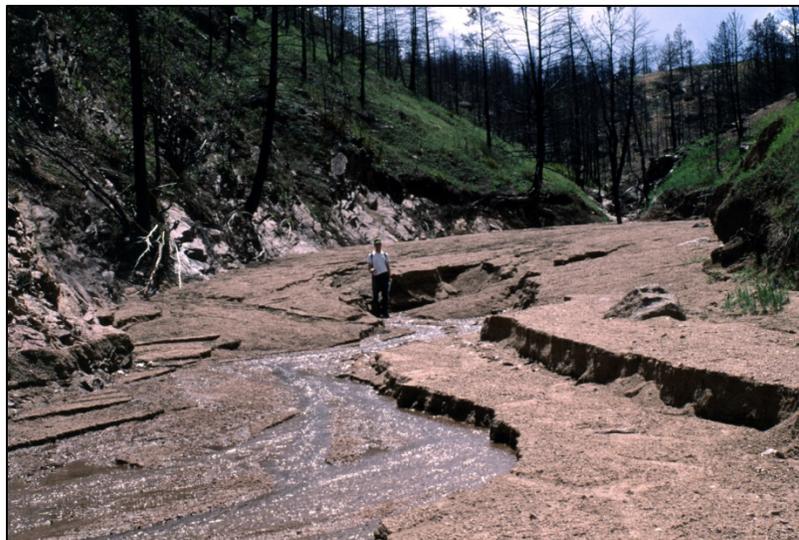
Figure 26. Photograph of the downstream end of an in-channel fan, May 1997. Photograph was taken in May 1997 looking upstream. Surface flow from upstream completely disappears into the fan and reappears downstream at approximately the location where D. Wolf (about 1.8 meters tall) is standing.

This section was observed to aggrade by two depositional processes. In the first process, surface water coming from upstream and transporting bedload flowed out onto the sediment deposit, percolated into the sediment, and left behind stranded bedload particles. This process slowly formed an “in-channel” fan (Moody, 2001) with no water on its surface but with surface water reappearing downstream at the base of the fan (fig. 26).

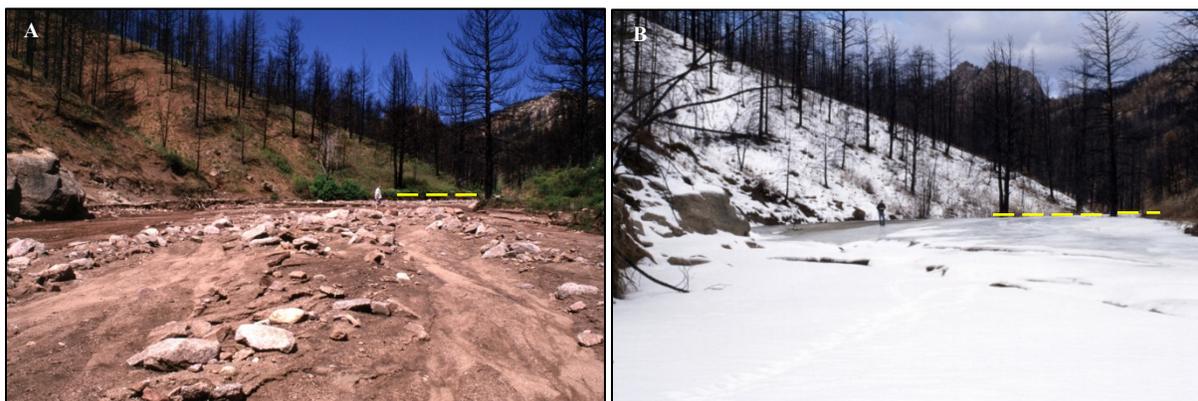
Figure 27. Summer and winter photographs of the in-channel fan at the location of cross section 679 (XS0679), 1998–1999. Views are looking upstream at the downstream face of the fan. The yellow dashed line in each photograph indicates the approximate location of XS0679. *A*, July 11, 1998. D. Kinner (about 1.8 meters [m] tall) is standing near XS0640. The cobbles and boulders were left by the flood on July 9, 1998 (48–58 cubic meters per second). *B*, January 12, 1999. Person (about 1.9 m tall) is standing near XS0660. Note that the elevation of the frozen surface of the in-channel fan is higher than in figure 27A; it has risen to the base of the twin trees on the right bank.

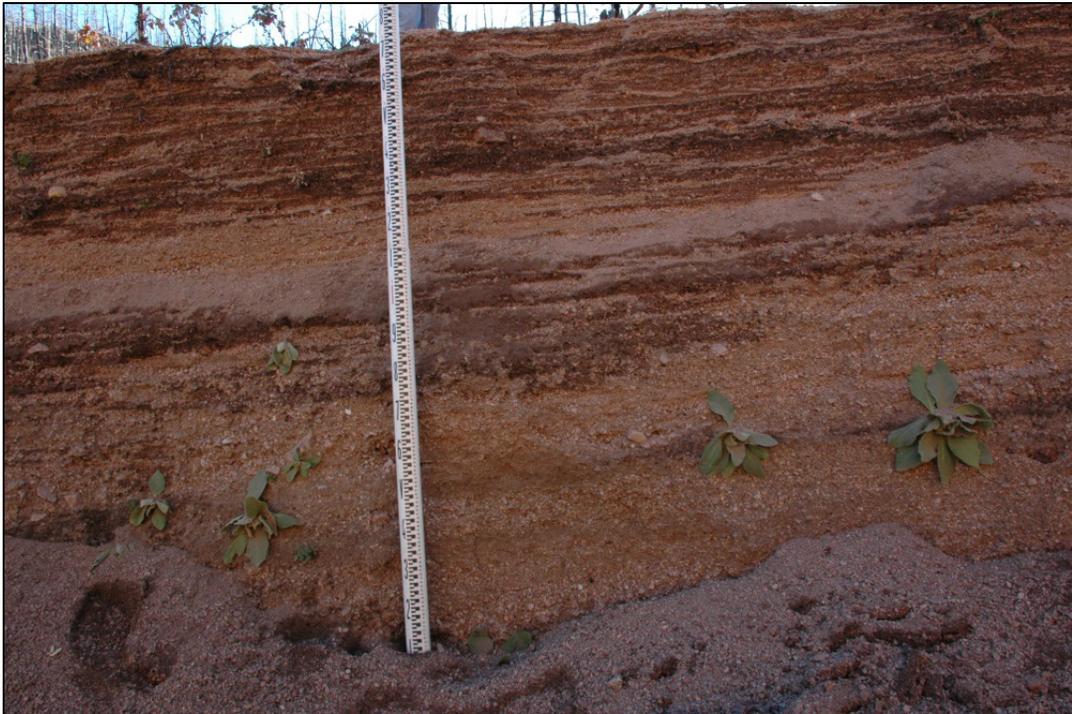
Figure 30. Close-up view of the lithology of the right bank at the location of cross section 679 (XS0679), 2007. Photograph was taken on October 25, 2007. Sediment is mostly sand and gravel (2–4-millimeter diameter) deposited by multiple floods. Layers are evident but extend continuously only for short distances, on the order of 2–4 meters (m). Larger numerals on left side of rod are 0.1 m apart. The height of the prominent black bars along the face of the rod is 1 centimeter.

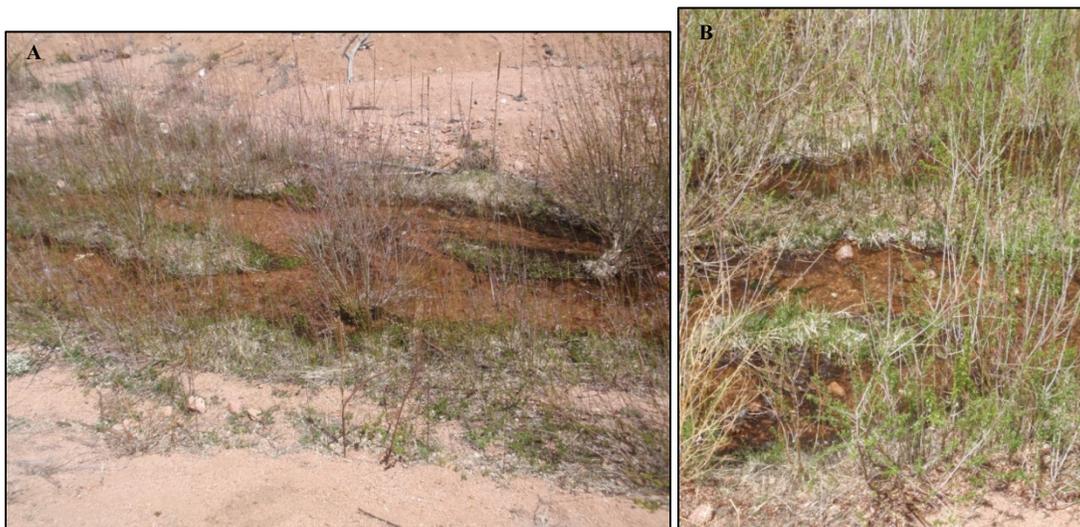
Figure 31. Photographs of an anabranching channel at the location of cross section 679 (XS0679), 2010–2011. *A*, May 8, 2010. *B*, May 7, 2011.

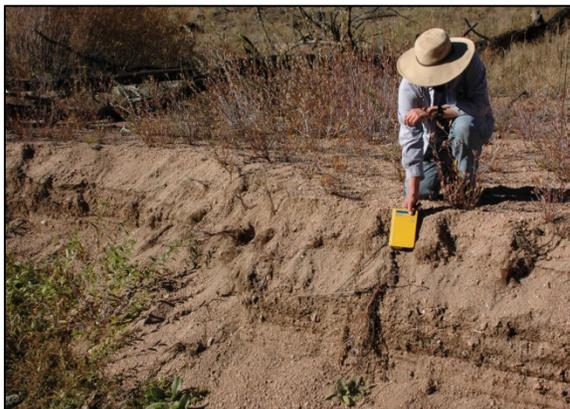
Figure 35. Photograph of left bank of cross section 755 (XS0755), 2007. Photograph is looking upstream and was taken on October 25, 2007. Recent erosion of young willows has left nearly vertical banks with apparent layers of sediment, but generally these layers are not continuous over tens of meters. The yellow level book is 19 centimeters tall.

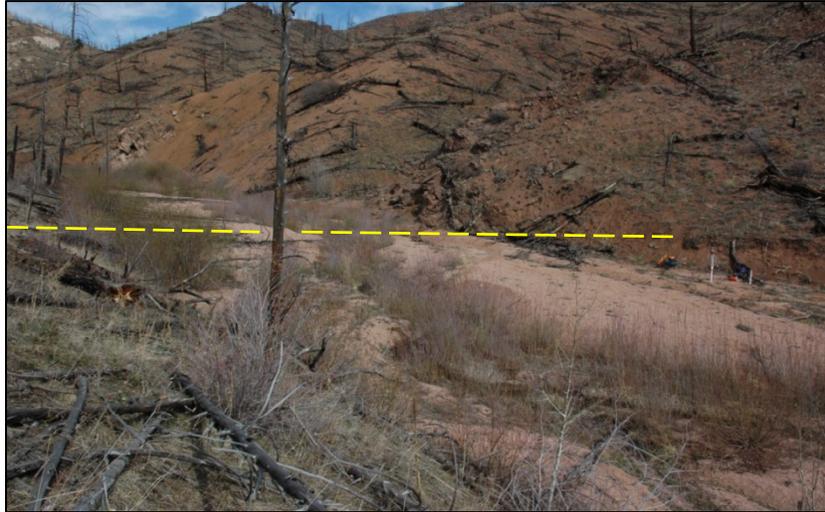
Figure 37. Photograph of the Spring Creek channel that includes cross section 0815 (XS0815), 2008. Photograph was taken on May 5, 2008, looking upstream. The yellow dashed line indicates the approximate location of XS0815. Two terraces can be seen along the left bank. One is a fill terrace created around October 2000 (the tripod [about 1.5 meters tall] is on this terrace). The other is a cut terrace formed around 2003 and is composed mostly of sand and gravel with little vegetation.

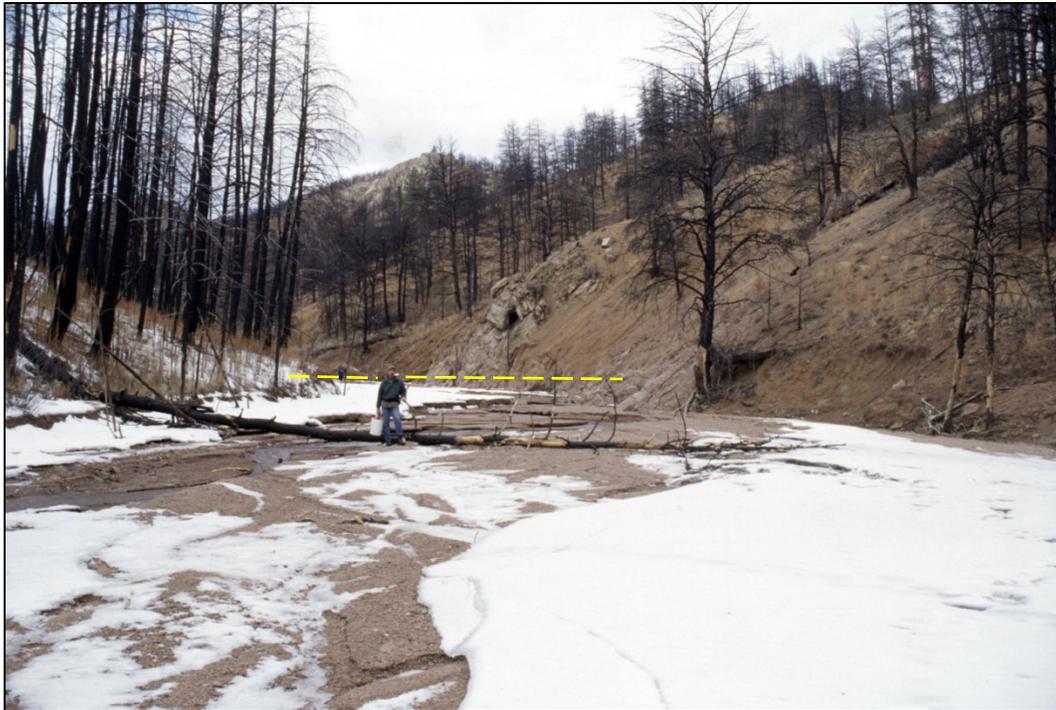
Figure 41. Photograph of the Spring Creek channel that includes the location of cross section 905 (XS0905), 1999. Photograph was taken on January 12, 1999. The yellow dashed line in the photograph indicates the approximate location of XS0905. B. Lange (about 1.8 meters tall) is standing near XS0865.

The large sediment deposit (yellow checkered polygon in figure 40) consists of braided-stream deposits from a major flood on August 4, 1999, and a series of eight minor floods from August 9 through September 10, 1999, when Spring Creek was still mostly a braided stream (fig. 39A). Braided-stream deposits were observed to form when multiple threads of shallow water deposited bedload as levees. These levees caused flow paths to alter directions, leaving the deposits to accumulate. Similar large sediment deposits were found at XS0567, XS0755, XS0815, and XS1200, but they are much smaller or nonexistent at other cross sections. The left bank terrace is capped by chronostratigraphic units deposited in winter (1999–2000 [grey densely stippled polygon] and 2000–2001 [vertically and horizontally striped polygon]). During winter, sediment filling the braided channel was frozen and, thus, cohesive (fig. 41). Sometimes flow during the winter exceeded the capacity of small (0.2–1.0 m wide), shallow channels, and sediment-bearing water spread out from the small channels, deposited sediment on the surface, and refroze (see also figs. 13, 45).

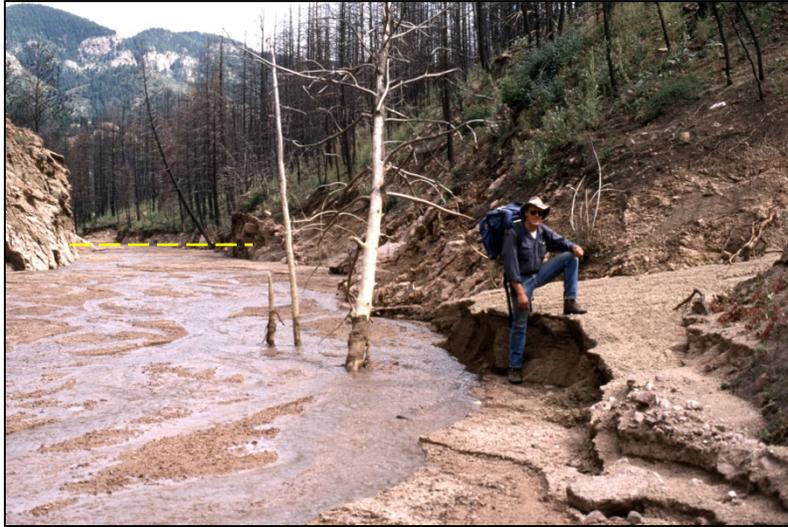
Figure 44. Photograph of the Spring Creek channel that includes the location of cross section 1100 (XS1100), 1997. Photograph was taken on September 15, 1997, looking downstream. The yellow dashed line indicates the approximate location of XS1100. J. Moody (1.9 meters tall) is standing on the truncated alluvial fan from tributary 1165. This photograph was taken by R. Meade when the deposition at XS1100 was at a maximum (green profile labeled 5–Oct–97 in figure 43).

Spring Creek at XS1100 alternated between a braided stream (fig. 44) and a single-thread stream (fig. 45). Major floods often filled the narrow channel with sediment, causing Spring Creek to take on a braided form. Steadier flow after the floods slowly eroded a channel. The chronostratigraphic unit shown as a yellow checkered polygon in figure 43 is a remnant of a braided-stream deposit from a major flood on August 4, 1999, and a series of eight minor floods from August 9 through September 10, 1999. Braided-stream deposits were observed to form when multiple threads of shallow water deposited bedload as levees. These levees caused flow paths to alter directions, leaving the deposits to accumulate (fig. 44). This unit was originally about 0.5 m thick, extended across the entire channel, and the top surface was the survey line dated 9–Nov–99 (long-dashed line in figure 43). As of 2014, the unit was only preserved along the right bank. Similar large units are found at XS0567, XS0755, XS0815, XS0905, and XS1200.

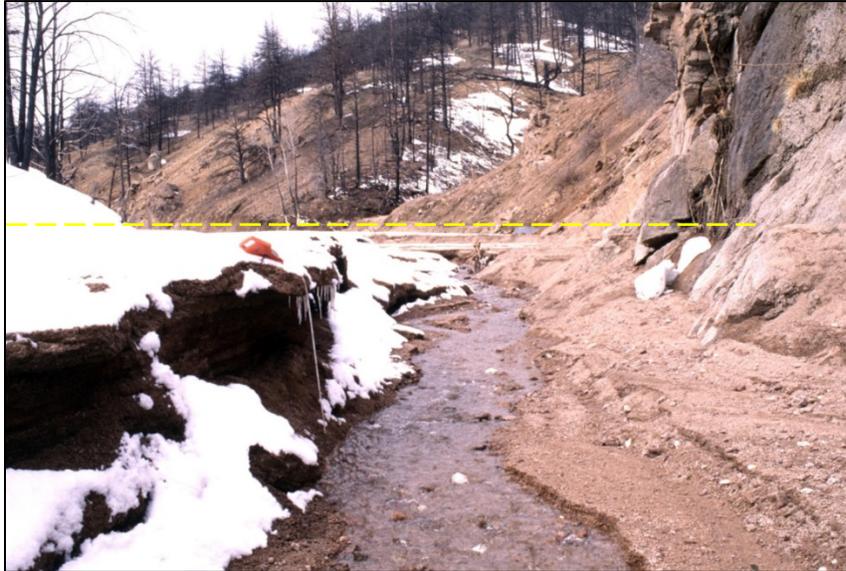
Figure 45. Photograph of the Spring Creek channel that includes the location of cross section 1100 (XS1100), 1998. Photograph was taken on February 18, 1998, looking upstream. The yellow dashed line in the photograph indicates the approximate location of XS1100. An equatorially (south) facing hillslope is on the right side of the photograph. The sediment in the channel on the left side of the photograph is frozen (and cohesive) and therefore leaves a vertical bank when eroded by water. The maximum elevation was during October 1997 and the top of the sediment can be seen on the bedrock outcrop at the right edge of the photograph.

Winter sediment deposits are notably absent at XS1100, as at XS1006 downstream. These frequently formed at other cross-section locations during the winter when the sediment filling the braided channel was frozen and, thus, cohesive (fig. 45). Sometimes, flow during the winter exceeded the capacity of small (0.2–1.0 m wide), shallow channels, and sediment-bearing water spread out from the small channels, deposited sediment on the surface, and refroze (figs. 13, 41, 45). Sediment thicknesses were about 0.2–0.5 m. At the location of this cross section, the runoff during the winter incised a channel (fig. 45) sufficient in size to convey any winter discharge, and thus overbank deposition was not common.

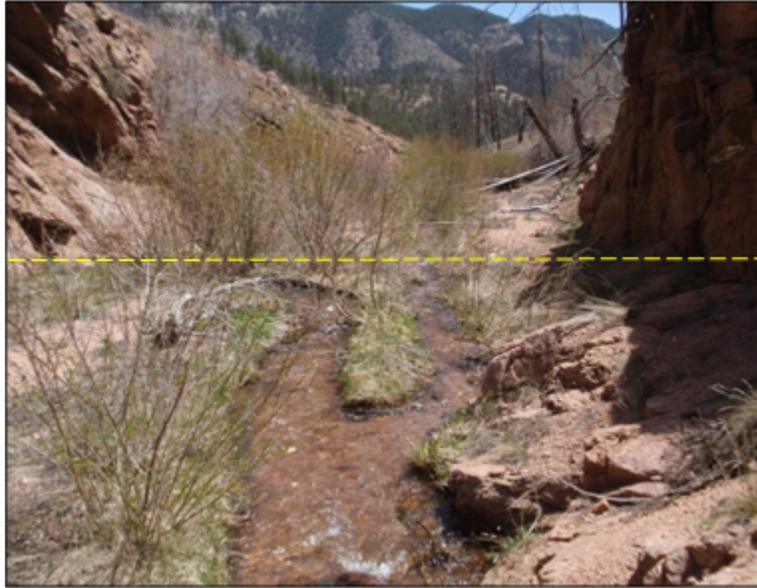
Figure 46. Photograph of the Spring Creek channel that includes the location of cross section 1100 (XS1100), 2010. View is looking downstream and the water surface is about 1 m wide. The yellow dashed line indicates the approximate location of XS1100. The effects of vegetation trapping and armoring have produced an anabranching channel as the willows re-colonized the reach.

As willows recolonized the channel, the stream formed anabranching channels (fig. 46). Similar channels in Australia were described by Nanson and Huang (1999) but were dominated by a eucalyptus species rather than the willows seen here. Anabranching channels are also found at other cross-section locations at the upper end of the study reach (upstream from XS0567, for example at XS0679), and, less commonly, at the lower end of the study reach (from XS0567 downstream to the mouth).

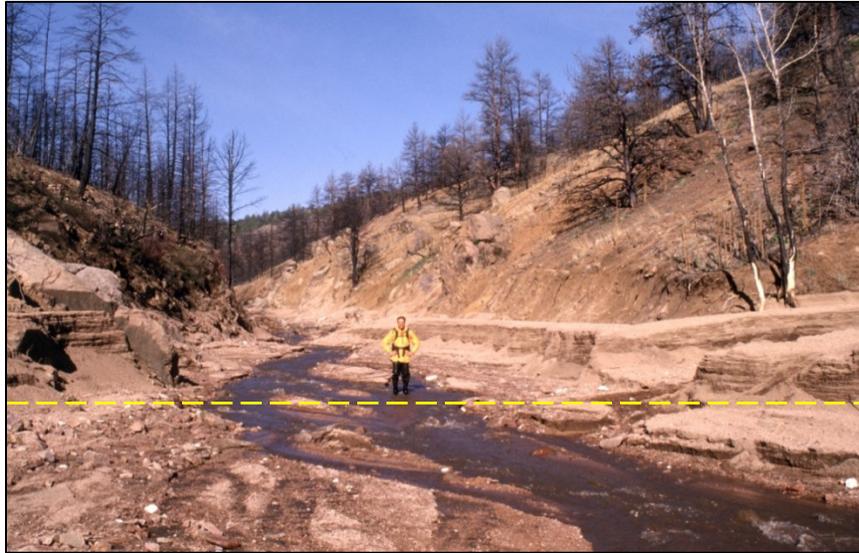
Figure 47. Photograph of the Spring Creek channel that includes the location of cross section 1200 (XS1200), 1998. Photograph was taken on May 3, 1998, looking upstream. The yellow dashed line indicates the approximate location of XS1200. B. Barkett (about 1.7 meters tall) is standing near cross section 1230 where a left-bank tributary joins Spring Creek. The upstream end of the narrow terrace on the right bank of XS1200 can be seen abutting the bedrock outcrop at the left center of the photograph.

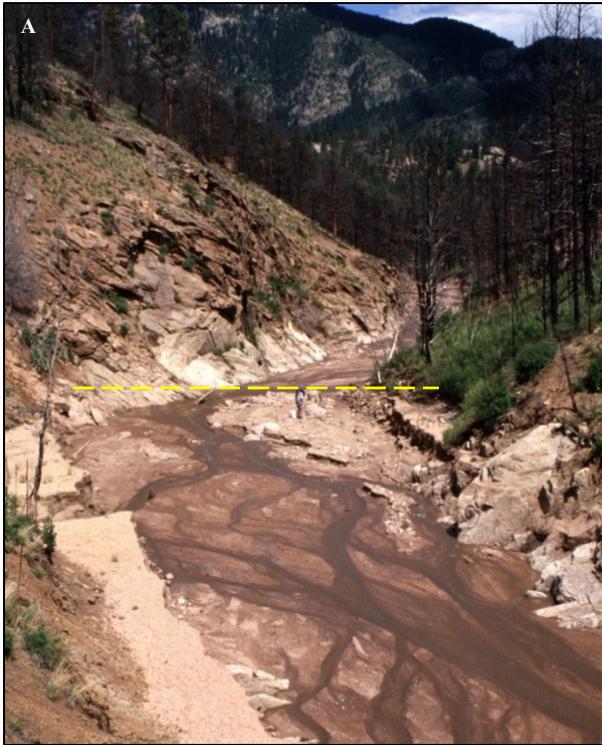
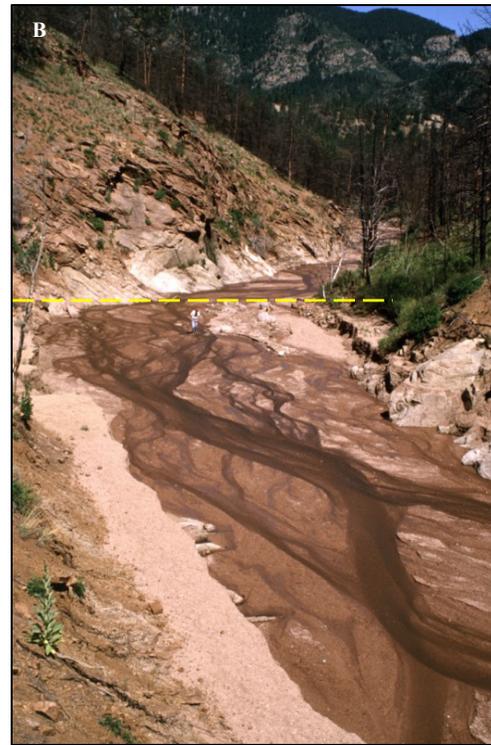
Figure 48. Repeated views of the Spring Creek channel that include the location of cross section 1200 (XS1200), 1998–2005. All views are looking downstream. The black or yellow dashed line in each photograph indicates the approximate location of XS1200. *A*, July 11, 1998. D. Kinner (about 1.7 meters [m] tall) is standing on the line of section for XS1200. The mouth of a substantial left-bank tributary is the gap in the light-colored sediment deposits along the left bank of Spring Creek (marked by a dead tree on the left side of the photograph). Photograph was taken 2 days after the major flood on July 9, 1998 (48–58 cubic meters per second). *B*, July 17, 1998. J. Blossom (about 1.9 m tall) is standing on the line of section for XS1200. *C*, May 18, 2005.

Revegetation of the location of cross section 1200 has not been as dramatic as that in the deposition reach between XS567 and XS1100. The braided character (fig. 48*A, B*) has evolved into a single-thread channel with primarily grass along the channel margins (fig. 48*C*). The thalweg elevation of this single-thread channel in June 2014 (1,919.5 m) was 0.2 m higher than the thalweg in 1997 after the extreme flood on July 12, 1996 (about 510 m³/s) (fig. 49).

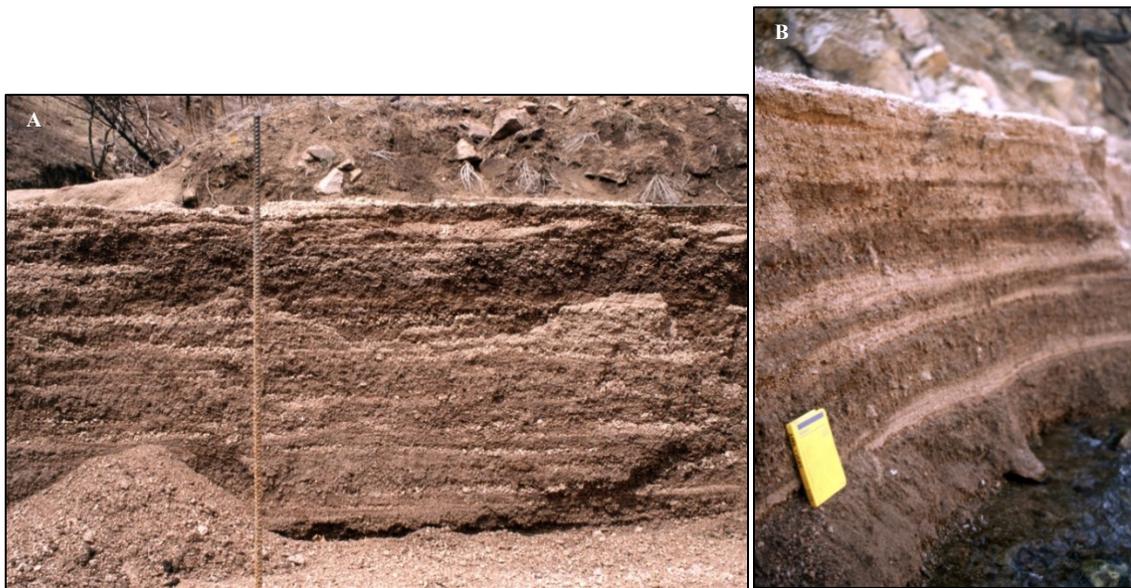
Figure 50. Photographs of the right-bank flood deposits near the location of cross section 1200 (XS1200), 1998. *A*, April 15, 1998. The layers appear continuous in this photograph over several meters but often are not continuous over distances of tens of meters. These sediment deposits were exposed after the major flood on August 31, 1997 (140–180 cubic meters per second [m³/s]). *B*, October 21, 1998. View is looking upstream at flood deposits (in the right bank at XS1230) exposed by the major flood on July 31, 1998 (about 82 m³/s). Yellow, level book is 19 centimeters (cm) tall and 12 cm wide.

The 1-m-diameter boulder (fig. 49) was on the line of section on May 2, 1998, and was transported and deposited by the extreme flood on August 31, 1997 (140–180 m³/s). It was not present during the survey on August 7, 1997, previous to the flood. It was gone after the flood on July 9, 1998. Although relatively large, a 1-m-diameter boulder can be easily transported by rolling when the bed is relatively smooth (composed of mostly 2–4-mm-diameter gravel, fig. 50) (Wiberg and Smith, 1987). A similar transport of a boulder probably happened at XS-2.7, emplacing the large boulder noted near station -3 in figure 6. Incision at XS1200 revealed apparent stratigraphic layers (fig. 50), but these layers were only continuous for short distances of about 1–5 m.

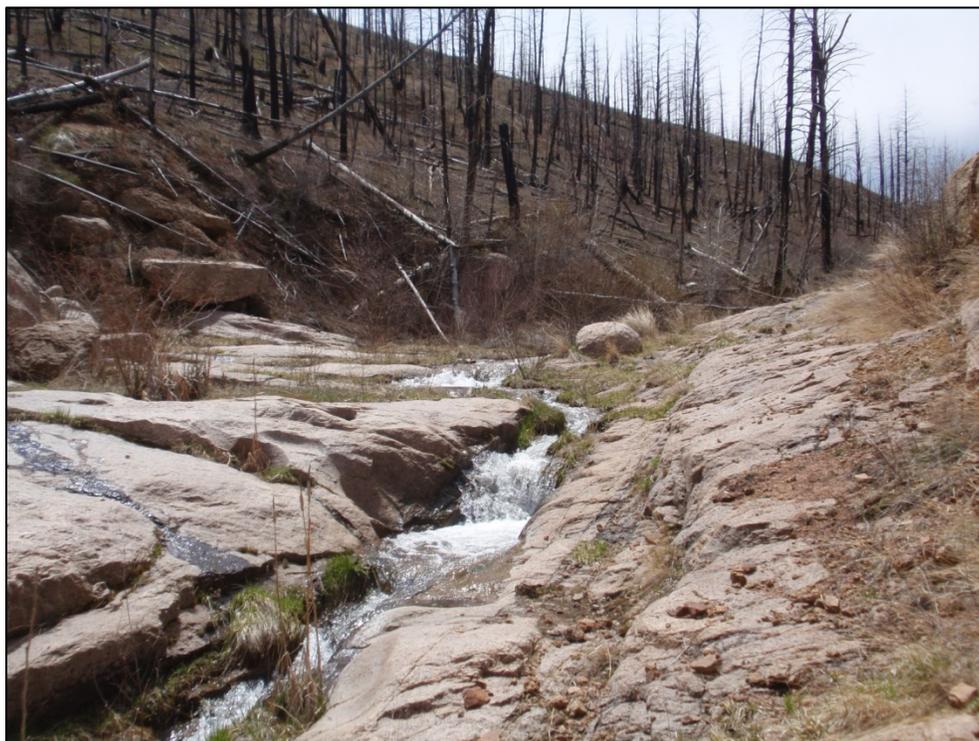
Figure 52. Photograph of incised bedrock about 10 meters upstream from the location of cross section 1340 (XS1340), 2010. This photograph taken on May 8, 2010, shows the characteristics of a relatively narrow, bedrock-dominated reach of Spring Creek between about XS1240 and XS1450, which is near the streamgage. A small colony of cattails is located at left-center of the photograph.

Cross section 1340 was measured in a narrow, bedrock-dominated reach of Spring Creek extending from 1,240 m to 1,470 m upstream from the confluence of Spring Creek with the South Platte River. Little sediment was preserved within this bedrock reach from June 1997 through June 2014 (fig. 52). Initially, sediment was deposited by the extreme flood on July 12, 1996, (about $510 \text{ m}^3/\text{s}$) along the right bank, and by June 2014 there had been a net erosion of about 2.5 m^2 of cross-sectional area (fig. 5).

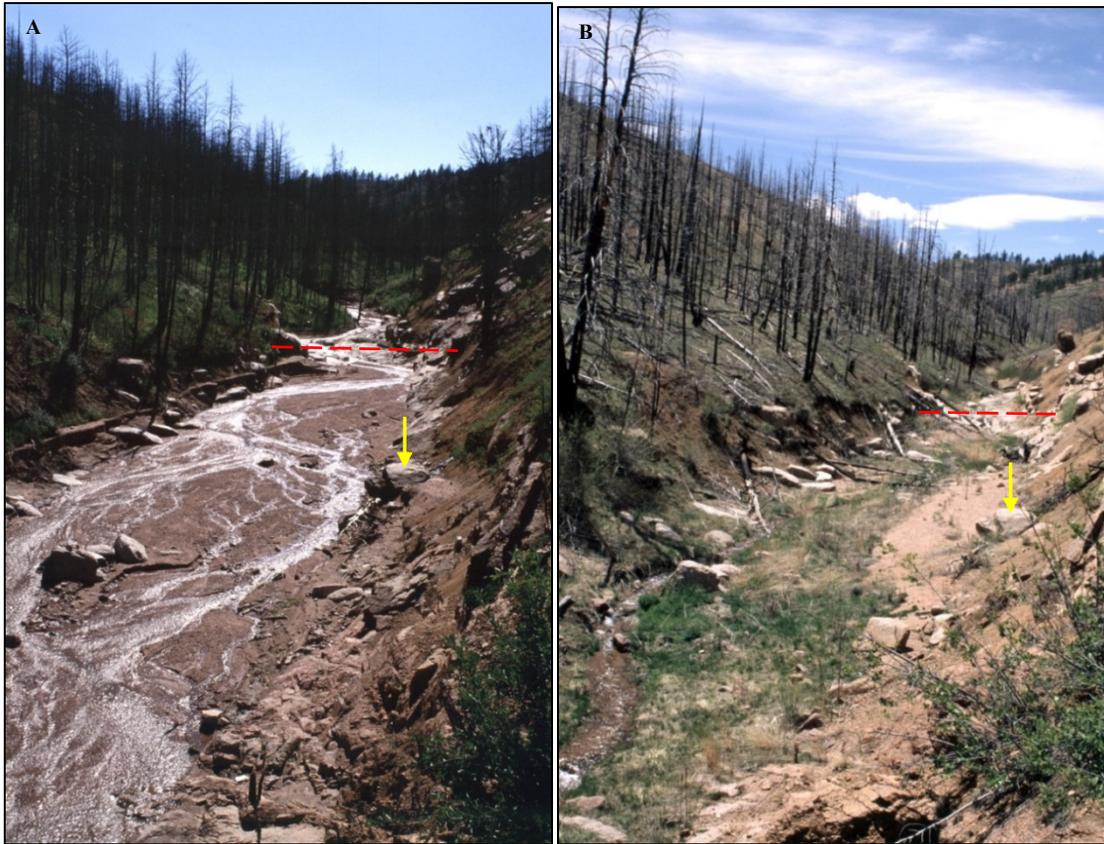
Figure 54. Repeated views of the Spring Creek channel that include the location of cross section 1340 (XS1340), 1998–2005. Both views are looking upstream. The red dashed line indicates the approximate location of XS1340. The yellow arrow points to the same boulder in both photographs. *A*, July 17, 1998. Channel contains a braided stream. *B*, May 18, 2005. Channel contains a single-thread stream.

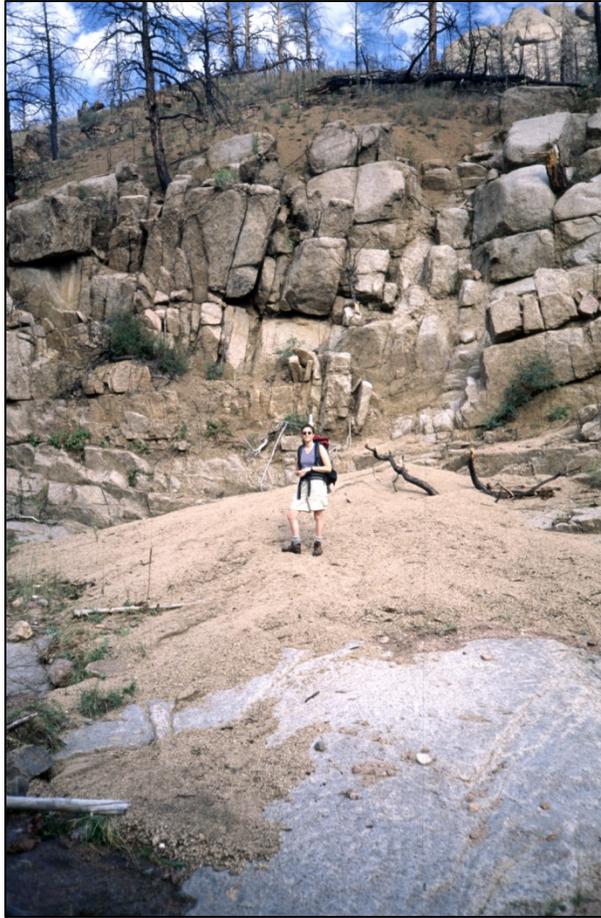
Figure 55. Hillslope fan between the locations of cross section 1340 (XS1340) and XS1450, 2001. The sediment in the fan was deposited in the bedrock channel by dry ravel during the summer, by the freeze-thaw process during the winter, and some hillslope runoff after a rain storm on August 13, 2001. L. Pine is about 1.8 meters (m) tall. This site is about 20 m upstream from XS1340 where similar hillslope processes were observed.

In this narrow reach, the hillslopes adjacent to the channel are steep and some sediment deposits at XS1340 were derived from the hillslope by the processes of dry ravel (Anderson and others, 1959; Gabet, 2003; Roering and Gerber, 2005), freeze-thaw during winter, and some overland flow (fig. 55). This type of chronostratigraphic unit made up a substantial accumulation at XS1340 after about 2000 (black irregularly stippled polygon in figure 53). The freeze-thaw component was observed in the winter when the equatorially (south) facing hillslope thawed in the morning light and sand and gravel was released to roll downslope. The overland flow component was in response to rainfall that caused a minor flood on August 31, 2001 ($0.24 \text{ m}^3/\text{s}$).
